Bridge Failures in Alberta

Technical Standards Branch
Class A Bridge Inspection Course

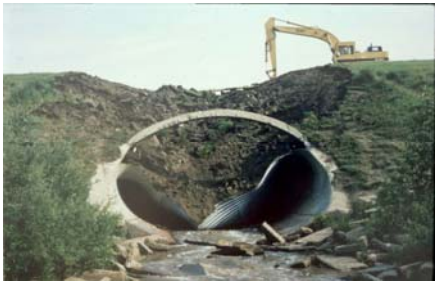
- SPCSP HE 5.5 x9m
- Installed in 1973
- Total collapse of structure in 1988
- No inspection after installation

Total collapse of culvert. Only headwall intact

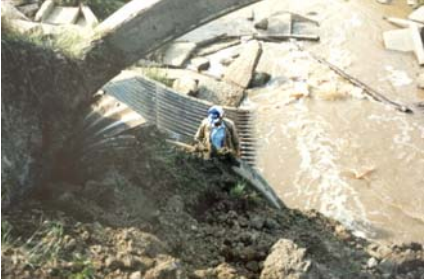
Outlet of culvert

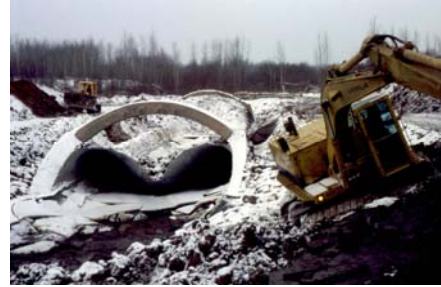
- SPCSP HE 4.8 x 7.3
- Installed in fall of 1987
- Extensive deformation in 1988
- Total collapse in 1989 while fill being removed for repair of culvert

Outlet showing intact end treatment

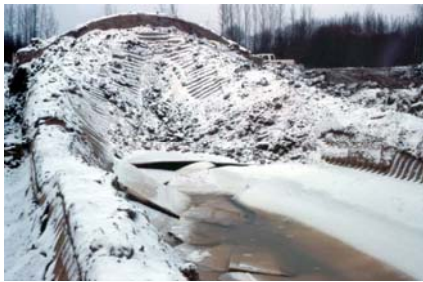
Inlet with culvert still connected to headwall

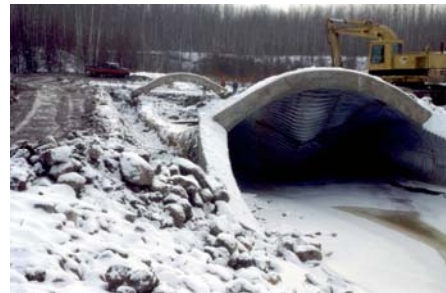
Overview of culvert inlet

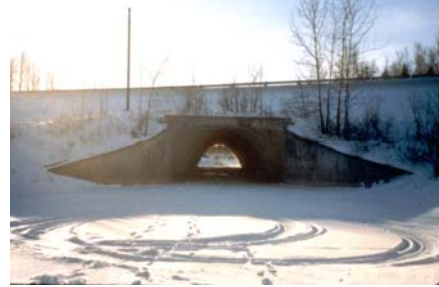
Concrete arch culvert in 1989

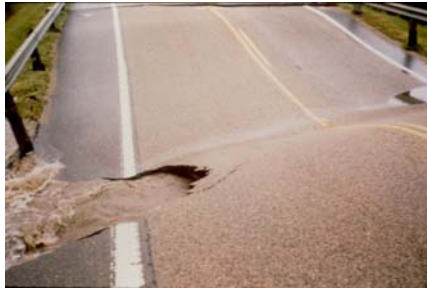
Water on U/S end up to shoulder of road

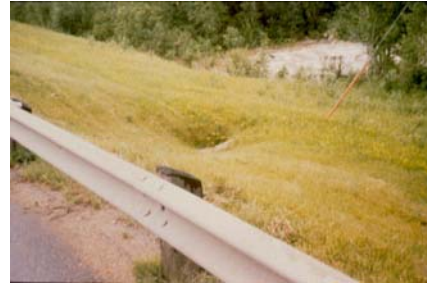
Hole in side slope on d/s side

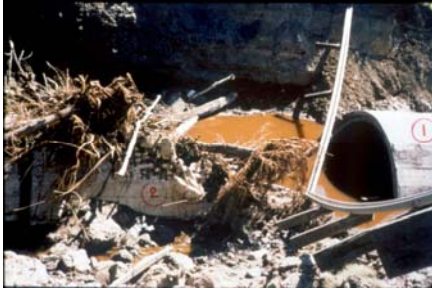
Centre section of culvert

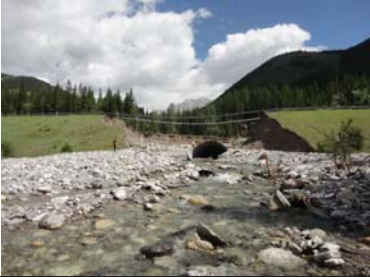
- 4.3M diameter Structural Plate Ellipse (SPE) culvert installed in 1983.
- 53M invert length.
- 9.1M road to streambed height.
- Washed out during 2013 flood event.

BF 77496 – Looking D/S at scale of washout (30m wide vs. 4.3M pipe).

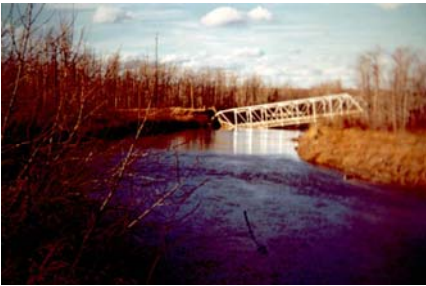
- 150' through truss built in 1927
- Bridge posted for 17 tons
- Bridge collapsed 1977
- Failure of rotten abutment corbel

Collapsed bridge

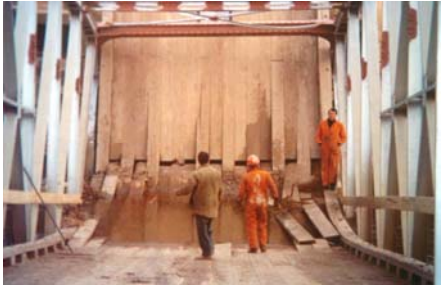
Abutment end of bridge showing timber deck etc.

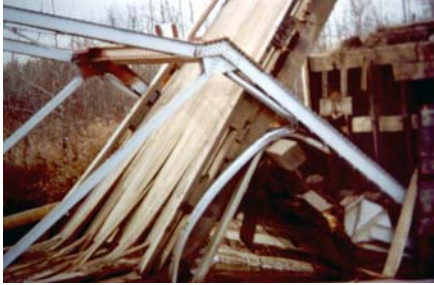
Abutment end of truss dropped and buckled the bottom chord

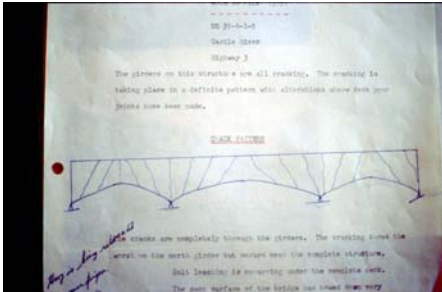
- built in 1951 designed by consultant in Toronto
- Concrete T girder poor condition in 1961
- replaced in 1981

Recorded crack pattern in 1964

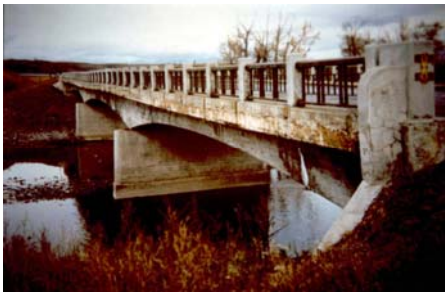
Bridge condition in 1979 (28 years old)

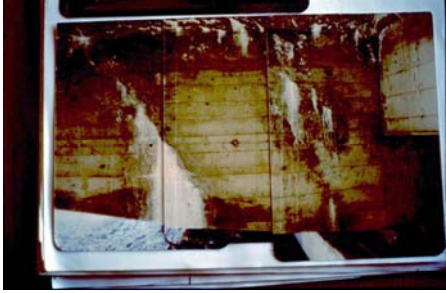
Shear crack in girder and efflorescence from cracks

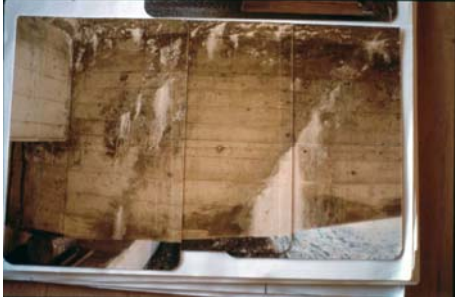
Shear crack at girder end

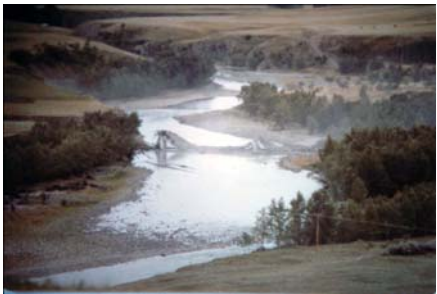
Bridge down

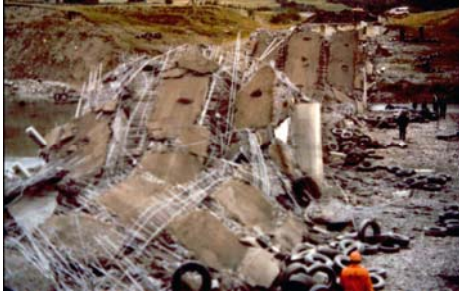
Bridge remains

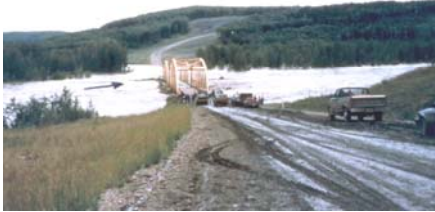
Forestry road with river in flood, 1987

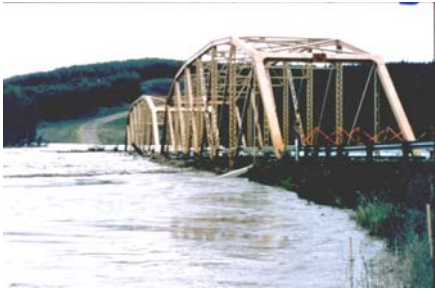
Truss partly under water

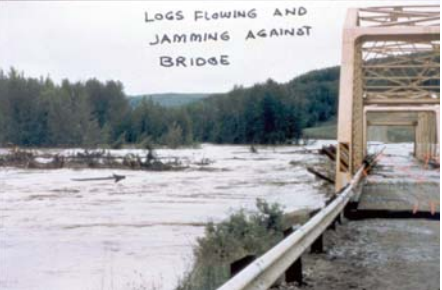
Drift jamming under bridge

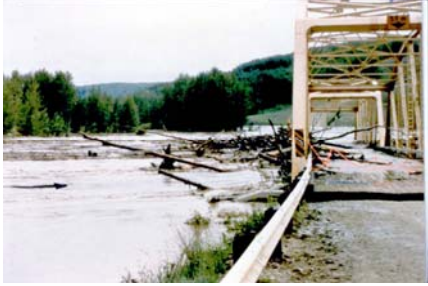
Bridge floating and starting to shift

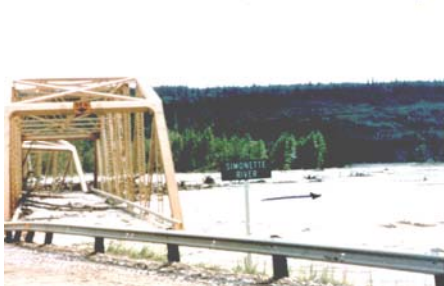
Bridge floating downstream

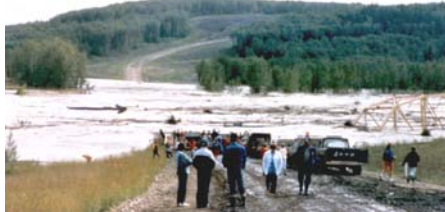
- Timber and Bailey built in 1960 deck to s/b 3m
- 1982, 2 through trusses 60.96m 9m deck to s/b
- Washed out in 1987 (Tornado Flood)
- Rebuilt in 1988

Bridge gone

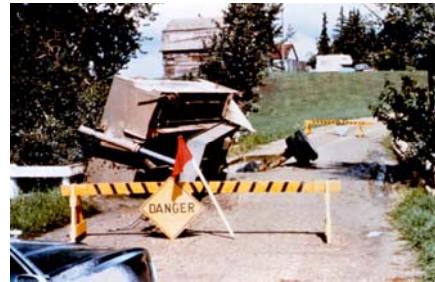
- 3-28' Precast Concrete
- Constructed in 1959
- North pier cap failure in August 1980

Local road with gravel truck pup remaining on bridge

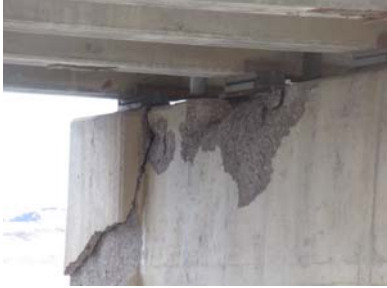
- 3 span Type PO girders on concrete substructure -built 1959.
- Span lengths of 20.7 – 29 – 29 M.
- Typ. Sliding Plate Bearing with Self-Lubricating Bronze Plates.
- Expansion Bearings at P1 and P3. Deck height is 18.5M.
- Routine Level 1 BIM inspection of December 2015 noted frozen bearings at the west end of P1 under Span 1 - G1 and G2.
- Significant portion of concrete pier cap under G1, G2 bearings had failed due to induced stresses into pier from frozen bearings resulting in G1 un-supported and near collapse.
- Lane above immediately closed and truck traffic detoured.
- Subsequent BIM Advisory bulletin #3 issued January 20, 2016.

BF 1153 – Failed concrete at west end of P1 from frozen bearings under G1, G2.

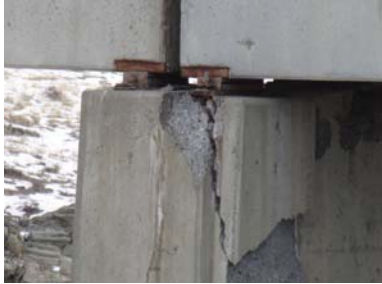
BF 1153 – Failed pier concrete and unsupported bearing under Sp. 1-G1.

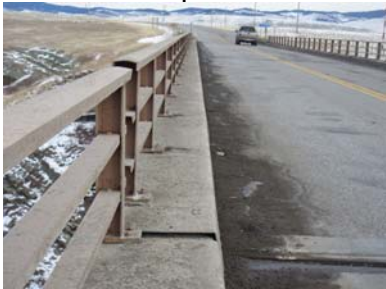
BF 1153 – 30mm drop in rail and curb over Sp.1-G1.
