GEOHAZARD ASSESSMENT PROGRAM
NORTH CENTRAL REGION – ATHABASCA
2012 INSPECTION

| Site Number | Location | Name | Hwy | km |
|---|---|--|---|---|
| NC 72 | 20 m east of south Mitsue access road | Graduation Rock Backslope Slump | 2:46 | 42.5 |

| | Date | PF | CF | Total |
|---|--|---|---|---|
| Current Inspection: | June 11, 2012 | 7 | 2 | 14 |

**NC72: HWY 2:46 GRADUATION ROCK
BACKSLOPE SLUMP (km 42.5)
SITE PLAN AND CROSS - SECTION A-A'**

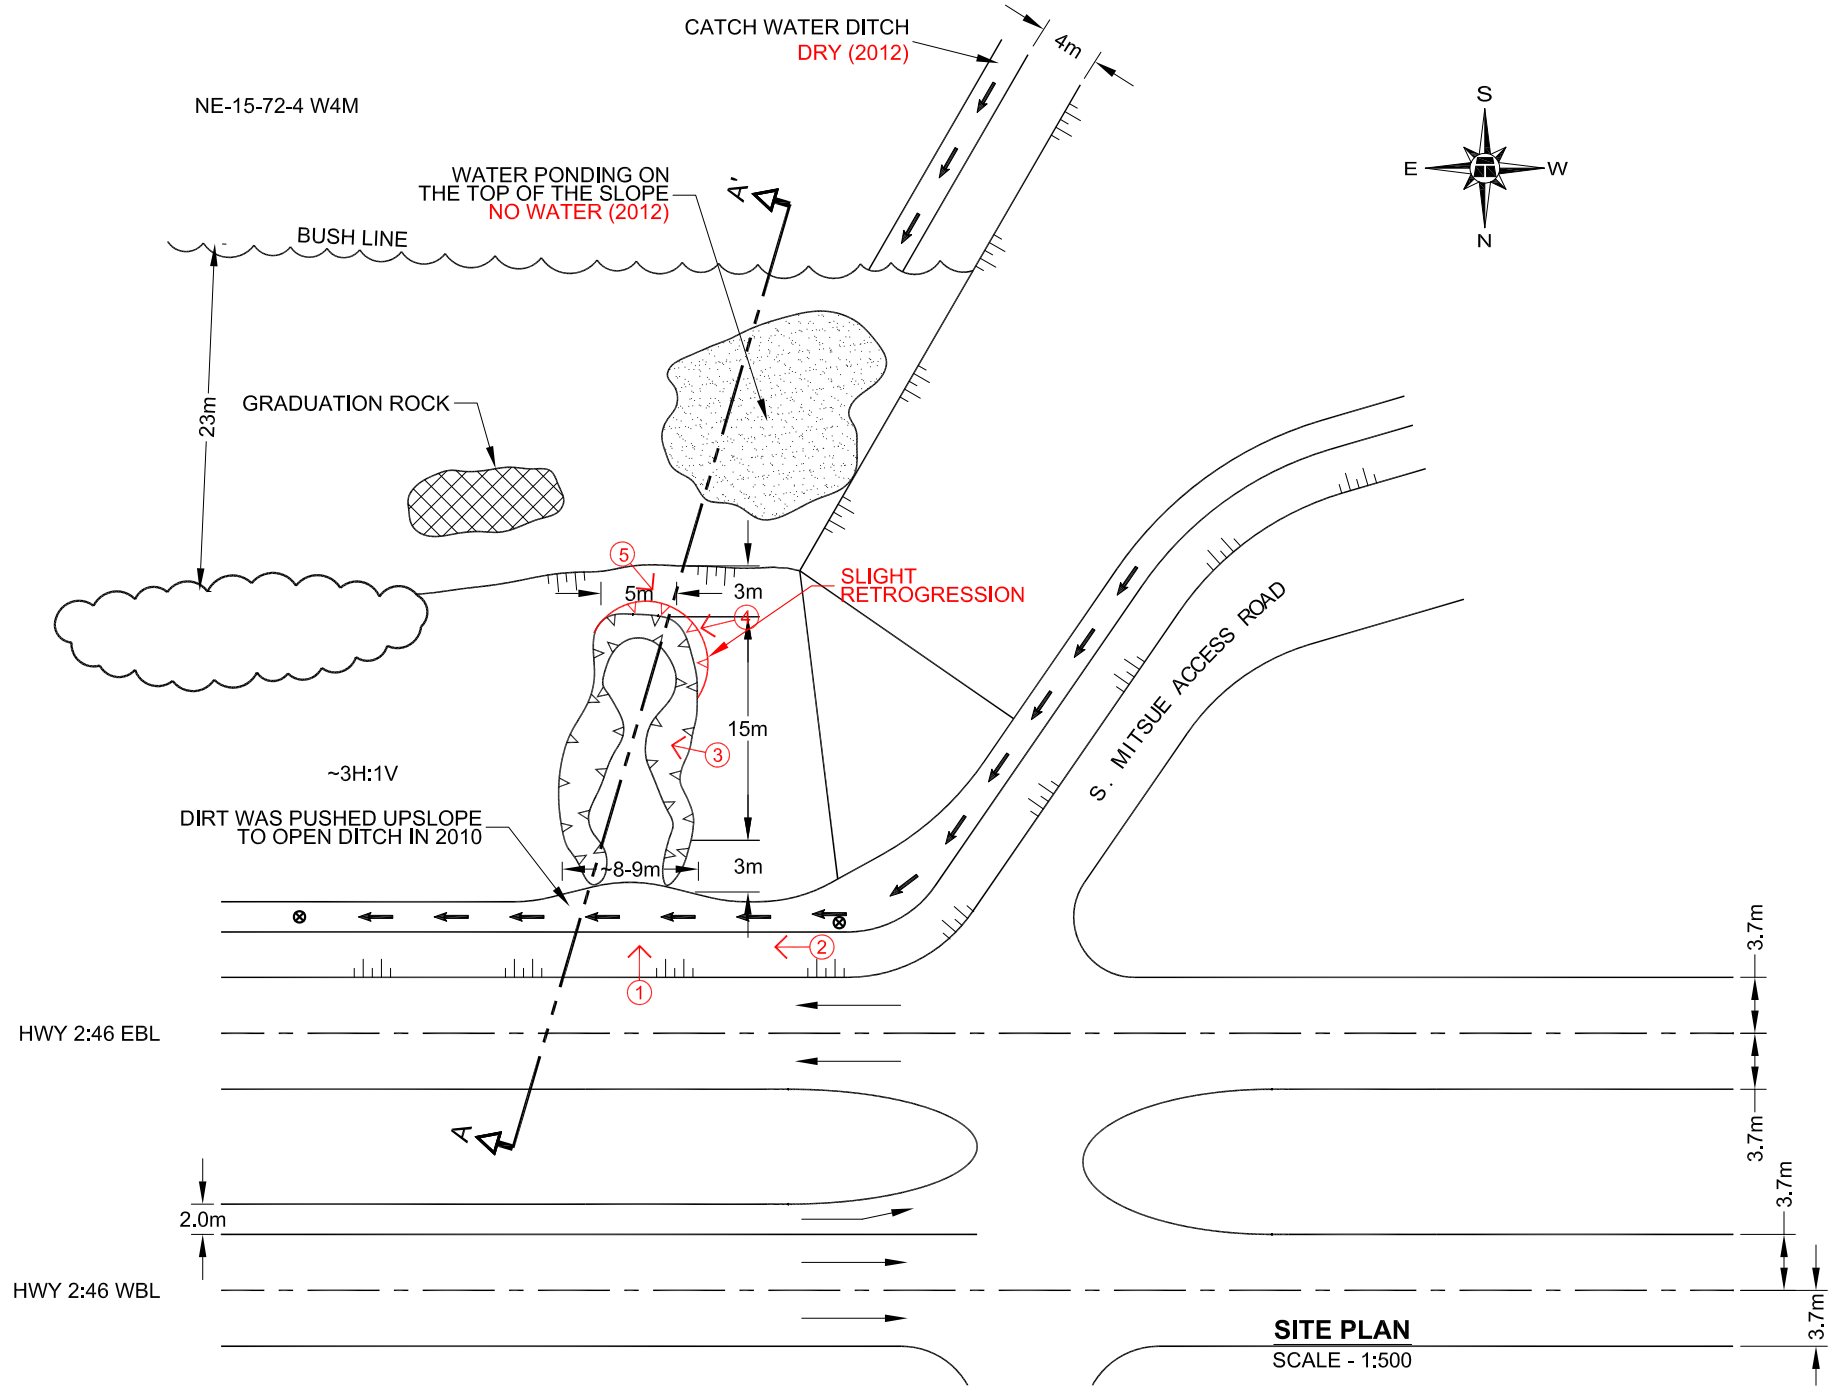
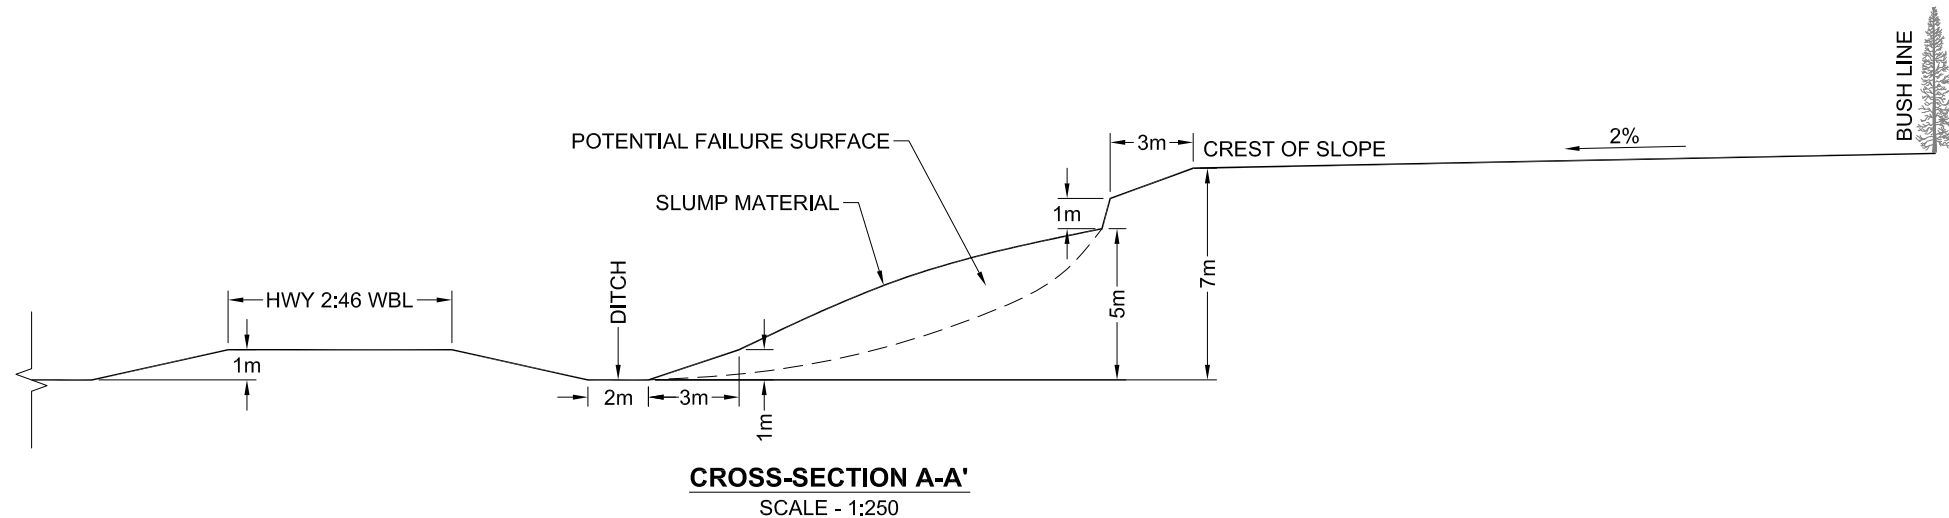
FIGURE NC72-1

It appears that the slump mass has moved a bit, as manifested from the slight retrogression of the headscarp cracks, however the site conditions did not change significantly from last year.

The vegetation growth should help increasing the overall stability of the slump mass. Erosion and transportation of sediments to the bottom of the slope may still occur, but at a slower rate than experienced in the past in the absence of vegetation cover.

In the short term, the local MCI should continue to monitor the site and clean the ditch, as required, to maintain its drainage characteristics. If the slump materials start to accumulate in the ditch and block natural drainage, ground water levels may rise in the vicinity of the highway embankment and result in instability of the highway side slopes.

The recommended long-term remedial measure consists of excavating and replacing the slump mass with compacted granular fill. This option will also require constructing a longitudinal sub-drain along the base of the excavated mass and a riprap lined swale extending from the bush line to the bottom of the slope to drain the surface water from the catch water ditch in a controlled manner into the highway ditch. Ditch armouring using riprap along the bottom of the slope will also be required. The pall bark cost of this option would be in the range of \$75,000.

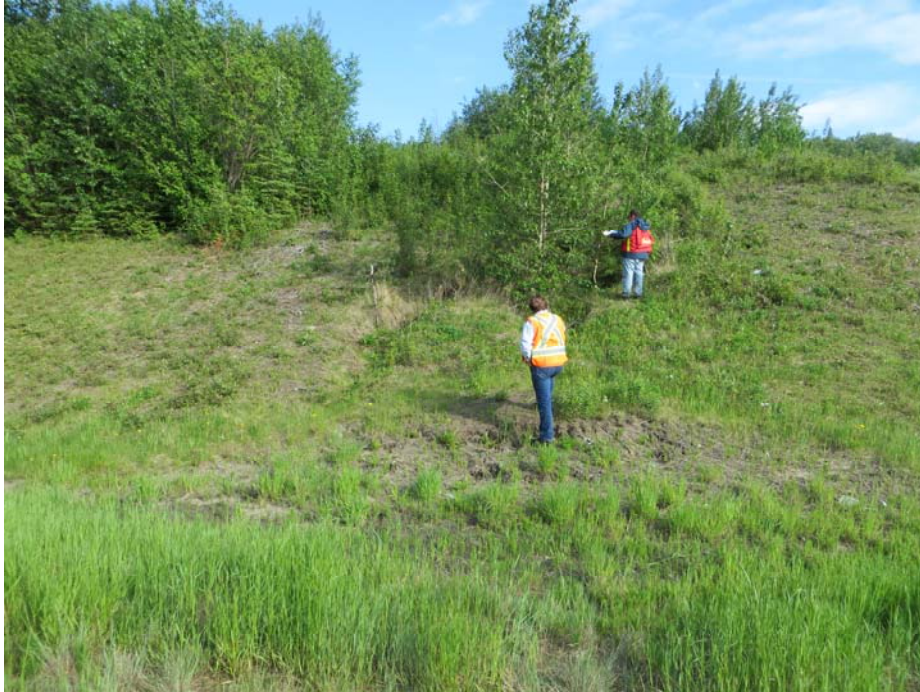
Photo# 1 General view of highway backslope slump; note that vegetation has grown within the slump mass (looking south)

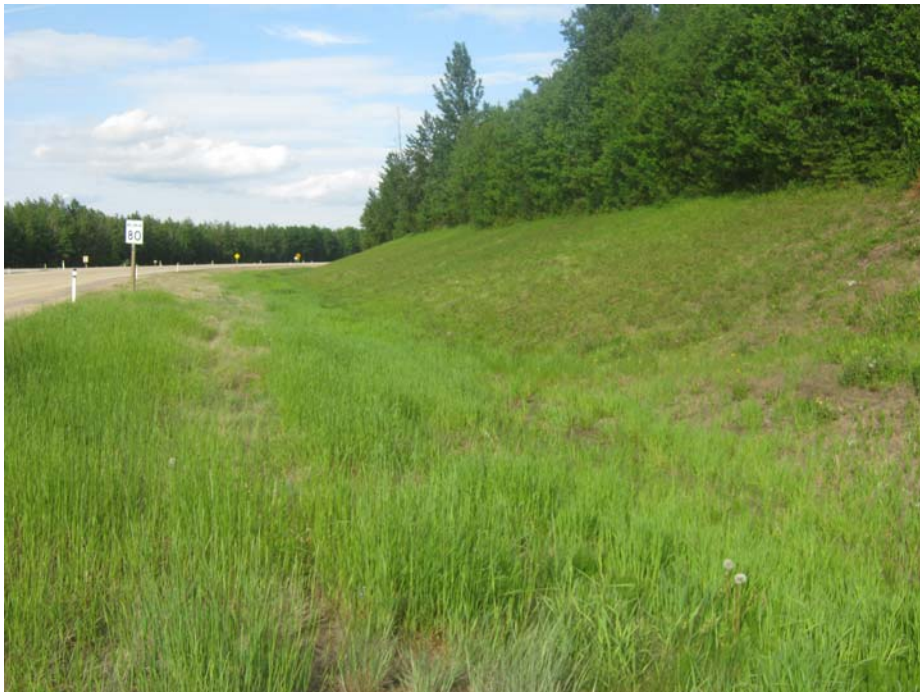
Photo# 2 Highway surface and side slope at the slump location, looking east

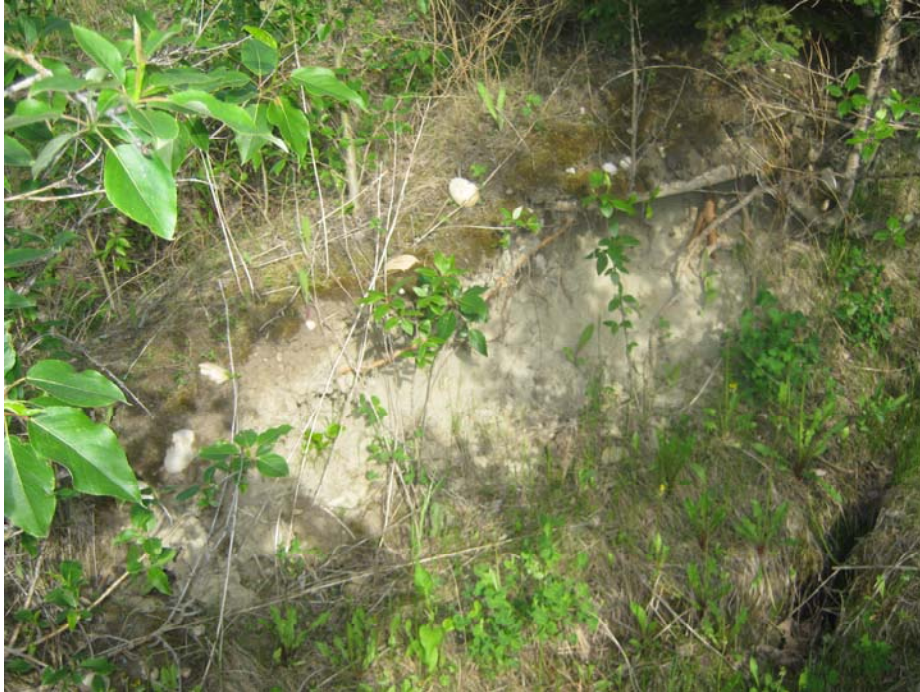
Photo# 3 Looking east at the west facing crack; the exposed face of the crack consists of fine silty sand

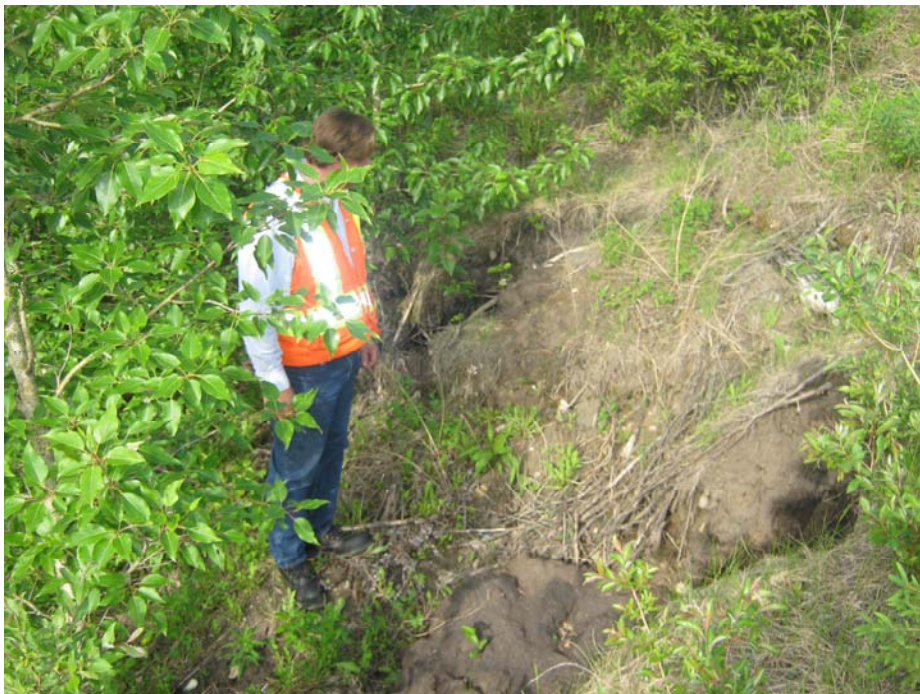
Photo# 4 Looking east at the slump cracks near the crest of the slope; note further movement of headscarp cracks

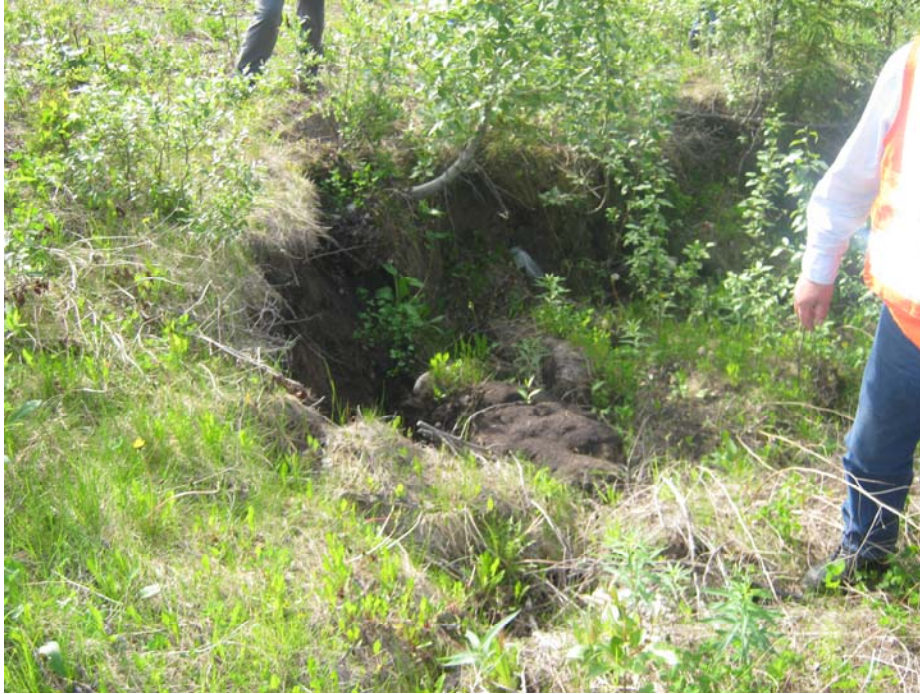
Photo# 5 Looking northwest at the slump cracks near the crest of the slope; note the retrogression of the scarp cracks
