GEOHAZARD ASSESSMENT PROGRAM
NORTH CENTRAL REGION – ATHABASCA
2013 INSPECTION

Site Number	Location	Name	Hwy	km
NC 72	20 m east of south Mitsue access road	Graduation Rock Backslope Slump	2:46	42.5
Legal Description		UTM Co-ordinates (NAD 83)		
N.E.15-72-4-W5M		12 N 6124185	E 656972

**NC72: HWY 2:46 GRADUATION ROCK
BACKSLOPE SLUMP (km 42.5)
SITE PLAN AND CROSS - SECTION A-A'**

FIGURE NC72-1

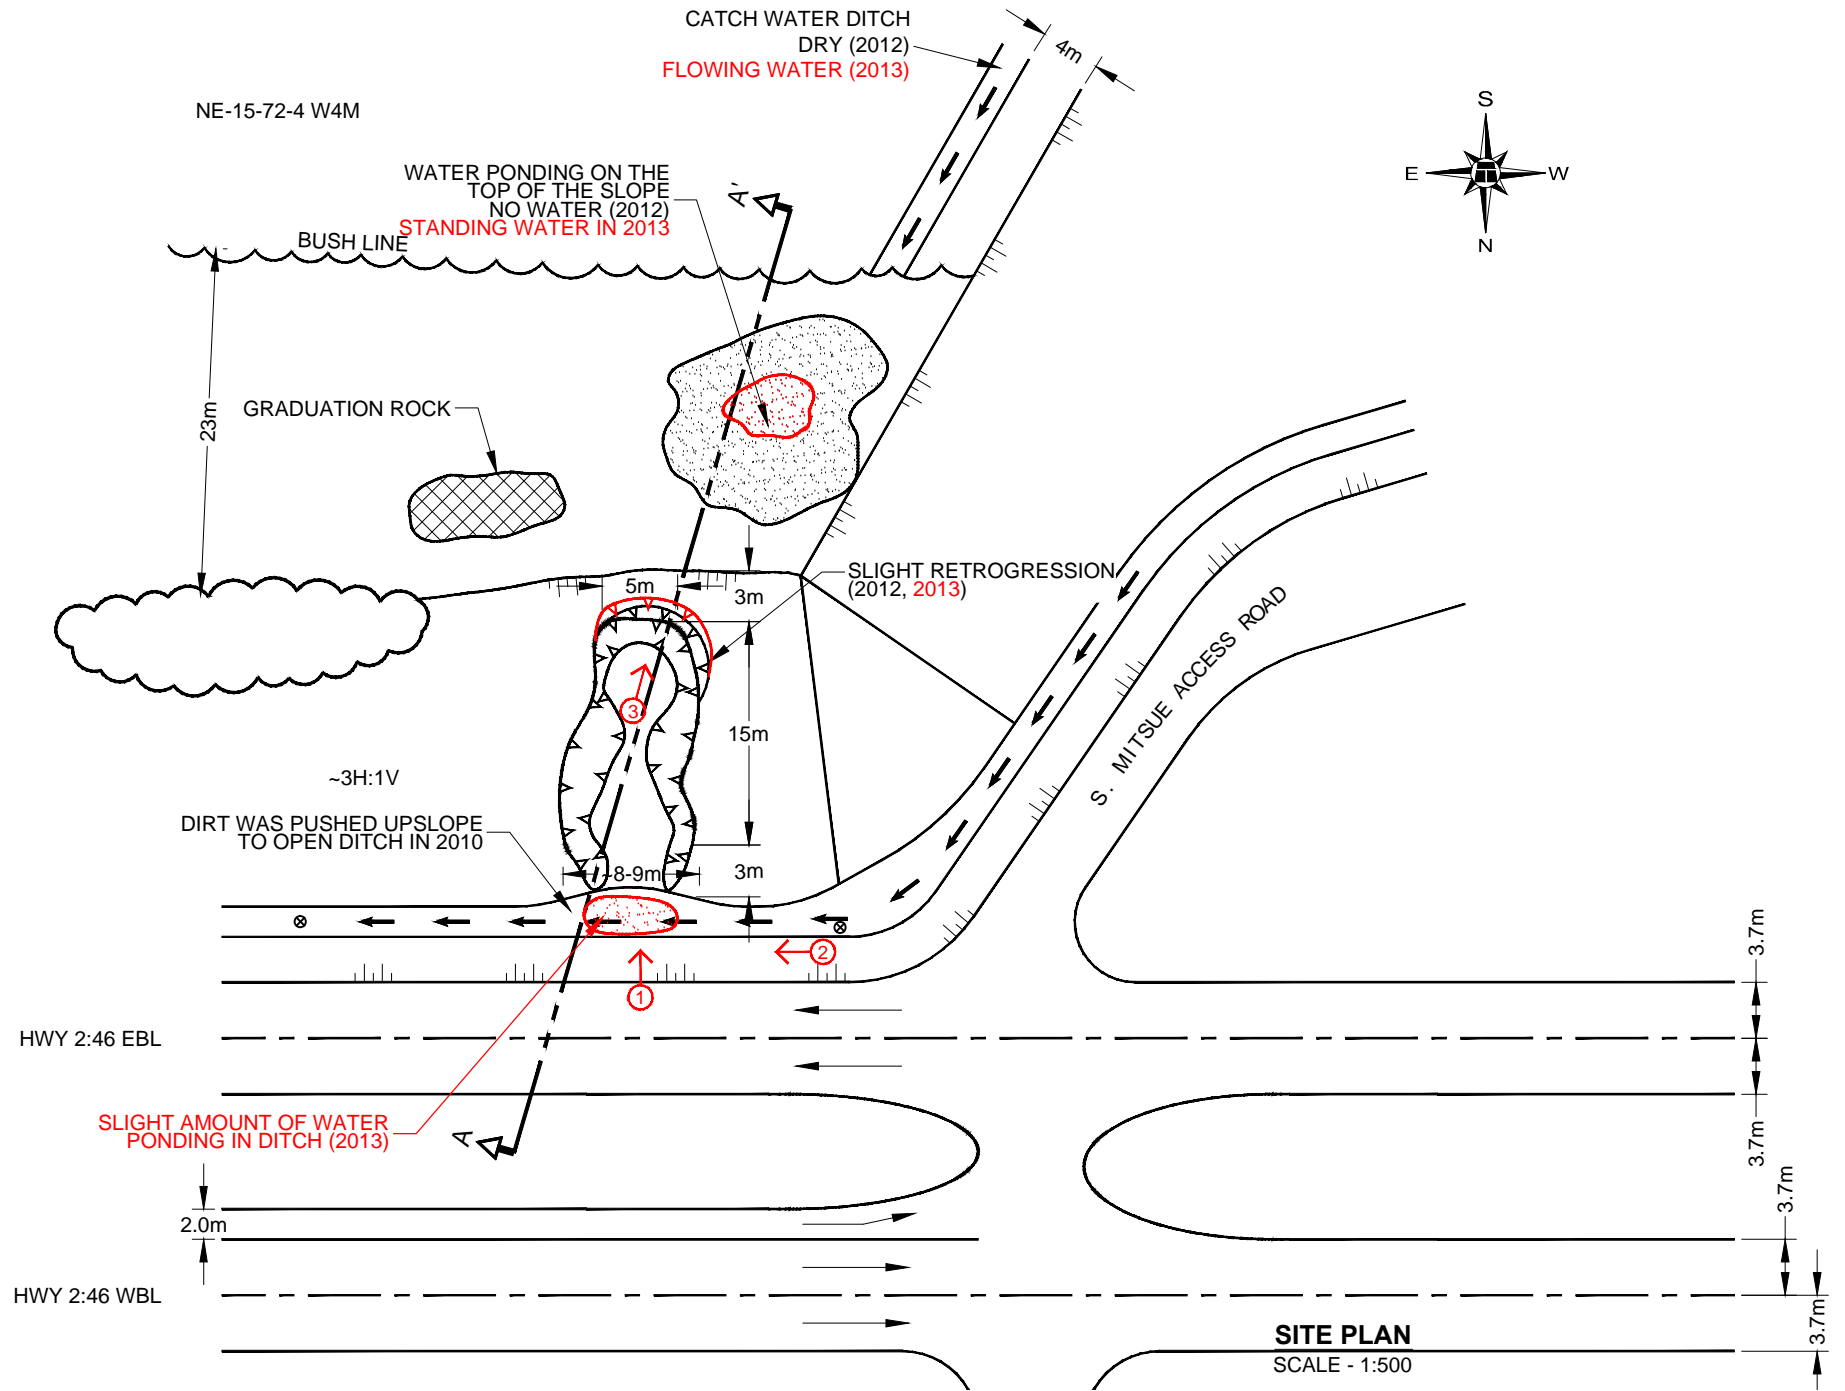
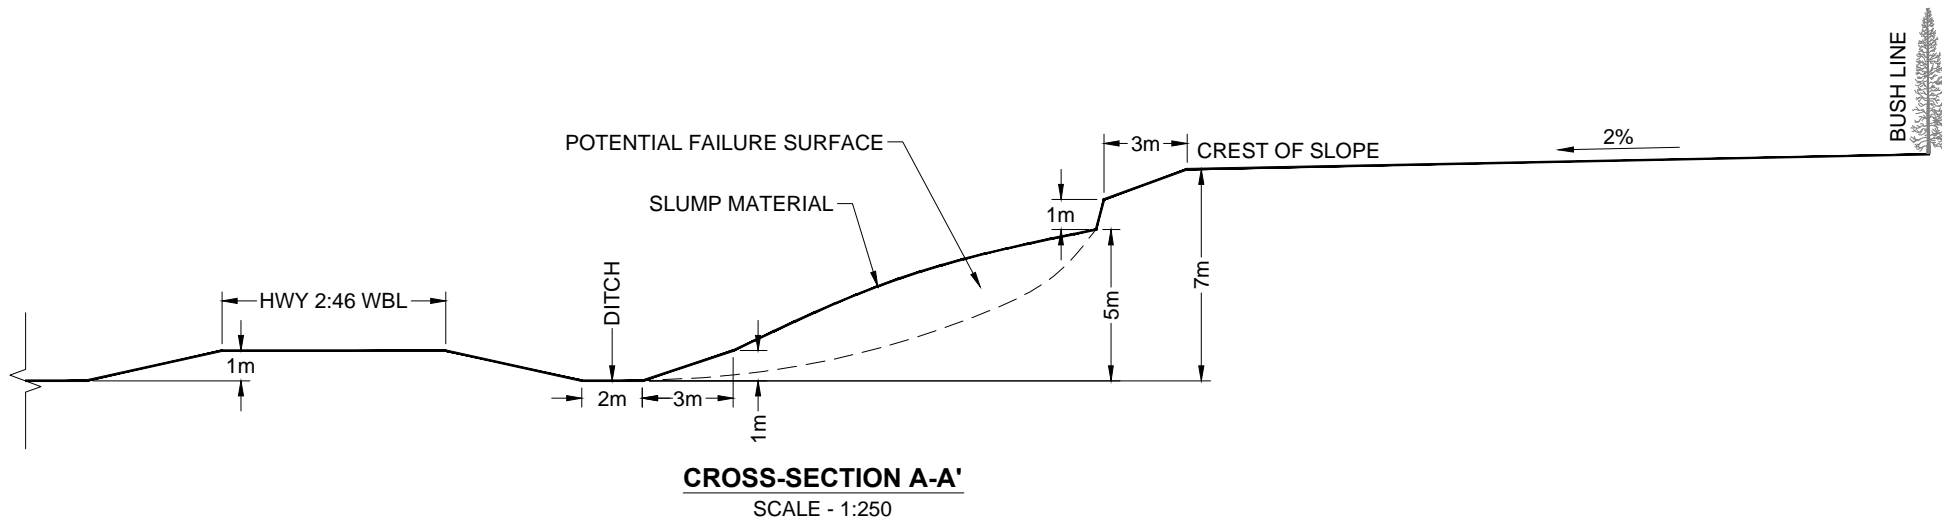
Primary Site Issue:	EBL backslope slump material pushing into highway ditch and impeding drainage.	
Dimensions:	5- 8 m wide (parallel to highway) x 16 m long (parallel to slope surface).	
Date of any remediation:	N/A	
Maintenance:	Issue was first noticed in 2009 and the ditch was maintained and cleared of the slump material in 2010 to enhance the drainage characteristics of the highway EBL ditch.	
Observations:	Description	Worse?
<input type="checkbox"/> Pavement Distress		<input type="checkbox"/>
<input checked="" type="checkbox"/> Slope Movement	Up to 1.5 m high multiple scarps within the slump mass. The slump materials consist of fissured low to medium plastic clay and silty fine sand; slight retrogression of headscarp cracks	<input type="checkbox"/>
<input checked="" type="checkbox"/> Erosion	Some erosion within the slump mass	<input type="checkbox"/>
<input checked="" type="checkbox"/> Seepage	Flowing water in the catch water ditch in 2013; slight amount of water ponding in the ditch but unimpeded surface water flow in the highway ditch	<input type="checkbox"/>

<input type="checkbox"/> Bridge/Culvert Distress		<input type="checkbox"/>
<input checked="" type="checkbox"/> Other	Vegetation has grown within the slump mass	<input type="checkbox"/>
Instrumentation: None		
Assessment (Refer to attached Figure 1):		
<p>It appears that the slump mass has moved a bit, as manifested from the slight retrogression of the headscarp cracks, however the site conditions did not change significantly from last year.</p> <p>The vegetation growth continued to increase the overall stability of the slump mass. Erosion and transportation of sediments to the bottom of the slope may still occur, but at a slower rate than experienced in the past in the absence of vegetation cover.</p>

In the short term, the local MCI should continue to monitor the site and clean the ditch, as required, to maintain its drainage characteristics. If the slump materials start to accumulate in the ditch and block natural drainage, ground water levels may rise in the vicinity of the highway embankment and result in instability of the highway side slopes.

The recommended long-term remedial measure consists of excavating and replacing the slump mass with compacted granular fill. This option will also require constructing a longitudinal sub-drain along the base of the excavated mass and a riprap lined swale extending from the bush line to the bottom of the slope to drain the surface water from the catch water ditch in a controlled manner into the highway ditch. Ditch armouring using riprap along the bottom of the slope will also be required. The ballpark cost of this option would be in the range of \$80,000.

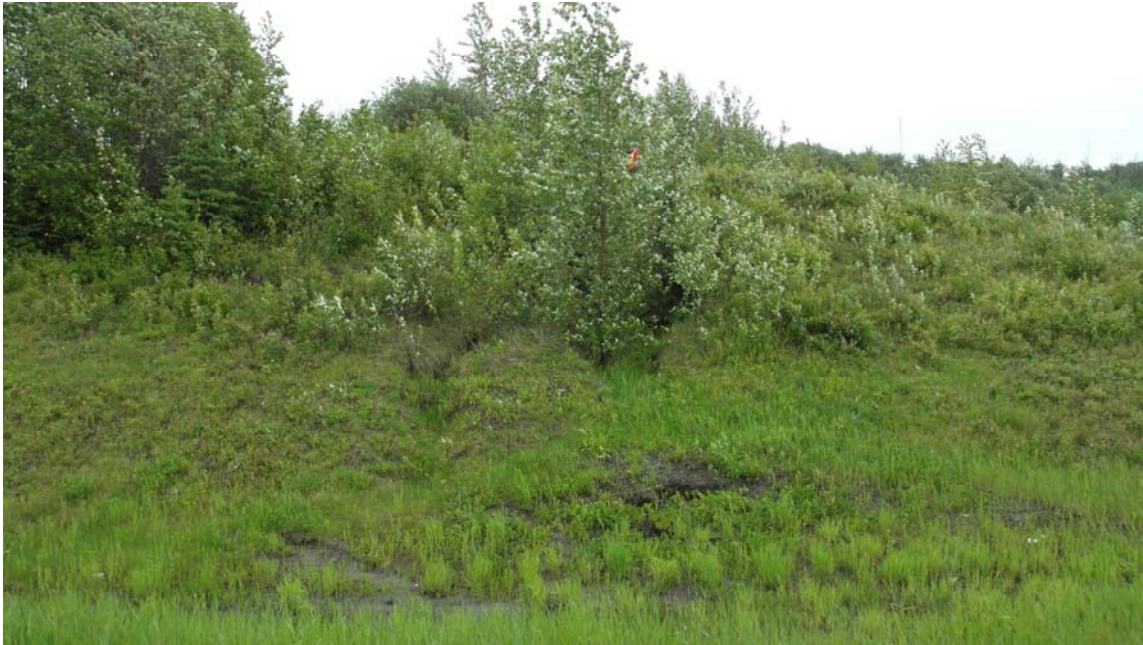
Photo# 1 General view of highway backslope slump; note that vegetation has grown within the slump mass (looking south)

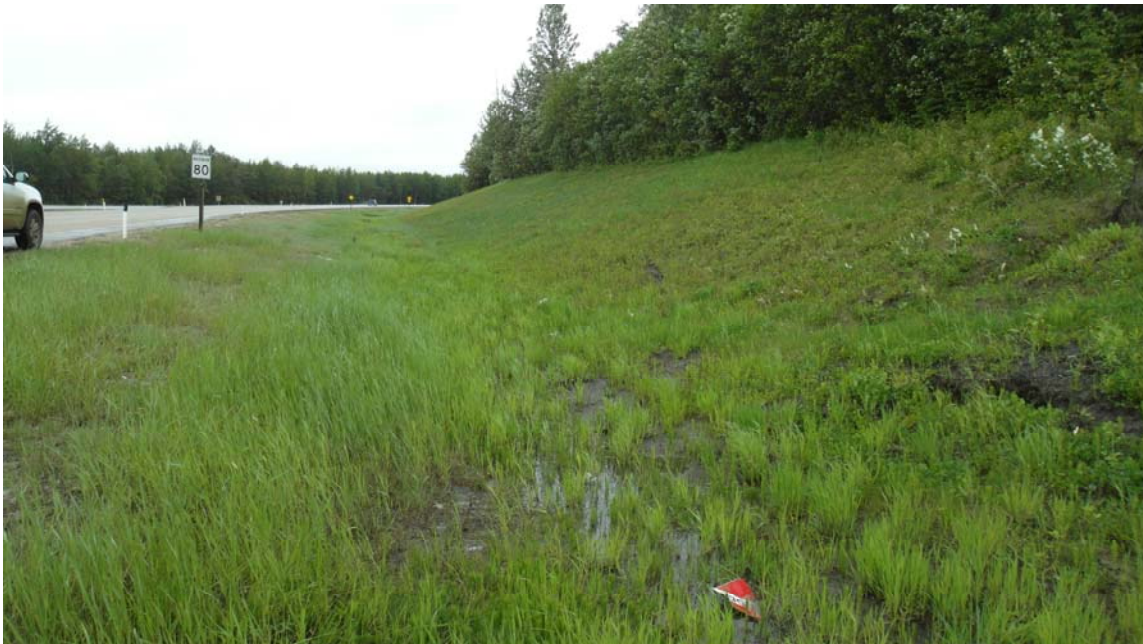
Photo# 2 Highway surface and side slope at the slump location, looking east; slight amount of water ponding in the ditch

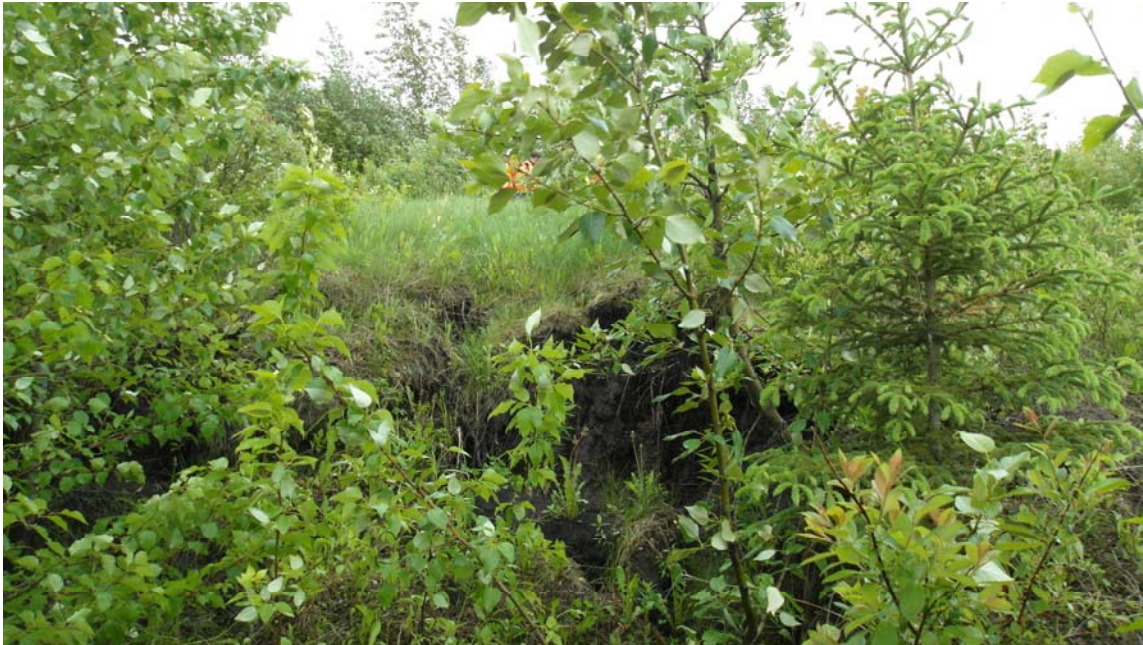
Photo# 3 Looking south at the north facing crack; note fresh scarp and slight retrogression of the slump
