December 4, 2006

File: 15-85-32

**NORTH CENTRAL REGION GEOHAZARD ASSESSMENT  
HWY 2:48 (NC 43), WEST OF WIDEWATER  
2006 ANNUAL INSPECTION REPORT**

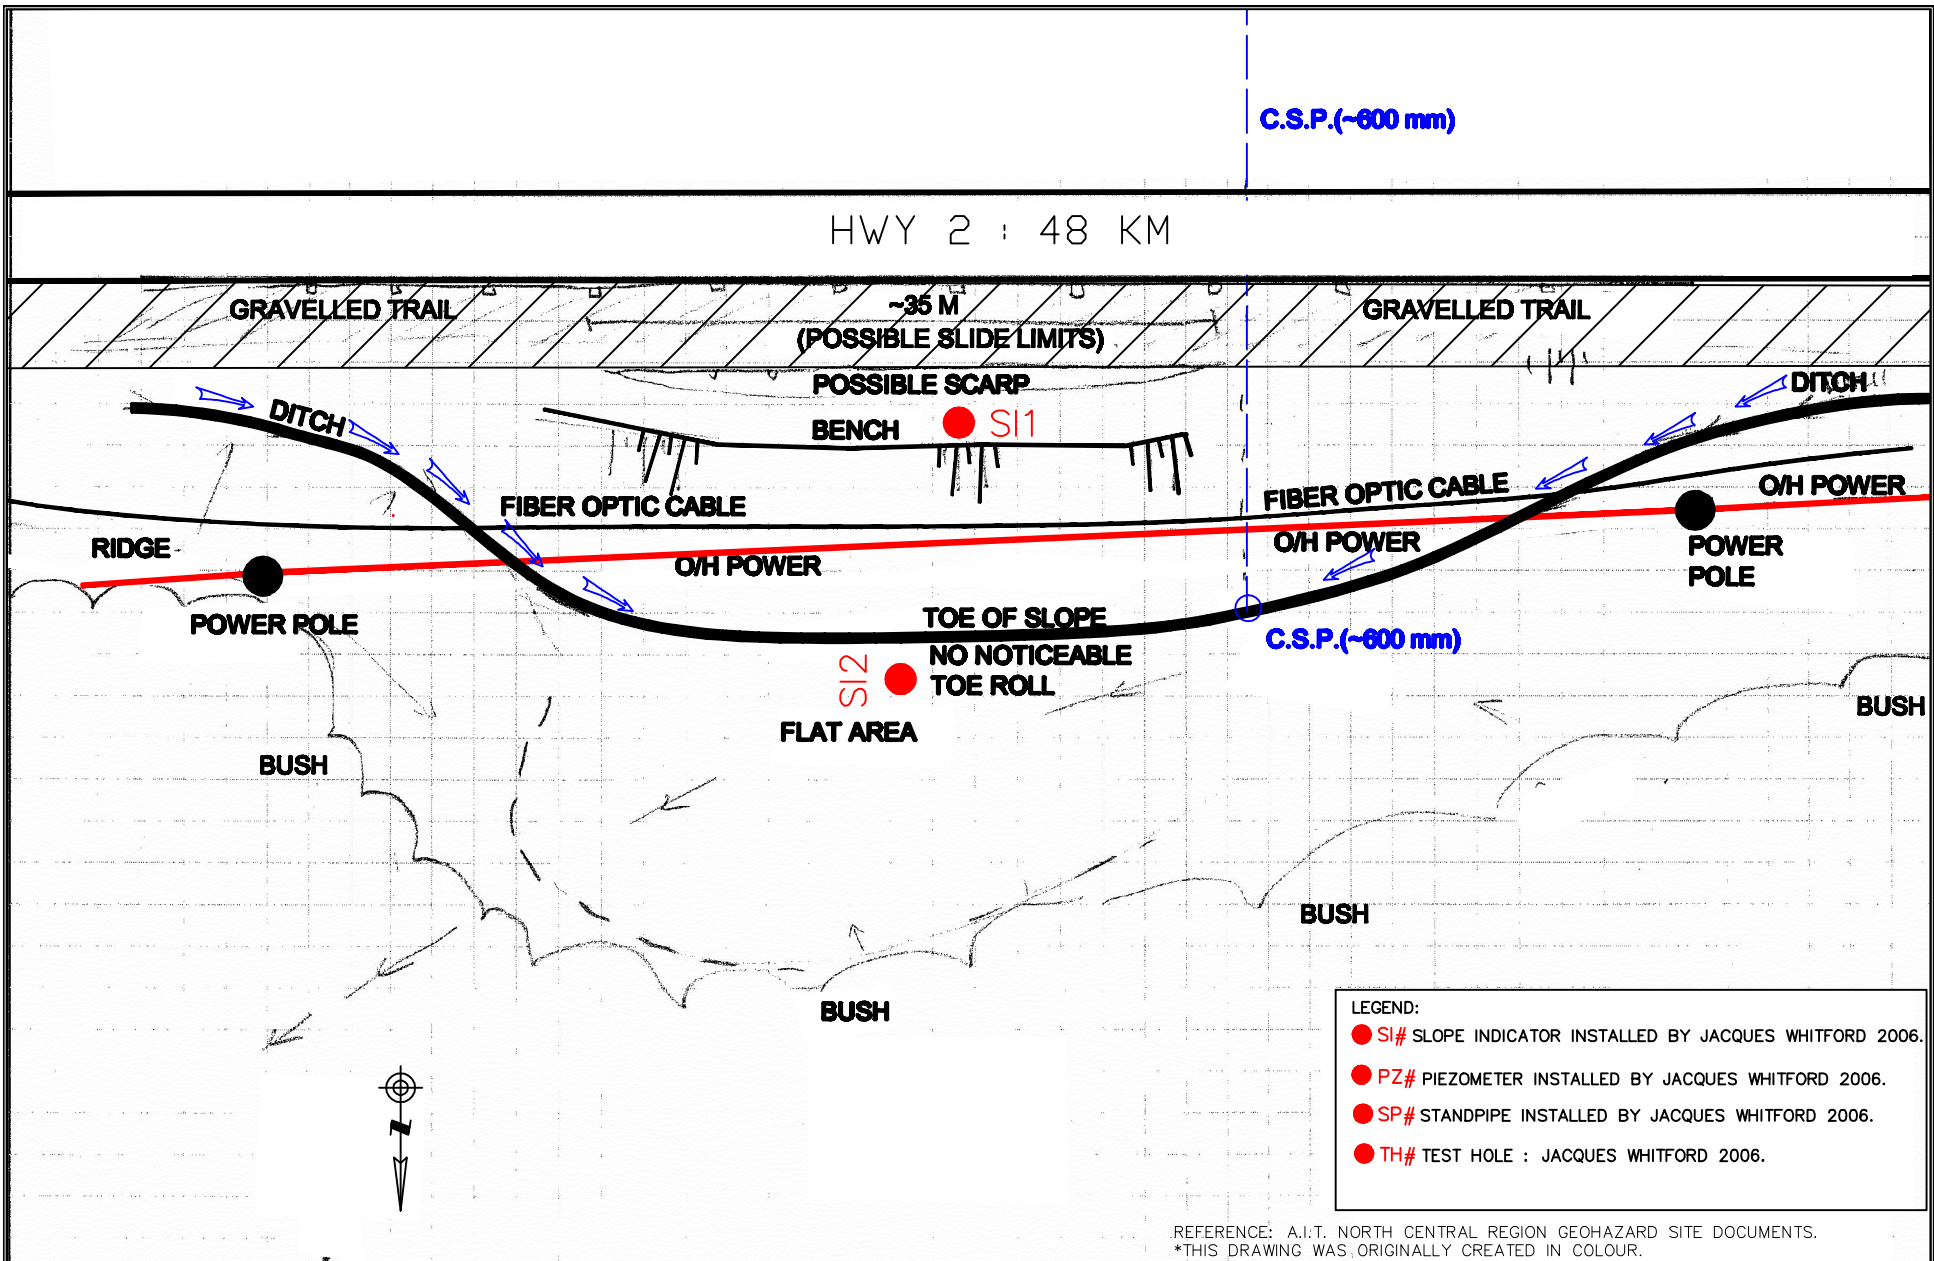
ALBERTA INFRASTRUCTURE AND TRANSPORTATION  
NORTH CENTRAL REGION GEOHAZARD  
**SITE PLAN AND BOREHOLE LOCATIONS (NC-43)**  
HWY 2:48  
PROJECT 1012822.12

Two slope inclinometers (SI1 and SI2) have been installed in 2006 by Jacques Whitford at the locations shown in Figure NC43-1.

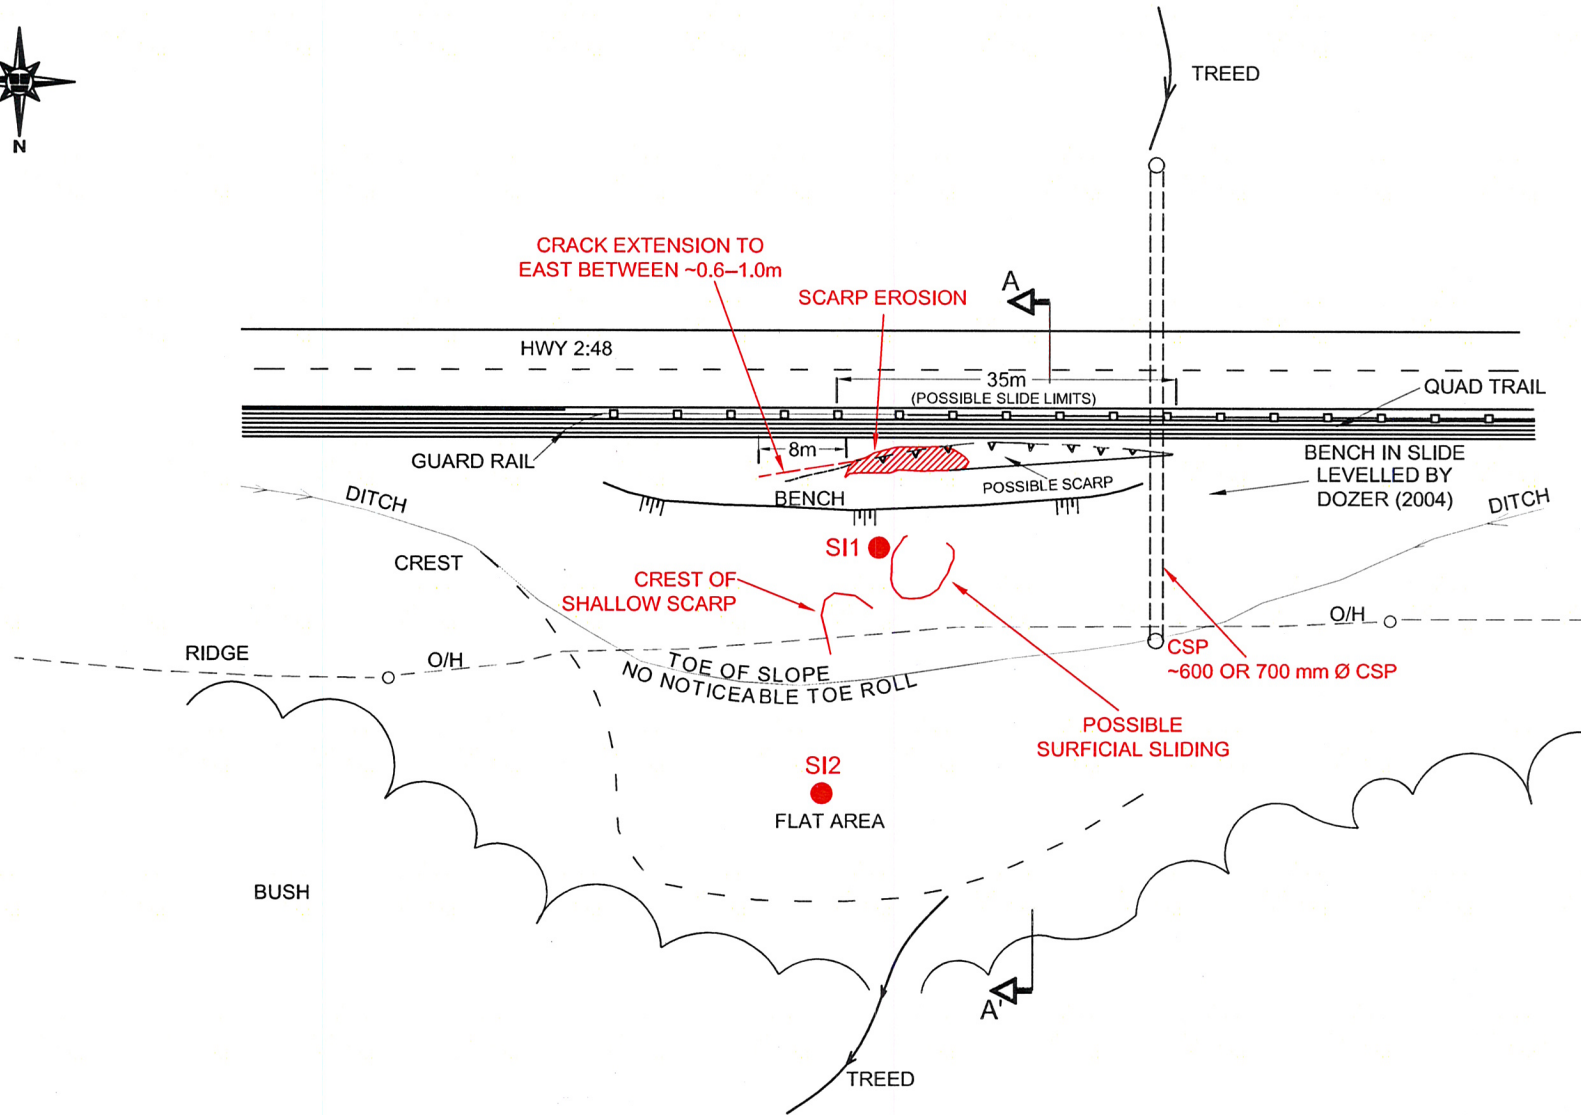
**FIGURE NC43-1 SKETCH SITE PLAN  
NC43- HWY 2:48 Km 21**

The changes in condition since last year are shown on the attached site sketch plan, Figure NC43-1, attached for inclusion in Appendix F of the binder. A cross-section is also attached for inclusion in Section F (Figure NC43-2). Selected photographs taken during the visit are also attached.

No significant changes were observed since the last visit in 2005 except some minor surficial slump development down slope of the bench, and minor erosion of the scarp face. The drop off from the top of the scarp to the bench area is approximately 0.6 to 1.0 m high. The scarp, bench and side slope areas were dry at the time of the visit and no evidence of seepage was noted.

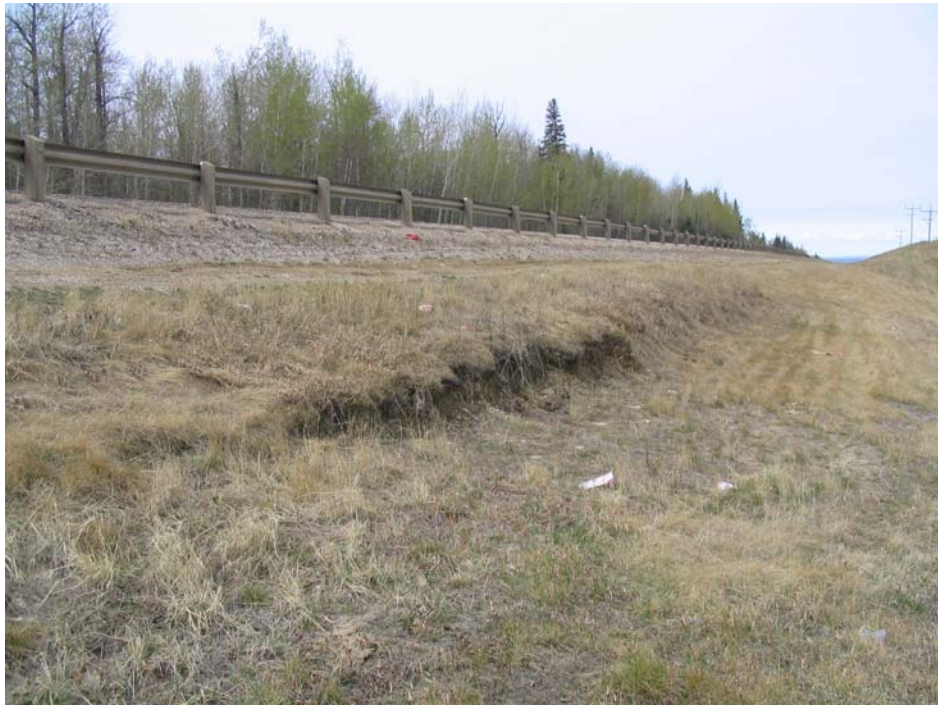
Photo 1 Looking northwest at the distress area, May 2, 2006.

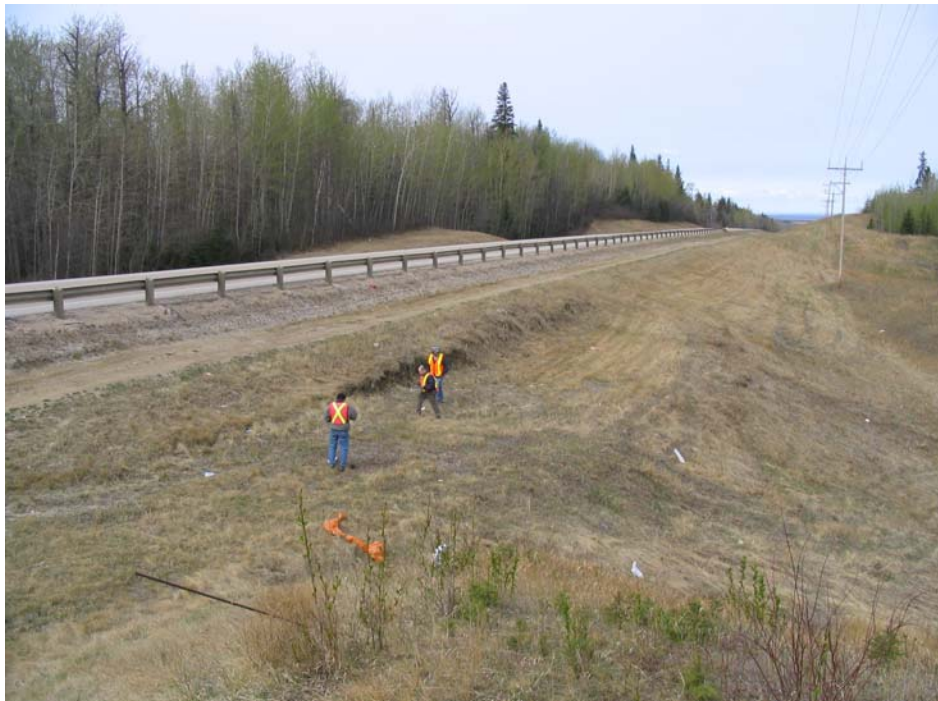
Photo 2 Looking from top at the distress area, May 2, 2006.

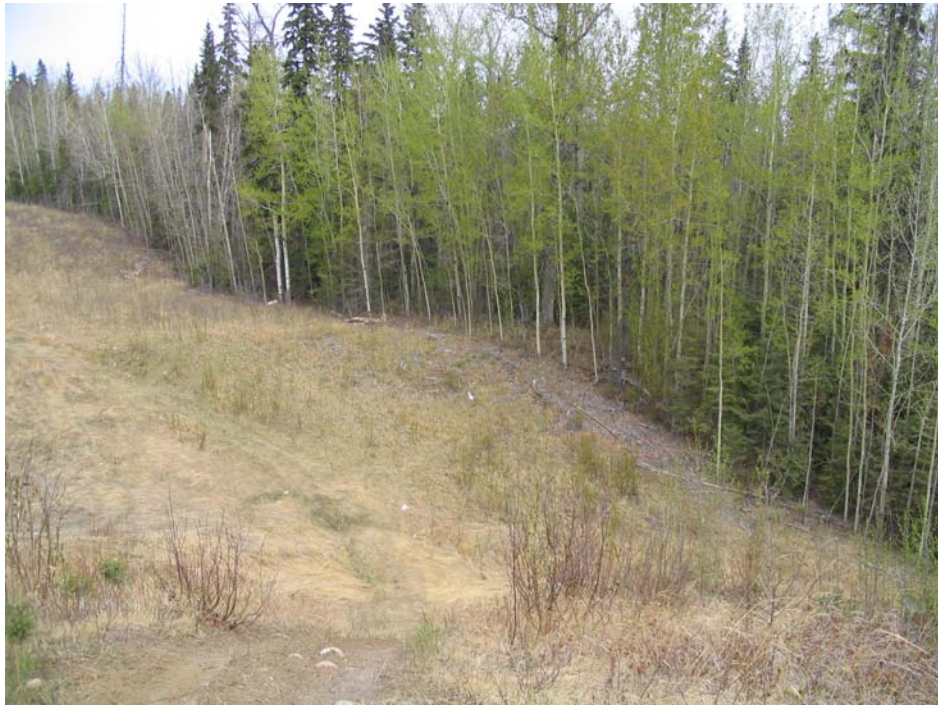
Photo 3 Looking northwest at the downslope toe area, May 2, 2006.

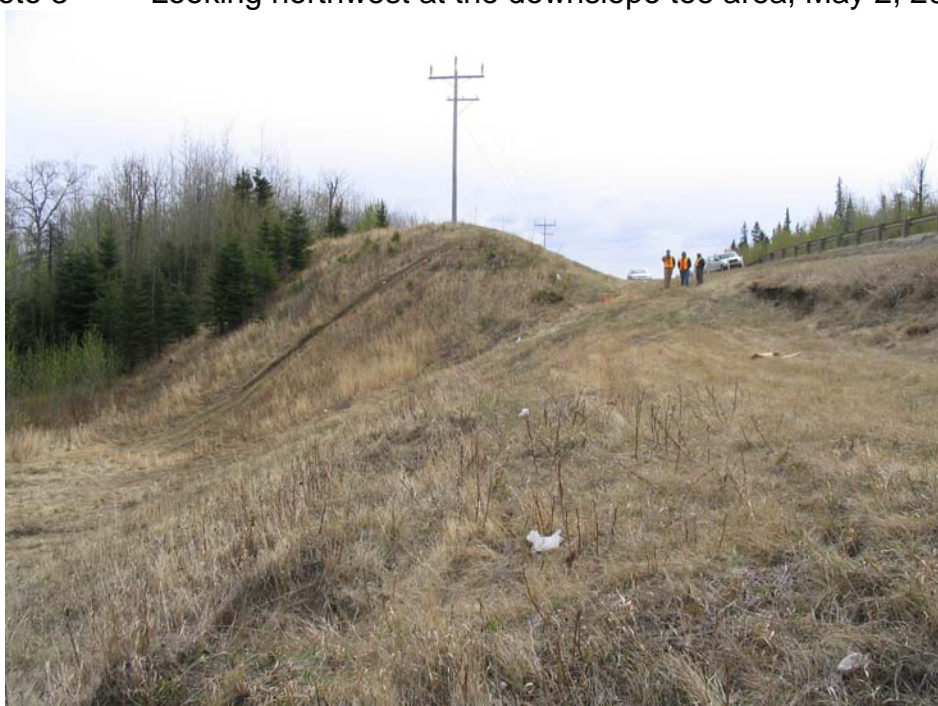
Photo 4 Looking southeast at the side slope area, May 2, 2006.
