THURBER ENGINEERING LTD.

December 4, 2007

File: 15-85-66

**NORTH CENTRAL REGION GEOHAZARD ASSESSMENT
HWY 2:48 (NC 43), WEST OF WIDEWATER
2007 ANNUAL INSPECTION REPORT**

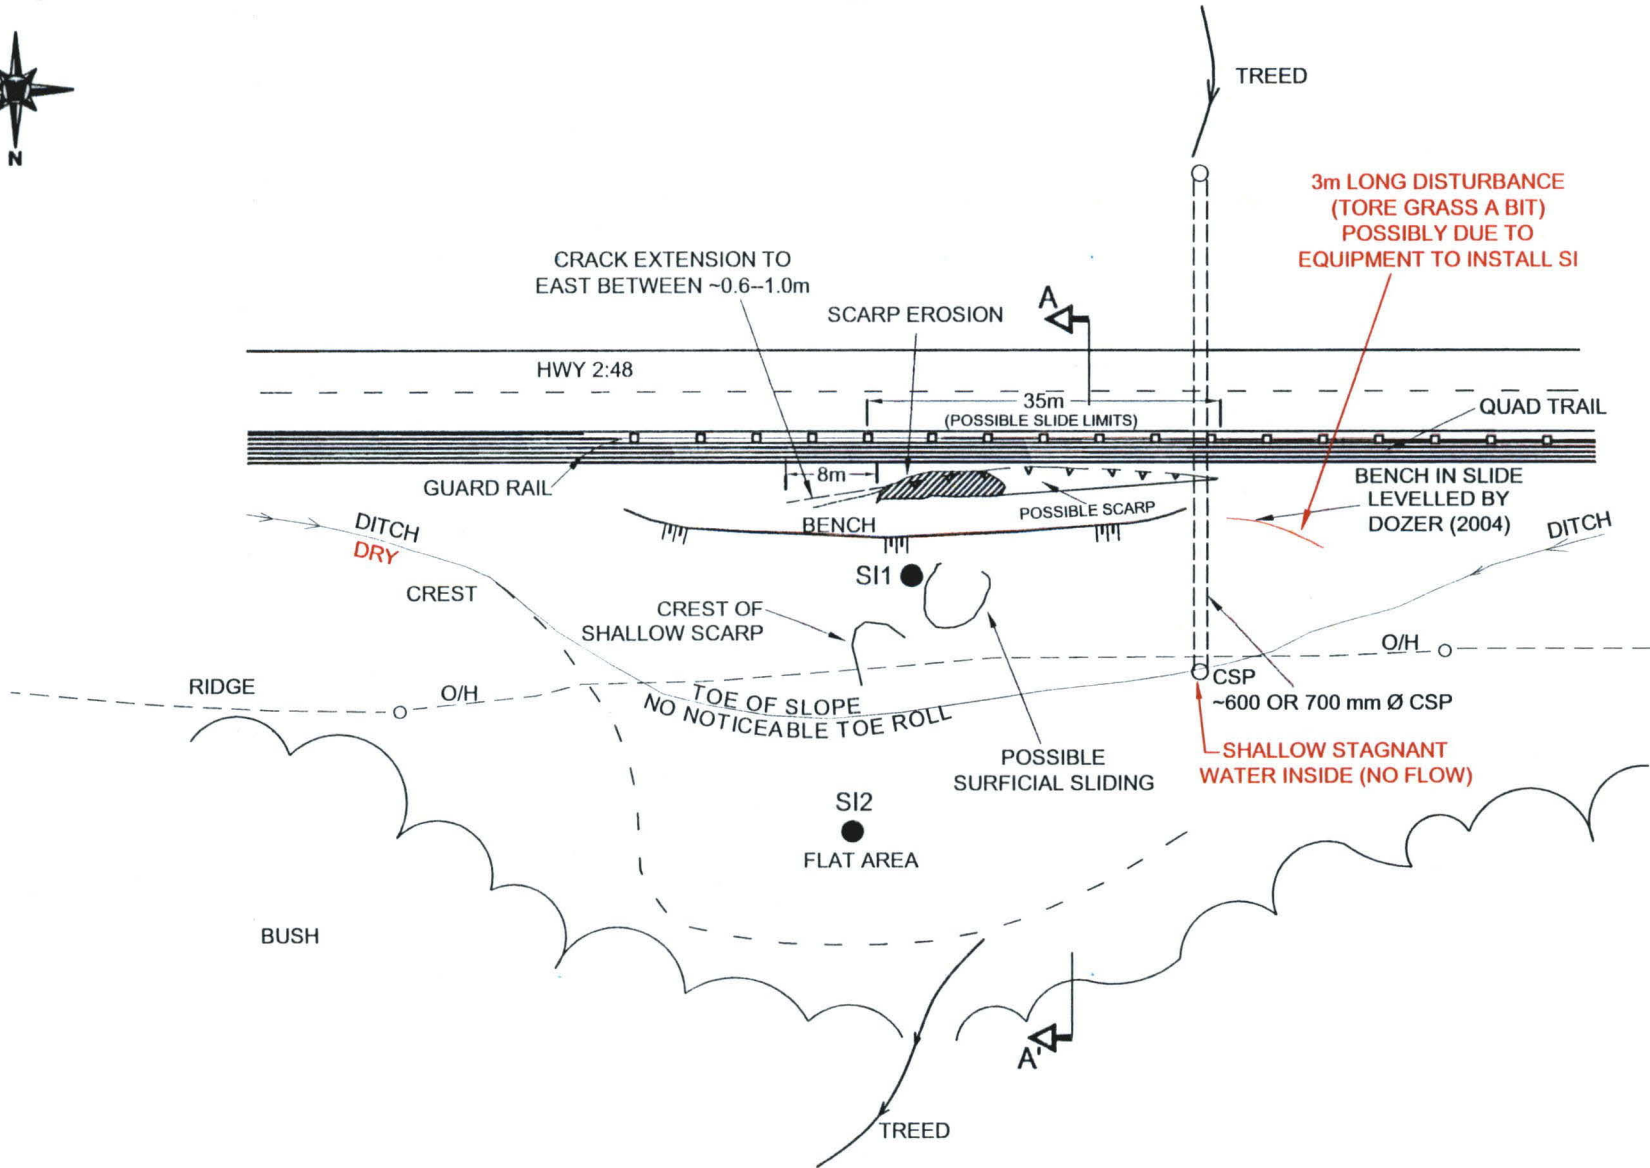
**FIGURE NC43-1 SKETCH SITE PLAN
NC43- HWY 2:48 Km 21**

The changes in condition since last year are shown on the site sketch plan, Figure NC43-1, attached for inclusion in Appendix F of the binder. A cross-section is also attached for inclusion in Section F (Figure NC43-2). Selected photographs taken during the visit are also attached.

No significant changes were observed since the last visit in 2006 except for surface disturbance at the west end of the bench area possibly due to the equipment running for SI installation. The cut slope, bench and side slope areas were dry at the time of the visit and no evidence of seepage was noted.

Similar to the previous observations the highway surface did not show any slide related cracks. A recent chipseal on the highway was observed. Shallow stagnant water was observed inside the CSP culvert near the west end of the bench area.

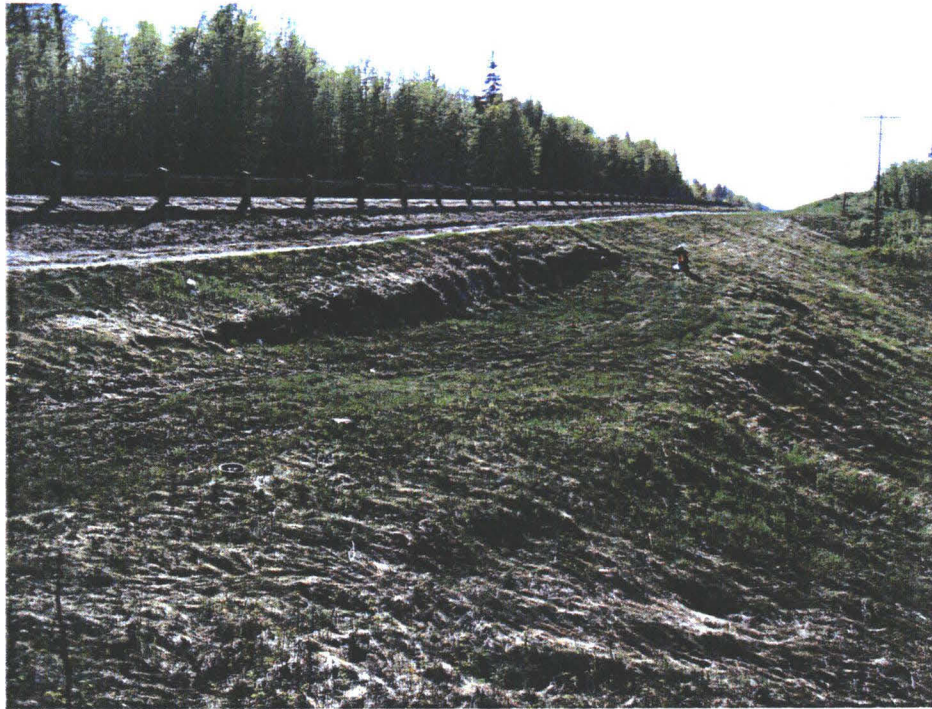
Photo 1 - Looking west at the distress area, May 24, 2007.

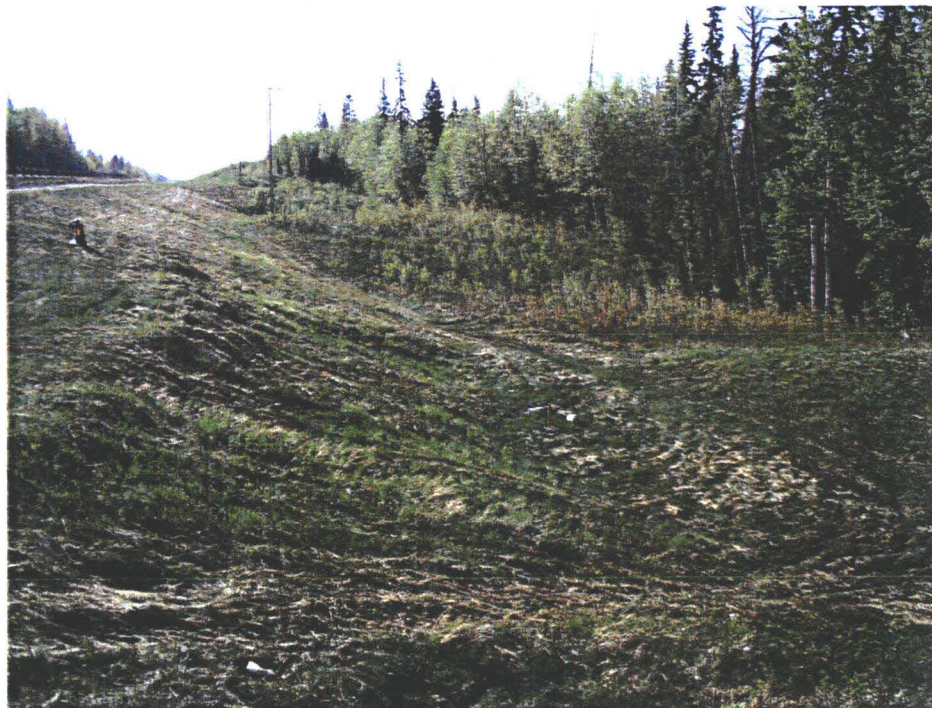
Photo 2 - Looking at the downslope toe area, May 24, 2007.

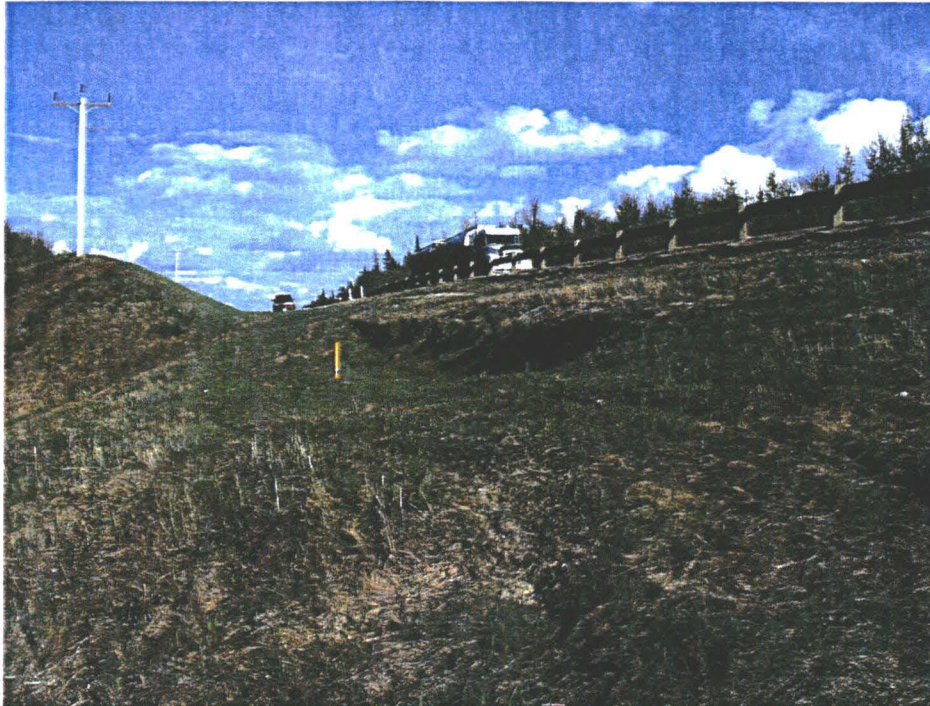
Photo 3 -Looking east at the distress area, May 24, 2007.

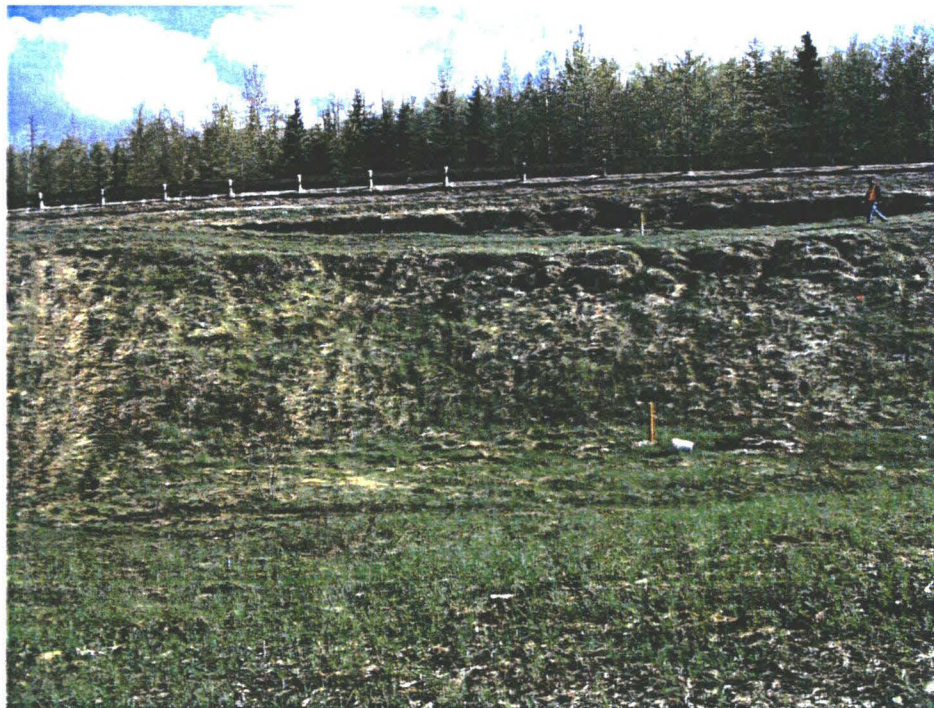
Photo 4 - Looking south at the side slope area (SI's), May 24, 2007.
