December 4, 2006

File: 15-85-32

**NORTH CENTRAL REGION GEOHAZARD ASSESSMENT
HWY 2:48 CANYON CREEK (NC 9)
2006 ANNUAL INSPECTION REPORT**

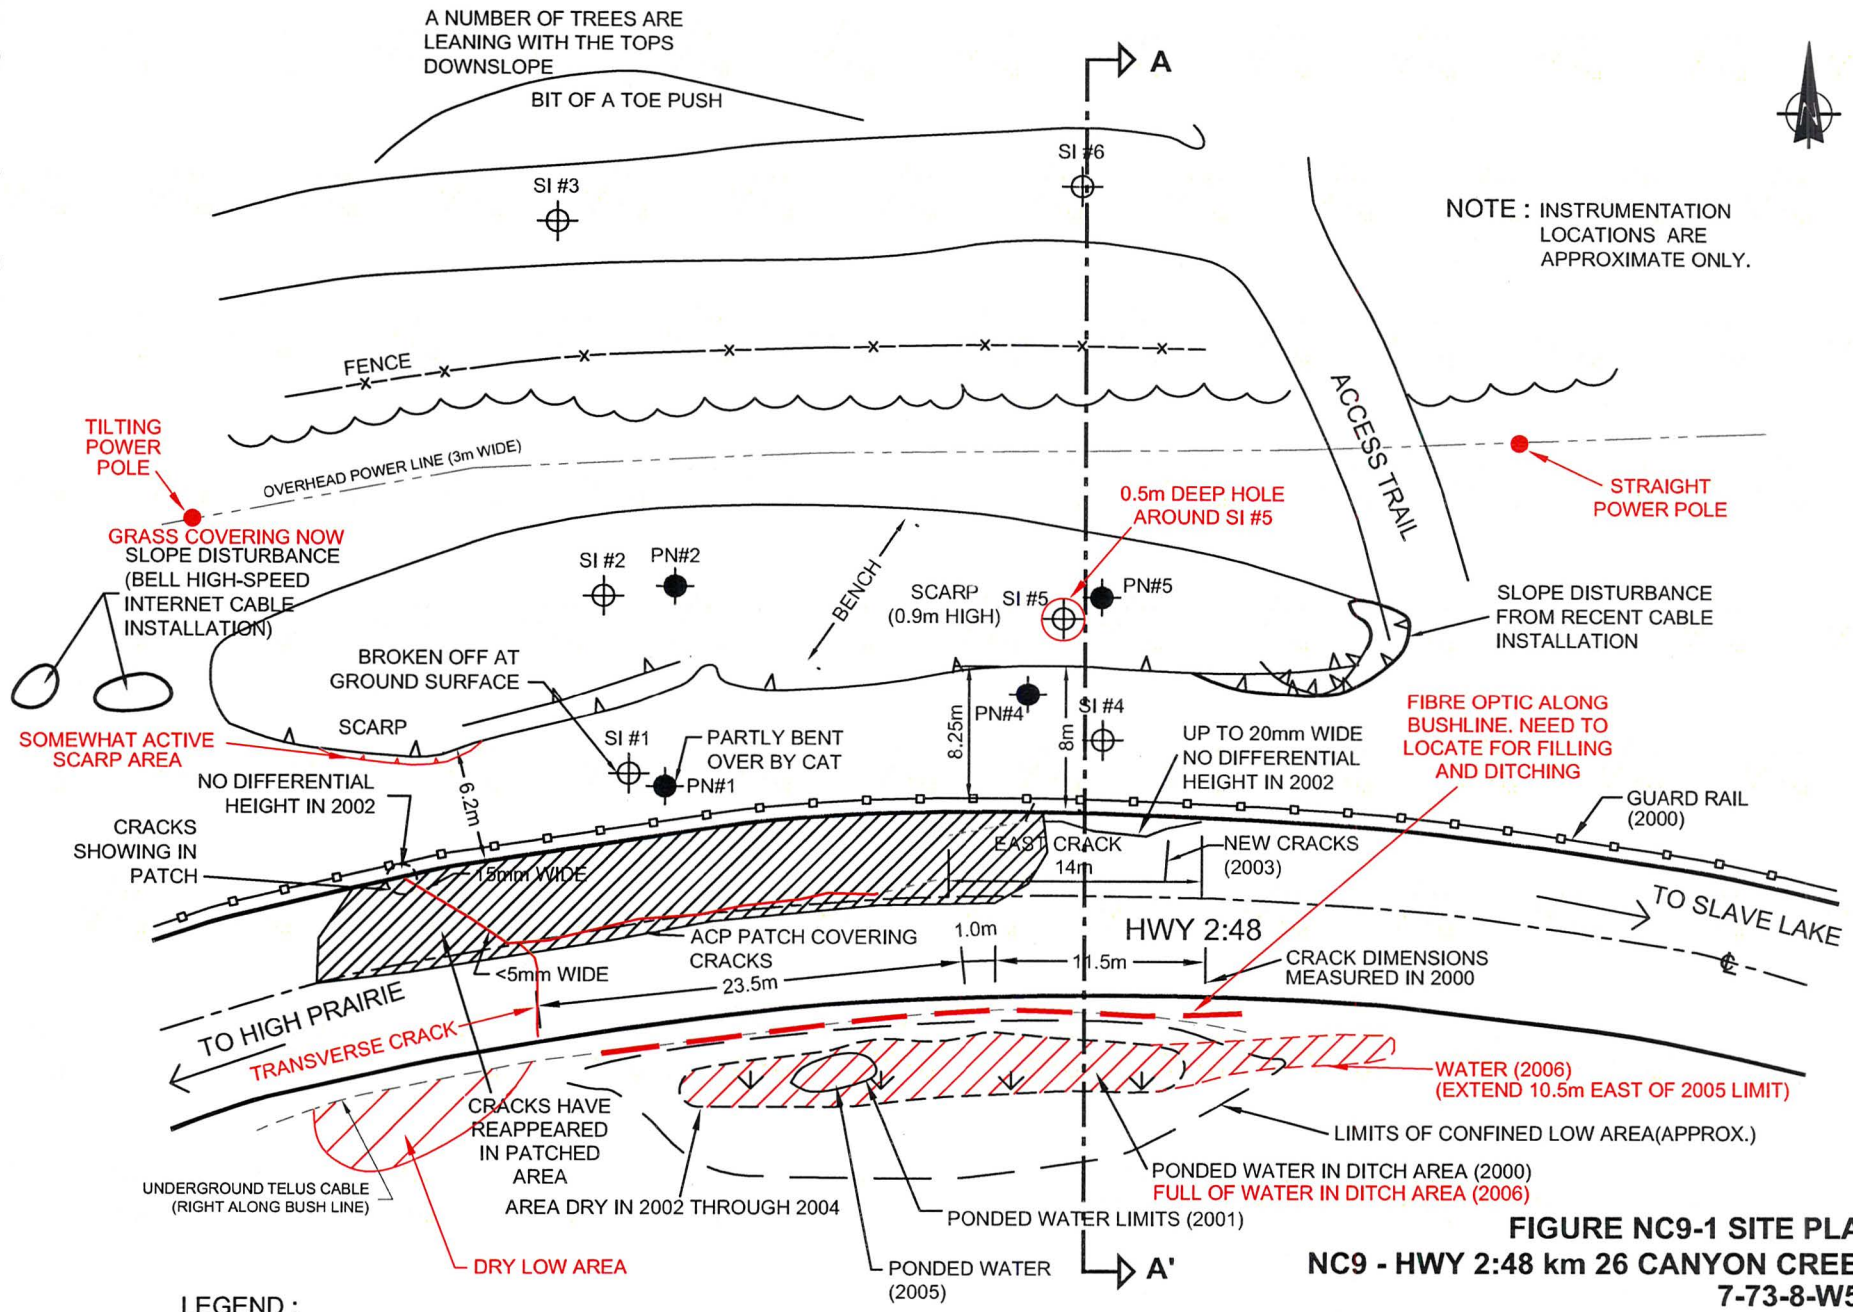
FIGURE NC9-1 SITE PLAN
NC9 - HWY 2:48 km 26 CANYON CREEK
7-73-8-W5M

The changes in condition since last year are shown on the site sketch plan, Figure NC9-1, attached for inclusion in Appendix F of the binder. The cross-section included previously in Section F (Figure NC9-2) is considered

A new transverse crack up to about 5 mm wide was observed extending from the centerline of the highway to the south shoulder. The crack appears to be connected to a longitudinal crack extending east west within the patched area.

The confined low area adjacent to the south ditch was full of water during this year's visit. The ponded water extended about 10 m further east than the largest extent observed during previous visits.

The western portion of the scarp of the bench located north of the highway, as shown on the site plan, is somewhat active. The power pole, also located at the western limit of the slide area, was found to be somewhat tilted with its top downslope. A man made hole was located beside the location of PN#5 and a SI casing, believed to be the abandoned SI#5, was noted to be approximately 0.5 m below ground surface within the hole. SI#4 could not be found, as per previous visits since 2004.

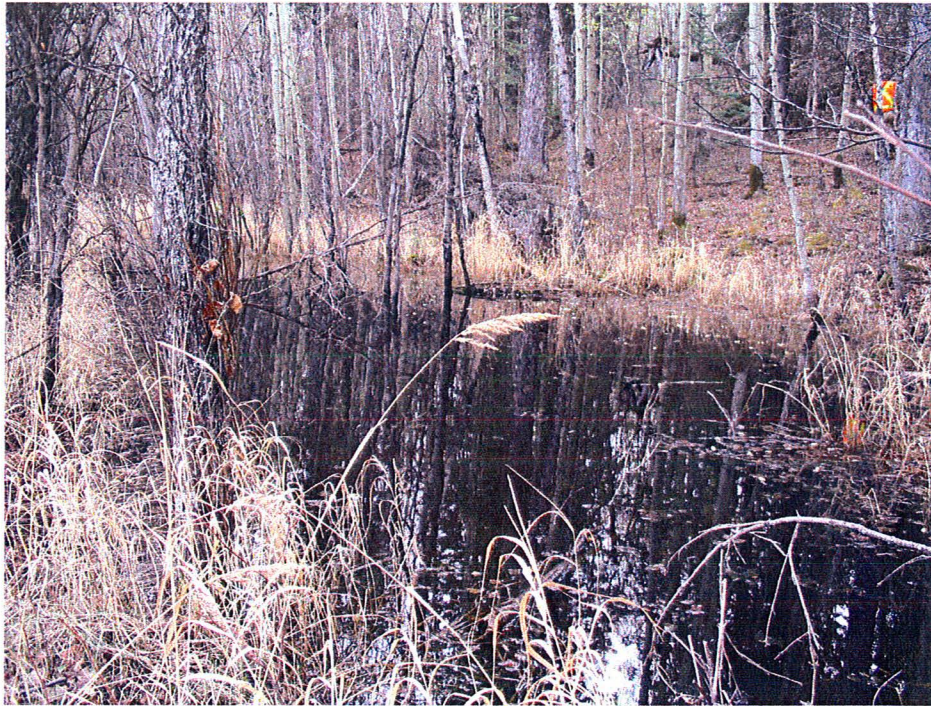
The slide movements in this area of slope instability appear to be related to variations in the groundwater level. Larger slope movement could occur during heavy or prolonged precipitation events. The confined low area adjacent to the south ditch is expected to be a source of water to the slide mass and could trigger future movements if water is allowed to pond in this location.

Photo 1 Confined low area adjacent to the south ditch. Ponded water is visible throughout, May 2, 2006.

Infill of the low area adjacent to the south ditch should be implemented to reduce the potential for water infiltration into the slide area, as recommended in previous assessment reports. A design and cost estimate has previously been submitted to AIT.

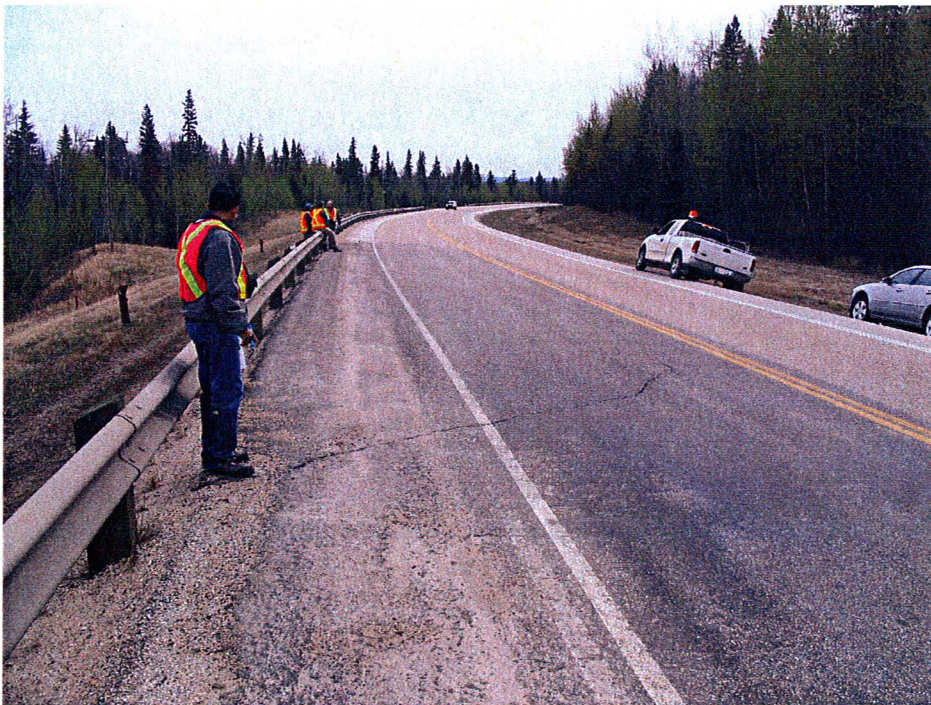
Photo 2 Transverse crack through the patched area, May 2, 2006.

In the short term the site should be regularly inspected by the MCI to determine when further asphalt patching maintenance is required to maintain a smooth even road surface for traffic safety.

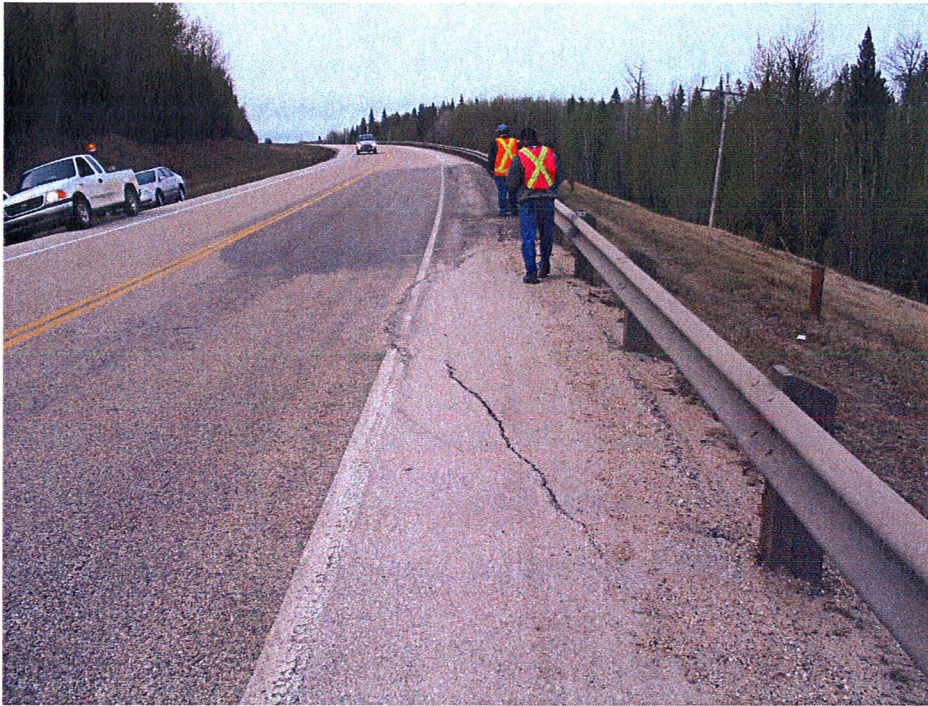
Photo 3 Looking West along Highway at cracks, May 2, 2006.

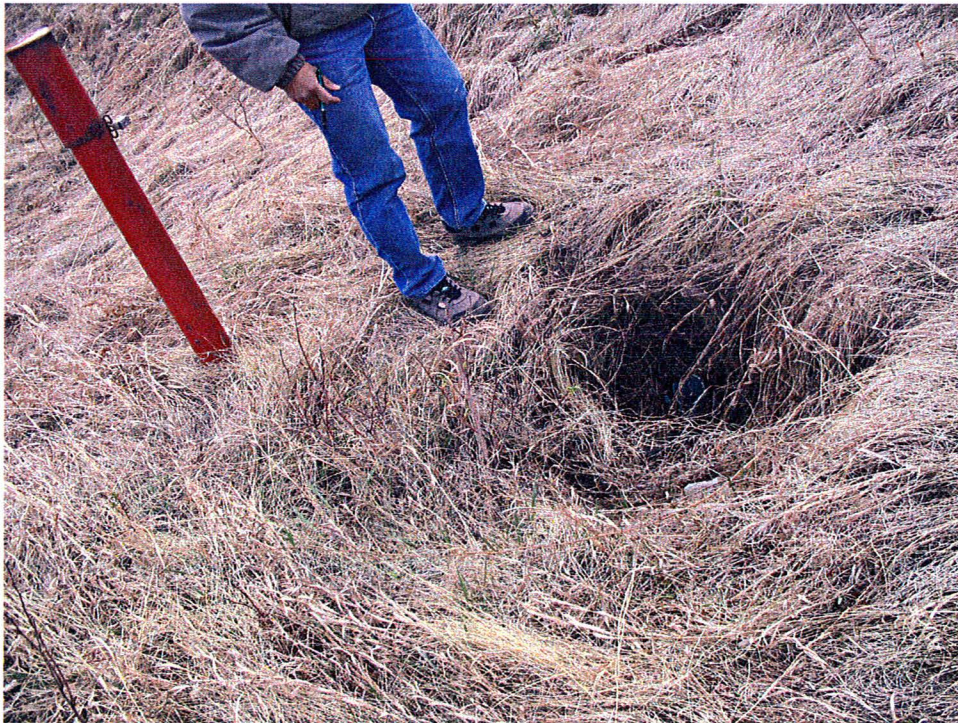
Photo 4 Hole around SI#5 location, May 2, 2006.
