**NORTH CENTRAL REGION GEOHAZARD ASSESSMENT
HWY 2:48 CANYON CREEK (NC 9)
2007 ANNUAL INSPECTION REPORT**

This letter documents the 2007 annual site inspection of an area of slope instability located along Hwy 2:48 at km 26, about 3.2 km west of Canyon Creek (refer to Figure NC9-1, Section F). Thurber Engineering Ltd. (Thurber) undertook this inspection in partial fulfillment of our Geotechnical Services for Geohazard Assessment, Instrumentation Monitoring and Related Work contract (**CE143/2007**) with Alberta Infrastructure and Transportation (INFTRA).

FIGURE NC9-1 SITE PLAN
NC9 - HWY 2:48 km 26 CANYON CREEK
7-73-8-W5M

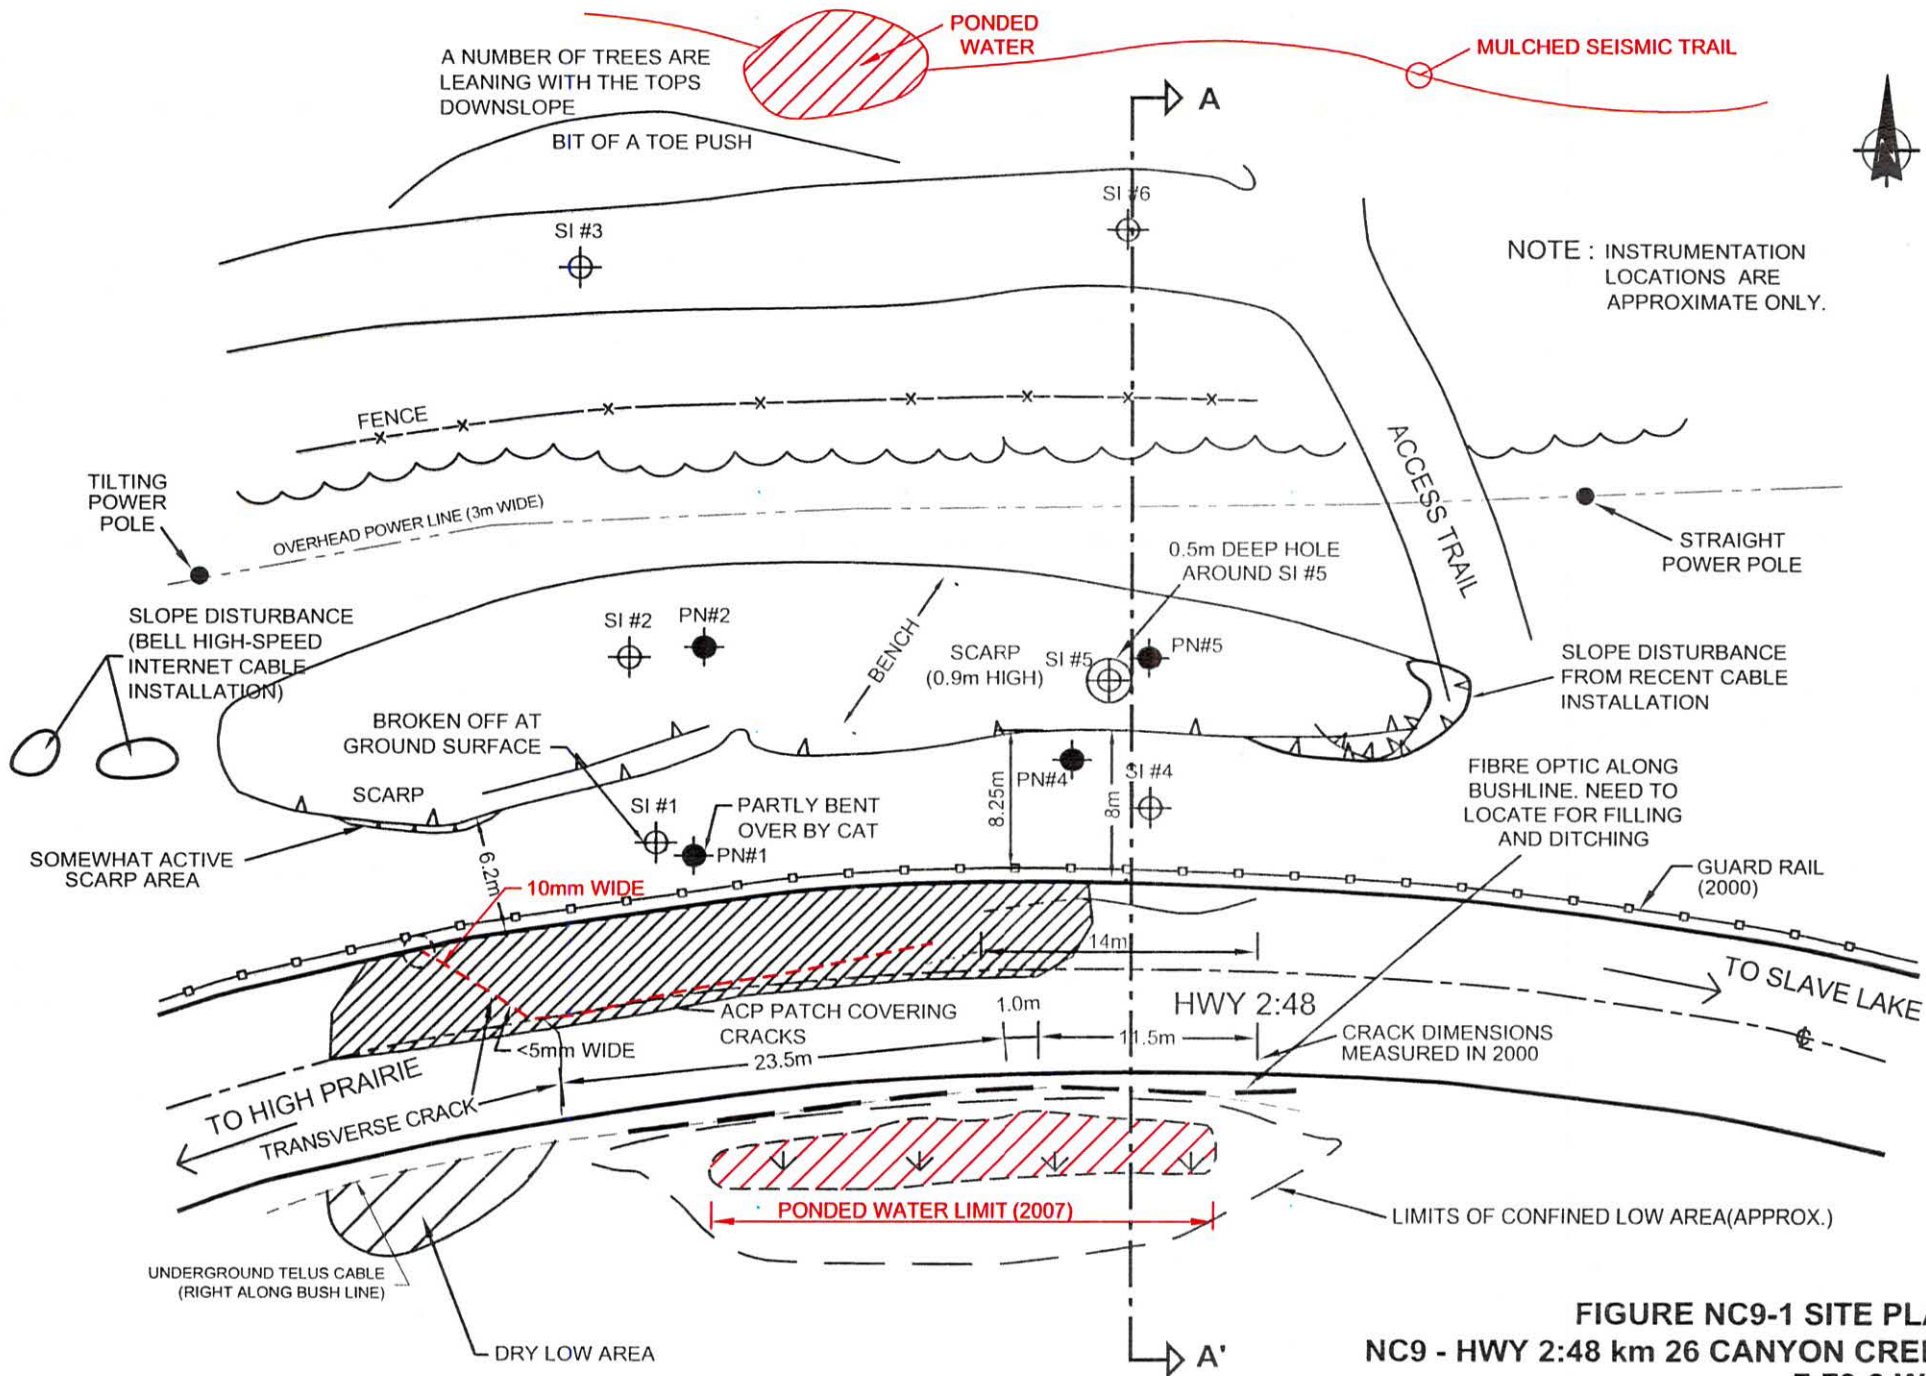
The changes in condition since last year are shown on the site sketch plan, Figure NC9-1, attached for inclusion in Appendix F of the binder. The cross-section included previously in Section F (Figure NC9-2) is considered

No new cracks were observed on the road. The transverse crack at the south edge of the road was about 10 mm wide.

No changes in site features were observed compared to last year at the slide area located north of the highway. However, the west portion of the scarp still seemed somewhat active as was observed last year. Ponded water was observed at the northern most part of the site in the flat area near the toe of the slope. Also a mulched seismic trail was found in the same area.

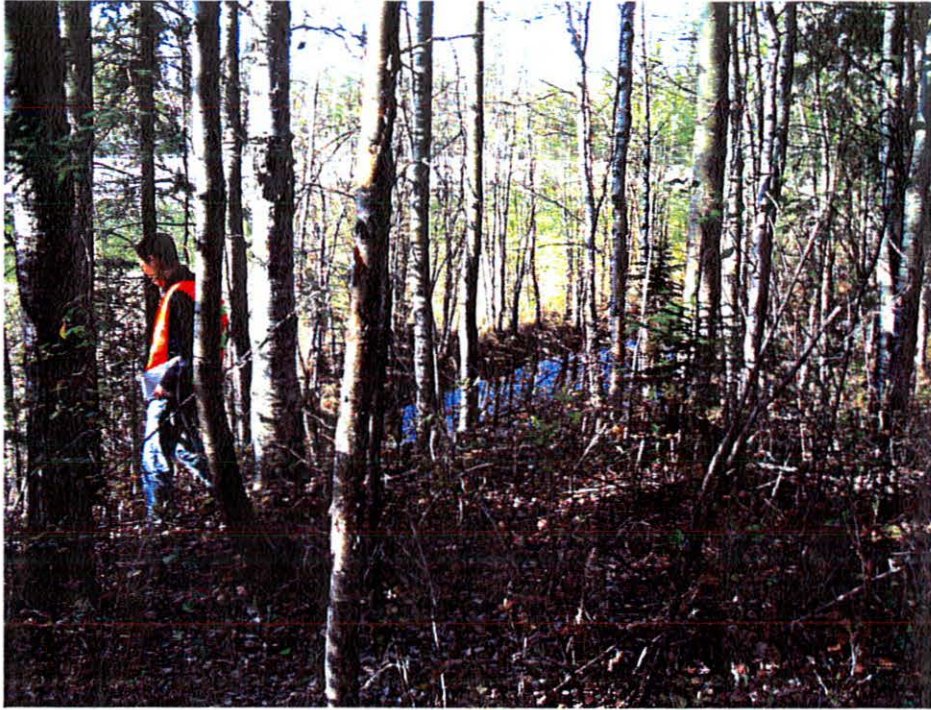
The confined low area adjacent to the south ditch was once again full of water.

Photo 1 - Confined low area adjacent to the south ditch. Ponded water is visible, May 24, 2007.

Details for the infill of the low area adjacent to the south ditch were discussed in the last report. Borrow material could be taken from ridges in the slope behind the low area as described in our 2006 report.

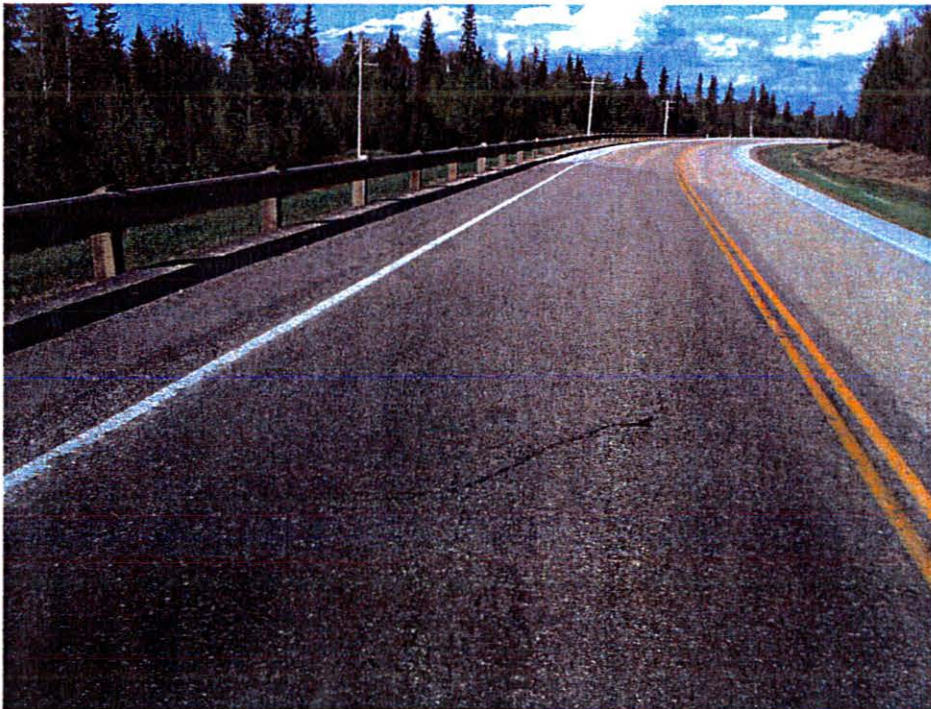
Photo 2 - Transverse crack through the patched area, May 24, 2007.

In the short term the site should be regularly inspected by the MCI to determine when further asphalt patching maintenance is required to maintain a smooth even road surface for traffic safety.

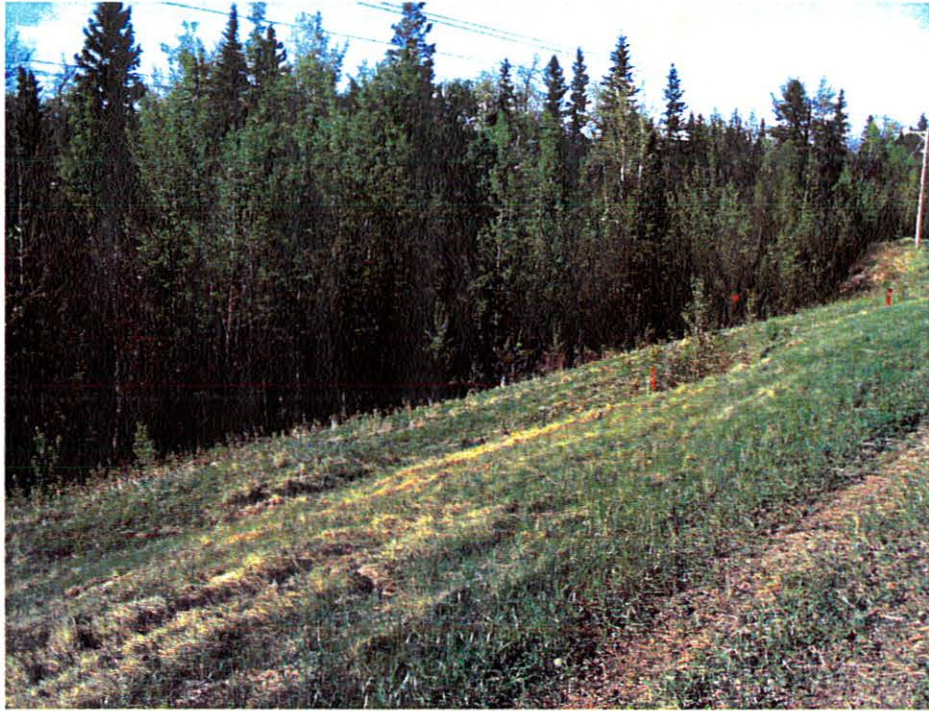
Photo 3 - Looking north at the distress area, May 24, 2007.

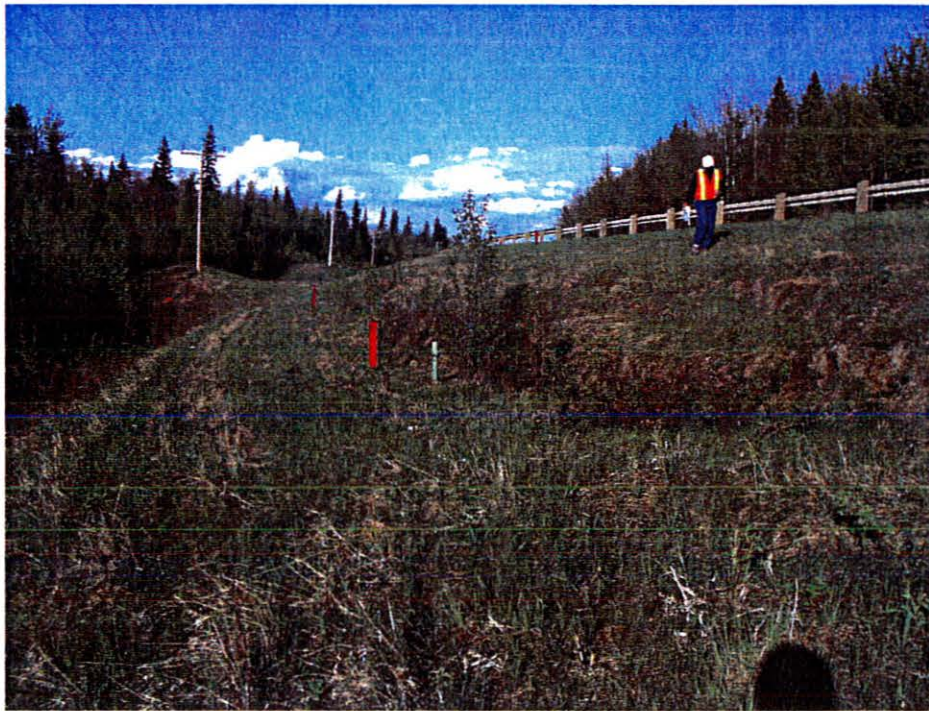
The tilting powerpole (observed last year), somewhat active scarp, a slight increase in movement rate and in pore pressures are all indicative of an active slide. As was mentioned last year, this could develop to a larger slope movement during heavy or prolonged precipitation events.

Photo 4 - Western portion of the scarp, May 24, 2007.

Due to some activity at the western portion of the slide area, the MCI should also regularly check for any new development at this location.
