GEOHAZARD ASSESSMENT PROGRAM
NORTH CENTRAL REGION – ATHABASCA

2010 INSPECTION

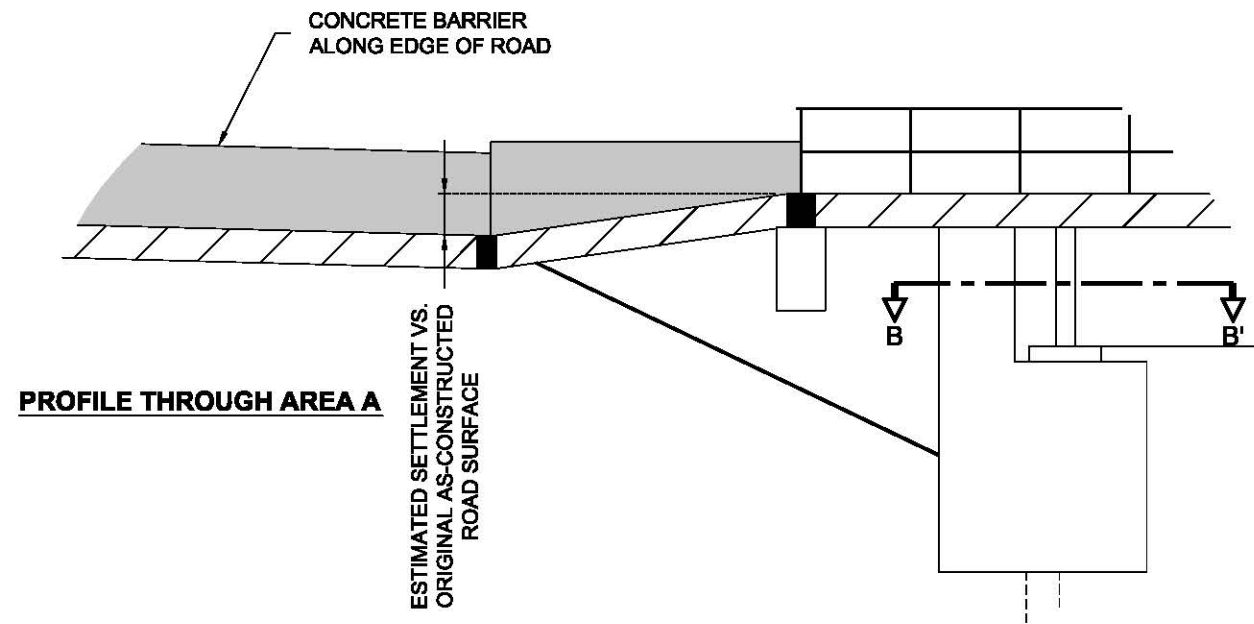
PROFILE THROUGH AREA A

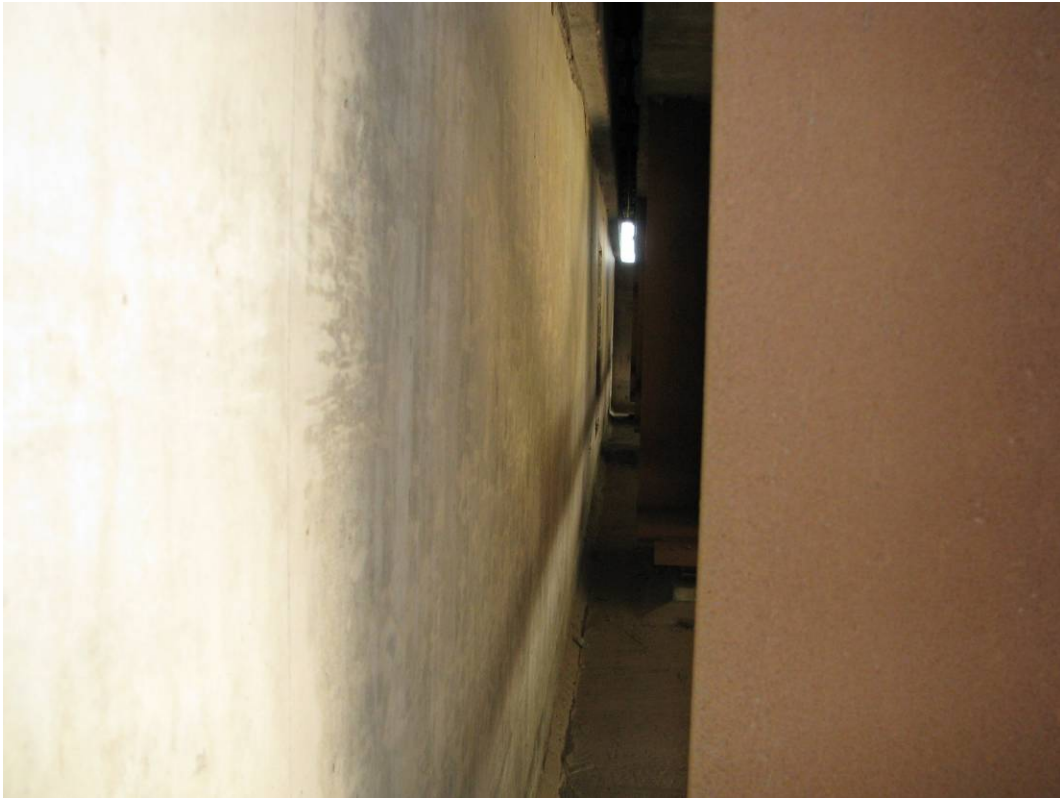
Photo #5 Looking along the west abutment wall face. No signs of abutment wall cracking/bulging. The clear space varied between the abutment wall face and girder ends from 180-200 mm (looking north)

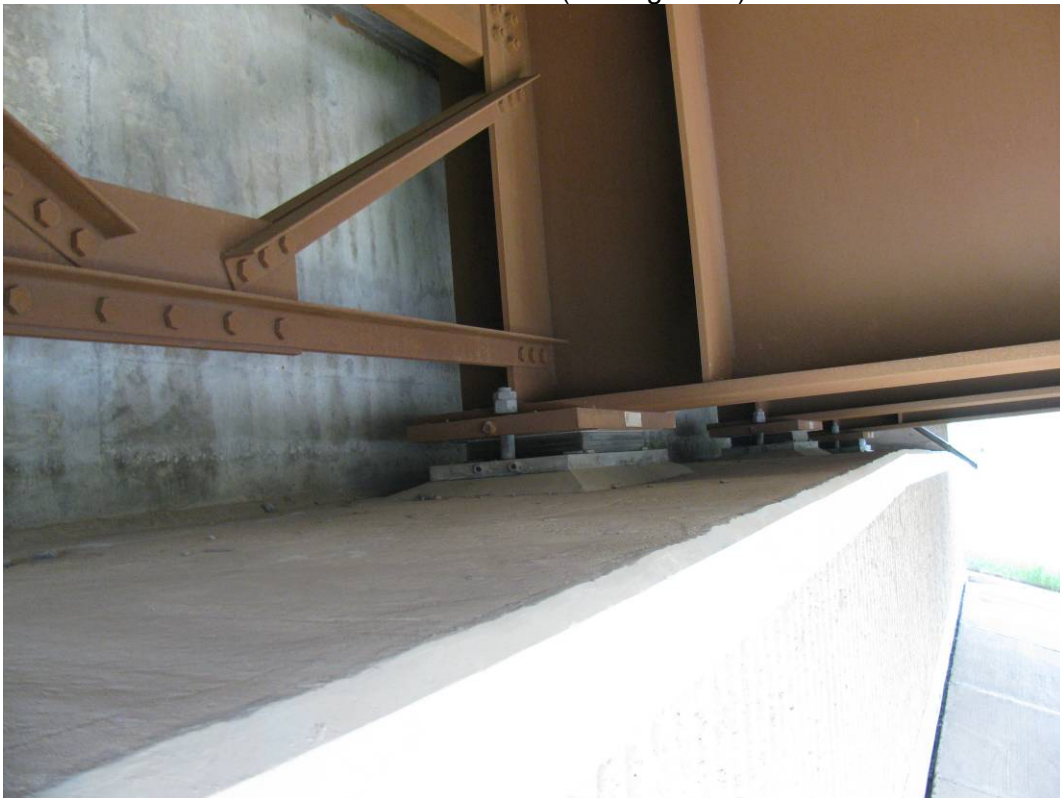
Photo #6 Looking northwest at the bridge girder bearings; no signs of distortion in the steel girder bearings
