**GEOHAZARD ASSESSMENT PROGRAM**  
**NORTH CENTRAL REGION – ATHABASCA**  
**2011 INSPECTION**

Site Number	Location	Name	Hwy	km
NC 35	City of Fort McMurray	King Street Bridge over Highway 63 in Fort McMurray: West Approach Slab Settlement	63:11	8.0
<b>Legal Description</b>		<b>UTM Co-ordinates (NAD 83)</b>		
NE 22-88-09-W4M		12 N 6284716	E 478265

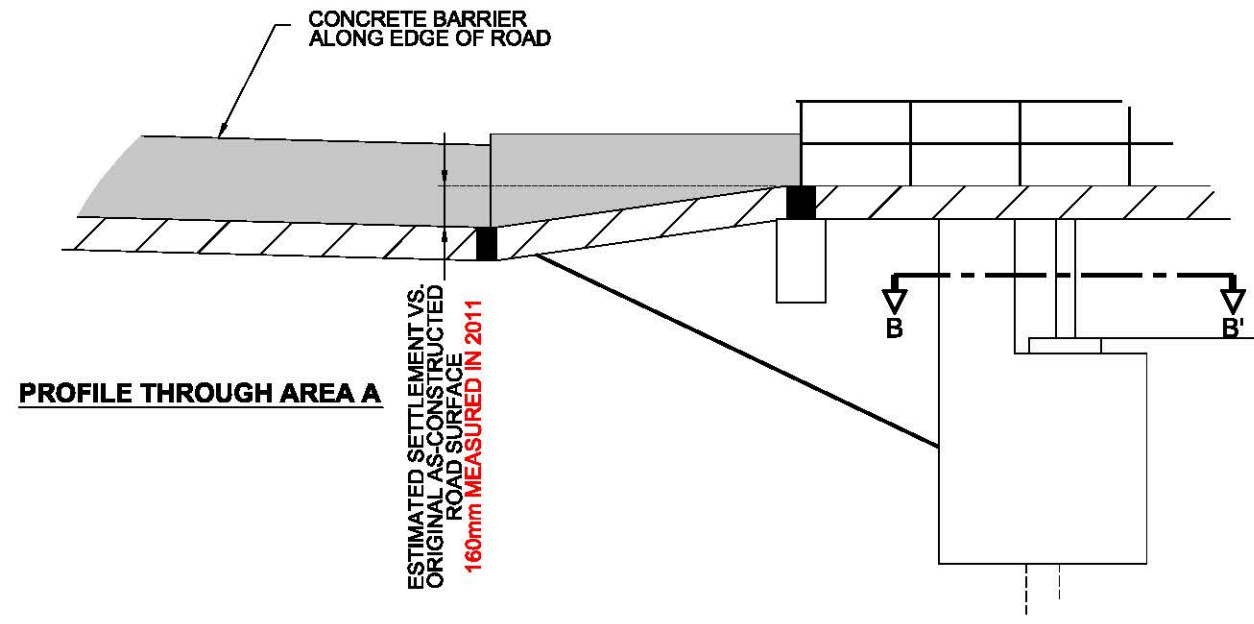
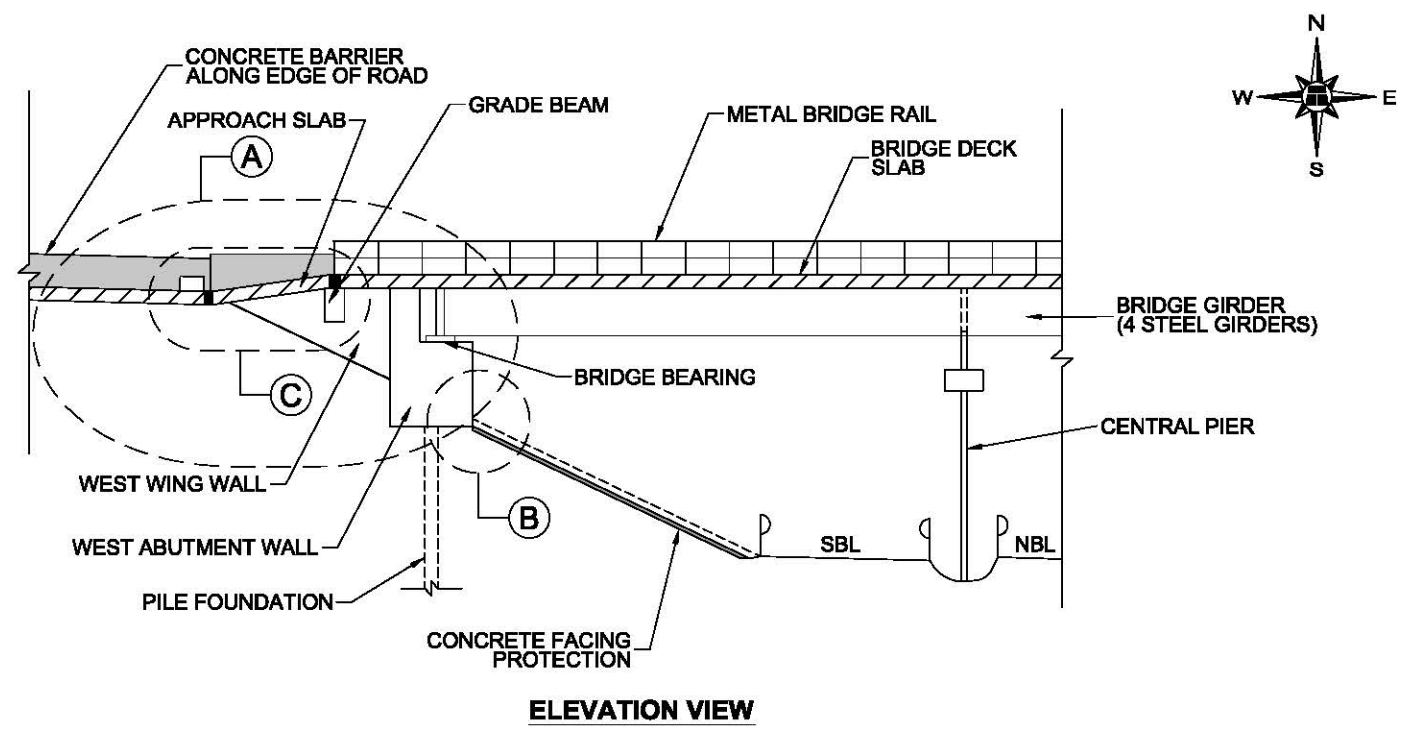
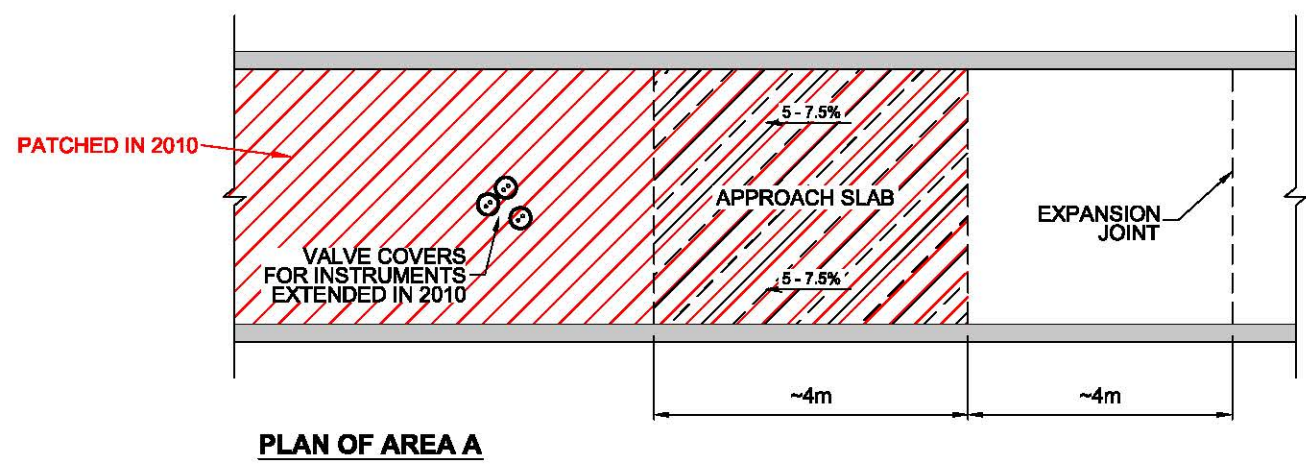
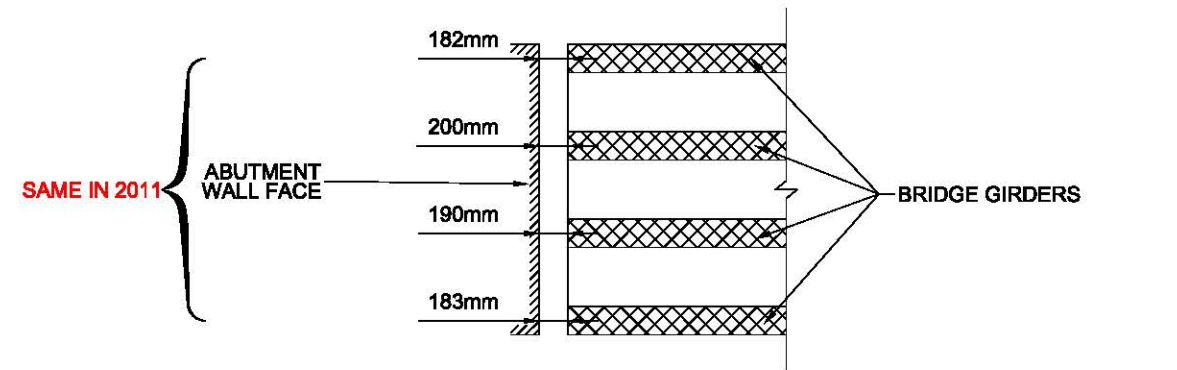
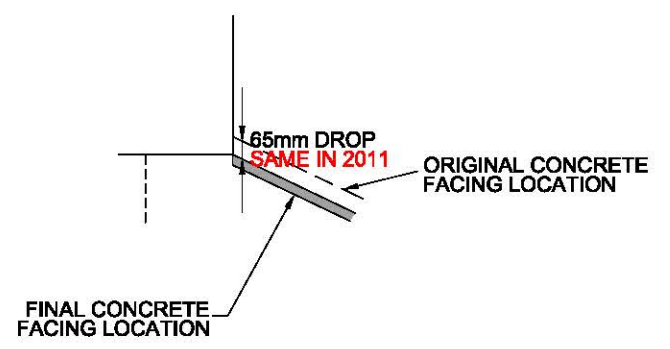
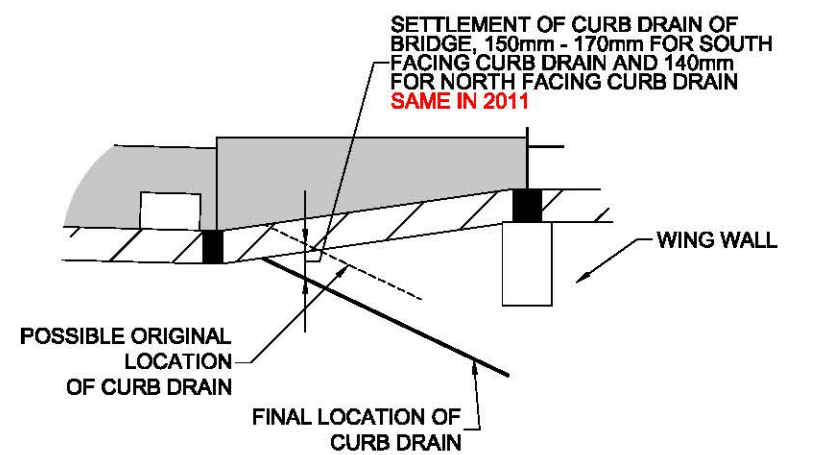
**FIGURE NC35-1**  
**NC35 - HWY 63:11 KING STREET BRIDGE**  
**WEST HEAD SLOPE SETTLEMENT - BF78154**  
**NE 22-88-9 W4M, FORT McMURRAY, AB**

The new pavement overlay provided a smooth ride to motorists and eliminated the safety concerns. Apart from filling the depression on the top of the bridge, the site conditions remained unchanged since the 2010 inspection event.

The depression developed at the end of the bridge was probably due to the settlement of the approach fill slab as a result of the continued self-weight settlement of the clay fill and the long-term consolidation of the native clay underlying the fill over the past years. The lateral slow creep movement of the clay fill and underlying native clay was probably another contributing factor to the current condition.

**NOTE:**  
MAY 5, 2011 OBSERVATIONS ARE SHOWN IN RED

This site could be removed from the Geo-hazard Assessment Program. The local MCI should continue to closely monitor the site and inform Thurber if the site conditions changed significantly.

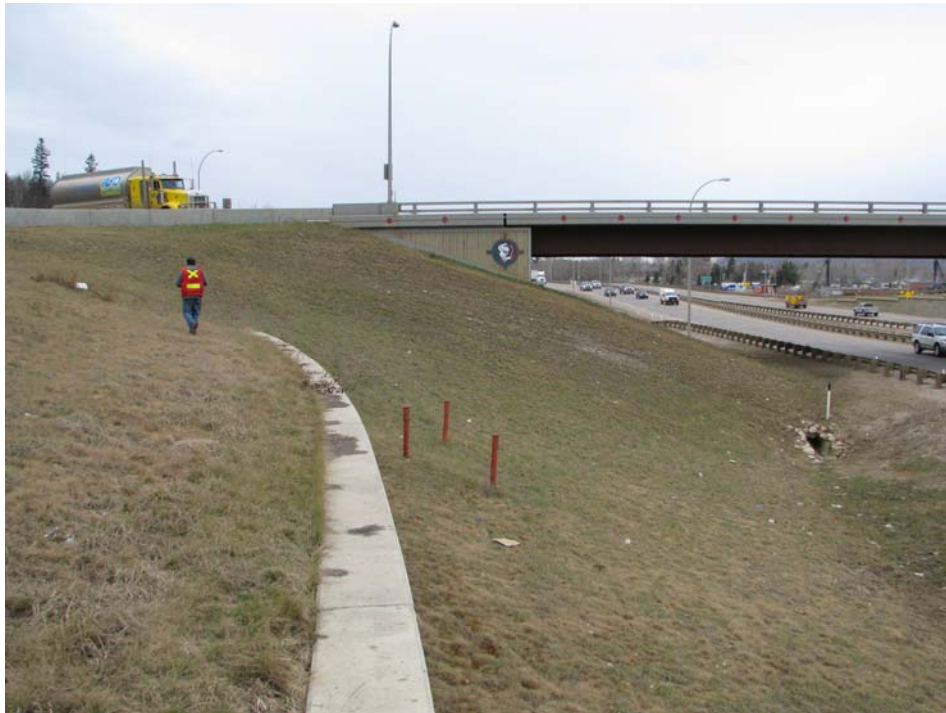
**Photo #1** General view of the west side of the bridge (looking northwest)

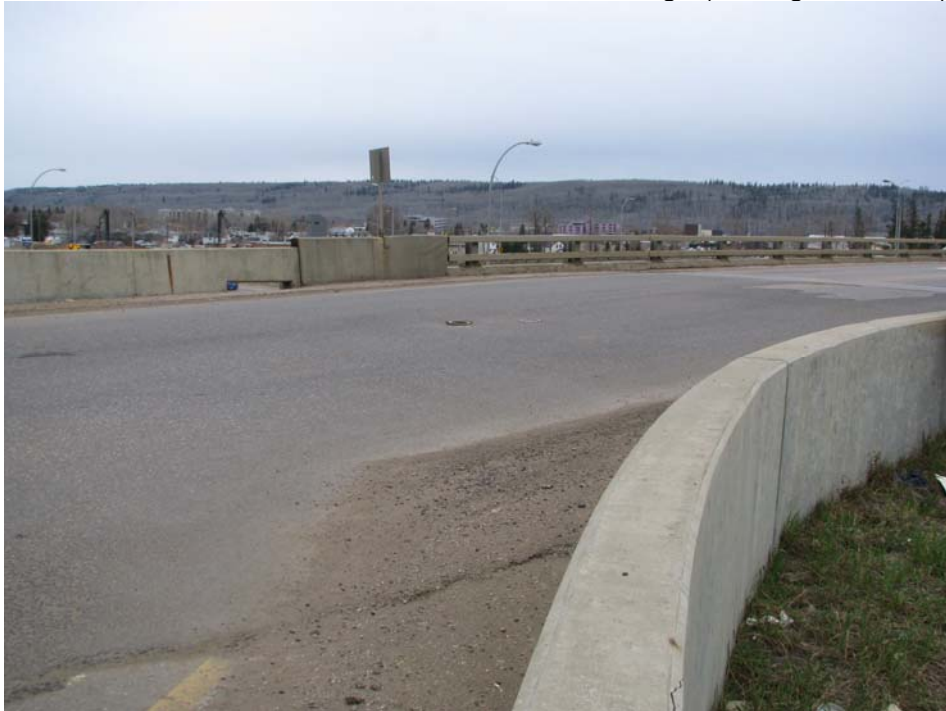
**Photo #2** ACP overlay placed on the top of the bridge (looking north east from top of west head slope)

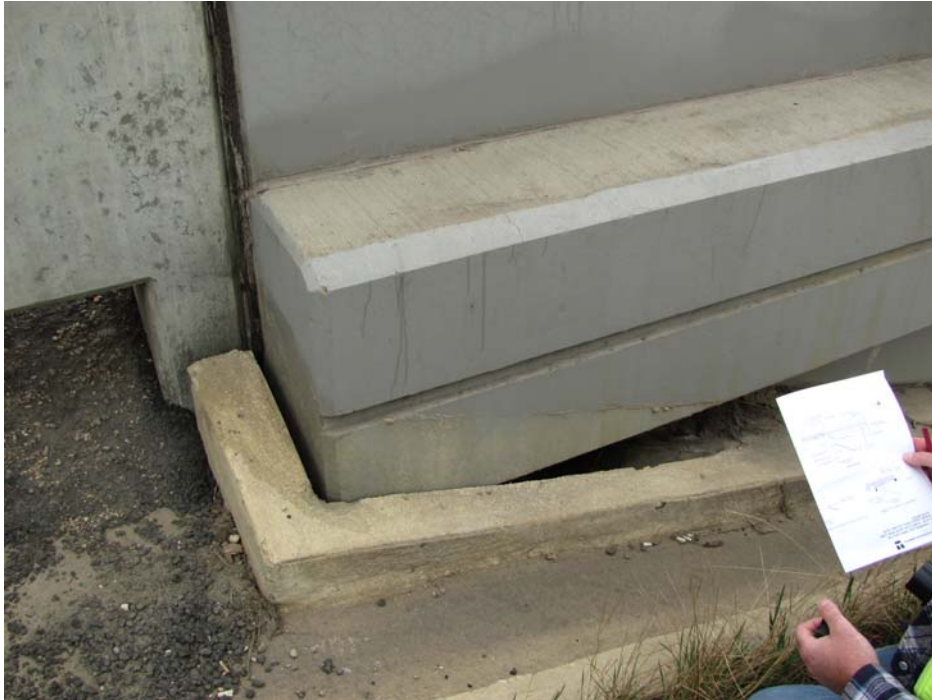
**Photo #3** Settlement of bridge curb drain; the change in color of the side barrier signifies the original location of drain prior to settlement (looking north)

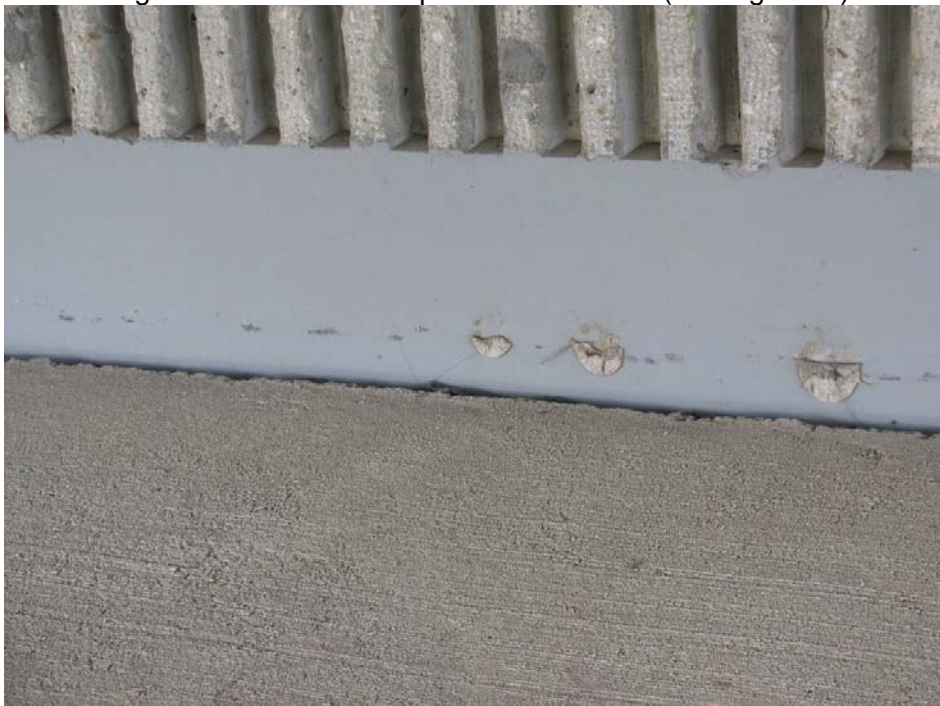
**Photo #4** Settlement of west headslope concrete facing. Note the dents on abutment wall seat (looking west)

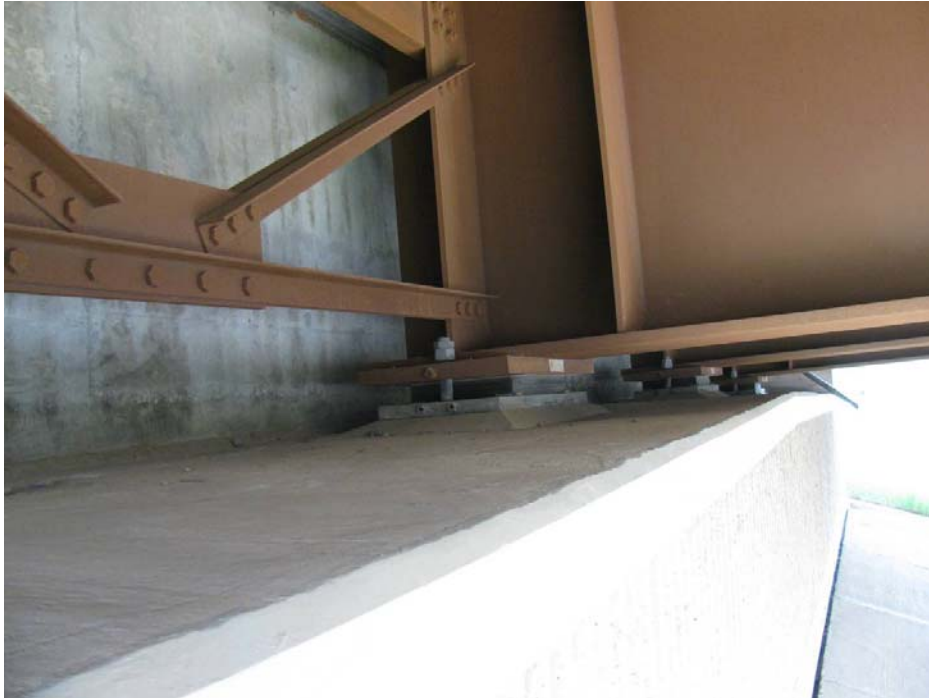
**Photo #5** Looking northwest at the bridge girder bearings; no signs of distortion in the steel girder bearings

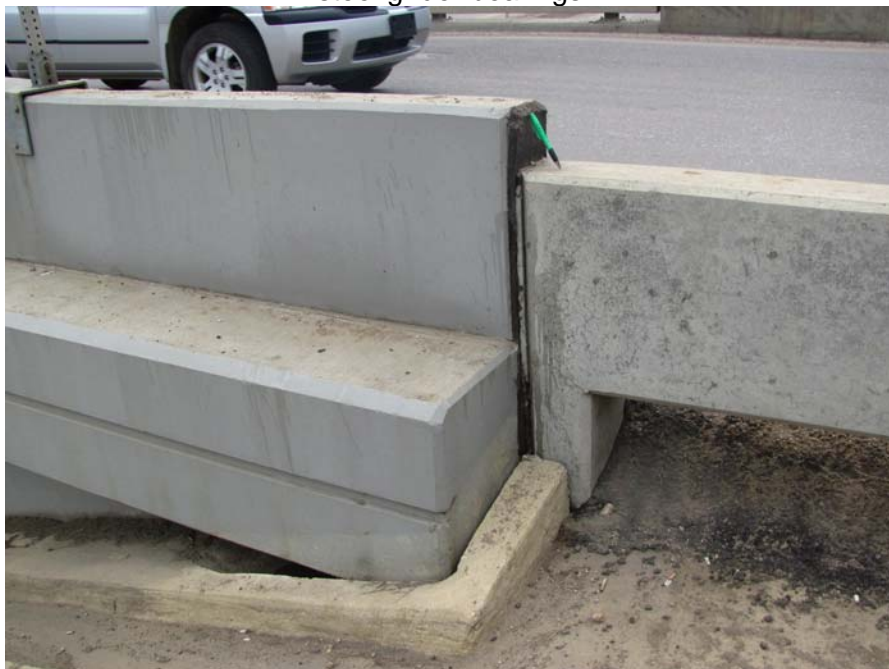
**Photo #6** Looking southwest at the concrete barrier; the concrete barrier dropped by about 160 mm
