December 21, 2007

File: 15-85-66

NORTH CENTRAL REGION (ATHABASCA AREA) GEOHAZARD ASSESSMENT HWY 63:12 BACKSLOPE SLUMPS (NC 17C), NORTH OF FORT MCMURRAY 2007 ANNUAL INSPECTION REPORT

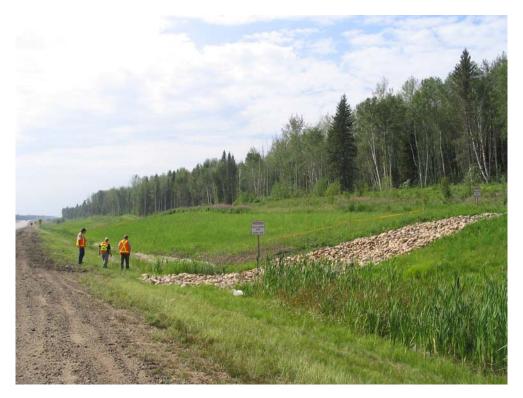
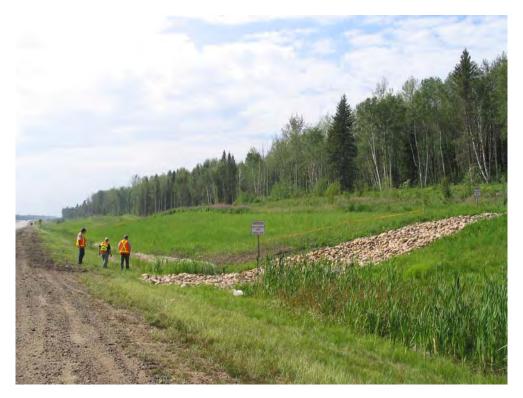
Photo 1 - Repaired North Slump Area and swale.

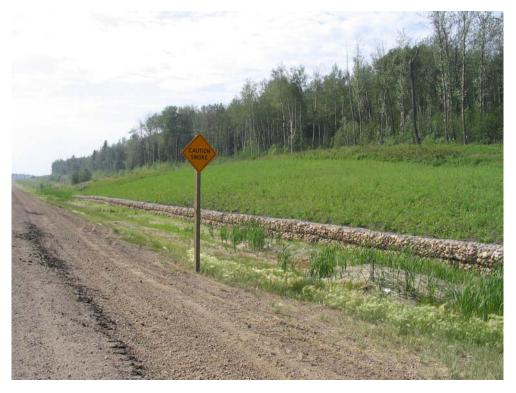
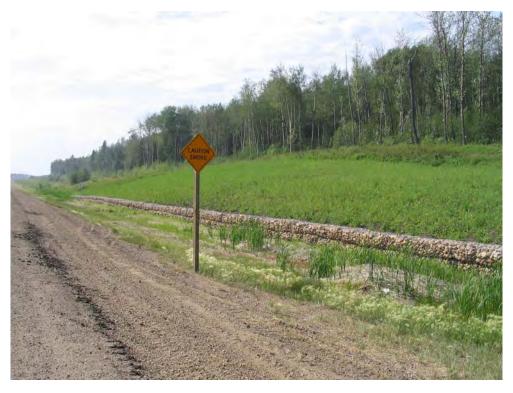
Photo 2 - Repaired South Slump Area.

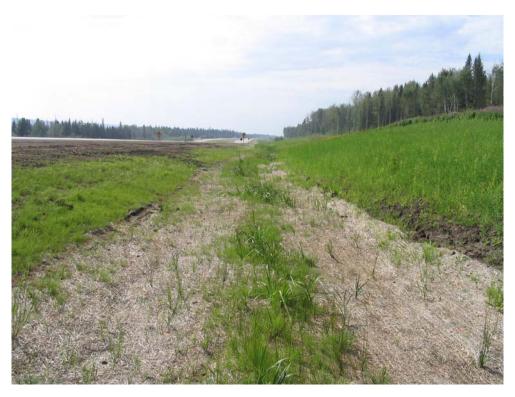
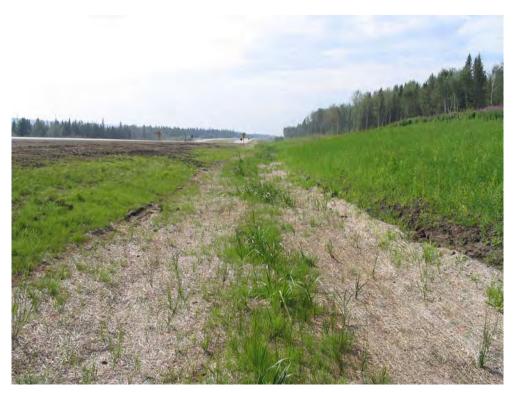
Photo 3 - Highway Ditch in Regraded Section.

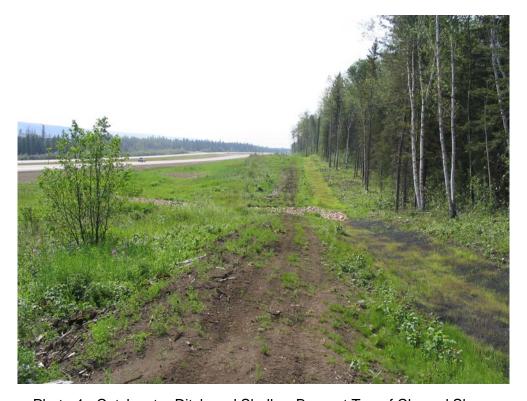
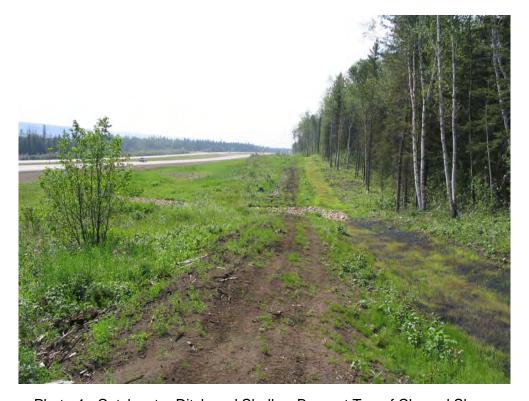
Photo 4 - Catchwater Ditch and Shallow Berm at Top of Cleared Slope.

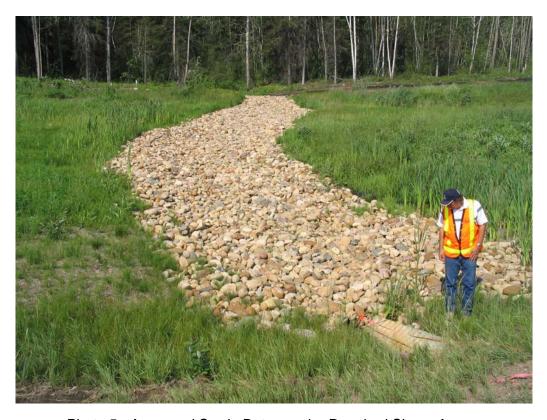
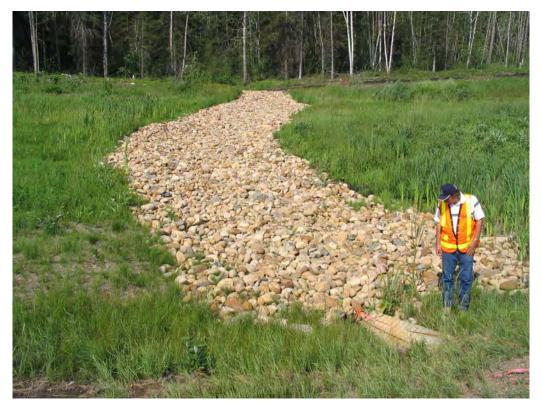
Photo 5 - Armoured Swale Between the Repaired Slump Areas.
