**NORTH CENTRAL - ATHABASCA**  
**GEOHAZARD RISK ASSESSMENT**  
**SITE INSPECTION FORM**

SITE NUMBER AND NAME: <b>NC17C: Hwy 63 Backslope Slumps</b>		HIGHWAY & KM Hwy 63:12 Km 11.3 to 11.6	PREVIOUS INSPECTION DATE: July 17, 2007	INSPECTION DATE: July 8, 2008
LEGAL DESCRIPTION: SW7-91-09-W4M	UTM COORDINATES (NAD83): 12 472593 E 6303916 N		RISK ASSESSMENT PF: 1 CF: 10 TOTAL: 10

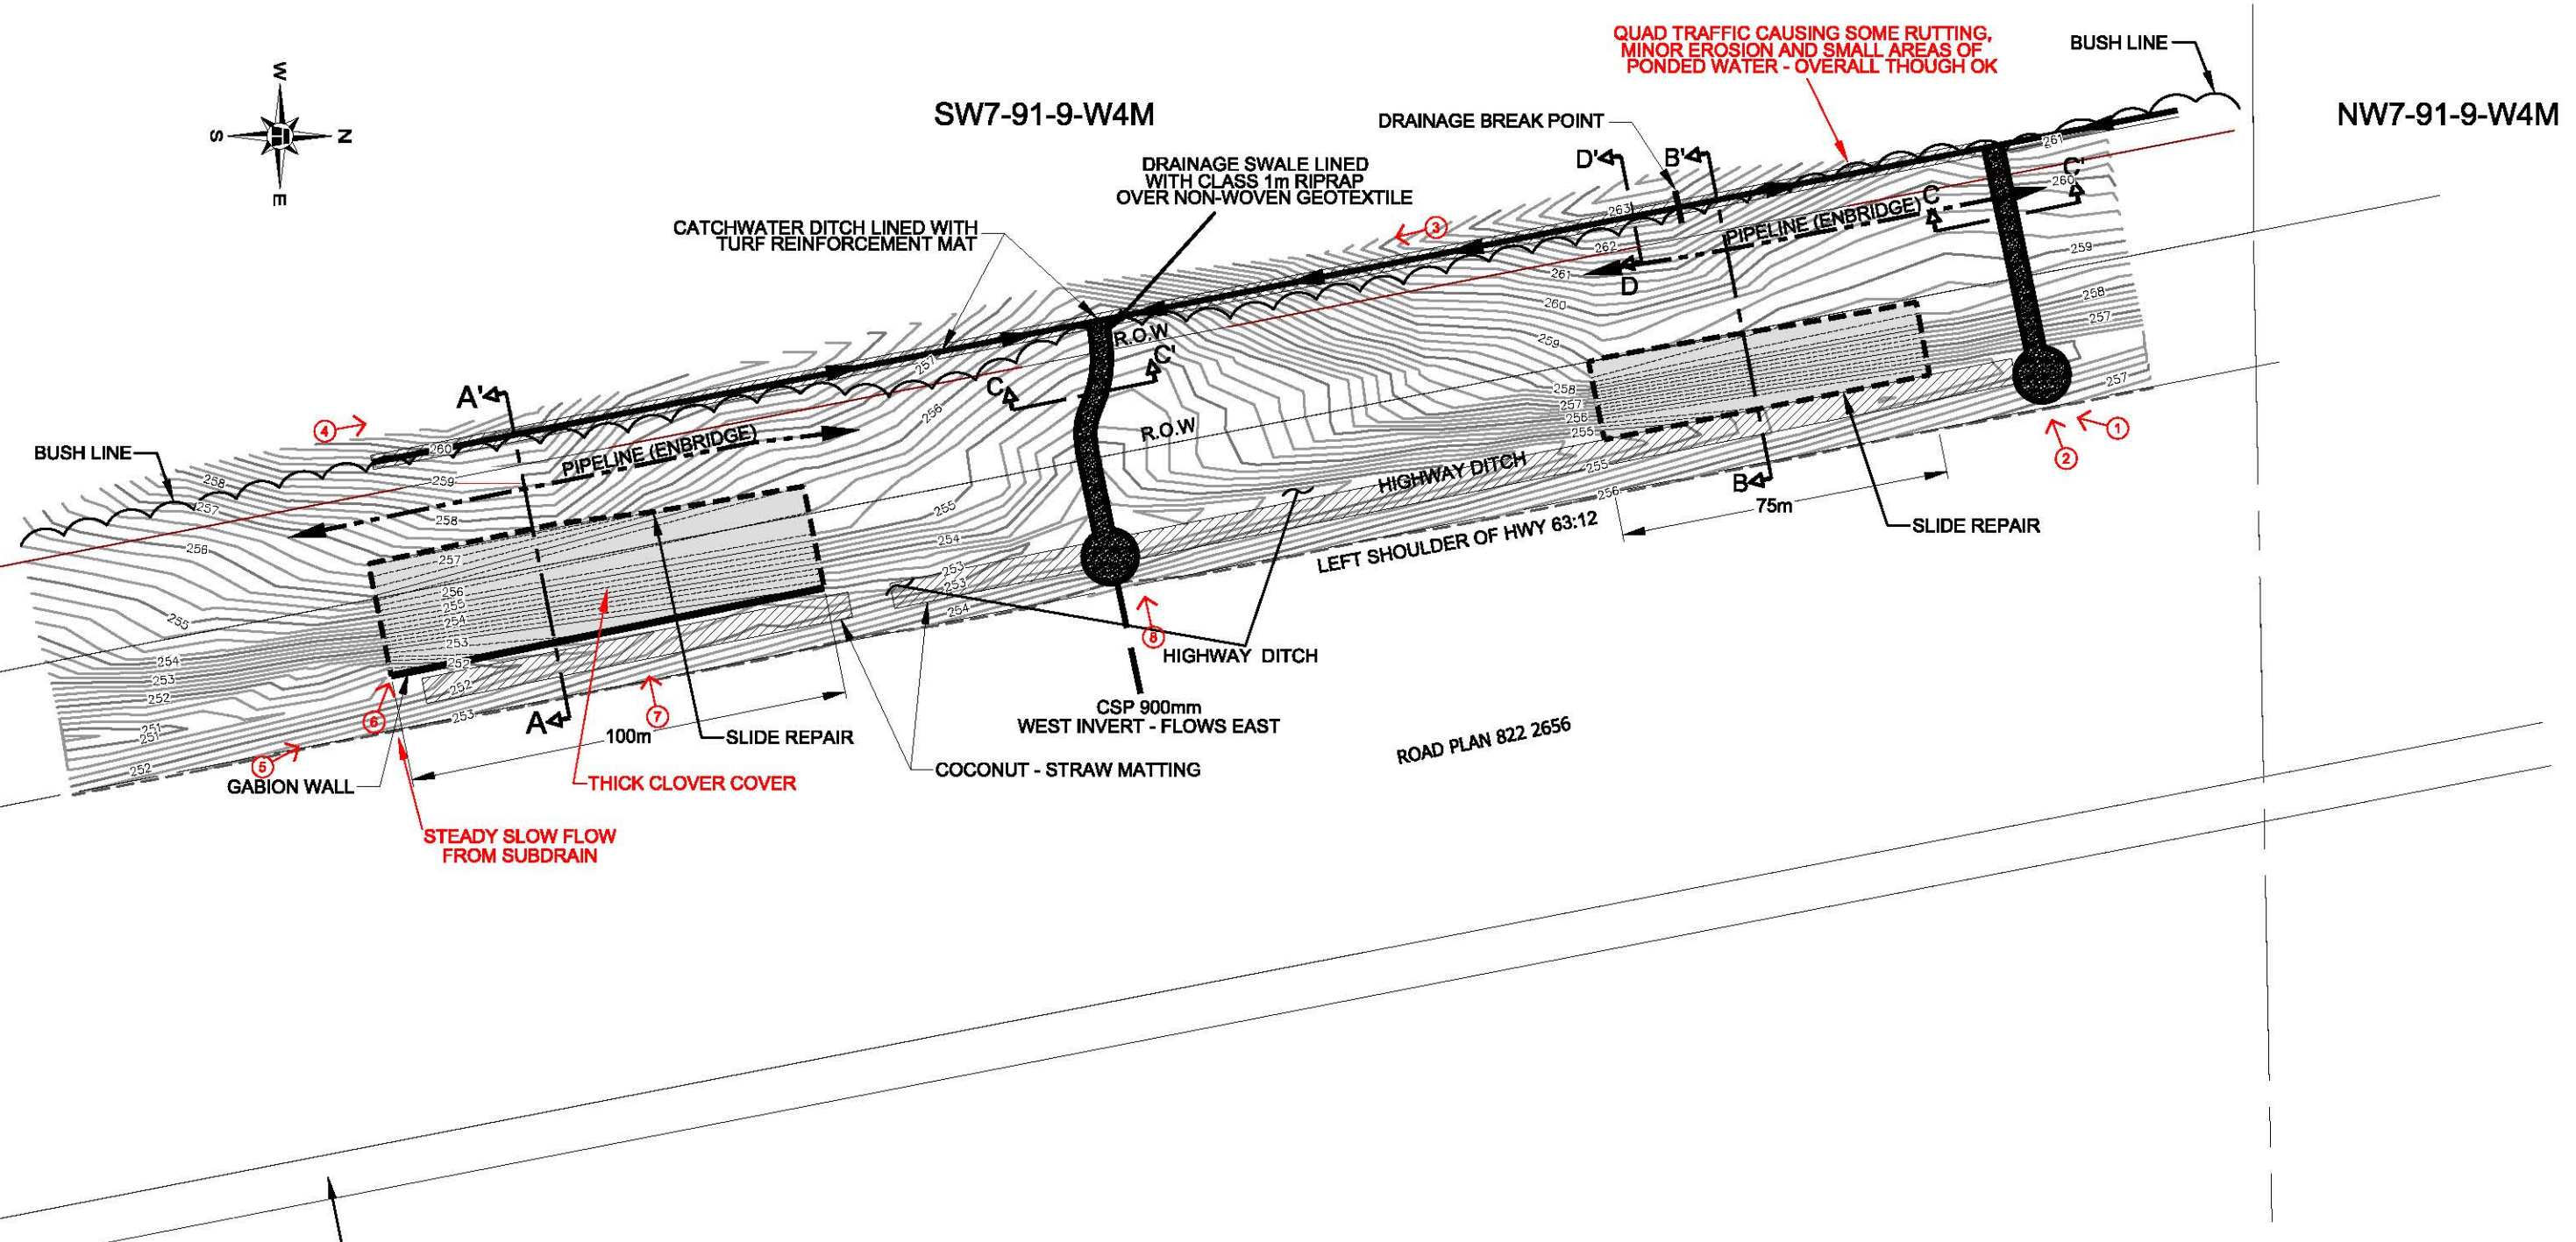
The slide repairs appear to be working very well. There were no signs of instability at the slide repair locations. Quad traffic has created some ruts along which some shallow erosion has occurred but the degree of erosion does not currently warrant additional remedial measures to be carried out.

This site may be removed from the yearly geohazard assessment program. The MCI should periodically inspect the quad trails to determine whether any erosion repair or prevention measures are required.

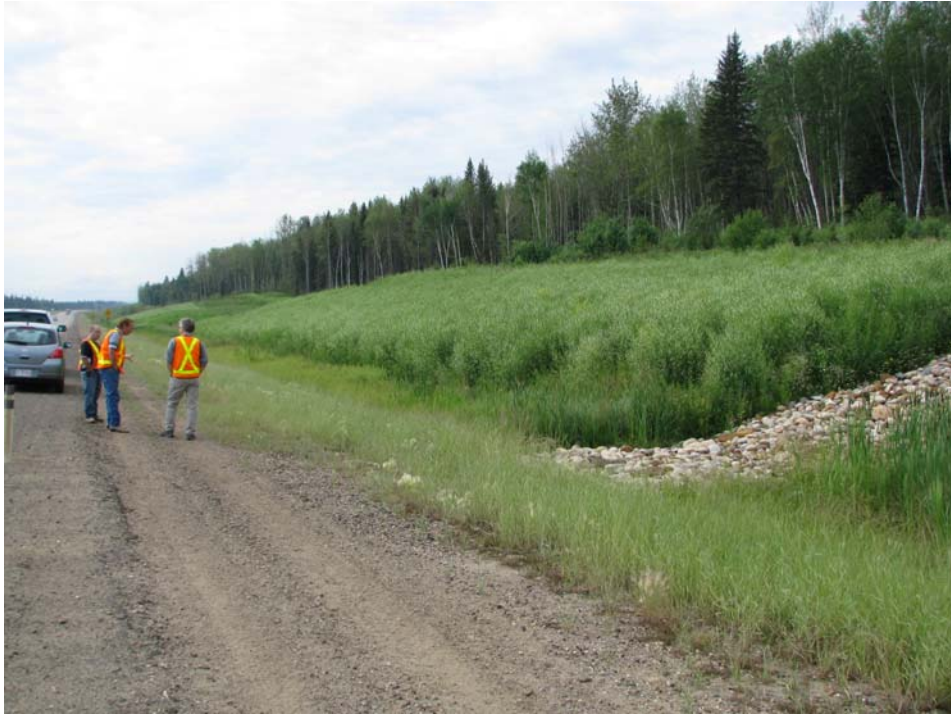
Photo 1 - North Slump, looking south (July 8, 2008).

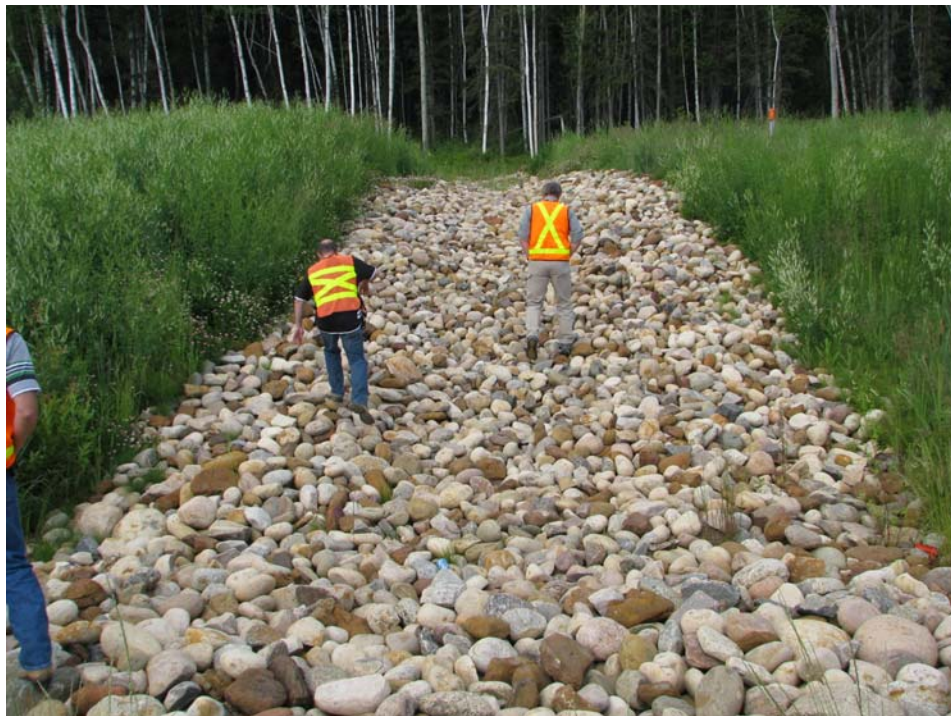
Photo 2 - North swale (July 8, 2008).

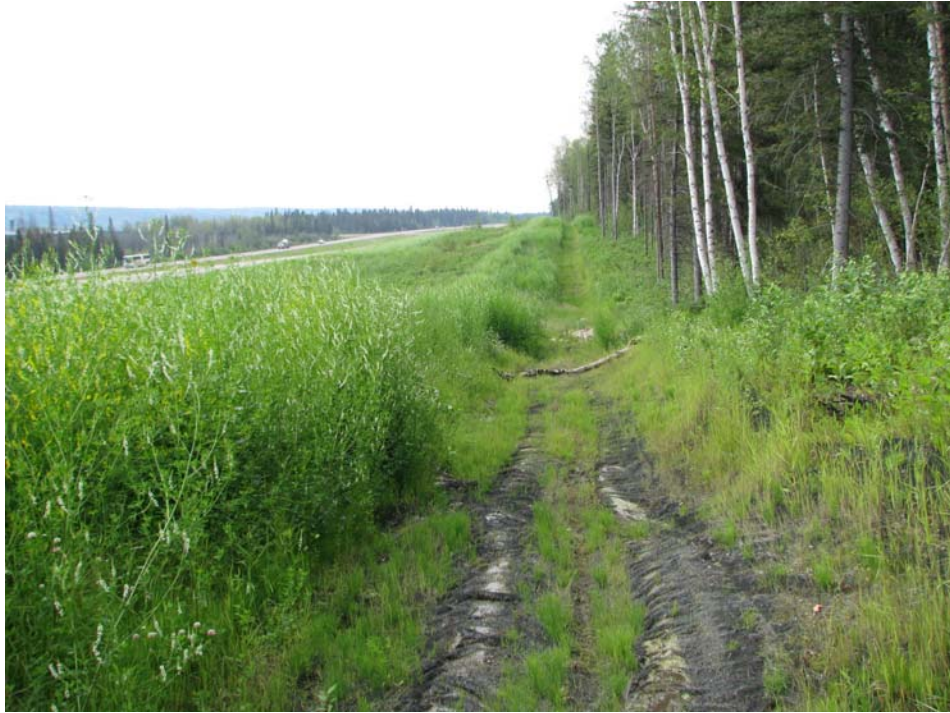
Photo 3 - Catch water ditch, looking south (July 8, 2008).

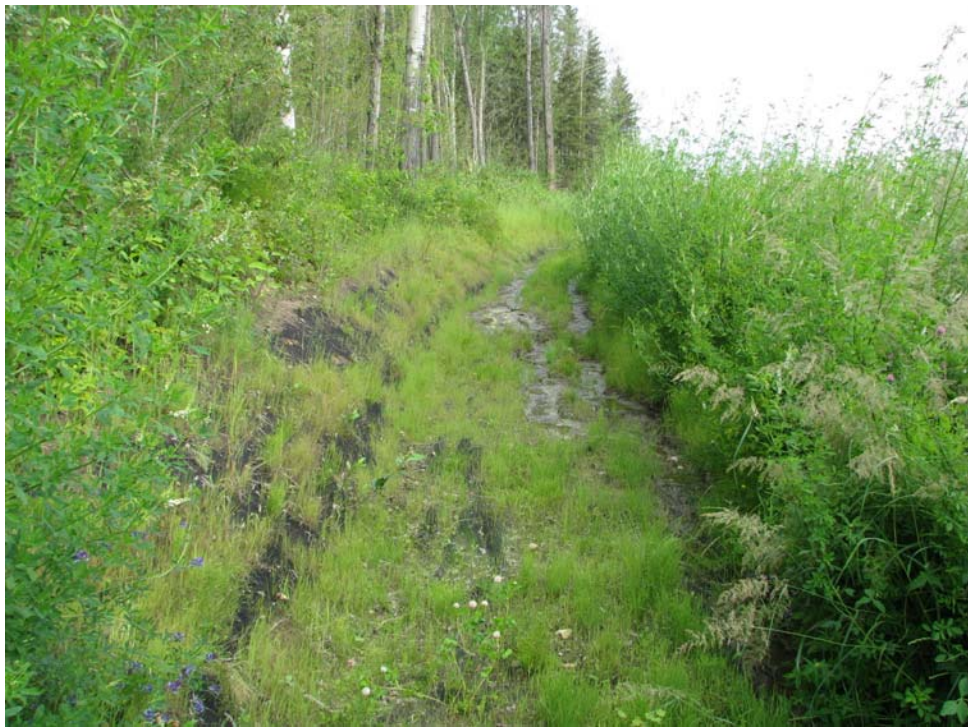
Photo 4 - South end of the catch water ditch, looking north (June 8, 2008).

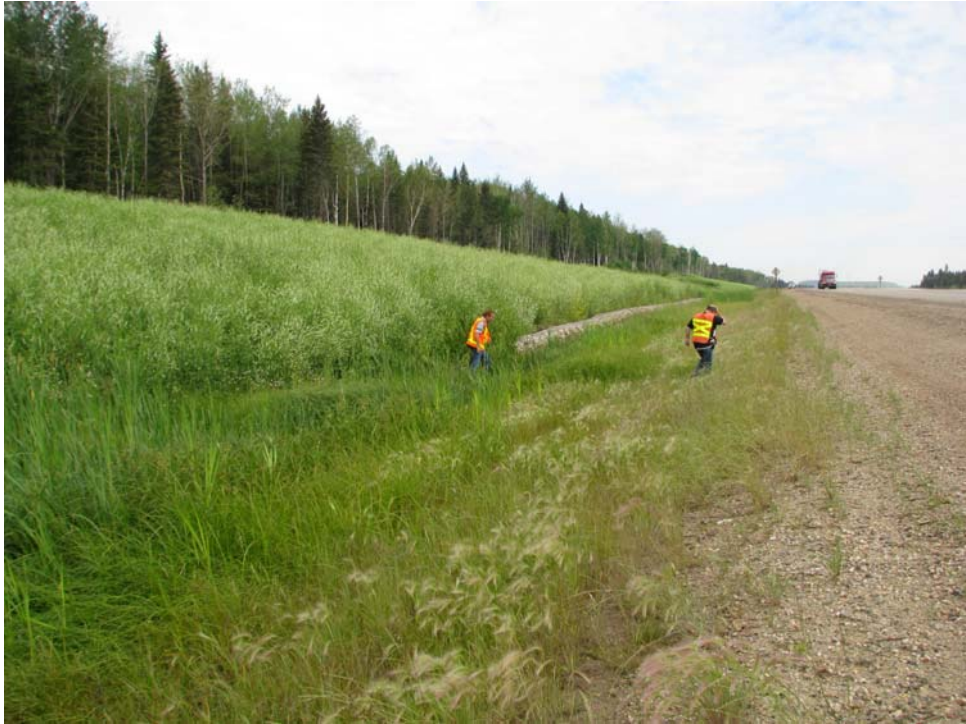
Photo 5 - Looking northwest at the South Slump repair (July 8, 2008).

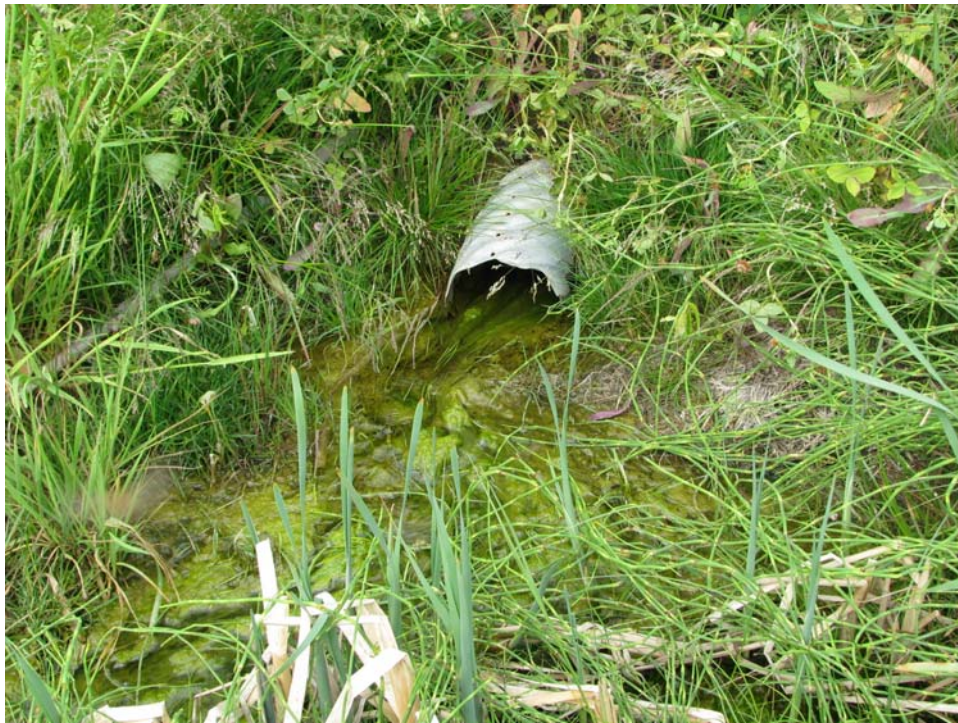
Photo 6 - Seepage from the subdrain of the South Slump repair (July 8, 2008).

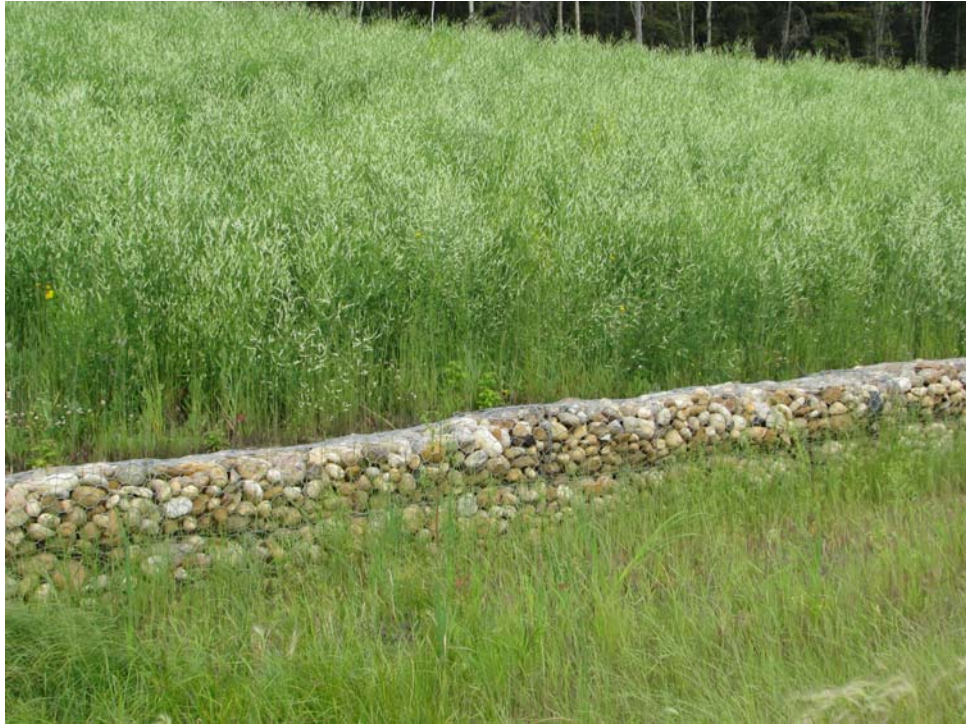
Photo 7 - Looking west at the South Slump repair (July 8, 2008).

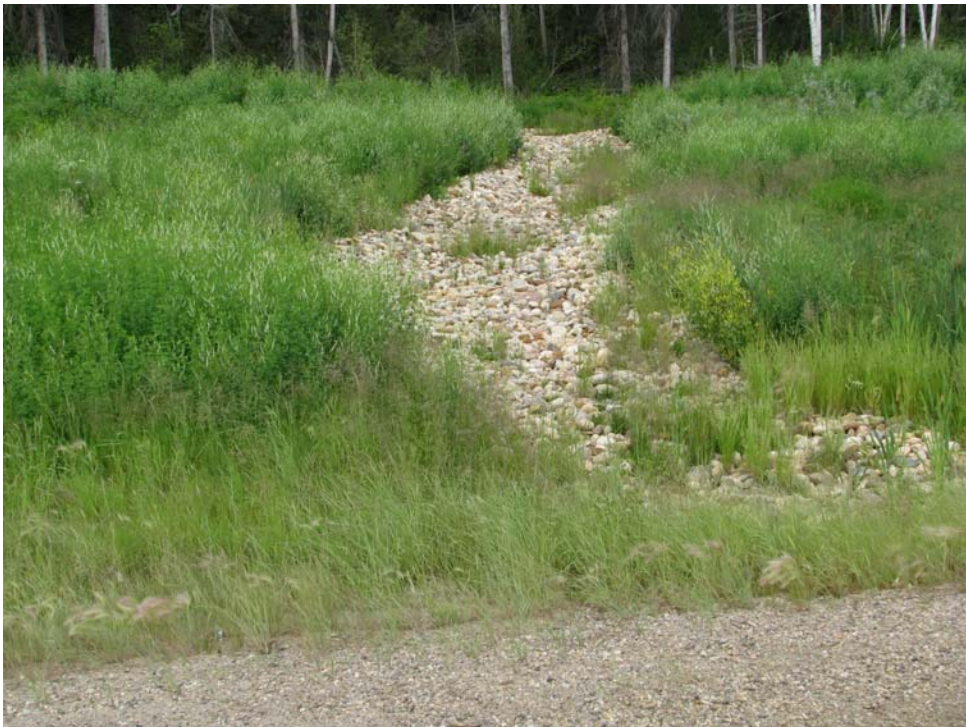
Photo 8 - South swale (July 8, 2008).
