THURBER ENGINEERING LTD.
GEOTECHNICAL • ENVIRONMENTAL • MATERIALS

File: 15-85-32

**NORTH CENTRAL REGION GEOHAZARD ASSESSMENT
HWY 754:02 km 10.2, km 10.45, AND km 10.8 (NC 41)
NORTH OF SLAVE LAKE
2006 ANNUAL INSPECTION REPORT**

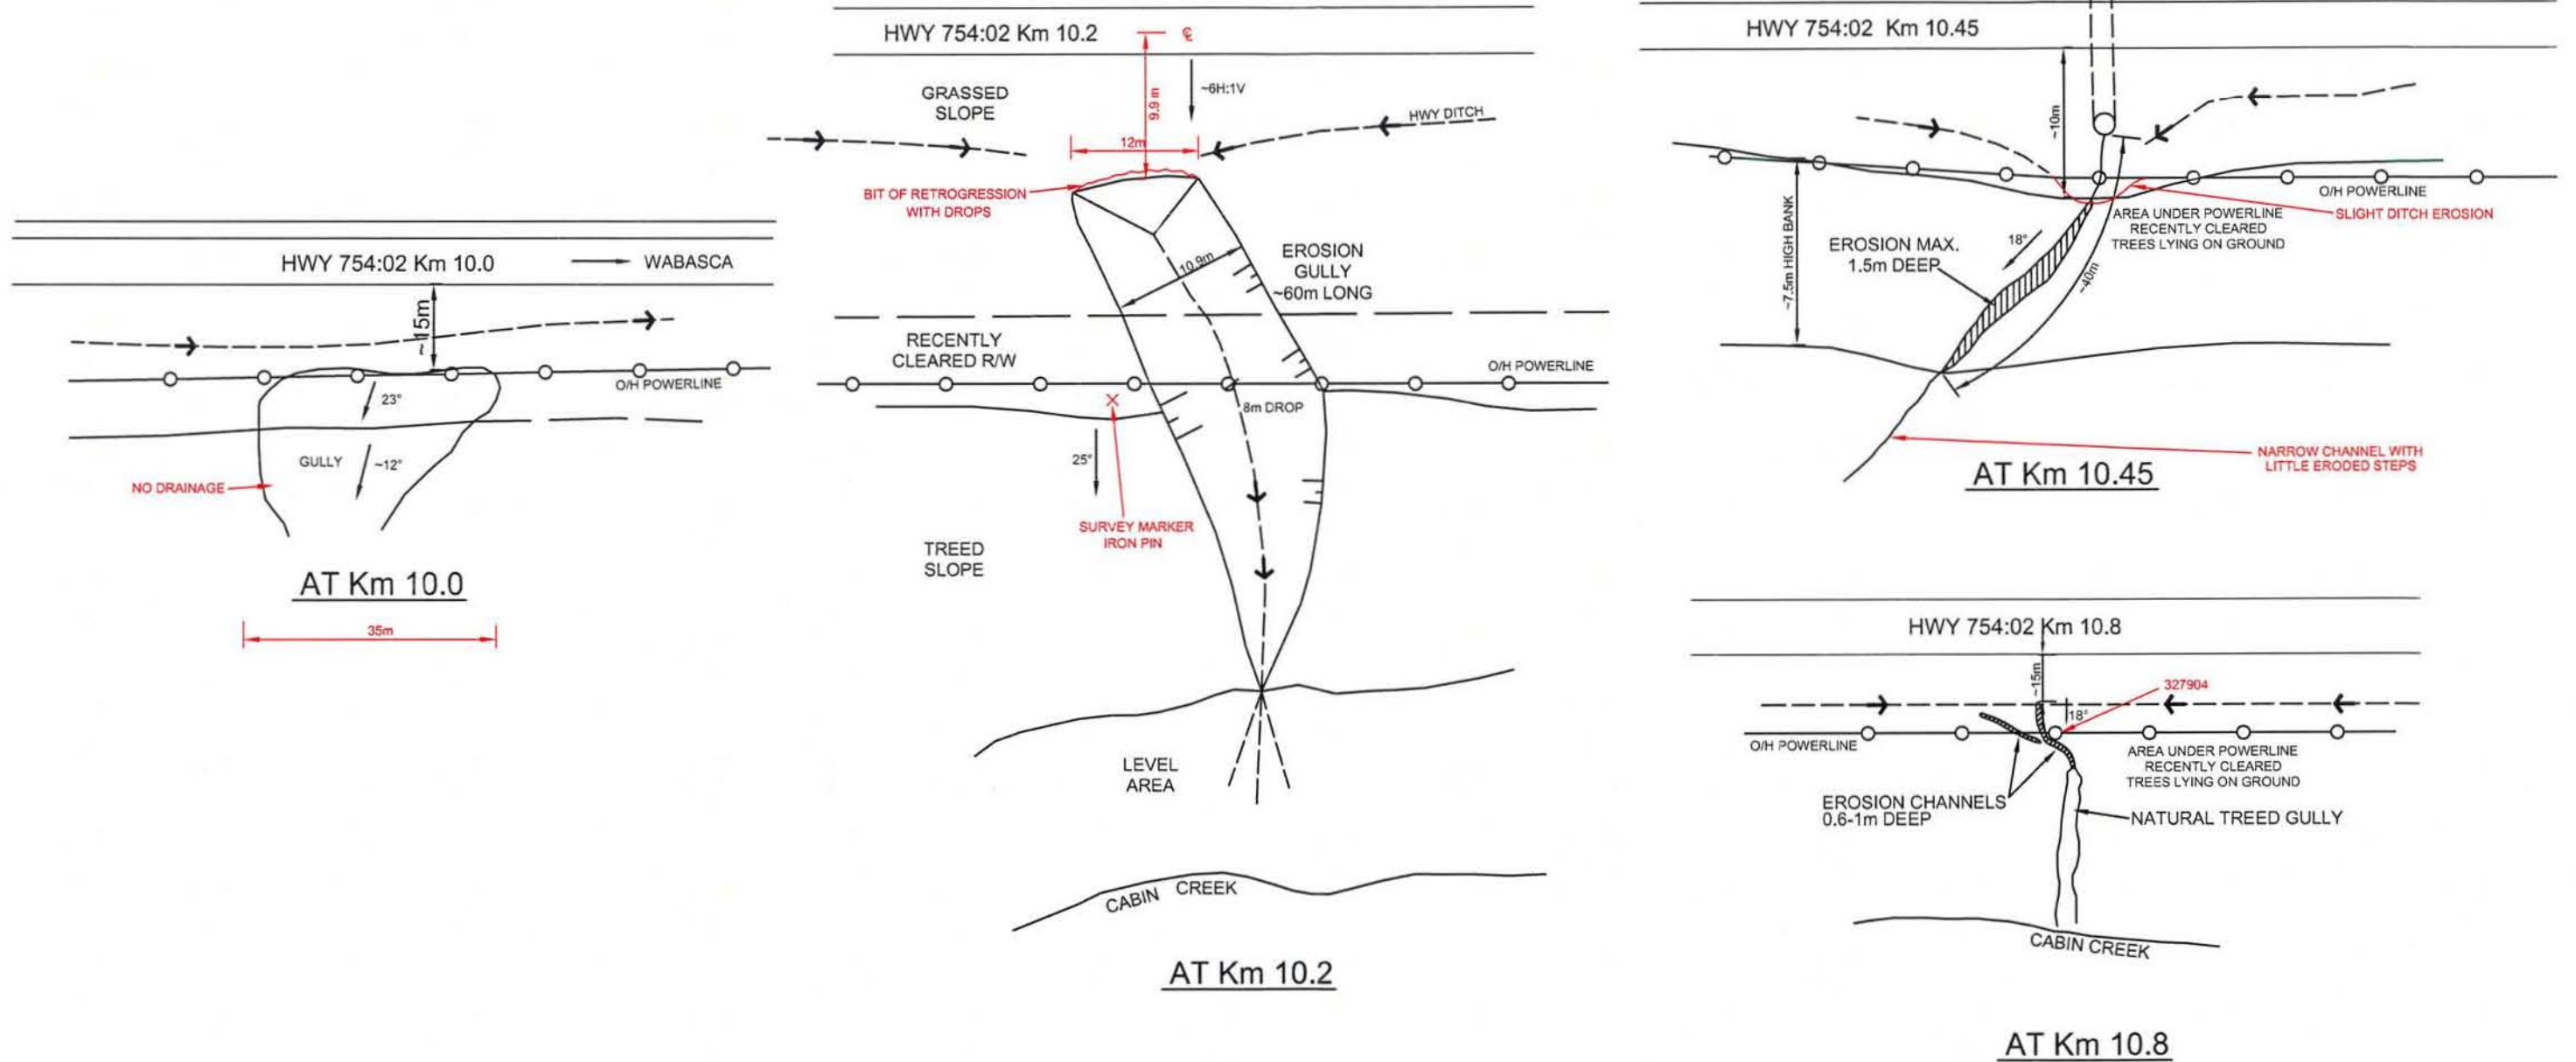
FIGURE NC41-1 SKETCH SITE PLANS
NC41- HWY 754:02 - Km10.0, 10.3, 10.45, AND 10.8

The changes in conditions noted at each of the sites since last year are shown on the site sketch plan, Figure NC41-1, attached for inclusion in Appendix F of the binder. Selected photographs taken during the visit are also attached.

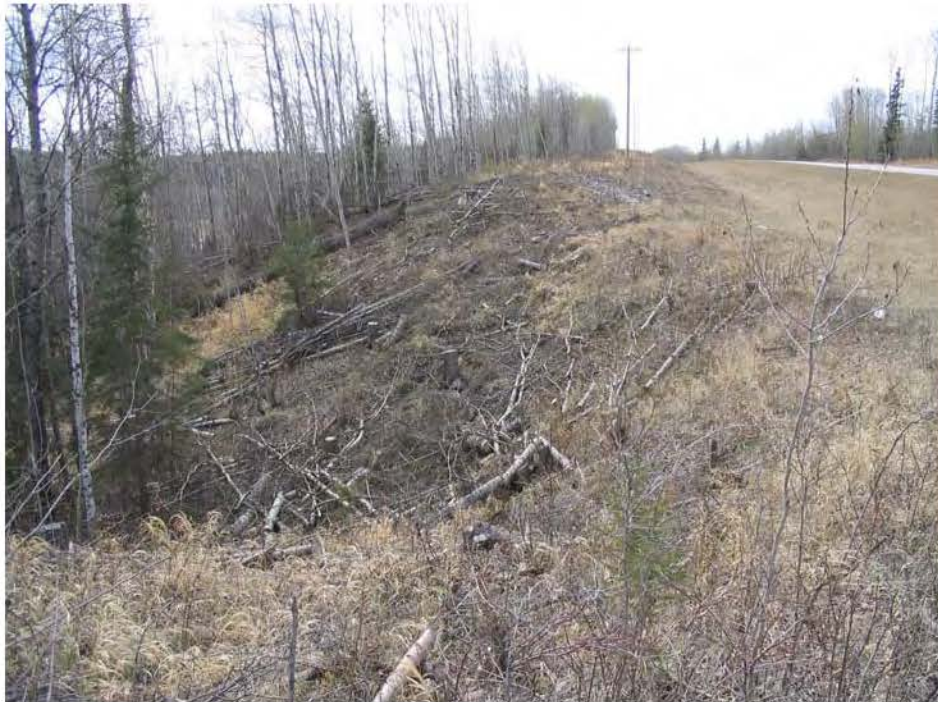
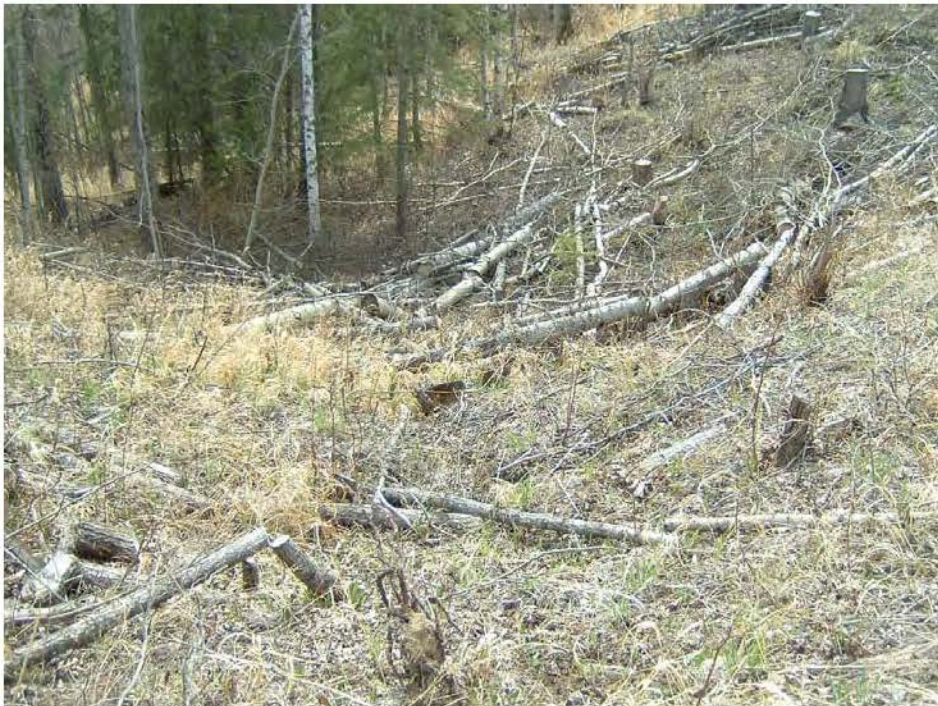
The gully had been created by erosion and is currently covered by grass, shrubs and debris left from clearing bushes. The erosion gully was dry, with no signs of seepage or active erosion noted at the time of the site reconnaissance. The width of the gully is approximately 35 m.

Photo 1 & 2 Looking at the Gully at km 10.0, May 2, 2006.

For public safety, it is recommended to install a guard rail at km 10.0 and 10.2 locations close to the crest of the gullies. At km 10.2, before installing the guard rails, a gravel wedge may be constructed in the upper slope to reduce the retrogression of the crest and side slopes of the gully.

At km 10.0, the berm to divert ditch flow into the gully could be about 0.3 m high and 2 m wide at the top with 3:1 side slopes.

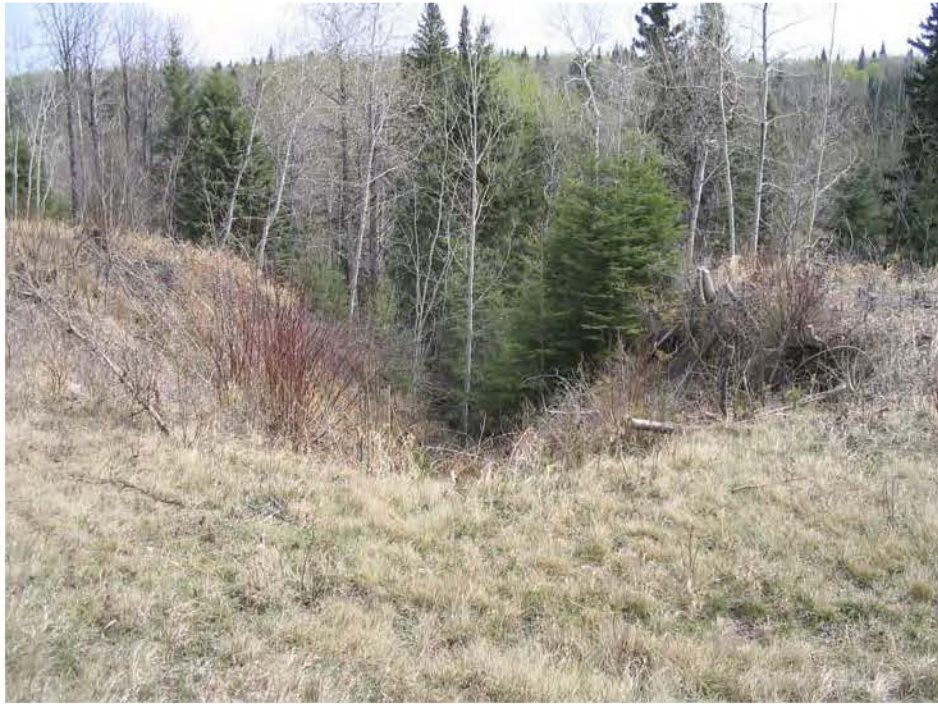
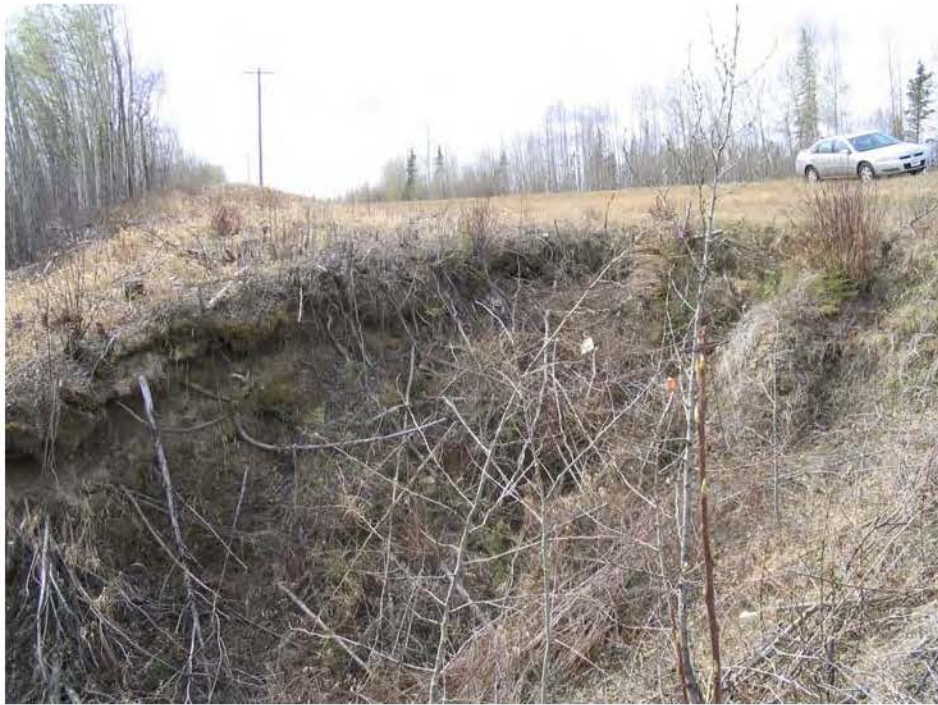
Minor sign of retrogression of the gully scarp toward the road surface was observed during this site visit. The gully is about 12 m wide.

There were no signs of cracks on the highway pavement, indicating the erosion gullies are not impacting the highway at the present time. However, as was mentioned in our last report, if left untreated, the gullies may migrate laterally to impact the highway in the future, especially gully at km 10.2, which has the highest potential of all of the sites to impact the highway in future.

A risk level of 18 is considered applicable to this site, based on a Probability Factor of 9 (active, moderate steady rate of erosion) and a Consequence Factor of 2 (small volume slide affecting roadway may be triggered by ongoing erosion).

Photo 3 & 4 Looking at the Gully at km 10.2, May 2, 2006.

At km 10.2, the erosion gully should be backfilled by pit run gravel to stop the headscarp erosion retrogression. As discussed with AIT during the site visit, a possible source of the pit run gravel is 6 to 8 km from Marten Creek Pit. The erosion of the gully is highest at this location and a swale should be built to divert the flow from km 10.2 to km 10.45 by re-sloping the side slope.

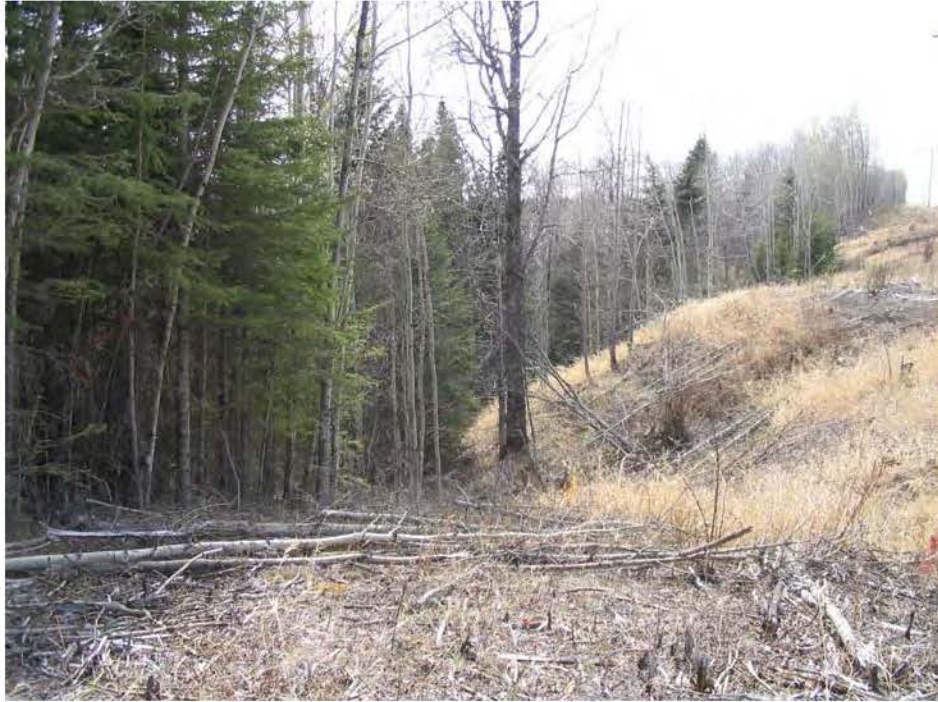
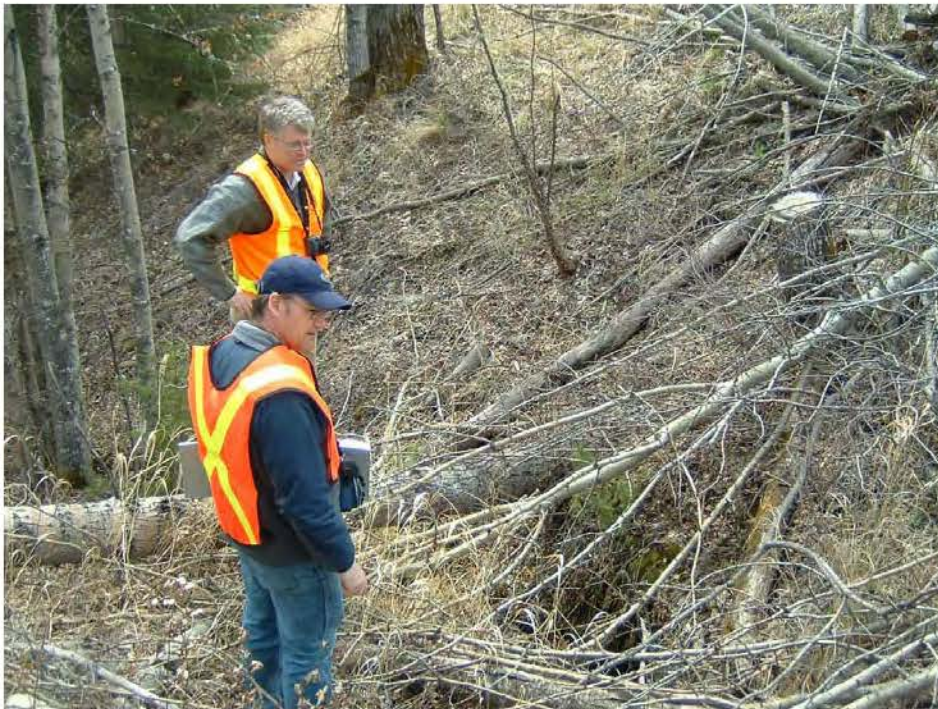
The gully is a direct result of the outflow from a steel culvert resulted in a 1.6 m deep down cut. A slight ditch erosion was noted at the crest of the gully. A narrow channel with eroded slope was noted beyond the gully down the creek valley.

Similar to the 2005 observation there is no evidence of slope instability during the site visit. However, slight retrogression in the upper portions of the erosion gullies was observed at km 10.2 and 10.45. Also it appeared that a narrow channel with eroded slopes has developed down from the bottom of the gully at km 10.45.

Photo 5 & 6 Looking at the Gully at km 10.45, May 2, 2006.

At km 10.45, remedial measures need to be undertaken to restore the gully itself and the down slope area below the gully bottom. Fallen trees need to be removed before any stabilization measure is undertaken. The base (0.3 m wide by 0.3 m deep) of the gully is recommended to be filled with cobbles. The narrow channel with little eroded slope below this point should be filled with pit run gravel. At km 10.8, similar to the gully at Km 10.0, a shallow berm needs to be constructed across the gully to divert ditch water to Km 10.45.

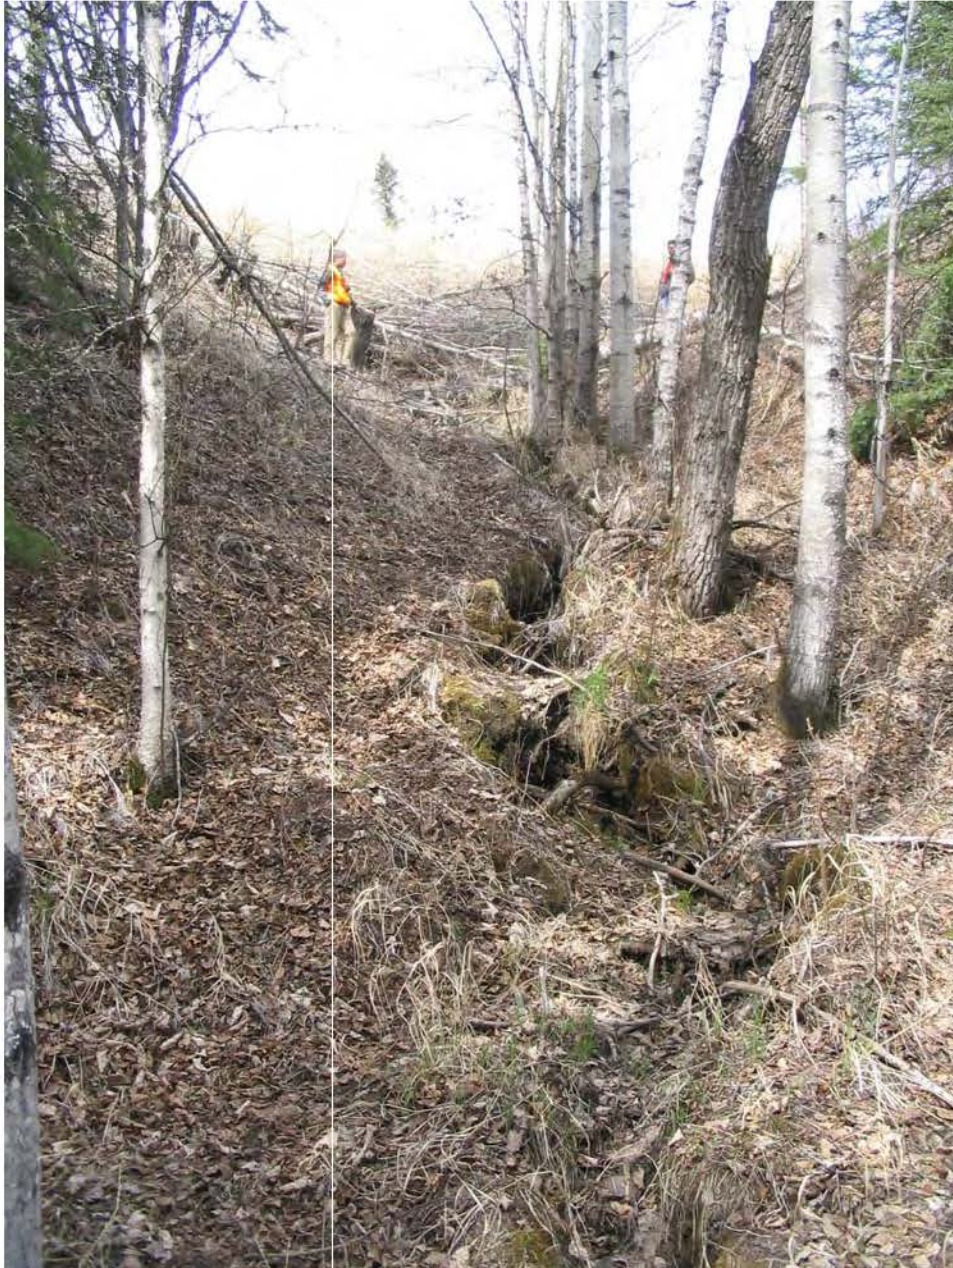
Photo 7 Looking at the Gully at km 10.45, May 2, 2006.

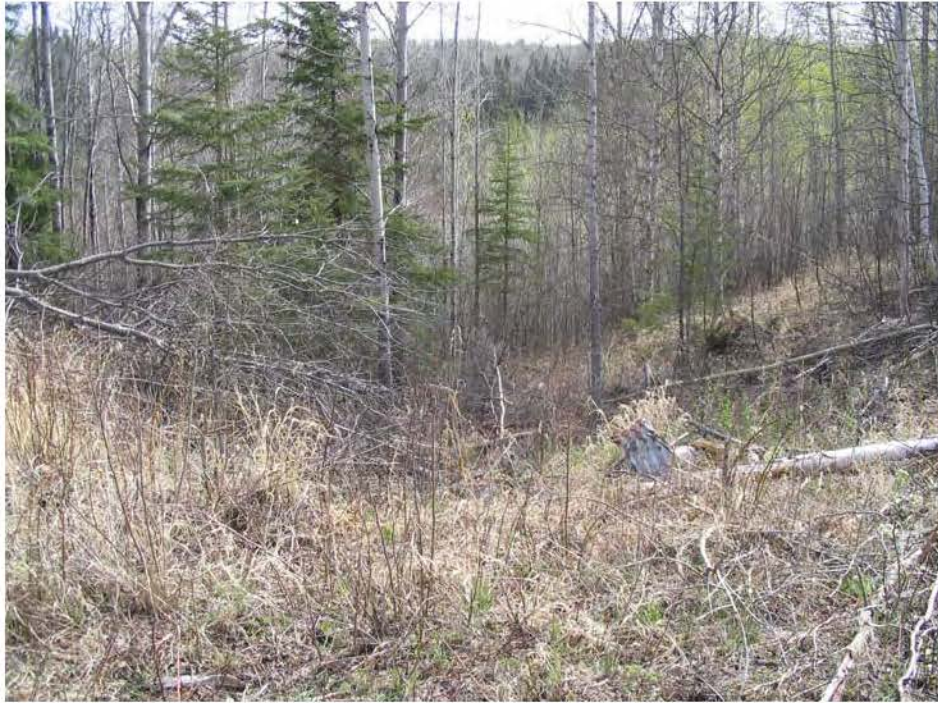
No changes in site features were observed compared to the 2005 inspection.

Photo 8 Looking at the Gully at km 10.8, May 2, 2006.
