THURBER ENGINEERING LTD.

December 4, 2007

File: 15-85-66

**NORTH CENTRAL REGION GEOHAZARD ASSESSMENT
HWY 754:02 KM 10.4, KM 10.5, KM 10.55 AND KM 10.68 (NC 41)
NORTH OF SLAVE LAKE
2007 ANNUAL INSPECTION REPORT**

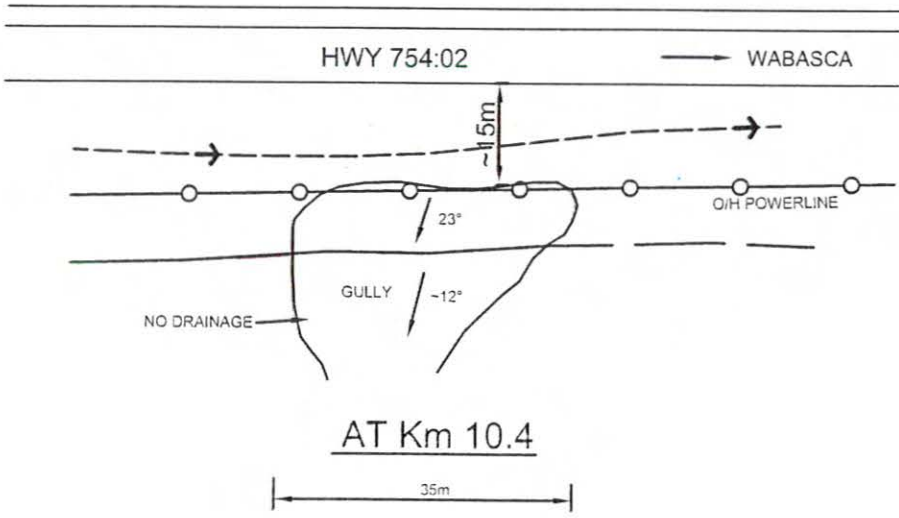
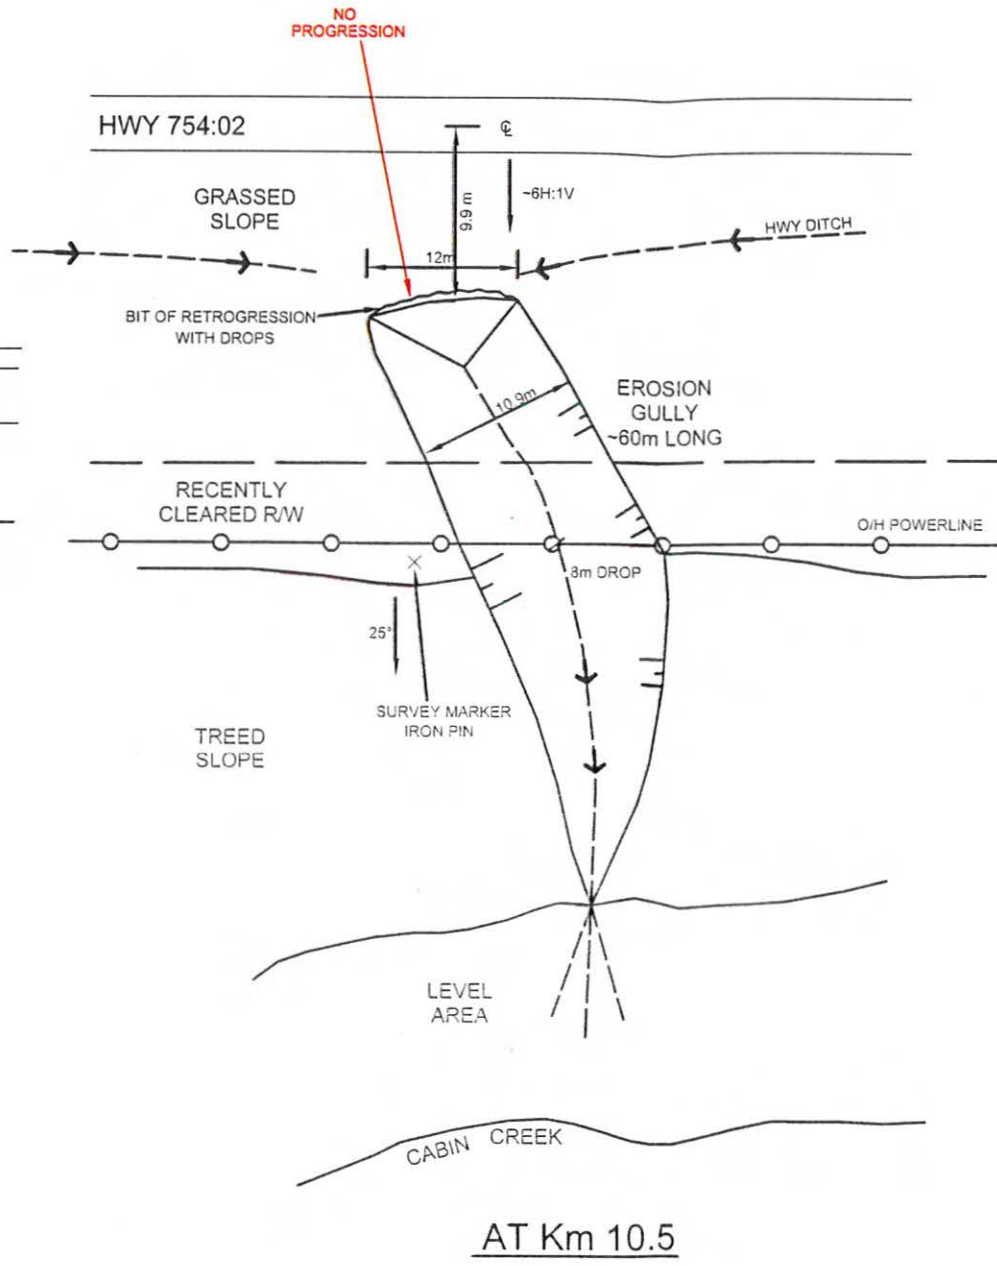
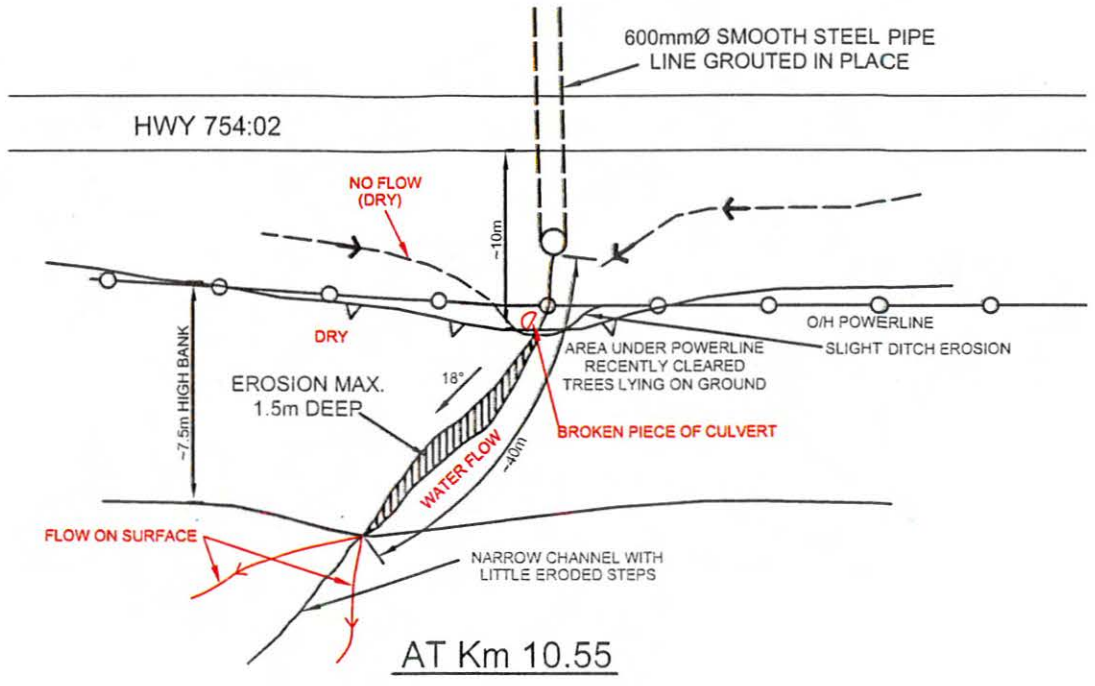
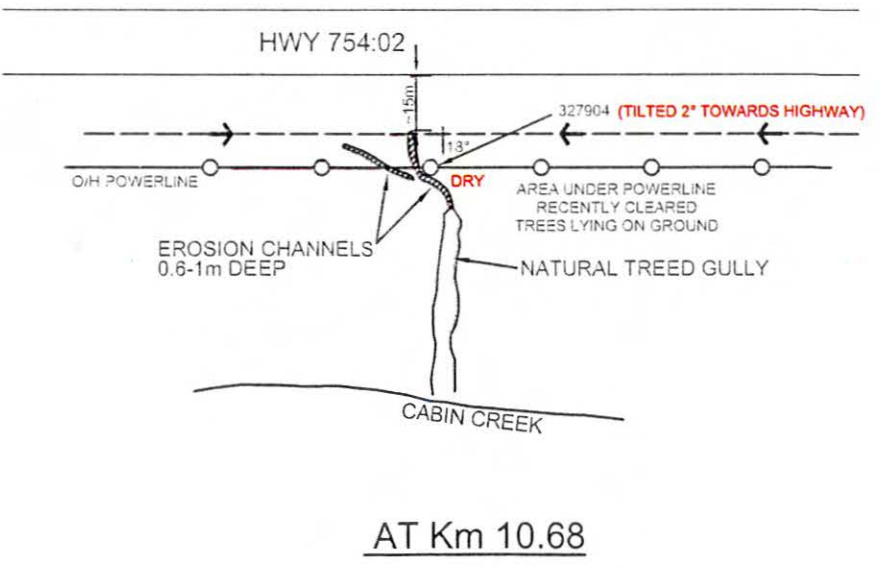
FIGURE NC41-1 SKETCH SITE PLANS NC41- HWY 754:02 - Km10.4, 10.5, 10.55, AND 10.68

The changes in conditions noted at each of the sites since last year are shown on the site sketch plan, Figure NC41-1, attached for inclusion in Appendix F of the binder. Selected photographs taken during the visit are also attached.

OBSERVATIONS IN 2007 ARE SHOWN IN RED

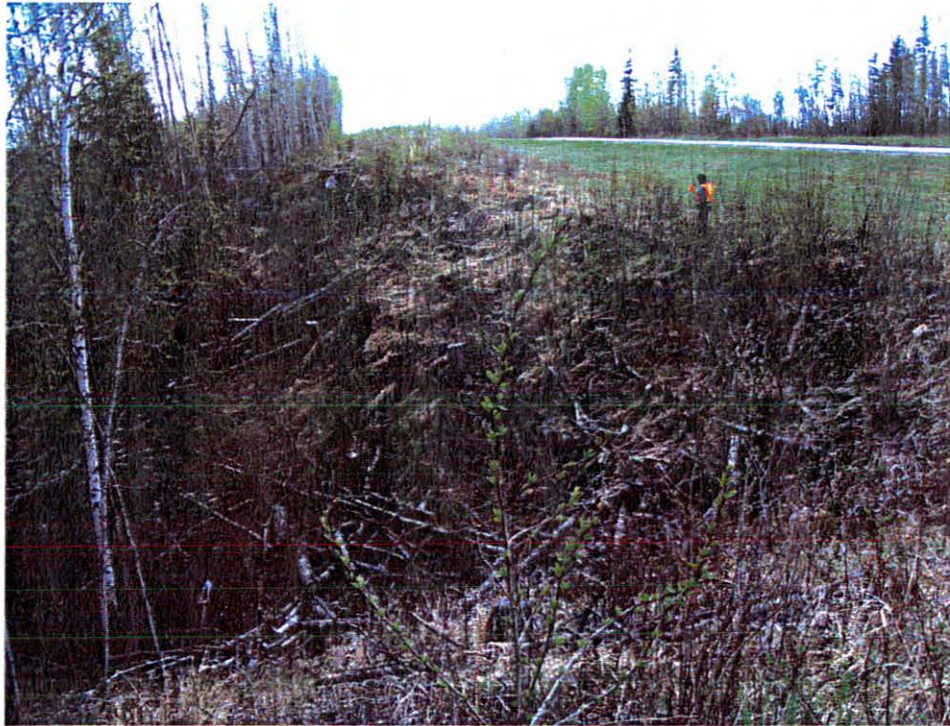
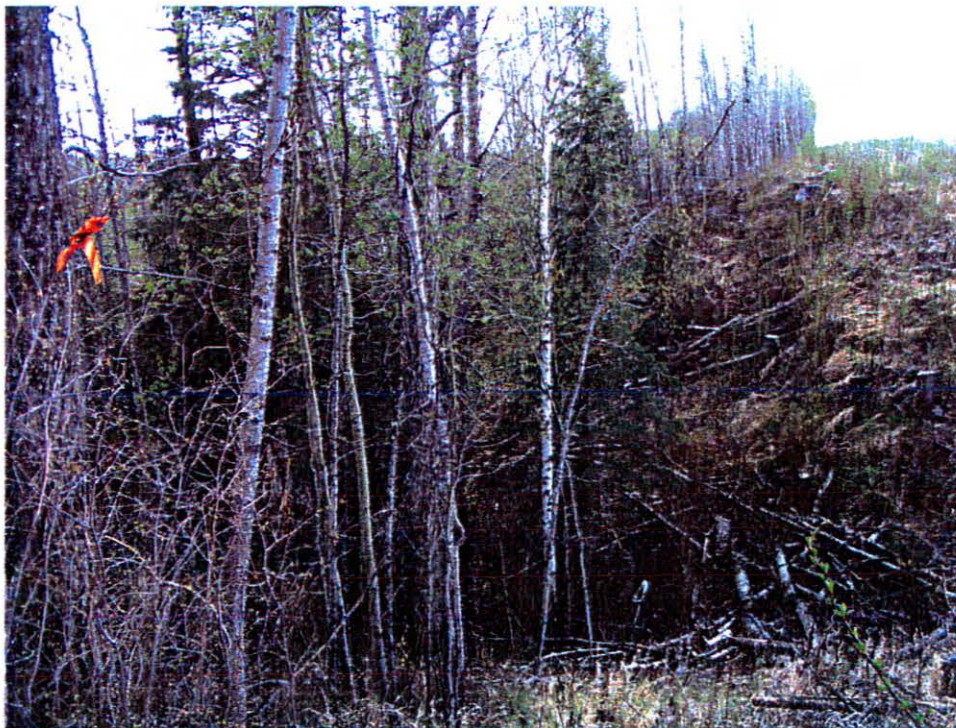
Photo 1 & 2 -Looking at the Gully at km 10.4, May 24, 2007.

No changes in site features were observed compared to the 2006 inspection.

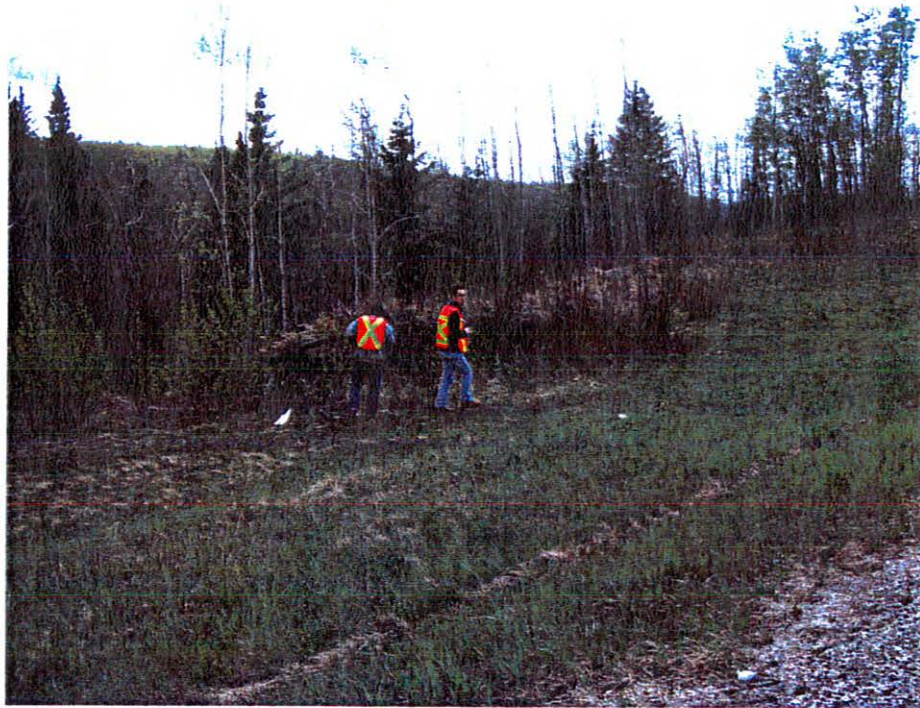
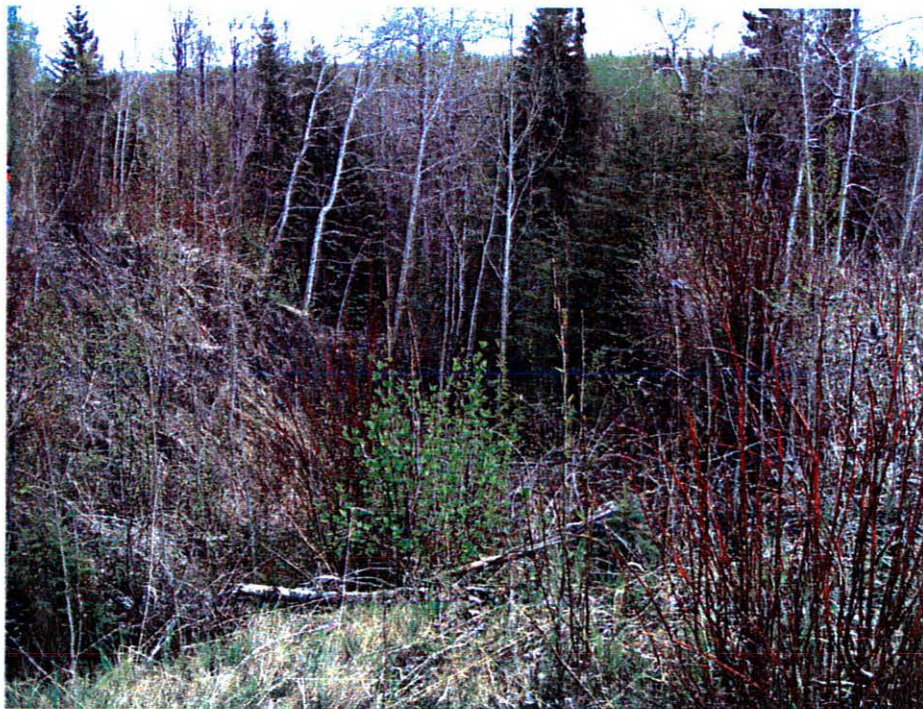
Photo 3 & 4 -Looking at the Gully at km 10.5, May 24, 2007.

No changes compared to last year.

A risk level of 14 is considered applicable to this site (compared to 18 last year), based on a Probability Factor of 7 (Inactive, moderate probability of future erosion) and a Consequence Factor of 2 (a small volume slide affecting the roadway could be triggered by future erosion).

The rating has been lowered compared to last year due to favourable condition observed at this site this year.

A guard rail should be installed at km 10.55 and a guard rail and end dumped gravel wedge should be installed at km 10.5 to protect traveling motorists from these geohazards that are encroaching close to or into the clear zone.

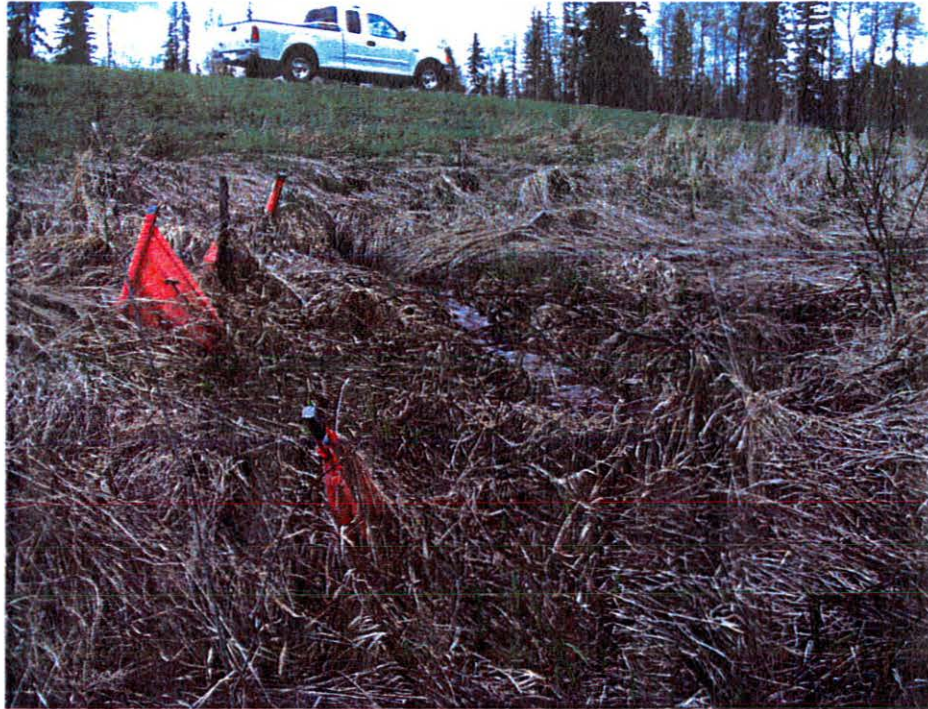
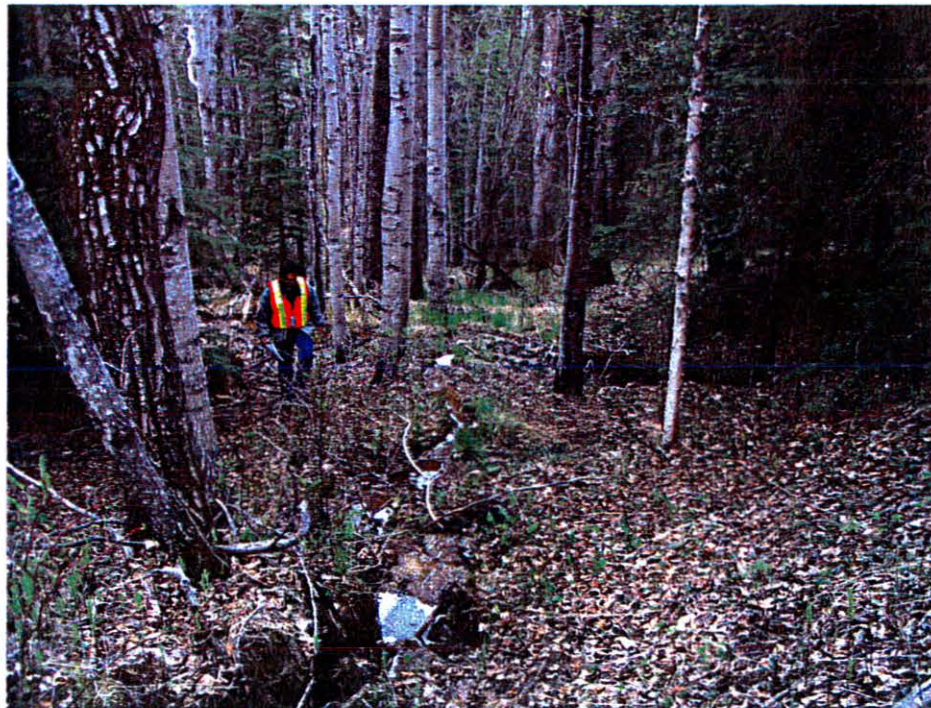
Photo 5 & 6 -Looking at the Gully at km 10.55, May 24, 2007.

Moderate flow from the culvert was flowing through the channel and spreading out nicely into the bush. The energy from the culvert water flow was being dissipated by the gulley before reaching the channel and no significant channel erosion was observed compared to last year.

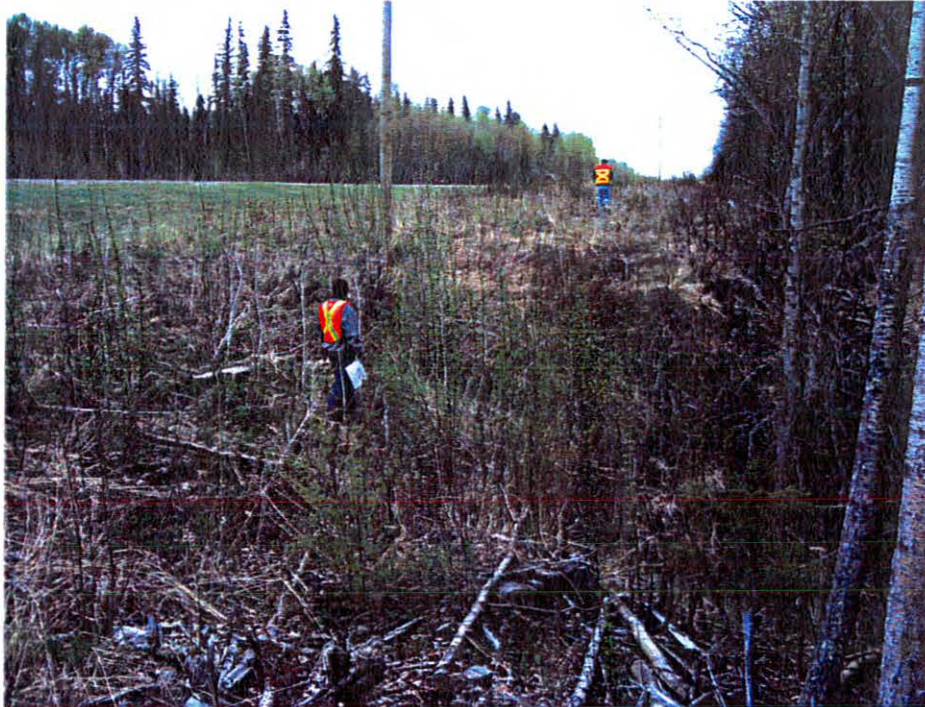
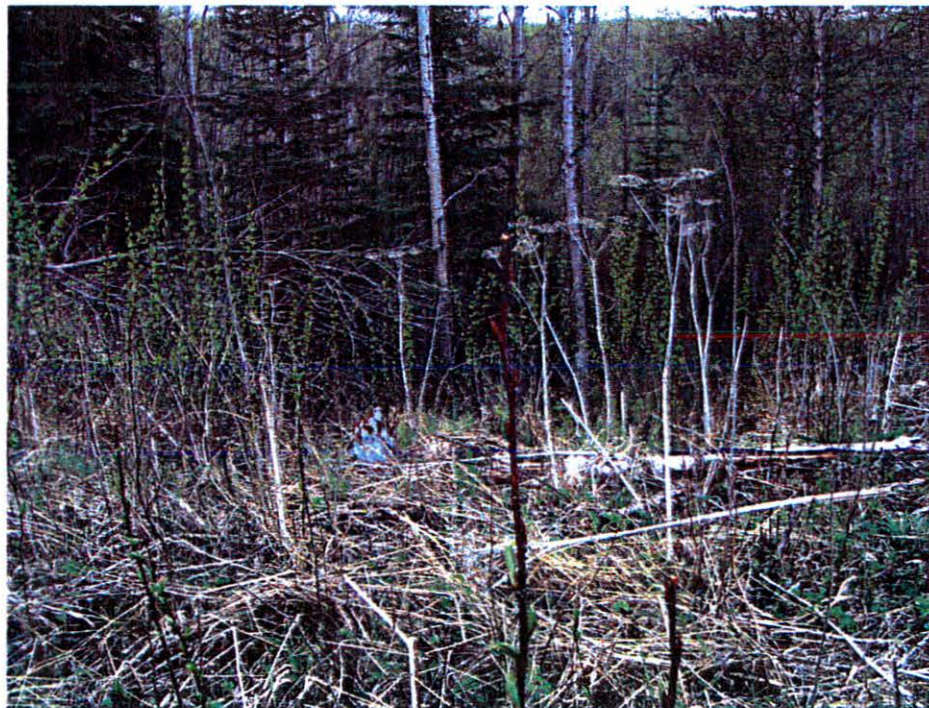
Photo 7 & 8 Looking at the Gully at km 10.68, May 24, 2007.

No changes compared to last year except that power pole post #327904 was tilted slightly (2 degrees) towards the highway.
