**GEOHAZARD ASSESSMENT PROGRAM**  
**NORTH CENTRAL REGION – ATHABASCA**  
**2009 INSPECTION**

Site Number	Location	Name	Hwy	km
NC 42	75 km north of Slave Lake and 40 km from the junction of highways 88 and 754	North of Slave lake	754:04	20.8
<b>Legal Description</b>		<b>UTM Co-ordinates (NAD 83)</b>		
SE-28-77-3-W5M		11 N 6177576	E 664053

Date	PF	CF	Total
<b>Previous Inspection:</b>	June 9, 2008	9	3	27
<b>Current Inspection:</b>	June 18, 2009	9	3	27
<b>Road AADT:</b>	720	<b>Year:</b>		2008
<b>Inspected By:</b>	Tarek Abdelaziz, Renato Clementino (Thurber) Roger Skirrow, Neil Kjelland, Arthur Kavulok, Gordon Wolters (TRANS)			
<b>Report Attachments:</b>	<input checked="" type="checkbox"/> Photographs <input checked="" type="checkbox"/> Plans <input type="checkbox"/> Maintenance Items

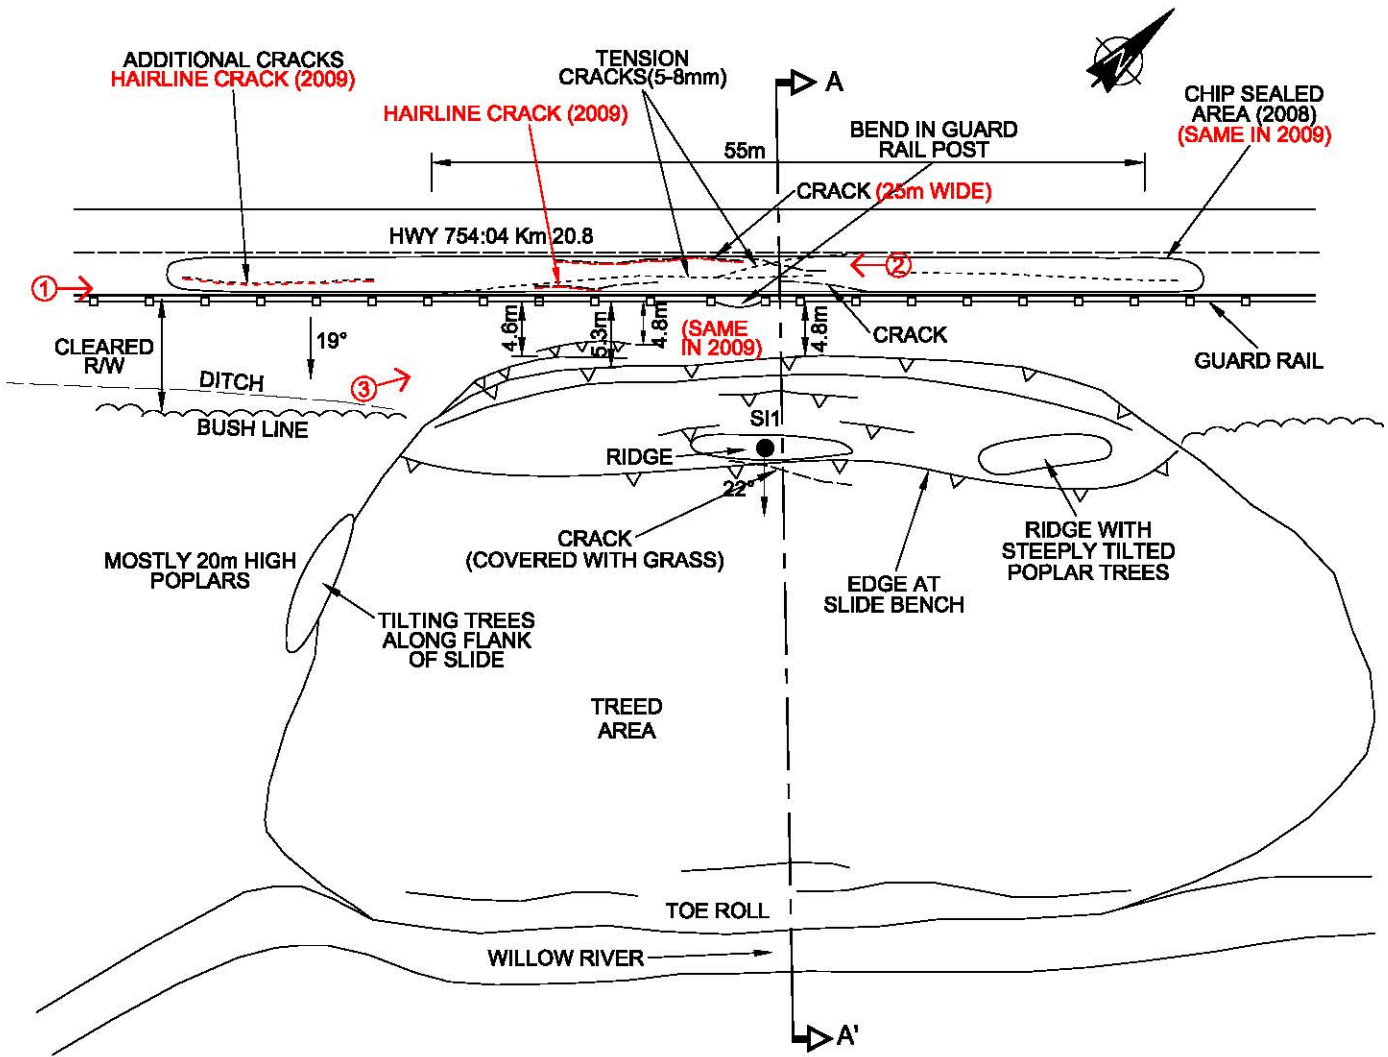
**FIGURE NC42-1 SKETCH SITE PLAN  
NC42- HWY 754:04 Km 20.8**

<b>Instrumentation: (1SI, No piezometers)</b>		
S11 operational; rate of movement increased by 2.8 mm/yr to 5.8 mm/yr		
<b>Assessment (Refer to attached Figure):</b>		
The reflective hairline and open cracks on the highway surface reveal the continued creep movement of the slide Retrogression of the head scarp to the highway could occur at some point in the future due to the continued creep movement.		
<b>Recommendations:</b>		
In the short term, the MCI should seal any open cracks to reduce the potential of increasing slide movement due to infiltration of surface water into the slide mass. As discussed on site, reinforcing the slide head scarp using soil nails could be undertaken as a short term solution to reduce the risk of future head scarp retrogression to the highway surface. A long term solution would consist of re-alignment of the highway further away from the slide. The pall bark cost for soil nails is \$170,000.

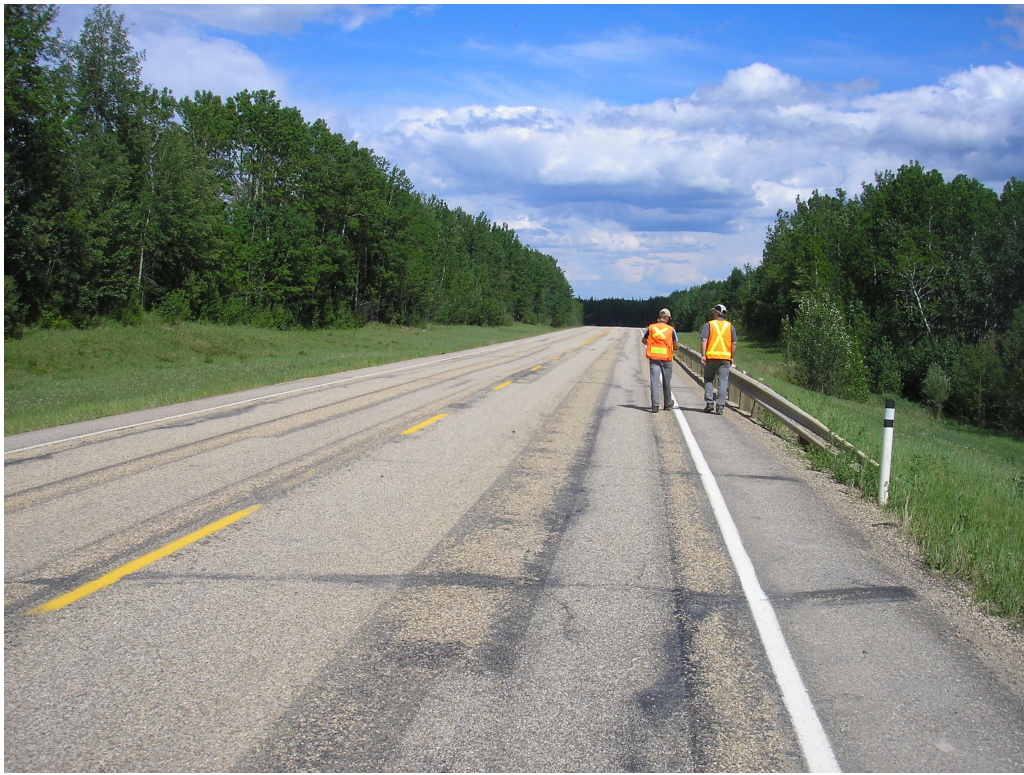
**Photo #1** General view of highway surface at slide location, looking north

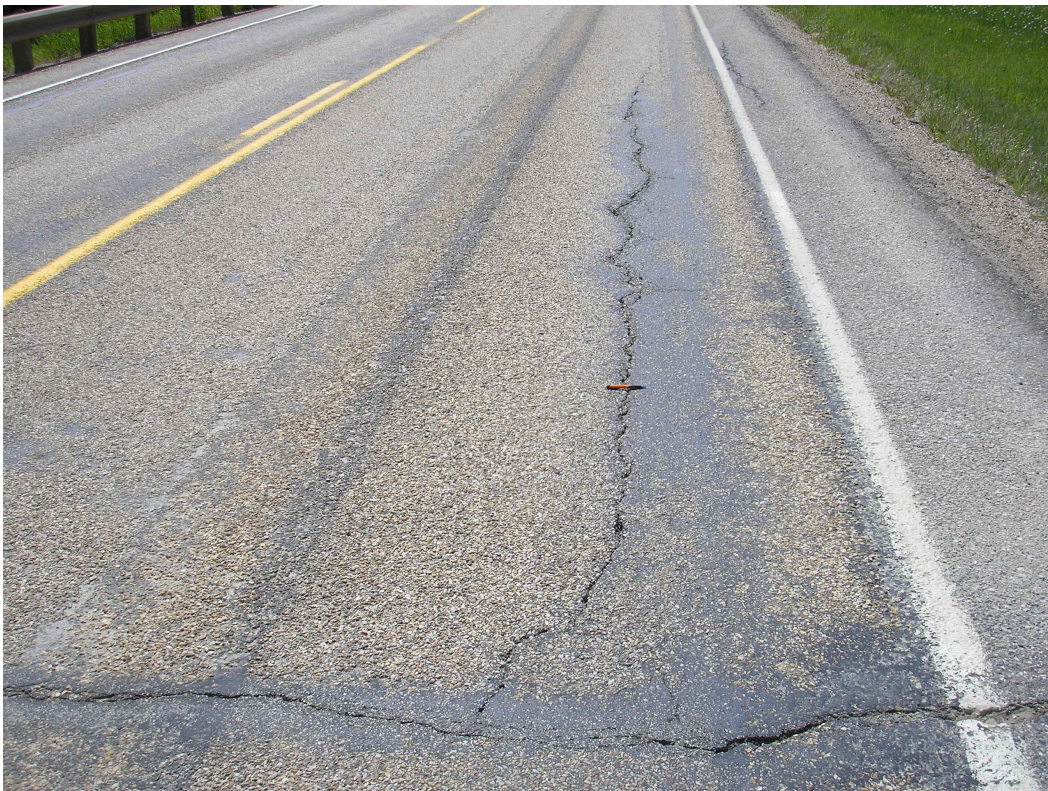
**Photo #2** Looking south toward an open longitudinal crack on the highway SBL

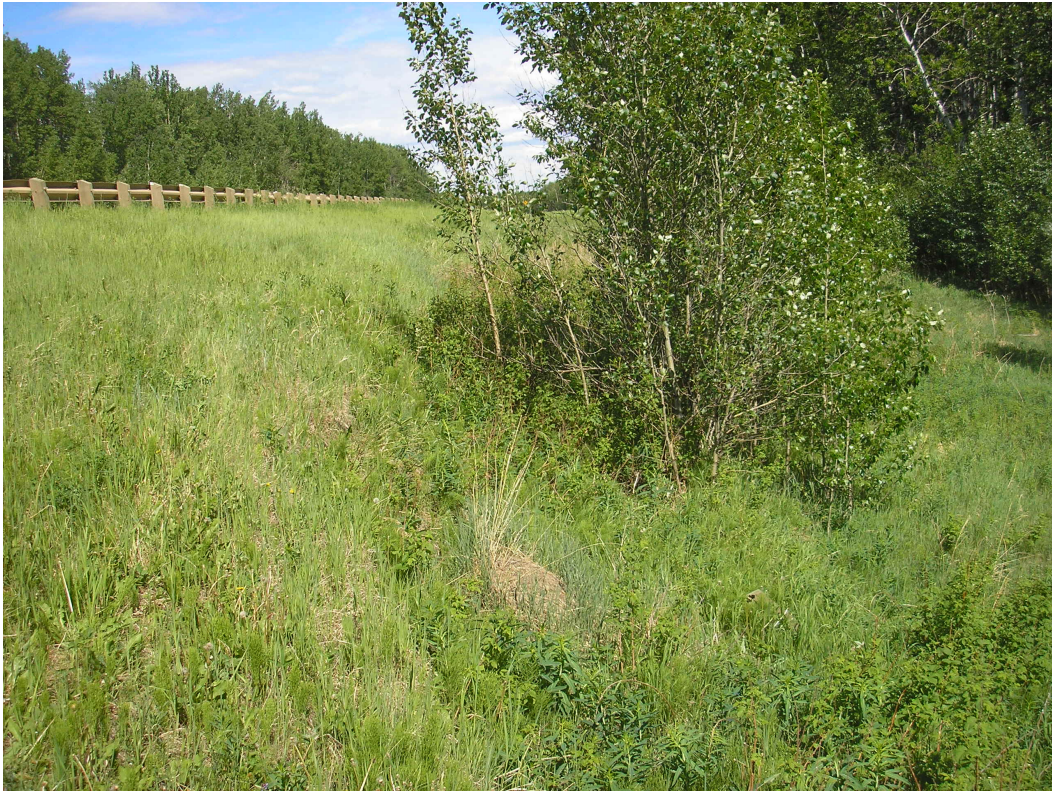
**Photo #3** Looking north from the southern limit of the slide headscarp
