GEOHAZARD ASSESSMENT PROGRAM
NORTH CENTRAL REGION – ATHABASCA
2012 INSPECTION

| Site Number | Location | Name | Hwy | km |
|---|--|---|---|---|
| NC 42 | 75 km north of Slave Lake and 40 km from the junction of highways 88 and 754 | North of Slave lake | 754:04 | 20.8 |

| | Date | PF | CF | Total |
|---|--|---|---|---|
| Current Inspection: | June 11, 2012 | 9 | 3 | 27 |

**NORTH CENTRAL REGION (ATHABASCA AREA)
- 2012 GEOHAZARD ASSESSMENT
NC42: HWY 754:04 NORTH OF SLAVE LAKE(km 20.8)
SITE PLAN AND CROSS - SECTION**

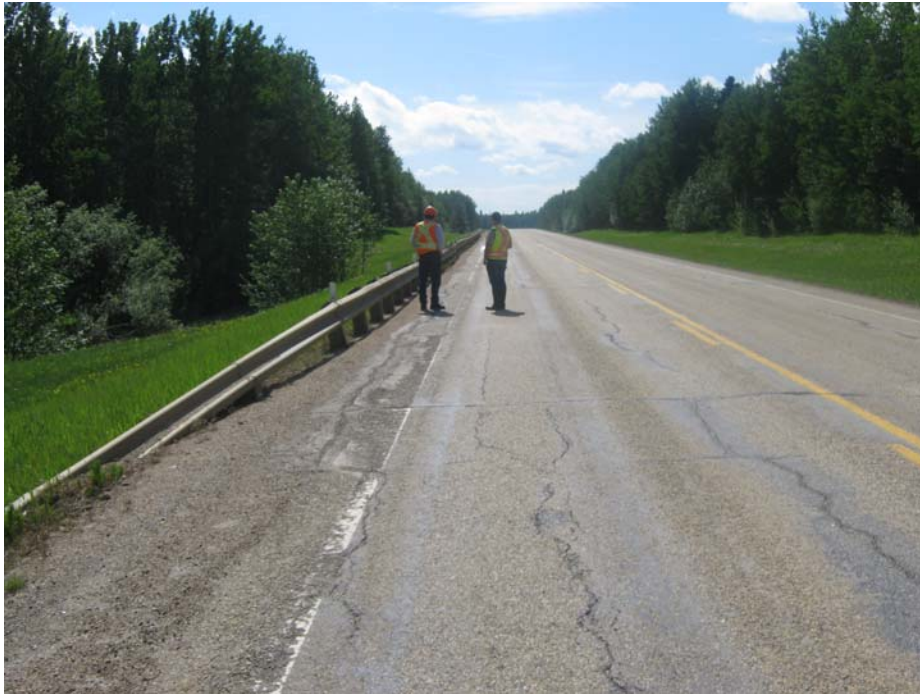
| <input checked="" type="checkbox"/> Pavement Distress | 10 to 15 mm wide cracks in the highway NBL; 25 mm wide crack in the highway SBL | <input type="checkbox"/> |
| The SI shows ongoing creep movement of the landslide mass. The cracks in the highway surface might be in response to the continued creep movement of the landslide. | | |

Photo#1 Looking southeast from the north side of the site at longitudinal cracks in the highway NBL

The site conditions did not change significantly since the 2009 site visit, and therefore future site inspections could be deferred for a few years. However, the MCI should visually inspect the extent of cracking in the highway surface and alert us if any sudden changes occur. In addition, any open cracks in the pavement should be sealed to reduce surface water infiltration into the highway subgrade in the vicinity of the landslide.

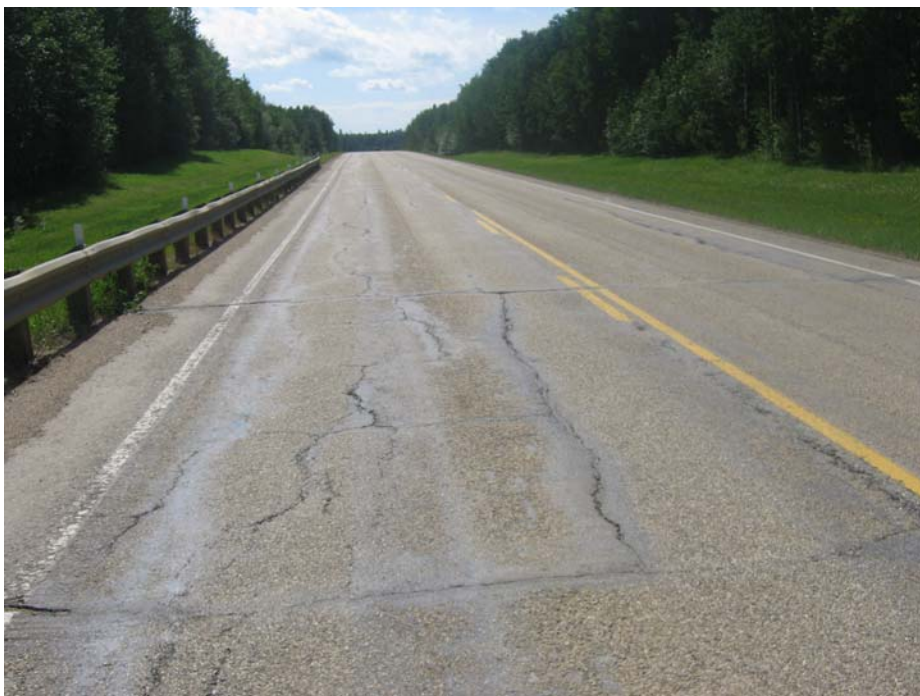
Photo#2 Looking southeast at an additional set of longitudinal cracks in the highway NBL

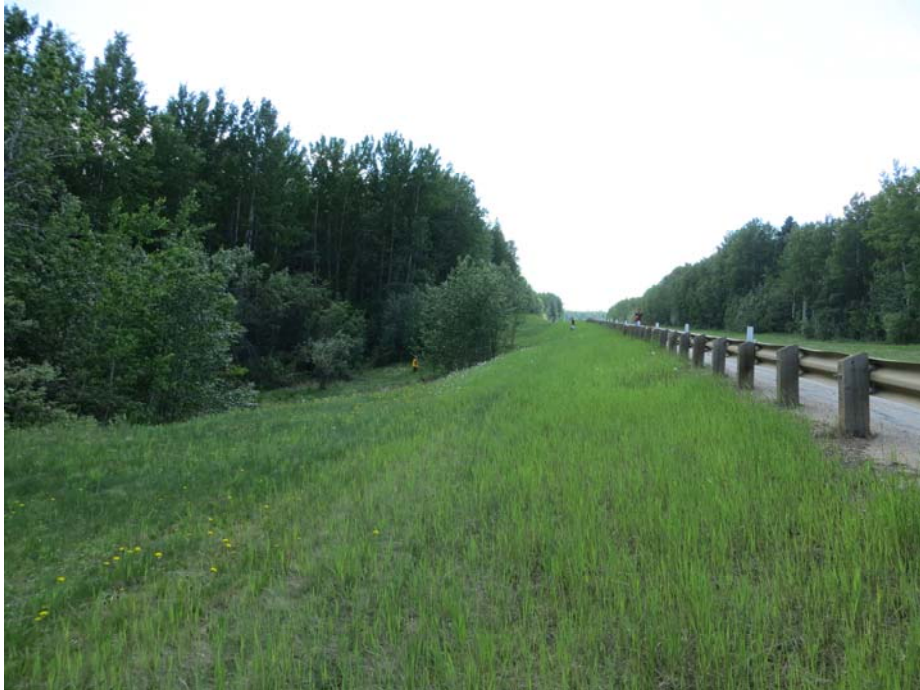
| Creep movement at a rate of 3.3 mm/yr | | |

Photo#3 Looking south east at the landslide mass

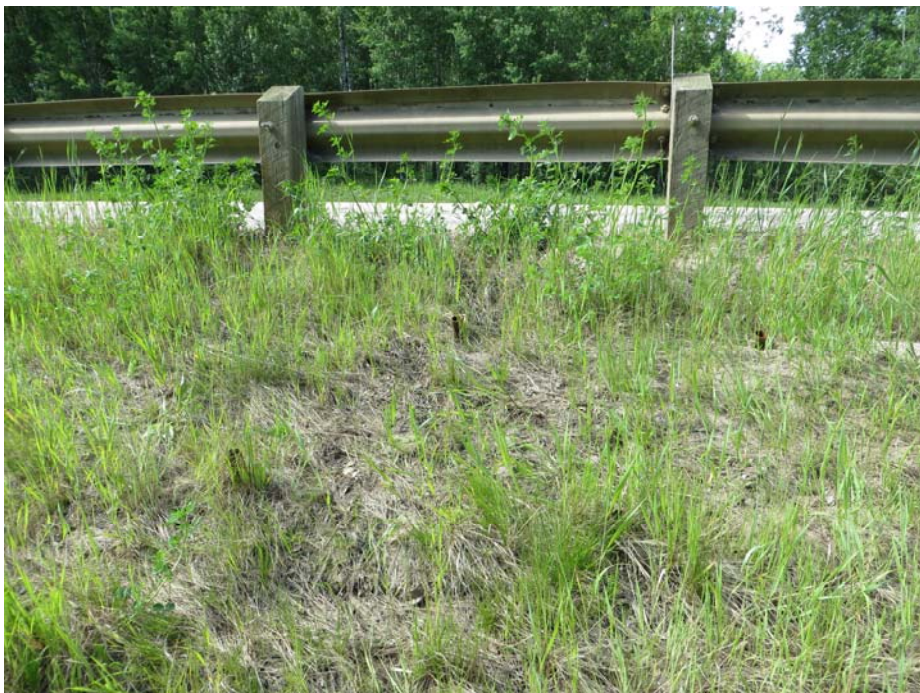
The soil nails should reduce the risk of head scarp retrogression into the highway lanes.

Photo#4 Looking northwest at the soil nails installed above the main headscarp
