GEOHAZARD ASSESSMENT PROGRAM
NORTH CENTRAL REGION – ATHABASCA

2009 INSPECTION

| Site Number | Location | Name | Hwy | km |
|---|--|---|---|---|
| NC 53 | 75 km north of Slave Lake and 36 km from the junction of highways 88 and 754 | North of Slave lake | 754:04 | 18.6 |

**FIGURE NC53-1 SKETCH SITE PLAN
NC53 HWY 754:04 Km 18.6**

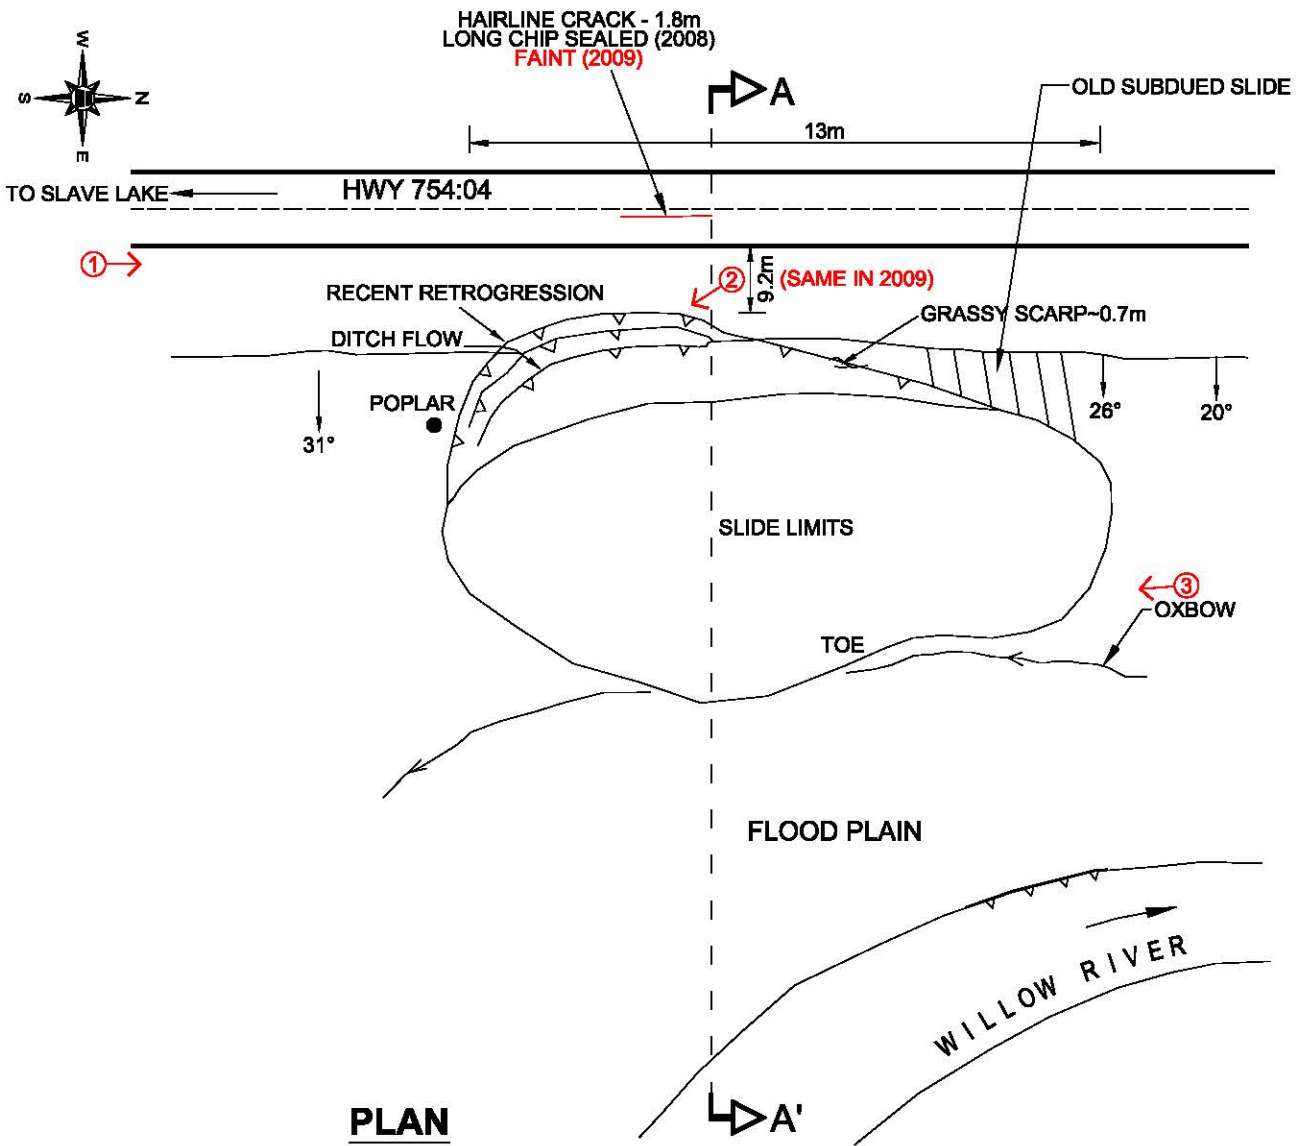
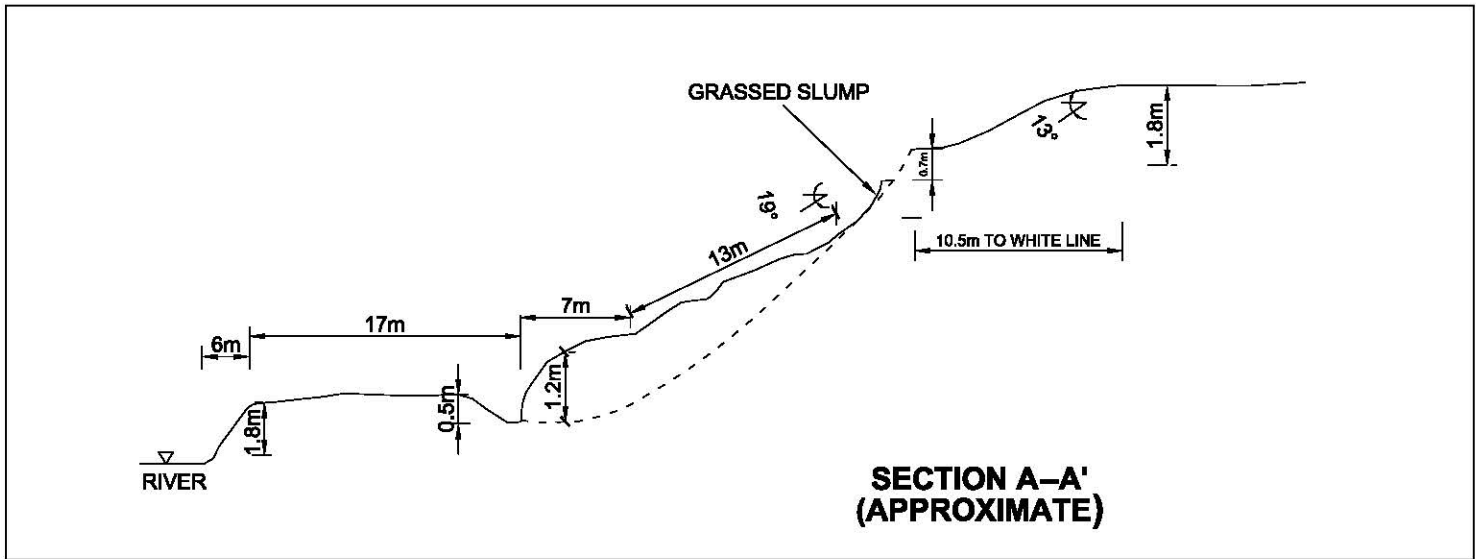
Assessment (Refer to attached Figure):
The site observations indicated that the slide has been creeping at a very slow rate.

2009 OBSERVATIONS SHOWN IN RED

Recommendations:
As discussed on site, the slide has been creeping at a very slow rate and the site conditions have not change significantly since being inspected. Therefore, this site will be temporarily removed from the Geo-hazard Assessment Program. However, the MCI will continue to visually inspect the site, seal any open cracks, monitor the retrogression of the slide head scarp to the highway lanes, and watch closely for any additional visible signs of slide movement.

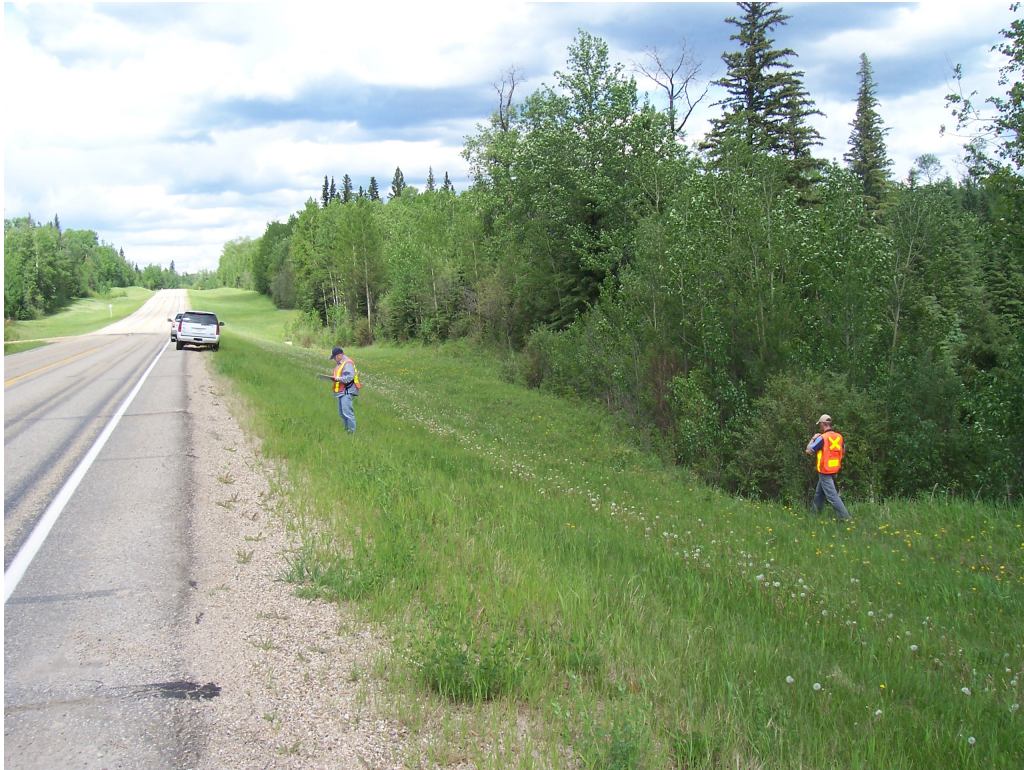
Photo #1 Looking North at the highway side slope

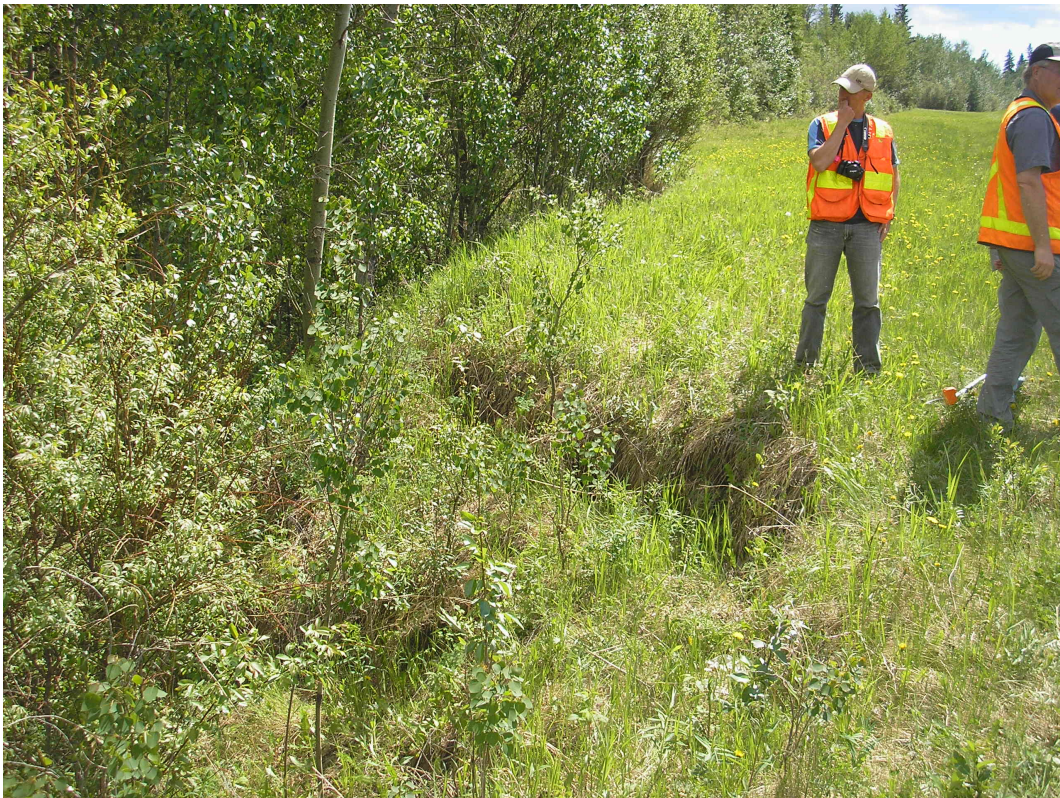
Photo #2 Looking south at the slide vegetated head scarp

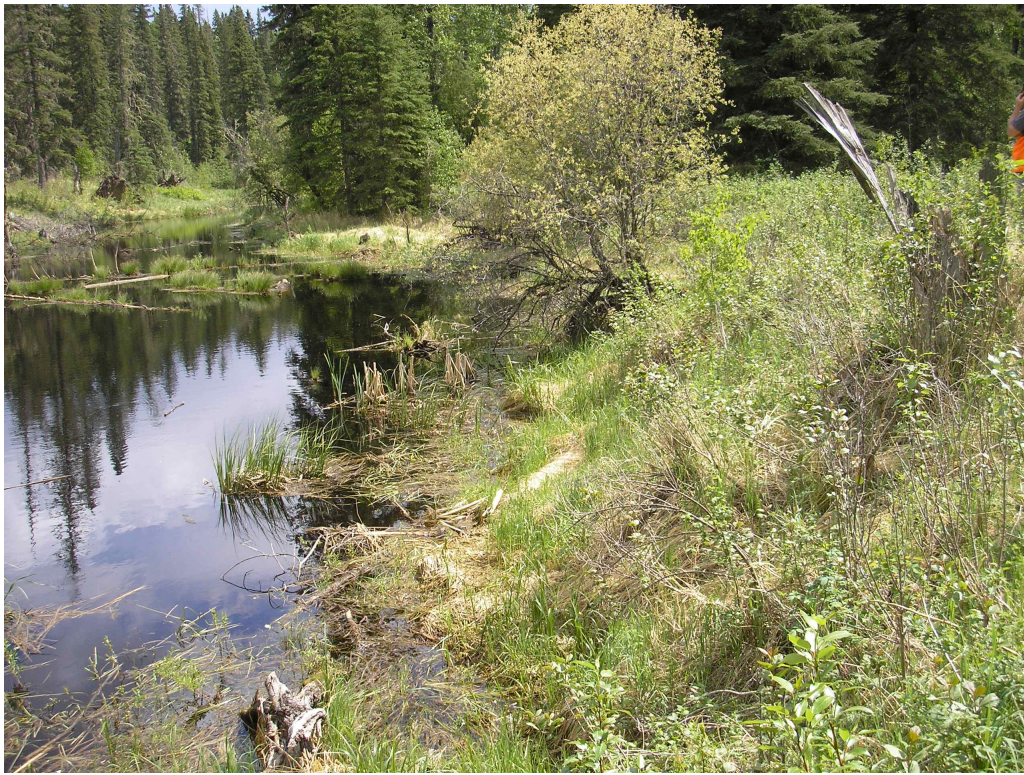
Photo #3 Looking south at the Willow River outside bend from the northeast side of the slide area
