GEOHAZARD ASSESSMENT PROGRAM
NORTH CENTRAL REGION – ATHABASCA
2012 INSPECTION

Site Number	Location	Name	Hwy	km
NC 53	75 km north of Slave Lake and 36 km from the junction of highways 88 and 754	North of Slave lake	754:04	18.6
Legal Description		UTM Co-ordinates (NAD 83)		
SE-29-77-3-W5M		11 N 6175492	E 661880

**NORTH CENTRAL REGION (ATHABASCA AREA)
- 2012 GEOHAZARD ASSESSMENT
NC 53: HWY 754:04 NORTH OF SLAVE LAKE (km18.6)
SITE PLAN AND CROSS - SECTION**

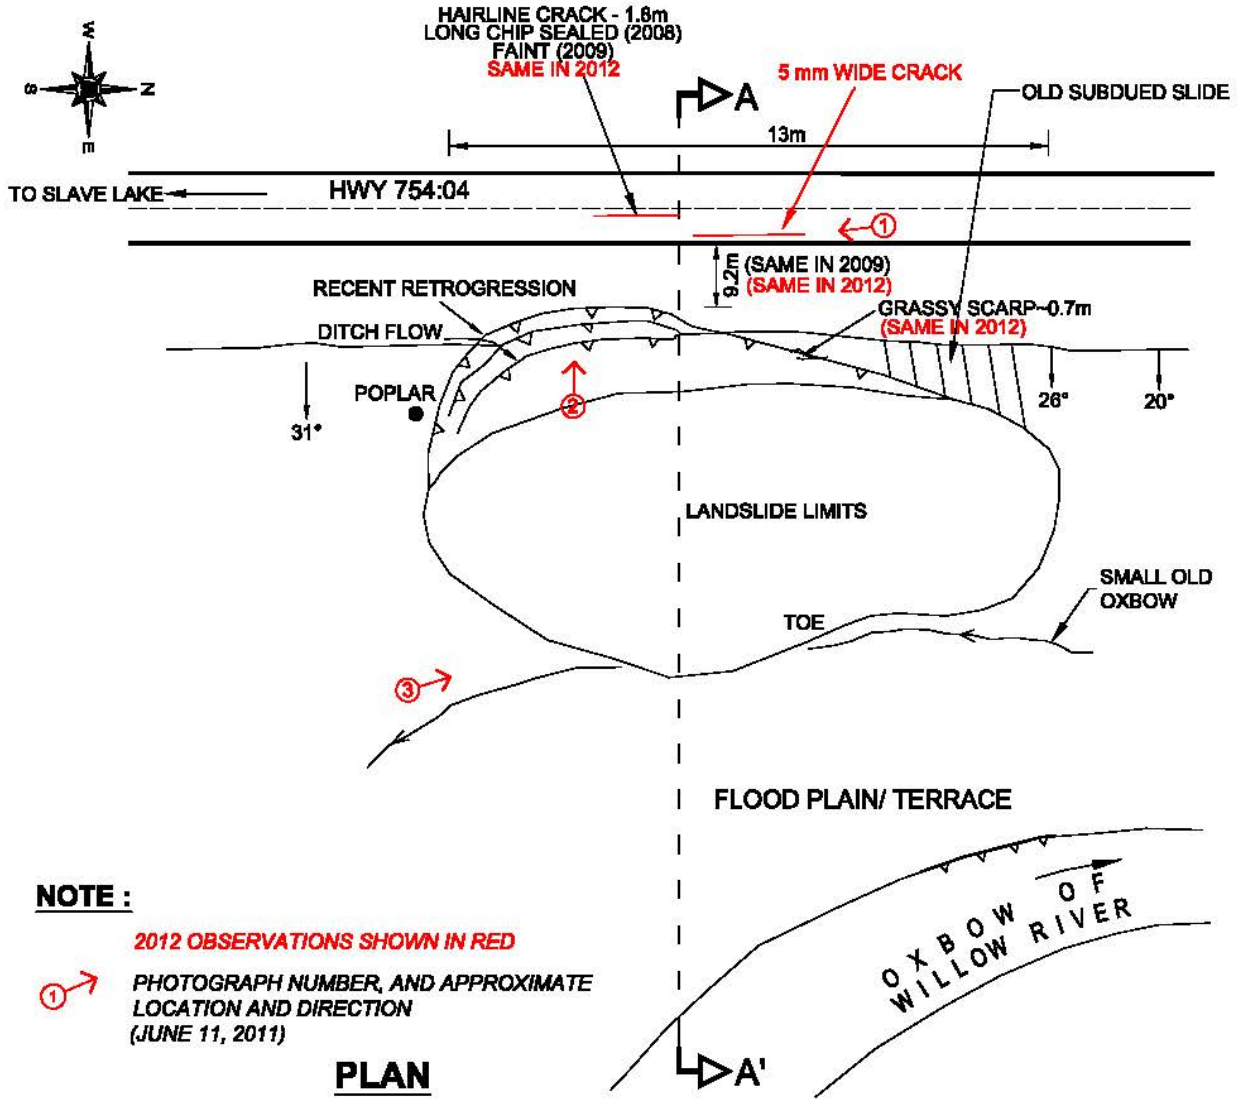
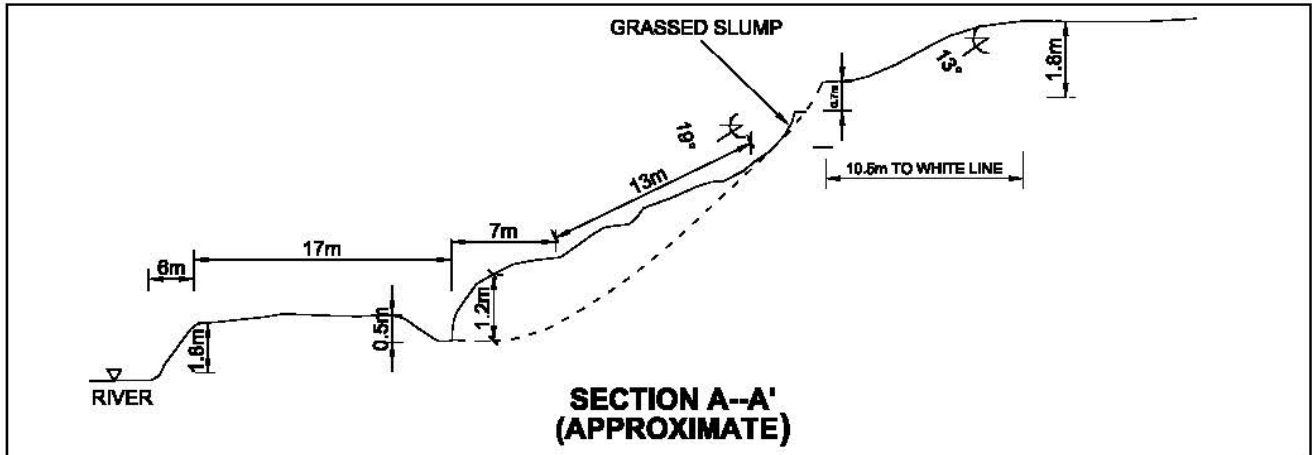
FIGURE NC53-1

Primary Site Issue:	A landslide near the edge of the highway clear zone		
Dimensions:	About 13 m long		
Date of any remediation:	N/A		
Maintenance:	Highway chip-sealed in 2008		
Observations:	Description	Worse?	
<input checked="" type="checkbox"/> Pavement Distress	5 mm wide longitudinal crack in the highway surface	<input type="checkbox"/>	
<input checked="" type="checkbox"/> Slope Movement	The distance between the eastern edge of the highway shoulder and the slide's headscarp remained unchanged (i.e. 9.2 m as measured in 2008)	<input type="checkbox"/>	
<input type="checkbox"/> Erosion		<input type="checkbox"/>	
<input type="checkbox"/> Seepage		<input type="checkbox"/>	
<input type="checkbox"/> Bridge/Culvert Distress		<input type="checkbox"/>	
<input type="checkbox"/> Other		<input type="checkbox"/>	
Instrumentation: None			
Assessment (Refer to attached Figure):			
The site observations indicated that the landslide has been creeping at a very slow rate.

Recommendations:			
The site conditions did not change between 2009 and 2012, and therefore it is recommended to defer future inspections for a few years. The MCI should continue to visually inspect the site, seal any open cracks, monitor the retrogression of the slide headscarp to the highway lanes, and watch closely for any additional visible signs of landslide movement.

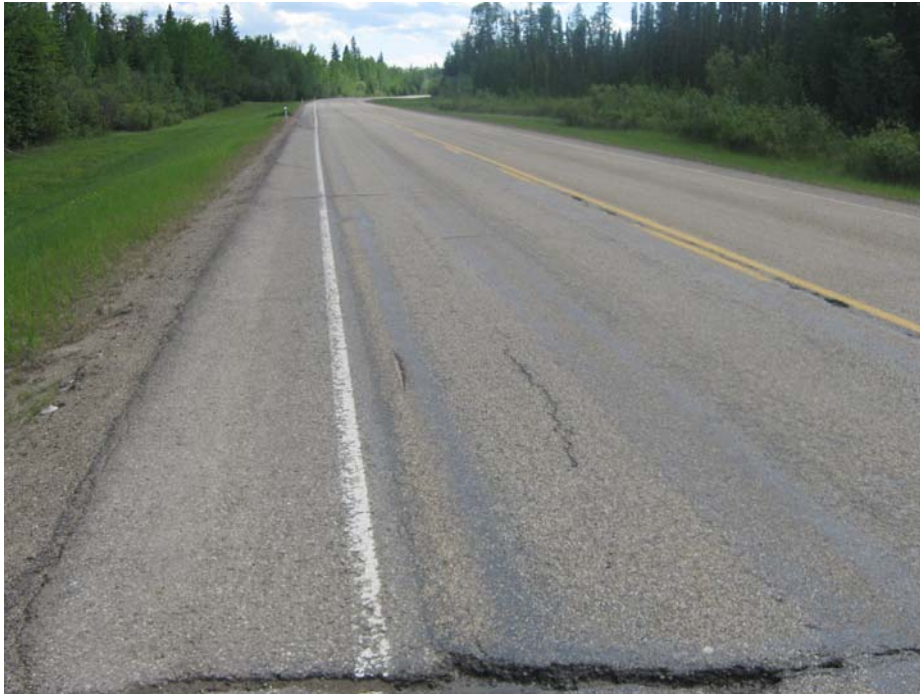
Photo#1 Looking south at a longitudinal crack in the highway NBL surface west of the landslide

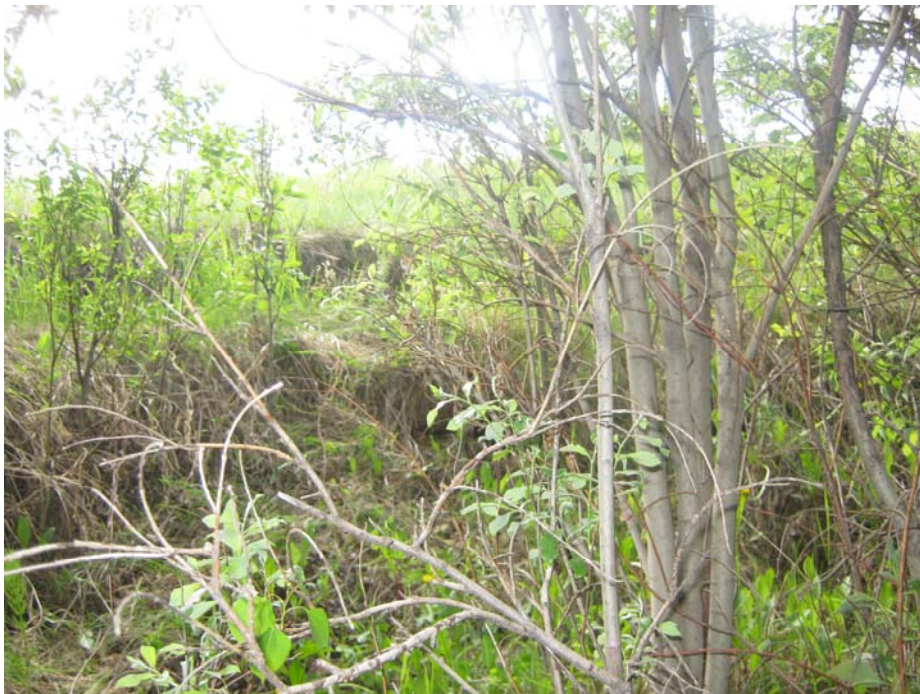
Photo#2 Looking west at the landslide head scarp area

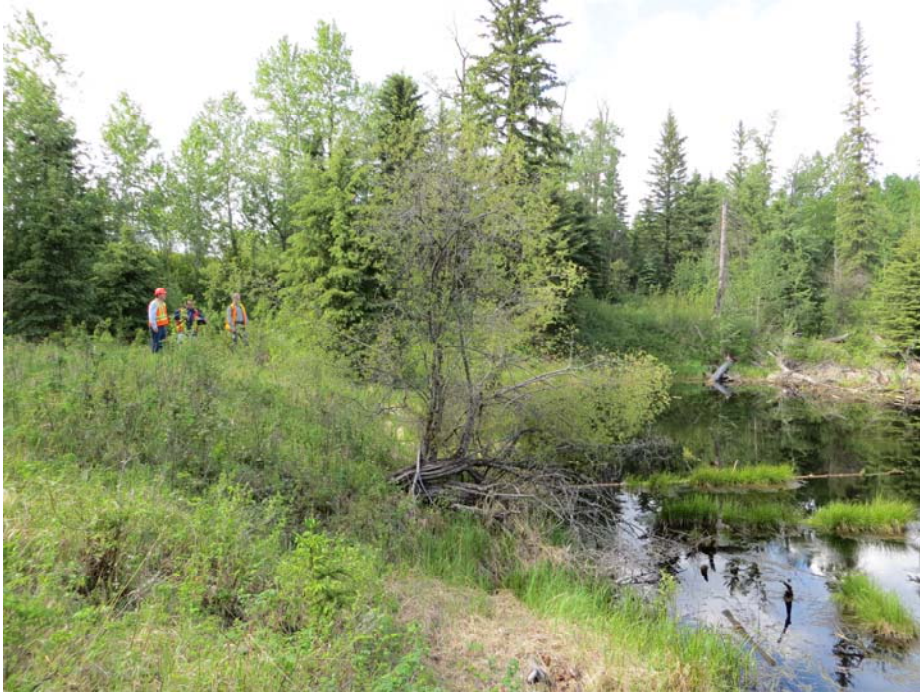
Photo#3 Looking north from the bottom of the landslide at the existing oxbow
