ALBERTA TRANSPORTATION LANDSLIDE RISK ASSESSMENT

SECTION A: GEOTECHNICAL FILE REVIEW

SITE NC53: HWY 754:04 NORTH OF SLAVE LAKE (km 18.6)

FIGURE NC53-1

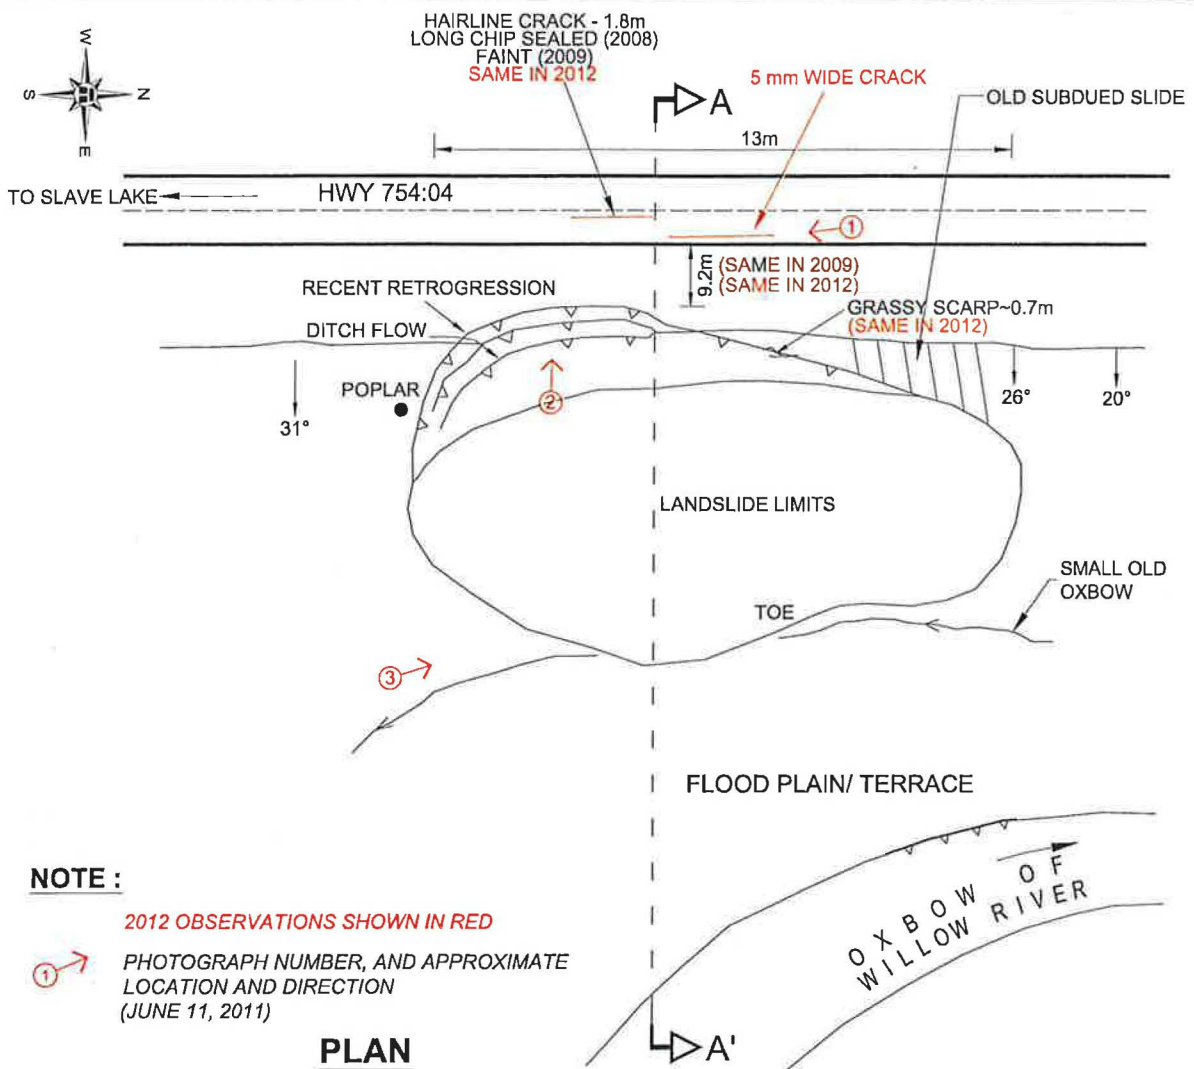
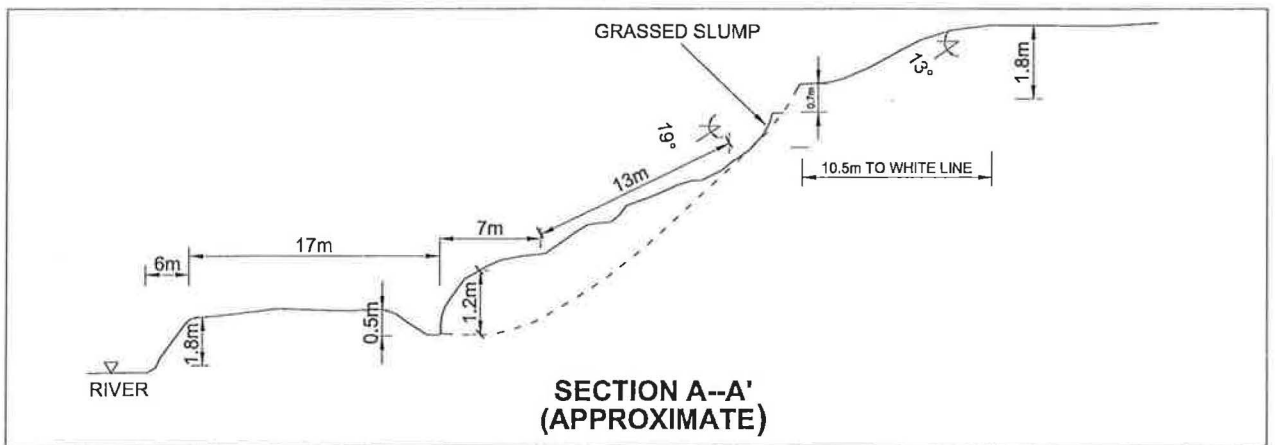
The head scarp of the slide is located at about 9.2 m from the edge of pavement (within the highway clear zone) and has dropped by about 0.7 m to 1.0 m. The original scarp was located at 10.5 m from the edge of pavement. Details of the slide main features are shown in sketch on Figure NC53-1.

2012 OBSERVATIONS SHOWN IN RED
