December 4, 2007

15-85-66

**NORTH CENTRAL REGION GEOHAZARD ASSESSMENT
(CE143/2006)
CALL-OUT FOR ROADWAY DISTRESS DUE TO FROST HEAVE
ON HWY 777:03, NC 61**

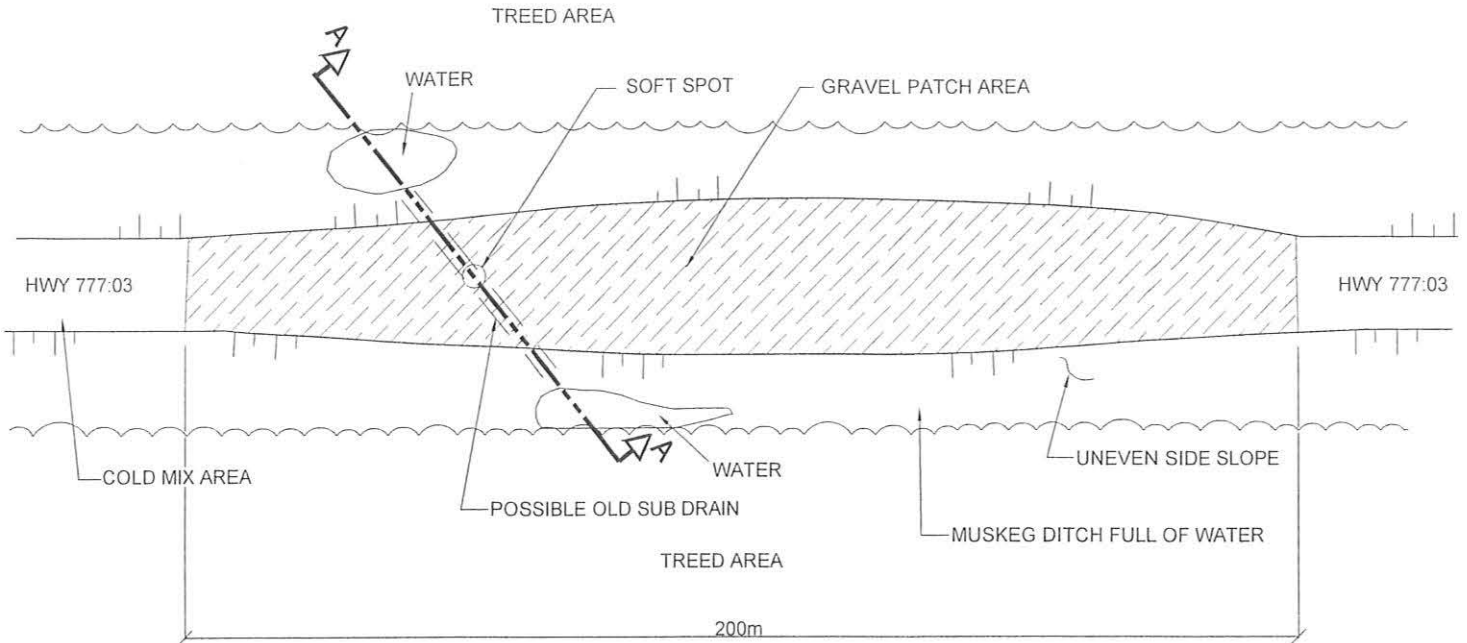
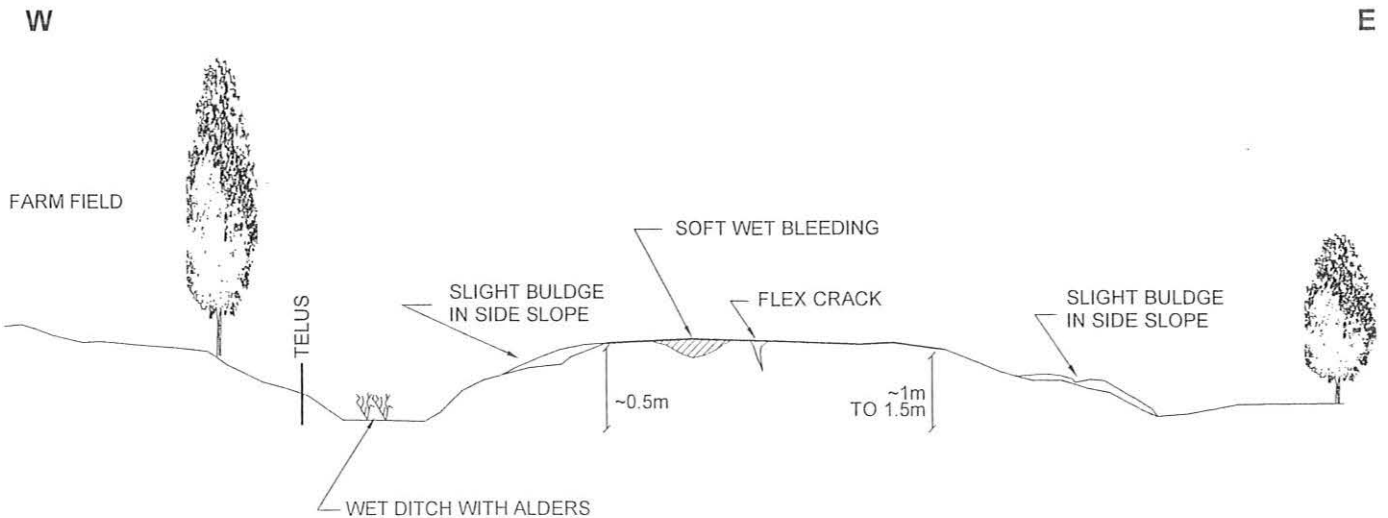
**FIGURE NC61-1 SKETCH SITE PLAN
NC61 HWY 777:03**

The roadway surface, the ditches and side slope areas on both sides of the distress highway alignment were inspected during the reconnaissance. Selected photographs taken during the site reconnaissance are attached. A sketch plan showing the location and extent of the roadway distress and other site features is provided on Figure NC61-1, along with a cross-section through the highway embankment.

The problem area was currently being levelled by gravel by INFTRA which was visible during the site visit. The bulging in the side slopes of the problem area was visible, which was the result of spreading of the gravel layer sideways. There was a wet spongy soft spot almost at the middle of the highway where a previous sub-drain might have been placed. The ditch along the west side of the highway was full of water and had small older trees growing in it but there was no sign of muskeg in the ditch.

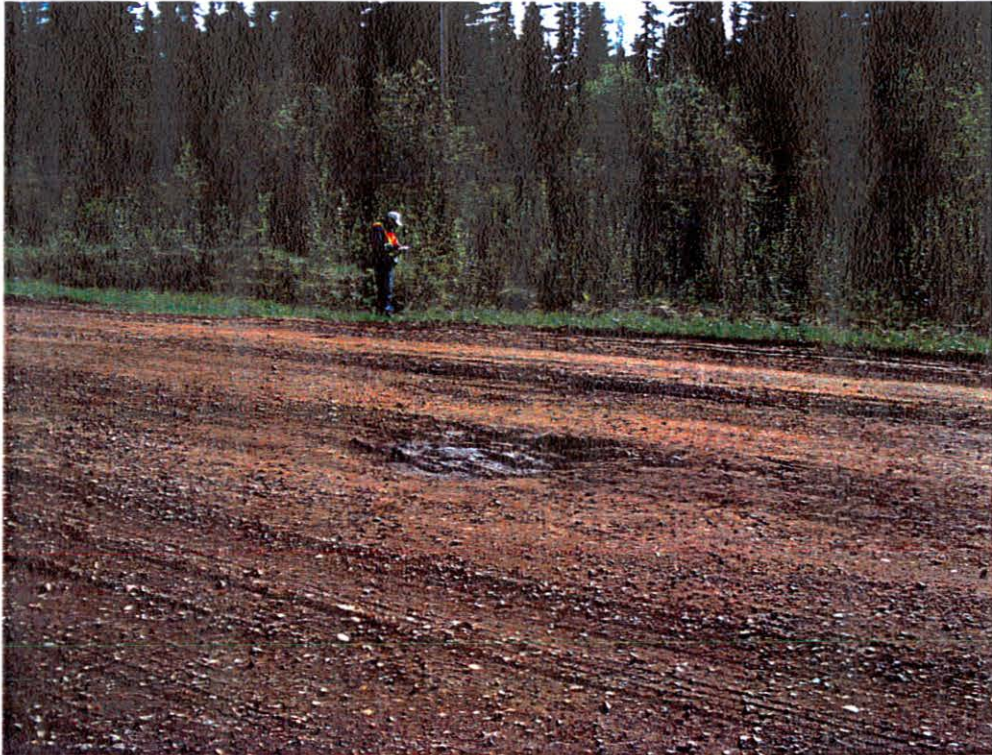
Photo 1 - Looking East at the Soft Spot.

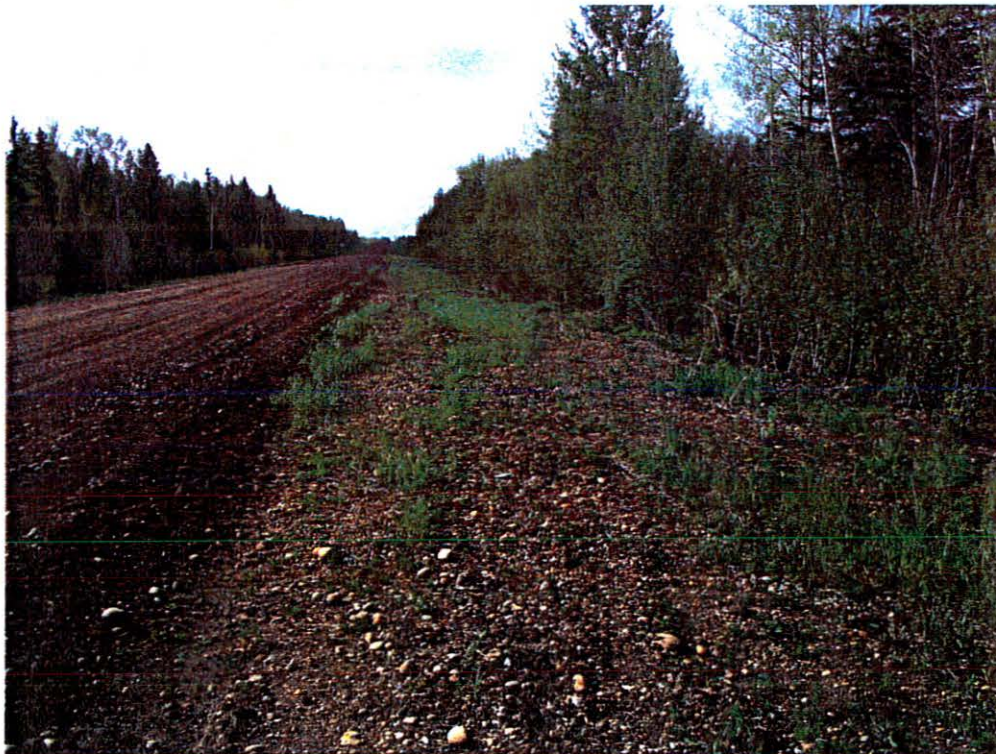
Photo 2 - Looking South at the West Ditch.

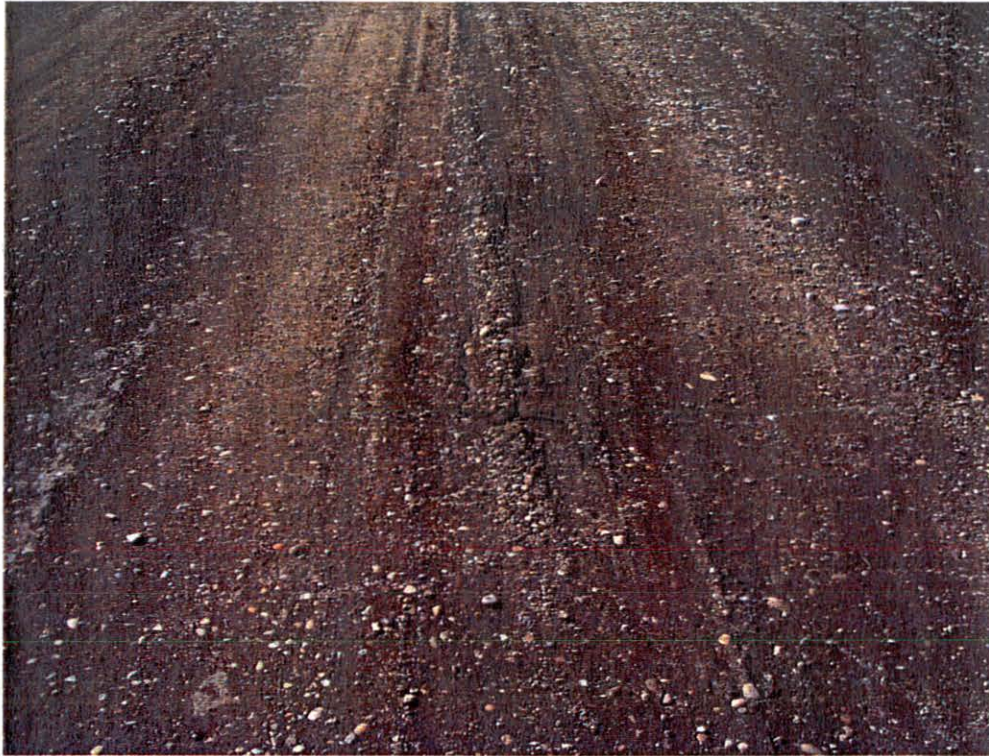
Based on the observations made during the site reconnaissance the uneven roadway surface is likely the result of high groundwater table, with possible springs, seasonal freezing temperatures, and the presence of frost susceptible silty soil beneath the road. Geotechnical investigation is required in order to confirm the soil conditions. It is expected that, if left untreated, the seasonal roadway distress will continue.

Photo 3 - Looking at the Roadway Surface at the Distress Area.

In the short term, the MCI should continue to monitor the roadway surface for any soft spots and maintain the road surface in a smooth condition through ongoing grading and addition of gravel. The site drainage should also be reviewed to see if clearing of vegetation from the ditches and construction of take-off ditches could be implemented to drain the standing water out of the existing ditches without deepening them.

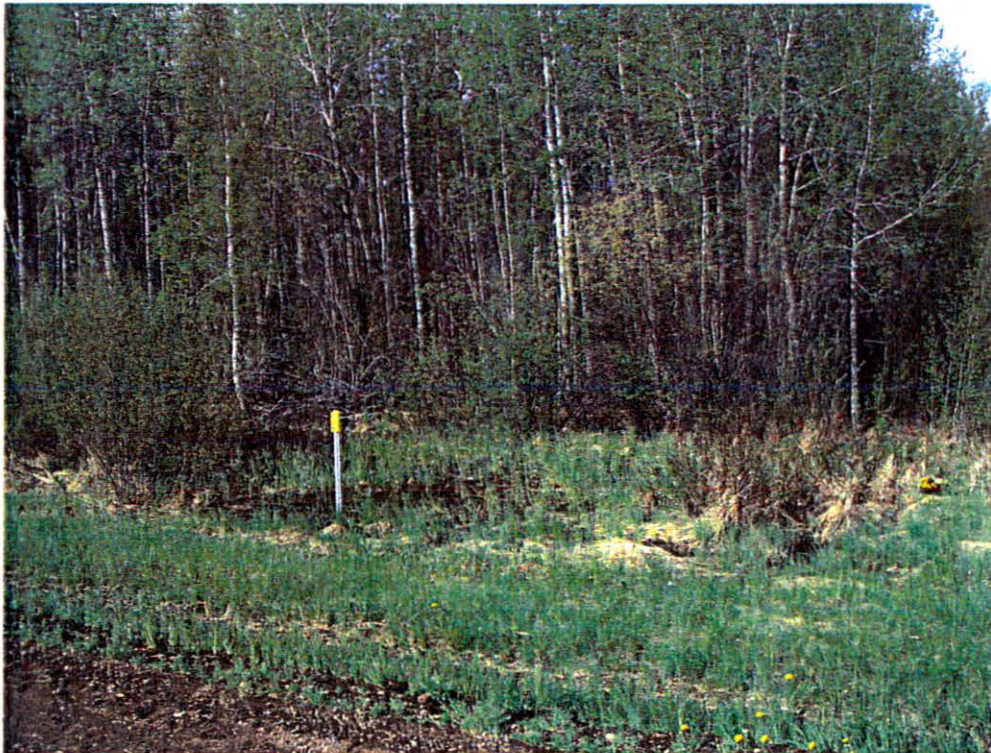
Photo 4 - Looking West at a Depressed Low Lying Area with Ponded Water.
