May 4, 2010

File:15-16-224

**NORTH CENTRAL REGION – ATHABASCA AREA – GEOHAZARD
ASSESSMENT (CE102/2008)
CALL-OUT FOR EMBANKMENT DISTRESS
ON HWY 813:02 (KM 0.5)**

SITE SKETCH PLAN SHOWING APPROXIMATE CONDITIONS DURING CALLOUT ON MARCH 31, 2010

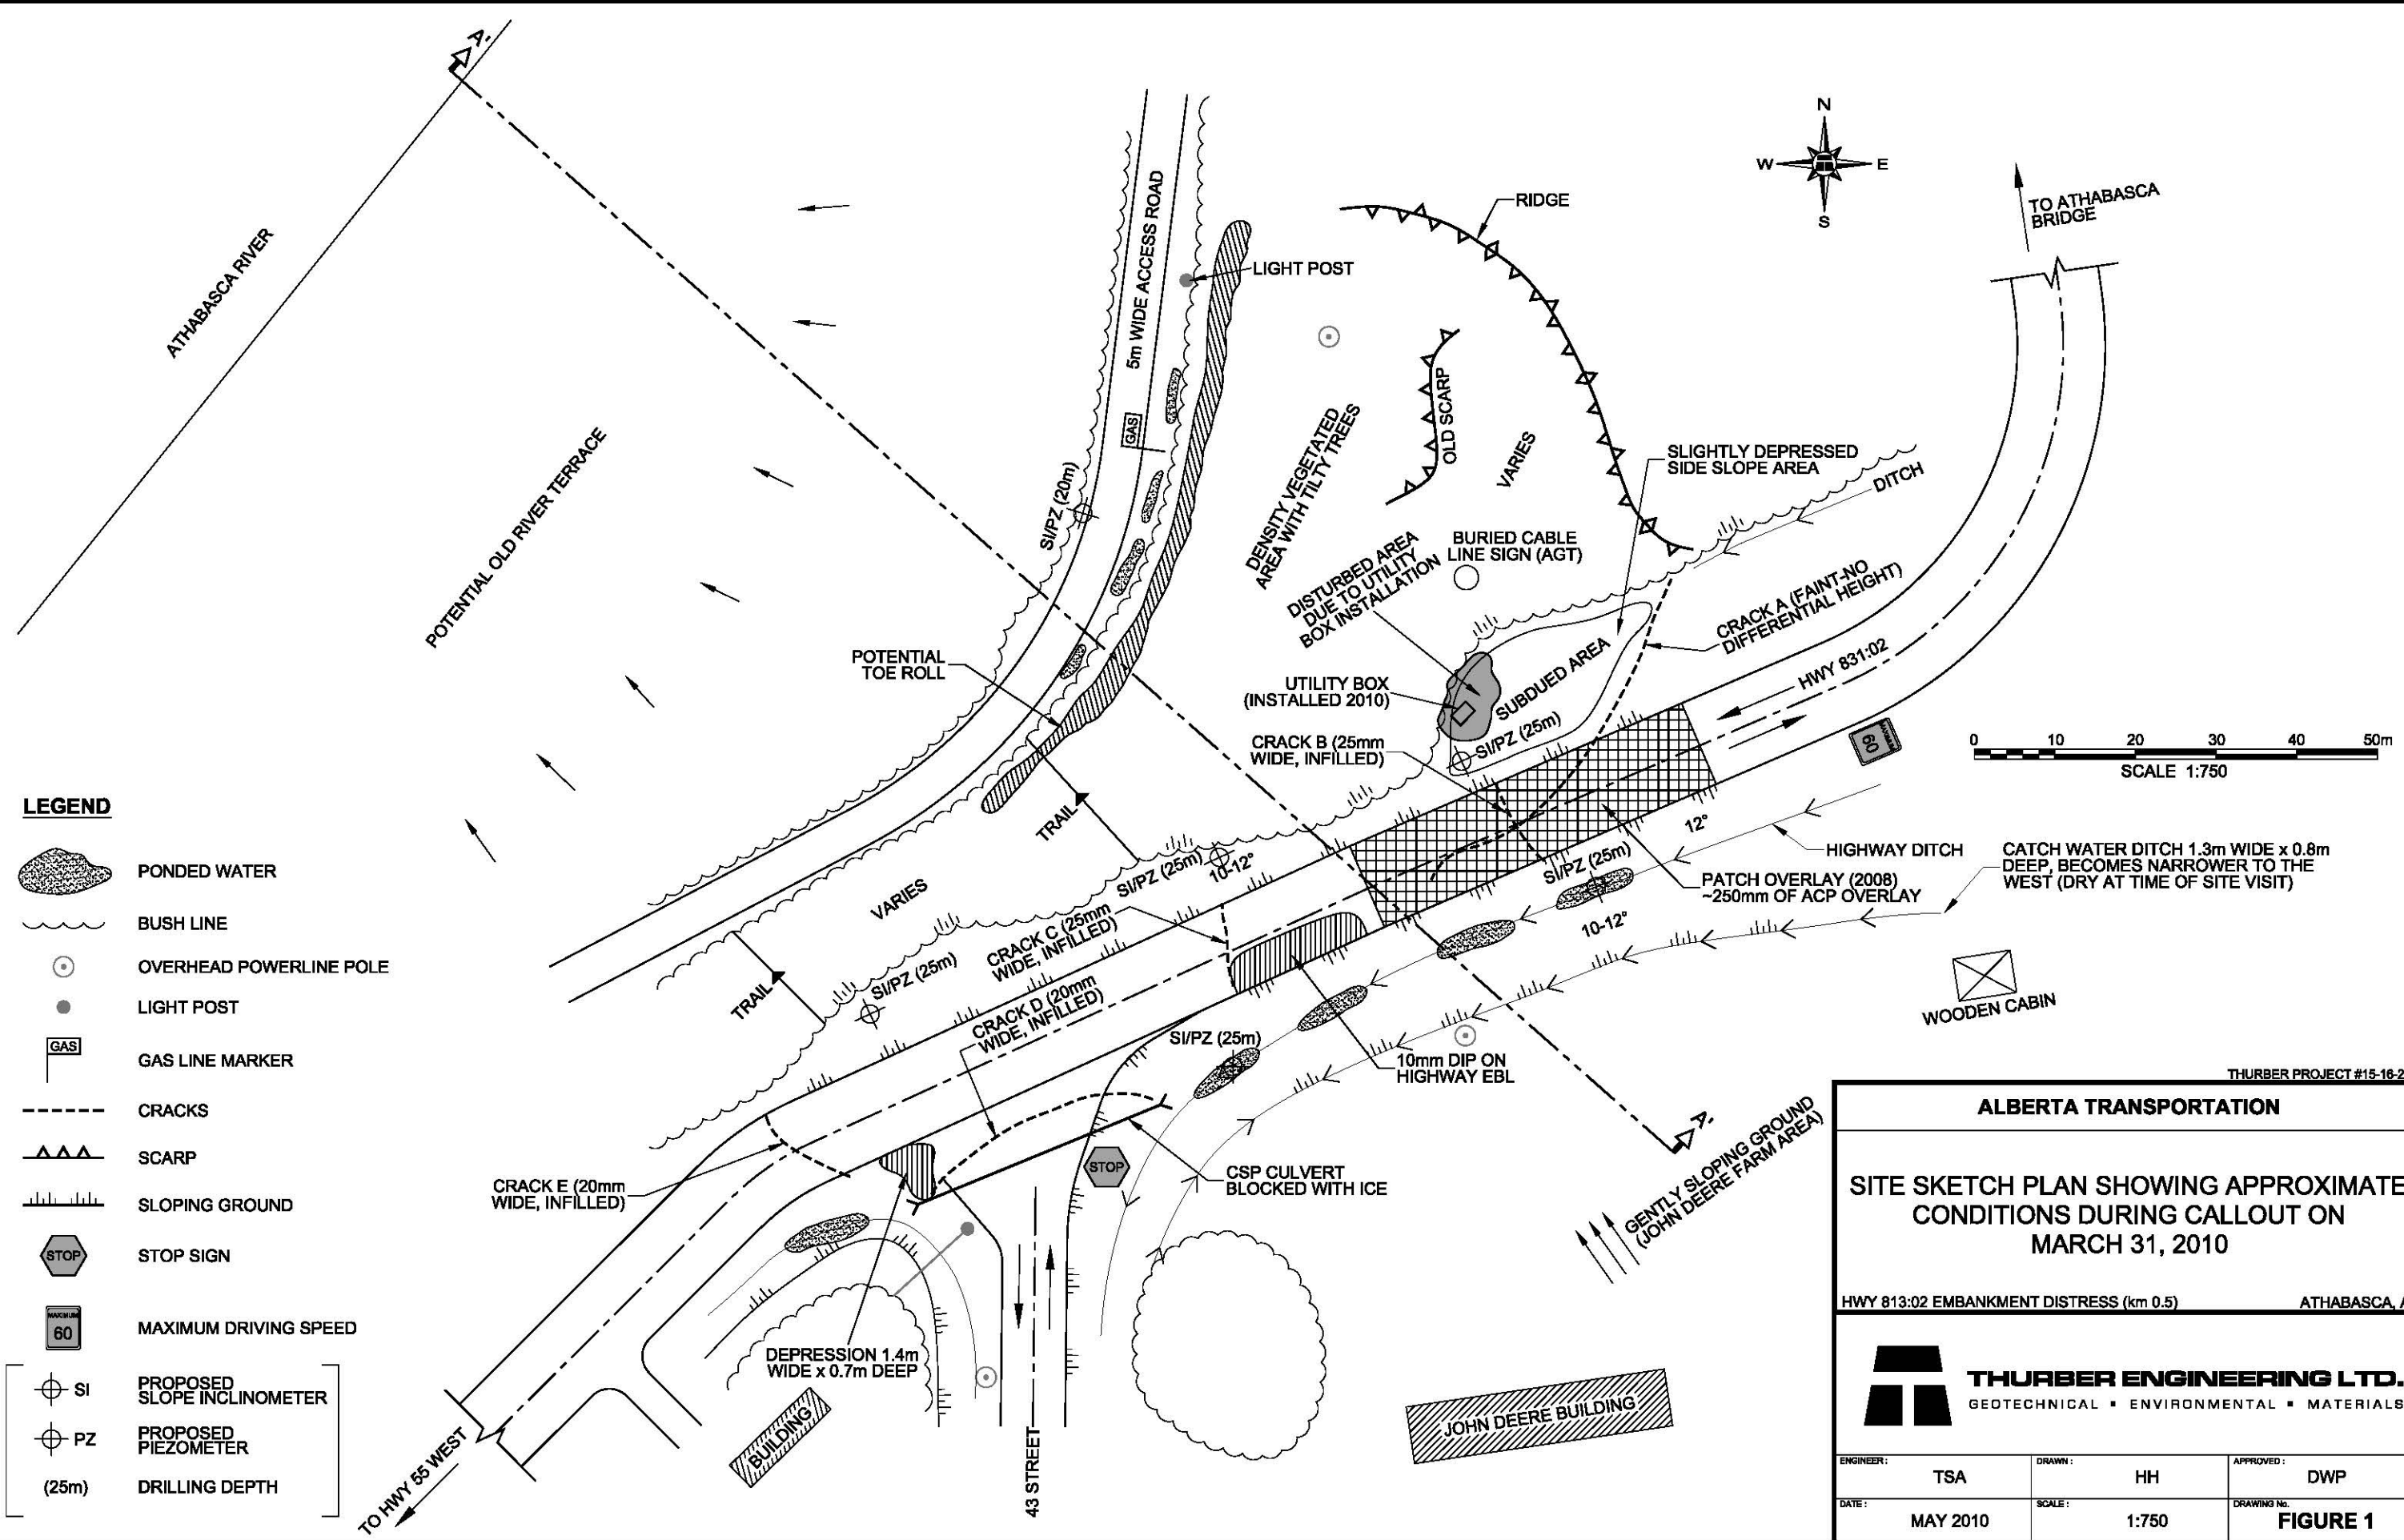
ENGINEER:	TSA	DRAWN:	HH
DATE:	MAY 2010	APPROVED:	DWP
		SCALE:	1:750
		DRAWING NO.:	FIGURE 1

Signs of instability were noted along the highway surface and side slopes. Detailed site features are presented in Figure 1. The highway east and west bound lanes appeared to be slightly depressed by no more than 10 mm over a distance of 140 m along the highway. A 45 m long ACP patch was located at the east side of the site and marked the east flank of the potential slide area. A 25 m long diagonal crack was noted downslope of the patched area. The crack appeared to be connecting to an old scarp crack in the bush down slope of the highway. This extended as a faint diagonal crack on the highway WBL (Crack A), which joined a 15 m long longitudinal faint crack on the highway EBL. The area bounded by the eastern diagonal crack downslope of the highway sideslope appeared to be slightly dishing by approximately 5 mm. A 20 m wide infilled diagonal crack (Crack E) was also noted at the west side of the highway and probably marked the western limit of the affected area by the slide movement along the highway. Additional cracks were noted on the highway surface; however they were not believed to be slide related cracks (Cracks B and C, refer to Figure 1). A potential toe roll was noted along the bottom of the slope to the south side of the access road. Cracks were not noted on the surface of the access road.

made regarding potential long-term remedial measures. The locations of proposed instruments are presented in Figure 1.

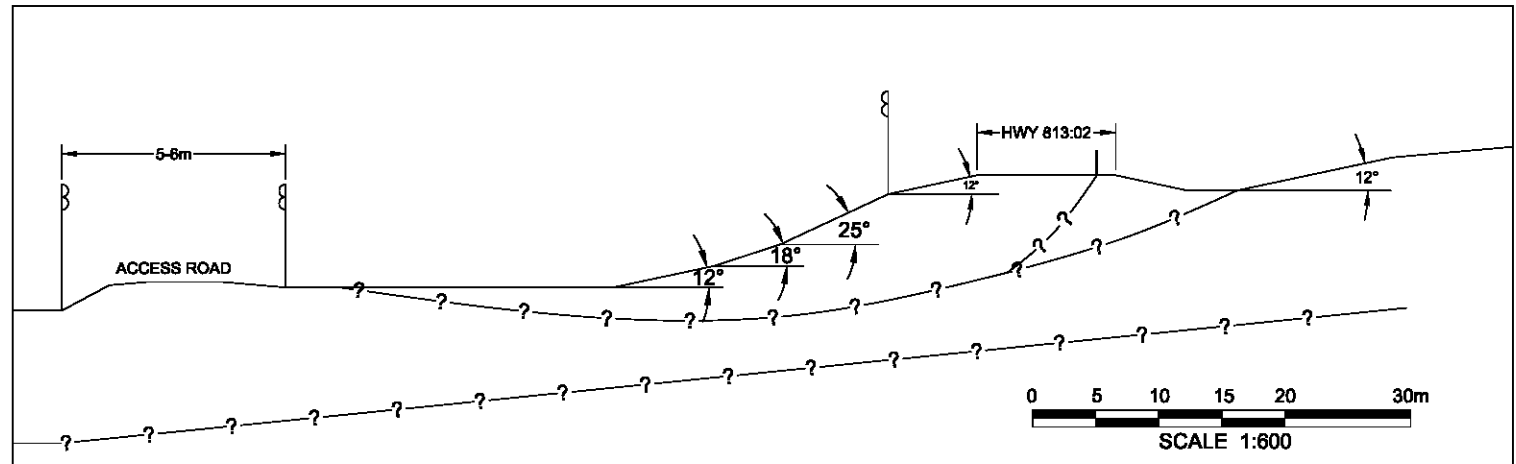
ENGINEER : TSA	DRAWN : HH	APPROVED : DWP
DATE : MAY 2010	SCALE : AS SHOWN	DRAWING No. FIGURE 2

At this location, signs of seepage and high groundwater conditions were noted in the highway south ditch and at the bottom of the natural slope below the highway. It appears that high ground water levels at this location promoted a local slide, moving slowly but presumably at slightly higher rates than the movement rates of the Athabasca river valley slope. The local slide appears to be about 140 m long (along the highway alignment) x 70-80 m wide (perpendicular to the highway alignment) x 8.5 m deep (refer to Figure 2).

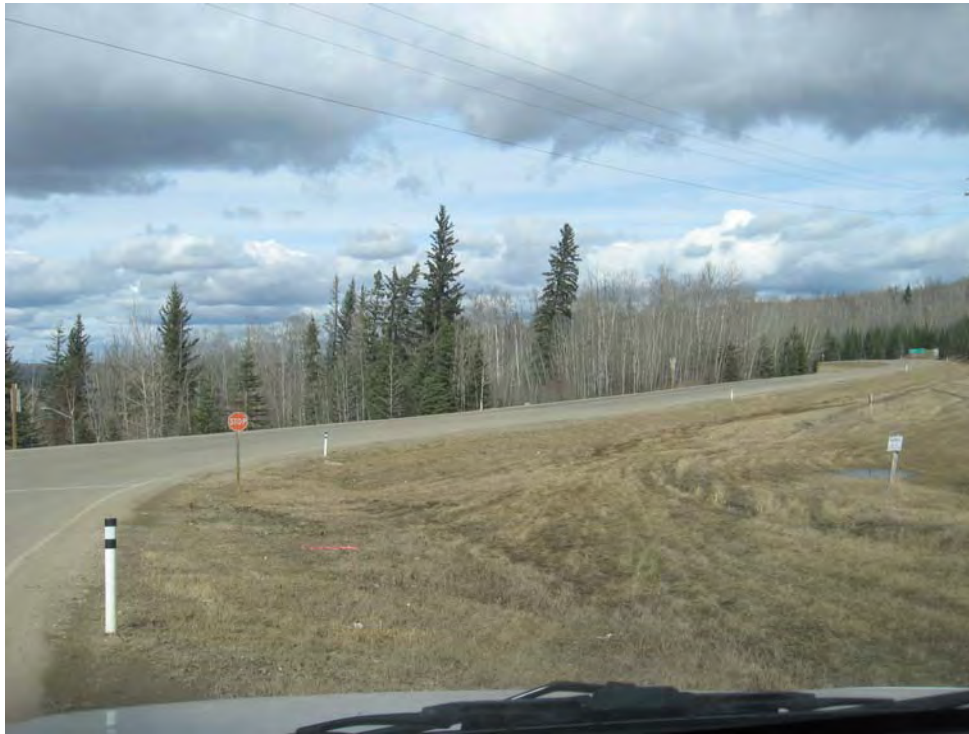
Photo 1 – General view of the subject site- Looking north from 43 Street

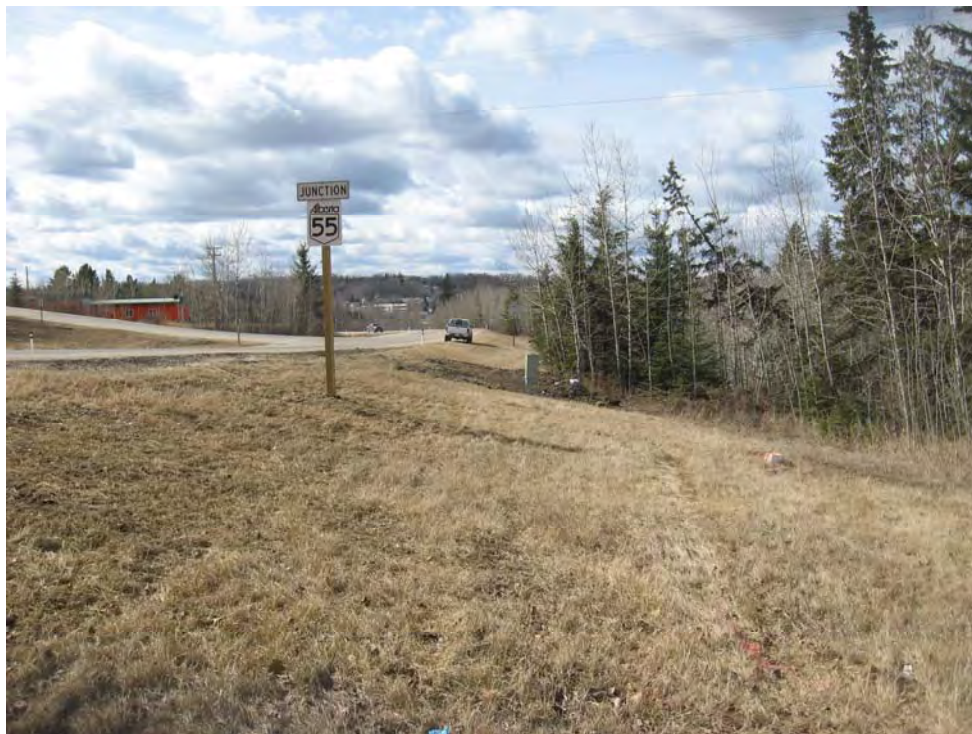
Photo 2 - Looking at the highway north side slope from the east side of the site

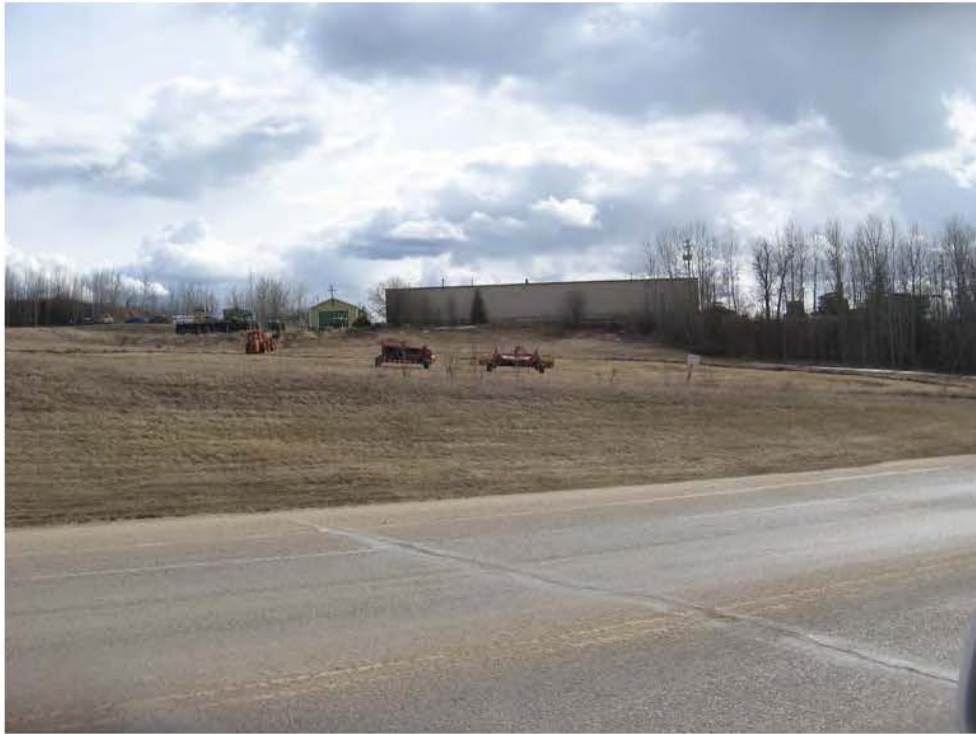
Photo 3 - Looking south towards the highway backslope

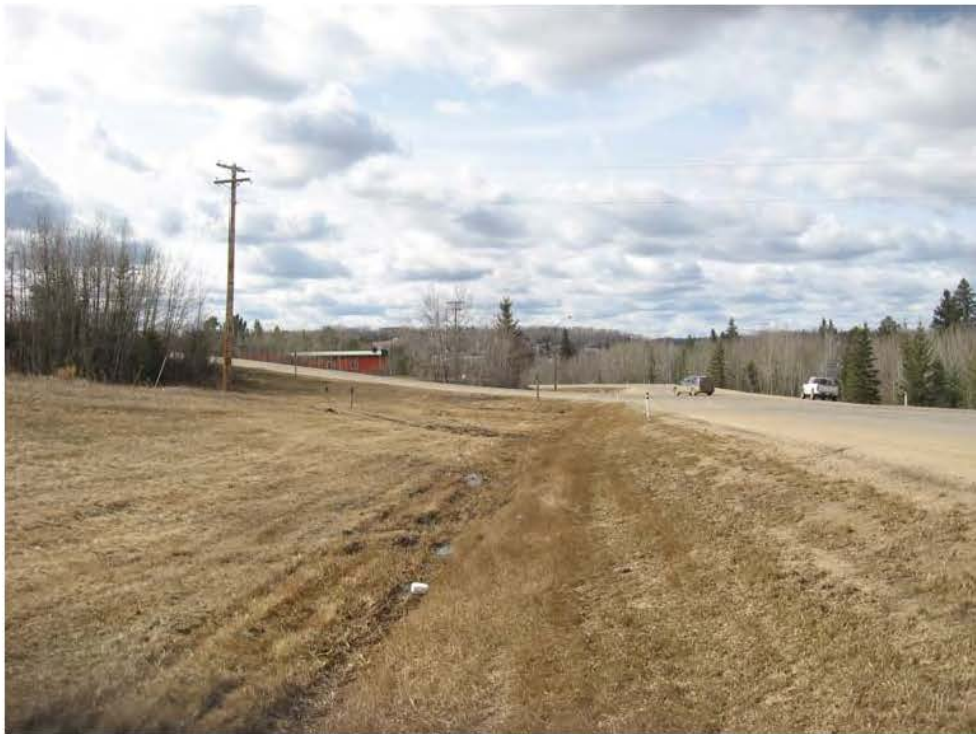
Photo 4 - Looking west at the highway south side slope and backslope

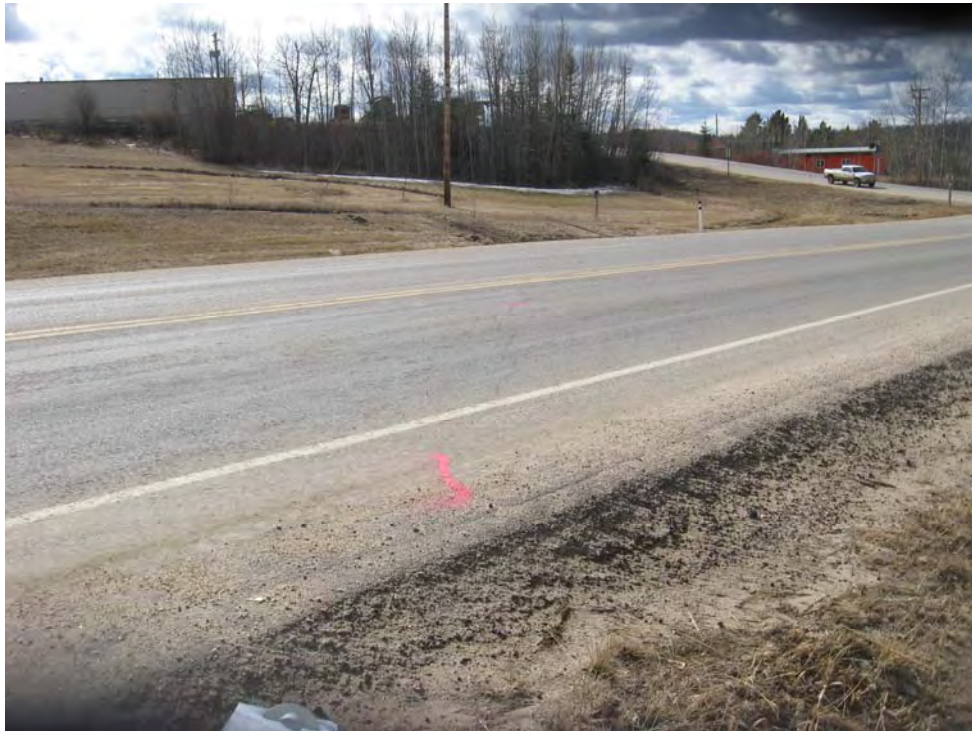
Photo 5 – Looking south at Crack A from the north ditch

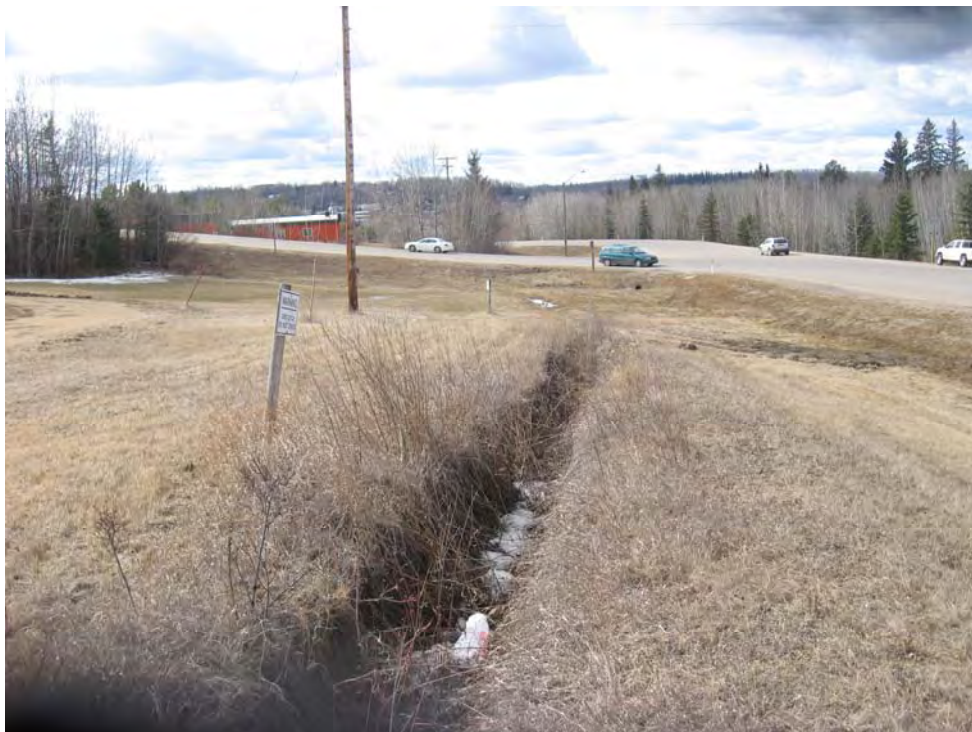
Photo 6 – Looking west at the catch water ditch at the top of the backslope

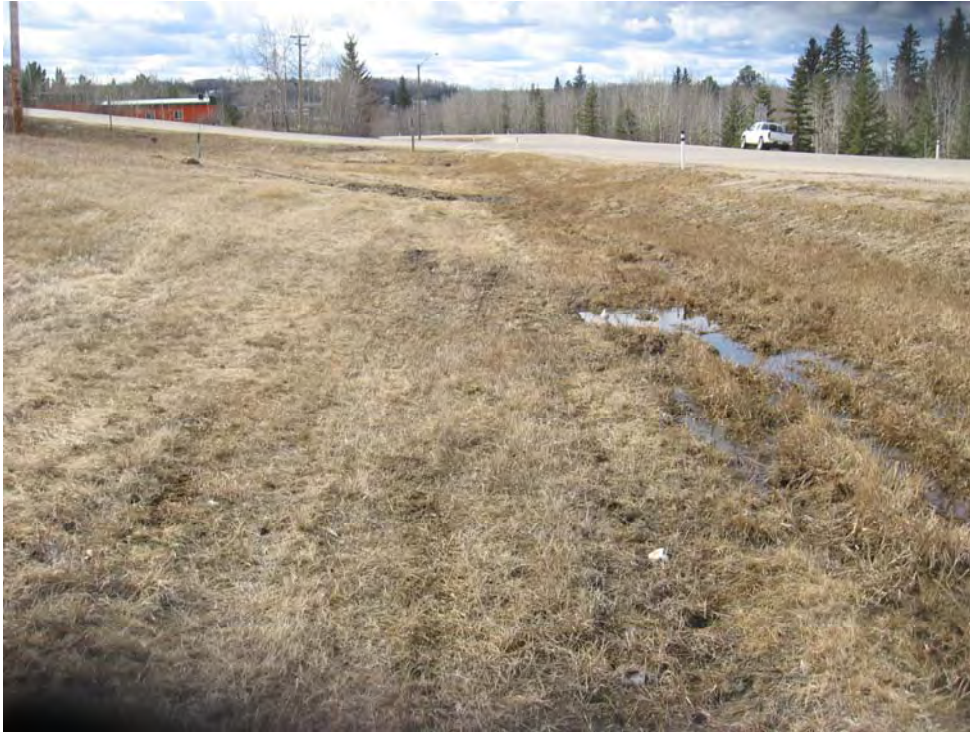
Photo 7 – Ponding water in the south highway ditch- Looking west

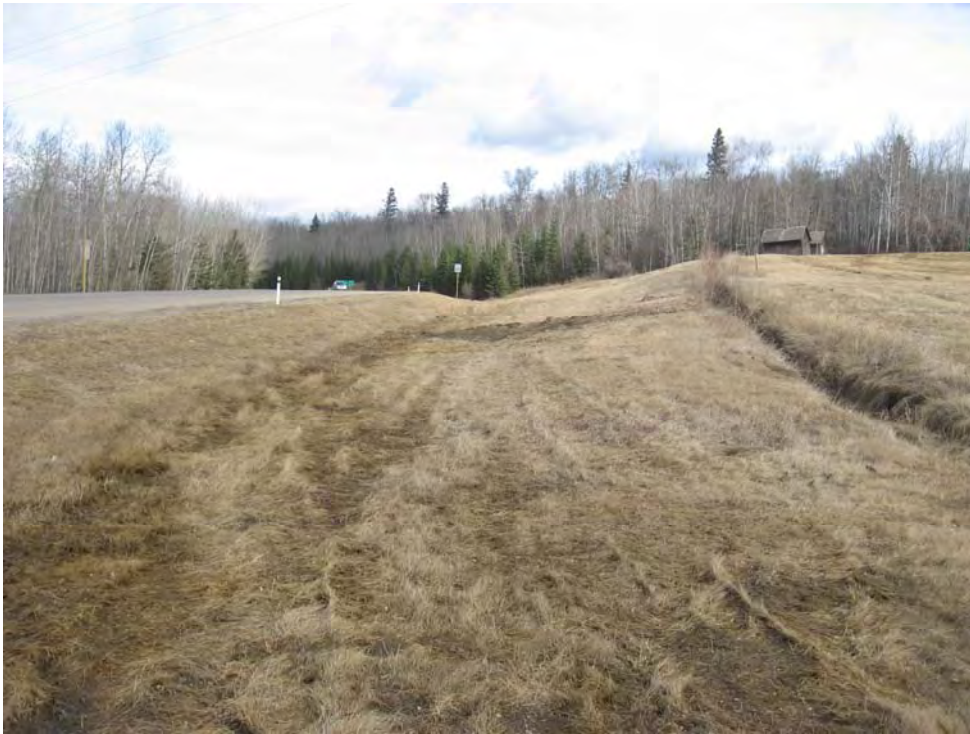
Photo 8 – Multiple wet spots in the south highway ditch- Looking east

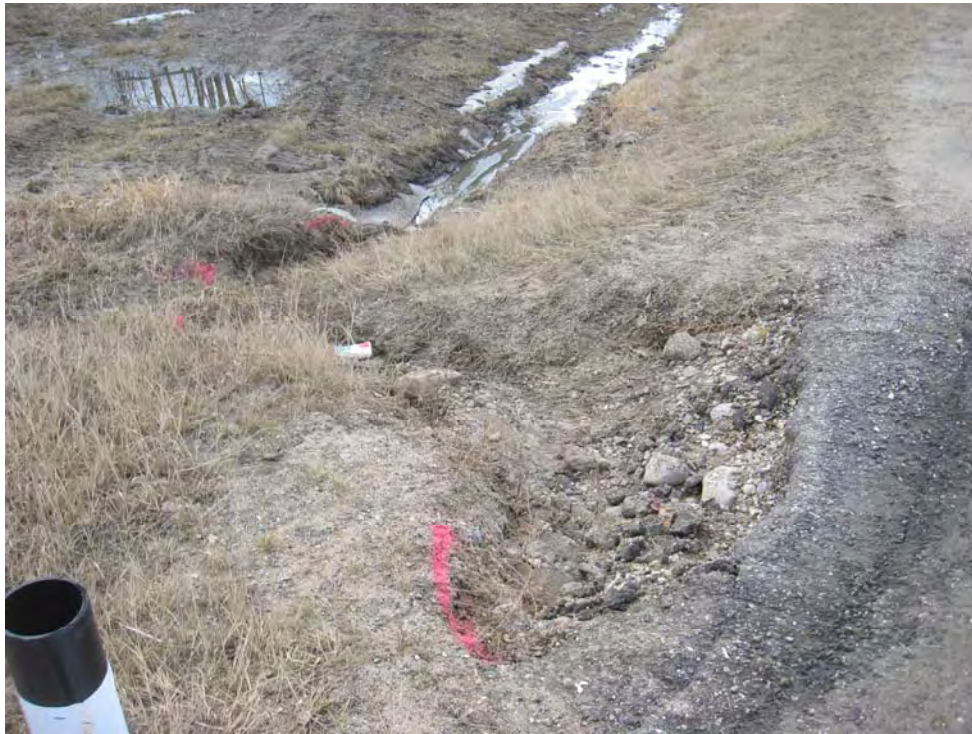
Wet spots were noted at several locations along the south ditch of the highway and at the bottom of the slope to the south of the access road. The existing culvert below 43 Street appeared to be distressed and partially blocked with ice at the inlet and outlet locations.

Photo 9 – Looking at ponded water at the outlet of the CSP culvert and erosion in the vicinity of the culvert

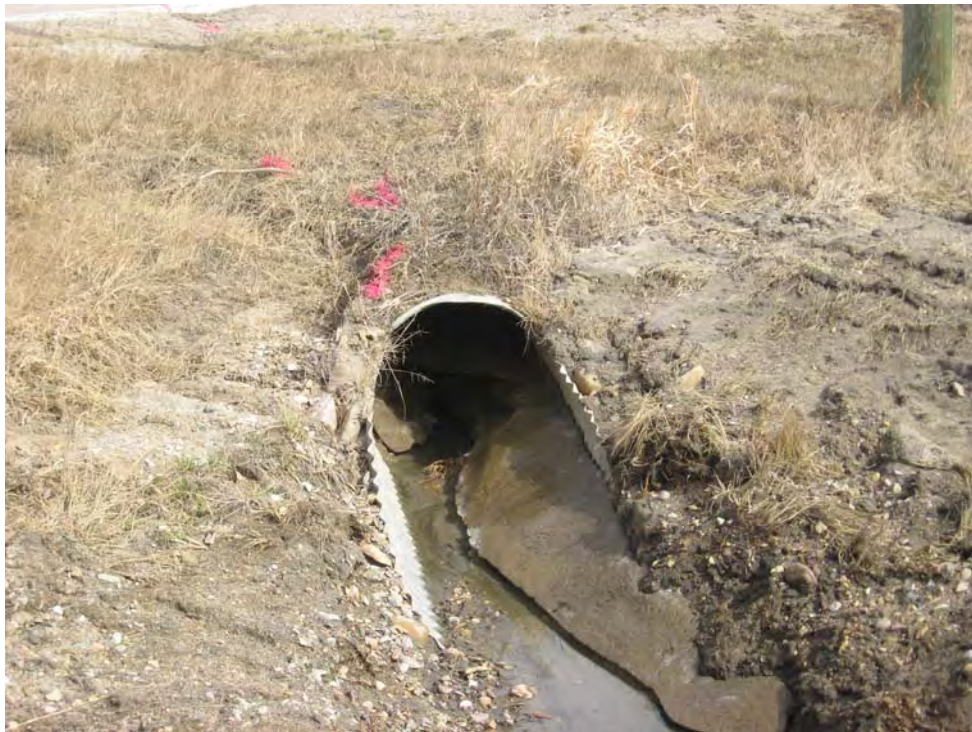
Photo 10 – Closer look at the culvert outlet. Note the cracks formed to the left of the culvert and formation of ice inside the culvert

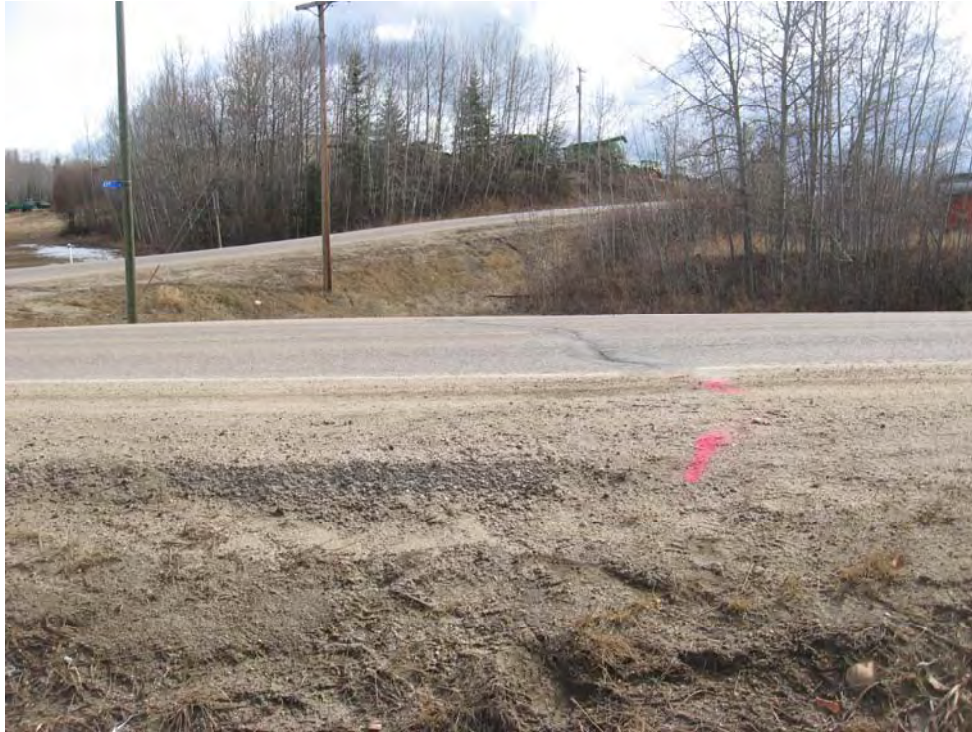
Photo 11 –Crack E at the west side of the site- Looking south from the north ditch

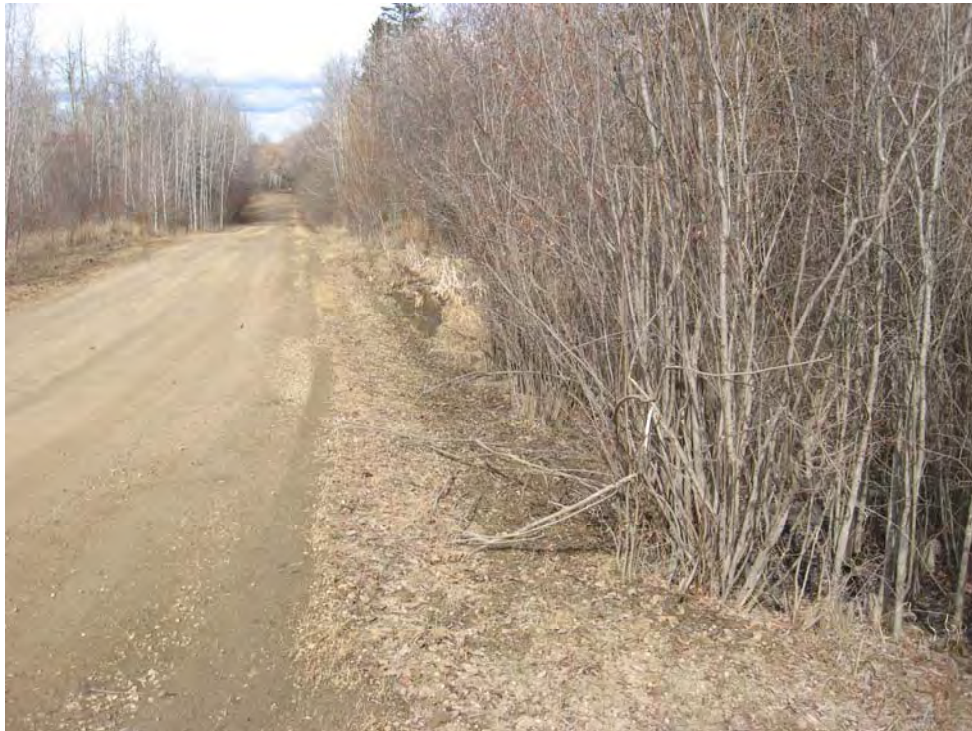
Photo 12 –Looking east at the existing access road at the bottom of the slope. Note the ponded water by the tree line

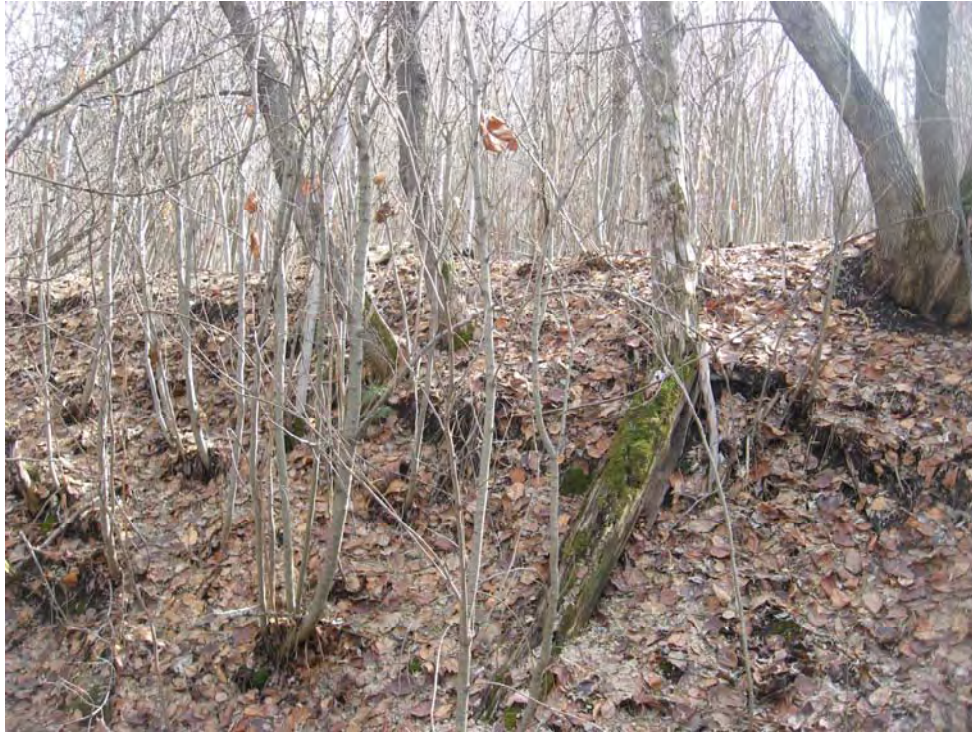
Photo 13 –Looking east at the ridge in the bush downslope of the highway.

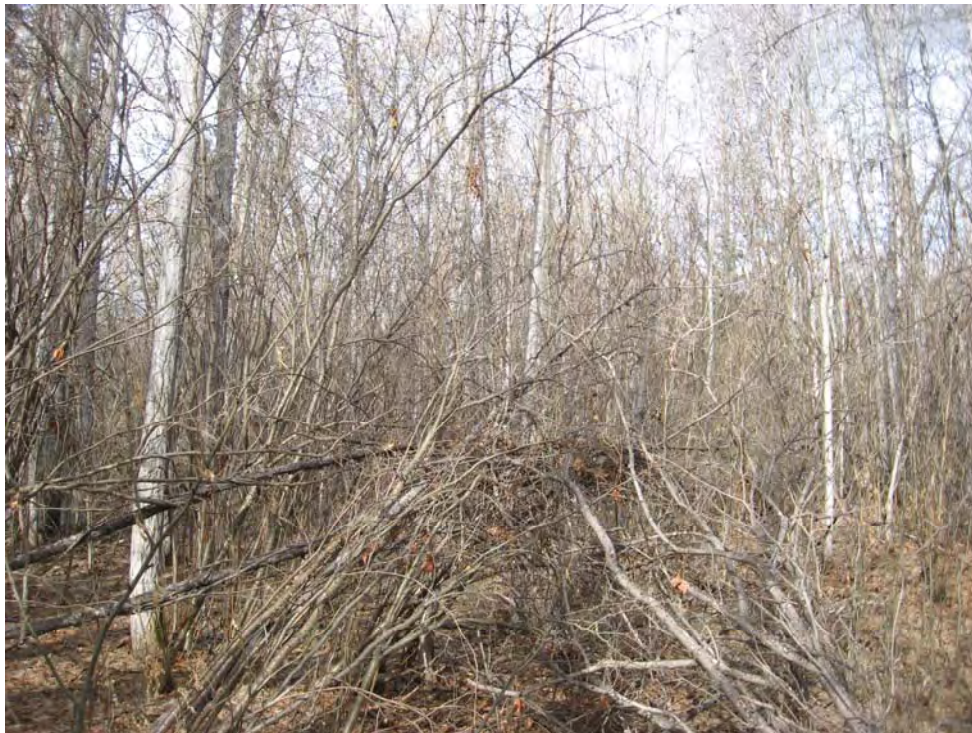
Photo 14 –Looking at falling trees in the bush downslope of the highway

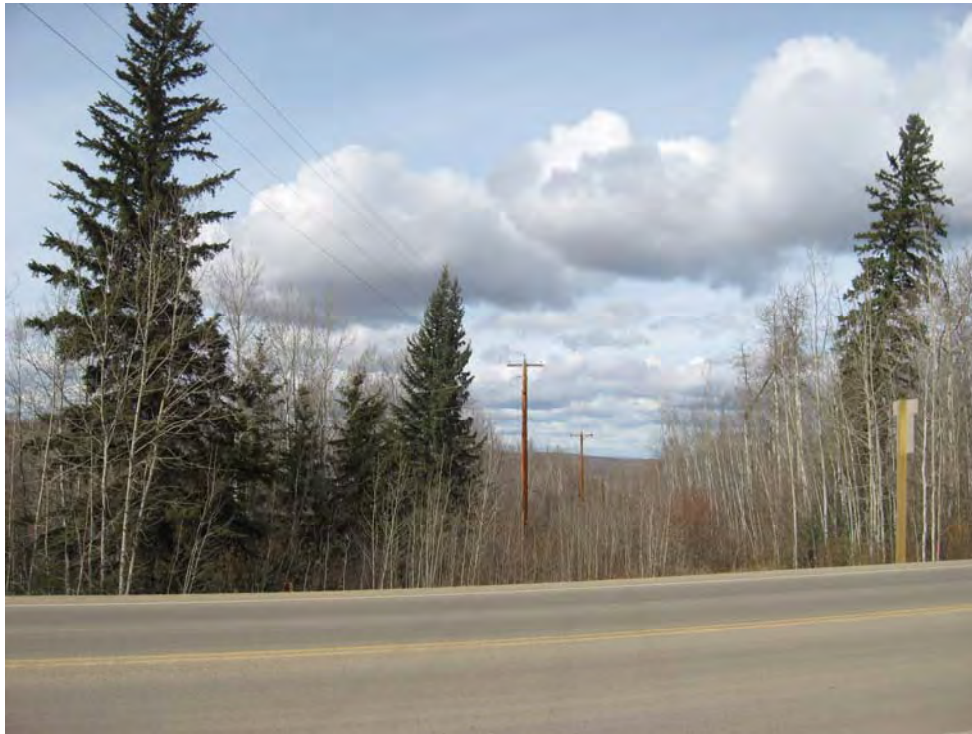
Photo 15 –Looking north at tilting trees downslope of the highway
