**GEOHAZARD ASSESSMENT PROGRAM**  
**NORTH CENTRAL REGION – ATHABASCA AREA**  
**2016 INSPECTION**

<b>Site Number</b>	<b>Location</b>	<b>Hwy 55:10 and 813:02 Intersection</b>	<b>km</b>
NC004-1	Athabasca		
<b>Legal Description</b>		<b>UTM Co-ordinates</b>	
21-066-22 W4M		12V E 6066180	N 353385

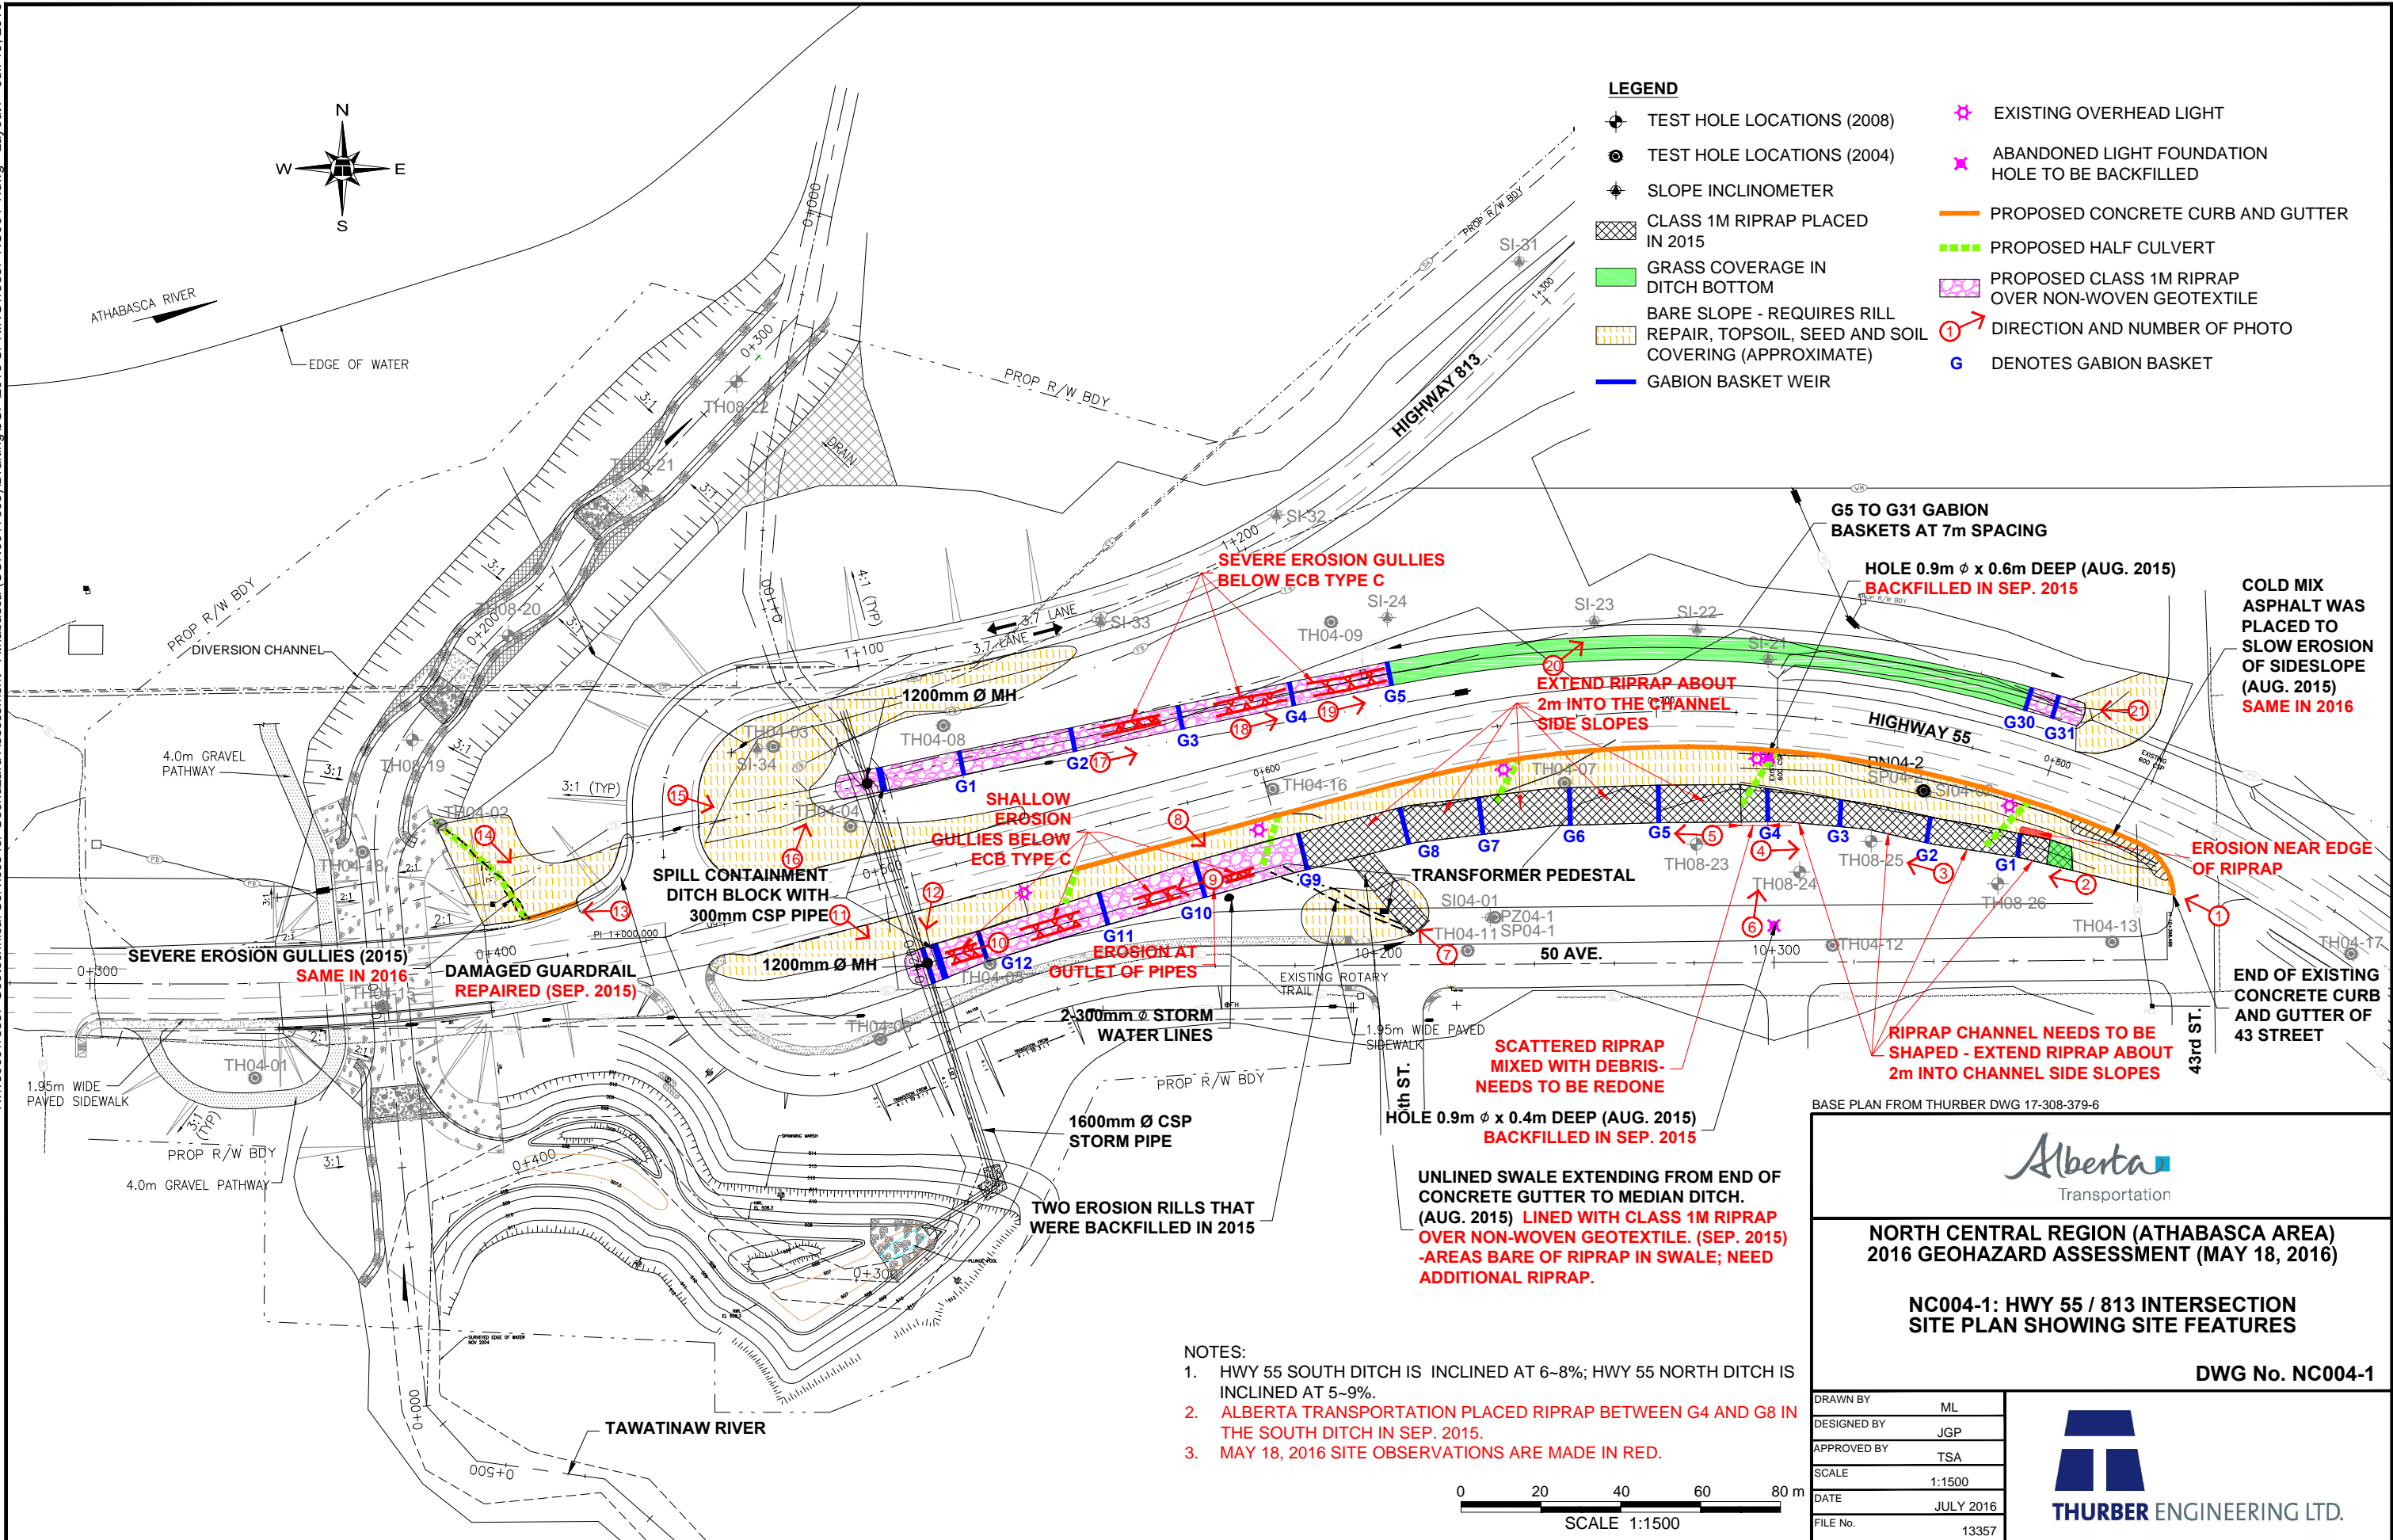
- NOTES:**
1. HWY 55 SOUTH DITCH IS INCLINED AT 6-8%; HWY 55 NORTH DITCH IS INCLINED AT 5-9%.
  2. ALBERTA TRANSPORTATION PLACED RIPRAP BETWEEN G4 AND G8 IN THE SOUTH DITCH IN SEP. 2015.
  3. MAY 18, 2016 SITE OBSERVATIONS ARE MADE IN RED.

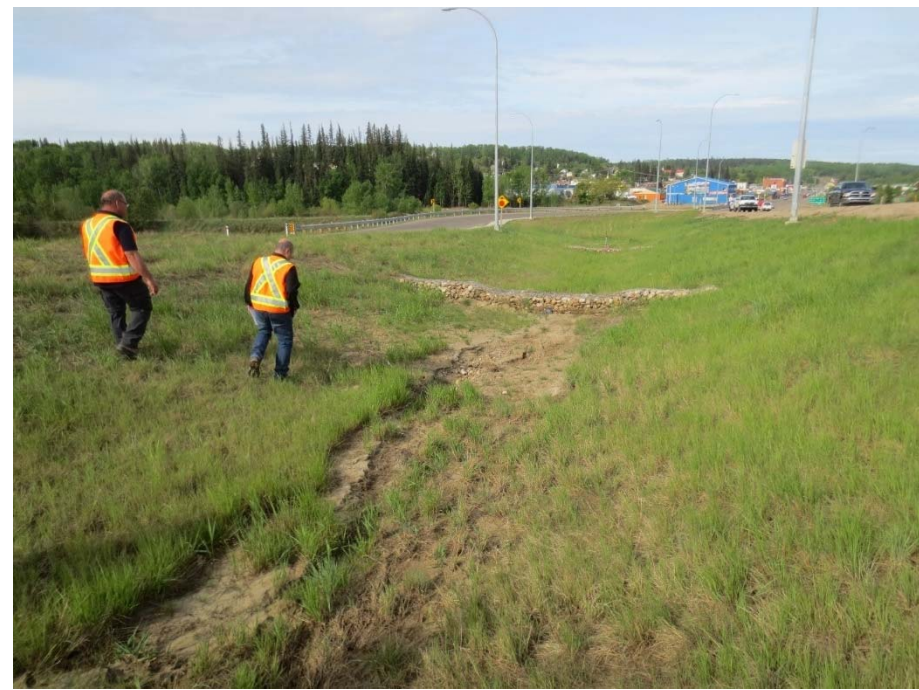
**Photo 9.**  
Hwy 55 south ditch:  
looking west at the  
ditch between G10  
and G11; the ditch  
bottom is bare of  
vegetation and signs  
of erosion were noted  
in this area

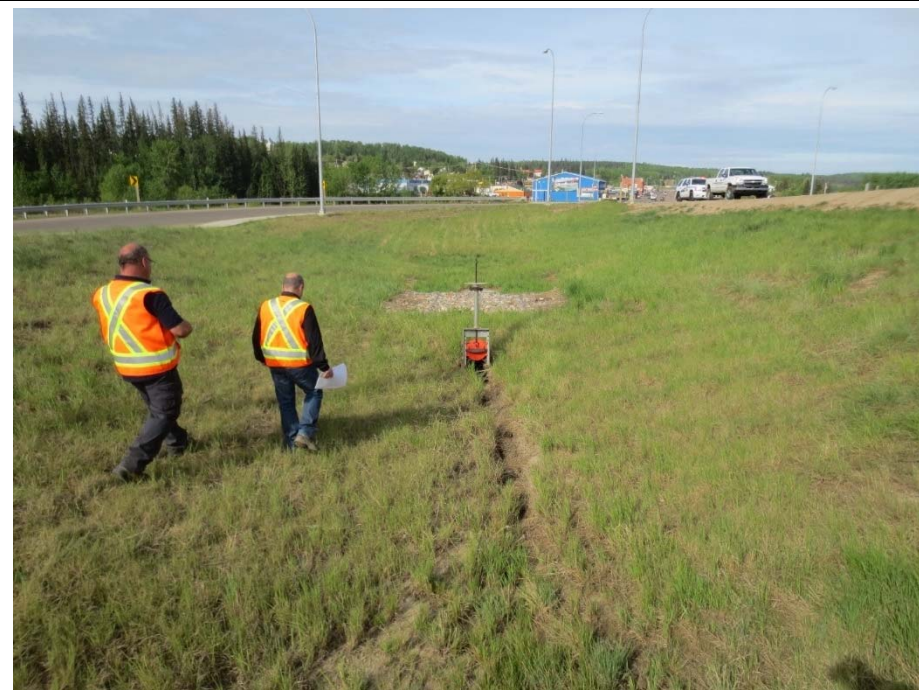
**Photo 10.**  
Hwy 55 south ditch:  
looking west at  
shallow erosion gully  
between G 12 and the  
spill containment ditch  
block

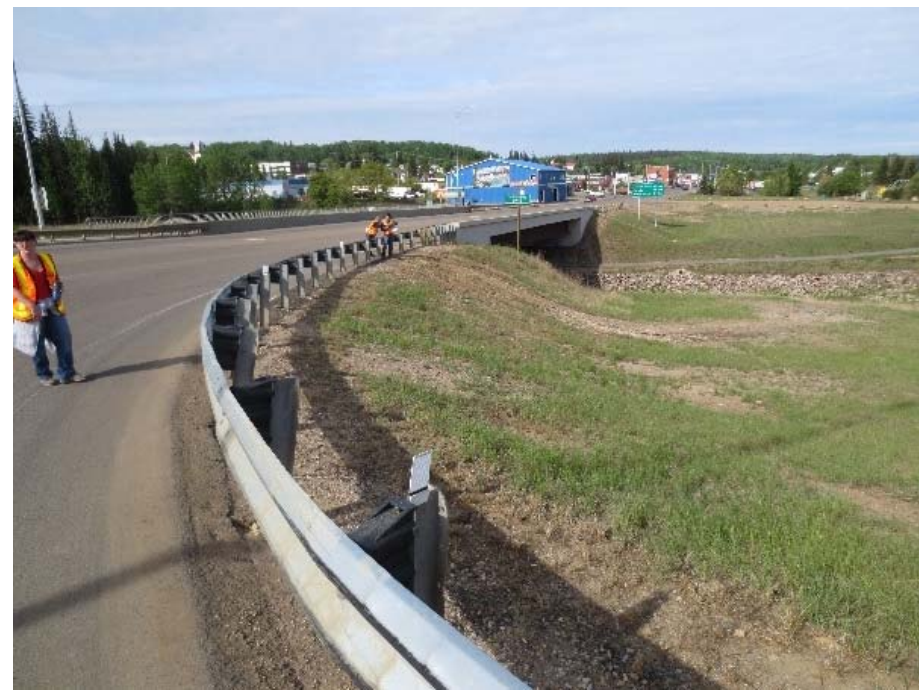
**Photo 13.**  
Looking west at the northwest corner of the intersection of Hwy 55 and 813. Existing guardrail was repaired by AT in September 2015; vegetation appears to be scarce in this area

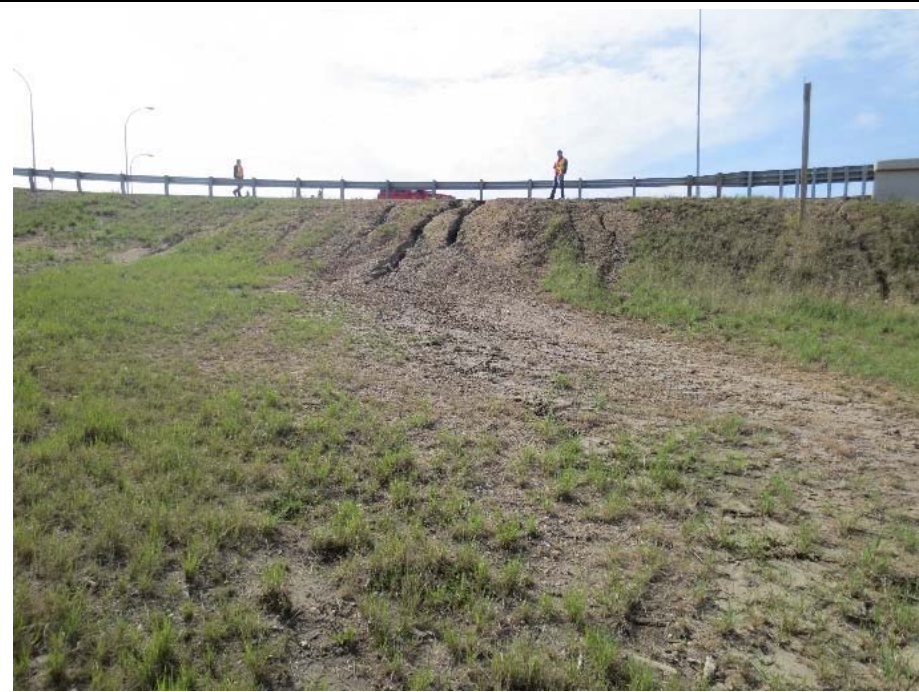
**Photo 14.**  
Looking south at deep erosion gullies developed within northwest side slopes of the bridge east approach fill

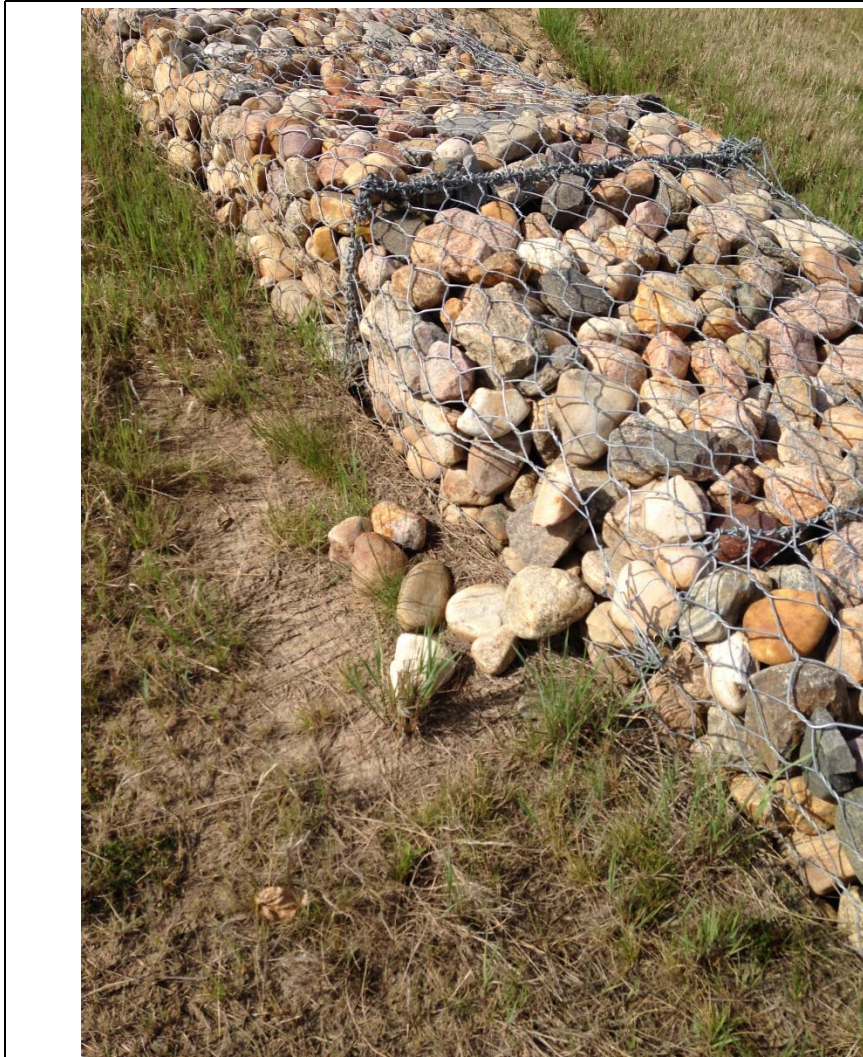
**Photo 20.**  
Hwy 55 North Ditch:  
G14 damaged wire  
mesh

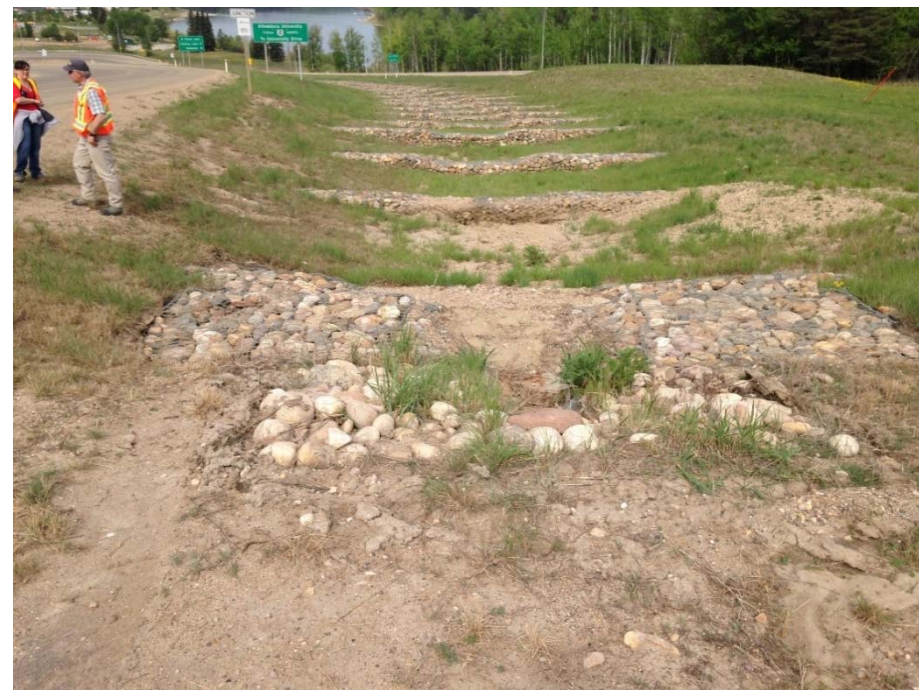
**Photo 21.**  
Hwy 55 North Ditch: looking west from the west side slope of 43 Street. Bare ground surface between west side slope of 43 St and G31 and between G30 and G31; sediment accumulated in the ditch behind the gabion baskets; ditch bottom should be cleaned of the built up sediment and riprap should be placed in these areas to reduce future erosion issues.
