GEOHAZARD ASSESSMENT PROGRAM
NORTH CENTRAL REGION – ATHABASCA
2017 INSPECTION

Site Number	Location	Hwy	Km
NC 004-1	Town of Athabasca	55:10 and 813:02 Intersection	Hwy 55:10: km 0.34 to 0.84 Hwy 813:02: km 0.00 to 1.97
Legal Description		UTM Co-ordinates (NAD 83)	
21-066-22 W4M		12 E 6066180	N 353385

Date	PF	CF	Total
Previous Inspection:	May 18, 2016	12	4	48
Current Inspection:	May 17, 2017	12	4	48
Road AADT:	9100		Year:	2016
Inspected By:	Tarek Abdelaziz, José Pineda (Thurber) Roger Skirrow, Arthur Kavulok, Ron Hilligas, Paula Campbell (TRANS)			
Report Attachments:	<input checked="" type="checkbox"/> Photographs <input checked="" type="checkbox"/> Plans <input checked="" type="checkbox"/> Maintenance Items

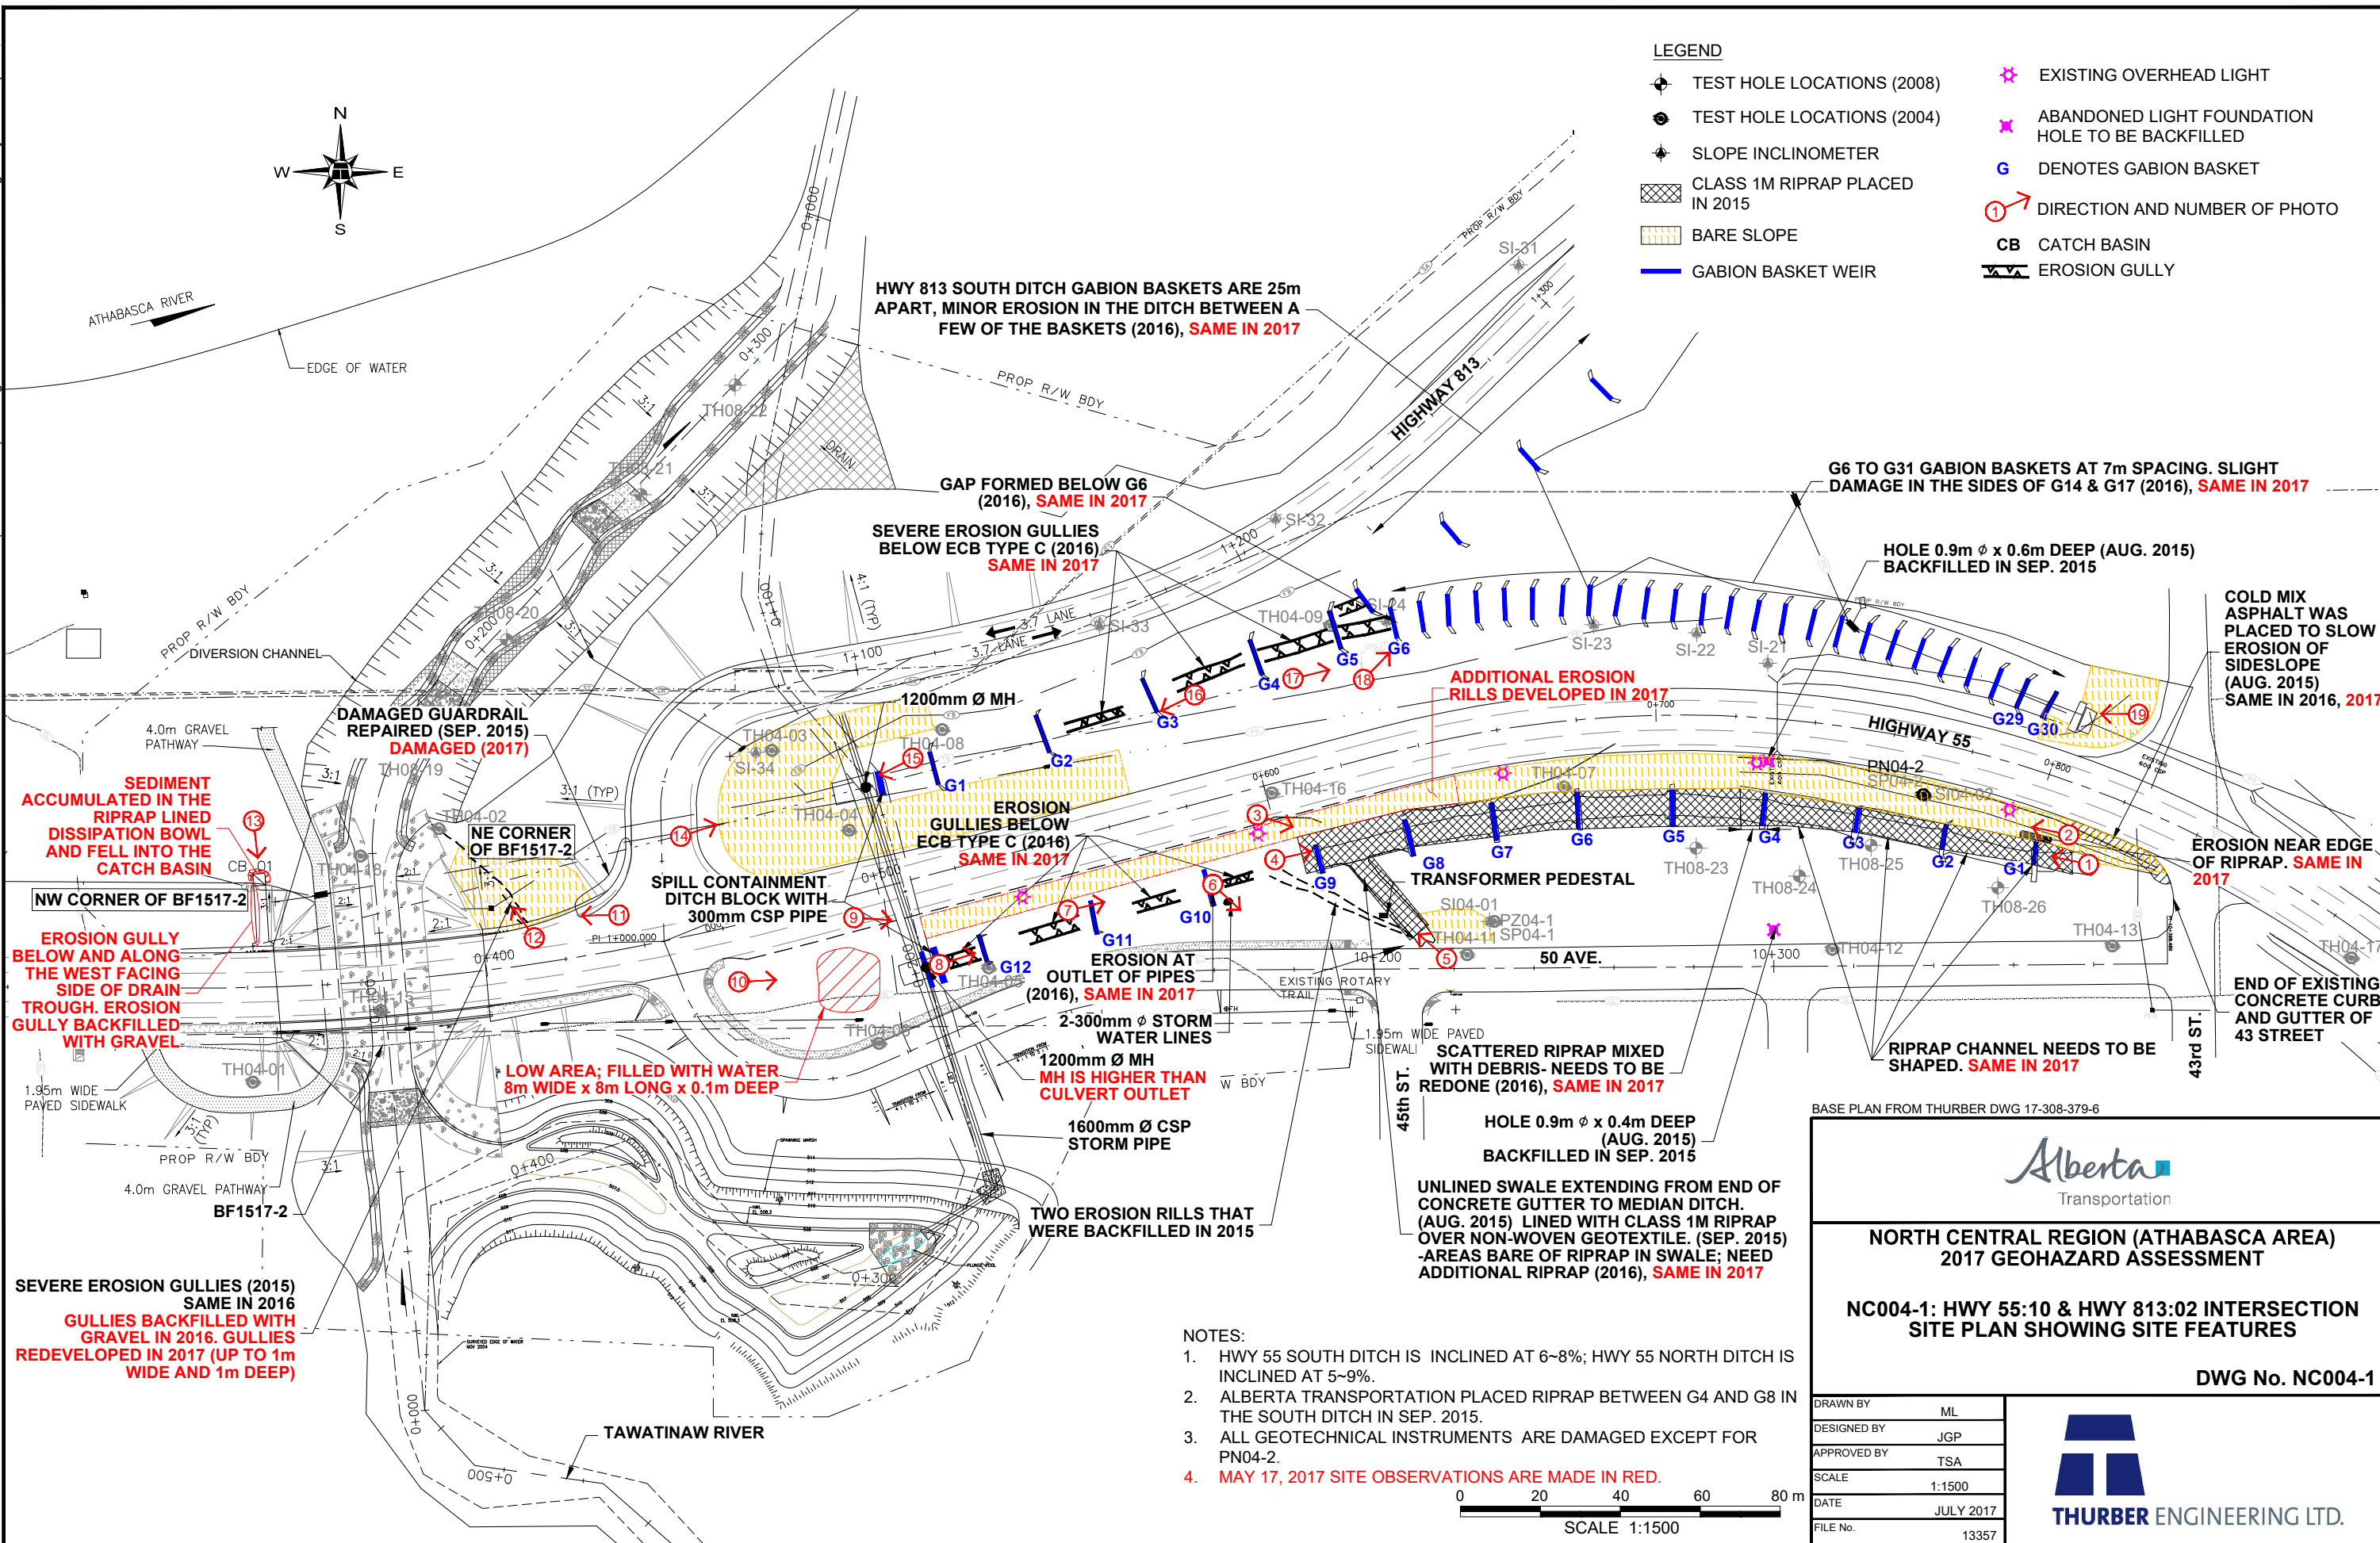
DWG No. NC004-1

HWY 813 SOUTH DITCH GABION BASKETS ARE 25m APART, MINOR EROSION IN THE DITCH BETWEEN A FEW OF THE BASKETS (2016), SAME IN 2017

G6 TO G31 GABION BASKETS AT 7m SPACING. SLIGHT DAMAGE IN THE SIDES OF G14 & G17 (2016), SAME IN 2017

GAP FORMED BELOW G6 (2016), SAME IN 2017

SEVERE EROSION GULLIES BELOW ECB TYPE C (2016) SAME IN 2017

ADDITIONAL EROSION RILLS DEVELOPED IN 2017

SEDIMENT ACCUMULATED IN THE RIPRAP LINED DISSIPATION BOWL AND FELL INTO THE CATCH BASIN

EROSION NEAR EDGE OF RIPRAP. SAME IN 2017

EROSION AT OUTLET OF PIPES (2016), SAME IN 2017

UNLINED SWALE EXTENDING FROM END OF CONCRETE GUTTER TO MEDIAN DITCH. (AUG. 2015) LINED WITH CLASS 1M RIPRAP OVER NON-WOVEN GEOTEXTILE. (SEP. 2015) -AREAS BARE OF RIPRAP IN SWALE; NEED ADDITIONAL RIPRAP (2016), SAME IN 2017

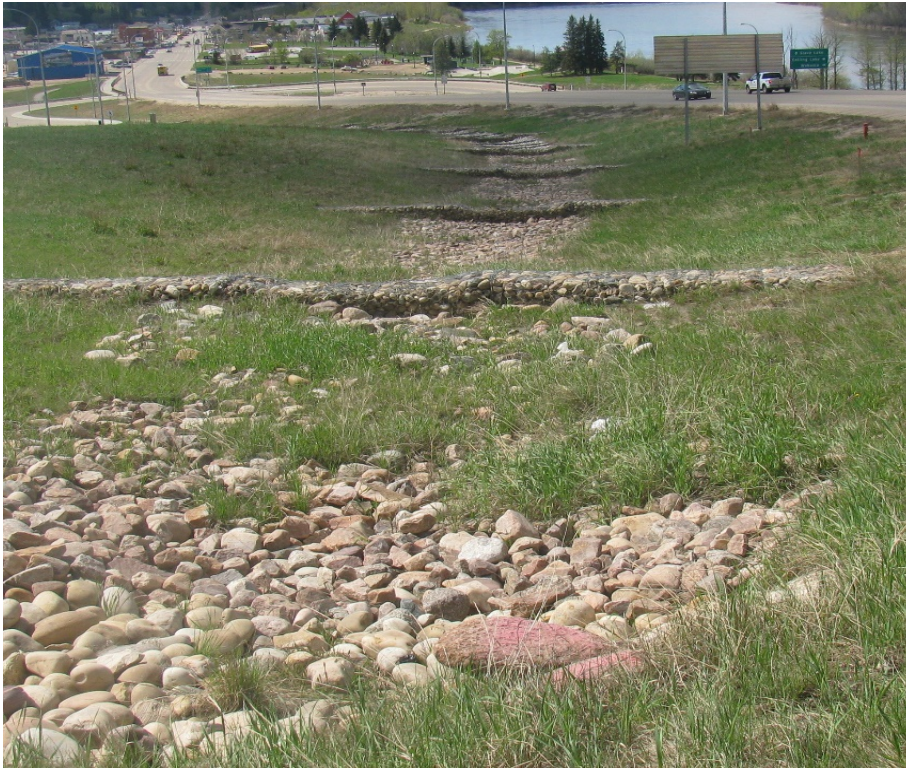
Photo #1.
*Hwy 55 South Ditch.
Looking west at
existing riprap
channel from the
east of G1.*

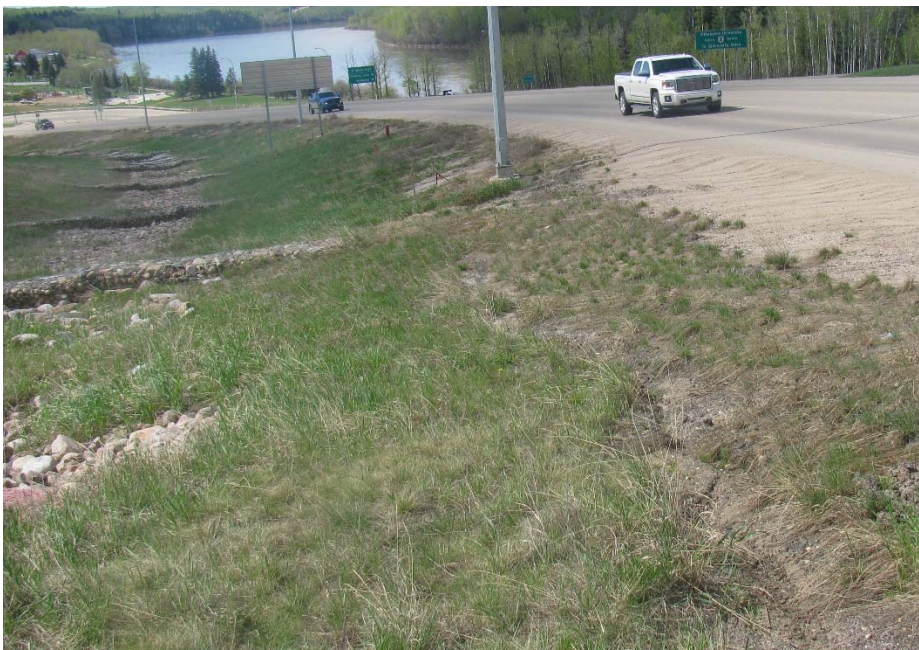
Photo #2.
*Hwy 55 South Ditch:
Looking west at the
east end of the
existing riprap
channel. Note the
presence of bare
side slopes and an
erosion gully on the
slope surface*

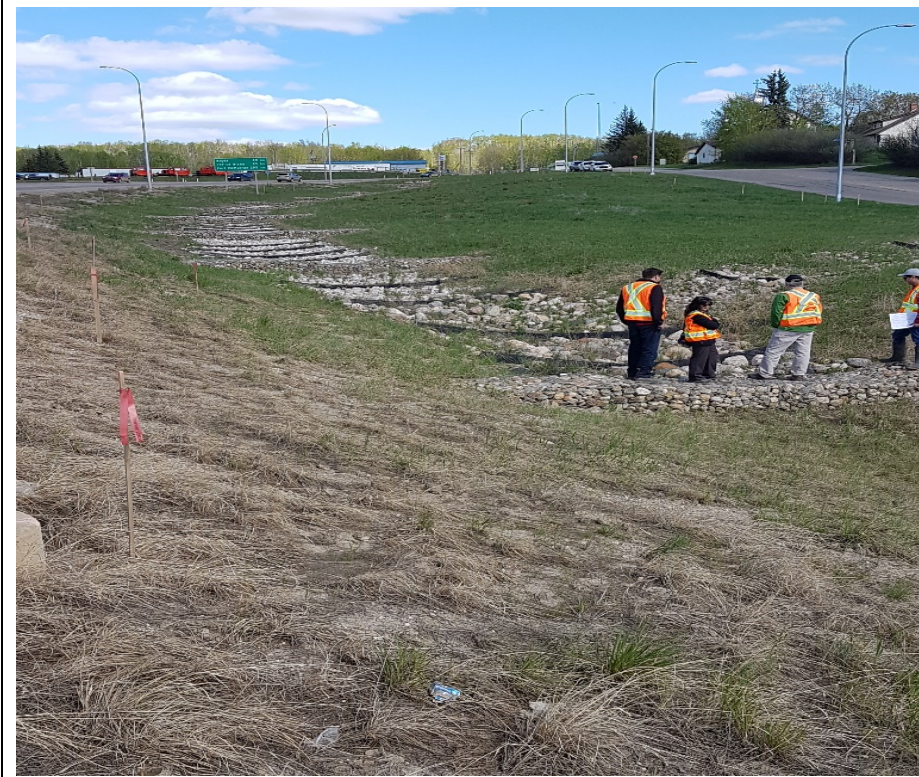
Photo #3.
*Hwy 55 South Ditch:
Looking east at the
existing riprap
channel*

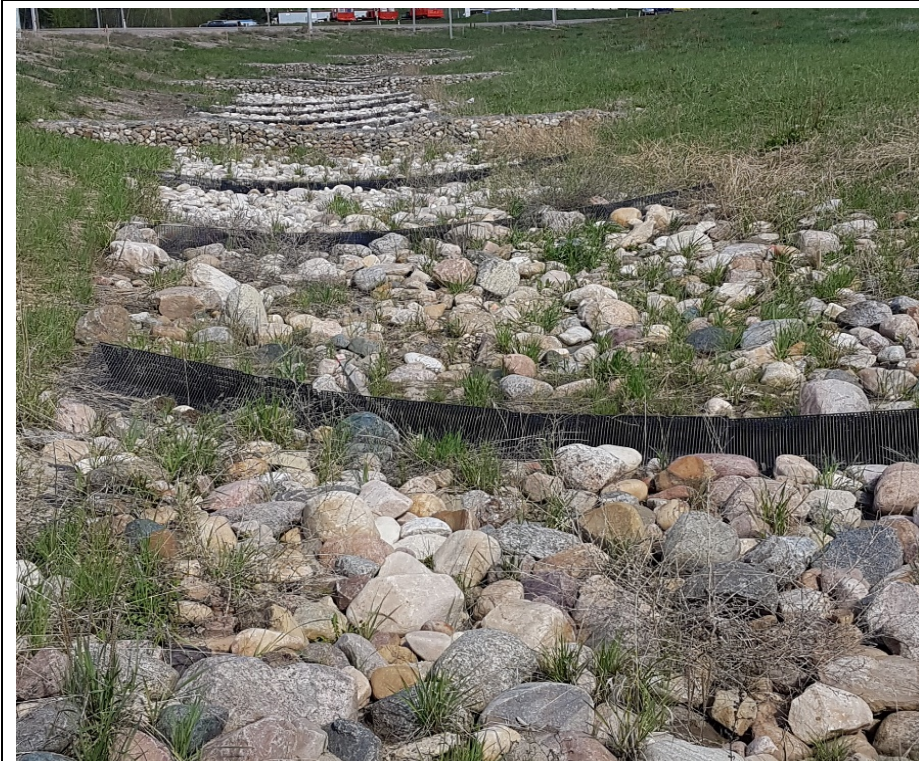
Photo #4.
*Hwy 55 South Ditch:
Looking east at
riprap between G9
and G8*

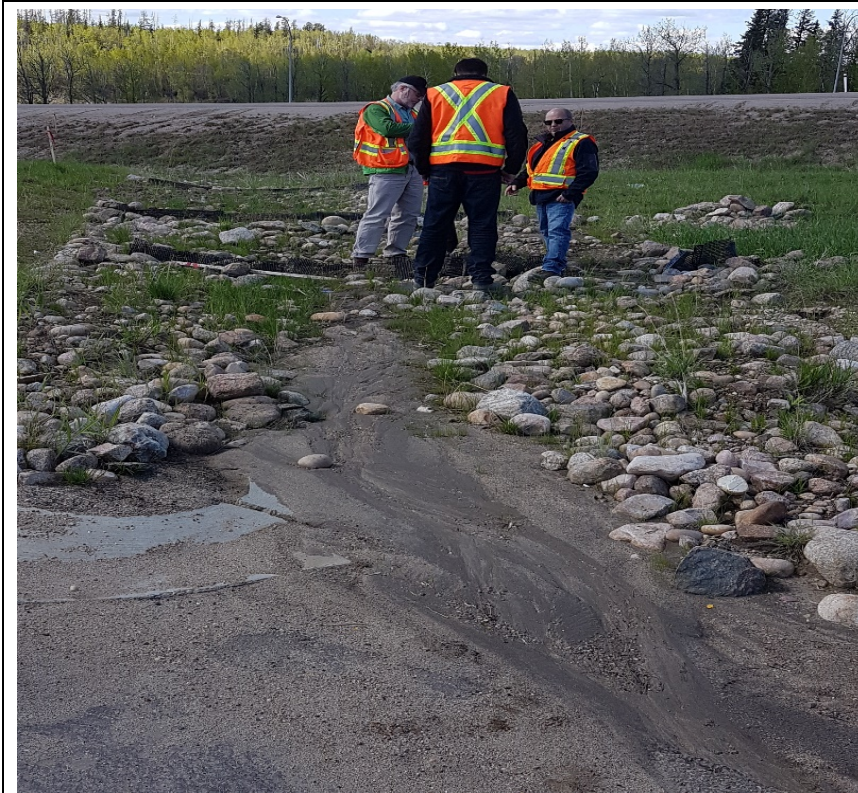
A few of the existing riprap channels in the south ditch of Hwy 55 are not well defined (i.e. appears to be flat) with no riprap along the ditch slopes and this could result in severe erosion developing near the edges of the riprap. The swale between 50 Ave and Hwy 55 south ditch was not provided with adequate thickness of Class 1 M riprap in addition to the presence of bare spots between the rocks. This deficiency could result in future erosion issues within the bottom and the sides of the swale.

Photo #5.
Looking northwest at the existing Class 1 M Riprap lined swale extending from the end of the concrete curb and gutter along the north edge of 50 Avenue to the south ditch of Hwy 55; swale is not well defined and a few areas are bare of riprap.

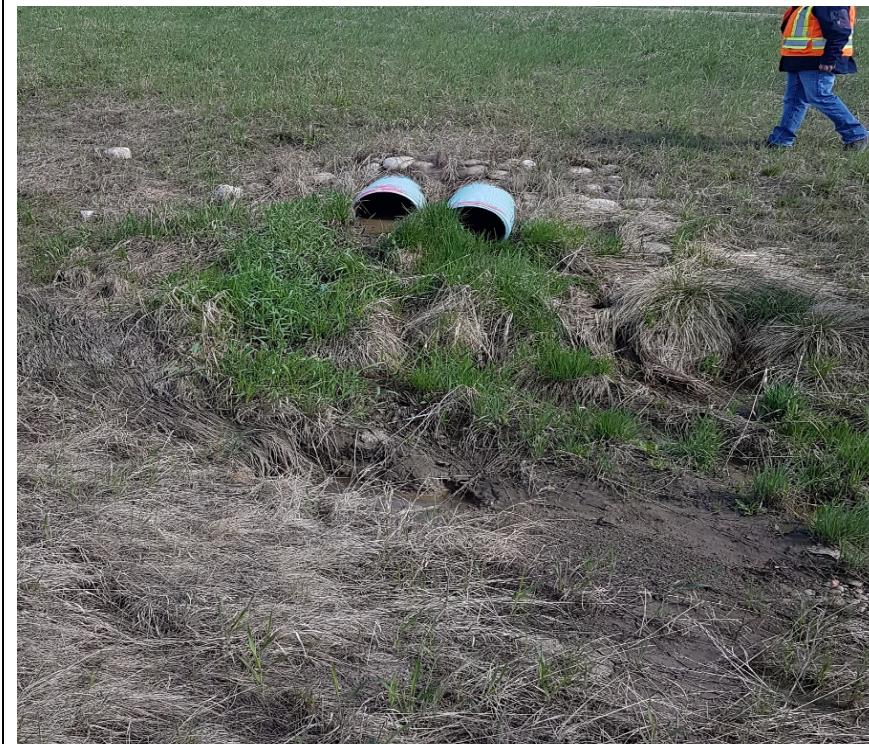
Photo #6.
Looking southeast at the outlets of the storm water pipes; signs of erosion near the outlets of the pipes

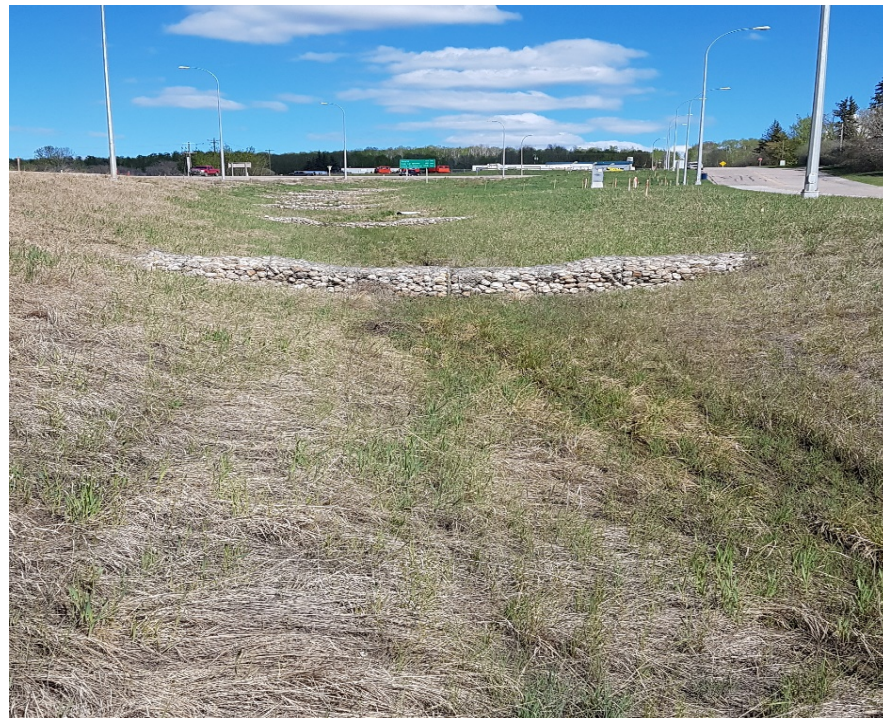
Photo #7.
*Hwy 55 south ditch:
looking east at signs
of erosion between
G10 and G11*

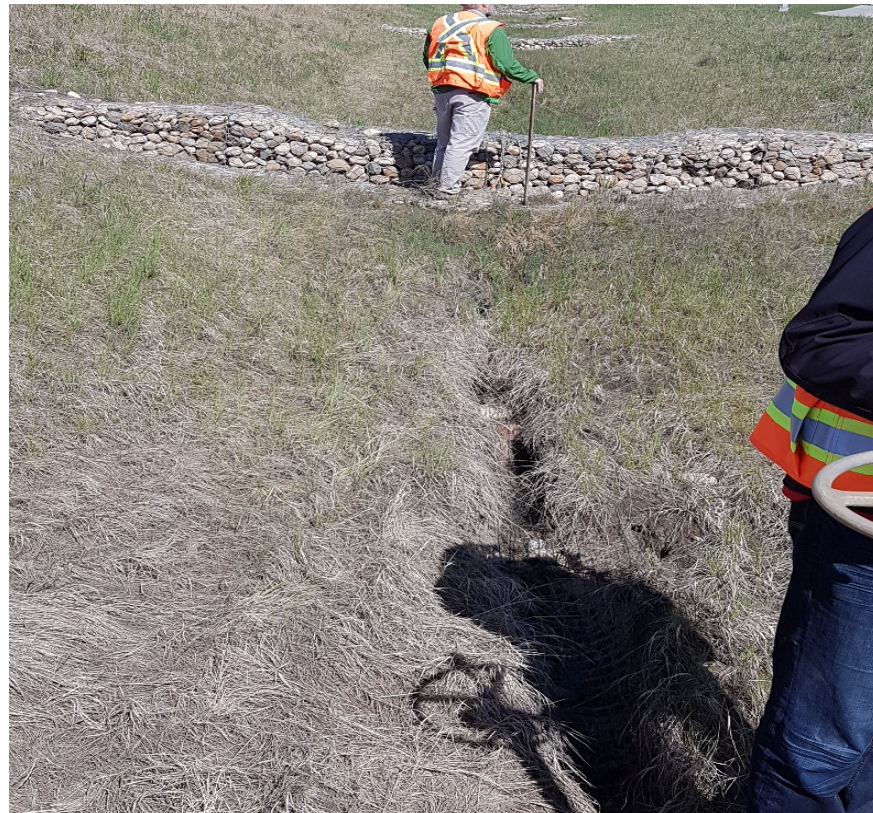
Photo #8.
*Hwy 55 south ditch:
looking east at
erosion gully
between G 12 and
the spill containment
ditch block*

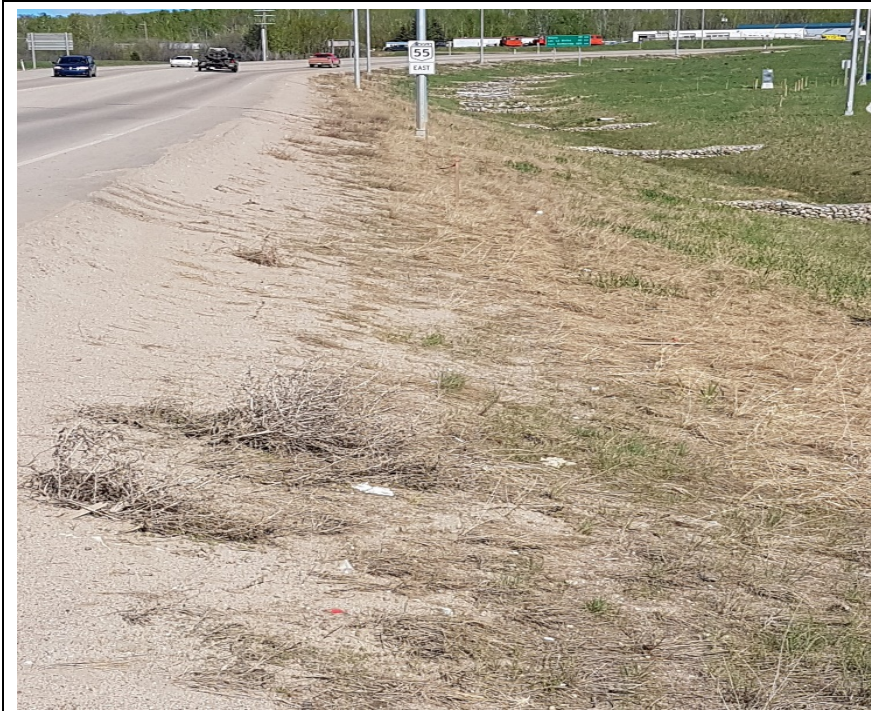
The sandy soil, that is present in the side slope and median ditch bottoms, is highly susceptible to erosion when left in a bare, unprotected condition and exposed to concentrated runoff. Similar ground conditions have performed much better in other areas on site where runoff occurs as sheet flow rather than a concentrated flow.

Photo #9.
Looking southeast at a bare sandy slope on the south side slope of Hwy 55

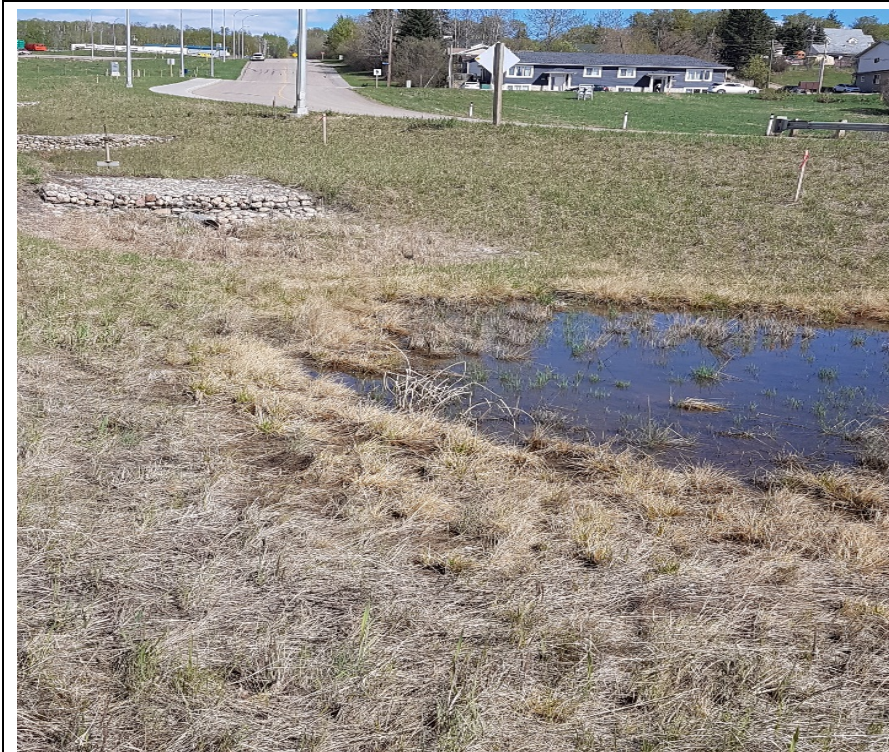
Photo #10.
Highway 55 south ditch: Ponding water within a low area to the west of the 1200 mm diameter manhole.

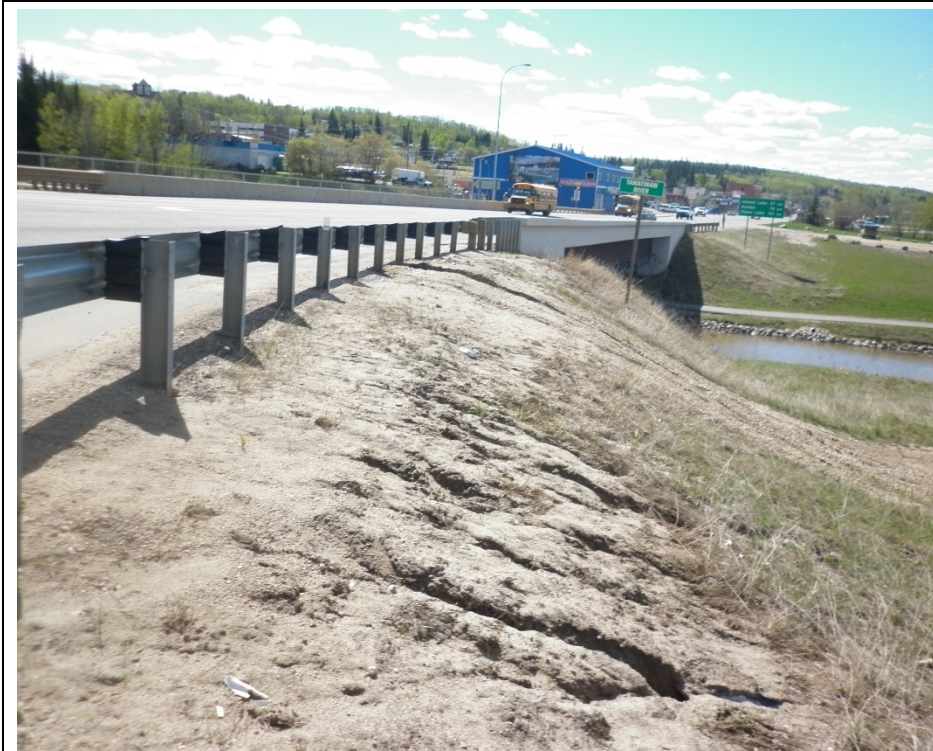
Photo #11.
Looking west at the northeast corner of the intersection of Hwy 55 and 813. Bare vegetation and erosion rills in this area

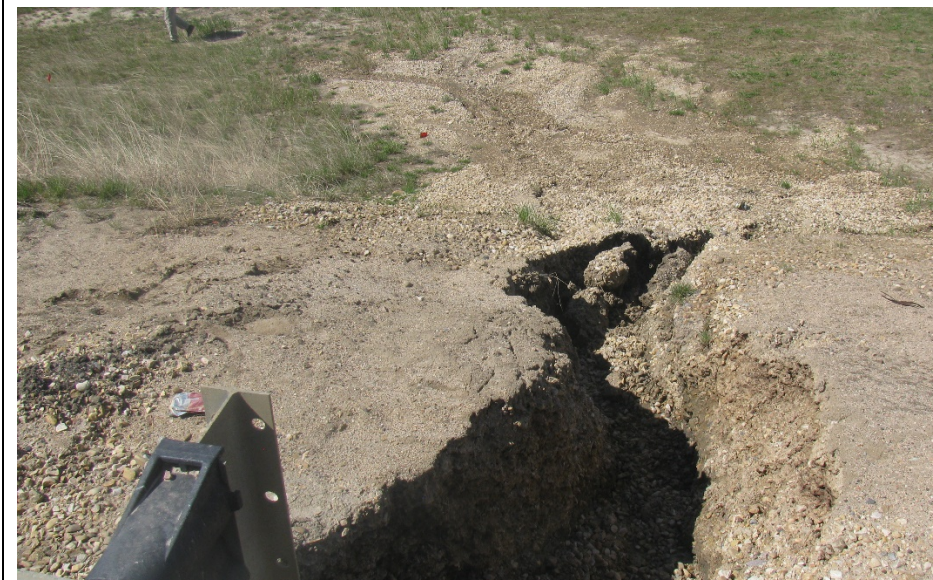
The concentrated runoff occurring at the northwest corner of the intersection of Hwy 55 and Hwy 813 (i.e. at the NE corner of the bridge) created 1 m deep and 1 m wide deep erosion gullies down the side slope. The existing erosion beside and below bridge NW corner drain trough indicates that the drain trough should have been designed with a wider taper to accommodate surface flow from the highway surface.

Photo #12.
Looking north at deep erosion gullies developed within NE corner of the bridge; erosion gully was backfilled with gravel in 2016

3. **NE and NW corners of Tawatinaw River Bridge:** Existing drain trough and dissipation bowl located west of the bridge will be upgraded and a new drain trough and dissipation bowl will be installed on the east side of the bridge. Slope regrading and rill repairs will also be completed east of the bridge.

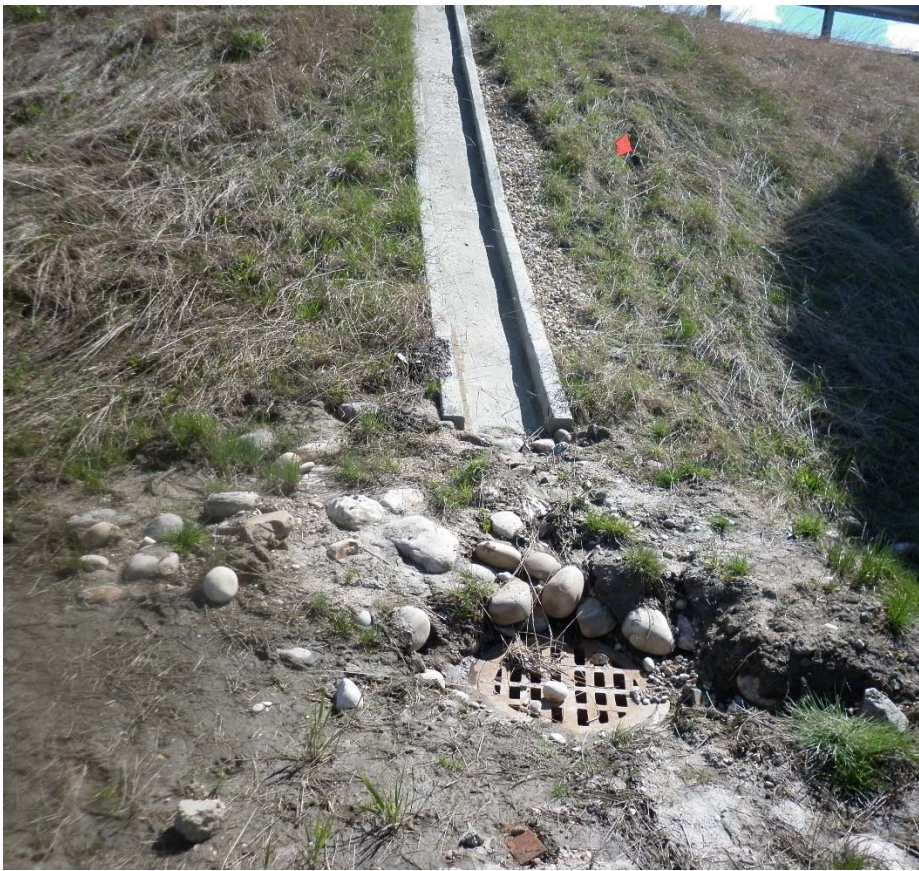
The top of the catch basin, located at the outlet of the bridge NW corner drain trough, is lower than the bottom of the riprap-lined dissipation bowl by at least 300 mm. Sand, salt and erosion debris accumulate within the bowl and fall into the catch basin. The catch basin, which is connected to the river through a 300 mm diameter outflow pipe, is likely full of sediment and needs to be cleaned to prevent the transport of sediment into the river.

Photo #13.
Drain trough on the northwest side of bridge crossing Tawatinaw River. Erosion developed below and on the west facing side the of the drain. Sediment accumulated around catch basin/ dissipation bowl.

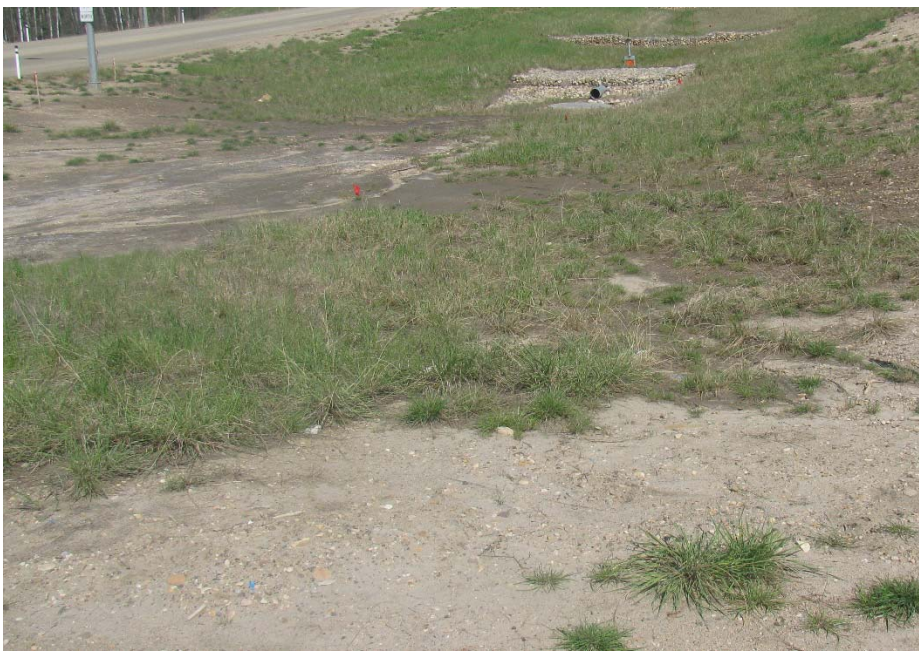
Photo #14.
Highway 55 north ditch: Looking east at bare side slopes

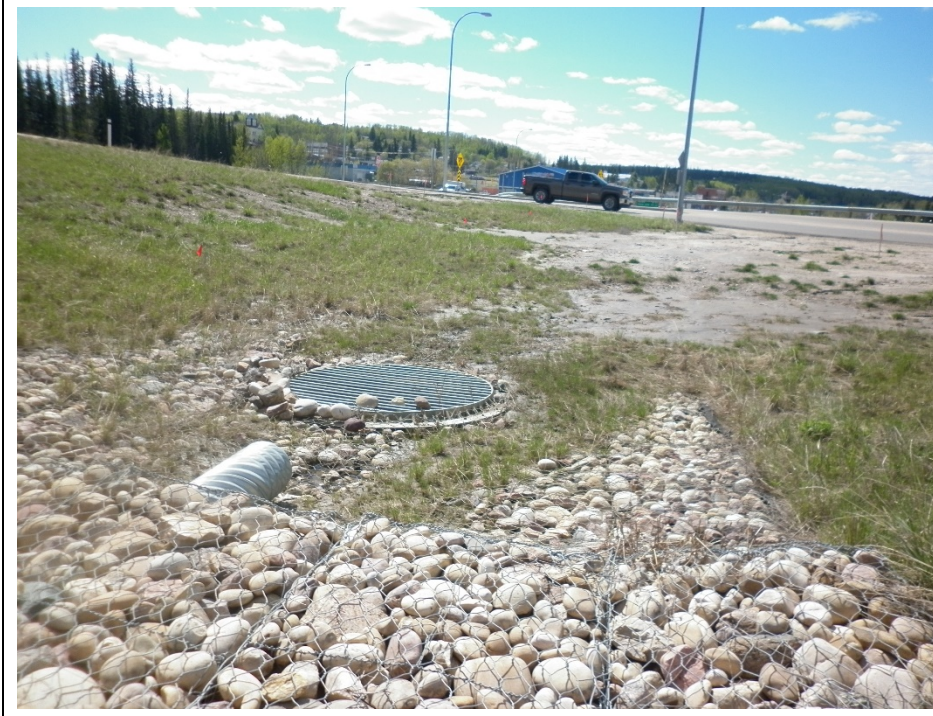
Photo #15.
*Hwy 55 North Ditch:
Looking north from
the manhole location
at erosion rills and
bare slopes*

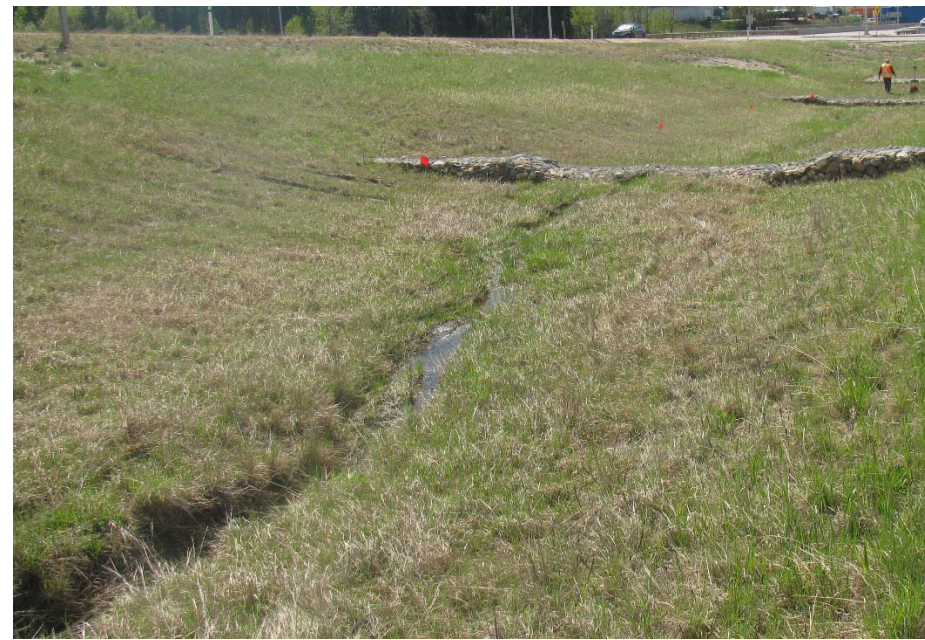
Photo #16.
*Hwy 55 North
Ditch: Erosion gully
between G2 and
G3*

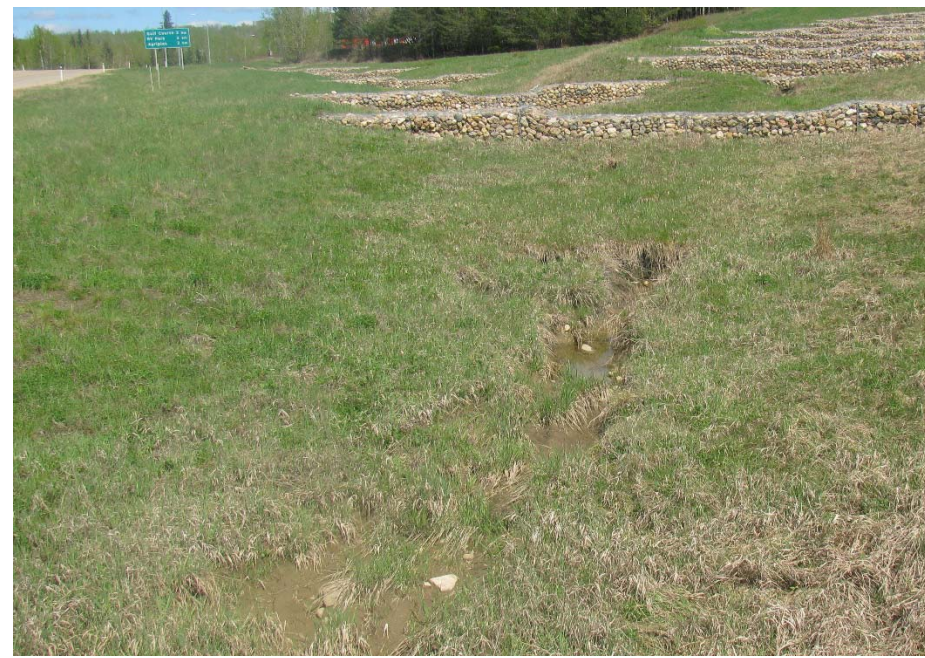
Photo #17.
*Hwy 55 North
Ditch: Erosion gully
between G4 and
G5*

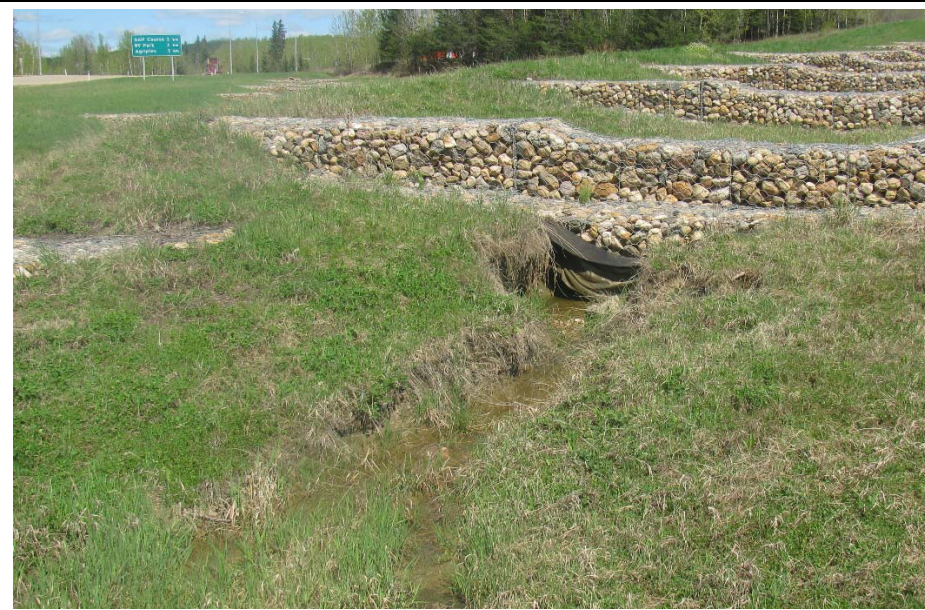
Photo #18.
*Hwy 55 North
Ditch: Erosion gully
between G5 and
G6; note the gap
developed below
G6*

2. **North of HWY 55 and south of HWY 813:** Eroded bare side slopes will be track packed to fill in erosion rills, slightly regraded and covered with a compost blanket and or Flexamat. Existing gullies between gabion baskets will be repaired and the ditches will be lined with either riprap or TRM type C. Damaged gabion baskets will be repaired; fillcrete will be used to backfill erosion developed below G6 in the Hwy 55 north ditch and below the Hwy 813 culvert outlet.

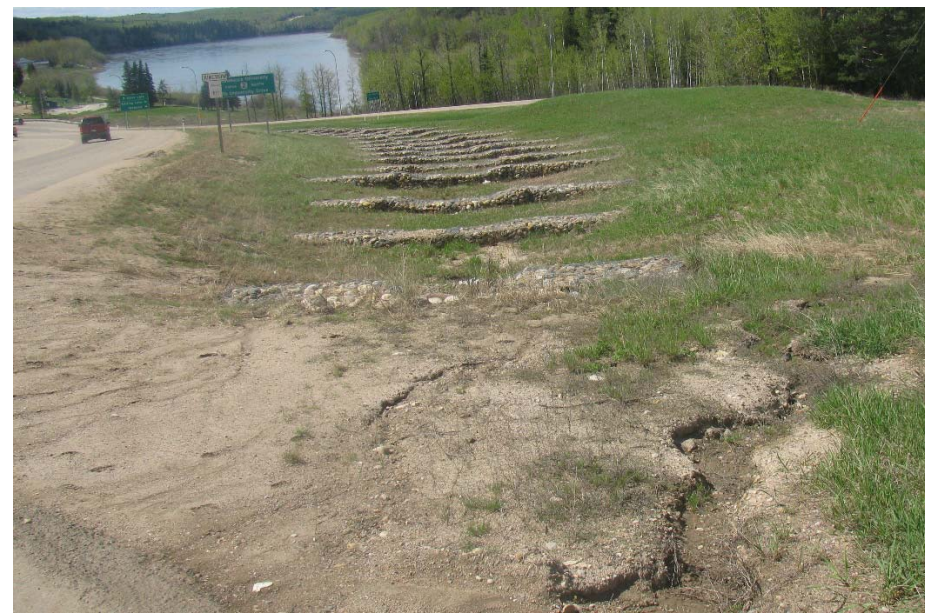
Photo #19.
*Hwy 55 North
Ditch: looking west
from the west side
slope of 43 Street.
Bare ground
surface and erosion
rills in the side
slope*
