**ALBERTA TRANSPORTATION
GEOHAZARD ASSESSMENT PROGRAM
NORTH CENTRAL REGION – ATHABASCA
2018 INSPECTION**

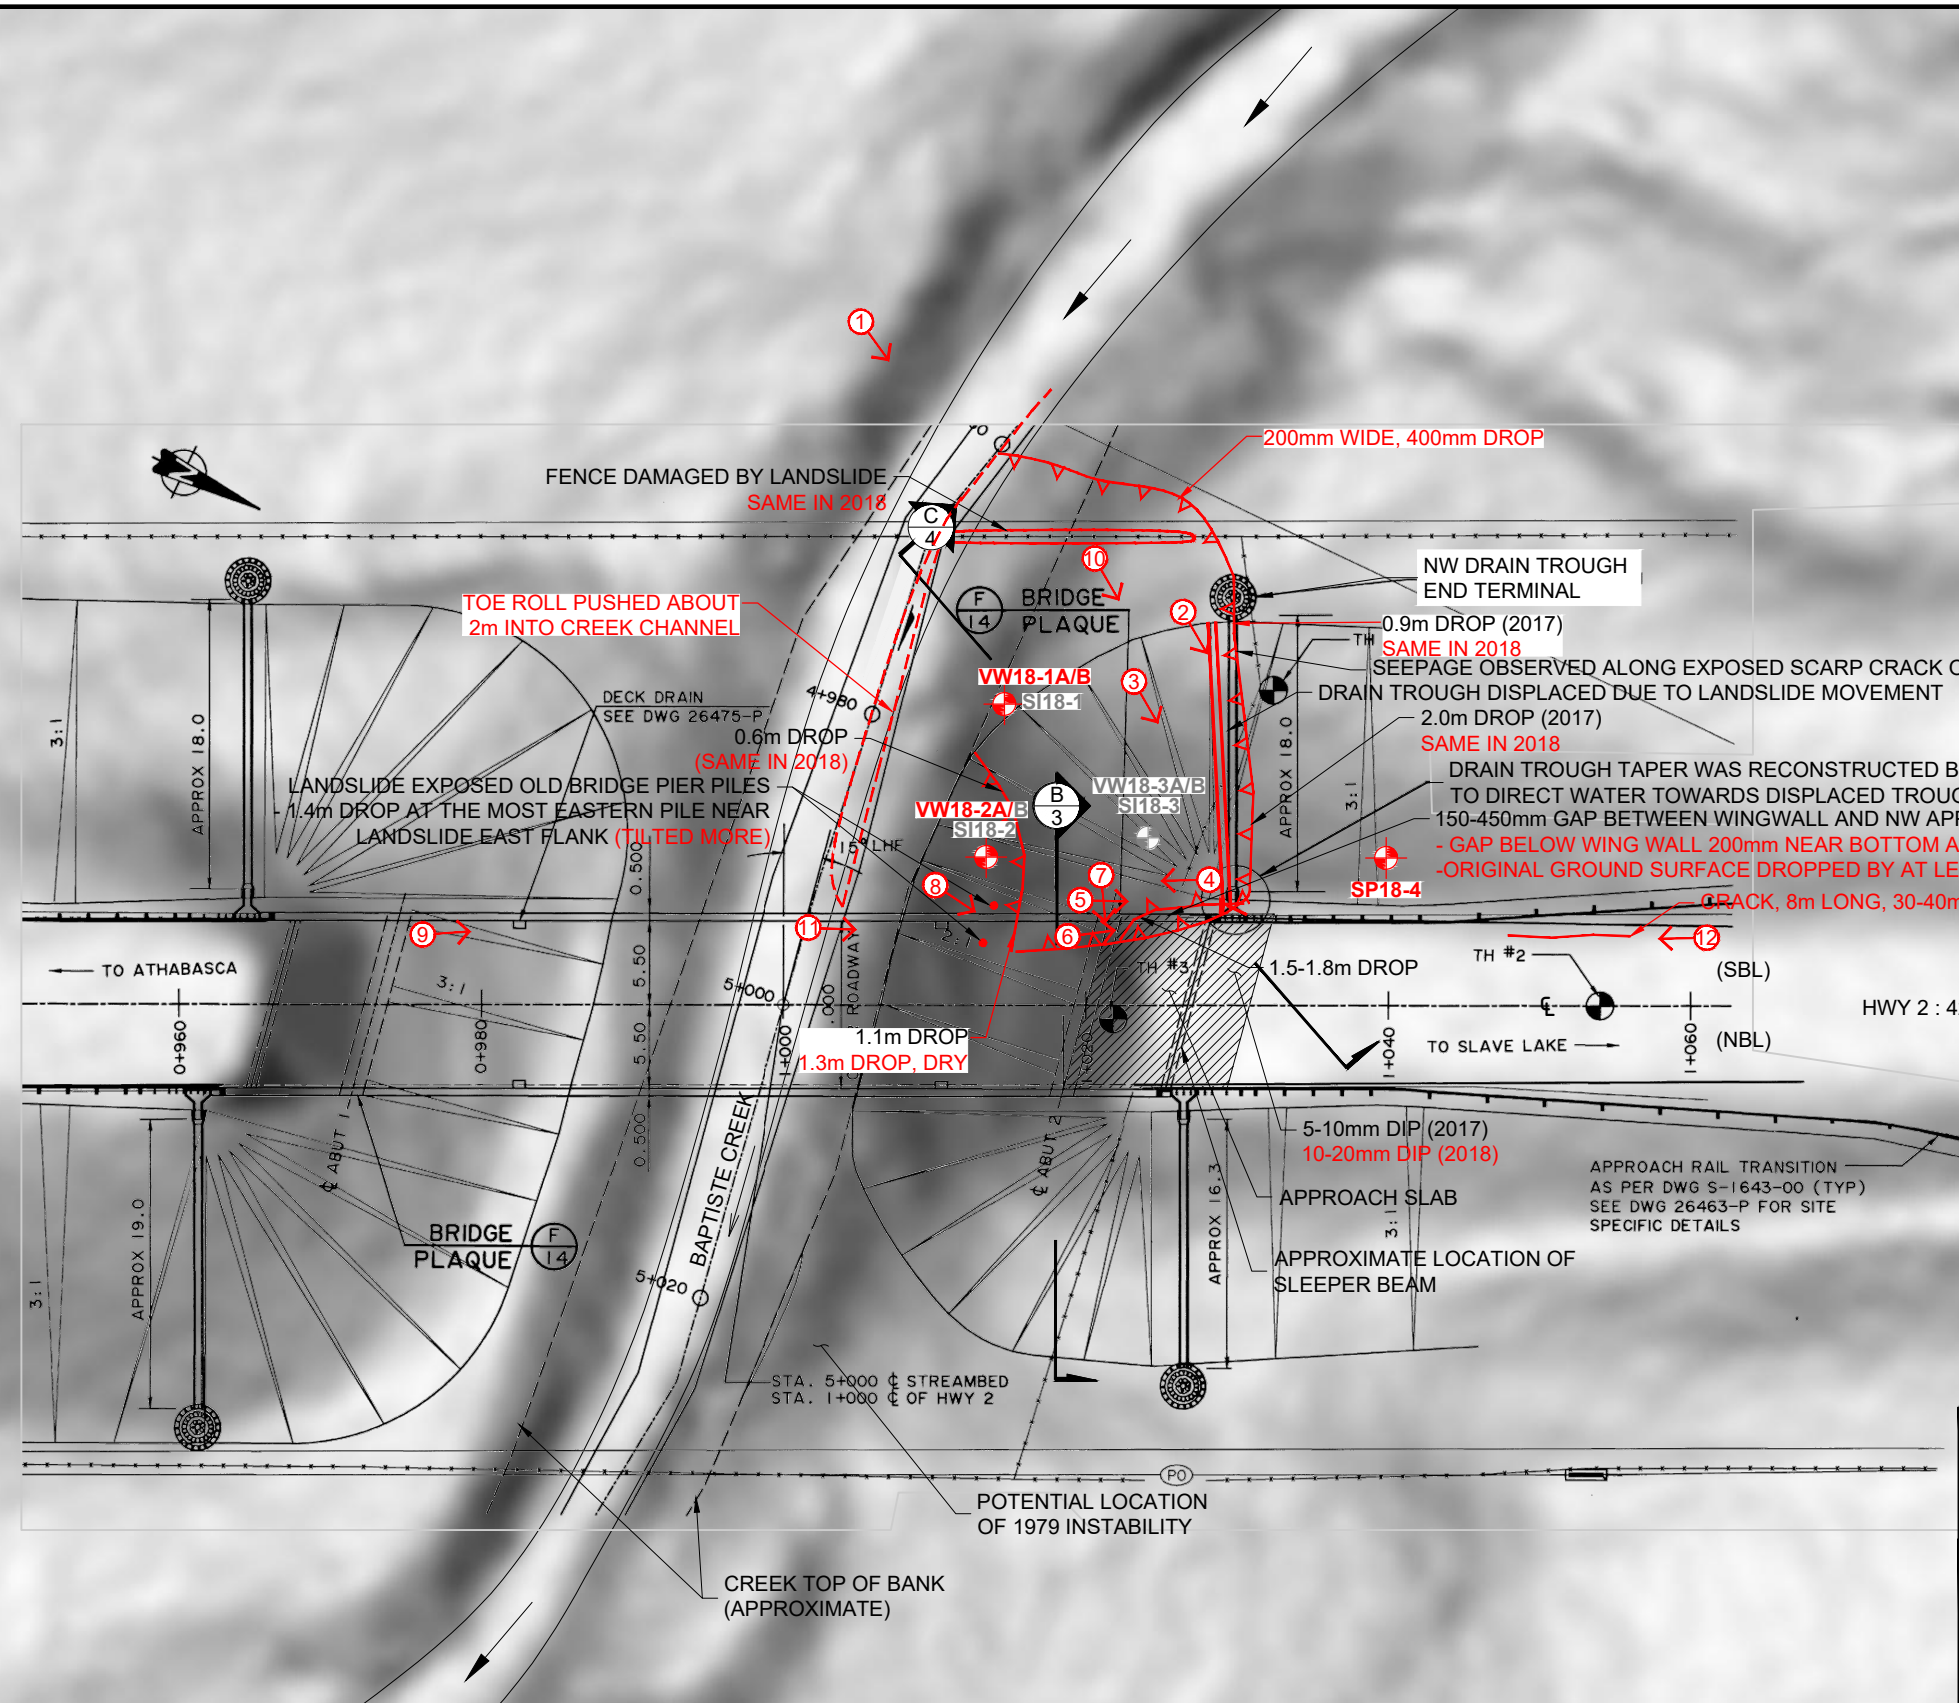
LIDAR OBTAINED FROM AIRBORNE IMAGING (2008)
 BASE PLAN PROVIDED BY ALBERTA TRANSPORTATION DRAWING 26462-P

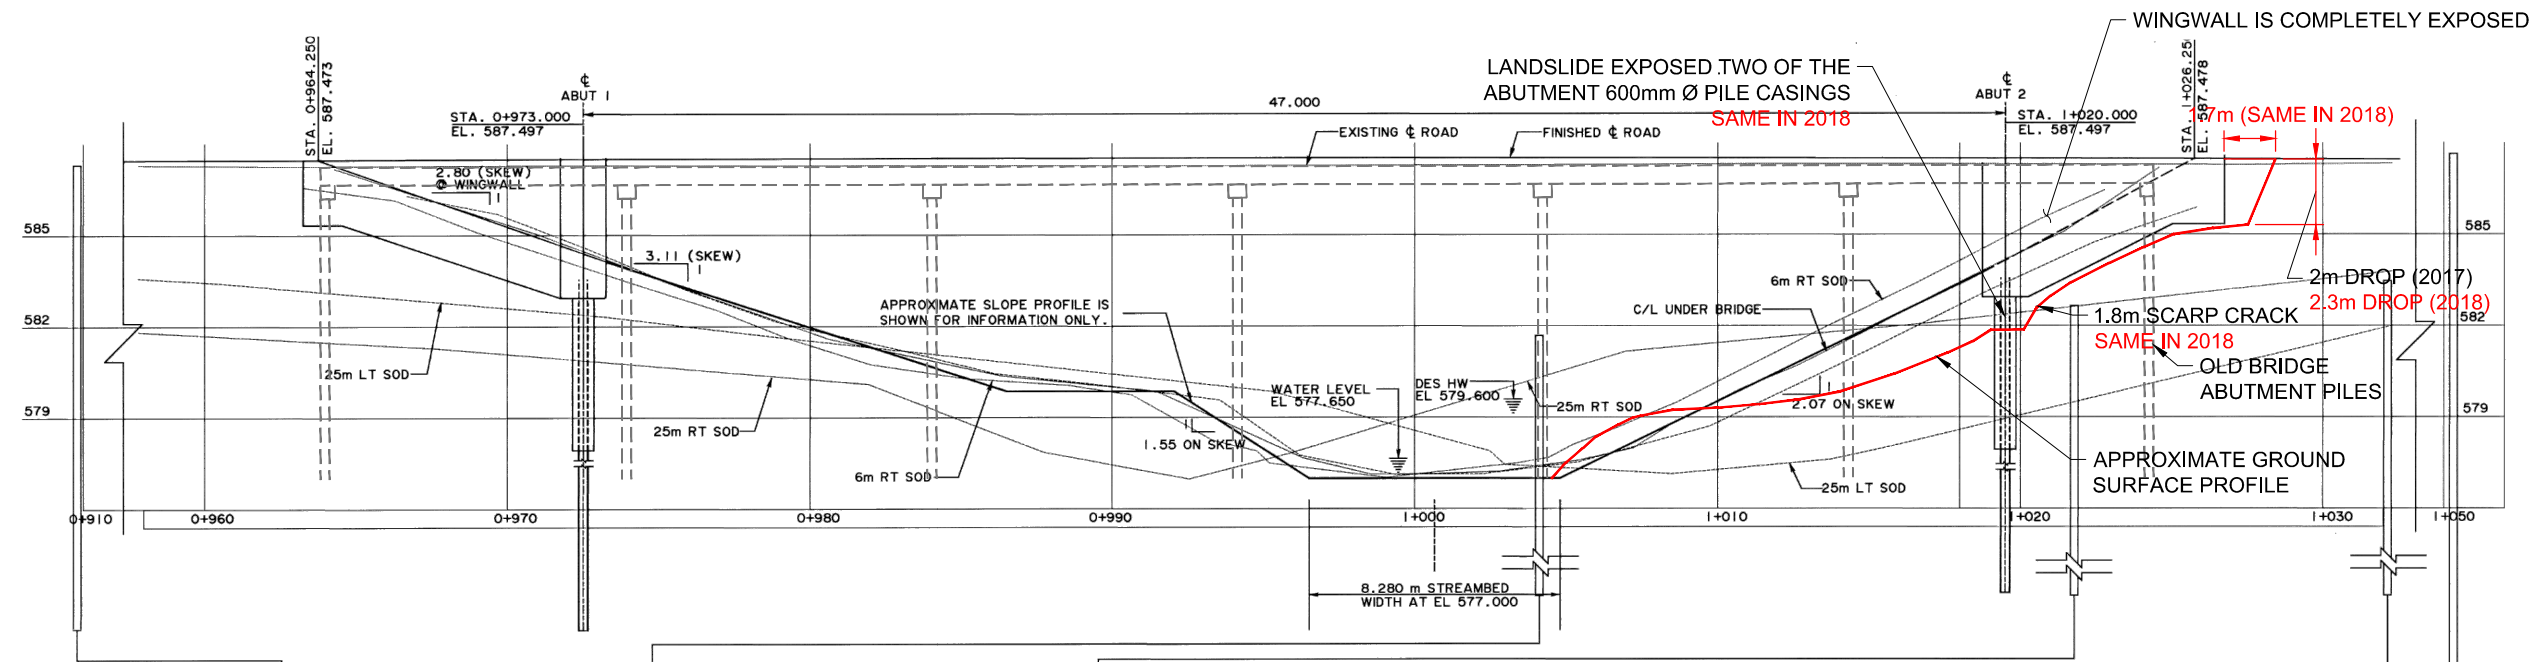
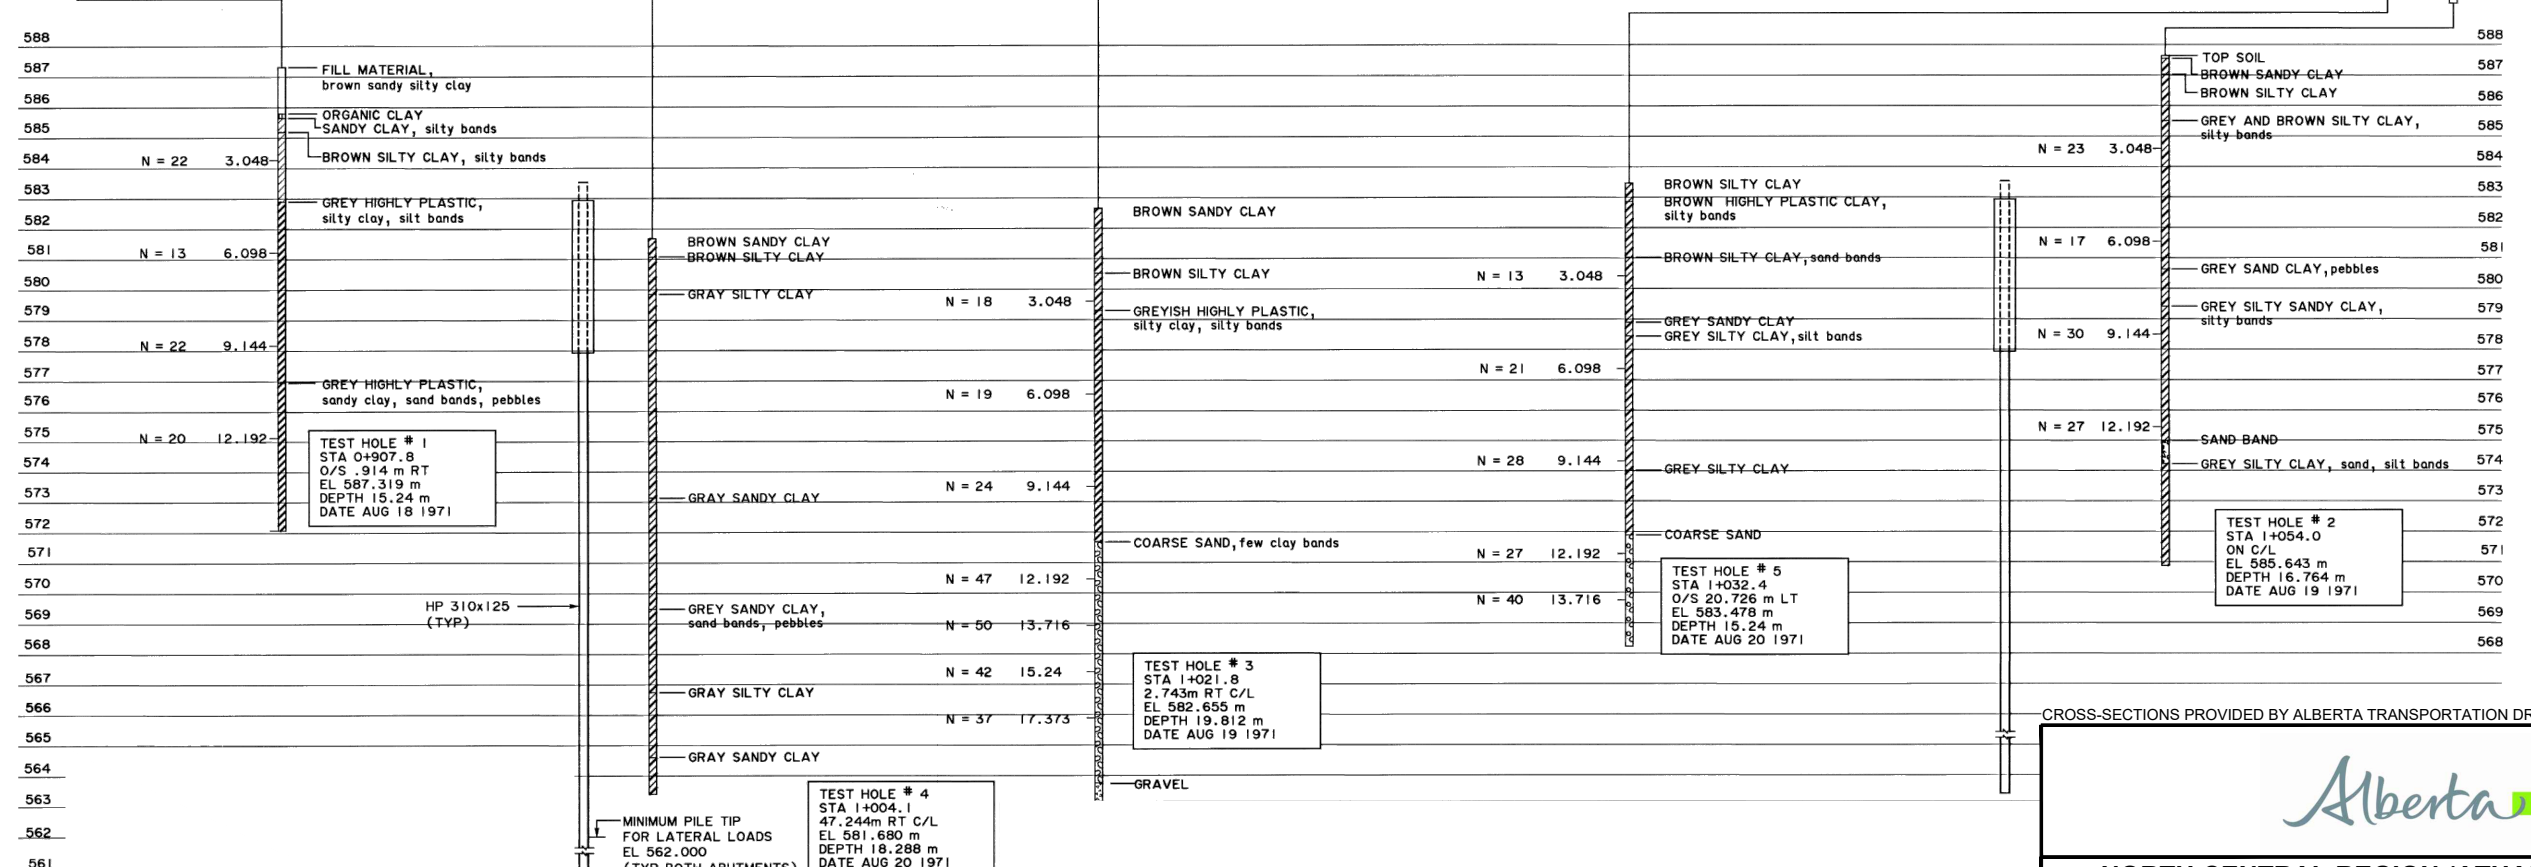
CROSS-SECTIONS PROVIDED BY ALBERTA TRANSPORTATION DRAWING NO. 26462-P & 26464-P

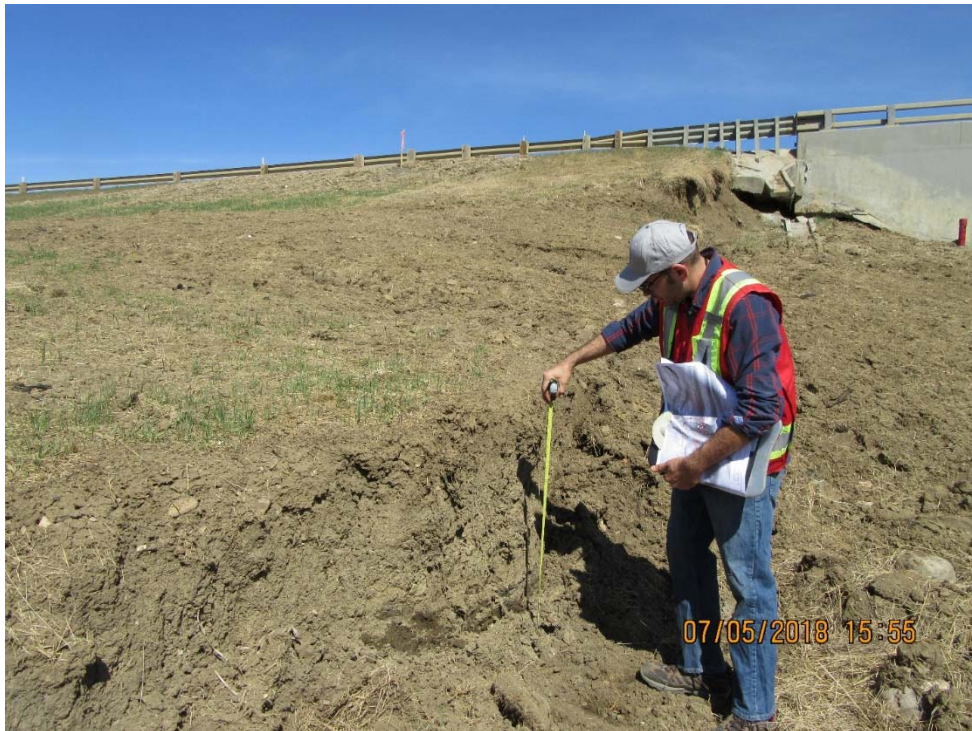
Photo No. 2. - Signs of seepage from the landslide head scarp crack (Looking East)

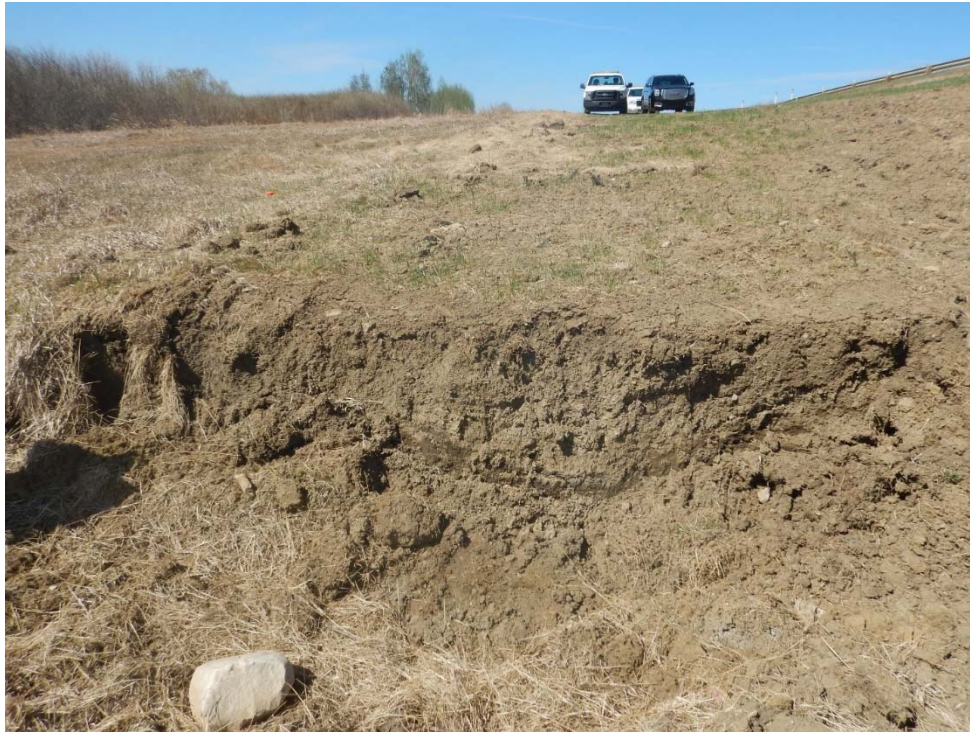
Photo No. 3. - A closer look at the observed seepage from the head scarp crack (Looking North)

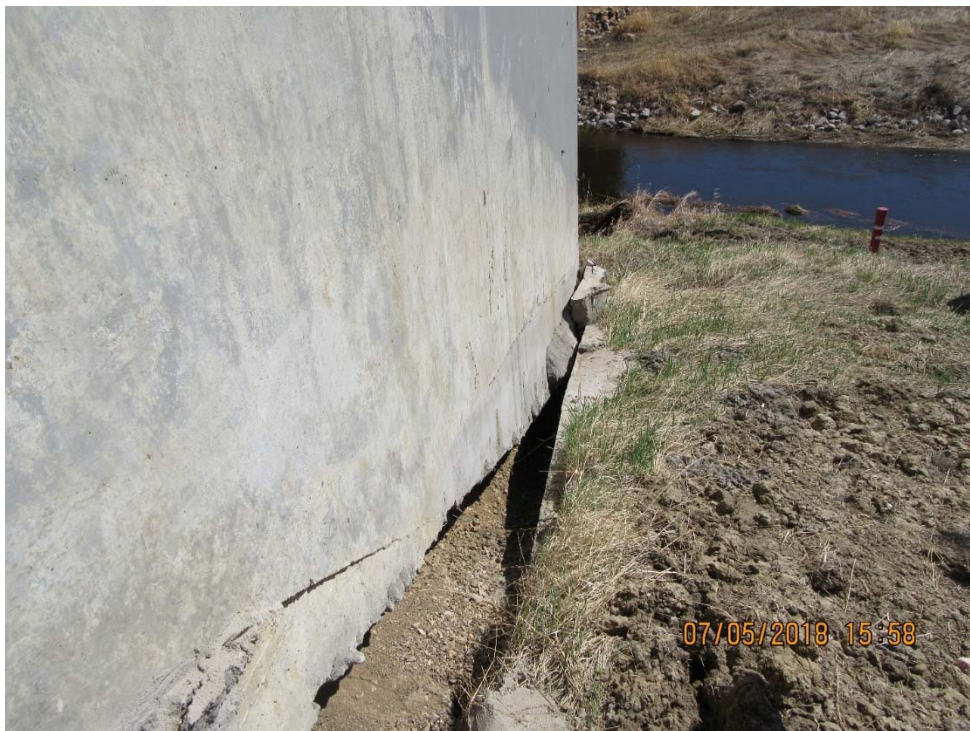
Photo No. 4. - Eastern flank of landslide created a void below the wingwall (Looking South)

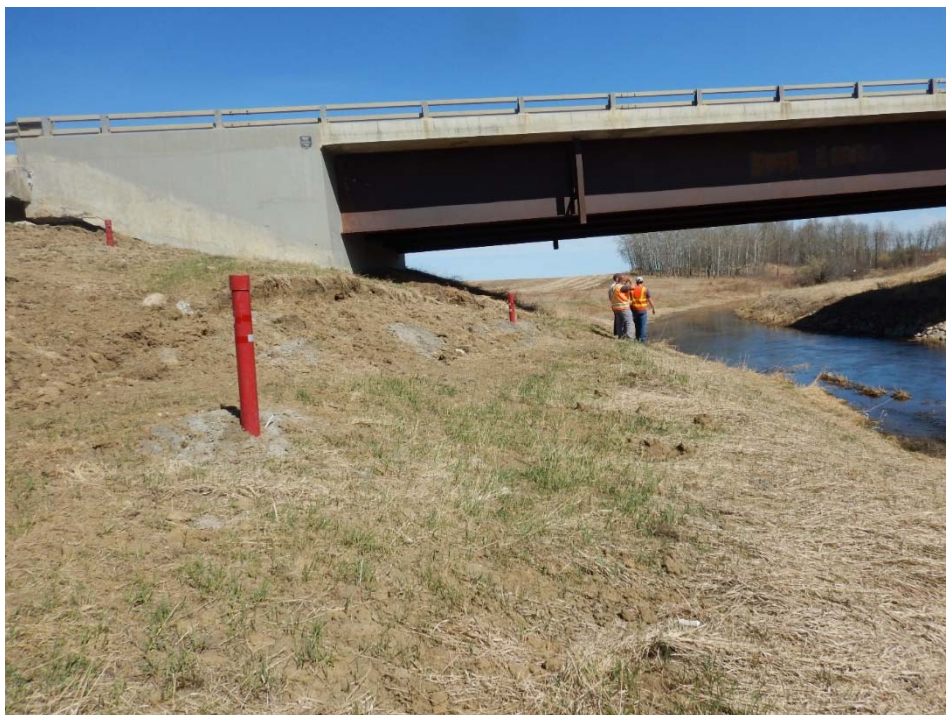
Photo No. 10. - Looking east at the tension cracks of a slump developed within the landslide mass near the bottom of the slope

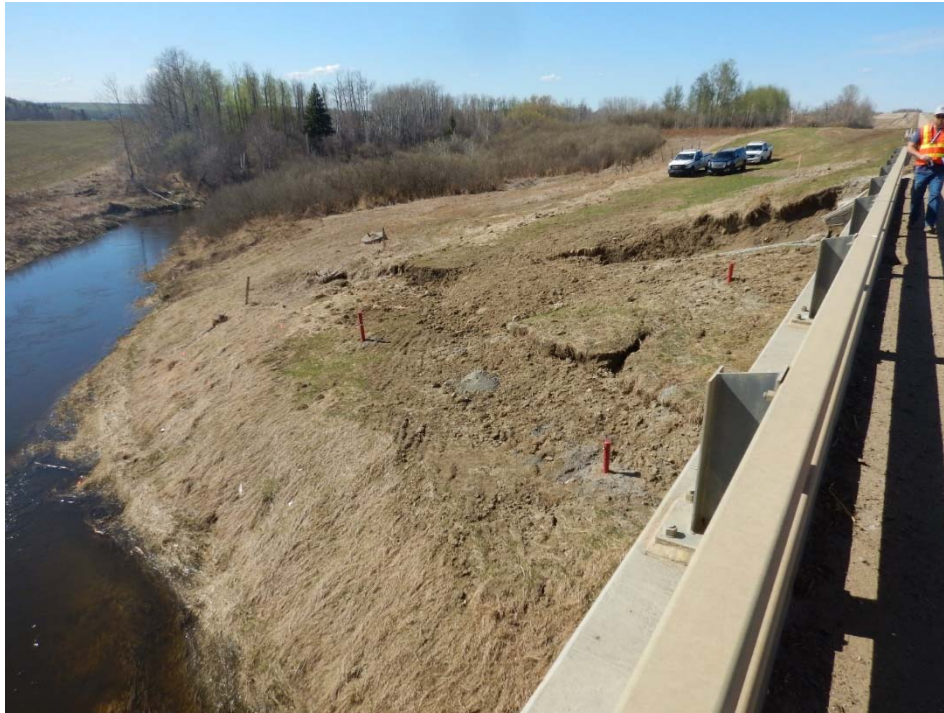
Photo No. 11. Backscarp, Lower Slump and Toe Roll in the Creek (Looking Northwest); the toe roll is reducing the capacity of the creek channel at the landslide location
