**ALBERTA TRANSPORTATION
GEOHAZARD ASSESSMENT PROGRAM
NORTH CENTRAL REGION – ATHABASCA
2020 INSPECTION**

| NC90-1 | 17 Km NW of Athabasca | Baptiste Creek Bridge NW Approach Fill Landslide | | | 02:42 | 17.94 |

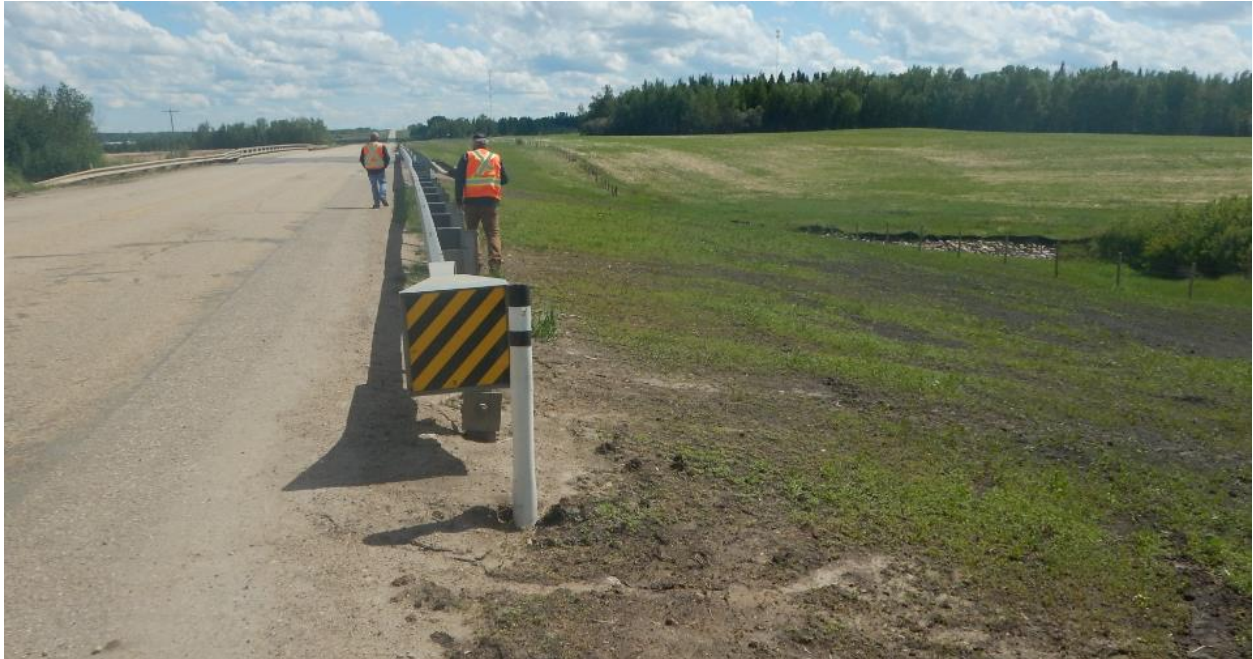
Photo No. 1 – Looking south at new guard rail and embankment west side slope; note growth of grass vegetation within the slope

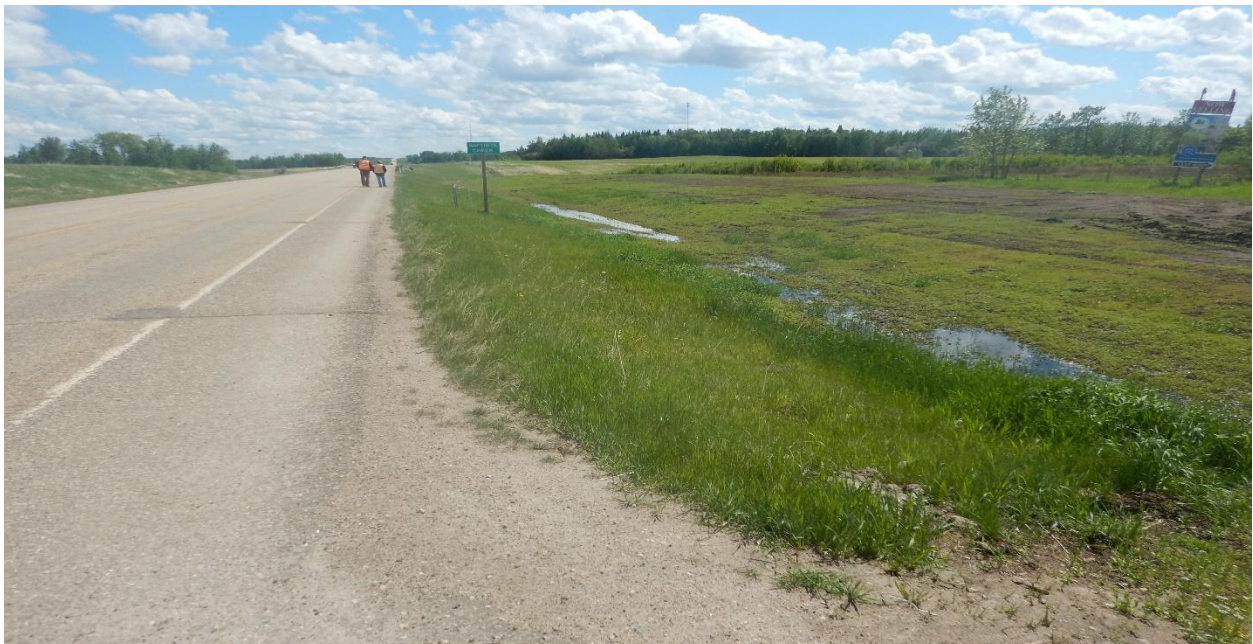
Photo No. 1a – Looking south at the highway east ditch to the south of the repair area; note ponding of surface water in the ditch

If water continues to pond in the east ditch, consideration should be given to re-grading the ditch to promote drainage. The flow from the ditch can be accommodated through the dug channel but it should be protected (armored with Class 1M Riprap) to avoid future erosion issues. Otherwise, a culvert could be installed below the existing approach to the south of the site to convey surface water towards north.

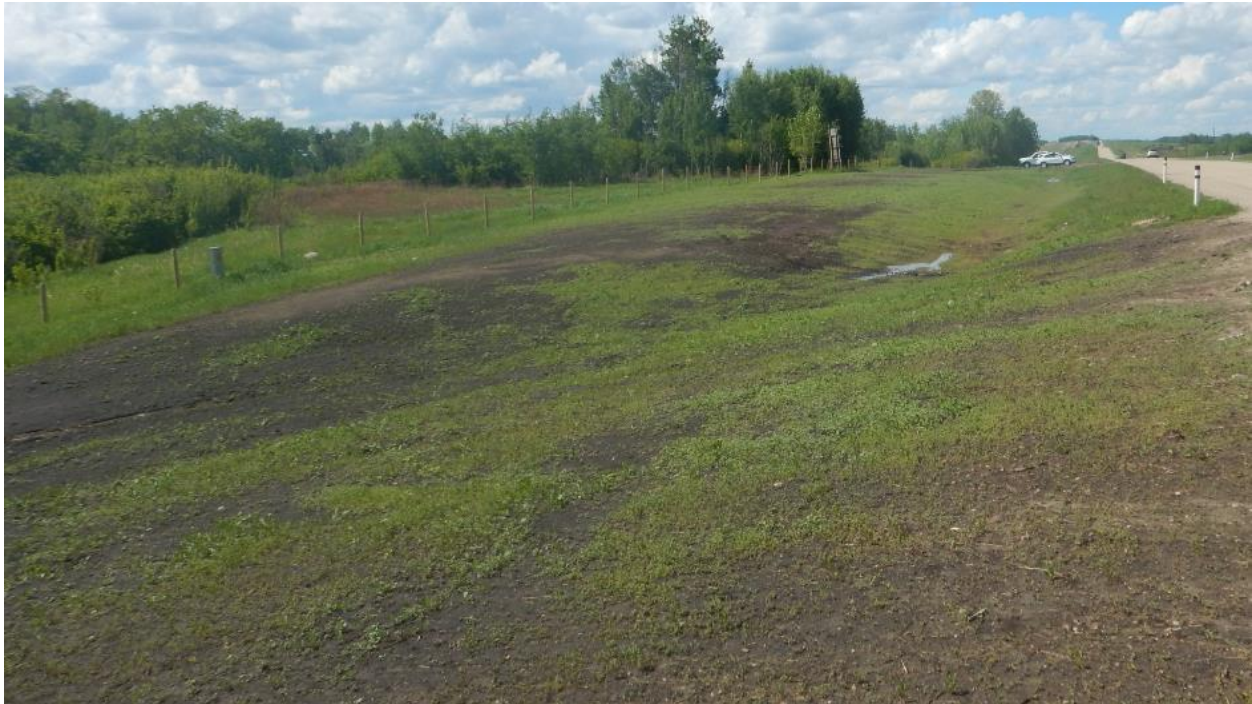
Photo No. 2 – Looking north at some rill erosion developing south of the highway ditch

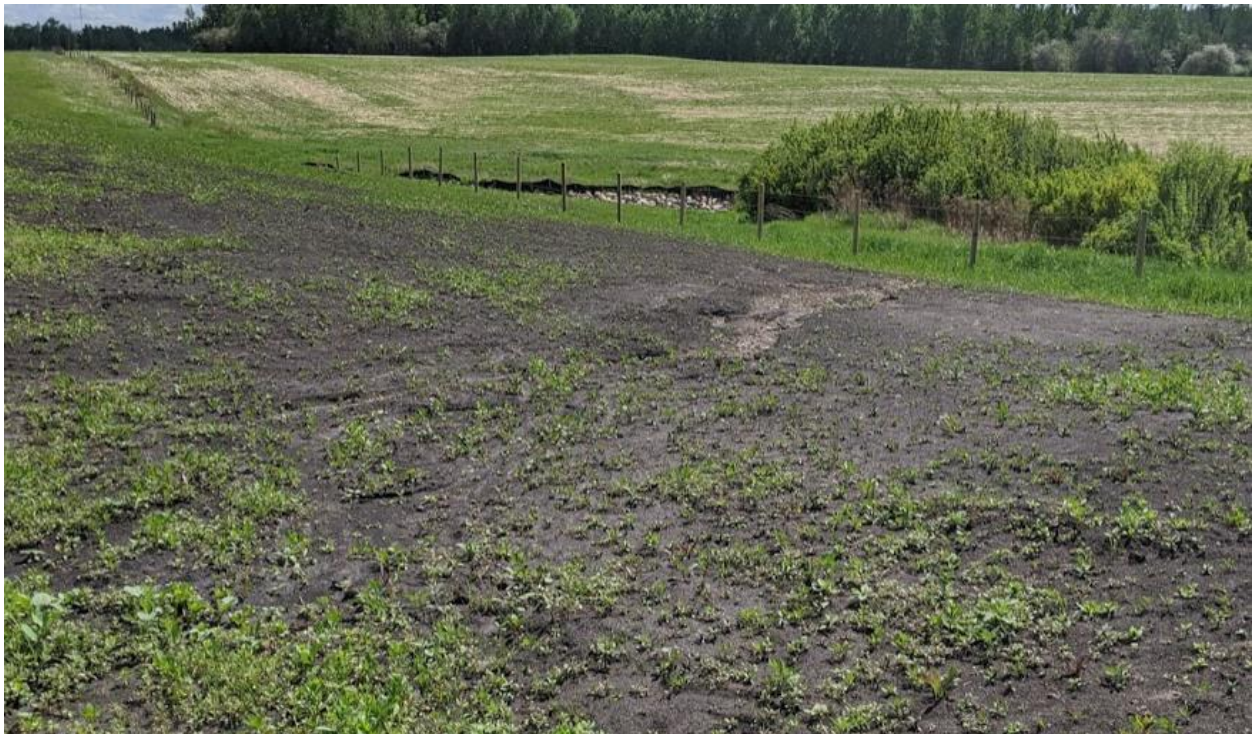
| <input checked="" type="checkbox"/> Erosion | Minor erosion rills noted within the dug channel north of the landslide area at the mouth of the highway east ditch (See Photos 3 and 4) | <input type="checkbox"/> |

The minor erosion rills shown in Photos 3 and 4 is within a shallow temporary channel dug during construction to the south of the east ditch to convey surface flow from the ditch to the bush. Rill erosion should not be an issue in the future as long as vegetation grows in the channel. If rill erosion continues to be an issue, an additional measure will need to be implemented.

Photo No. 3 – Closer look at rill erosion mentioned in Photo No. 2

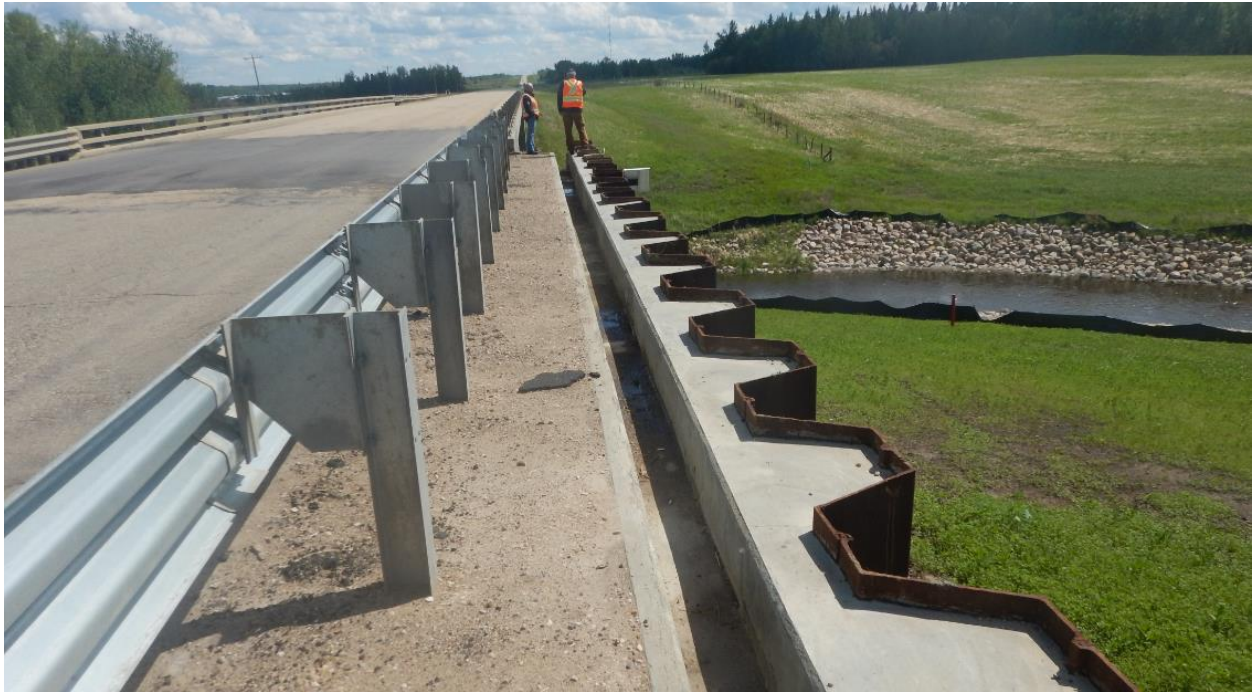
Photo No. 4 – Looking south at guardrail and concrete drain trough behind Sheet Pile Wall B

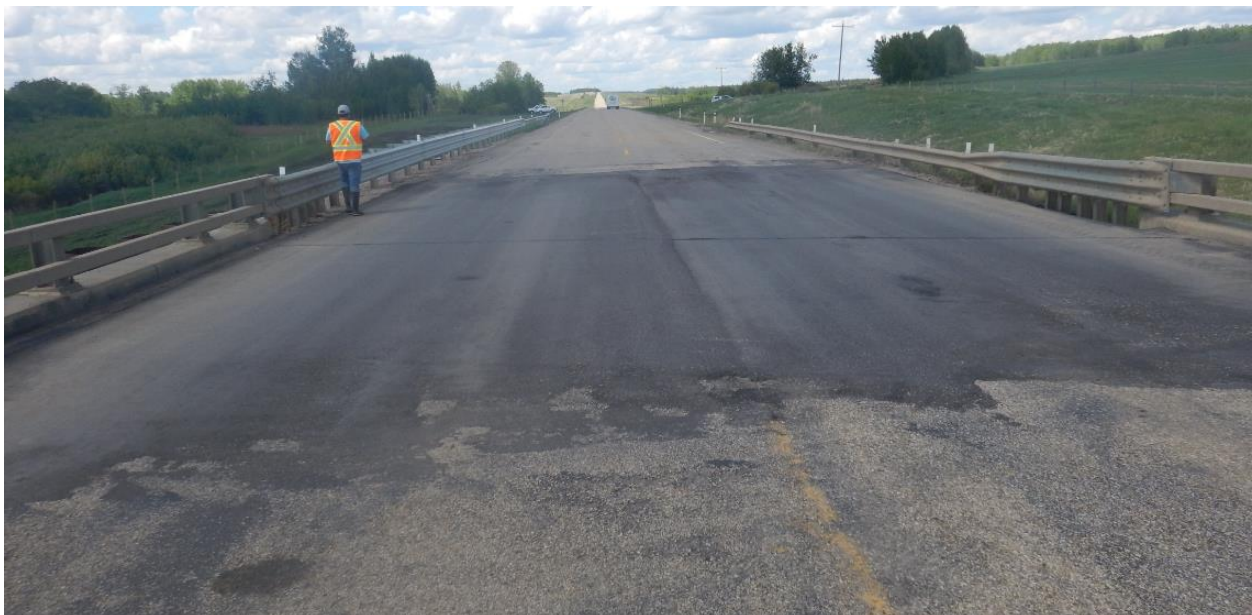
Photo No. 5 – Looking north at a 19 m long ACP patch placed along the highway behind the north abutment

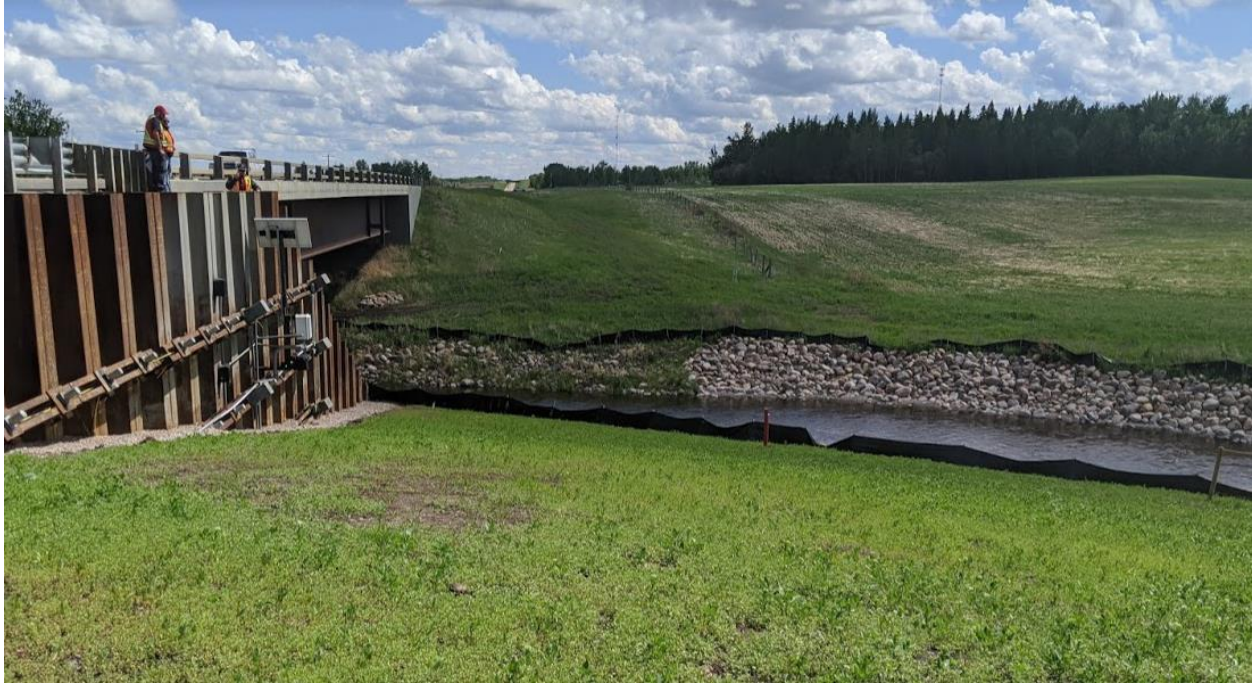
Photo No. 6 – Sheet Pile Wall B with three rows of anchors supporting the highway embankment; Sheet Pile Wall A is buried below ground and is parallel to the toe of the slope.

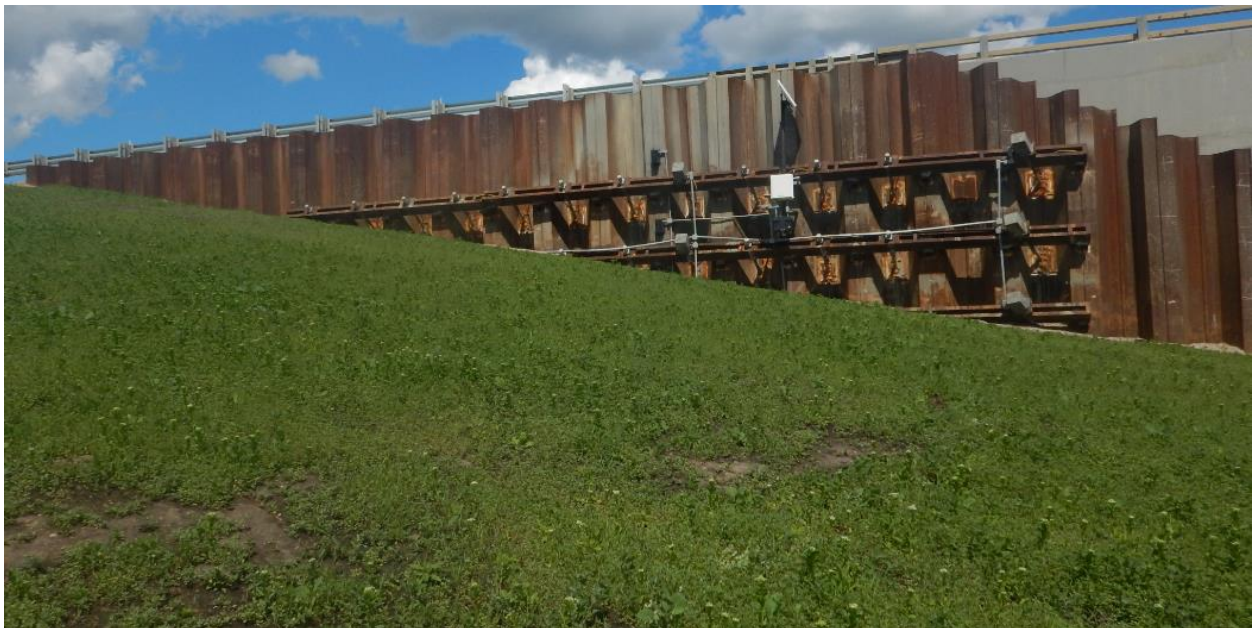
Photo No. 7 – Vegetation growing nicely along the newly graded 5H:1V north facing slope

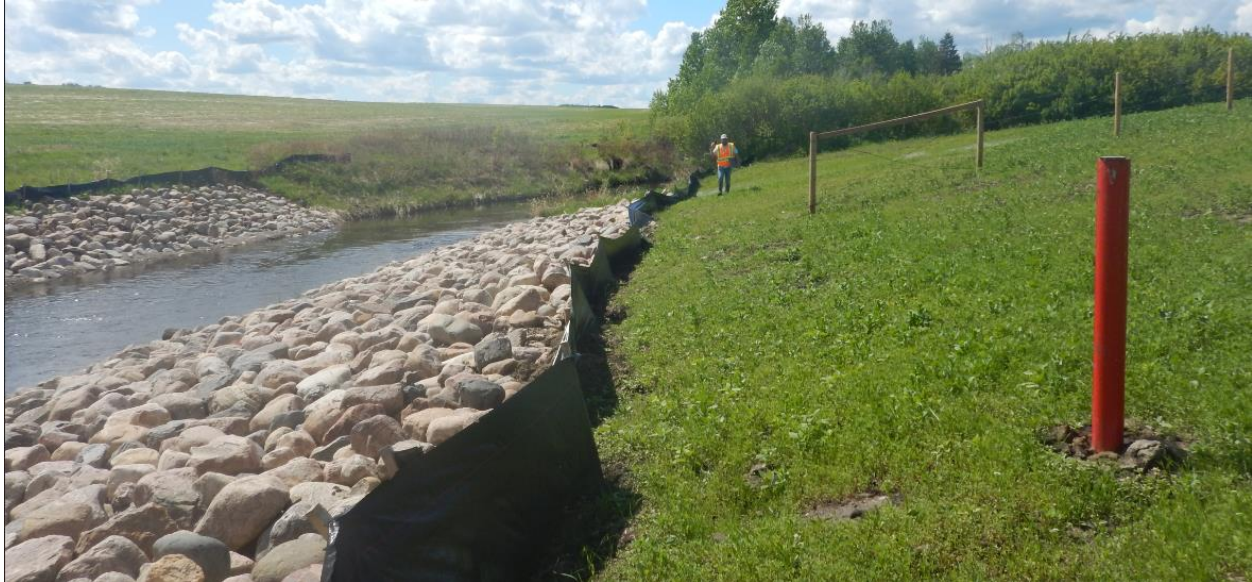
Photo No. 10 – Looking west at the armored creek bank from the bottom of the slope (i.e. at Sheet Pile Wall A location); banks were armored using Class 1 Riprap

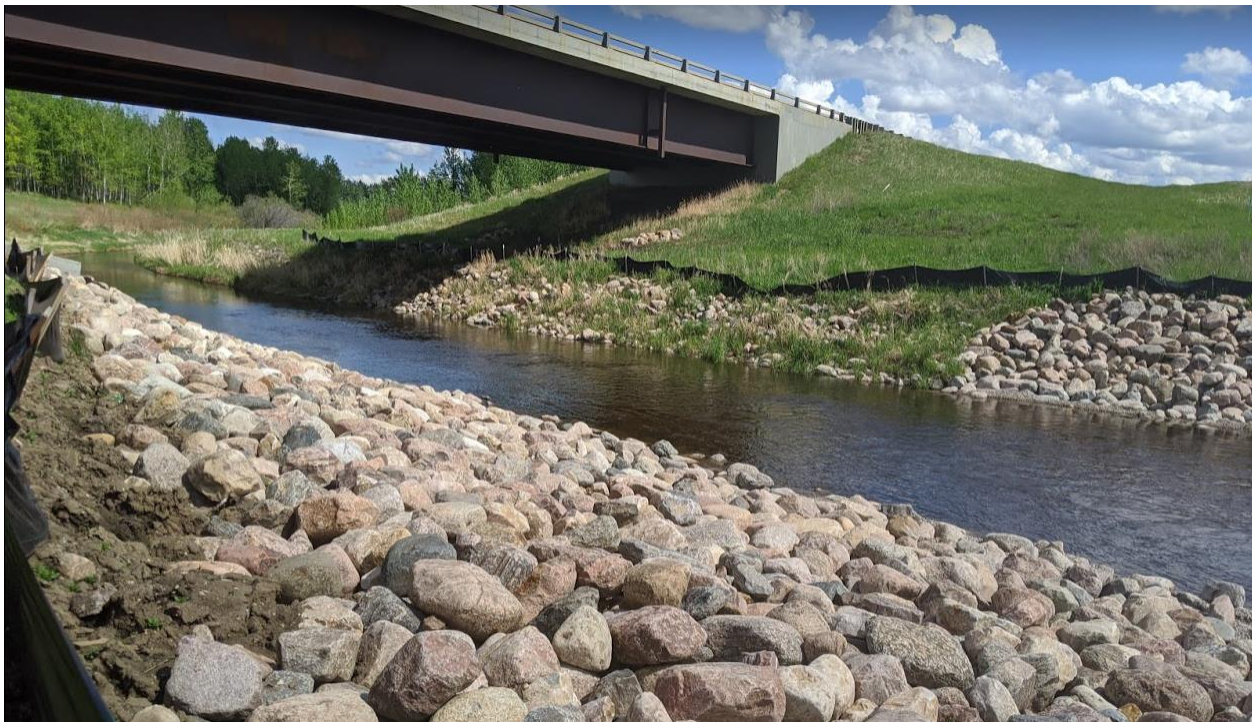
Photo No. 11 – Looking east at the armored creek banks from the bottom of the slope
