**ALBERTA TRANSPORTATION AND ECONOMIC CORRIDORS  
GEOHAZARD ASSESSMENT PROGRAM  
NORTH CENTRAL REGION – ATHABASCA &  
FORT MCMURRAY DISTRICTS  
2023 SITE INSPECTION**

<b>Site Number</b>	<b>Location</b>	<b>Name</b>			<b>Hwy</b>	<b>km</b>
NC90-1	17 Km NW of Athabasca	Baptiste Creek Bridge NW Approach Fill Landslide			02:42	17.94
<b>Legal Description</b>		<b>UTM Co-ordinates (NAD 83)</b>				
SW-6-67-23-W4M		12	6071799	E	338303	
	<b>Date</b>	<b>PF</b>	<b>CF</b>	<b>Total</b>		
<b>Previous Inspection:</b>	June 5, 2020	6	3	18		
<b>Current Inspection</b>	May 16, 2023	4	3	12		
<b>Road WAADT:</b>	1,460	<b>Year:</b>		2022		
<b>Inspected By:</b>	Arthur Kavulok, Amy Driessen and Kristen Tappenden (TEC) Tarek Abdelaziz and José Pineda (TEL)					
<b>Report Attachments:</b>	<input checked="" type="checkbox"/> Photographs		<input checked="" type="checkbox"/> Plans		<input checked="" type="checkbox"/> Maintenance Items	
<b>Primary Site Issue</b>	Landslide within the NW approach fill of Bridge File (BF) 7055, impacting highway, NW wing wall, abutment supports, and the capacity of the creek channel

**NORTH CENTRAL  
(ATHABASCA AND FORT MCMURRAY DISTRICTS)  
2023 GEOHAZARD ASSESSMENT  
NC90 - BAPTIST

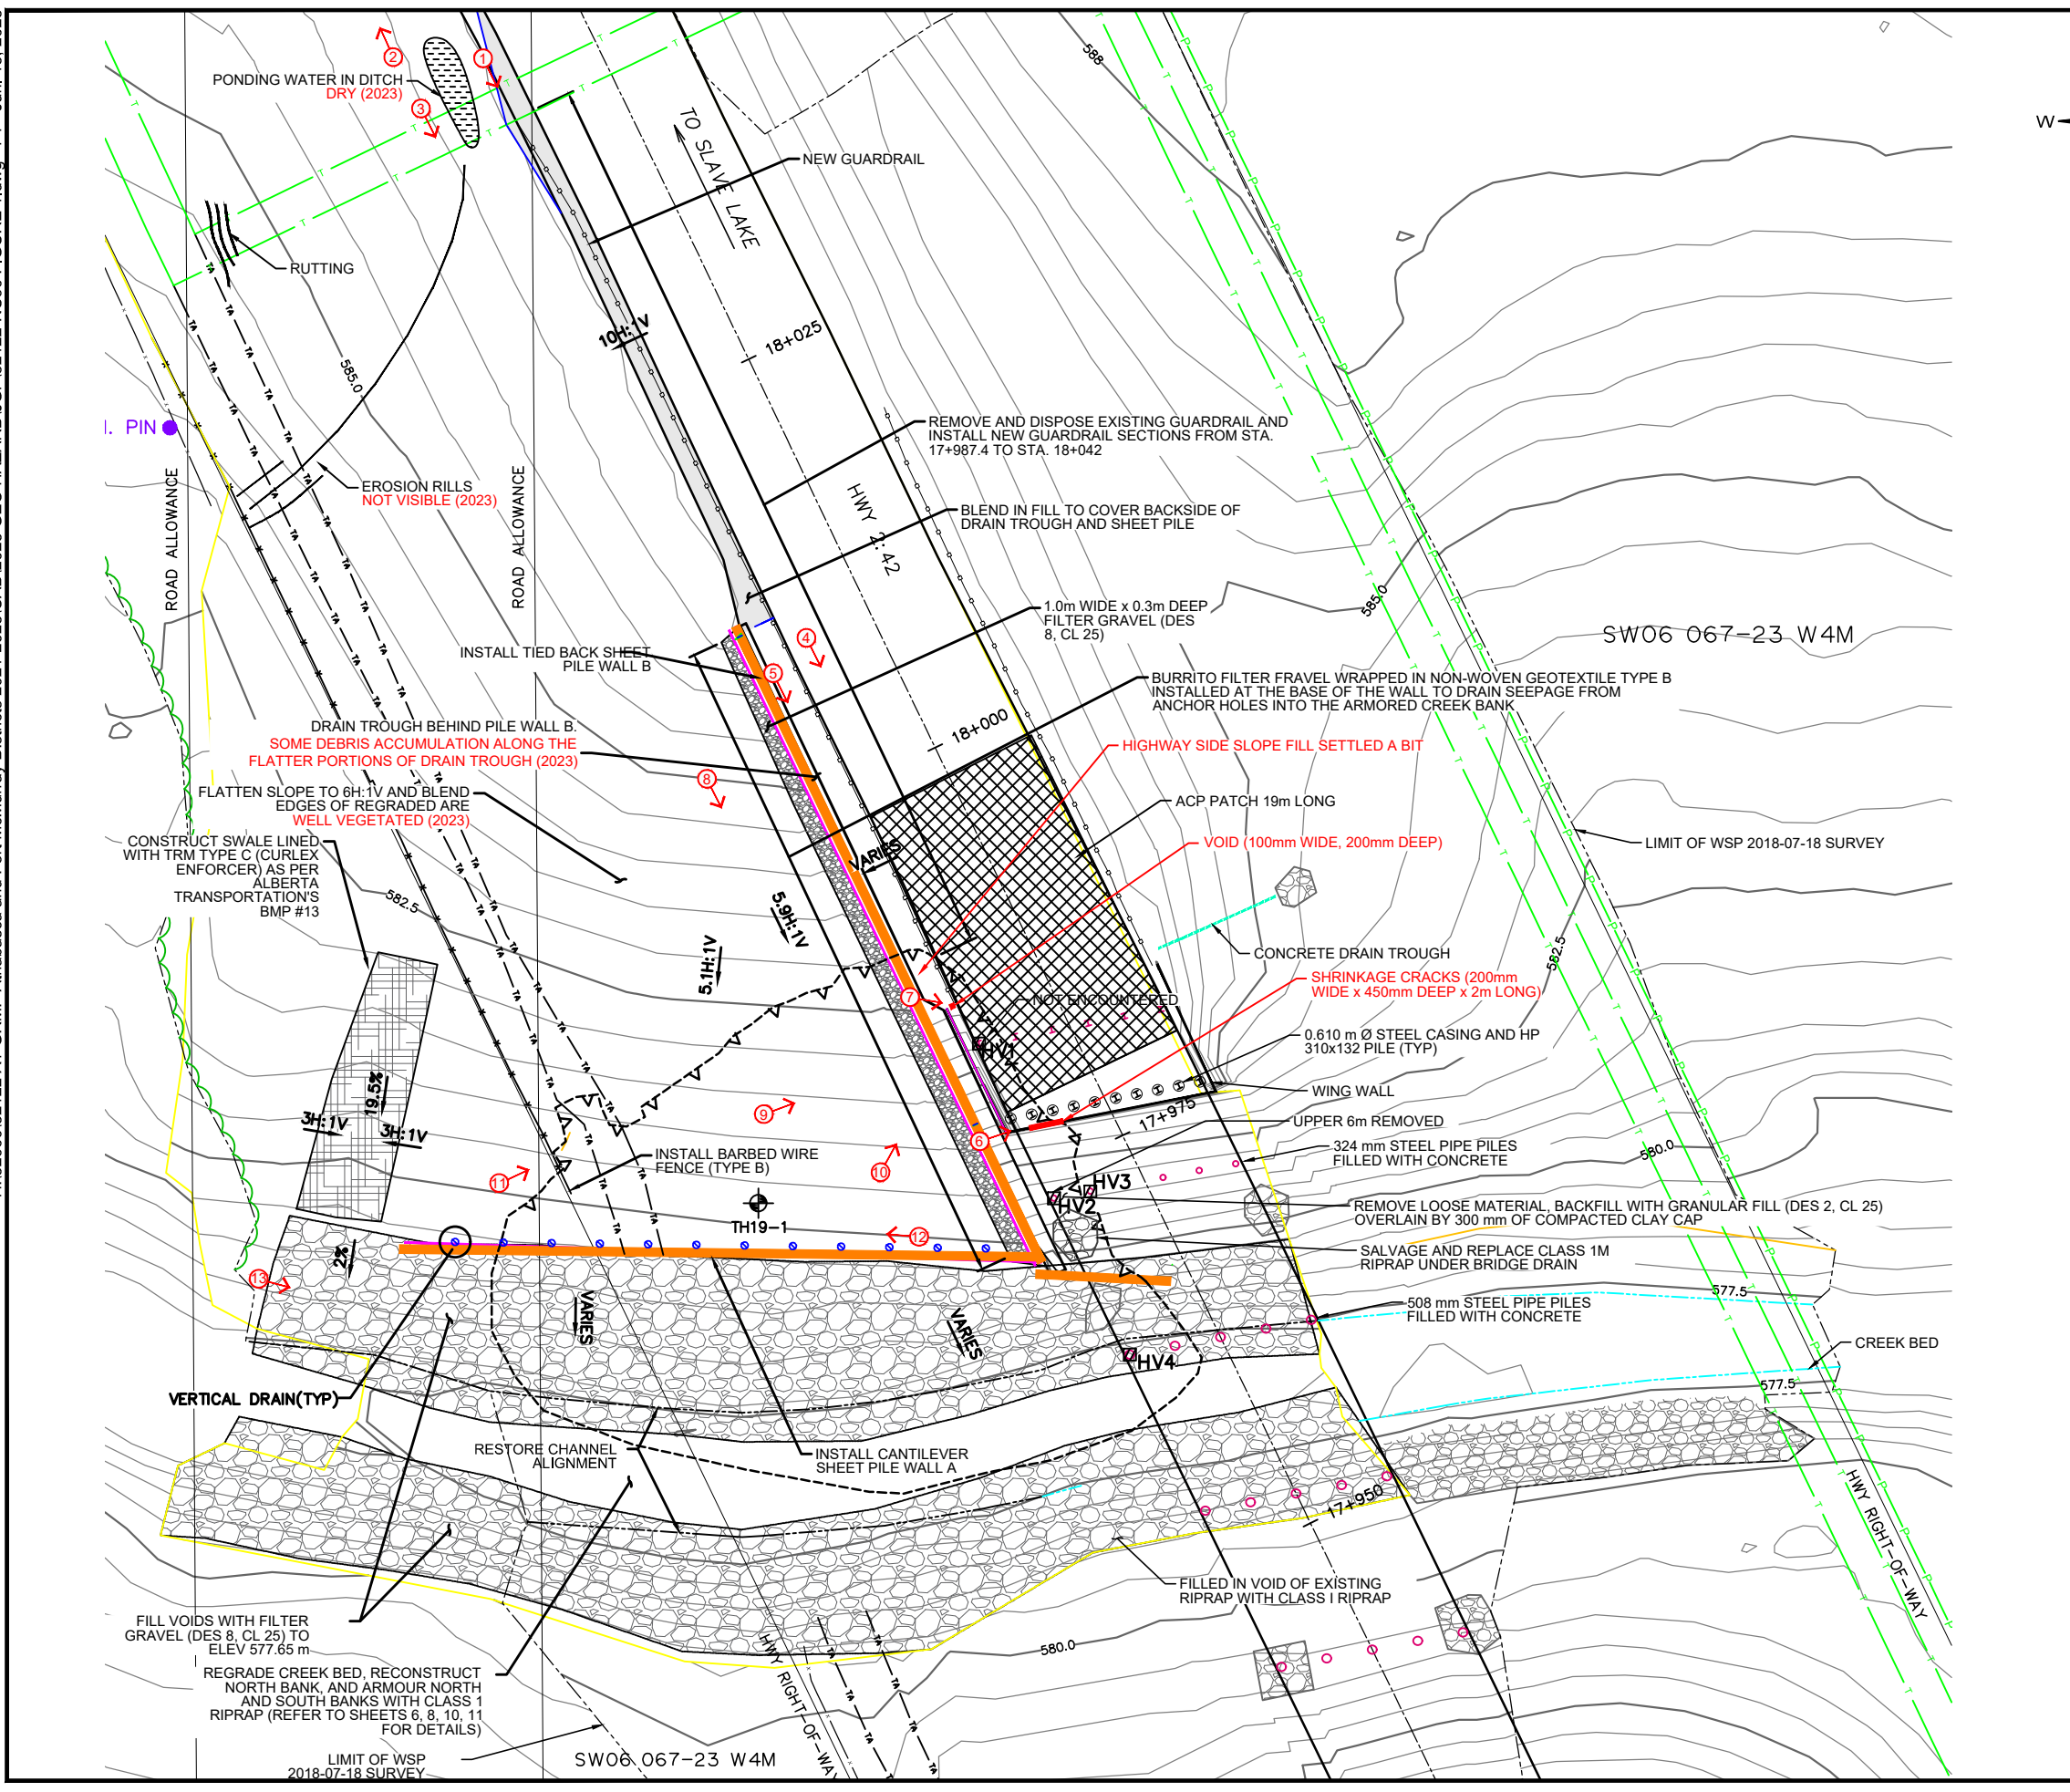
**FIGURE 1**

NOTE:  
JUNE 16, 2023 SITE INSPECTION OBSERVATIONS SHOWN IN RED.

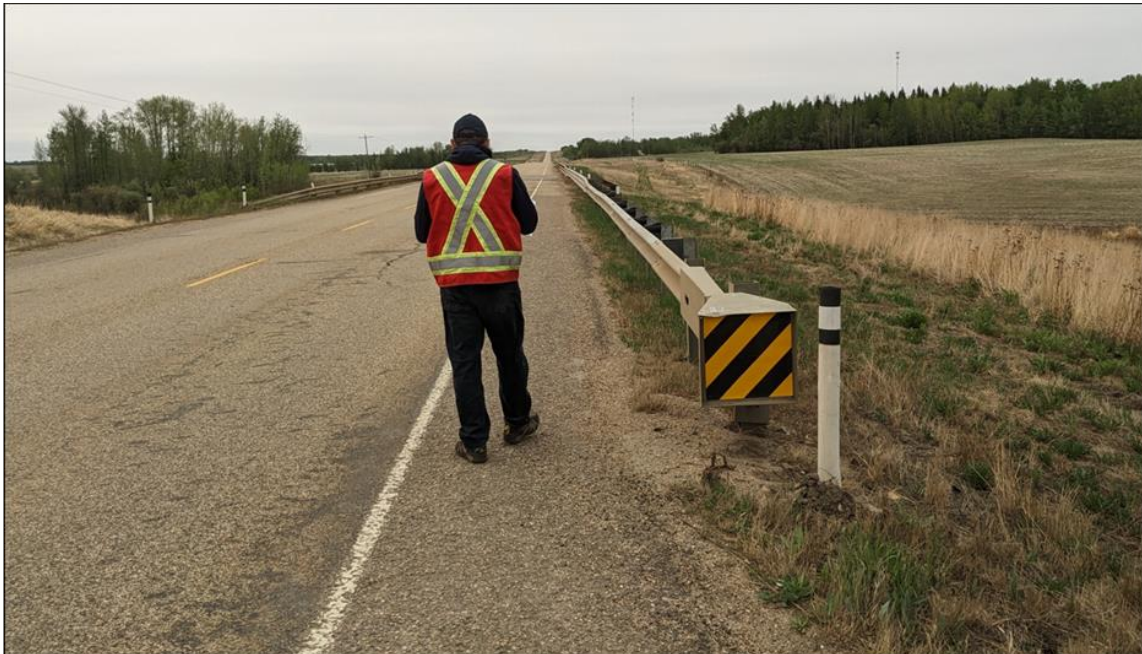
**Photo 1. Looking south at guardrail and embankment west side slope; note growth of grass vegetation within the slope surface**

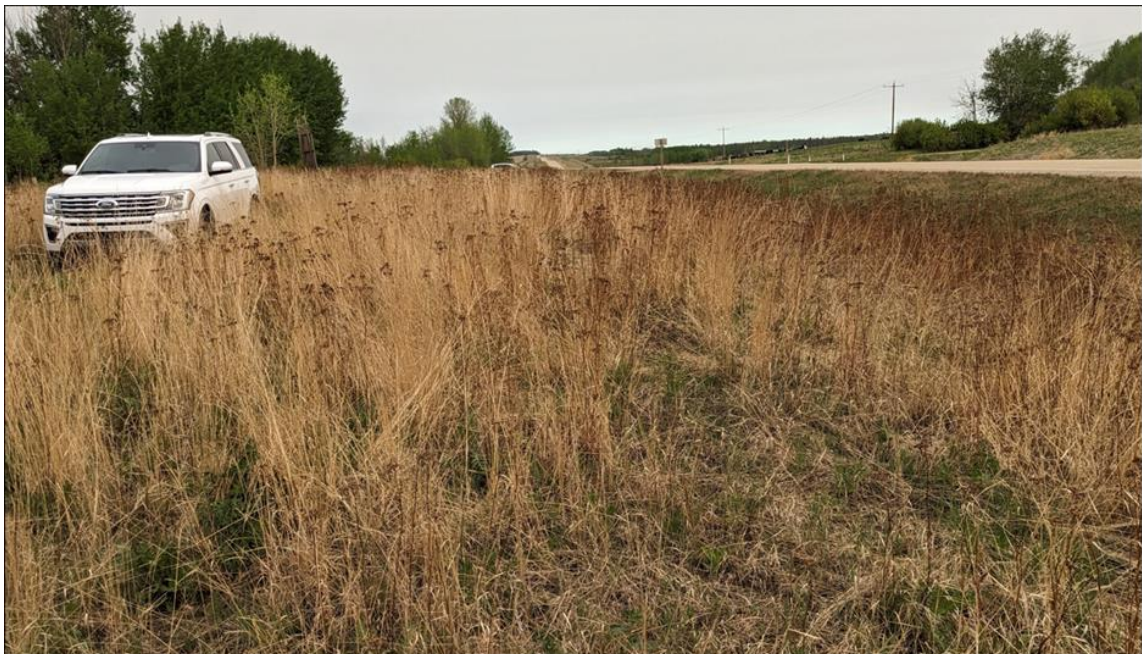
**Photo 2. Looking north at the highway west ditch to the north of the repaired area; note growth of grass vegetation.**

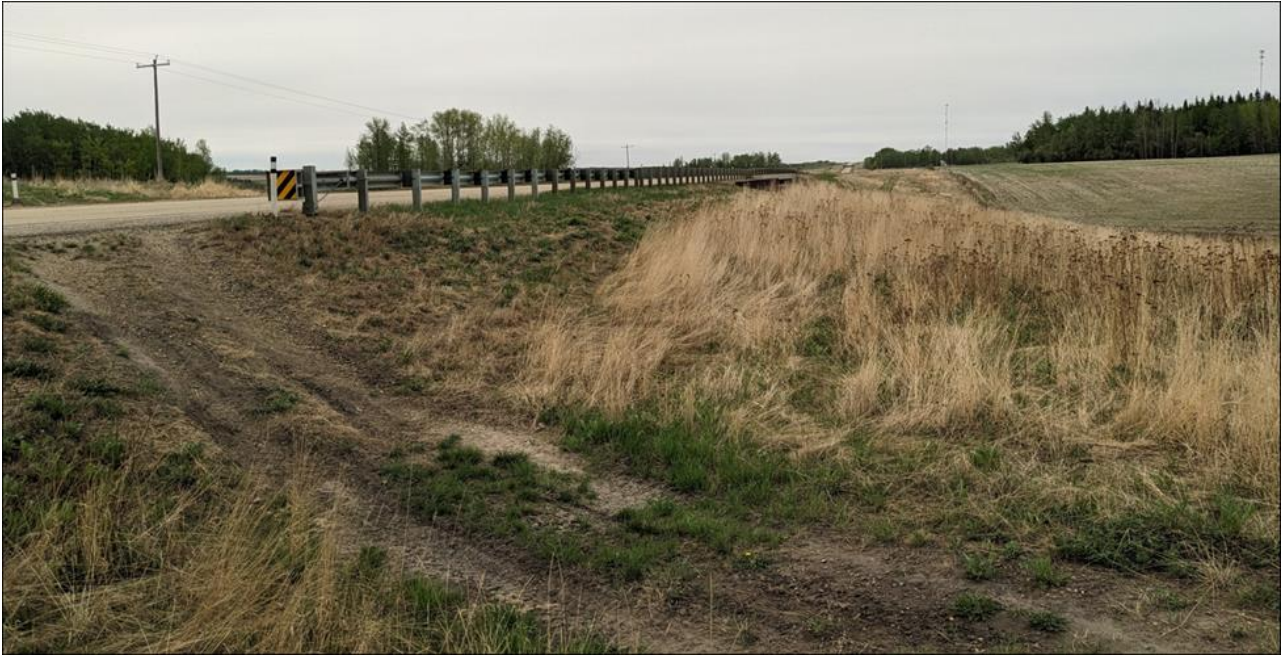
**Photo 3. Looking south at the highway west ditch to the north of the repaired area.**

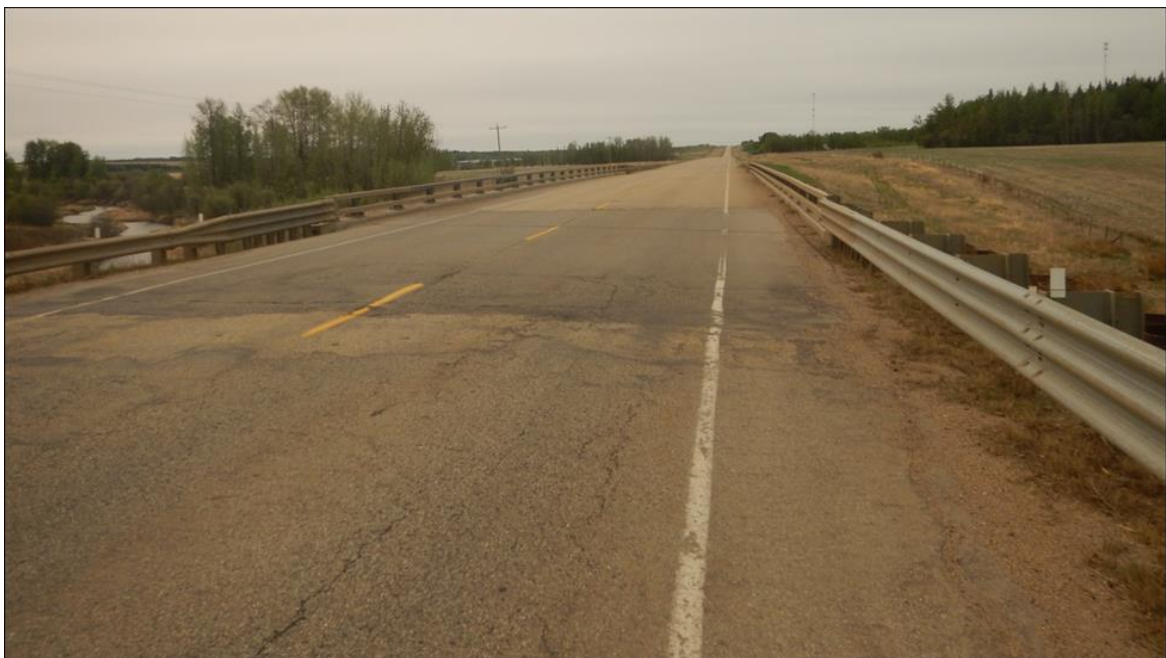
**Photo 4. Looking south at the 2019 ACP Patch.**

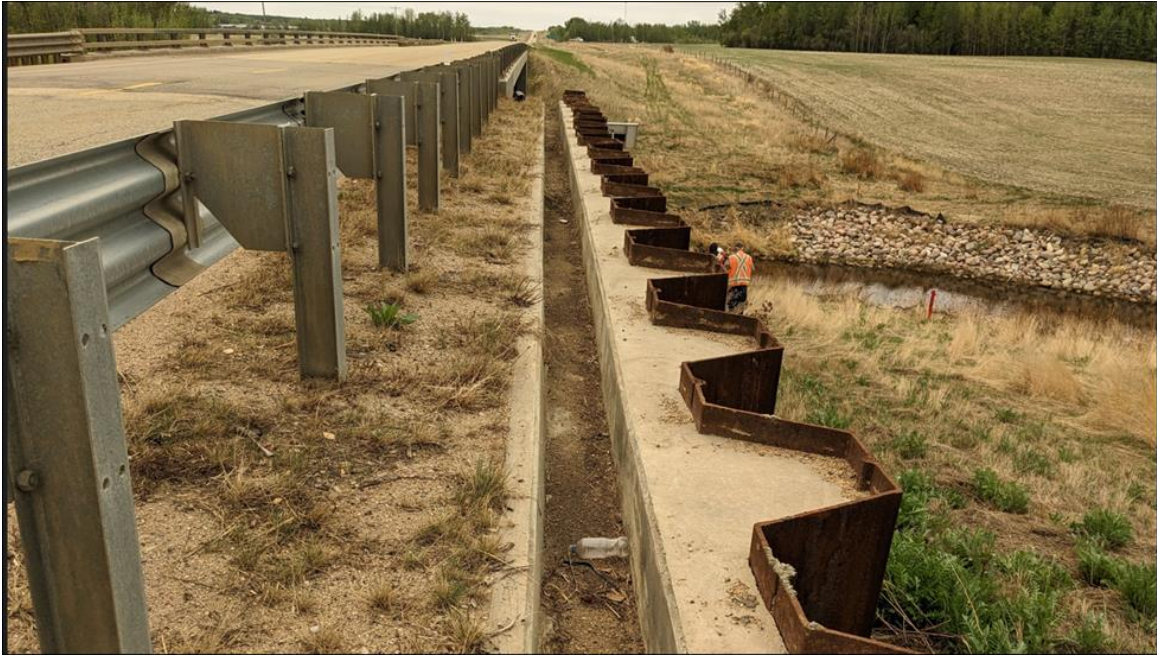
Photo 5. Looking south at guardrail and concrete drain trough behind Sheet Pile Wall B; accumulated debris from the road in the drain trough.

The local MCI should get the drain trough cleared of debris on a regular basis (at least once a year), and undertake the following maintenance items in the short-term:

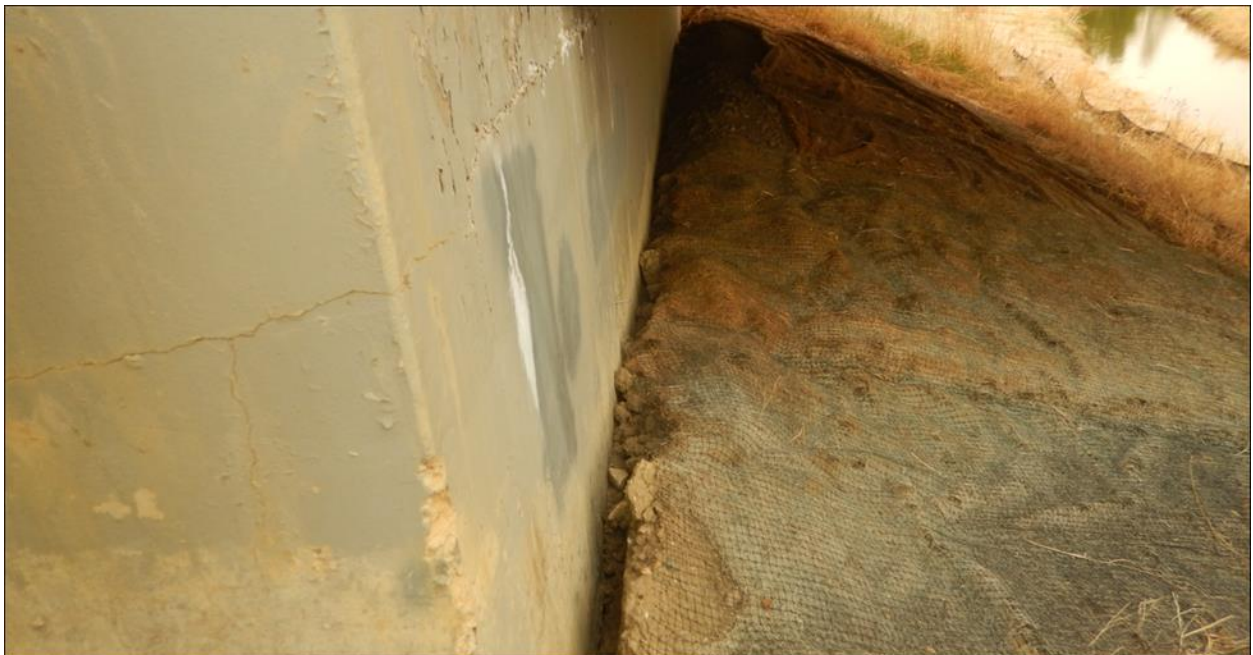
The shrinkage cracks and voids noted during the site visit may reflect minor grading issues during construction.

Photo 6. Shrinkage crack along the face of the abutment seat (200 mm wide, 450 mm deep, 2 m long)

(a) fill the cracks developed along the face of abutment seat below the bridge with low strength fillcrete,

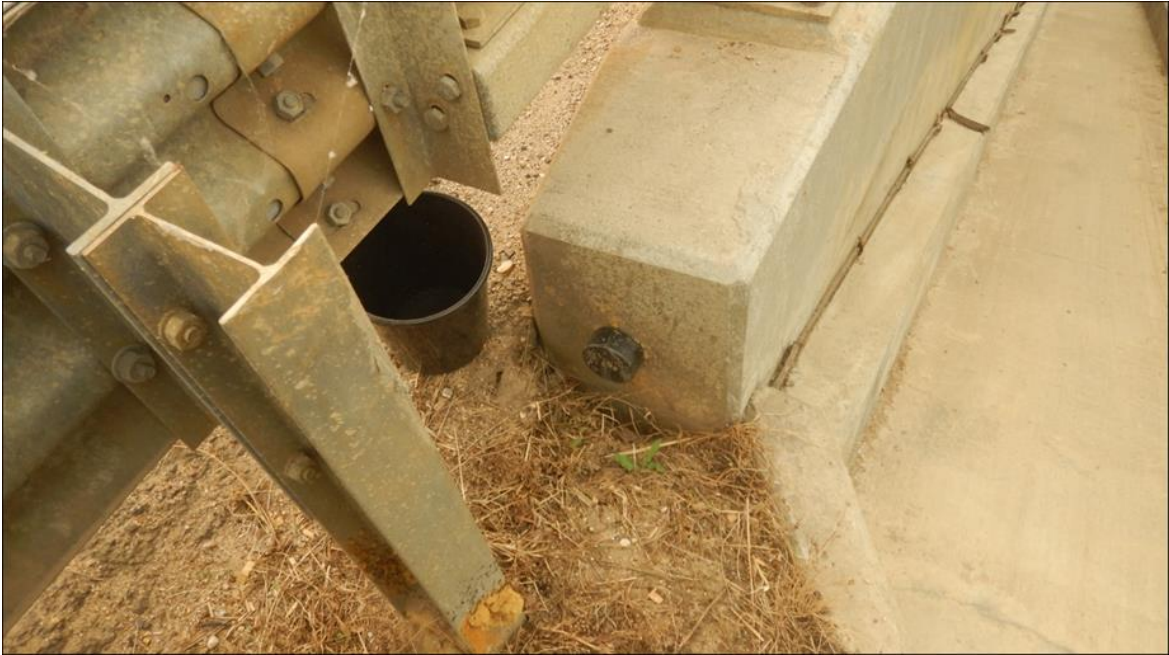
Photo 7. Looking at 100 mm wide x 200 mm deep void at the end of the wing wall

(b) fill the void developed at the top of the slope by the edge of the wing wall with ACP or fillcrete, and

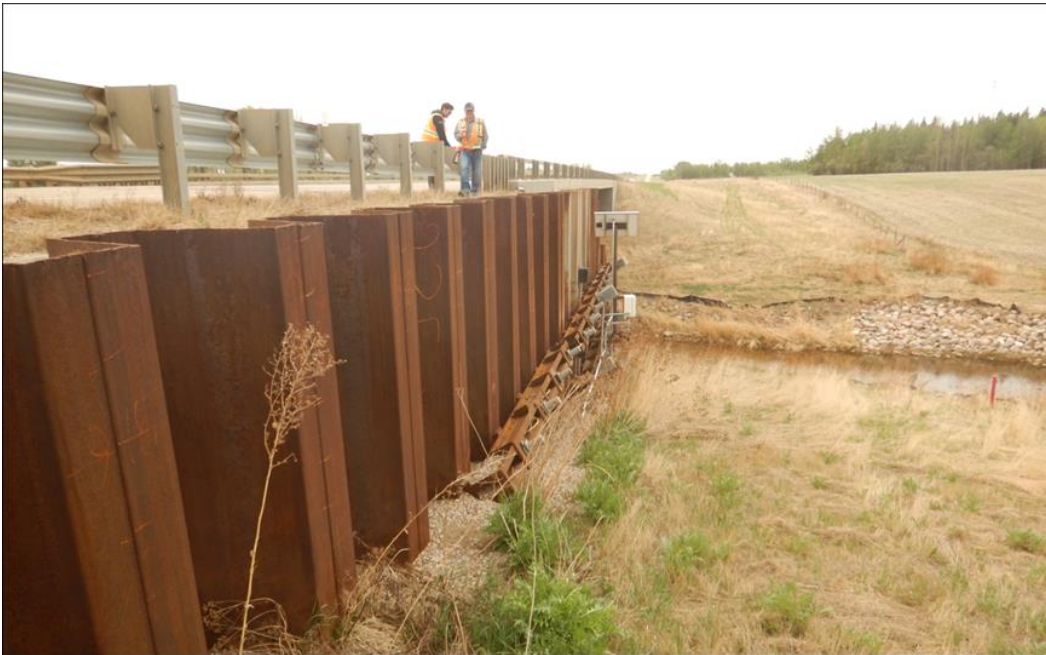
Photo 8. Sheet Pile Wall B with three rows of anchors supporting the highway embankment.

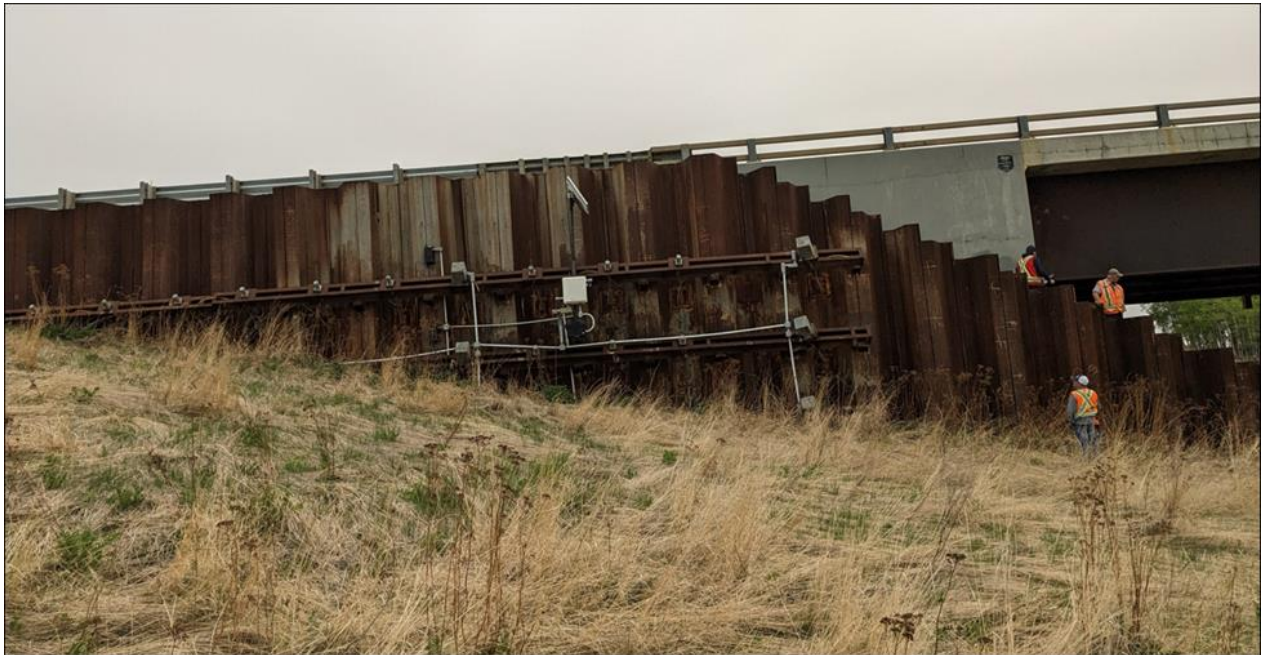
**Photo 9. Well grown vegetation along the 6H:1V north facing slope**

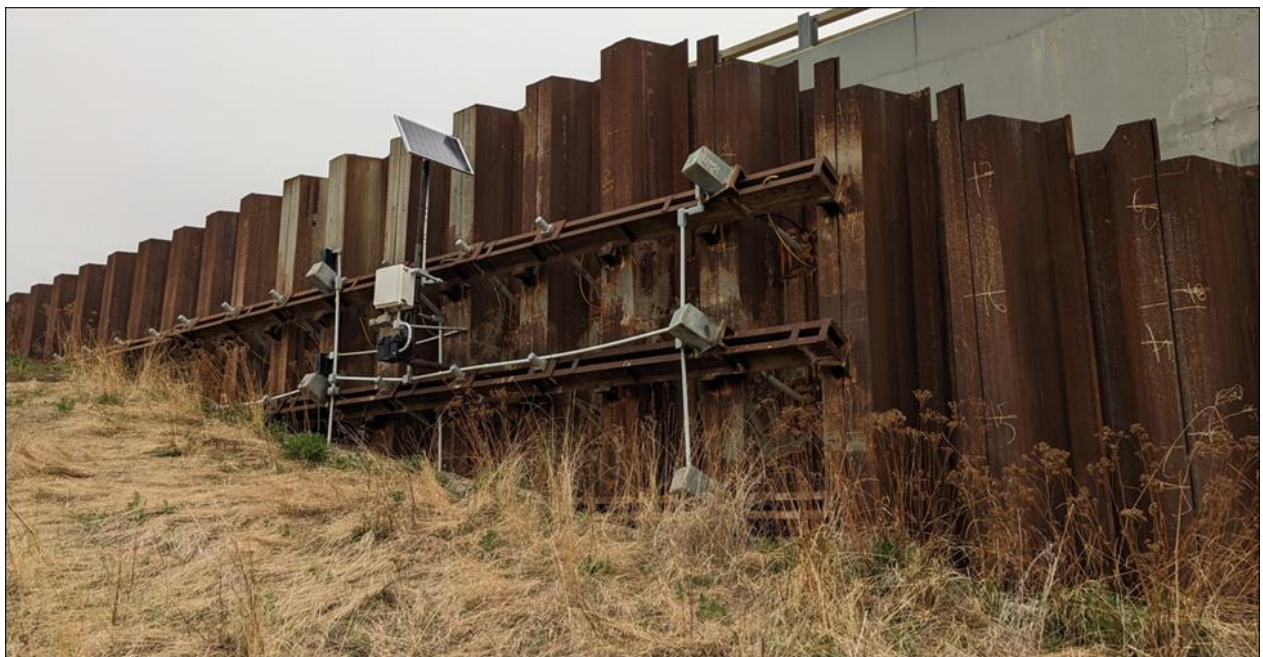
**Photo 10. Datalogger enclosure and solar panel installed on Sheet Pile Wall B**

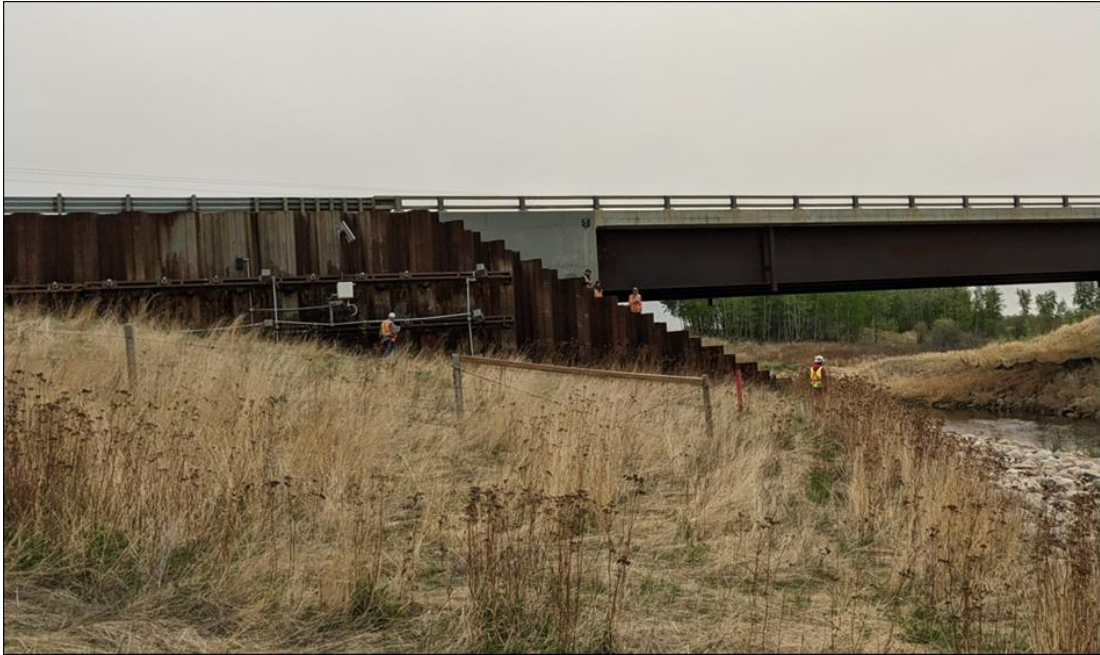
**Photo 11. Well grown vegetation on both sides of the barbed Wire Fencing Installed on 6H:1V north facing slope**

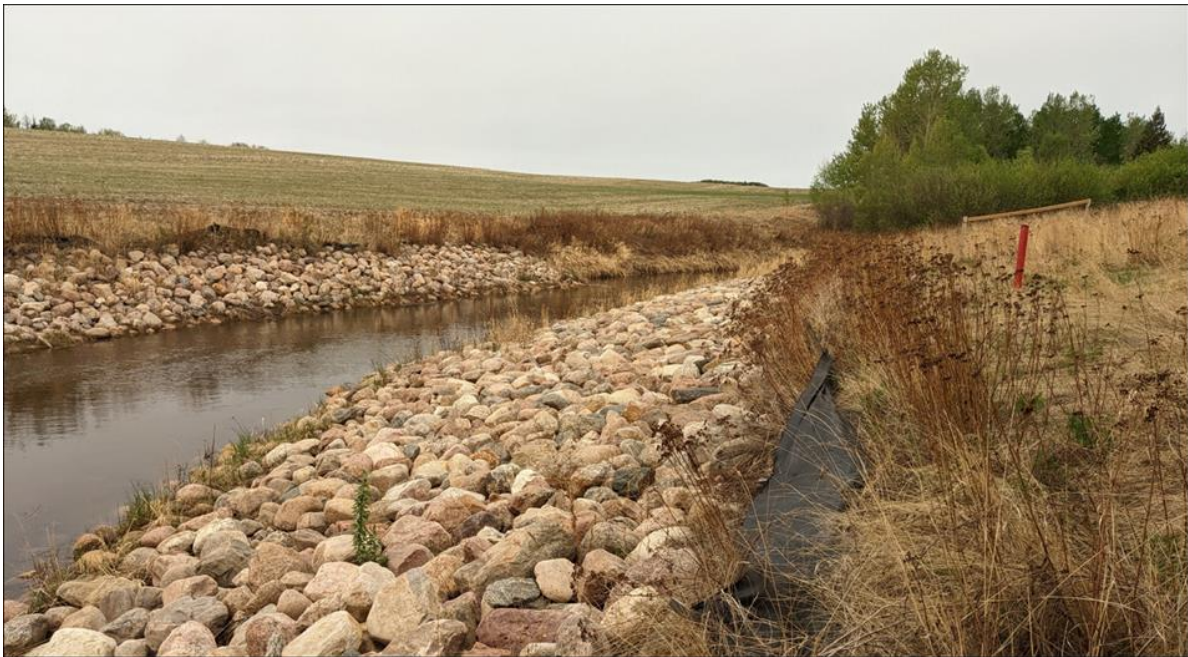
**Photo 12. Looking west at the armored creek bank from the bottom of the slope (i.e.at Sheet Pile Wall A location); banks were armored using Class 1 Riprap**

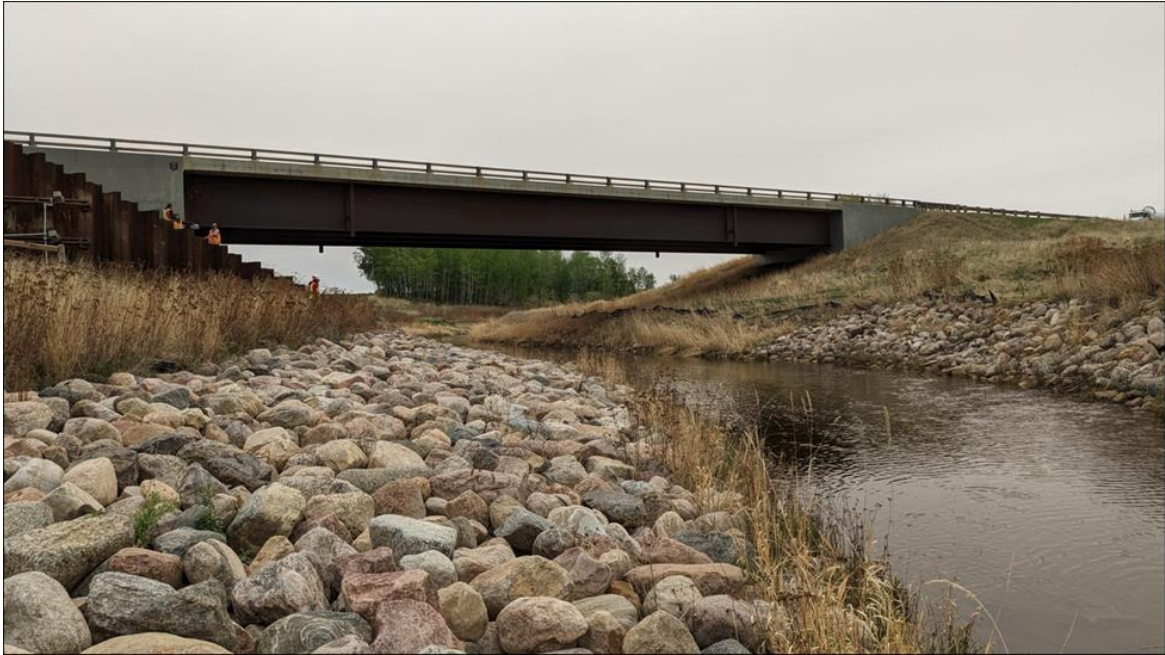
**Photo 13. Looking east at the armored creek banks from the bottom of the slope |**
