**ALBERTA TRANSPORTATION
GEOHAZARD ASSESSMENT PROGRAM
NORTH CENTRAL REGION – ATHABASCA &
FORT MCMURRAY DISTRICTS
2021 SITE INSPECTION**

Site Number	Location	Name	Hwy	km
NC100	35 km Northwest of the Junction of Hwy 2:46 and Hwy 44:04	BF76193 OTAUWAW RIVER	2:46	38.76
Legal Description		UTM Co-ordinates (NAD 83)		
S.W.14-72-4-W5M		11 N 6123853	E 659514

**NORTH CENTRAL REGION
(ATHABASCA AND FORT McMURRAY DISTRICTS)
2021 GEOHAZARD ASSESSMENT**

**NC100: HWY 2:46 BF76193
OTAUWAWU RIVER (km 38.7)**

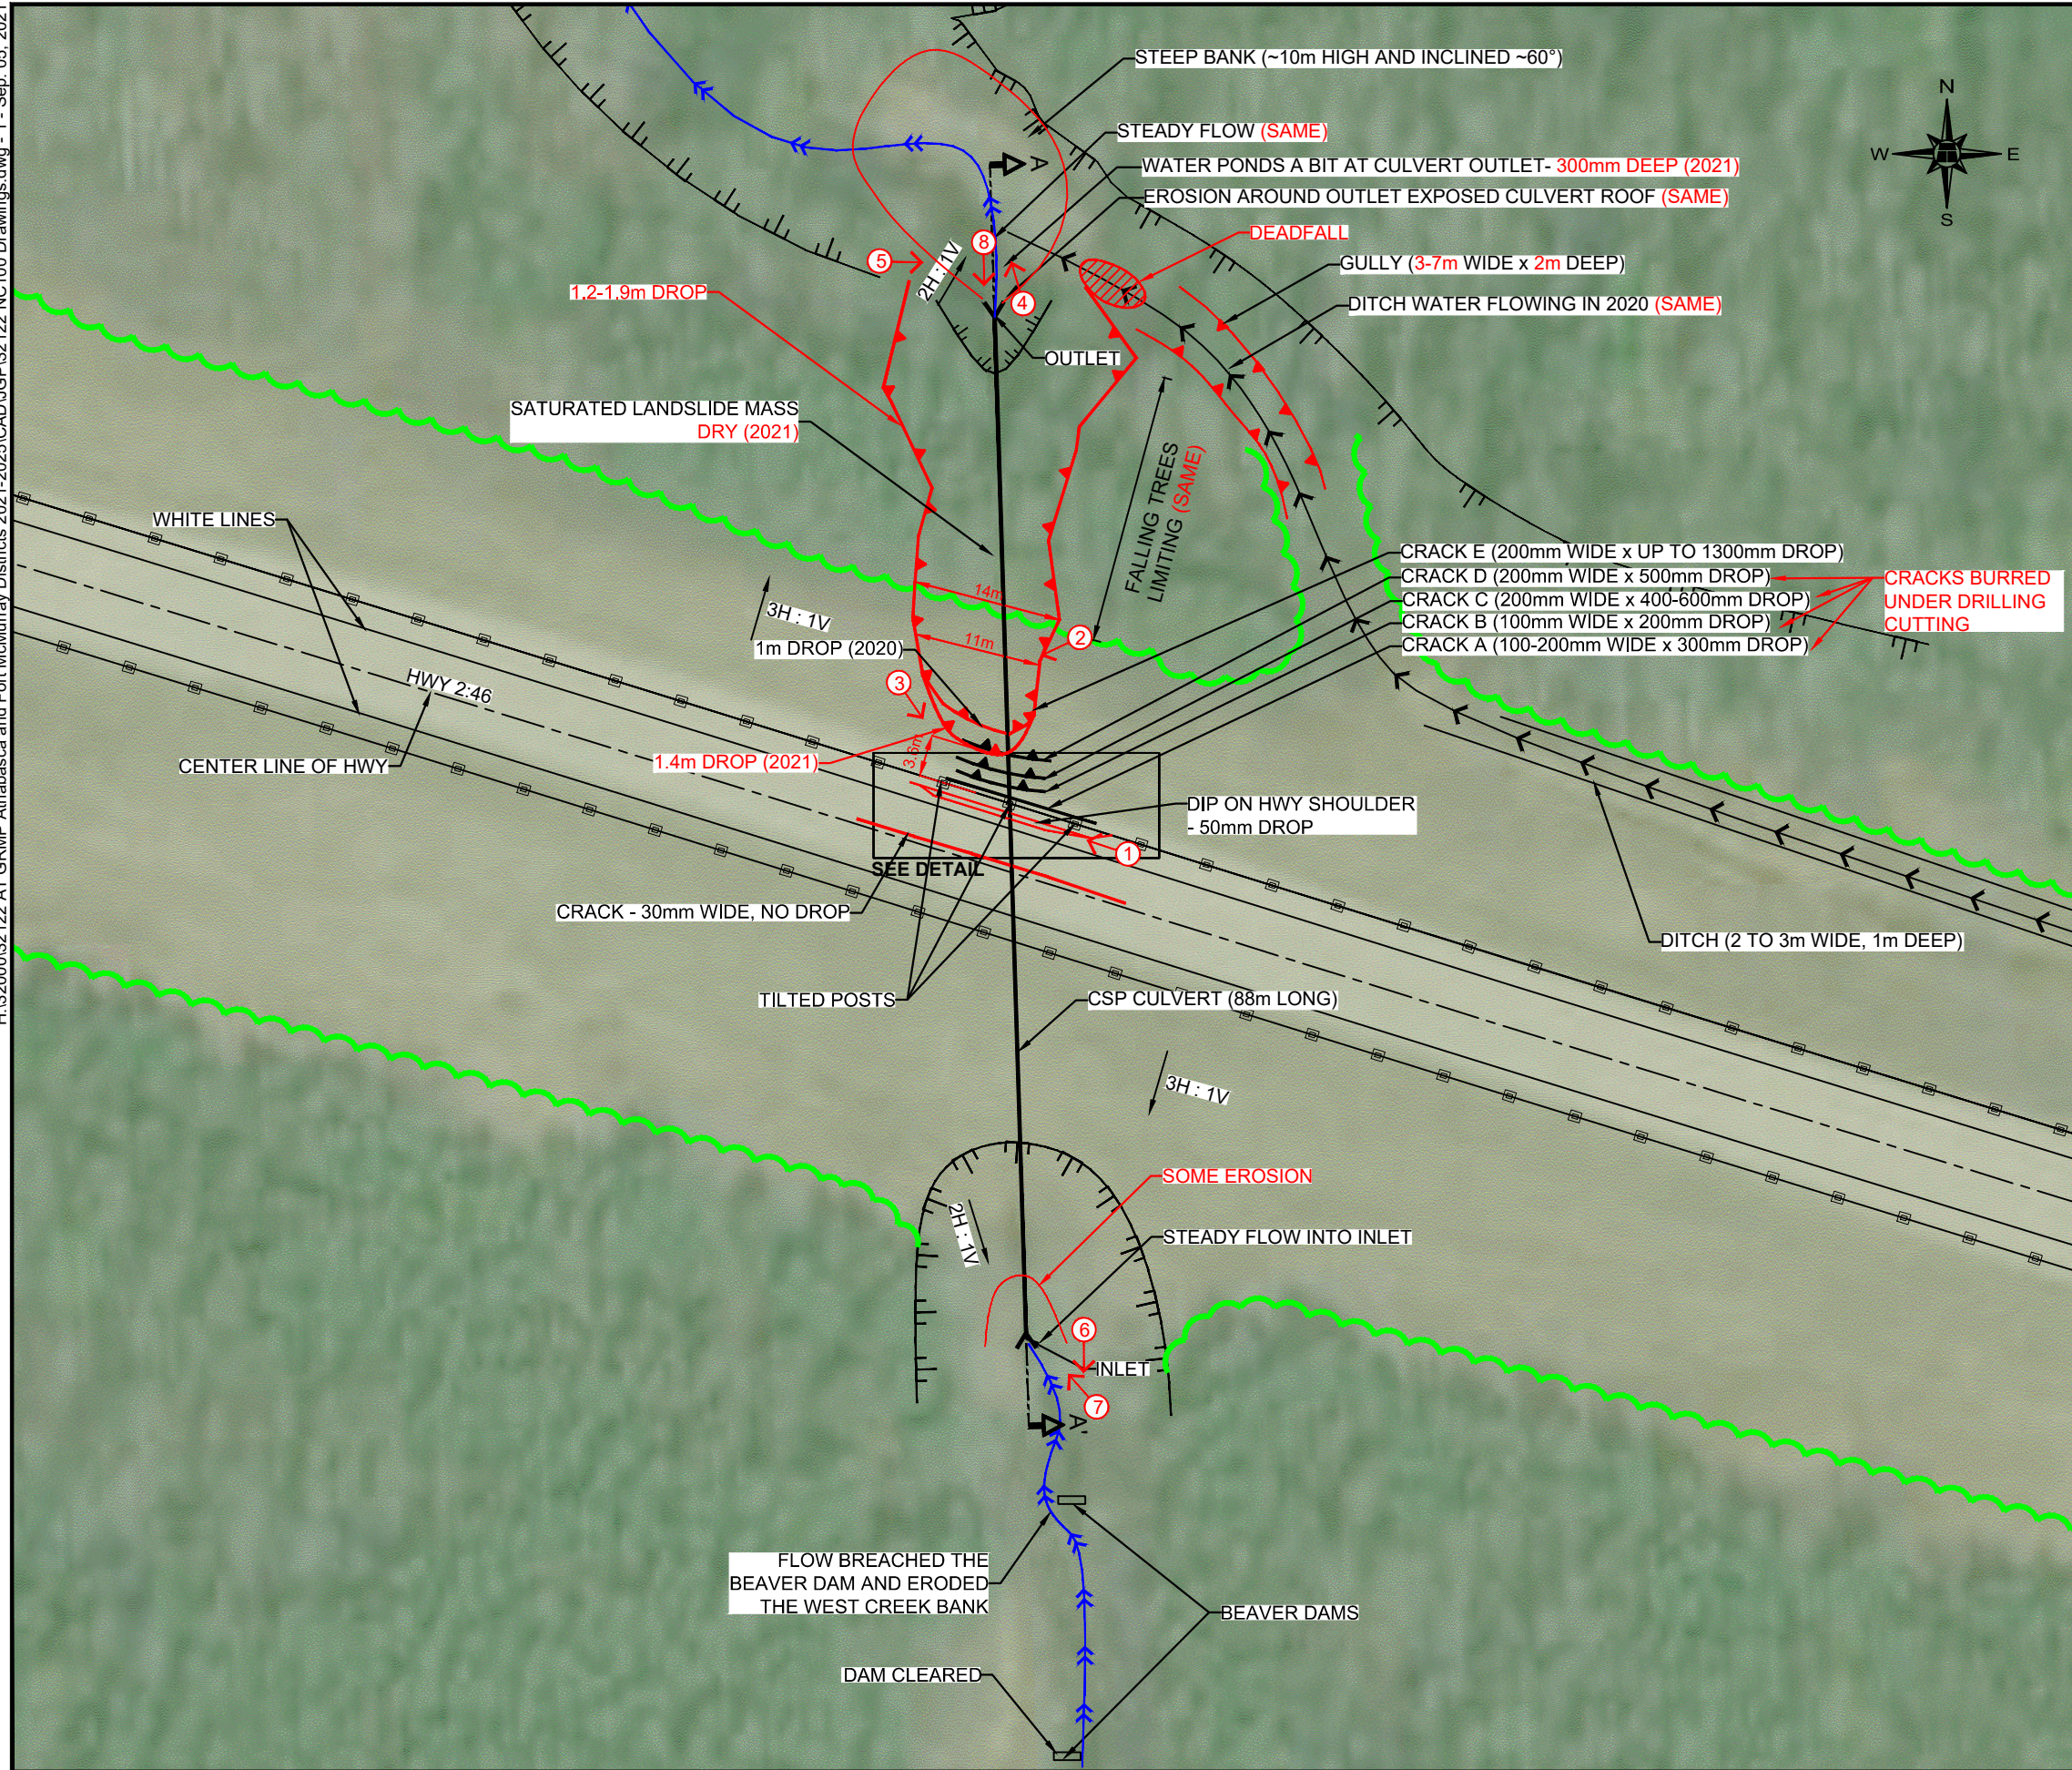
FIGURE 1

The site observations indicate the presence of a deep-seated landslide on the north side of the highway. The landslide is about 40 m long (perpendicular to the highway alignment) x 14 to 20 m wide (parallel to the highway alignment) x 9 m deep and is toeing out at the culvert outlet location. The landslide resulted in the development of a dip in the highway shoulder and impacted the integrity of the 2 m diameter bridge size culvert.

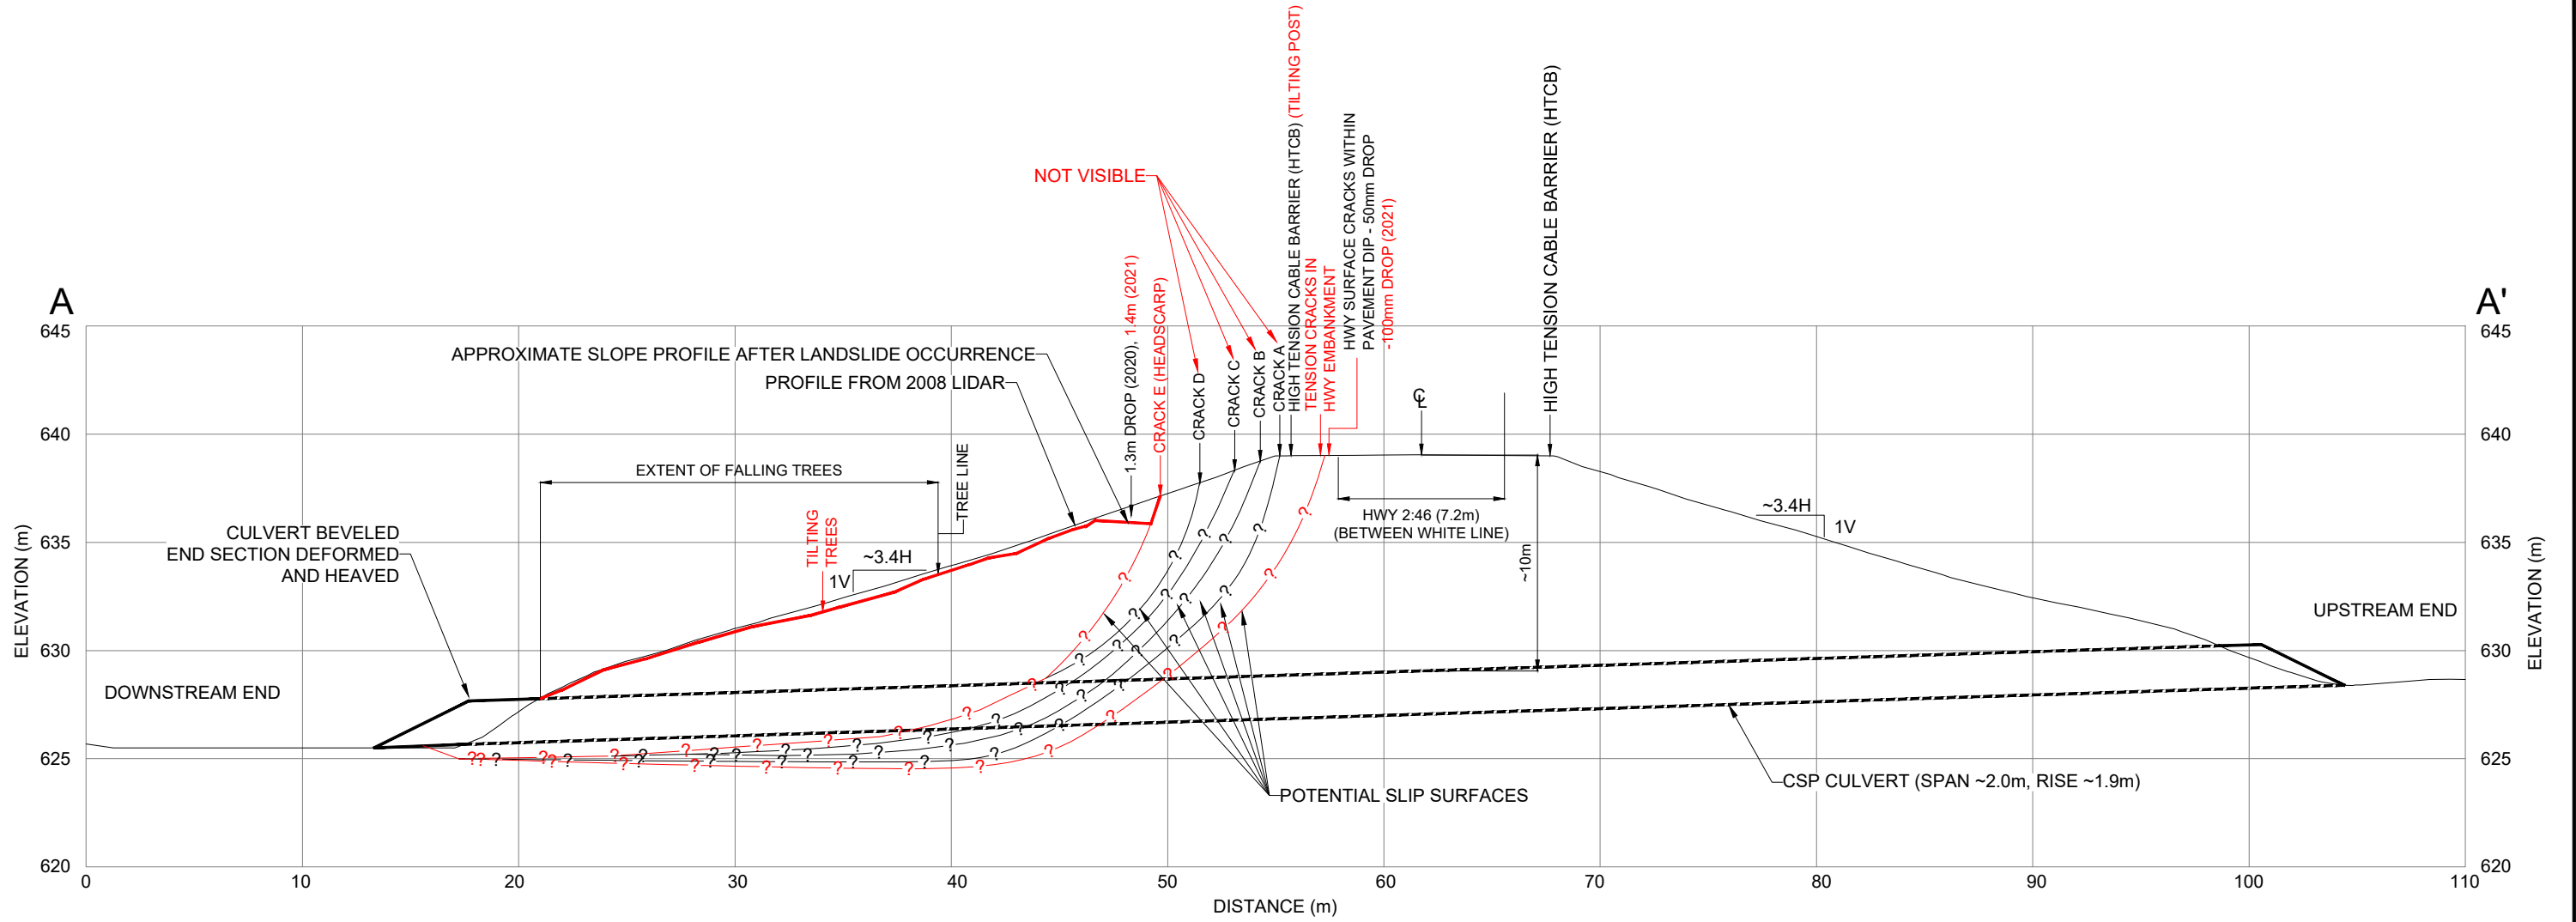
FIGURE 2

NC100: CROSS - SECTION A - A'

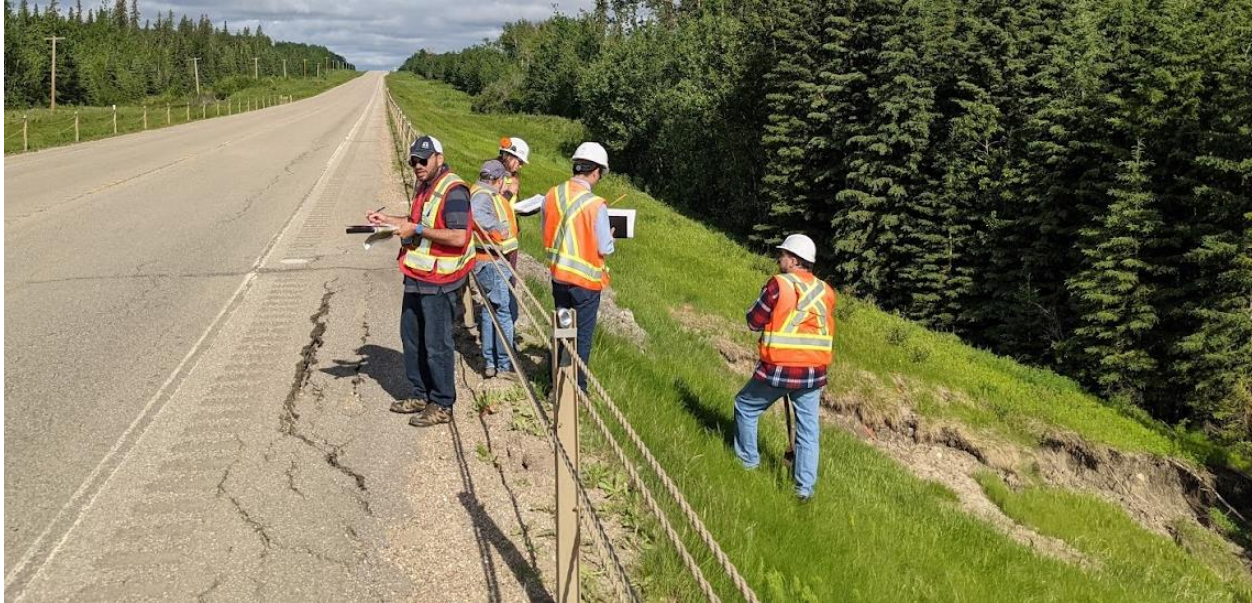
Observations:	Description	Worse?
<input checked="" type="checkbox"/> Pavement Distress	A 50 to 100 mm dip in the highway WBL shoulder above the landslide area; 15 m long, 200 to 270 mm deep open cracks within the dip area	<input checked="" type="checkbox"/>
<input checked="" type="checkbox"/> Slope Movement	1.4 m deep head scarp crack on the north embankment side slope; heads carp crack located approximately 3.6 m from the edge of pavement; previously noted four tension cracks (Cracks A to D) above the head scarp crack of the landslide mass as shown on Figure 1 were buried under excess cuttings of the drilling program completed by Wood.	<input checked="" type="checkbox"/>
<input checked="" type="checkbox"/> Erosion	Eroded natural gully (3 to 7 m wide and up to 2 m deep) surrounded by fallen trees/deadfall is located northeast of the culvert outlet; heavy flow from the mouth of the gully	<input checked="" type="checkbox"/>

Photo No. 1 – Looking at WBL landslide; note the presence of open tension cracks on the highway shoulder; main head scarp crack of landslide is about 3.6 m north from the edge of pavement

In the short term, the MCI should periodically monitor the highway for additional movement or cracking. Speed reduction and landslide warning signs should be placed along the highway at this location. If the dip becomes severe, minimal ACP patch should be placed on the highway surface to provide a smooth surface to motorists. This is to avoid excessive loading of the crest of the slope at the landslide location.

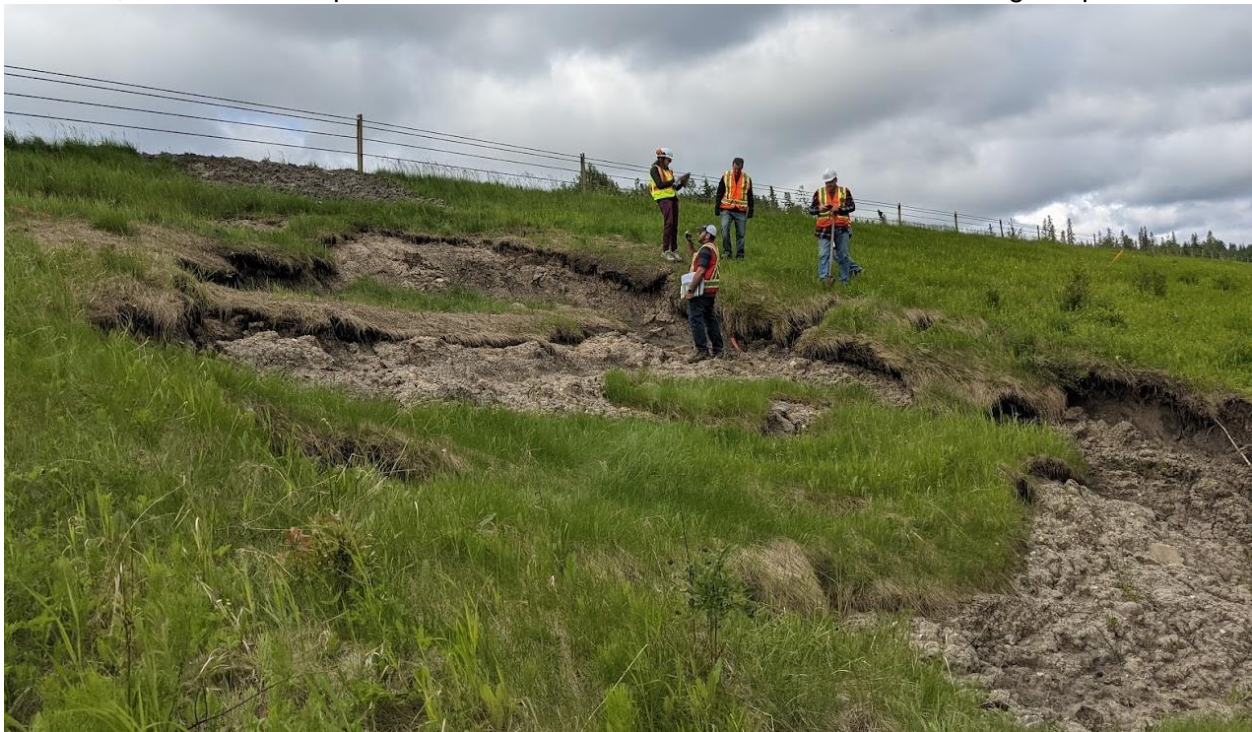
<input checked="" type="checkbox"/> Seepage	Landslide mass was noted a bit drier than during the 2020 inspection. Water ponding 300 mm downstream of the culvert outlet.	<input type="checkbox"/>
<input checked="" type="checkbox"/> Bridge/Culvert Distress	The bridge inspection reports indicated that the culvert had bolts cracked near the inlet, the roof was damaged at rings 29, 30, and 31 with a reverse curvature close to the outlet. Silt accumulated at the bottom of these rings, but the inspector was unable to take measurements at these locations. The report also indicates that the culvert outlet heaved by about 300 mm.	<input type="checkbox"/>
<input checked="" type="checkbox"/> Other	Two-third of the landslide area is covered with falling trees; two beaver dams were noted upstream of the culvert inlet location; scattered riprap at culvert inlet and outlet locations; water ponding zone increased at outlet location	<input type="checkbox"/>

Photo No. 2 – Looking southwest at the north embankment landslide's head scarp and western flank; landslide mass was noted to drier than in 2020.

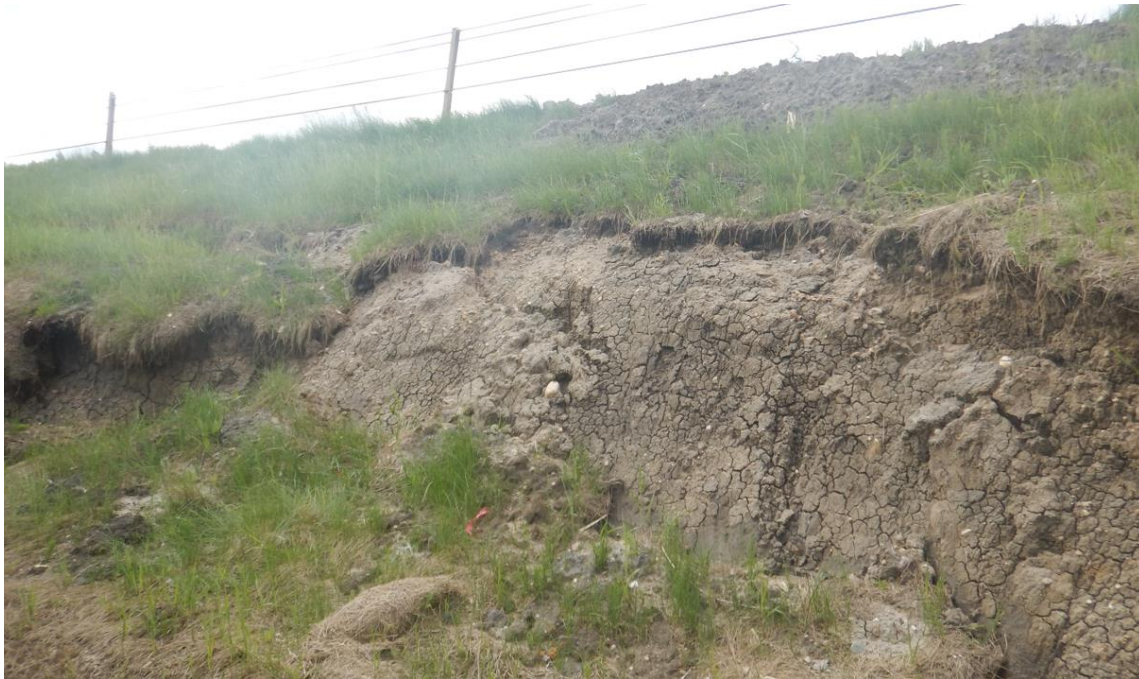
Photo No. 3 – Looking southeast at the landslide’s head scarp and eastern flank; multiple tension cracks noted between the head scarp and the guardrail during the previous inspection were buried under drill cuttings

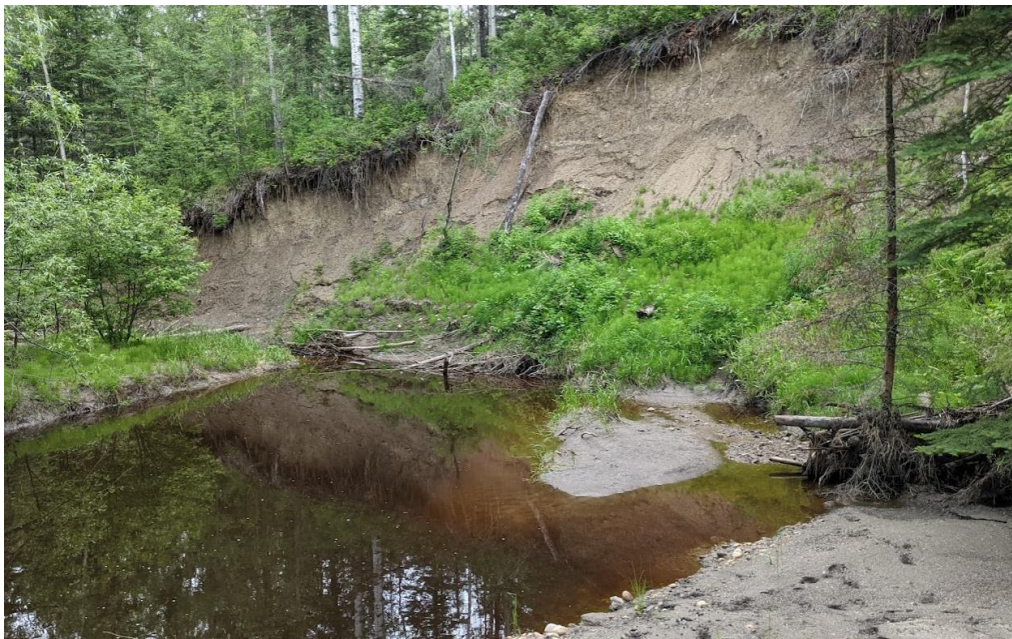
Photo No. 4. Looking northwest at the CSP culvert outlet; note water ponding near the culvert outlet

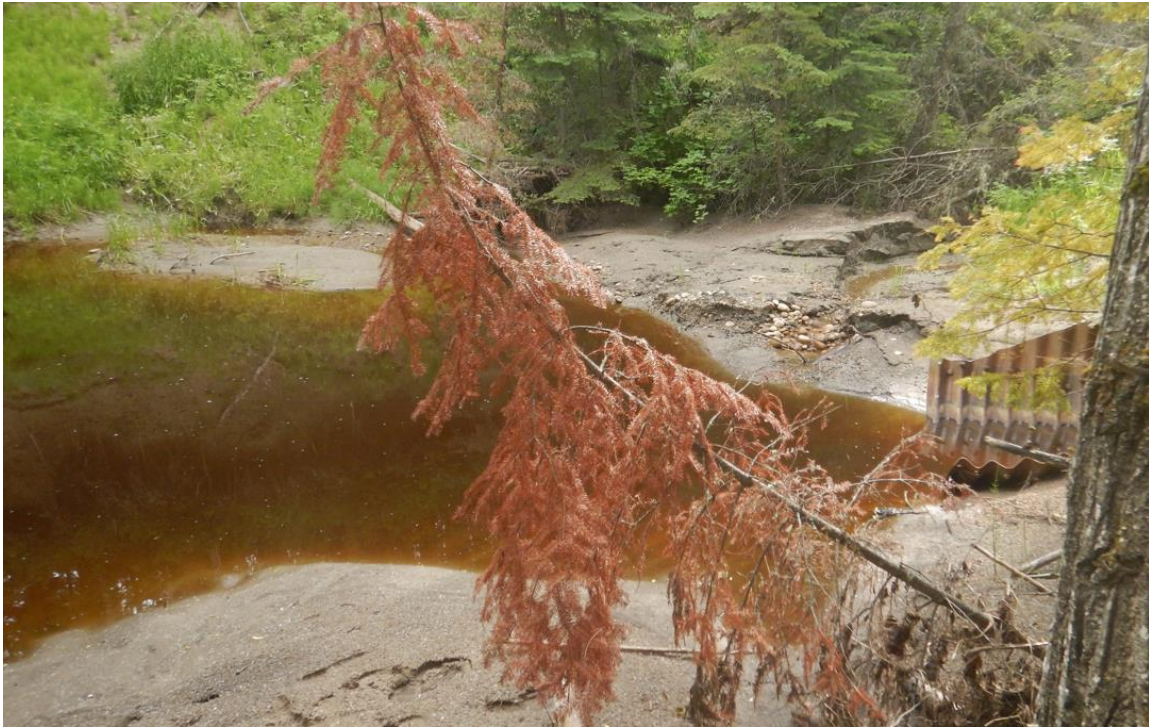
Photo No. 5 – Looking east; water ponding a bit around culvert outlet location

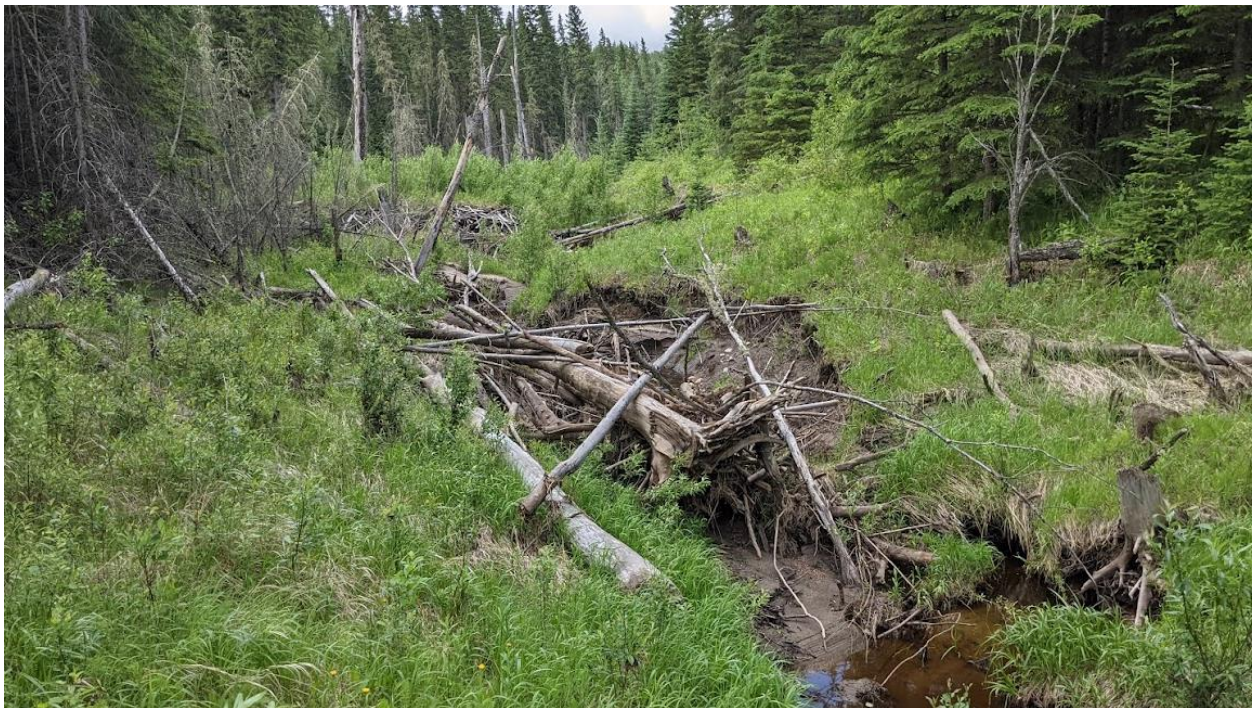
Photo No. 6 – Two beaver dams noted upstream of the culvert inlet

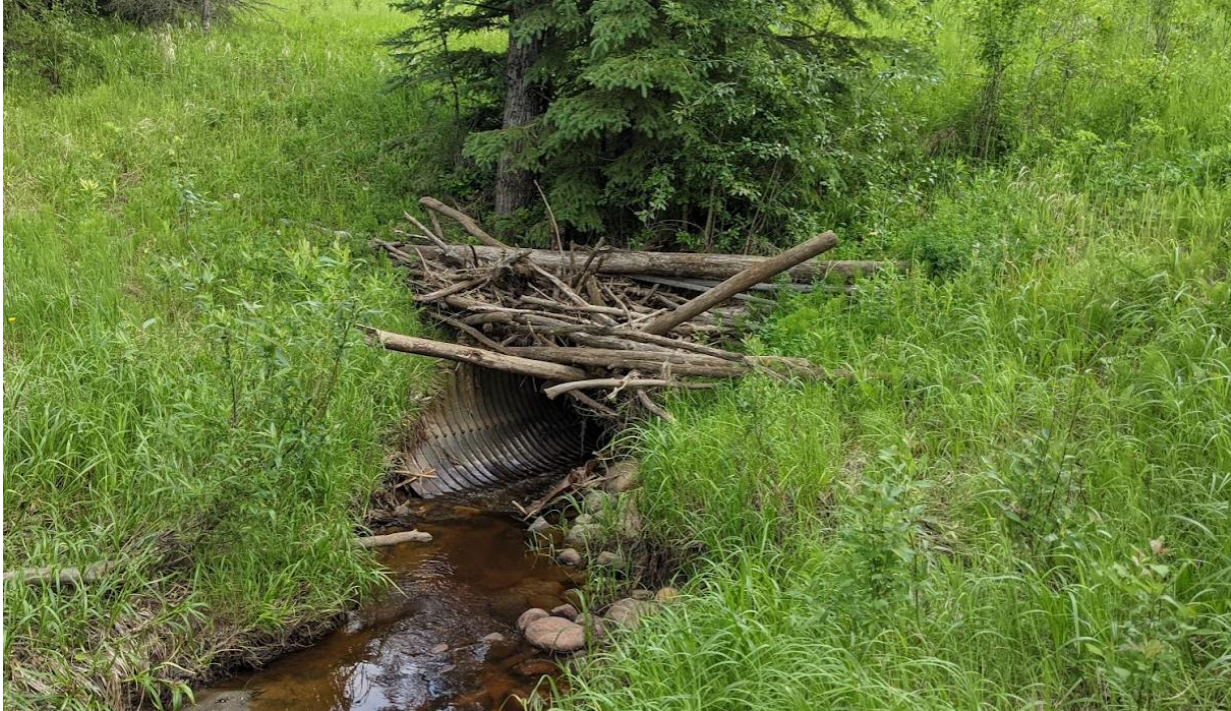
Photo No. 7 – Looking at CSP Culvert Inlet (1.9 m diameter); scattered riprap was noted at inlet location

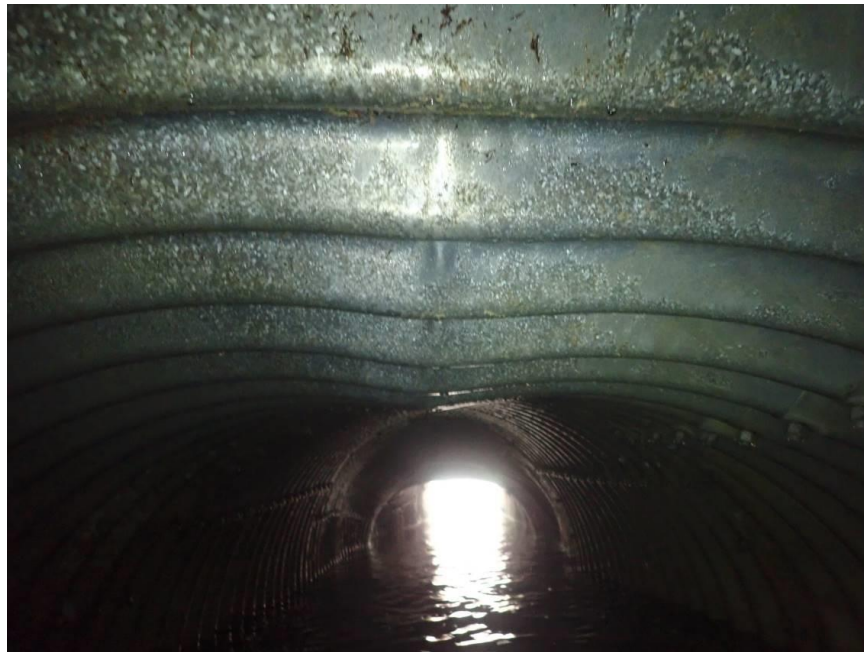
The 2020 bridge inspection report indicated reverse curvatures and silt accumulation on in rings 29 to 31, potentially indicating that the culvert has failed or excessively deformed.

Photo No. 8 – Looking inside CSP Culvert outlet; note reverse curvature in the roof (Photograph was taken by AT during bridge culvert inspection completed on June 3,2020). This is approximately 27 to 30 m from the culvert outlet location.

- (a) excavation and replacement of the landslide mass with a stronger material (either gravel or geo-grid reinforced fill),
- (b) construction of a gravel shear key at the base of the slope,
- (c) installation of a bigger diameter SWSP culvert to replace the existing one, and
- (d) shaping and armoring eroded gully to the east of the landslide mass
