**ALBERTA TRANSPORTATION
GEOHAZARD ASSESSMENT PROGRAM
NORTH CENTRAL REGION – ATHABASCA &
FORT MCMURRAY DISTRICTS
2022 SITE INSPECTION**

Site Number	Location	Name	Hwy	km
NC100	35 km Northwest of the Junction of Hwy 2:46 and Hwy 44:04	BF76193 OTAUWAW RIVER	2:46	38.76
Legal Description		UTM Co-ordinates (NAD 83)		
S.W.14-72-4-W5M		11 N 6123853	E 659514

Date	PF	CF	Total
Previous Inspection:	June 23, 2021	14	5	70
Current Inspection:	June 06, 2022	14	5	70
Road AADT:	2180	Year:	2021	
Inspected By:	José Pineda, Tarek Abdelaziz (Thurber) Gordon Wolters, Arthur Kavulok, Amy Driessen, Rishi Adhikari (Alberta Transportation)			
Report Attachments:	<input checked="" type="checkbox"/> Photographs <input checked="" type="checkbox"/> Plans <input type="checkbox"/> Maintenance Items

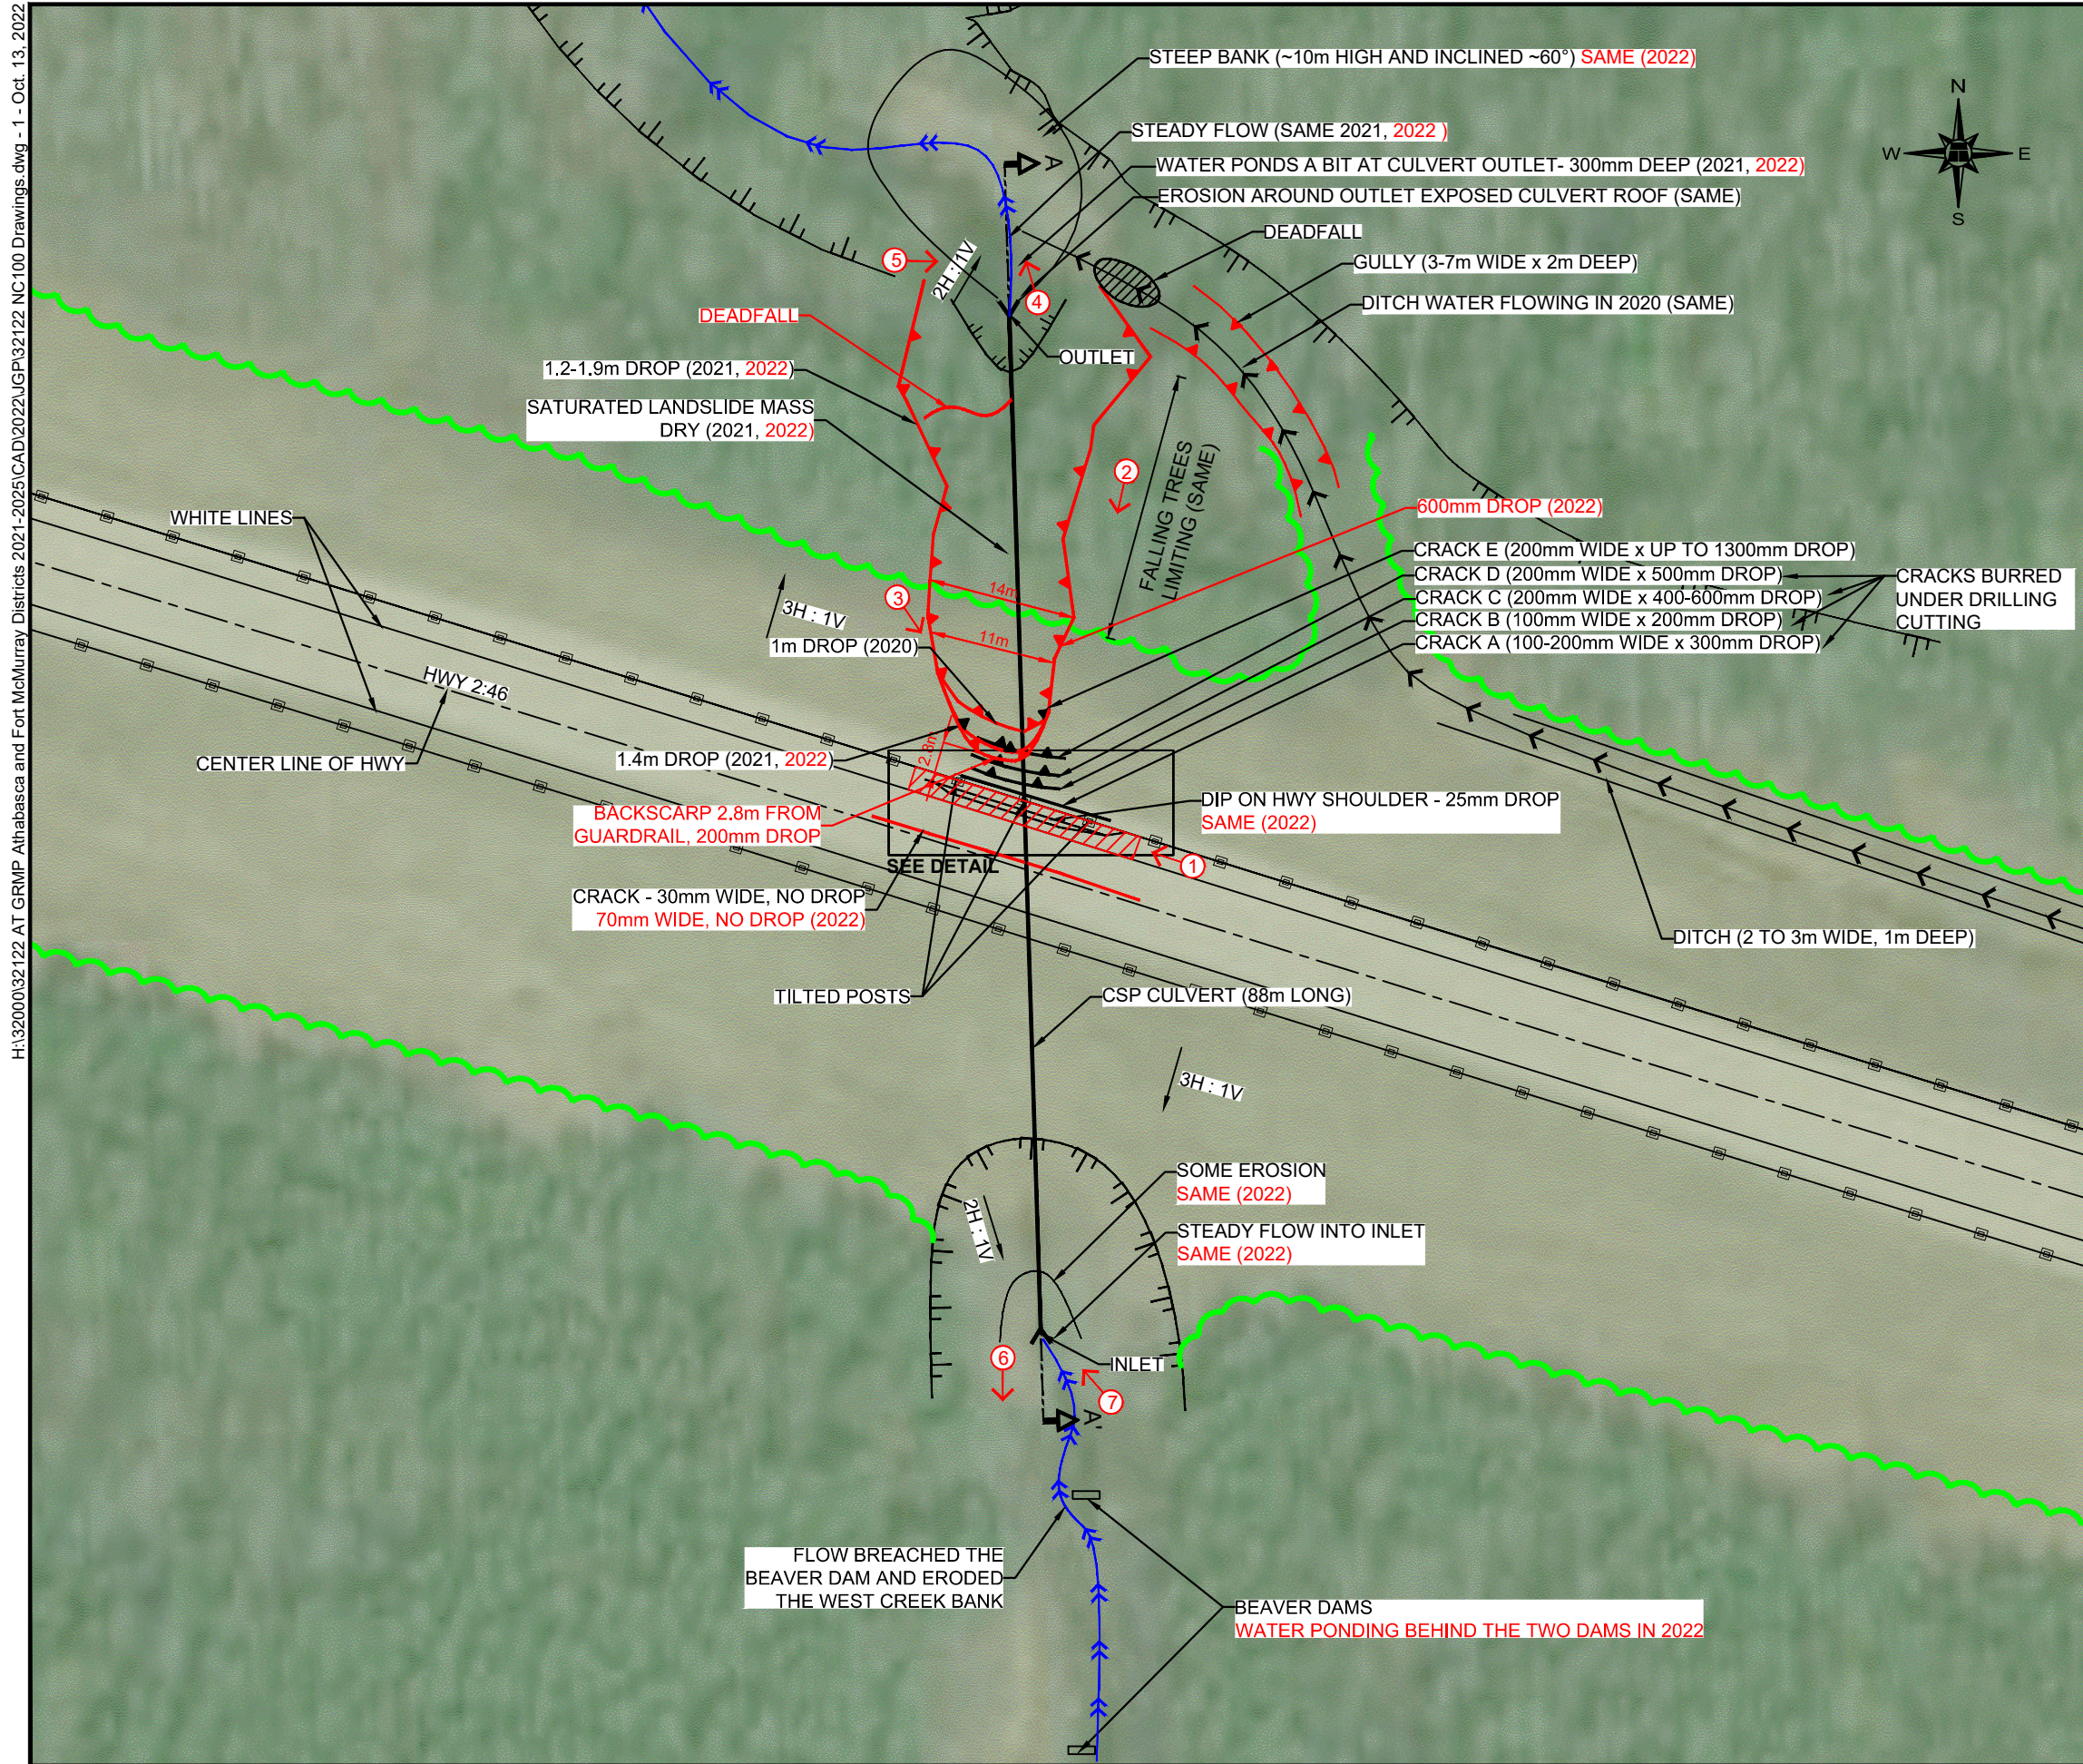
FIGURE 1

The site observations indicate the presence of a deep-seated landslide on the north side of the highway. The landslide is about 40 m long (perpendicular to the highway alignment) x 14 to 20 m wide (parallel to the highway alignment) x 9 m deep and is toeing out at the culvert outlet location. The landslide resulted in the development of a dip in the highway shoulder and impacted the integrity of the 2 m diameter bridge size culvert.

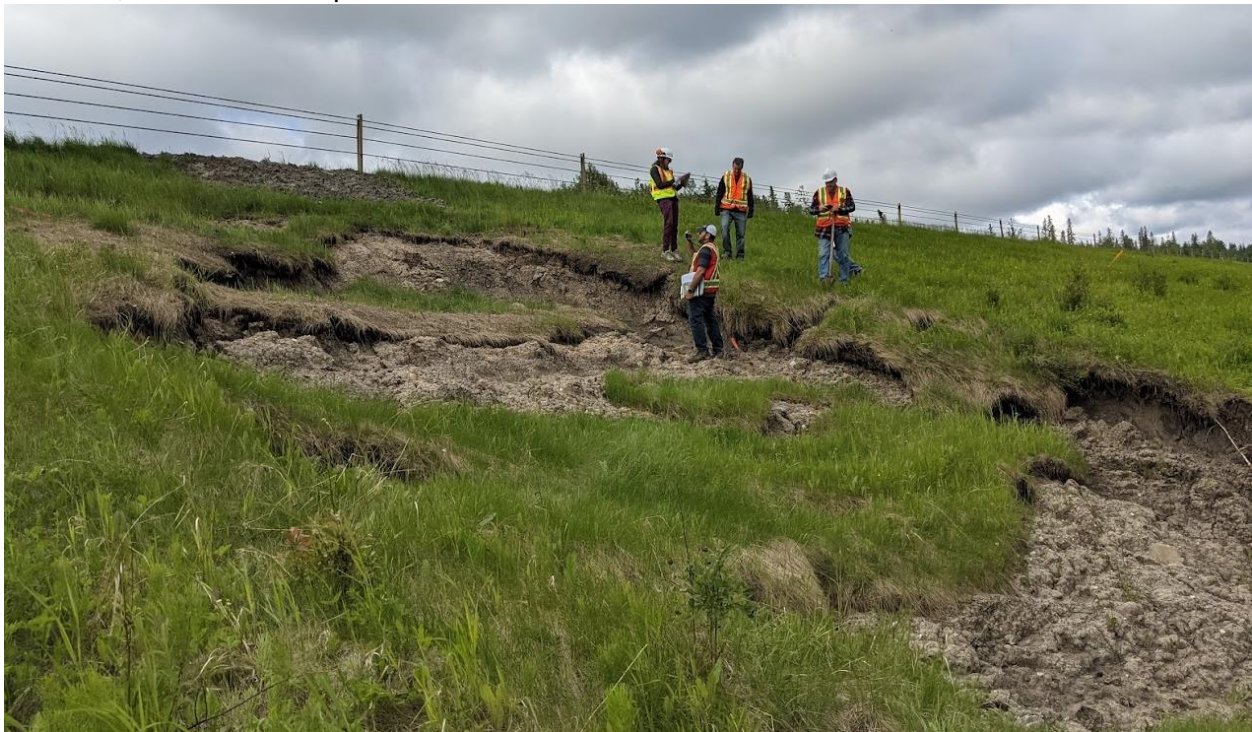
Photo No. 2 – Looking southwest at the north embankment landslide's head scarp crack and western flank; landslide mass was noted to be dry in 2022

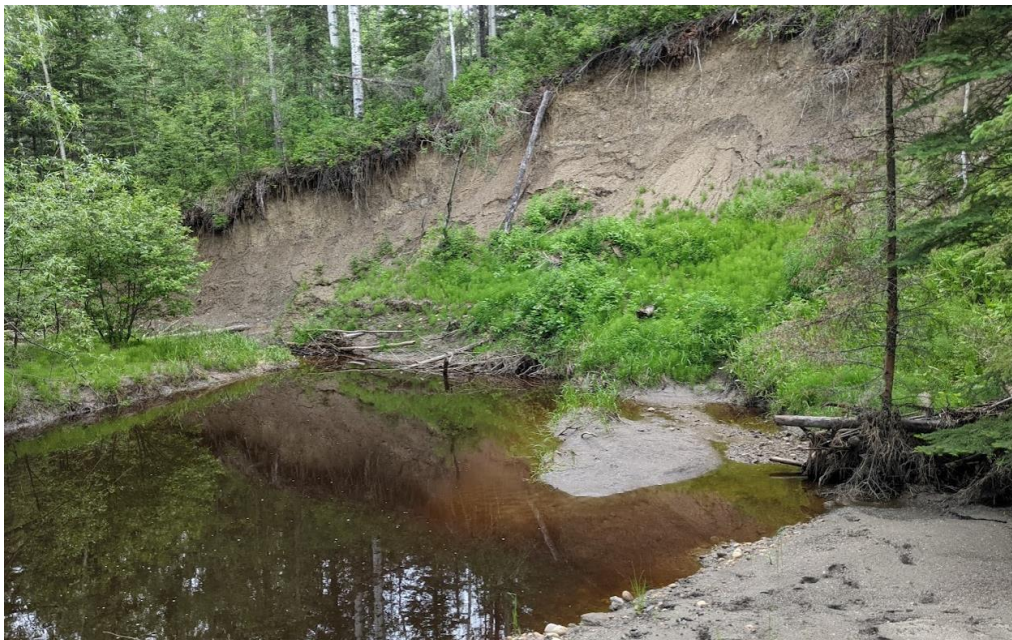
Photo No. 4. Looking northwest at the CSP culvert outlet; note water continues to pond in this area
