**ALBERTA TRANSPORTATION
GEOHAZARD ASSESSMENT PROGRAM
NORTH CENTRAL REGION – ATHABASCA &
FORT MCMURRAY DISTRICTS
2021 SITE INSPECTION**

Site Number	Location	Name	Hwy	km
NC006	11 Km East of Slave Lake	Mitsue Recreation Area	2:46	47.33
Legal Description		UTM Co-ordinates (NAD 83)		
NW-7-72-4-W5M		11	N 6122200	E 651552

Date	PF	CF	Total
Previous Inspection:	June 5, 2020	14	5	70
Current Inspection:	June 23, 2021	14	5	70
Road AADT:	2,120	Year:	2020	
Inspected By:	José Pineda, Tarek Abdelaziz (Thurber) Gordon Wolters, Arthur Kavulok, Kristen Tappenden, Bernard Ching, Brent Herrick (Alberta Transportation)			
Report Attachments:	<input checked="" type="checkbox"/> Photographs <input checked="" type="checkbox"/> Plans <input type="checkbox"/> Maintenance Items

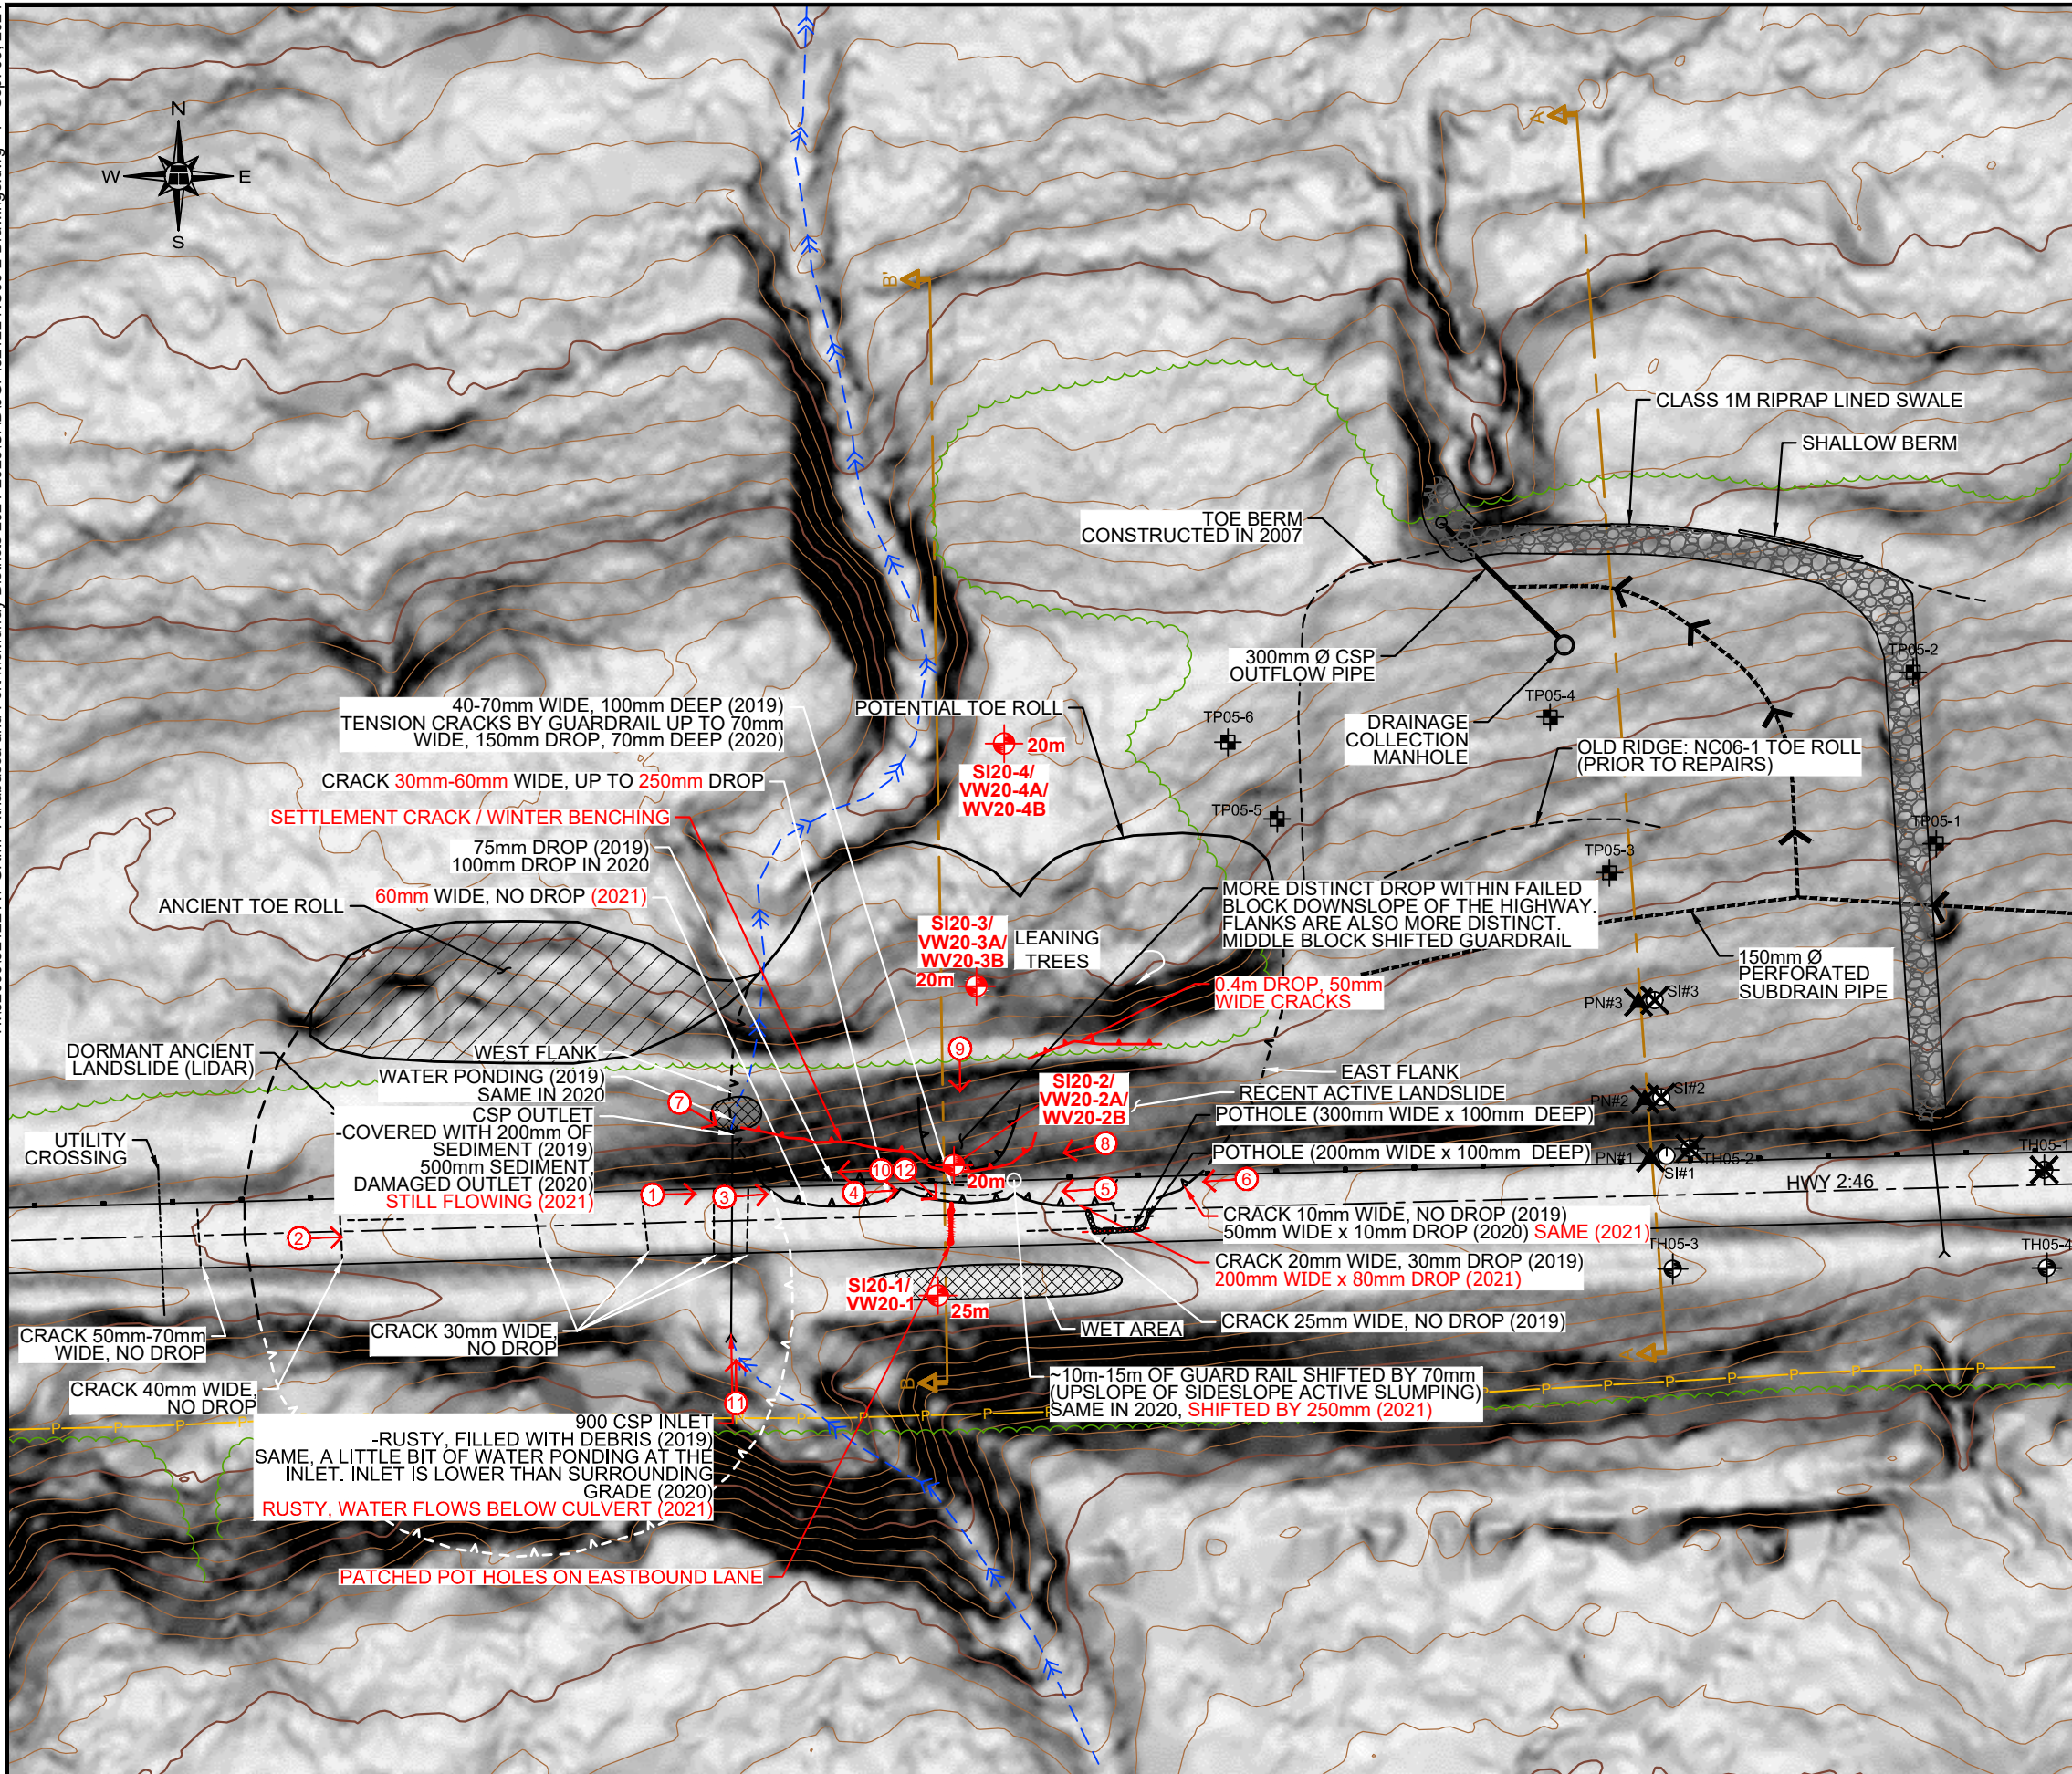
FIGURE 1

The active landslide is about 80 m wide and 60 m long, and it has created a severe drop within the highway WBL (particularly within the middle section of the landslide) and a distinct distress in the highway north side slope.

The LiDAR suggests that there is a dormant ancient landslide located west of the active landslide. This dormant landslide may also become active in the future and could impact the highway conditions.

**NORTH CENTRAL
(ATHABASCA AND FORT McMURRAY DISTRICTS)
2021 GEOHAZARD ASSESSMENT
NC06: HWY 2:46 MITSUE RECREATION AREA (km 47.6)
SITE PLAN SHOWING LANDSLIDE FEATURES**

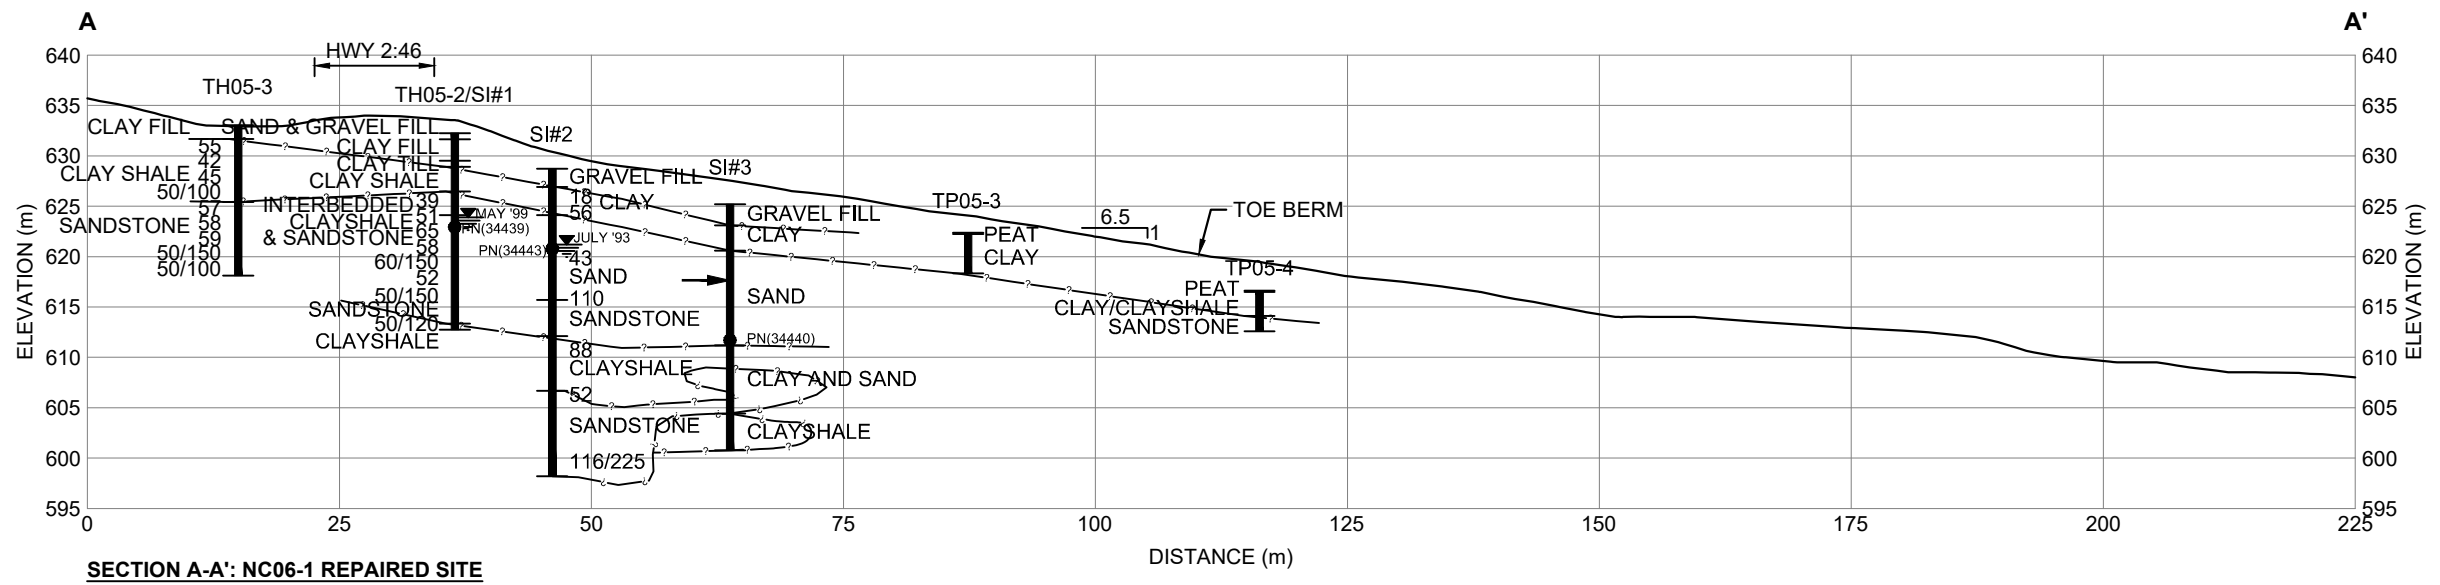
SECTION A-A': NC06-1 REPAIRED SITE

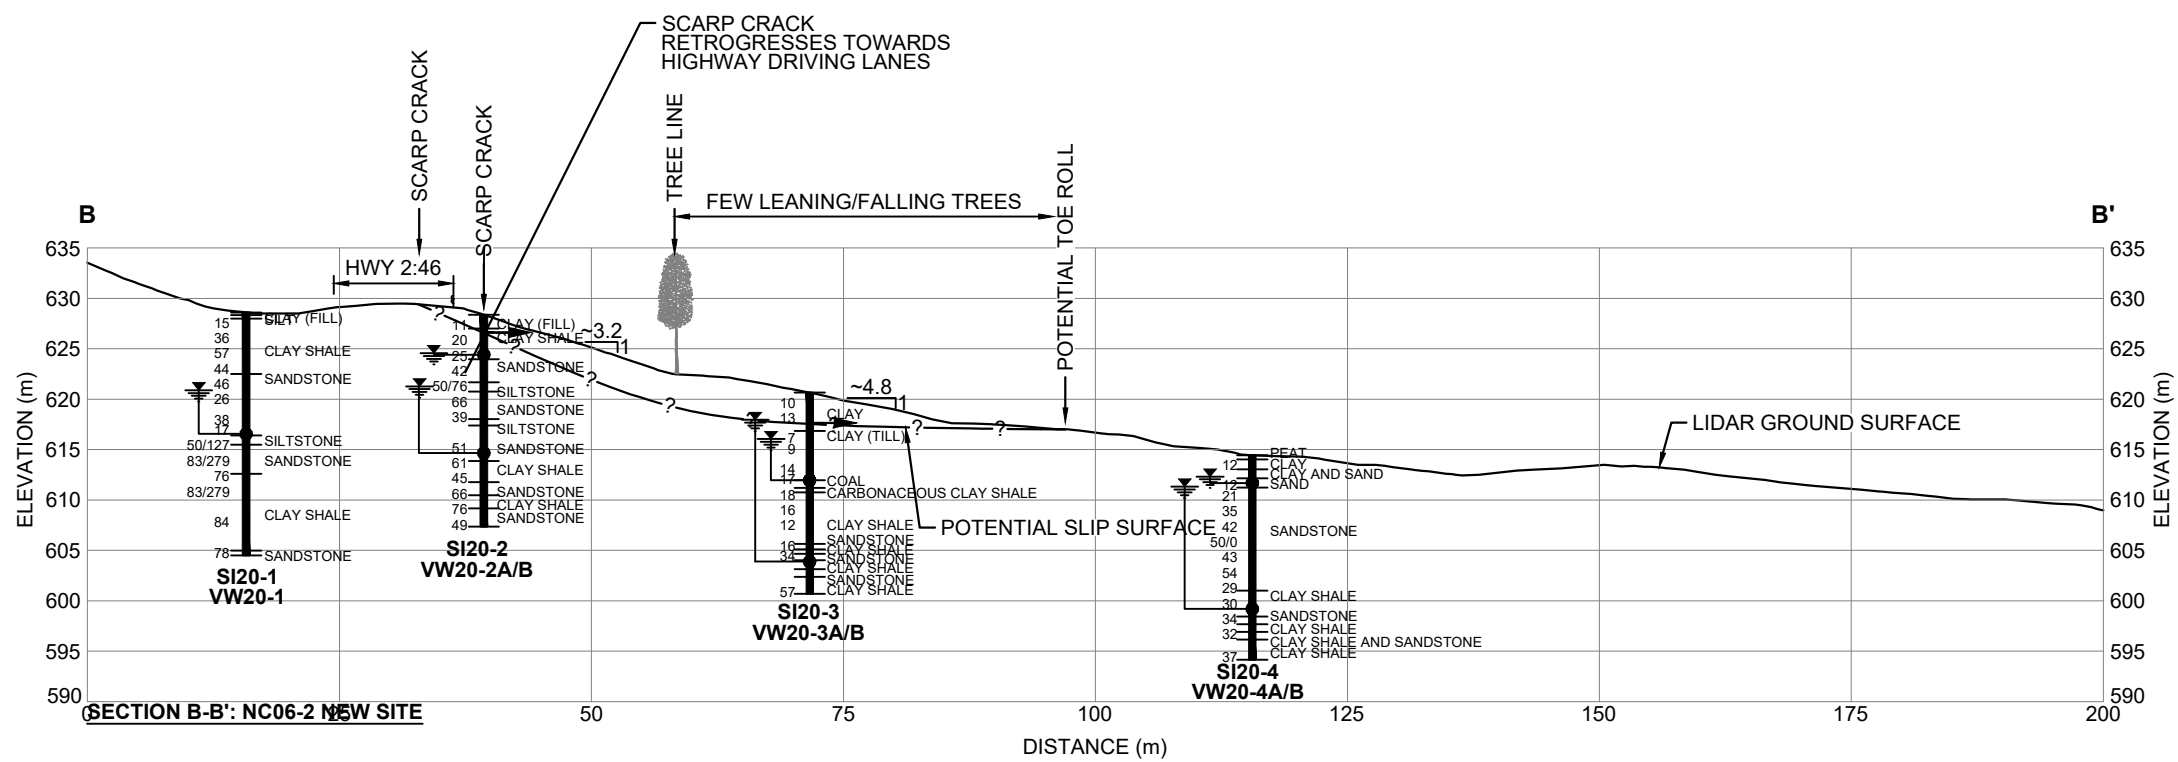
SECTION B-B': NC06-2 NEW SITE

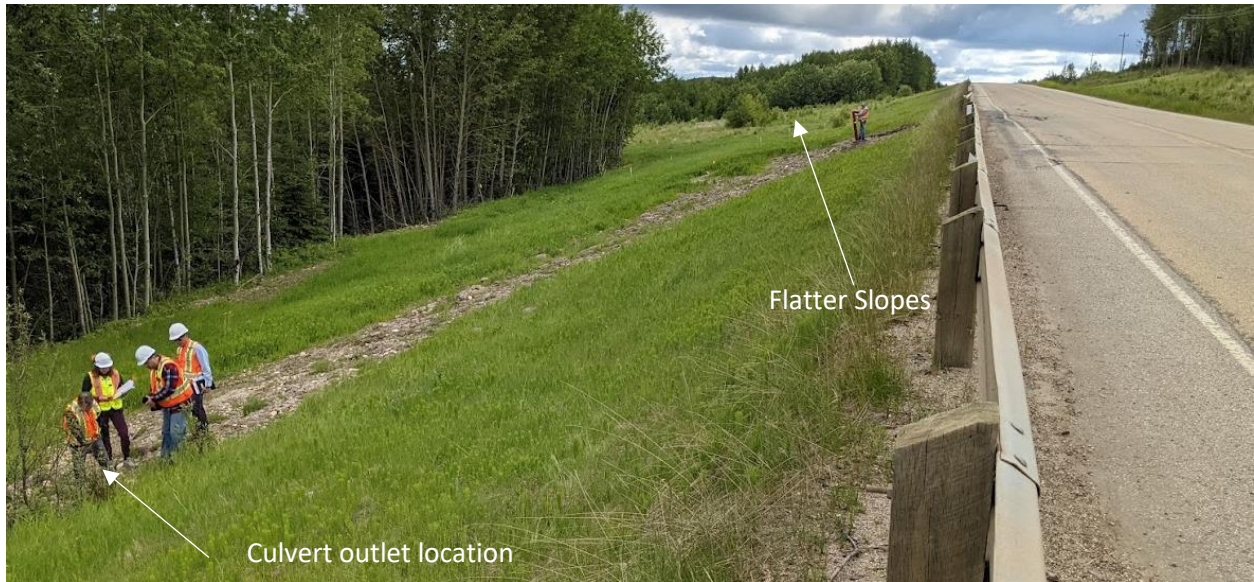
Photo No. 1 – Looking east toward the landslide and side slope distress between eastern edge of the tree line and the culvert outlet location. Note flatter side slopes constructed east of the tree line as part of the old landslide repair completed in 2007

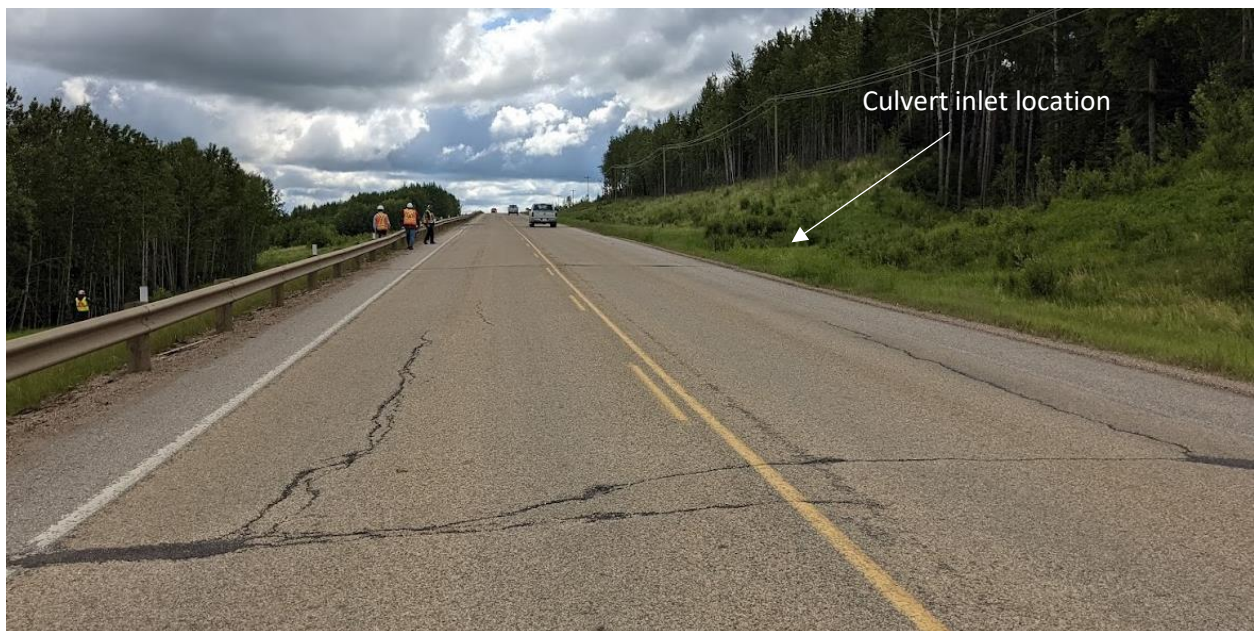
Photo No. 2 – Looking southeast at a transverse crack. Note the presence of a natural gully at the back slope as well as power lines

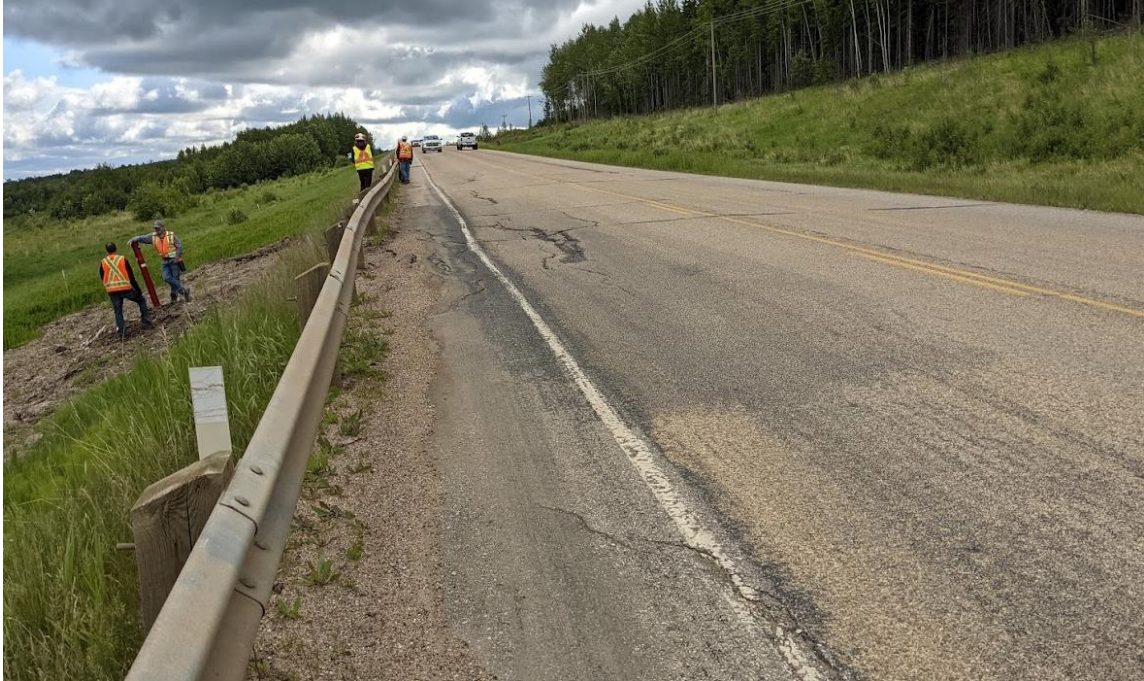
Photo No. 3 – Diagonal cracks on the highway surface near the western flank of the landslide (western section of landslide block)

If it is not planned to place ACP patch in the near future, all highway surface cracks should be sealed to prevent surface water infiltration into the landslide mass, which would result in further landslide movement and retrogression. Speed reduction signs should also be used, as needed, to warn motorists of existing hazard.

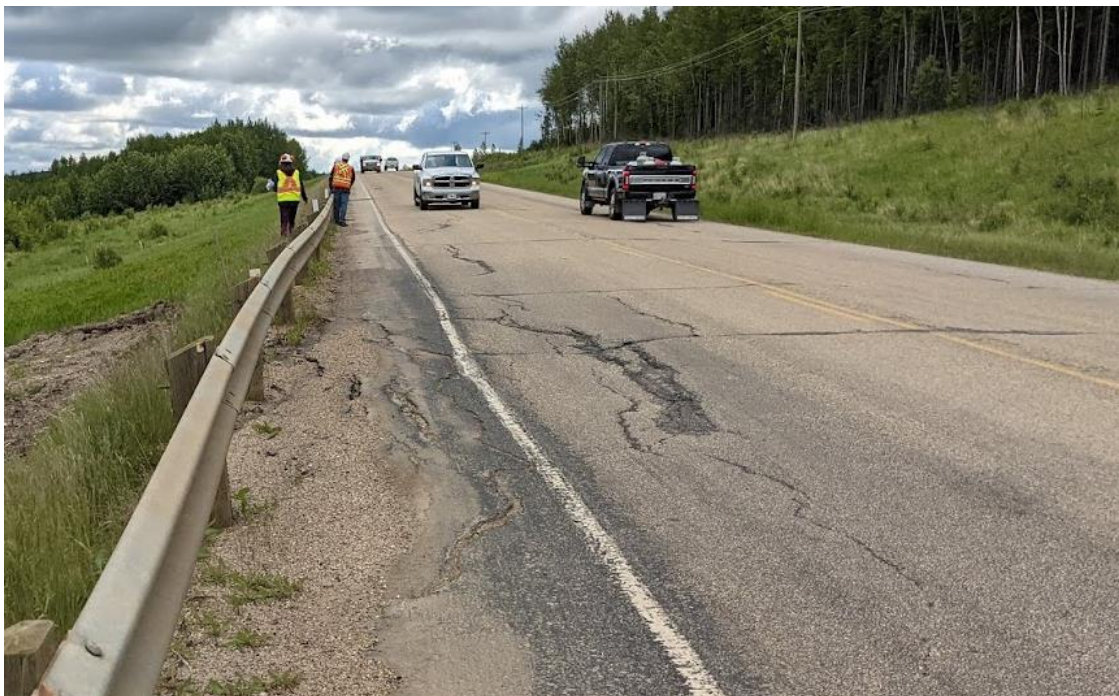
The site observations and instrument monitoring indicate that the landslide is very active and is moving at high rates. The drop in the westbound lane is significant and constitutes a safety hazard to motorists. If the landslide continues to move at high rates, additional landslide retrogression could result in partial or full road closure and a major detour may be required.

Photo No. 4 – Most active landslide block impacting the highway (middle section of landslide block). Note multiple retrogressive cracks impacting the highway WBL; cracks are 30 to 60 mm wide X 70 mm deep under the guardrail with up to 150 mm drop

In the short term, the local MCI should monitor the highway periodically for signs of distress and watch closely for the development of additional retrogressive cracks and highway dips (particularly after prolonged rainfall events). Consideration should be given to placing ACP patch along the impacted section of the highway by the landslide movement to eliminate existing hazard and provide a smooth ride to motorists. The thickness of the patch should be the minimum needed to eliminate existing hazard without overloading the landslide mass.

Since the landslide is very active and failure of the highway lane(s) may occur abruptly, it is recommended to get the site repaired in the near future. The repair may include any of the following options:

Option 1: Reinforce the slip surface through the construction of a cantilever pile wall 3 m north of the edge of the highway. The ballpark cost of a 100 m long cast-in-place concrete pile wall would be in the range of \$1,800,000 (excluding engineering). This option is not weather dependent in terms of constructability and it does not require environmental studies, land acquisition or regulatory authority approvals.

Option 2: Buttress the landslide through the construction of a large toe berm and reduce groundwater levels through the installation of sub-horizontal drains connected to a manhole that drains into the gully through an outflow pipe. The construction of the berm will require either extending the culvert under the berm or the construction of a new riprap channel to convey the flow from the outlet of the culvert to the existing gully to the north of the berm. This option will require a common borrow material source; environmental, hydraulic, and historical resources studies; land acquisition; approvals from regulatory authorities for in-stream work, tree clearing; and land acquisition. The ballpark cost for this option would be in the range of \$1,300,000 (excluding engineering). This option should ideally be implemented under warm weather conditions.

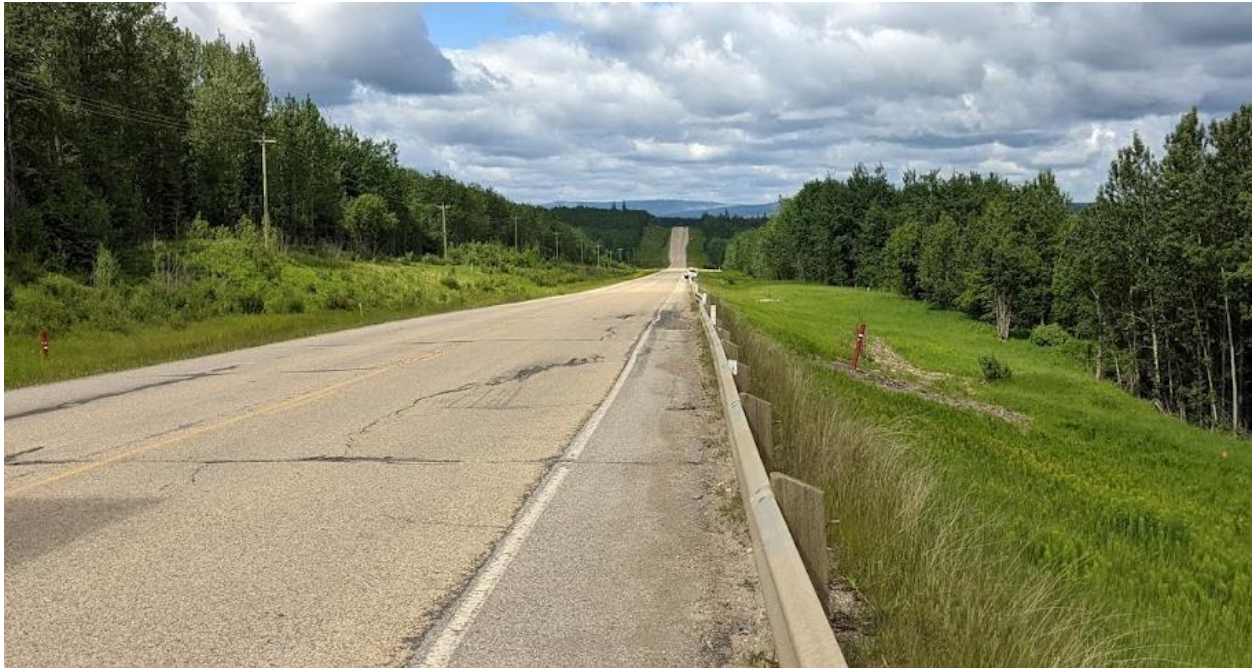
Photo No. 5 – Diagonal cracks to the east of the most active area (up to 200 mm wide with 80 mm drop)

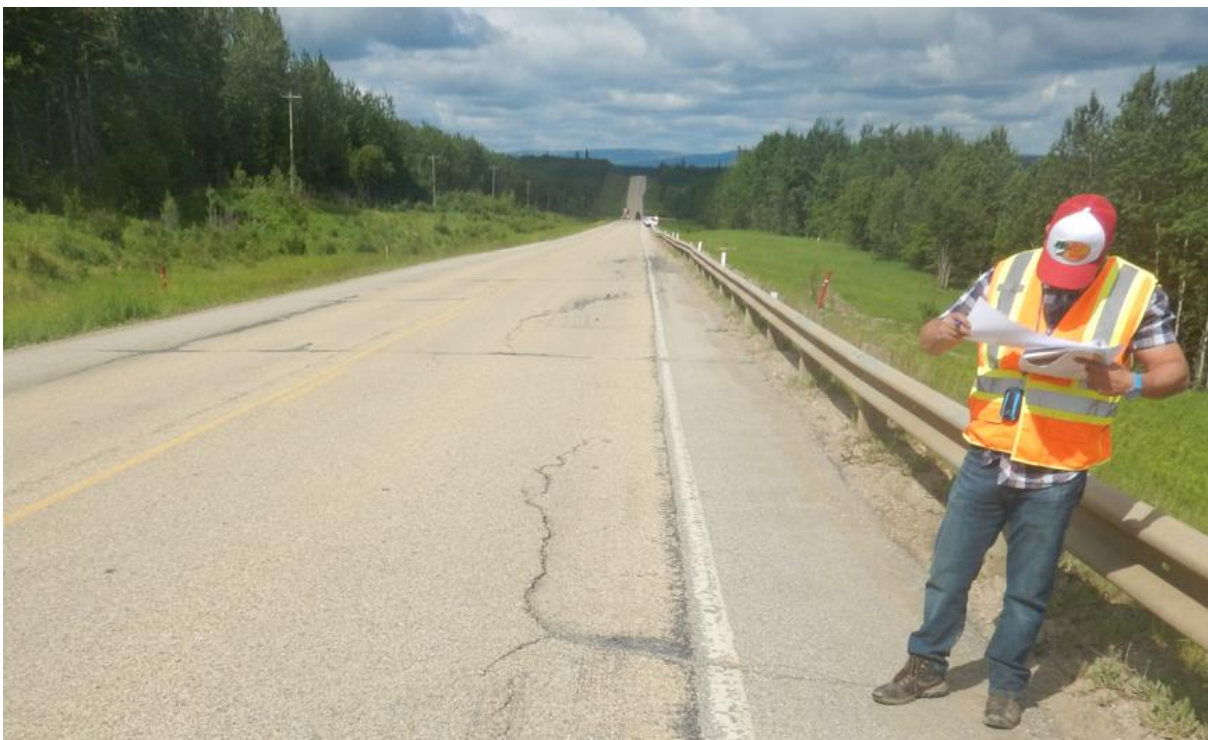
Photo No. 6 – Looking west at the middle section of the landslide block;

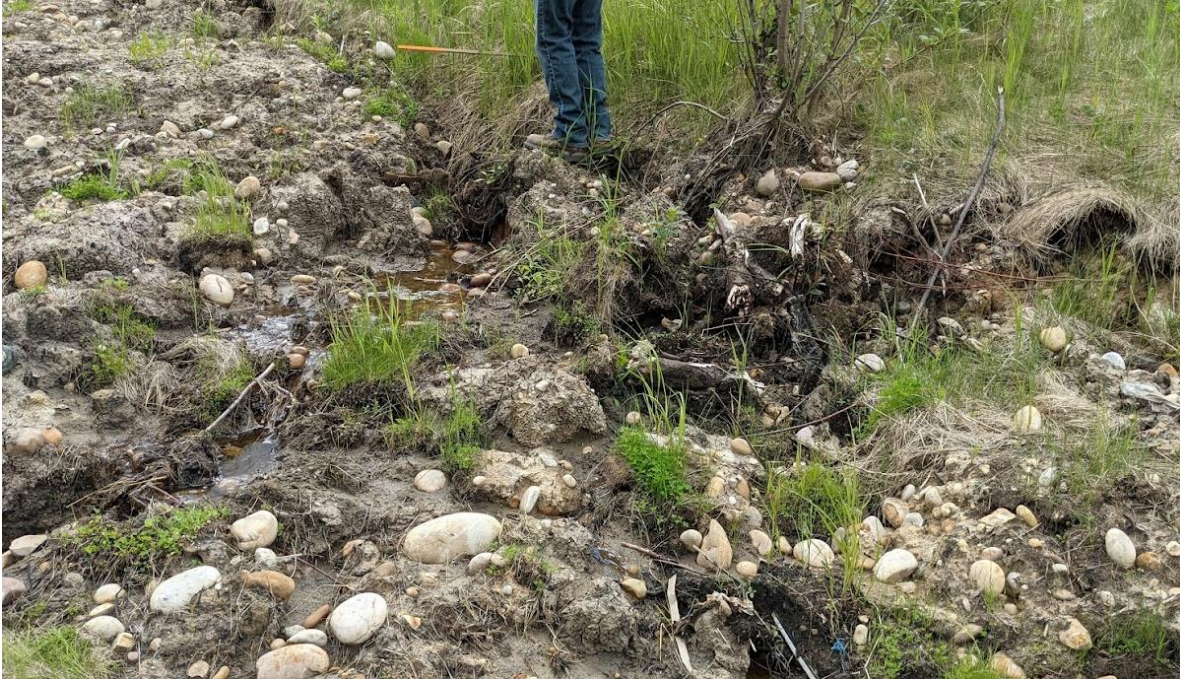
The surface water in the south ditch was noted to be draining under the highway centerline culvert. The outlet of the culvert previously noted to be lower than adjacent terrain has kept the water ponding inside the culvert outlet until it overflows to drain into the gully. Recent winter benching for instrument installation further impacted the culvert outlet by further restricting the surface water free flow into the gully. These factors may have resulted in high ground water levels in the highway embankment.

Photo No. 7 – Looking at damaged 900 mm culvert outlet. Water is still flowing from the culvert outlet

The south ditch and north side slopes should be slightly re-graded to direct surface water towards the culvert and provide suitable surface drainage into the gully located north of the highway. The culvert inlet and outlet should be cleared of garbage and sediment and slight grading should be done near the inlet and outlet locations to prevent water ponding near culvert ends.

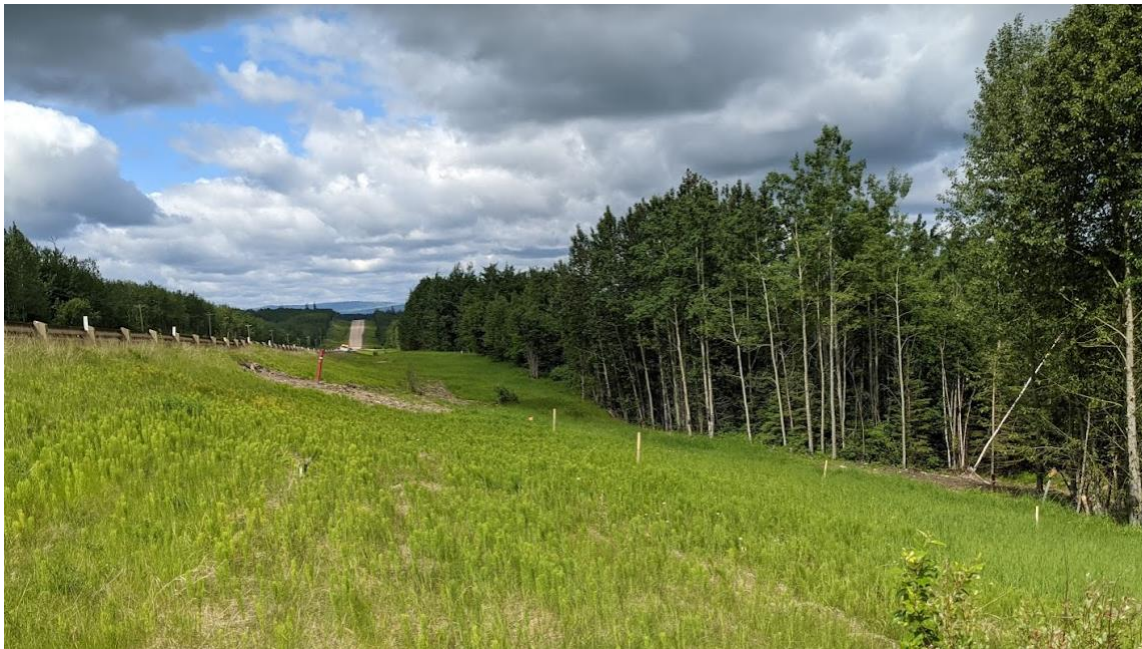
Photo No. 8 – Side slopes near the landslide head scarp

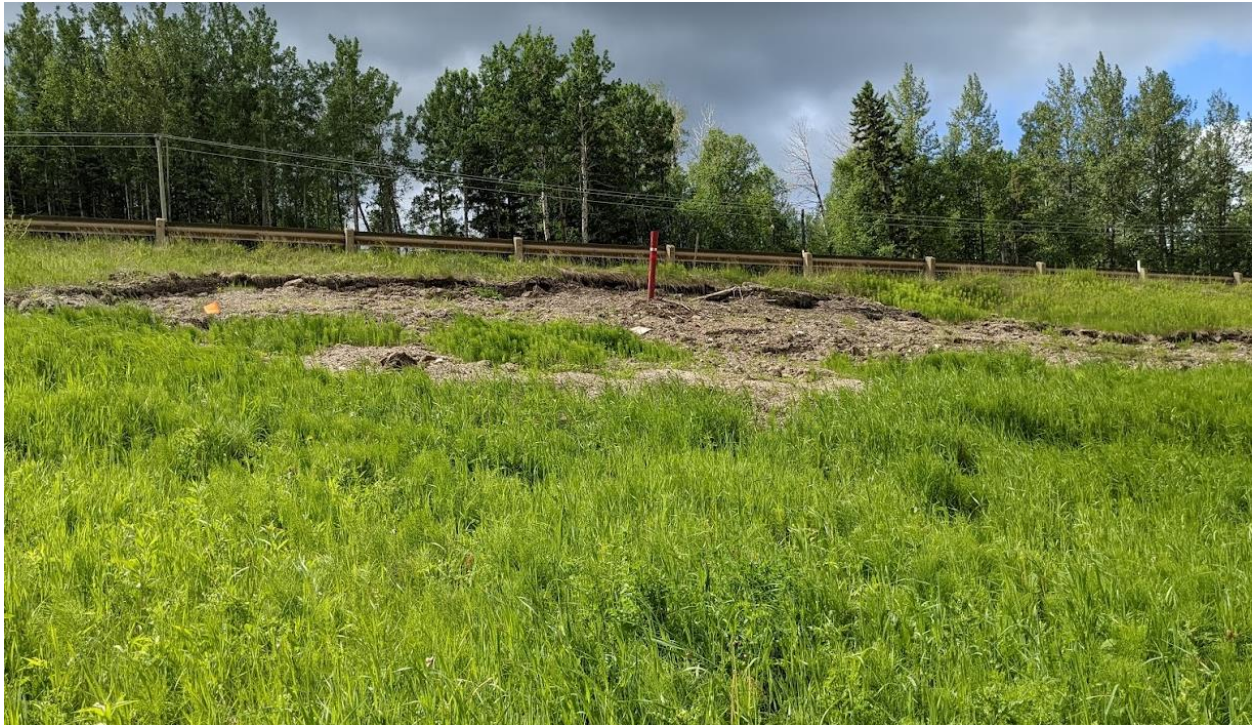
Photo No. 9 – Looking south at active landslide area

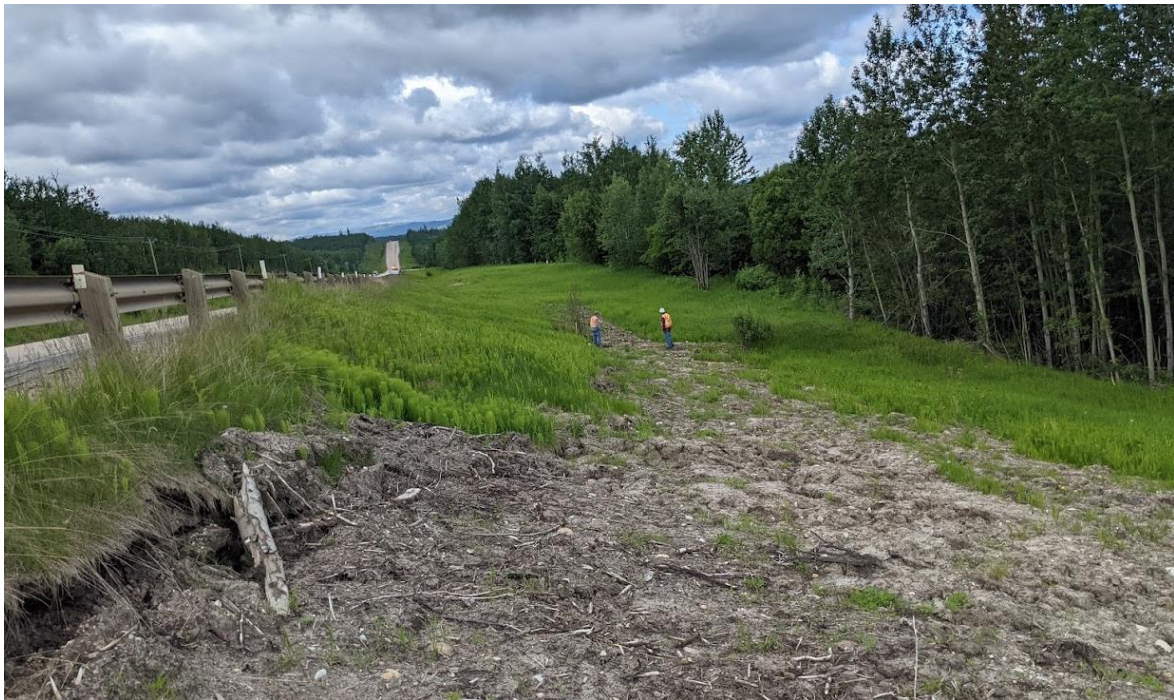
The open cracks noted in the highway side slope are likely due to the settlement of the winter drilling benches after spring thaw. These cracks, if noted sealed, and will likely impact the stability of the side slope and retrogress back to impact the integrity of the guardrail and the highway surface.

Photo No. 10 - Tension cracks on the side slope extending up to the guardrail

A bobcat should be used to slightly grade and contour the drilling benches and seal the settlement cracks within the north side slope.

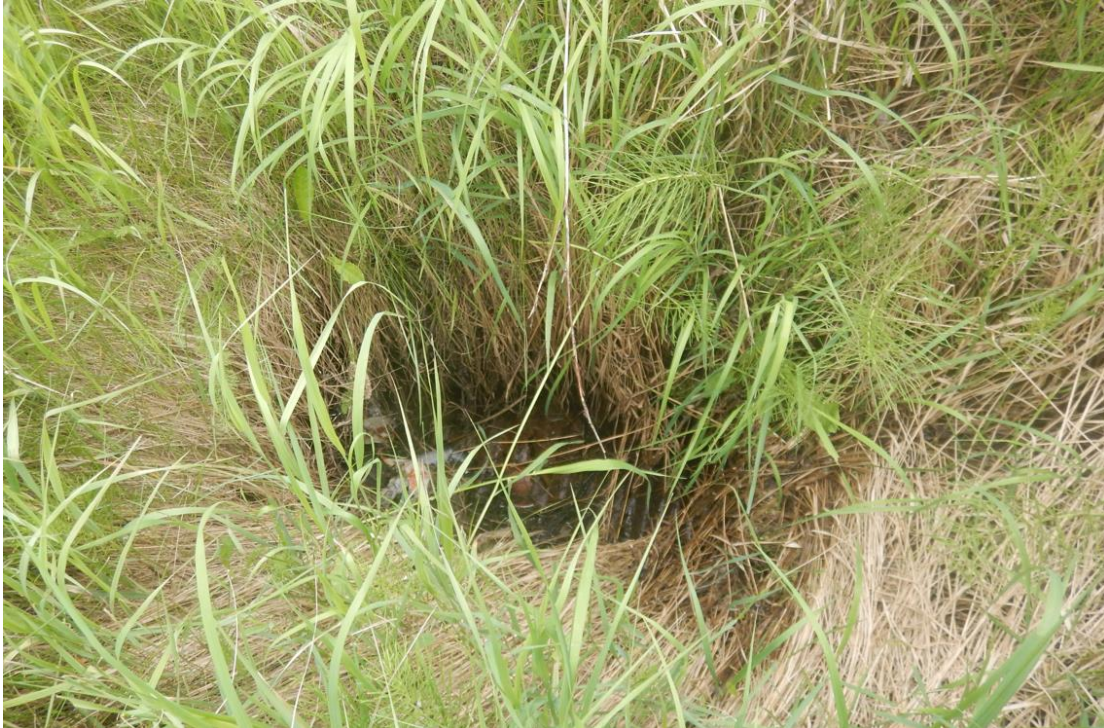
Photo No. 11 – 900 mm diameter culvert inlet. Culvert was rusty and filled with garbage

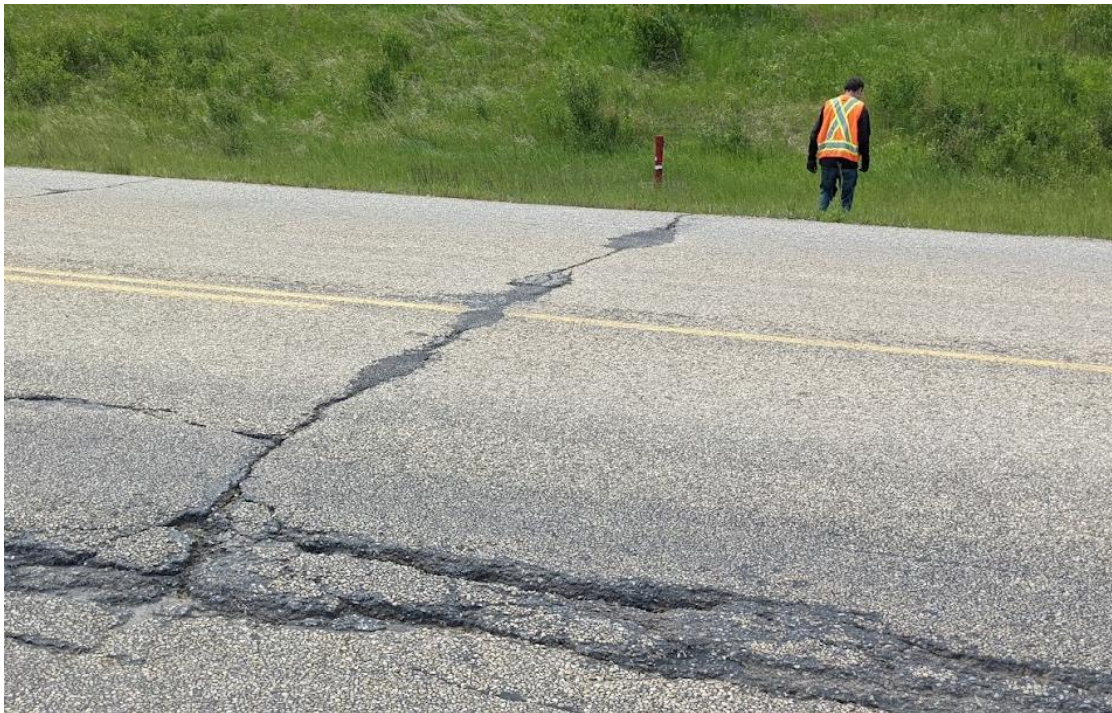
Photo No. 12 – Looking south at patched potholes on the east bound lane
