File No.: 32122

**ALBERTA TRANSPORTATION GRMP (CON0022163)
NORTH CENTRAL (ATHABASCA AND FORT McMURRAY DISTRICTS)
INSTRUMENTATION MONITORING RESULTS – FALL 2022**

SITE NC006: HWY 2:46 MITSUE LAKE RECREATION AREA (KM 47.6)

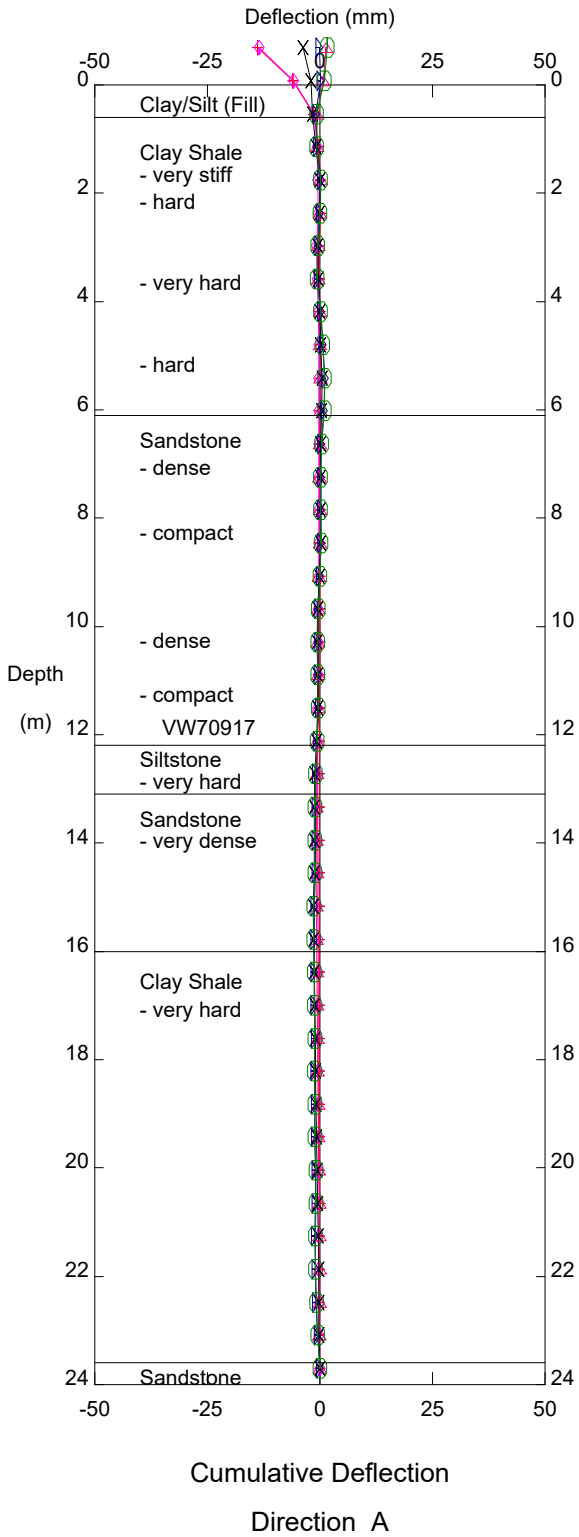
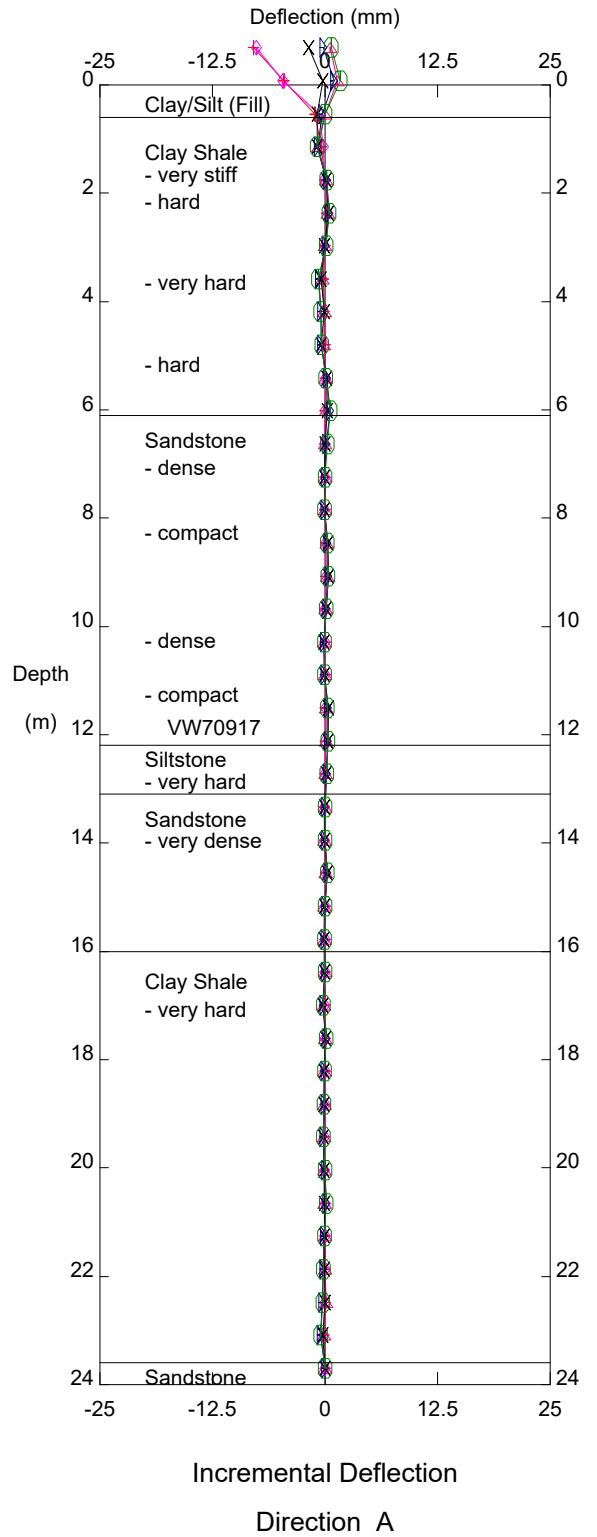
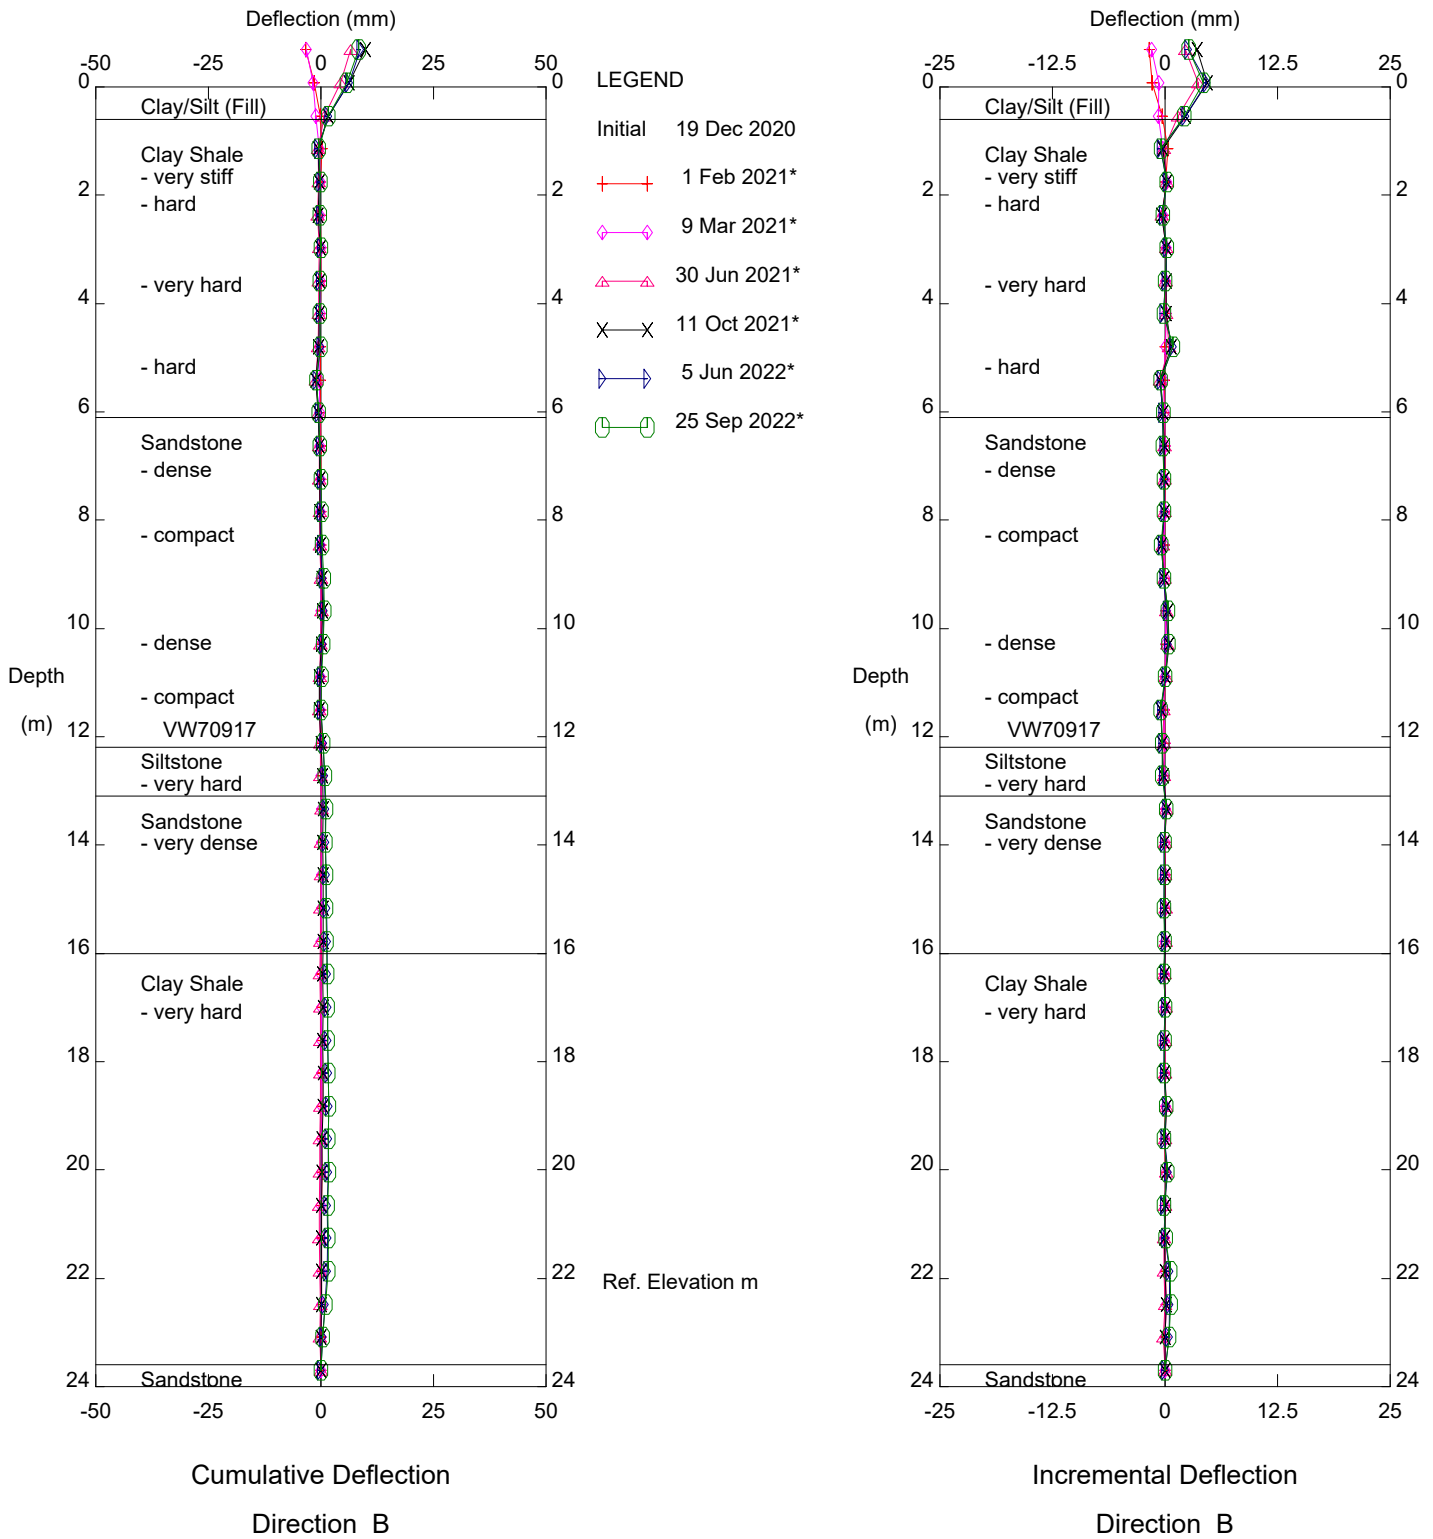
NC006 - Hwy 2:46 Mitsue Lake (km 47.6), Inclinometer SI20-1

SI20-1, installed in the south ditch of the highway, has shown no discernible movement since initialization. SI20-2, installed through the embankment on the north side of the highway, showed a rate of movement of 25.8 mm/yr over 0.6 m to 2.4 m depth since the spring of 2022 readings. The movement in this instrument is within the highway embankment fill above the bedrock. SI20-3, installed downslope of the highway inside the tree line, showed no discernible movement since the spring of 2022 readings. SI20-3 showed a similar movement trend in 2021, with movement observed in the spring readings, followed by no discernible movement in the fall. This appears to correspond with higher groundwater levels measured at the instrument location during the spring, with the groundwater level lowering in the fall. SI20-4, installed further downslope of SI20-3 within the tree line, has shown no discernible movement since initialization.

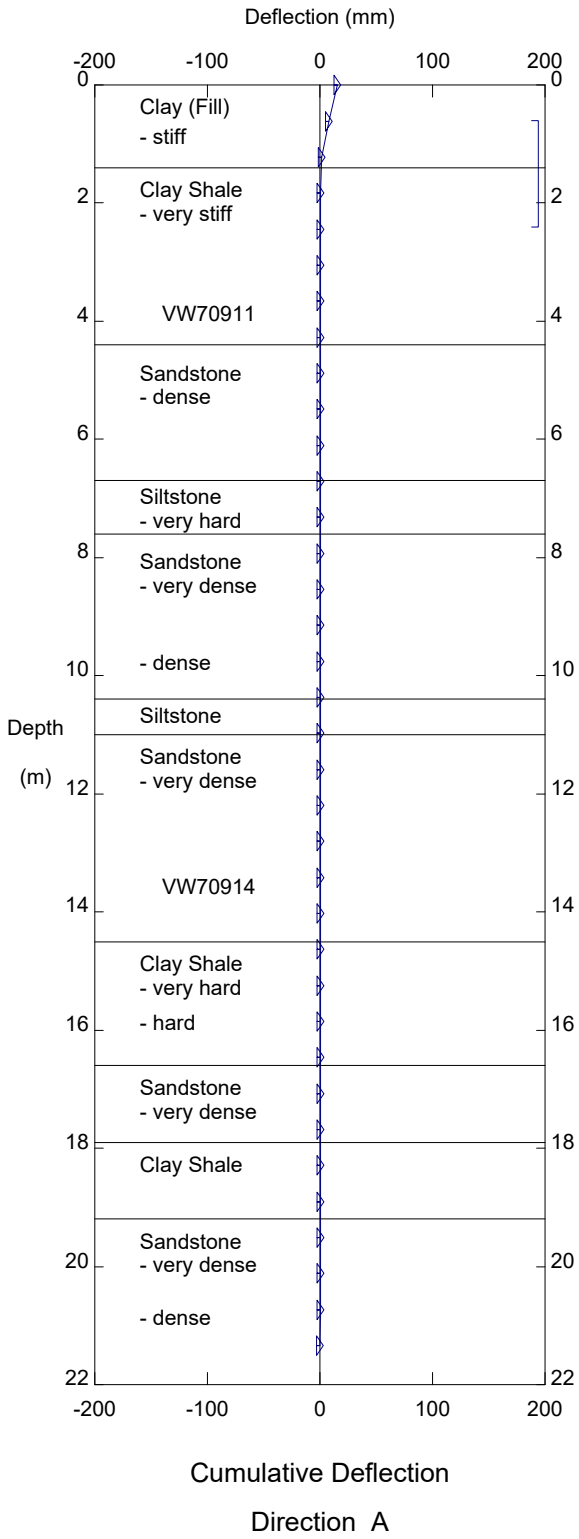
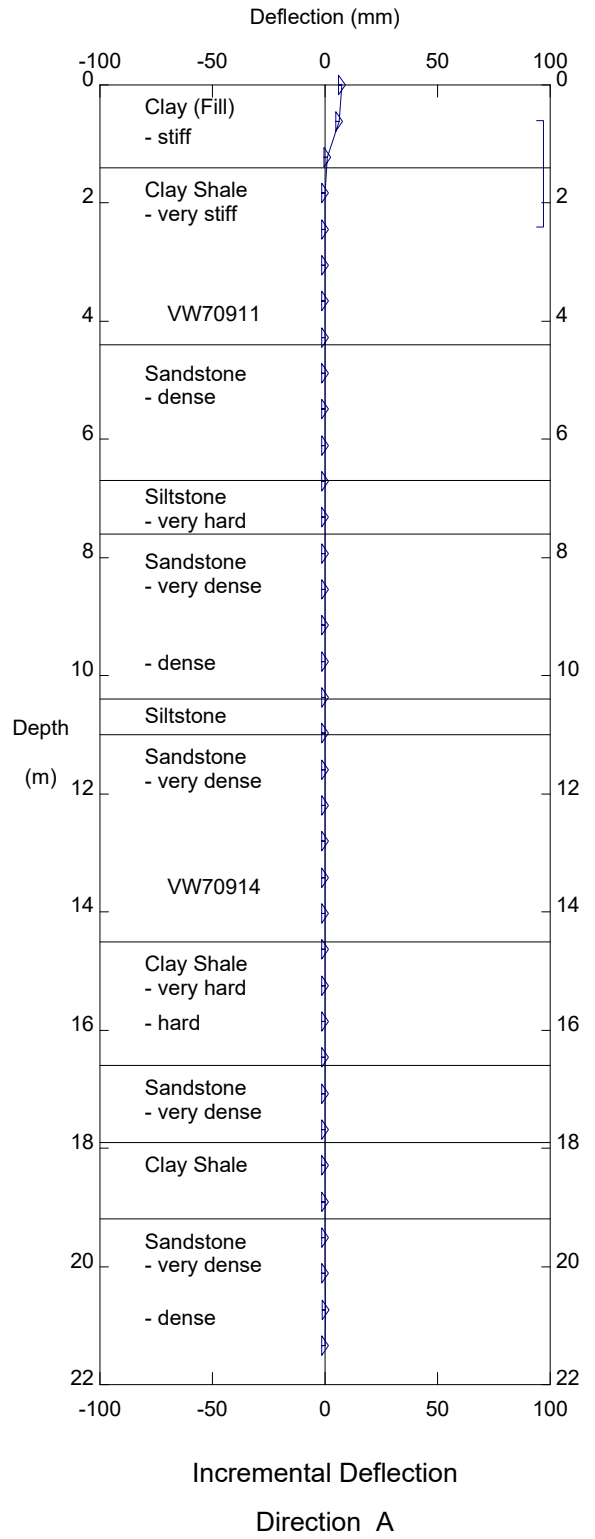
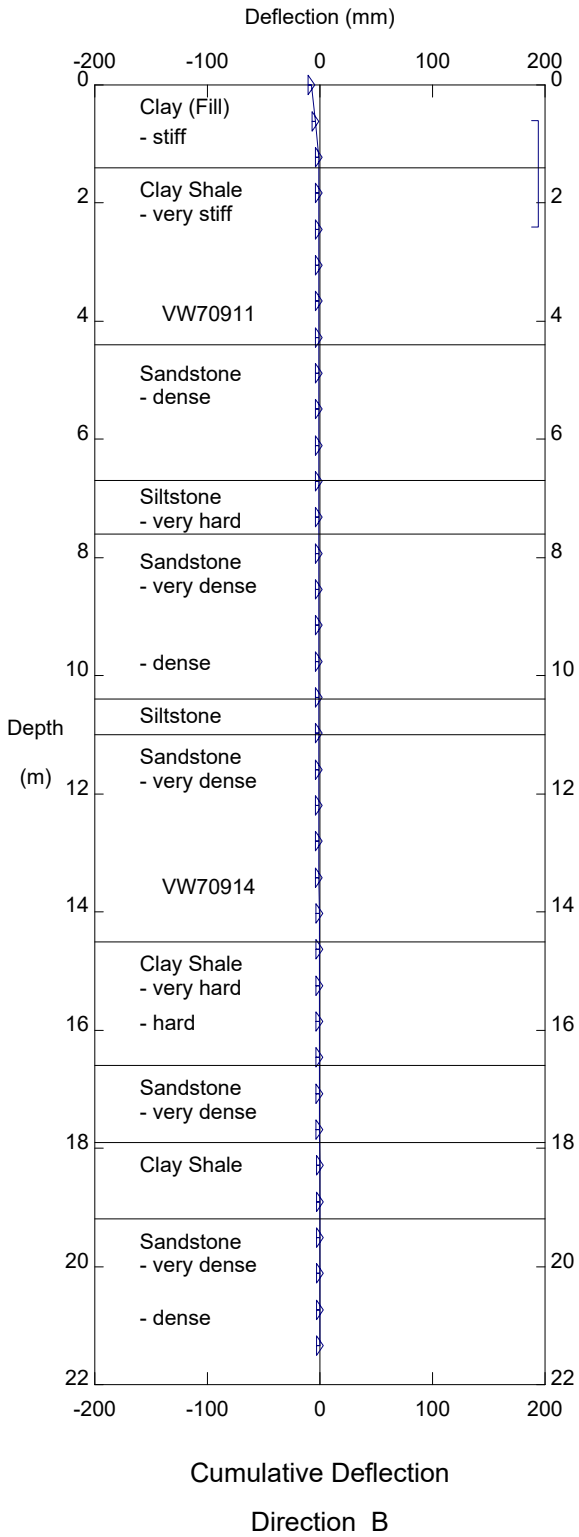
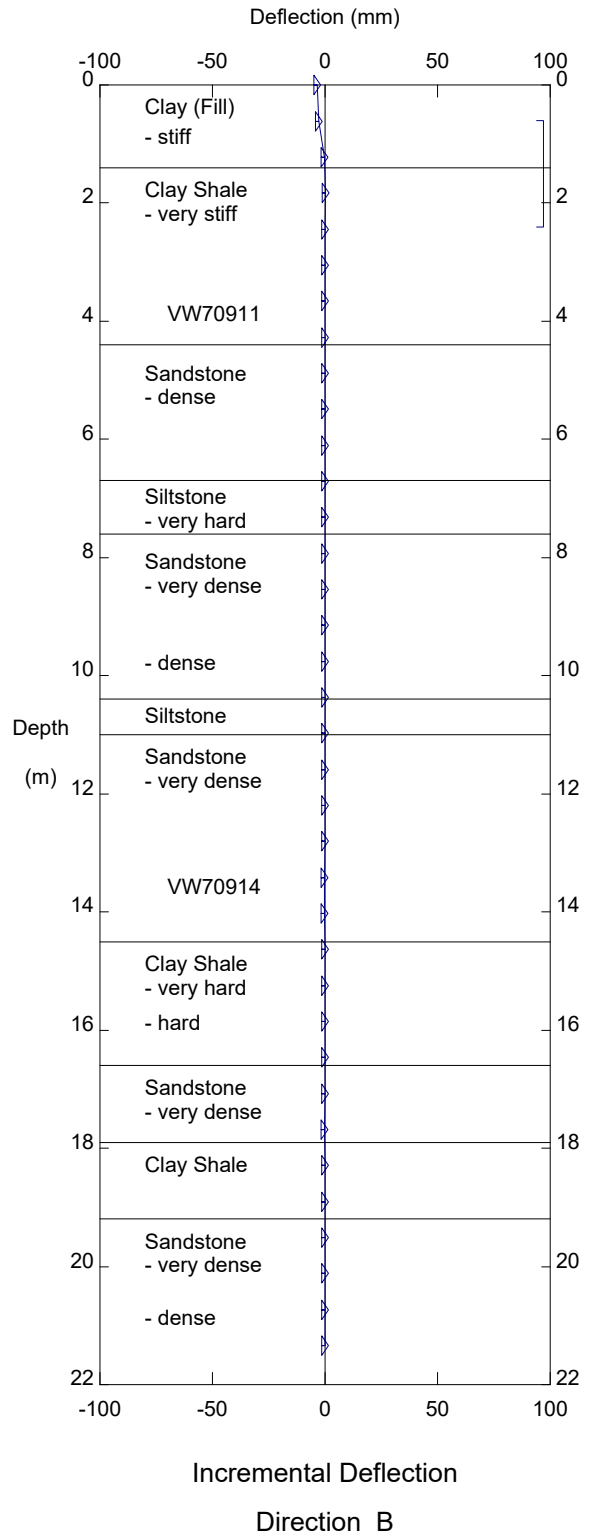
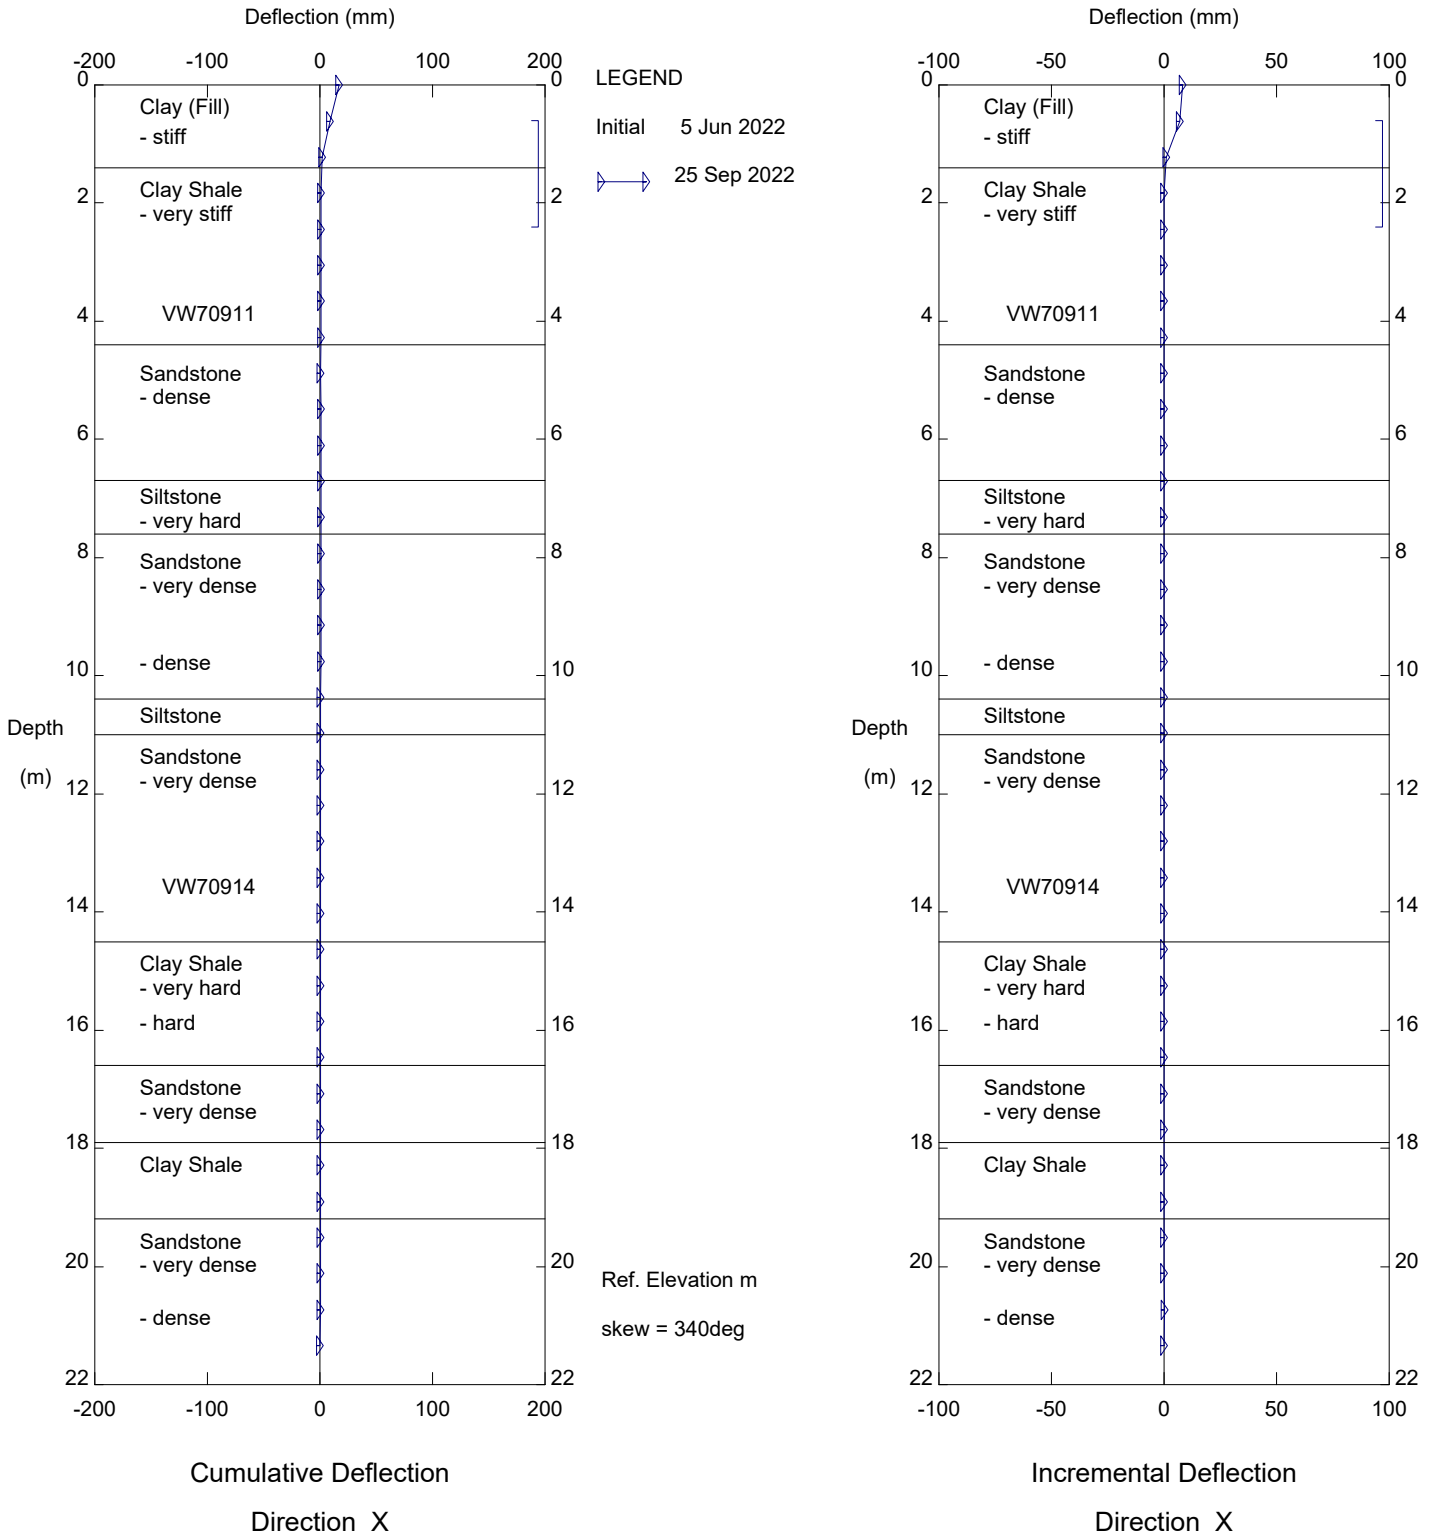
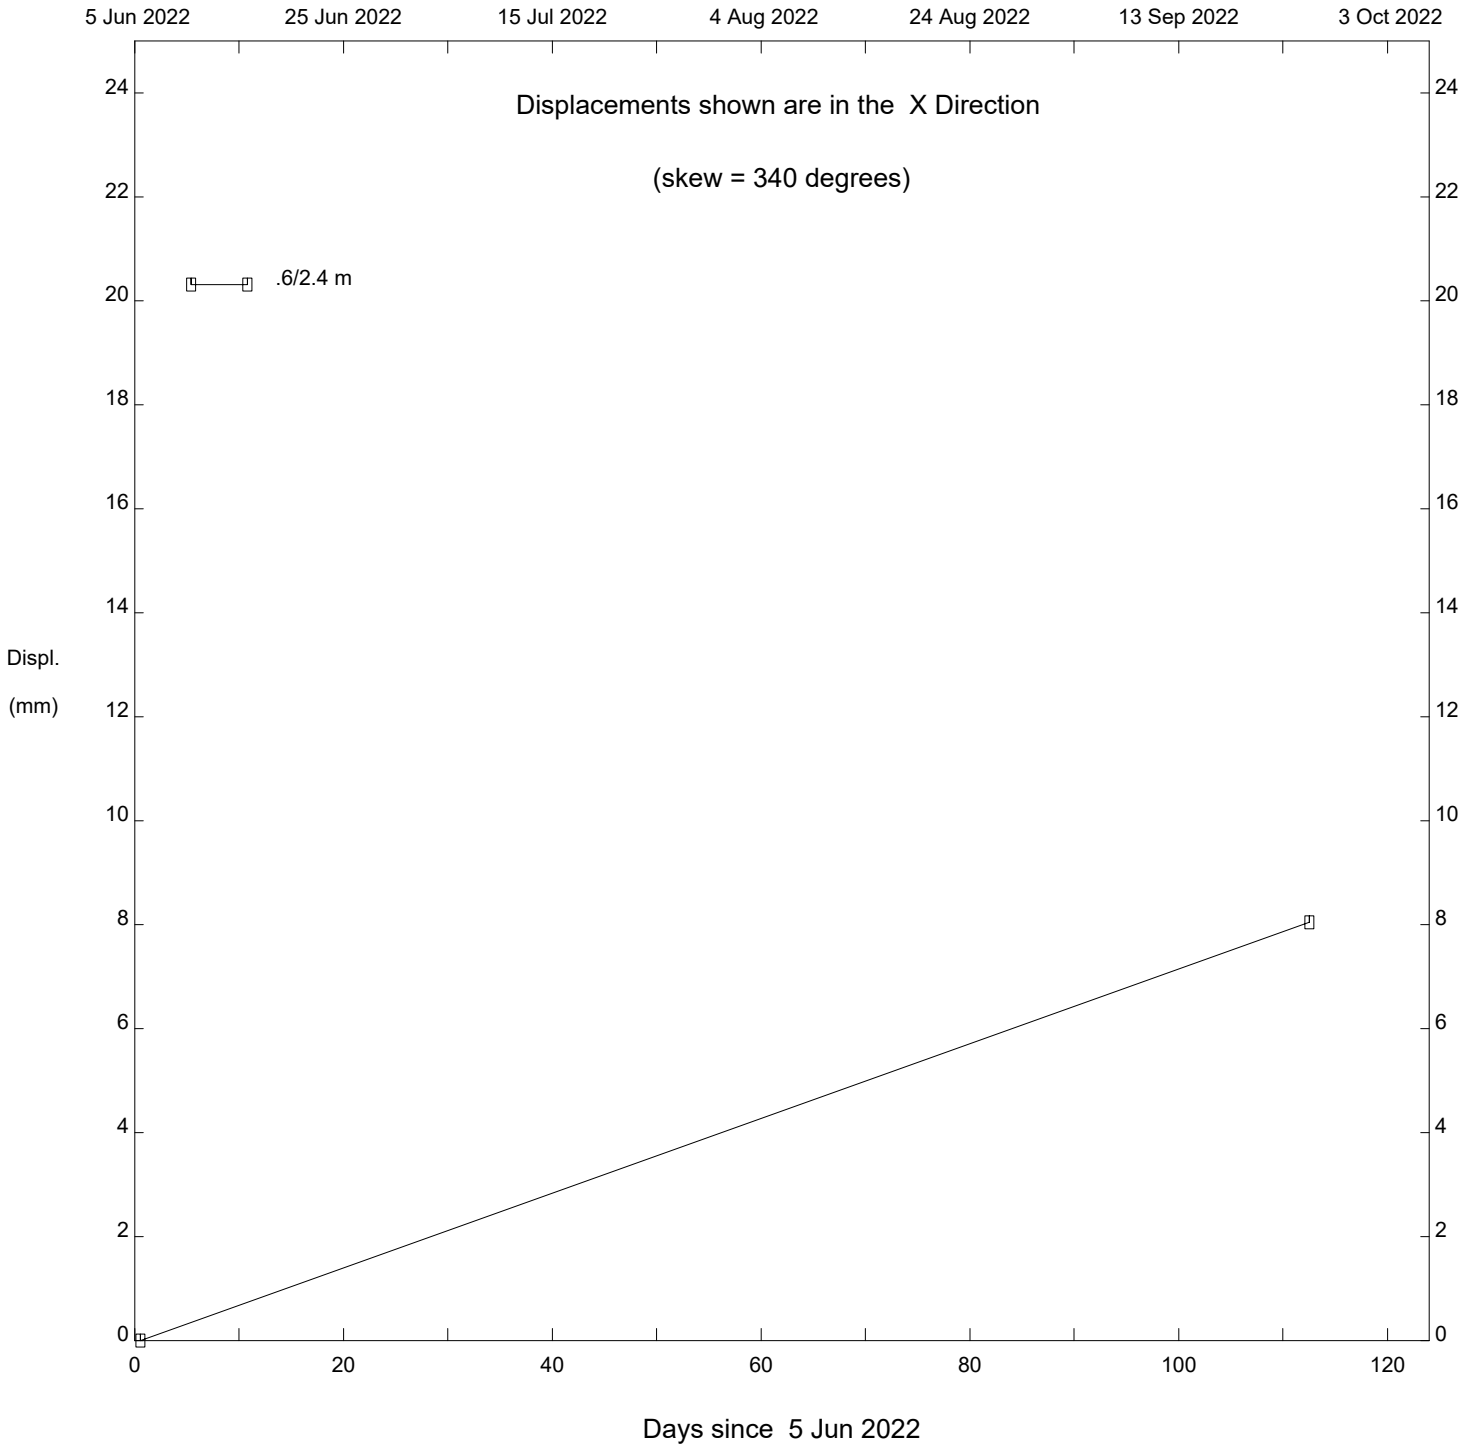
NC006 - Hwy 2:46 Mitsue Lake (km 47.6), Inclinometer SI20-2

A zone of movement had been previously observed in SI20-2 over 0.6 m to 1.8 m depth. This instrument seemed to show an apparent upslope movement in the spring of 2022 readings, when compared to the spring of 2021 readings. However, SI20-2 had been damaged between the spring of 2021 and the fall of 2021 readings, and when it was repaired in the spring of 2022, the upper portion of the SI casing was somewhat shifted, leading to erroneous reading. Therefore, the spring of 2022 reading has been chosen to be the new initial reading for this instrument. The zone of movement has also been expanded to 0.6 m to 2.4 m depth.

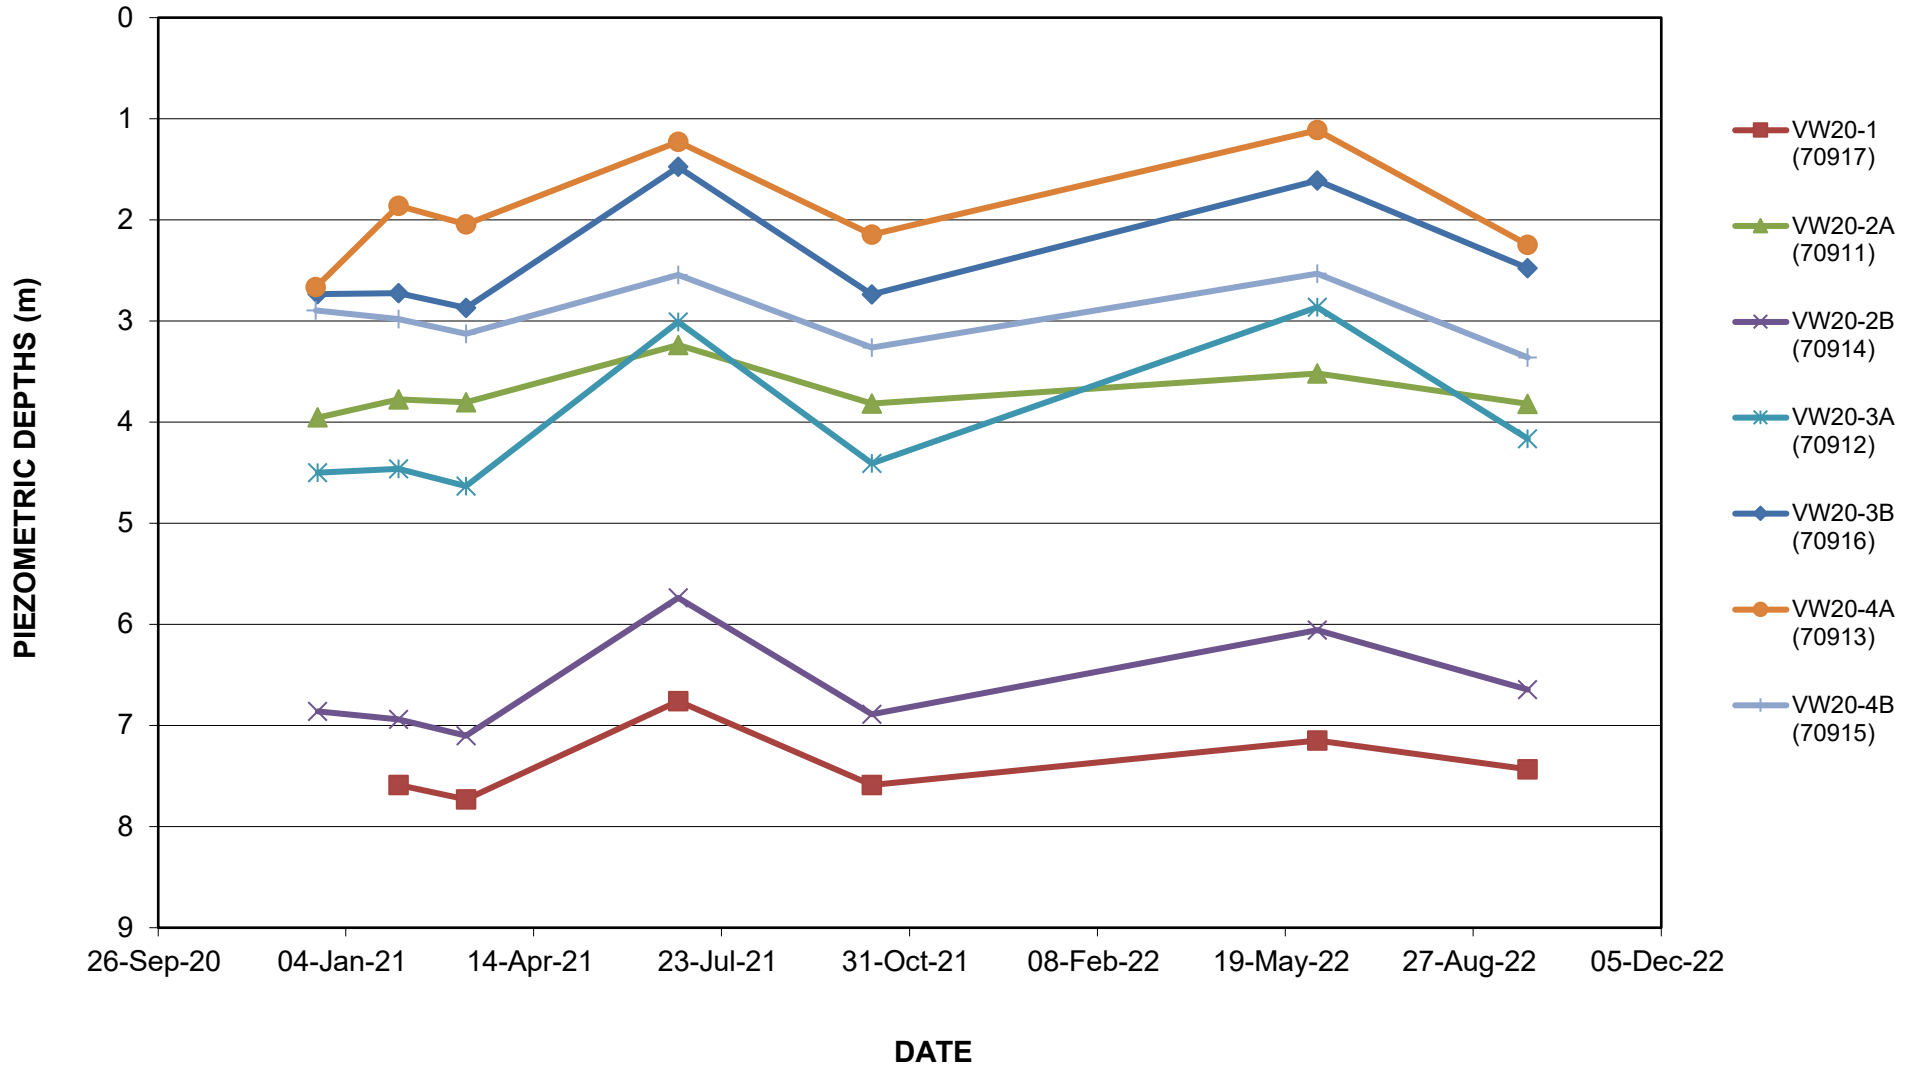
**FIGURE NC006-1
HWY 2:46 MITSUE LAKE SLIDE (KM 47.6)
VIBRATING WIRE PIEZOMETER DATA**

The vibrating wire piezometers all showed decreases in groundwater level since the spring of 2022 readings, ranging from a decrease of 0.28 m in VW20-1 to a decrease of 1.30 m in VW20-3A. The vibrating wire piezometers at this site have shown a general pattern of higher groundwater levels in the spring and lower groundwater levels in the fall. VW20-4B is currently showing the lowest groundwater level measured in the instrument since it was initialized. The vibrating wire piezometer readings are summarized in Table NC006-4 and are plotted in Figure NC006-1 in Appendix A.
