**ALBERTA TRANSPORTATION
GEOHAZARD ASSESSMENT PROGRAM
NORTH CENTRAL REGION – ATHABASCA &
FORT MCMURRAY DISTRICTS
2022 SITE INSPECTION**

Site Number	Location	Name	Hwy	km
NC006	11 Km East of Slave Lake	Mitsue Recreation Area	2:46	47.33
Legal Description		UTM Co-ordinates (NAD 83)		
NW-7-72-4-W5M		11	N 6122200	E 651552

**NORTH CENTRAL REGION
 (ATHABASCA AND FORT MCMURRAY DISTRICTS)
 2022 GEOHAZARD ASSESSMENT**

**NC006: HWY 2:46 MITSUE RECREATION AREA (km 47.6)
 CROSS-SECTIONS**

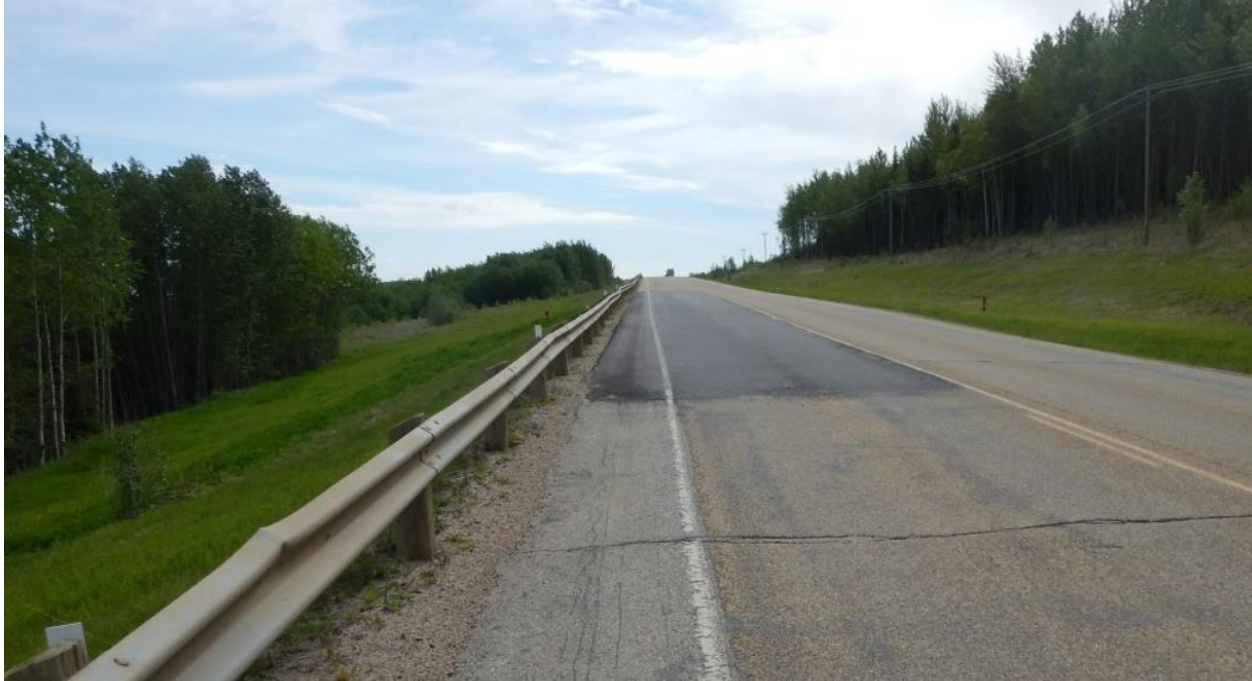
The ACP patched placed in 2021 has improved the driving conditions. However, the highway condition is expected to continue deteriorating until an effective remedial measure is implemented.

Photo No. 1 – Looking east toward the landslide and 2021 ACP patch; more vegetation grew on the highway side slope

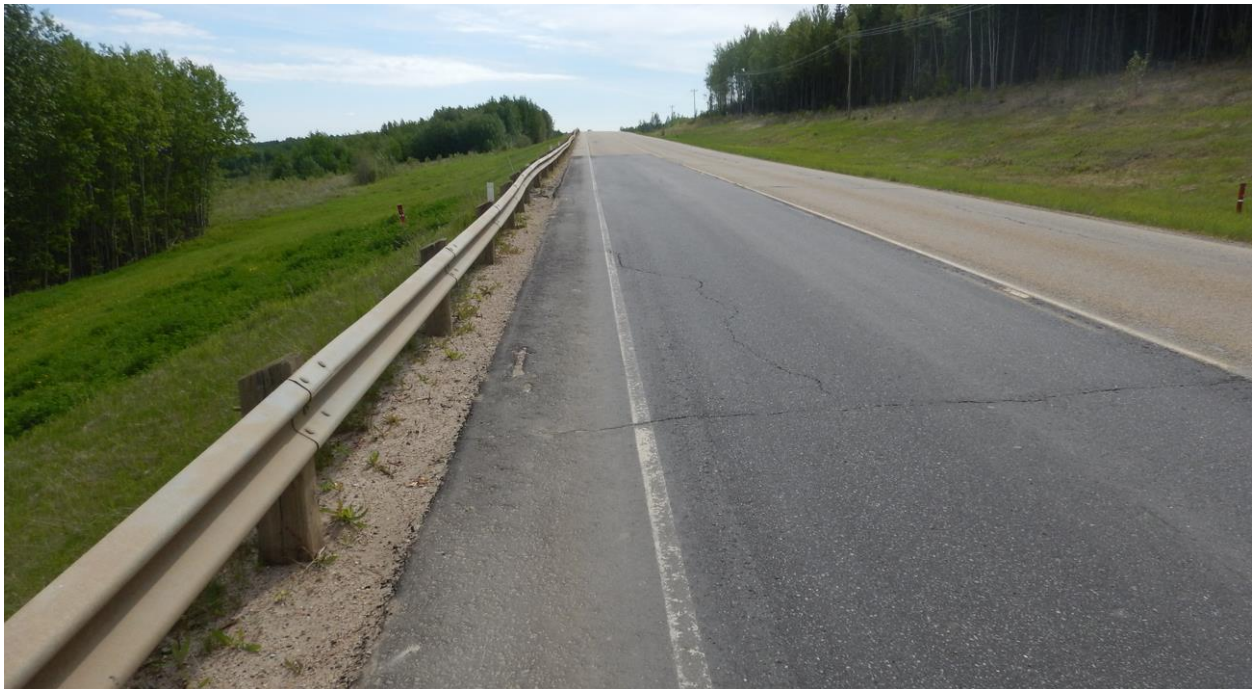
The re-appearance of landslide cracks on the ACP patch, and the presence of a dip on the highway surface suggest that the landslide continued to be active.

Photo No. 2 – Looking east at reflective cracks near the eastern limit of the landslide

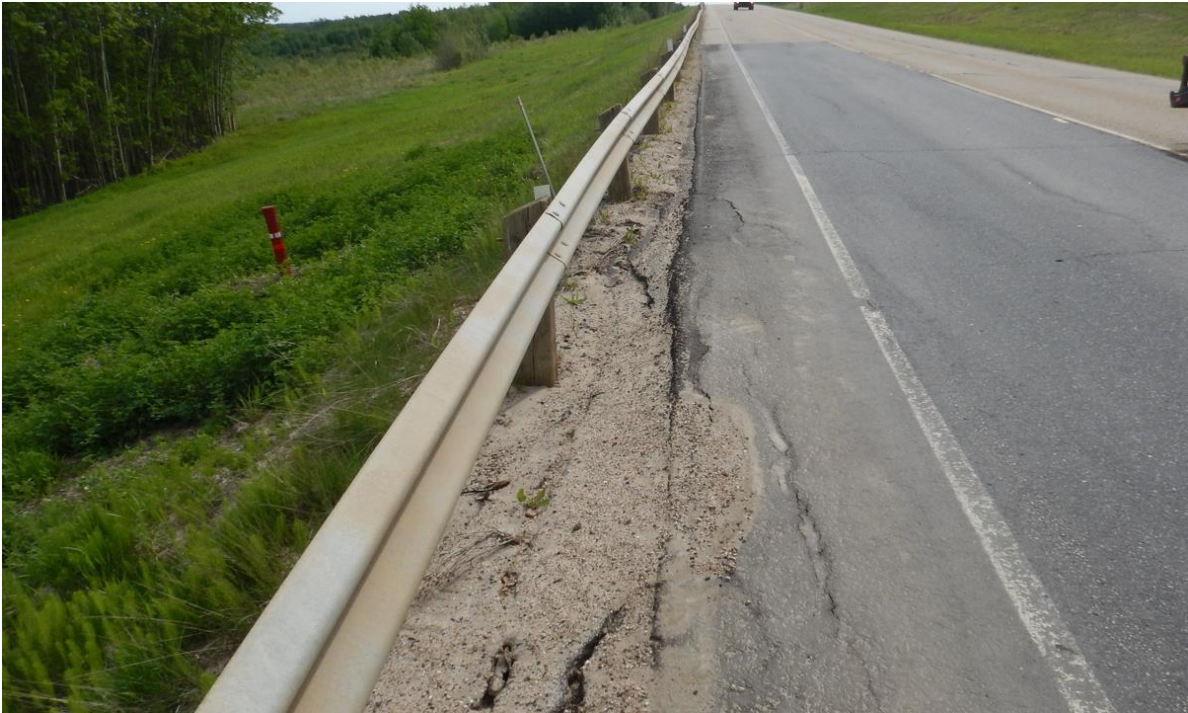
The site observations and past instrument monitoring have indicated that the landslide is very active and is moving at high rates. If the landslide continues to move at high rates, additional landslide retrogression could result in partial or full road closure and a major detour may be required.

Photo No. 3 – Most active landslide block impacting the highway (middle section of landslide block); note the presence of multiple retrogressive cracks impacting the highway WBL

Since the landslide is very active and the failure of the highway lane(s) may occur abruptly, it is recommended to get the site repaired in the near future. The repair may include any of the following options. These options are based on the preliminary engineering assessment completed for this site.

Option 1: Reinforce the slip surface through the construction of a 15 m deep cantilever pile wall, 3 m away from of the northern edge of the highway. The ballpark cost of a 100 m long cast-in-place concrete pile wall would be in the range of \$2,000,000 (excluding engineering). This option does not require land acquisition or regulatory authority approvals.

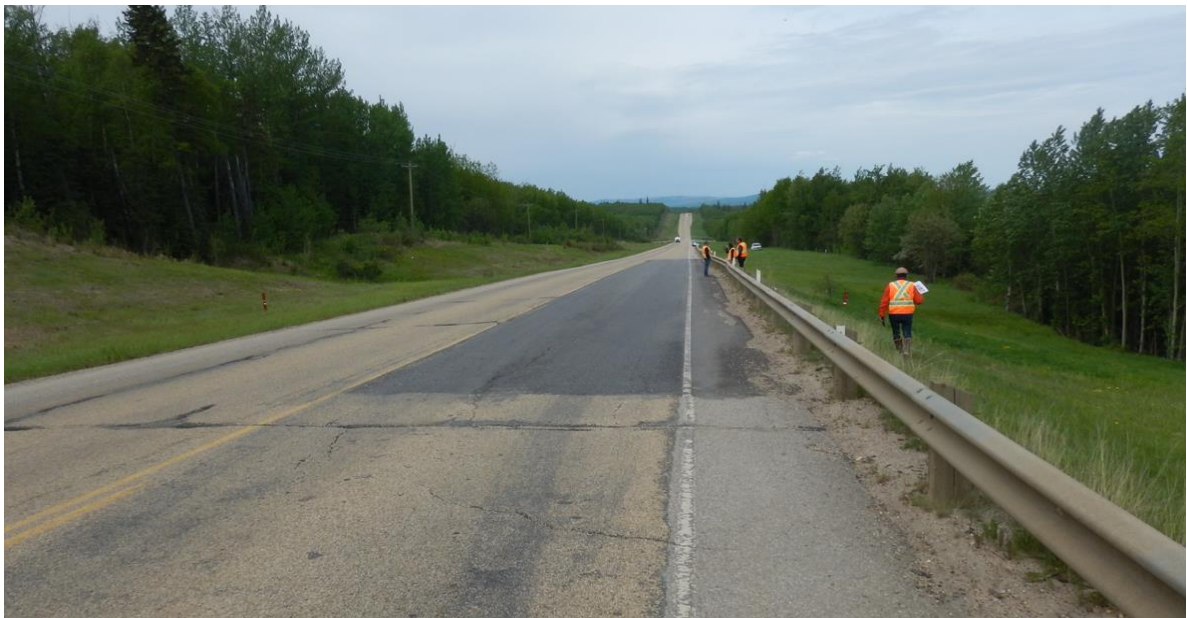
<input checked="" type="checkbox"/> Slope Movement	Reflective landslide within the 2021 ACP patch area; eastern flank diagonal cracks, located outside the patched area, are up to 50 mm wide and with a 10 mm drop across the crack surfaces multiple tension cracks on the north side slope; depression in the north side slope between the culvert outlet and the eastern edge of the bush; guardrail displaced laterally by approximately 250 mm to the north (middle section of the landslide); titling and bent trees in the bush; distinct toe roll in the bush	<input type="checkbox"/>
<input type="checkbox"/> Erosion		<input type="checkbox"/>
<input checked="" type="checkbox"/> Seepage	Water flowing under the 760 mm CSP culvert inlet	<input type="checkbox"/>
<input checked="" type="checkbox"/> Bridge/Culvert Distress	760 mm CSP culvert outlet was damaged; restricted water flow from culvert outlet	<input type="checkbox"/>

Photo No. 4 – Looking west toward the landslide and 2021 ACP patch; landslide cracks extend beyond the patched area

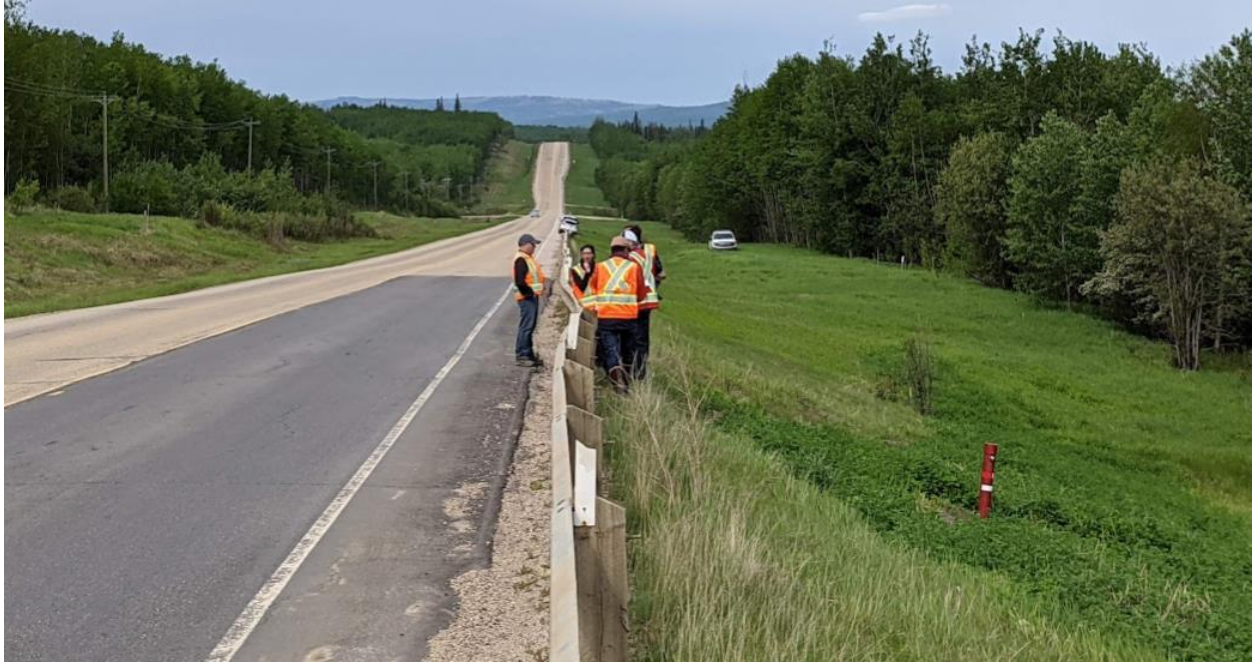
Photo No. 5 – Looking west at the most active area; note guardrail bowing out by 250 mm

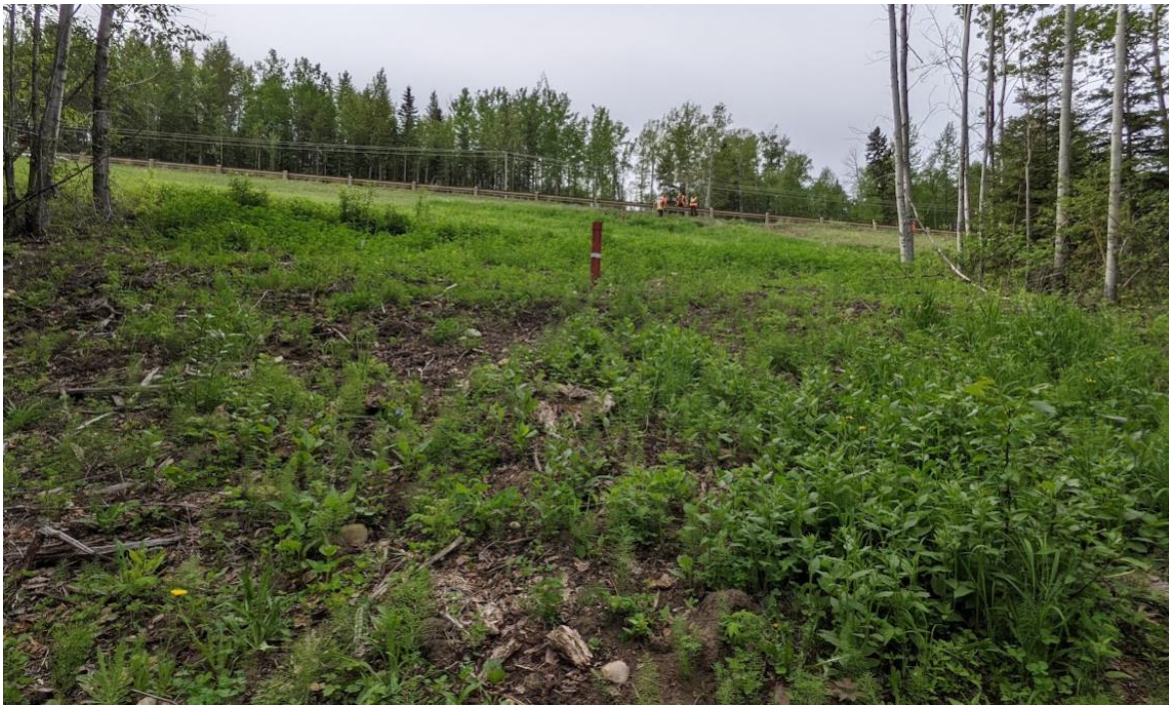
Photo No. 6 – Looking south at highway side slopes; more vegetation noted in 2022

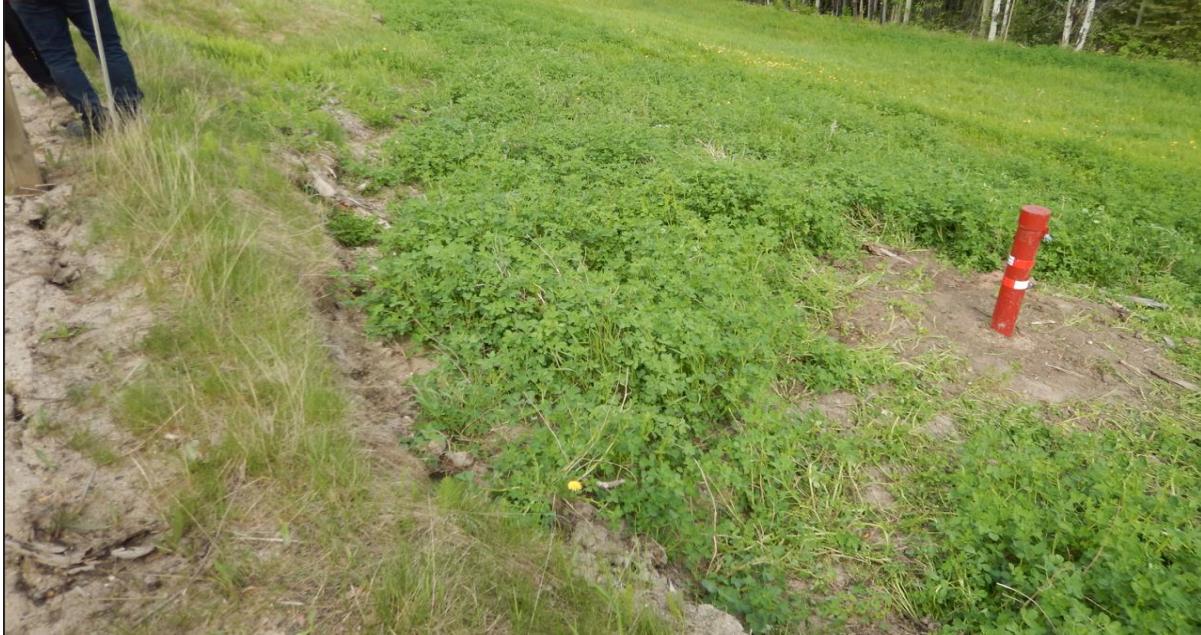
The open cracks noted in the highway side slope are likely due to the settlement of the winter drilling benches after spring thaw. These cracks, if noted sealed, will likely impact the stability of the side slope, and retrogress back to impact the integrity of the guardrail and the highway surface.

Photo No. 7 – Looking west at active landslide cracks on the highway side slope; these cracks may reflect the failure of the restored drill benches constructed in the winter of 2020. to install the instrumentation.

The cracks developed within the north side slope in response to the failure of the winter drilling benches are currently vegetated and may stabilize with time. These cracks should however be monitored, and a bobcat should be used to slightly contour and seal these cracks, if needed.

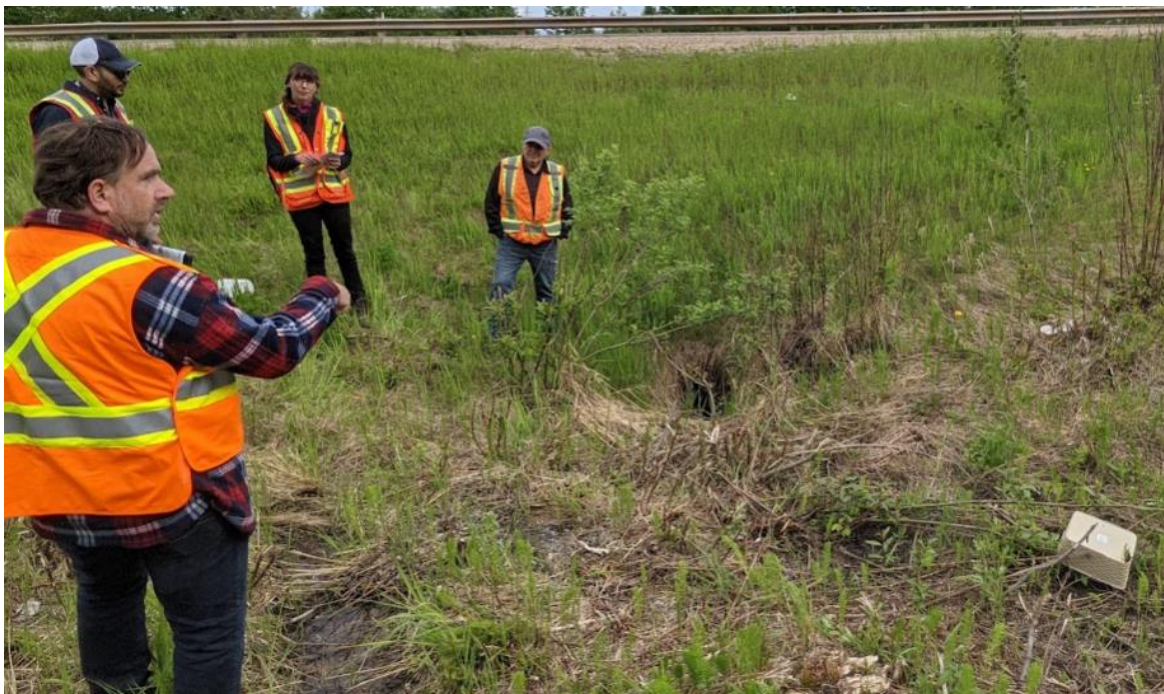
The surface water in the south ditch was noted to be draining under the highway centerline culvert. The outlet of the culvert previously noted to be lower than adjacent terrain has kept the water ponding inside the culvert outlet until it overflows to drain into the gully.

Photo No. 8 – 760 mm diameter culvert inlet. Culvert was rusty and filled with garbage

The south ditch should be slightly re-graded to direct surface water towards the culvert inlet. The final ditch surface should be lined with TRM type C for erosion protection. The existing culvert should be grouted and replaced with a new pipe. Riprap protection should be provided at the inlet and outlet locations of the new pipe.

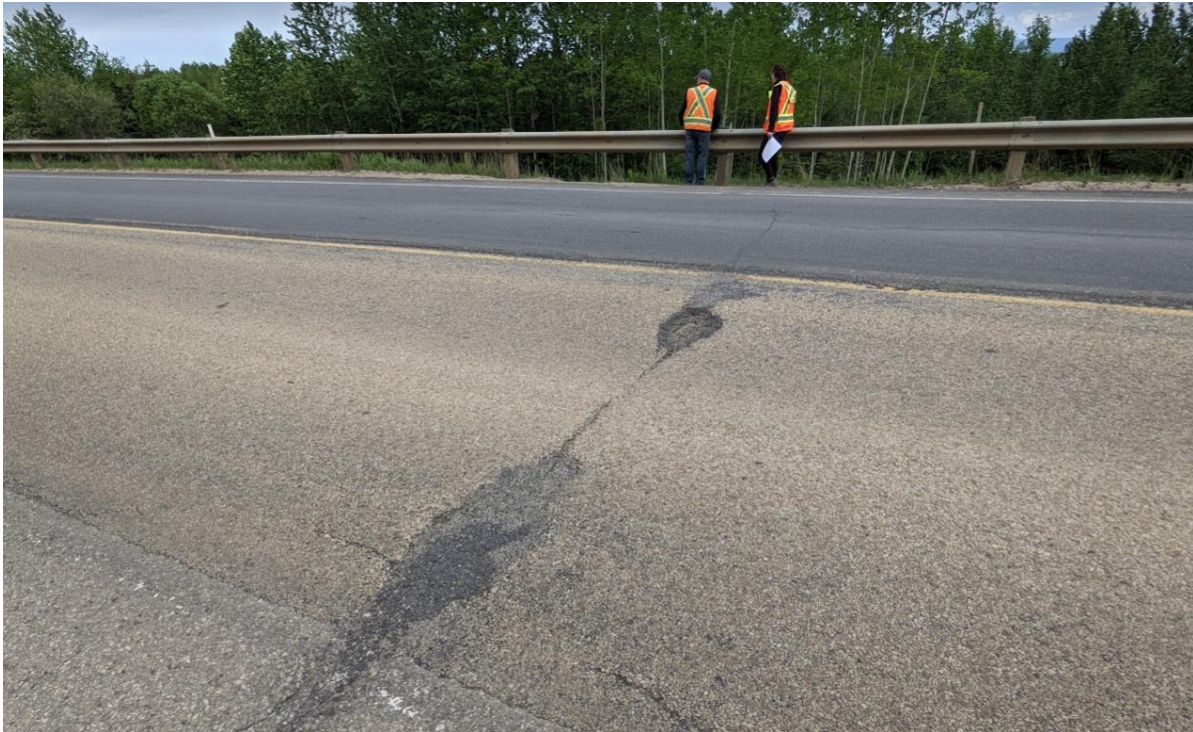
Photo No. 9 – Looking north at patched potholes on the east bound lane

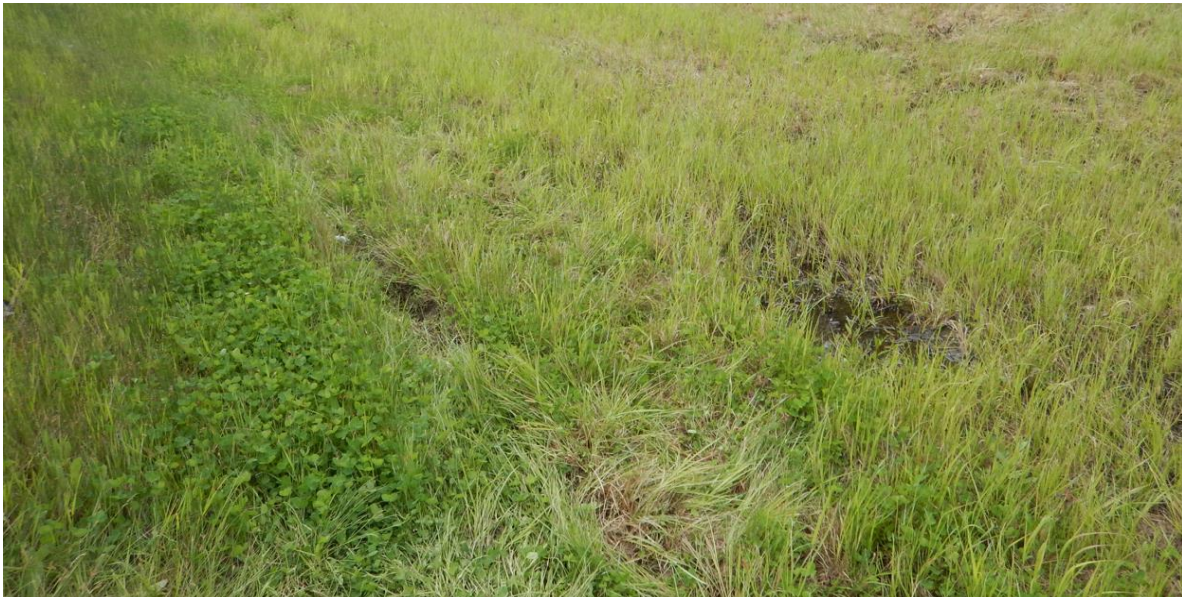
<input checked="" type="checkbox"/> Other	Settlement of drill benches, constructed in the winter of 2020 to install geotechnical instruments, created severe open cracks in the highway side slope; the upper settlement crack is about 1 m from the highway guardrail; water ponding within the highway south ditch	<input type="checkbox"/>

Photo No. 10 – Looking at wet area within the south ditch to the east of the 760 mm CSP culvert inlet location
