**TRANSPORTATION AND ECONOMIC CORRIDORS
GEOHAZARD ASSESSMENT PROGRAM
NORTH CENTRAL REGION – ATHABASCA &
FORT McMURRAY DISTRICTS
2023 SITE INSPECTION**

Site Number	Location	Name		Hwy	km
NC006	11 Km East of Slave Lake	Mitsue Recreation Area		2:46	47.33
Legal Description		UTM Co-ordinates (NAD 83)			
NW-7-72-4-W5M		11	N	6122200	E 651552
	Date	PF	CF	Total	
Previous Inspection:	June 07, 2022	14	5	70	
Current Inspection:	May 16, 2023	14	5	70	
Road AADT:	3,200	Year:	2022		
Inspected By:	José Pineda, Tarek Abdelaziz (Thurber) Arthur Kavulok, Amy Driessen, Kristen Tappenden (TEC)				
Report Attachments:	<input checked="" type="checkbox"/> Photographs <input checked="" type="checkbox"/> Plans <input type="checkbox"/> Maintenance Items				
Primary Site Issue	Active landslide causing severe deterioration to highway conditions.				
Dimensions:	About 80 m wide (parallel to the highway alignment) and 60 m long (perpendicular to the highway alignment)				
Site History:	<p>In the Spring of 2019 Mr. Gordon Wolters, local MCI of TEC, noticed a sudden severe depression on the highway surface. TEC requested Thurber to conduct a call out.</p> <p>During Thurber's inspection on June 10, 2019, it became c

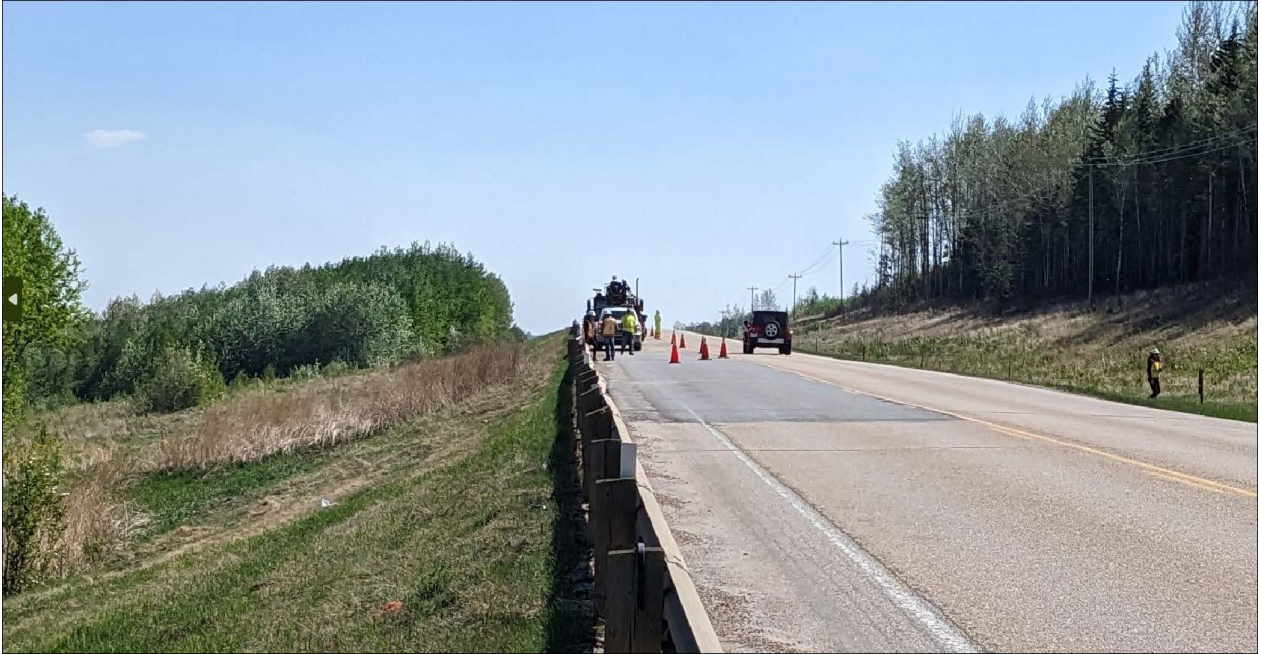
Photo No. 1 – Looking east toward the landslide and the 2021 ACP patch; more vegetation grew on the highway side slope within the landslide mass

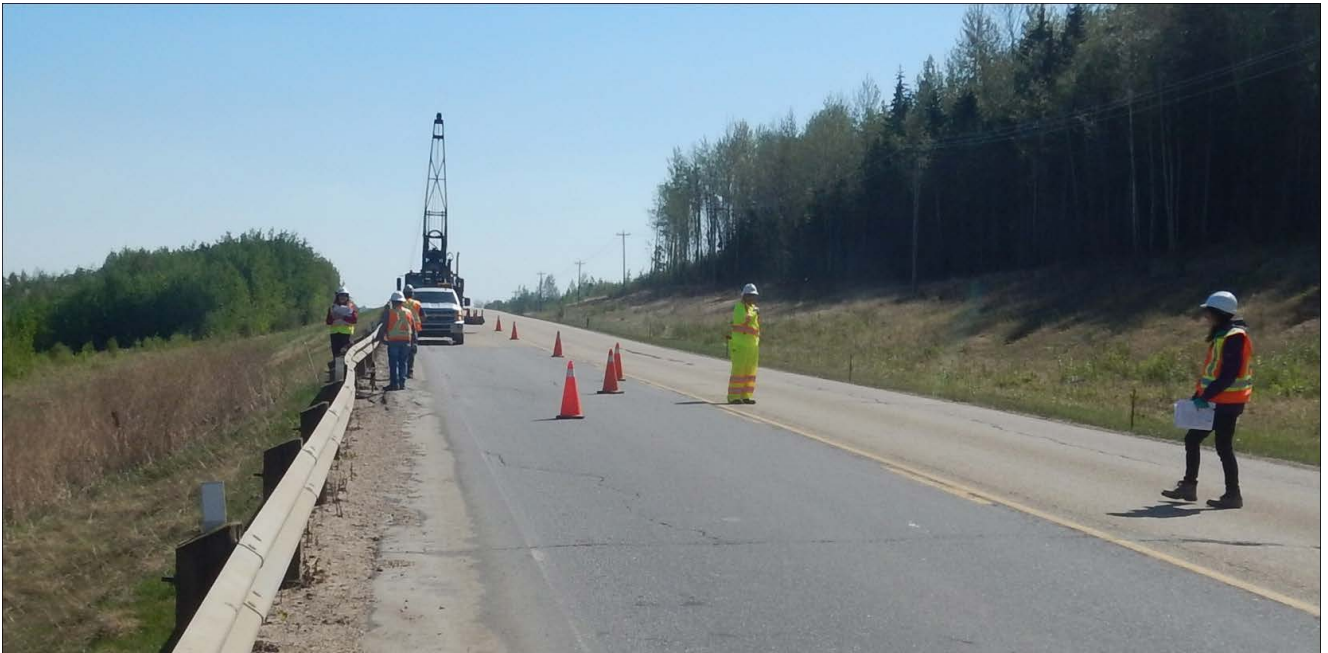
Photo No. 2 – Looking east at reflective cracks near the western limit of the landslide

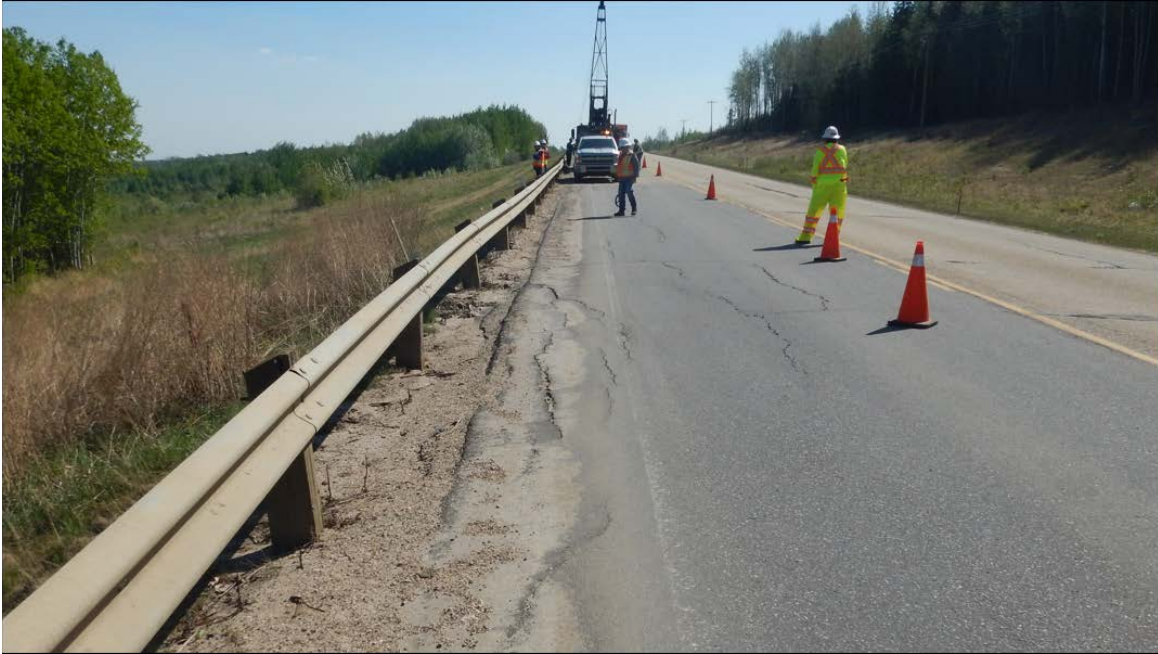
Photo No. 3 – Most active landslide block impacting the highway (middle section of landslide mass); note the presence of multiple retrogressive cracks impacting the highway WBL

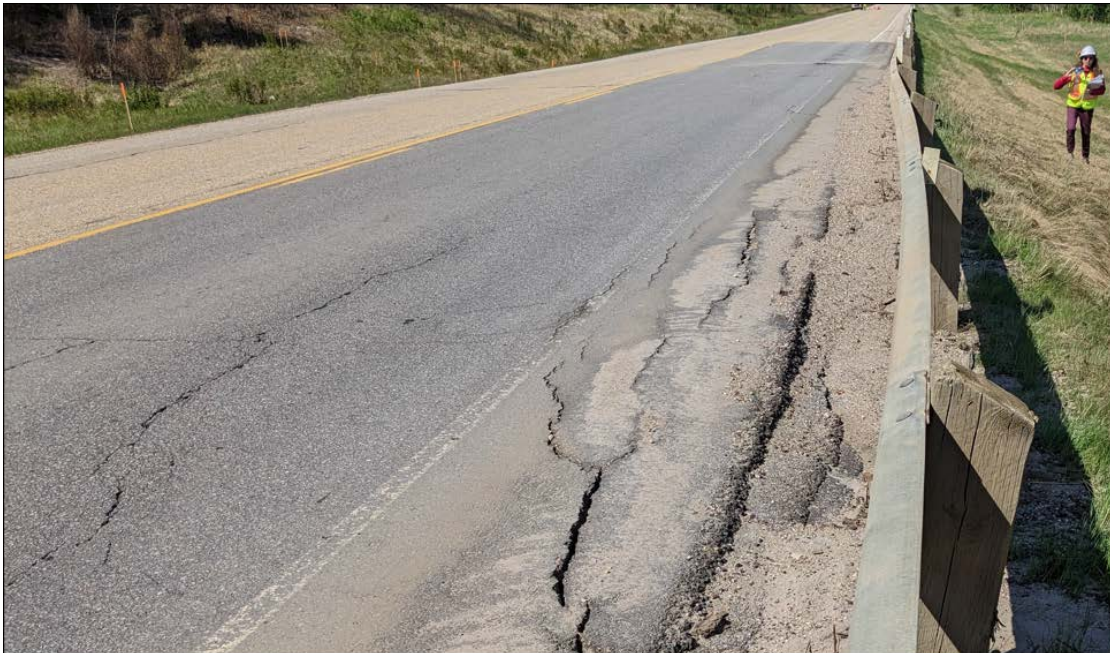
Photo No. 4 – Looking west at the most active area; note guardrail bowing out by 300 mm

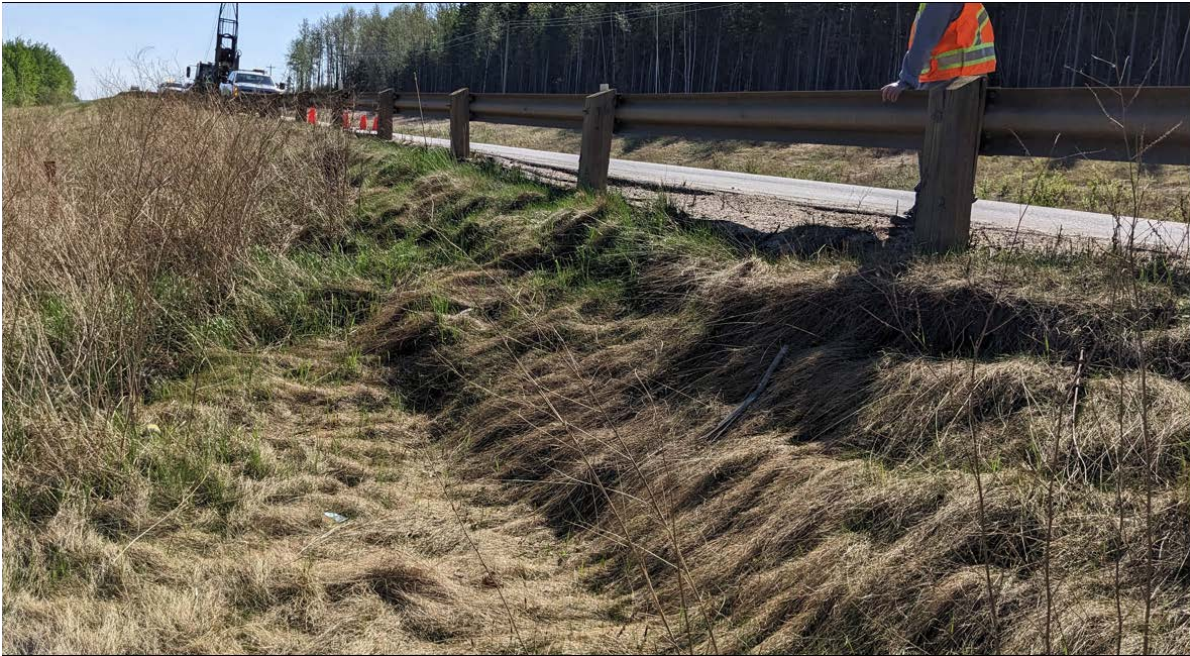
Photo No. 5 – Middle landslide block: Head scarp crack retrogressing into the highway; 600 to 1.2 m drop from original ground

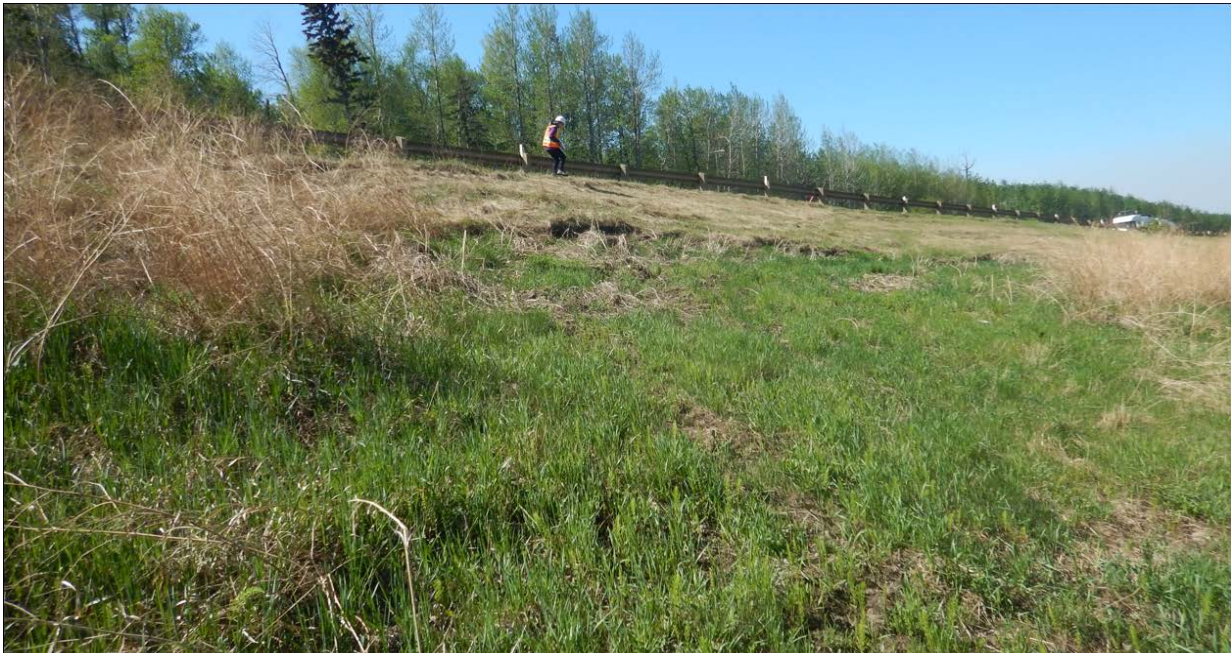
Photo No. 6 – Looking west at active landslide cracks on the highway side slope; these cracks may reflect the failure of the restored drill benches constructed in the winter of 2020 to install geotechnical instruments.

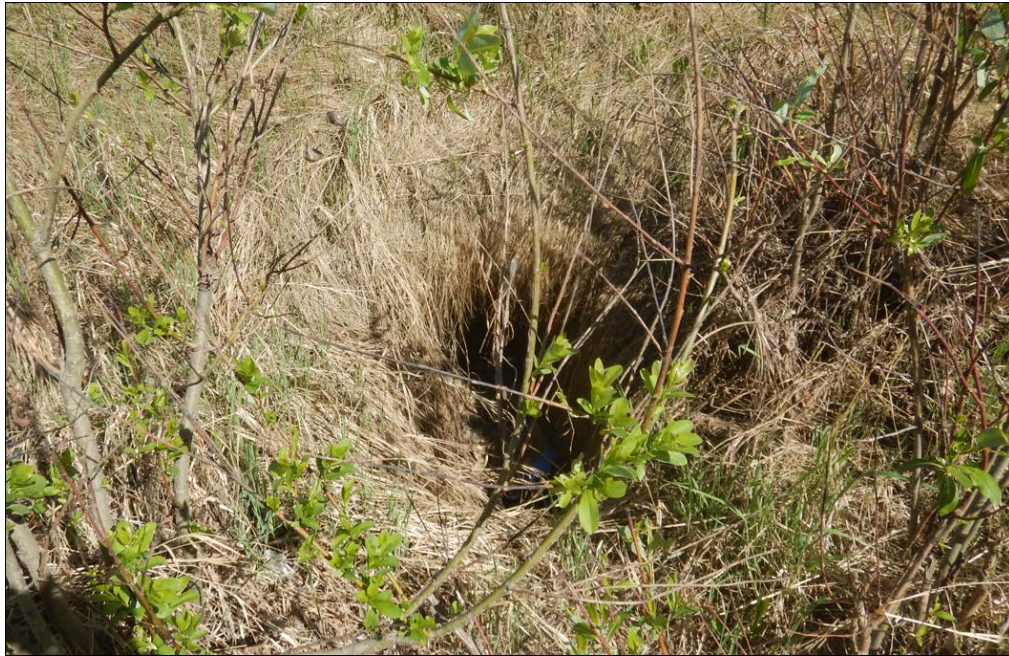
Photo No. 7 – 800 mm diameter culvert inlet. Culvert was rusty, partially blocked with vegetation and filled with garbage.
