ALBERTA TRANSPORTATION AND
ECONOMIC CORRIDORS GRMP
NORTH CENTRAL (ATHABASCA AND FORT
McMURRAY DISTRICTS)
INSTRUMENTATION MONITORING- SPRING 2024

Site Number	Location	Name	Hwy	km
NC006	HWY 2:46 C1 47.6	Mitsue Lake Recreation Area	2:46	Km 47.6
Legal Description: 9-12-72-5 W5		UTM Co-ordinates		
		11U E 651534	N	6122185

Current Monitoring:	14-June-2024	Previous Monitoring	07-Oct-2023
Instruments Read By:	Mr. Niraj Regmi, G.I.T and Mr. Nixson Mationg, of Thurber

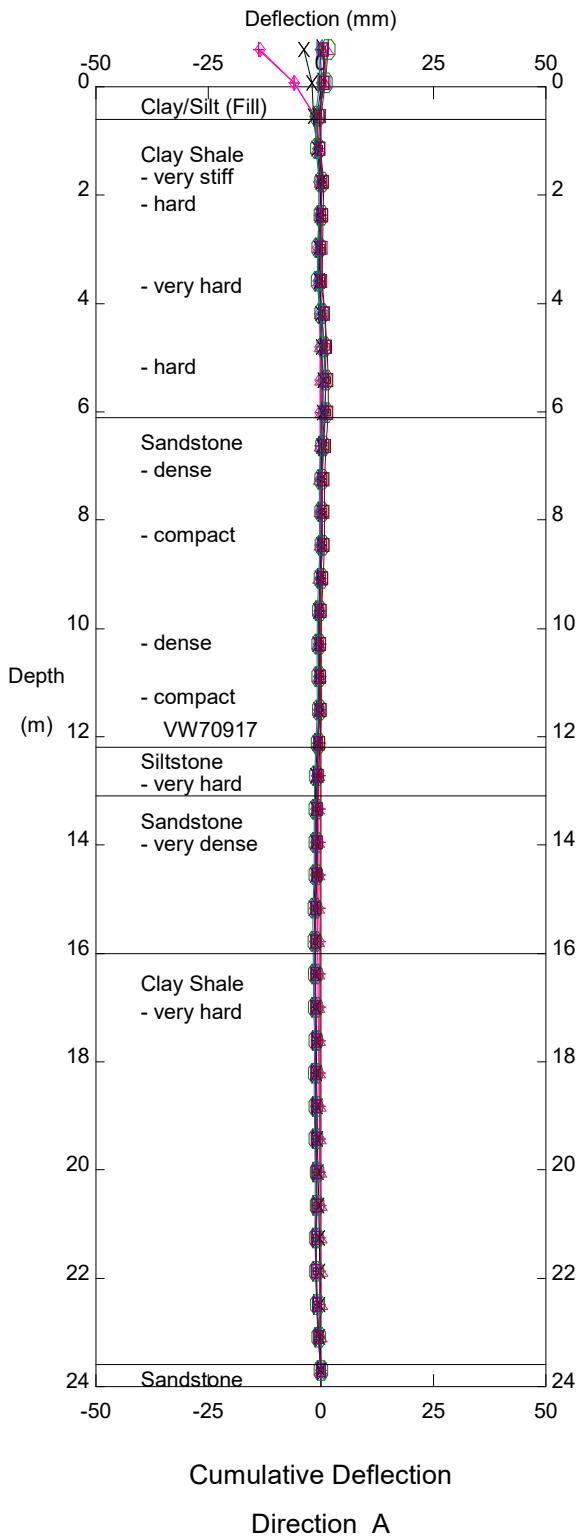
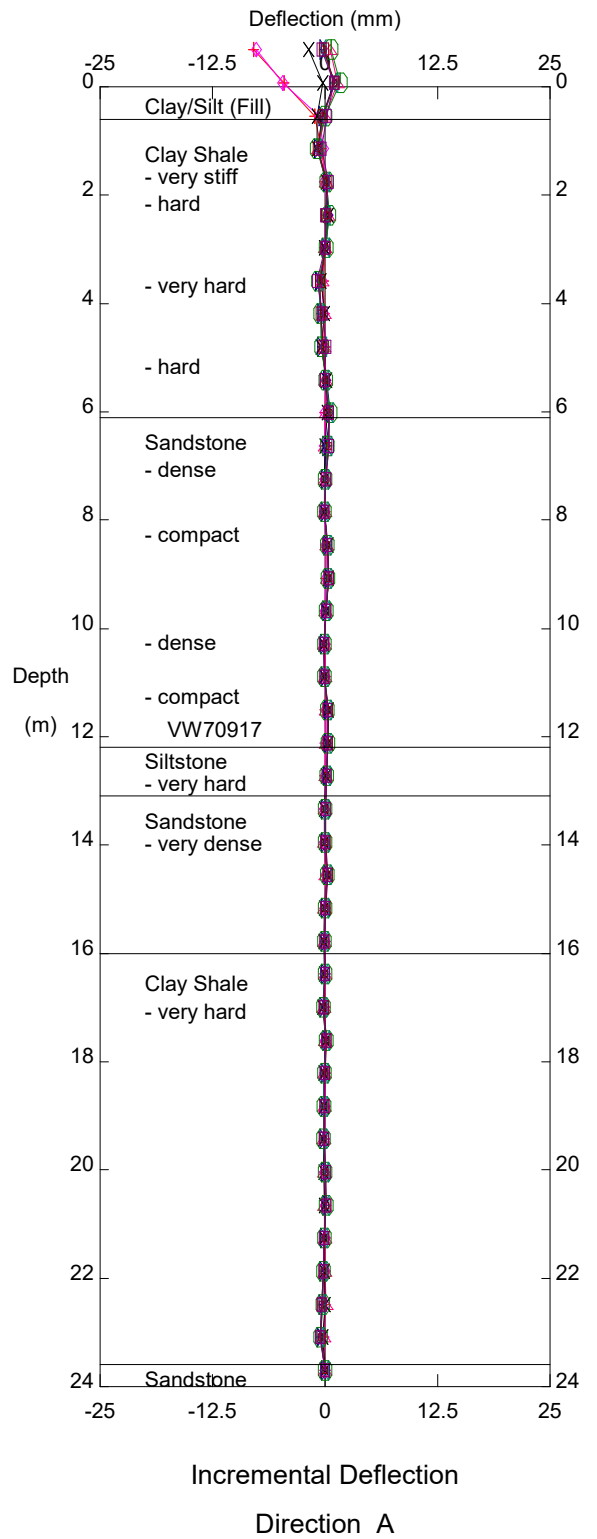
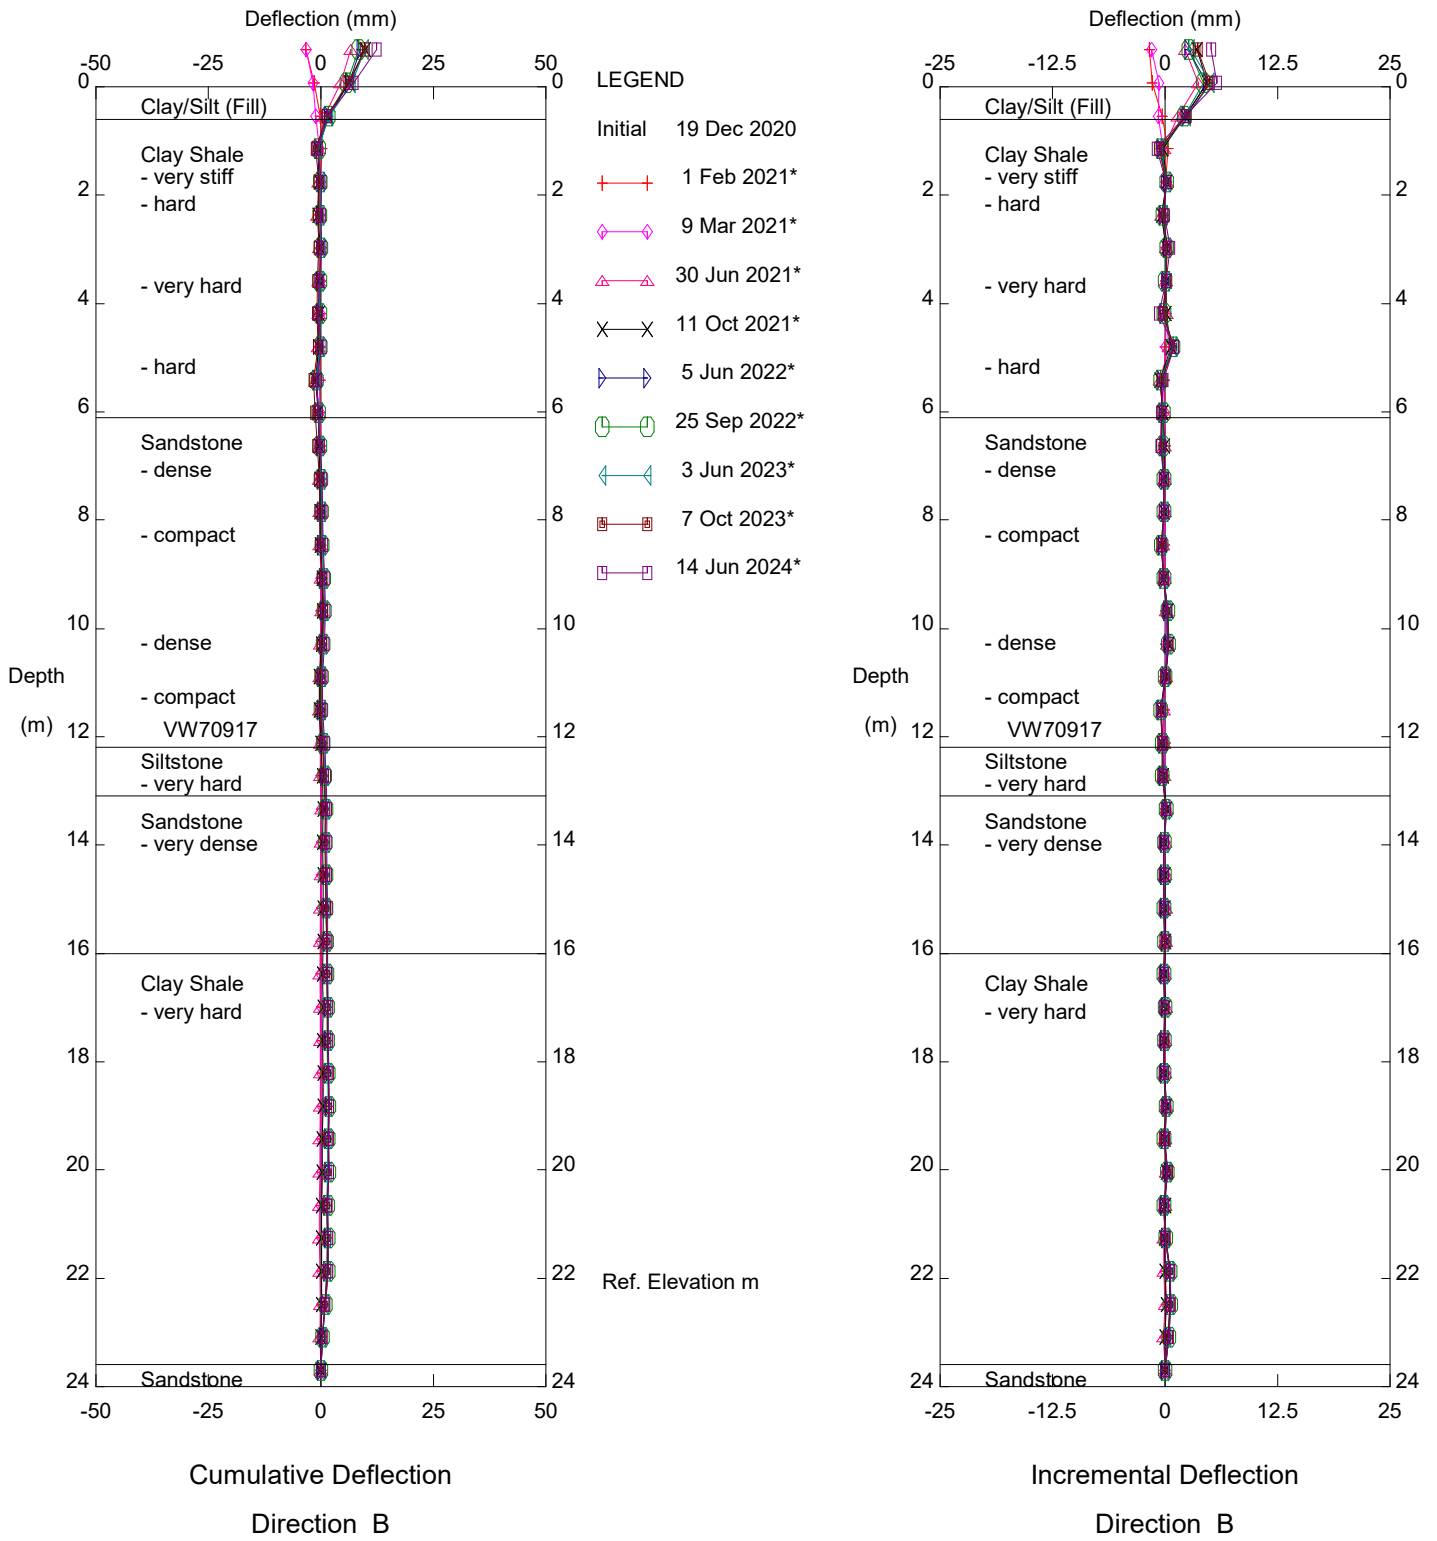
NC006 - Hwy 2:46 Mitsue Lake (km 47.6), Inclinometer SI20-1

Discussion	
Zones of New Movement:	None
Interpretation of Monitoring Results:	<p>SI20-1, installed in the south ditch of the highway, has shown no discernible movement since initialization. SI20-2, installed through the embankment on the north side of the highway, showed a rate of movement 23.9 mm/yr over 0 m to 1.8 m depth since the fall of 2023 readings. SI20-3, installed downslope of the highway inside the tree line, showed a rate of movement of 3.1 mm/yr over 1.4 m to 3.2 m depth since the fall of 2023 readings. SI20-4, installed further downslope of SI20-3 within the tree line, has shown no discernible movement since initialization.</p> <p>Vibrating wire piezometers VW20-1, VW20-2B and VW20-3B showed decreases in groundwater level of 0.30 m, 0.14 m and 0.24 m, respectively, since the fall of 2023 readings. VW20-2A,</p>

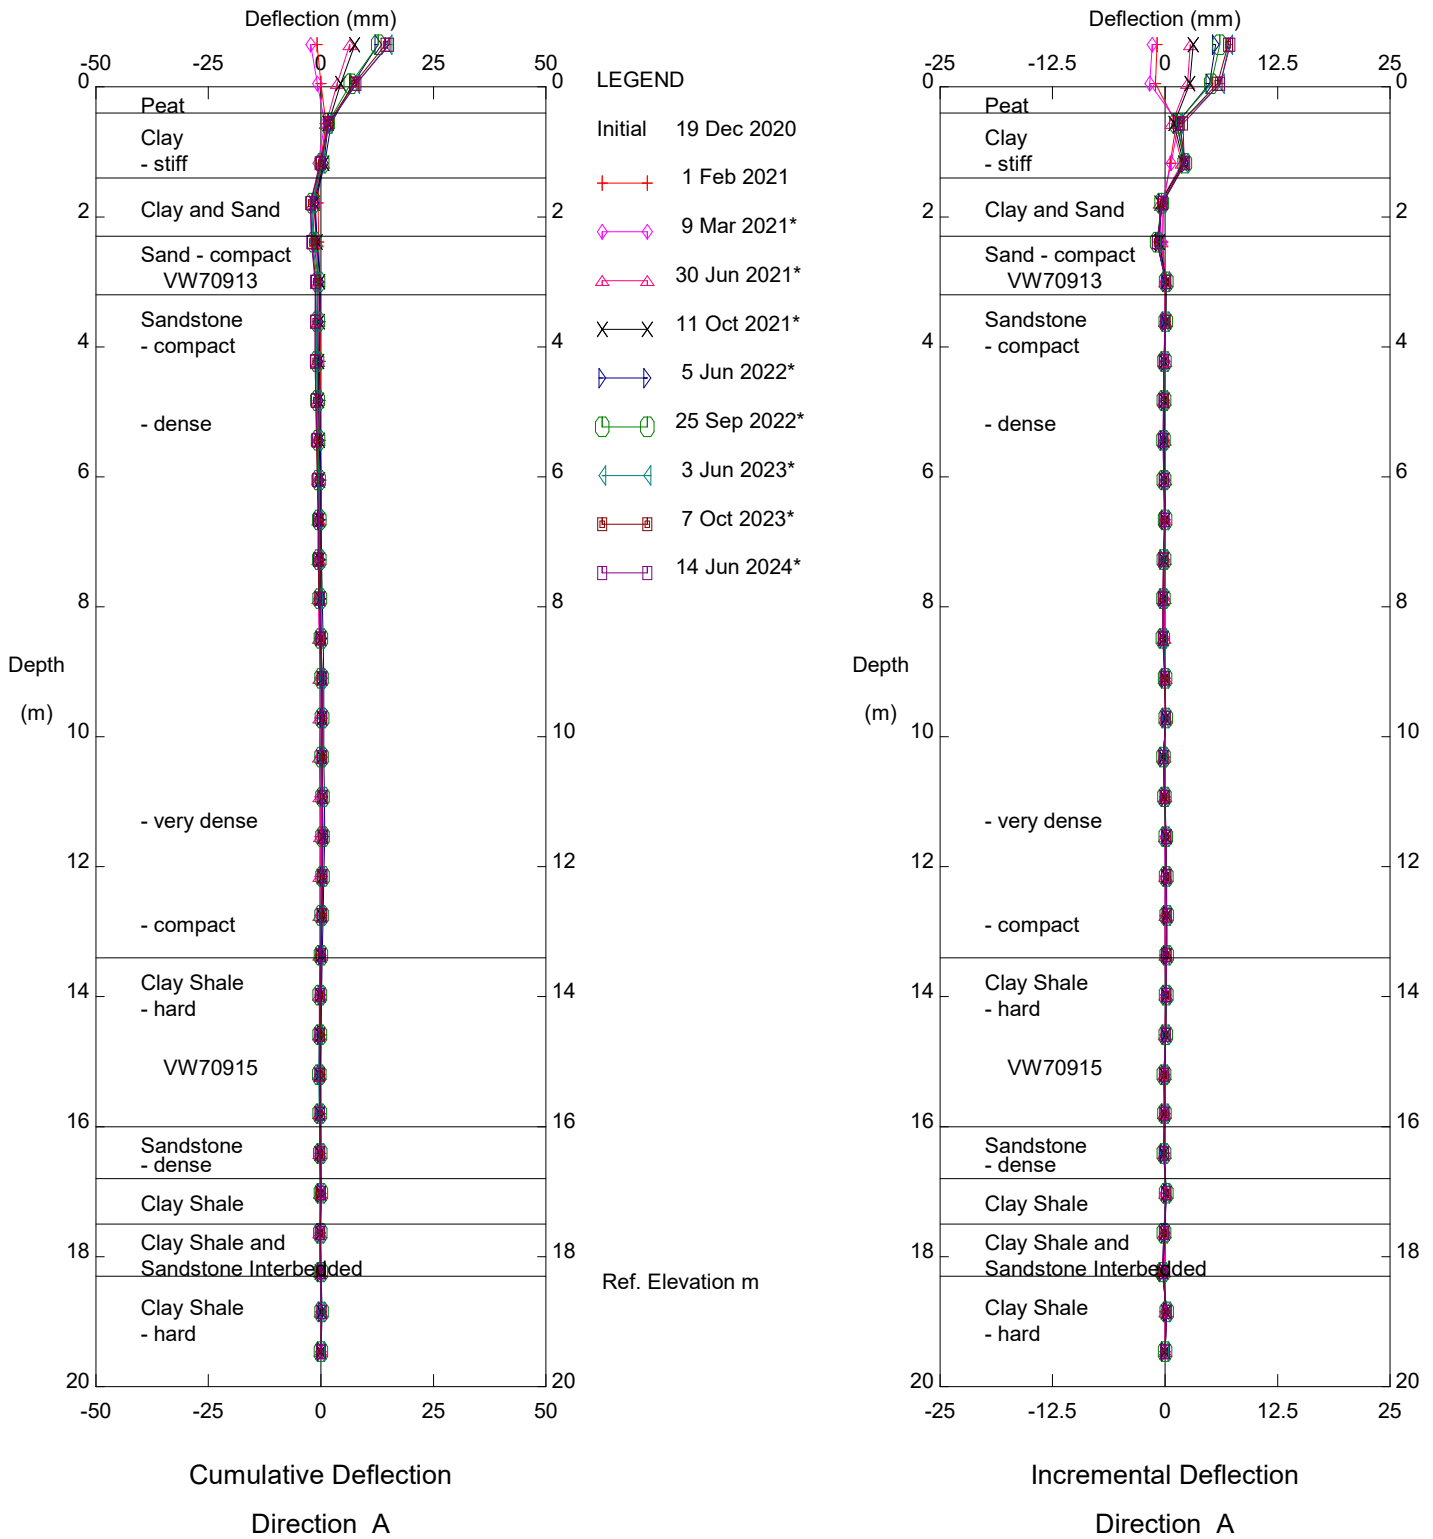
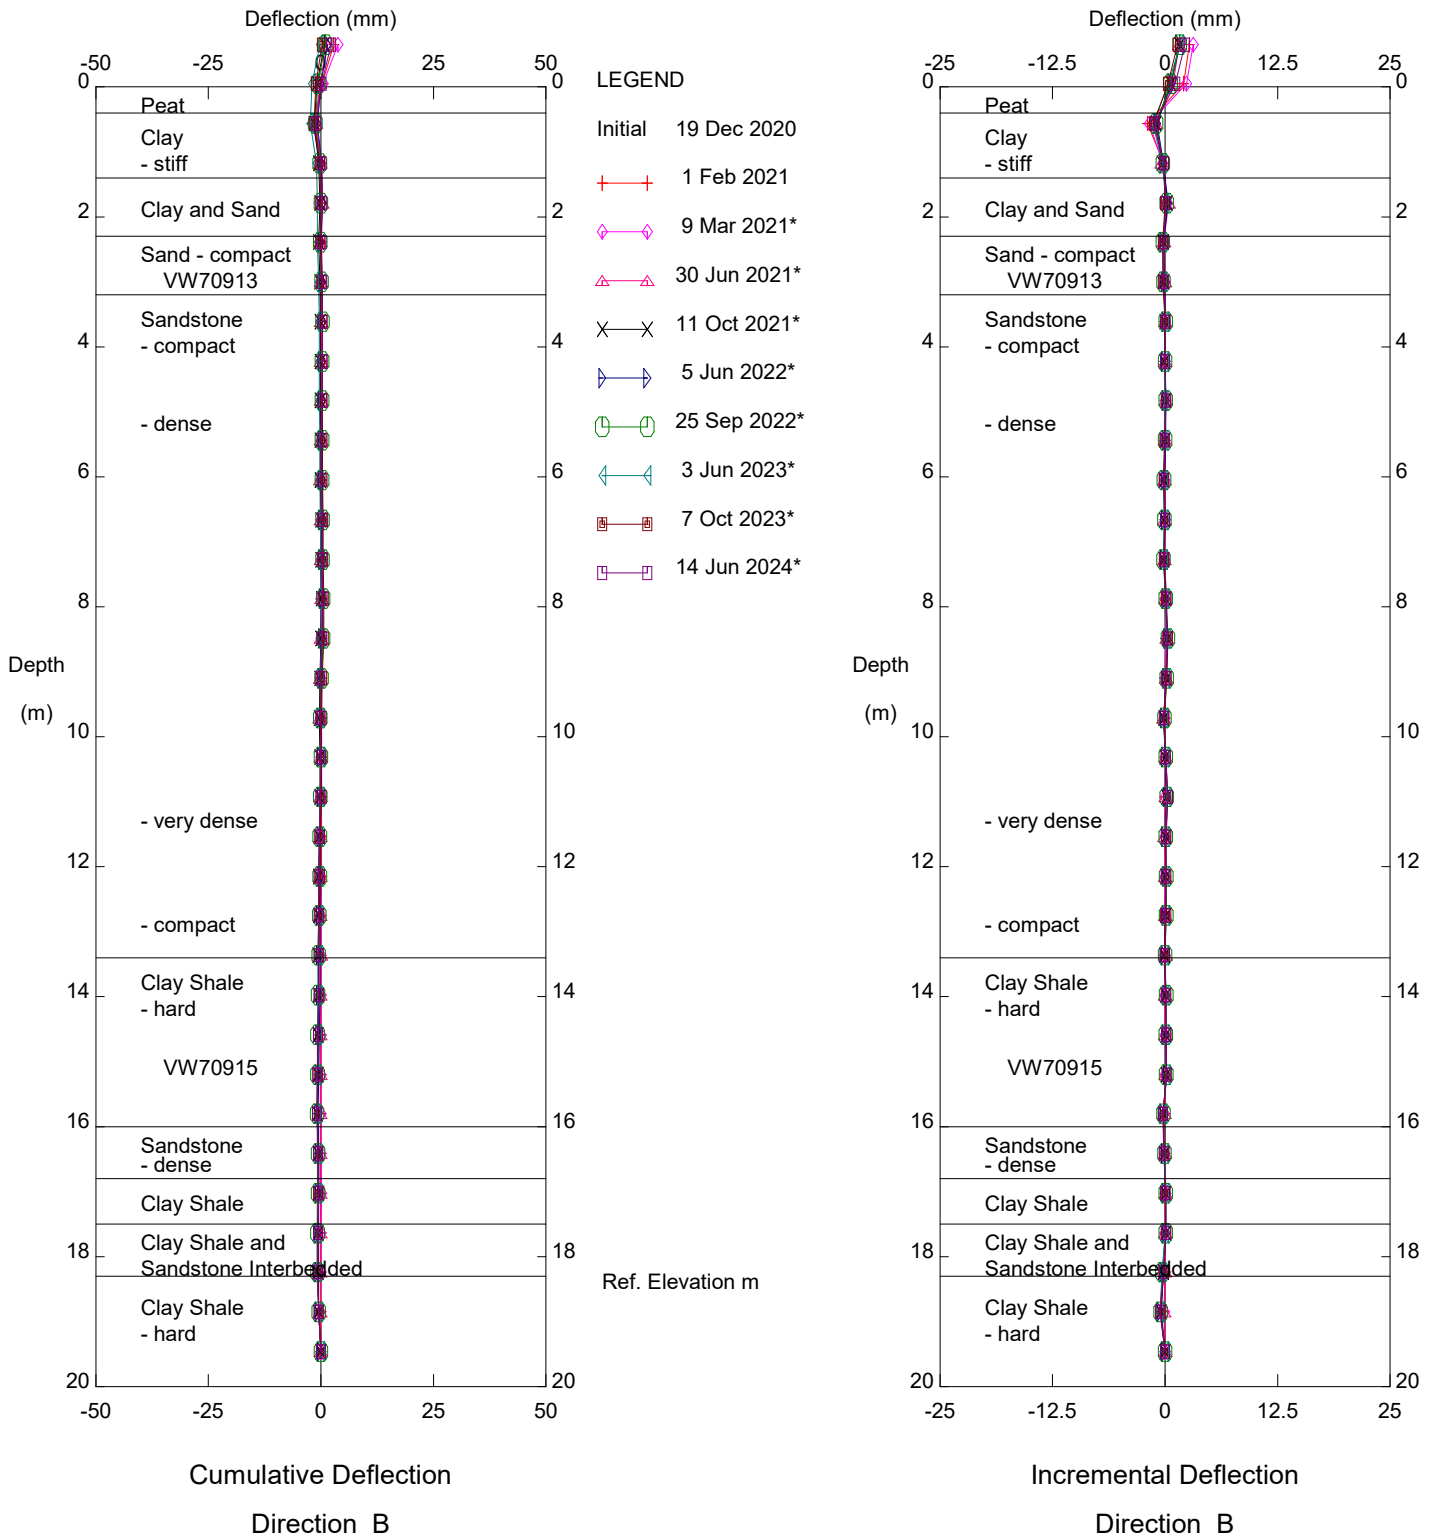
NC006 - Hwy 2:46 Mitsue Lake (km 47.6), Inclinometer SI20-4

INSTRUMENT #	DATE INITIALIZED	TOTAL CUMULATIVE RESULTANT MOVEMENT AND DEPTH OF MOVEMENT TO DATE (mm)	MAXIMUM RATE OF MOVEMENT (mm/yr)	CURRENT STATUS OF SI	DATE OF PREVIOUS READING	INCREMENTAL MOVEMENT SINCE PREVIOUS READING (mm)	CURRENT RATE OF MOVEMENT (mm/yr)	CHANGE IN RATE OF MOVEMENT SINCE PREVIOUS READING (mm/yr)
SI20-1	December 21, 2020	No discernible movement	N/A	Operational	October 7, 2023	N/A	N/A	N/A
SI20-2	June 5, 2022 (reinitialized)	34.5 over 0 m to 1.8 m depth in 345° direction	25.8 in September 2022	Operational	October 7, 2023	16.5	23.9	23.8
SI20-3	December 20, 2020	13.2 over 1.4 m to 3.2 m depth in 348° direction	22.2 in June 2021	Operational	October 7, 2023	2.2	3.1	-0.4
SI20-4	December 19, 2021	No discernible movement	N/A	Operational	October 7, 2023	N/A	N/A	N/A

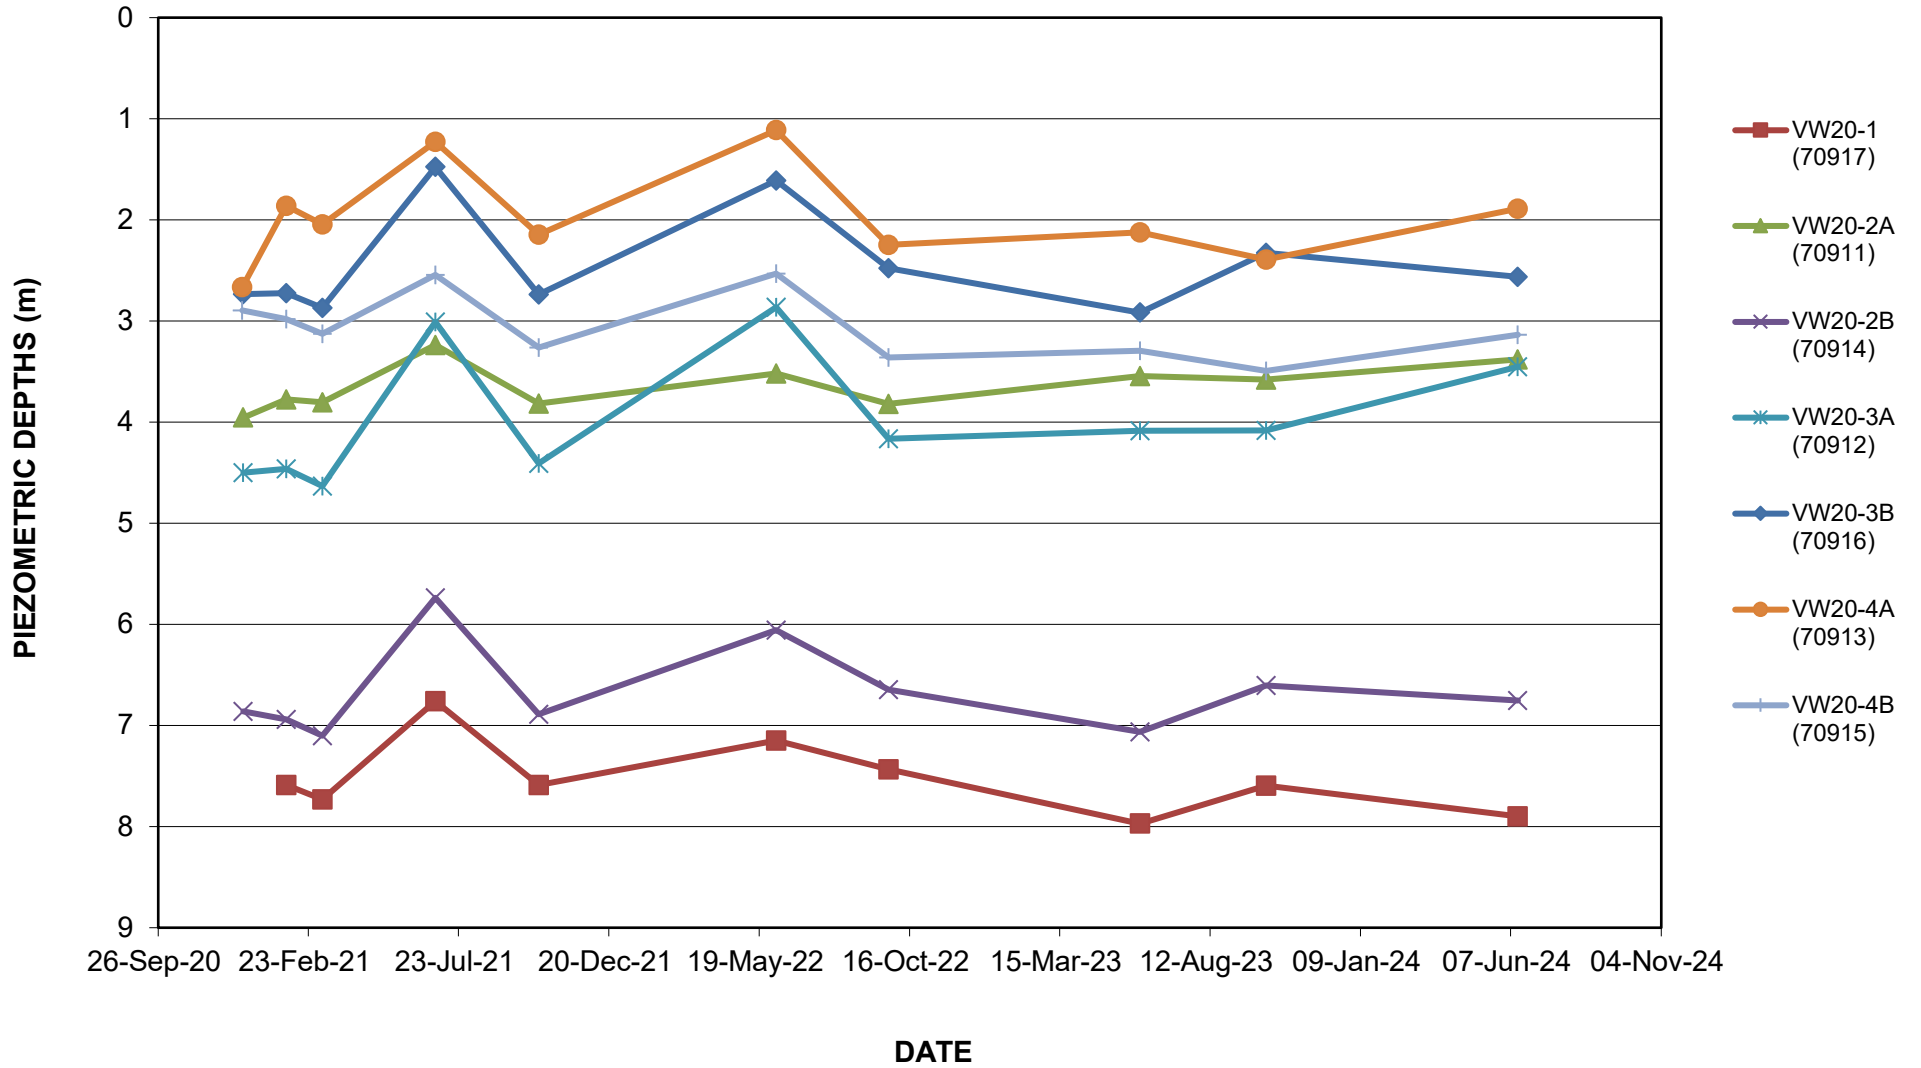
**FIGURE NC006-1
HWY 2:46 MITSUE LAKE SLIDE (KM 47.6)
VIBRATING WIRE PIEZOMETER DATA**

VW20-3A, VW20-4A and VW20-4B showed increases in groundwater level of 0.20 m, 0.63 m, 0.50 m and 0.35 m, respectively. Overall, the measured groundwater levels are within the historically measured groundwater levels for the site.
Future Work:	The instruments should be read again in the fall of 2024.
Instrumentation Repairs:	No instrument repairs are required at this time.
Additional Comments:
