**ALBERTA TRANSPORTATION AND  
ECONOMIC CORRIDORS GRMP  
NORTH CENTRAL (ATHABASCA AND FORT  
MCMURRAY DISTRICTS)  
2024 SITE INSPECTION**

<b>Site Number</b>	<b>Location</b>	<b>Name</b>		<b>Hwy</b>	<b>km</b>
NC006	11 Km East of Slave Lake	Mitsue Recreation Area		2:46	47.33
<b>Legal Description</b>		<b>UTM Co-ordinates (NAD 83)</b>			
NW-7-72-4-W5M		11	N 6122200	E	651552
	<b>Date</b>	<b>PF</b>	<b>CF</b>	<b>Total</b>	
<b>Previous Inspection:</b>	May 16, 2023	14	5	70	
<b>Current Inspection:</b>	June 3, 2024	14	5	70	
<b>Road WAADT:</b>	2,480	<b>Year:</b>		2023	
<b>Inspected By:</b>	José Pineda, Tarek Abdelaziz (Thurber) Arthur Kavulok, Gordon Wolters, Rocky Wang (TEC)				
<b>Report Attachments:</b>	<input checked="" type="checkbox"/> Photographs <input checked="" type="checkbox"/> Plans <input type="checkbox"/> Maintenance Items				
<b>Primary Site Issue</b>	Active landslide causing severe deterioration to highway conditions.				
<b>Dimensions:</b>	About 80 m wide (parallel to the highway alignment) and 60 m long (perpendicular to the highway alignment)

**NC006: HWY 2:46 MITSUE RECREATION AREA (km 47.6)  
SITE PLAN SHOWING LANDSLIDE FEATURES**

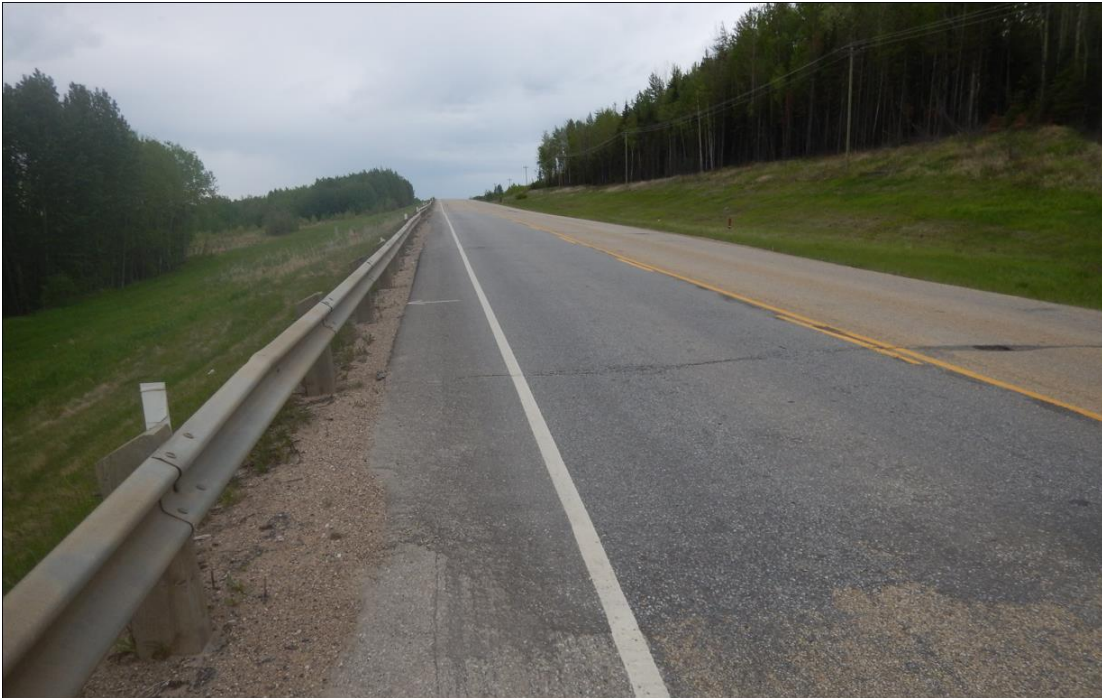
<b>Maintenance</b>	ACP patch placed in 2021 on the west bound lane covering most of the landslide impacted section of the highway.

**Photo No. 1 – Looking east towards the landslide and the extent of 2021 ACP patch**

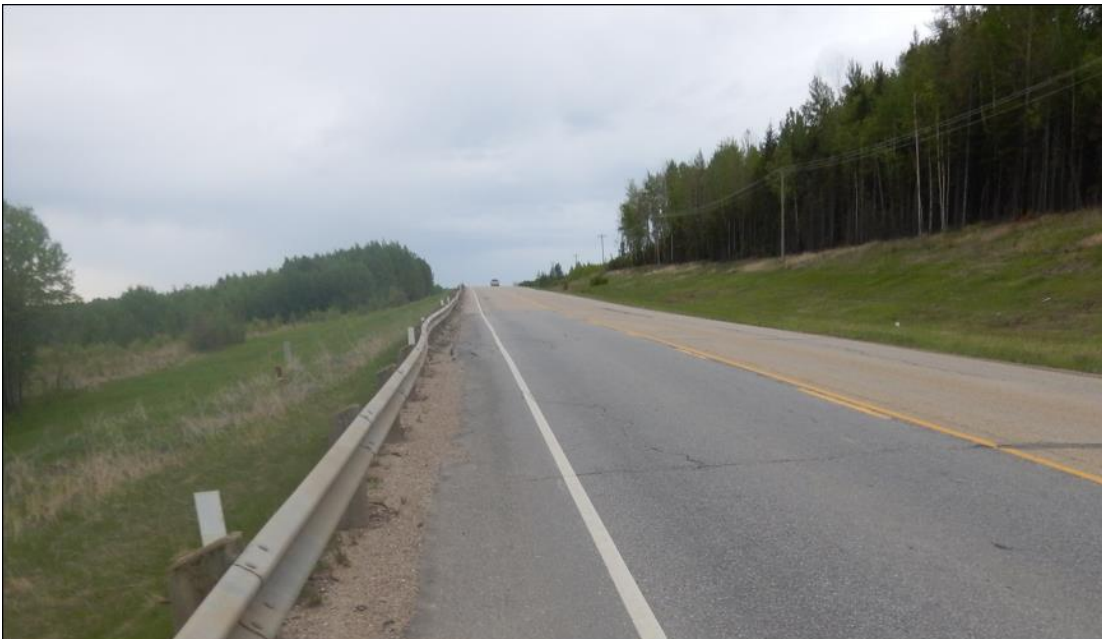
**Photo No. 2 – Looking east at reflective cracks near the western limit of the landslide**

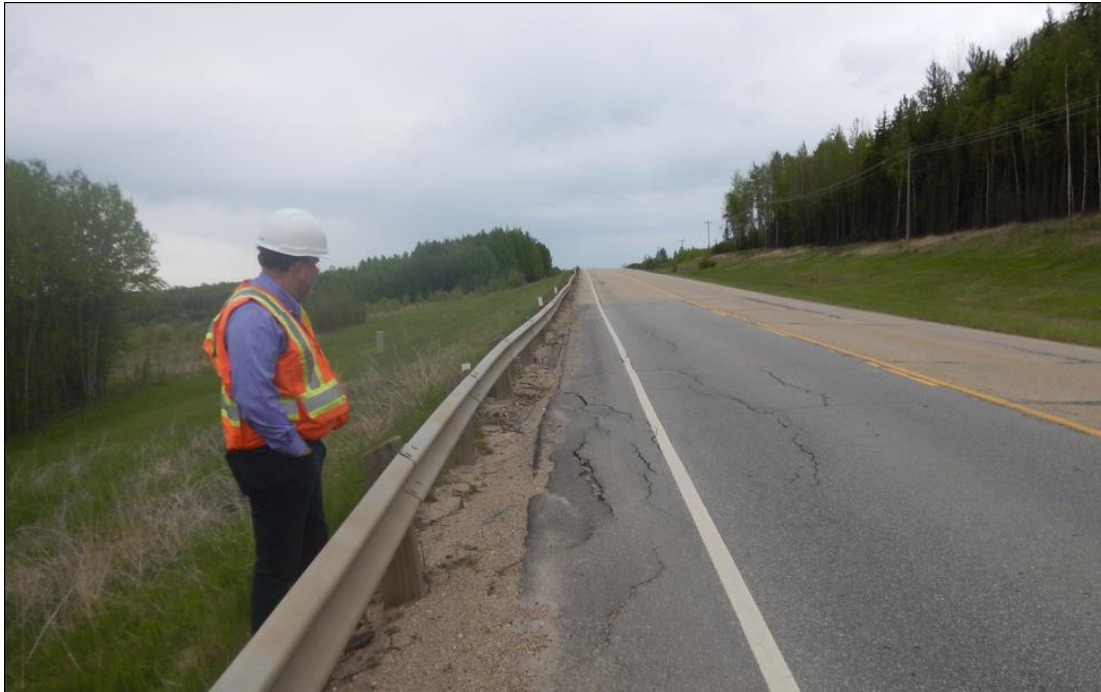
**Photo No. 3 – Most active landslide block impacting the highway (middle section of landslide mass); note the presence of multiple retrogressive cracks impacting the highway WBL**

The selected remedial measure by TEC involves installing a shallow pile wall to address the shallow movement at the site. The tender closed in June 2024, and the repair is scheduled to be completed by May 31, 2025.

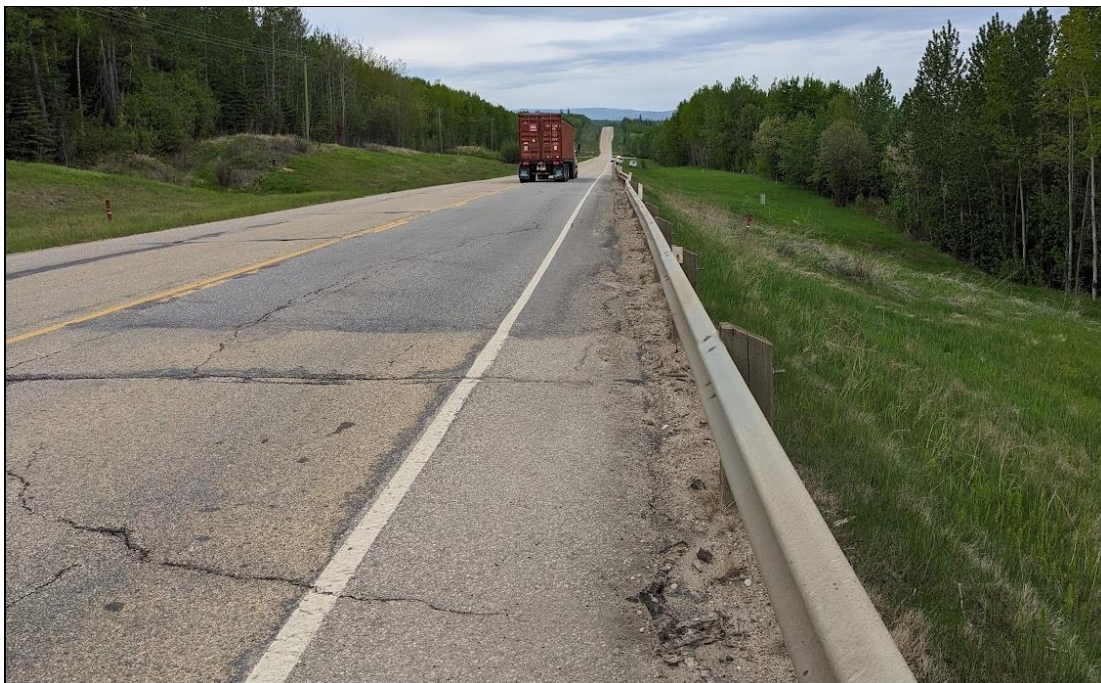
**Photo No. 4 – Looking west at reflective cracks from the eastern limit of the landslide**

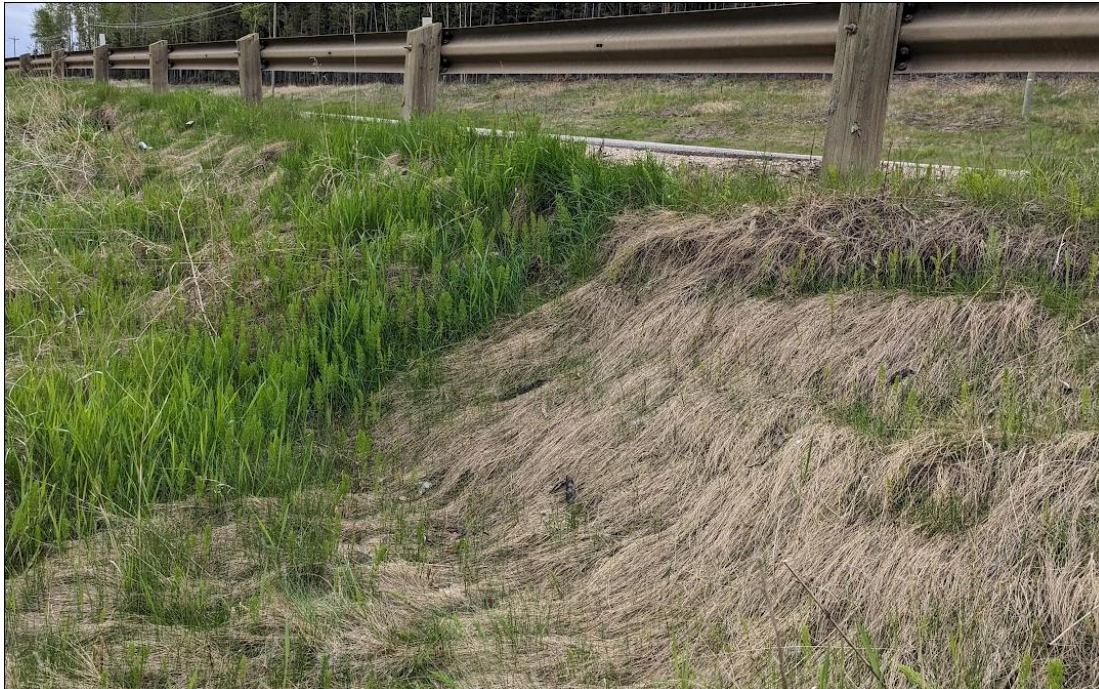
**Photo No. 5 – Middle landslide block: Head scarp crack retrogressing into the highway; 600 to 1.2 m drop from original ground ( no change from 2023)**

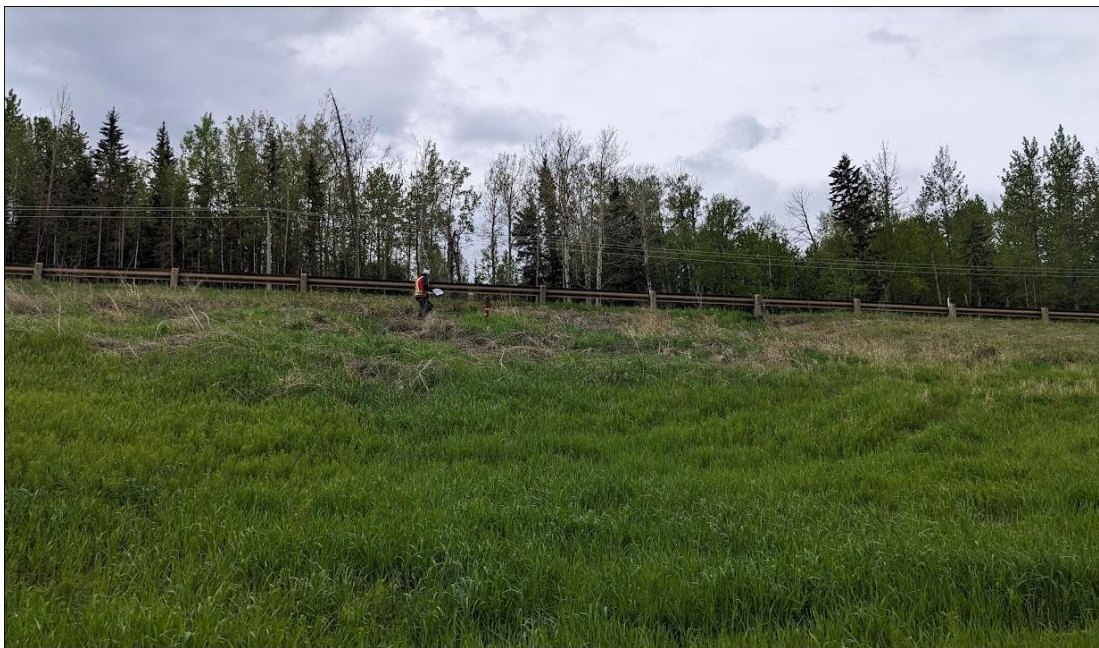
**Photo No. 6 – Looking south at active landslide scarp cracks on the highway side slope**

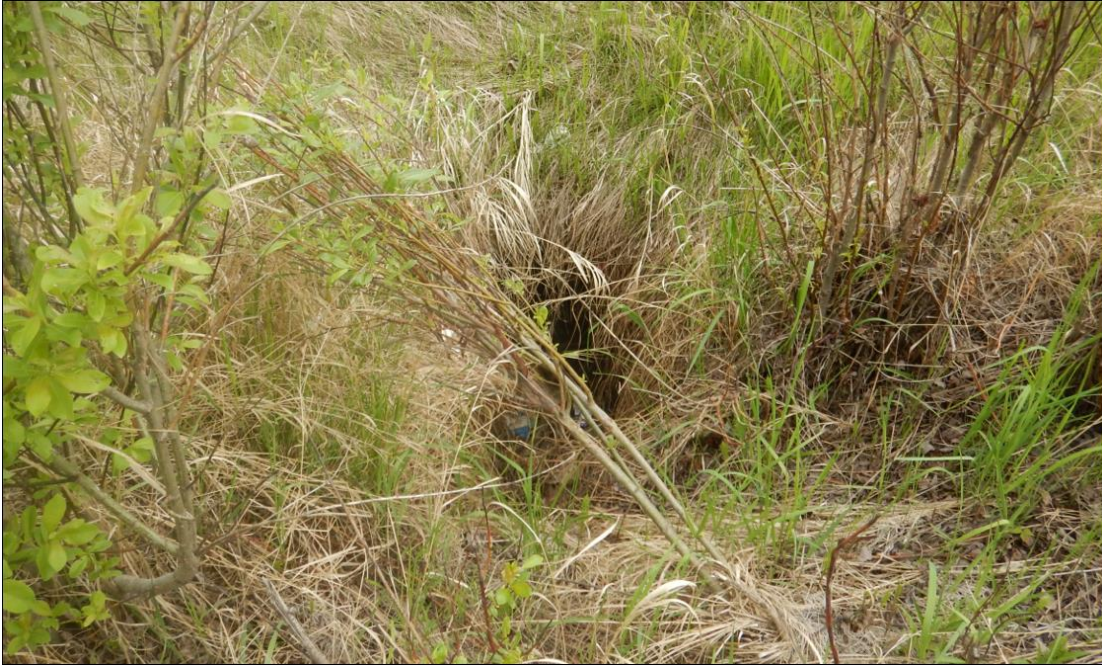
Furthermore, the existing culvert to the west of the active landslide area is in a poor condition.

**Photo No. 7 – 800 mm diameter culvert inlet. Culvert was rusty, partially blocked with vegetation and filled with garbage**

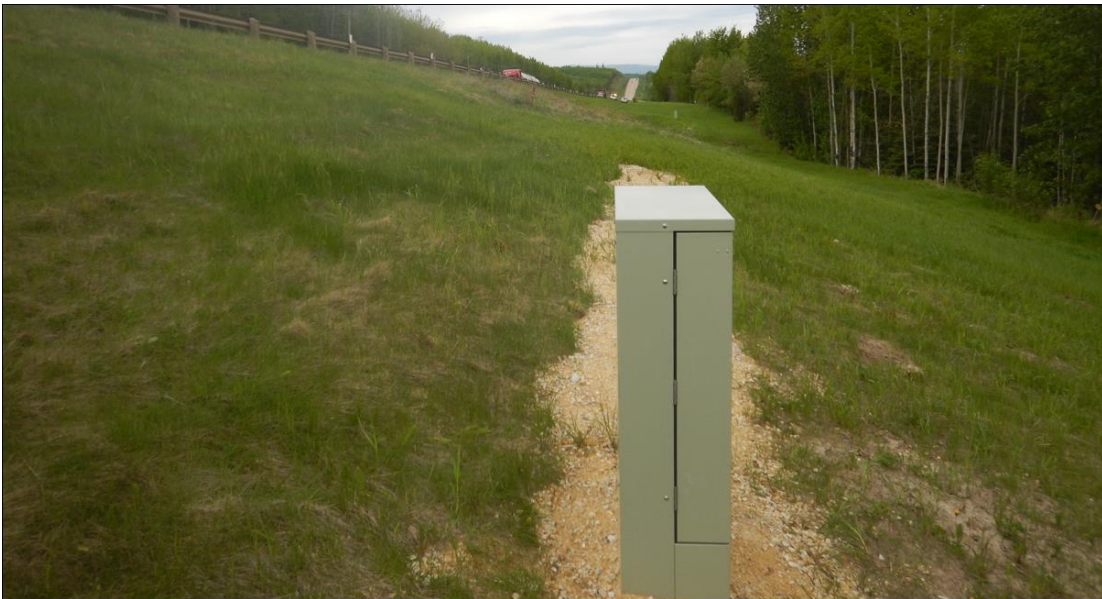
**Photo No. 8 – Looking west at the TELUS box installed as part of the line relocation in 2024**

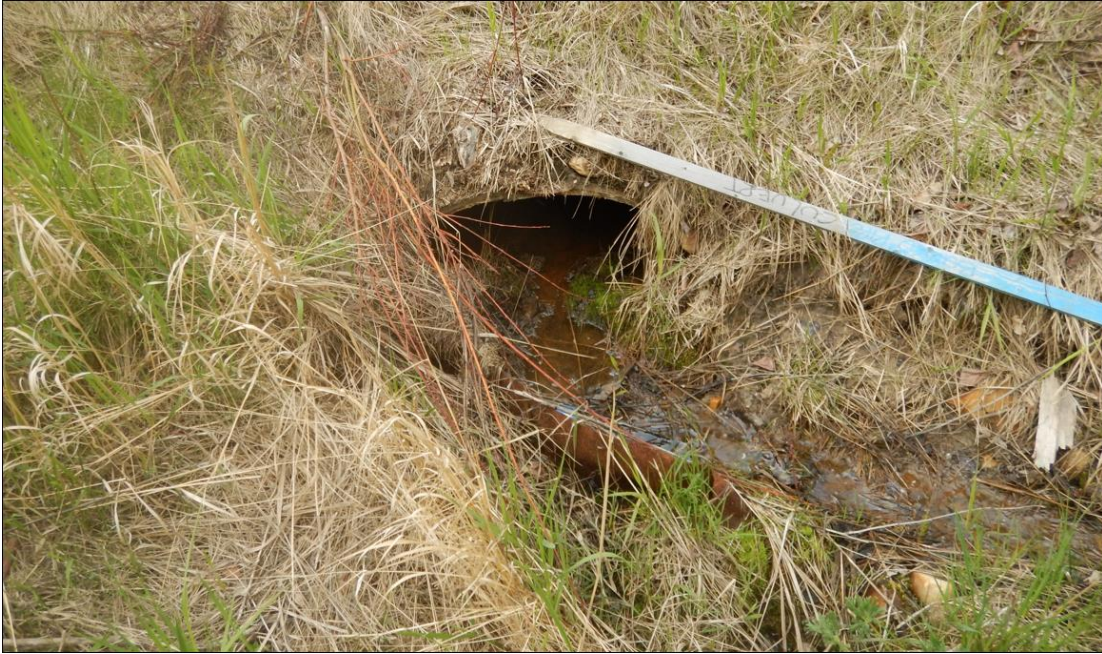
**Photo No. 9 – Looking at 800 mm CSP culvert outlet**
