ALBERTA TRANSPORTATION LANDSLIDE RISK ASSESSMENT

SECTION A: GEOTECHNICAL FILE REVIEW

SITE NC73: HWY 2:46 MITSUE FROST HEAVE (km 39.5)

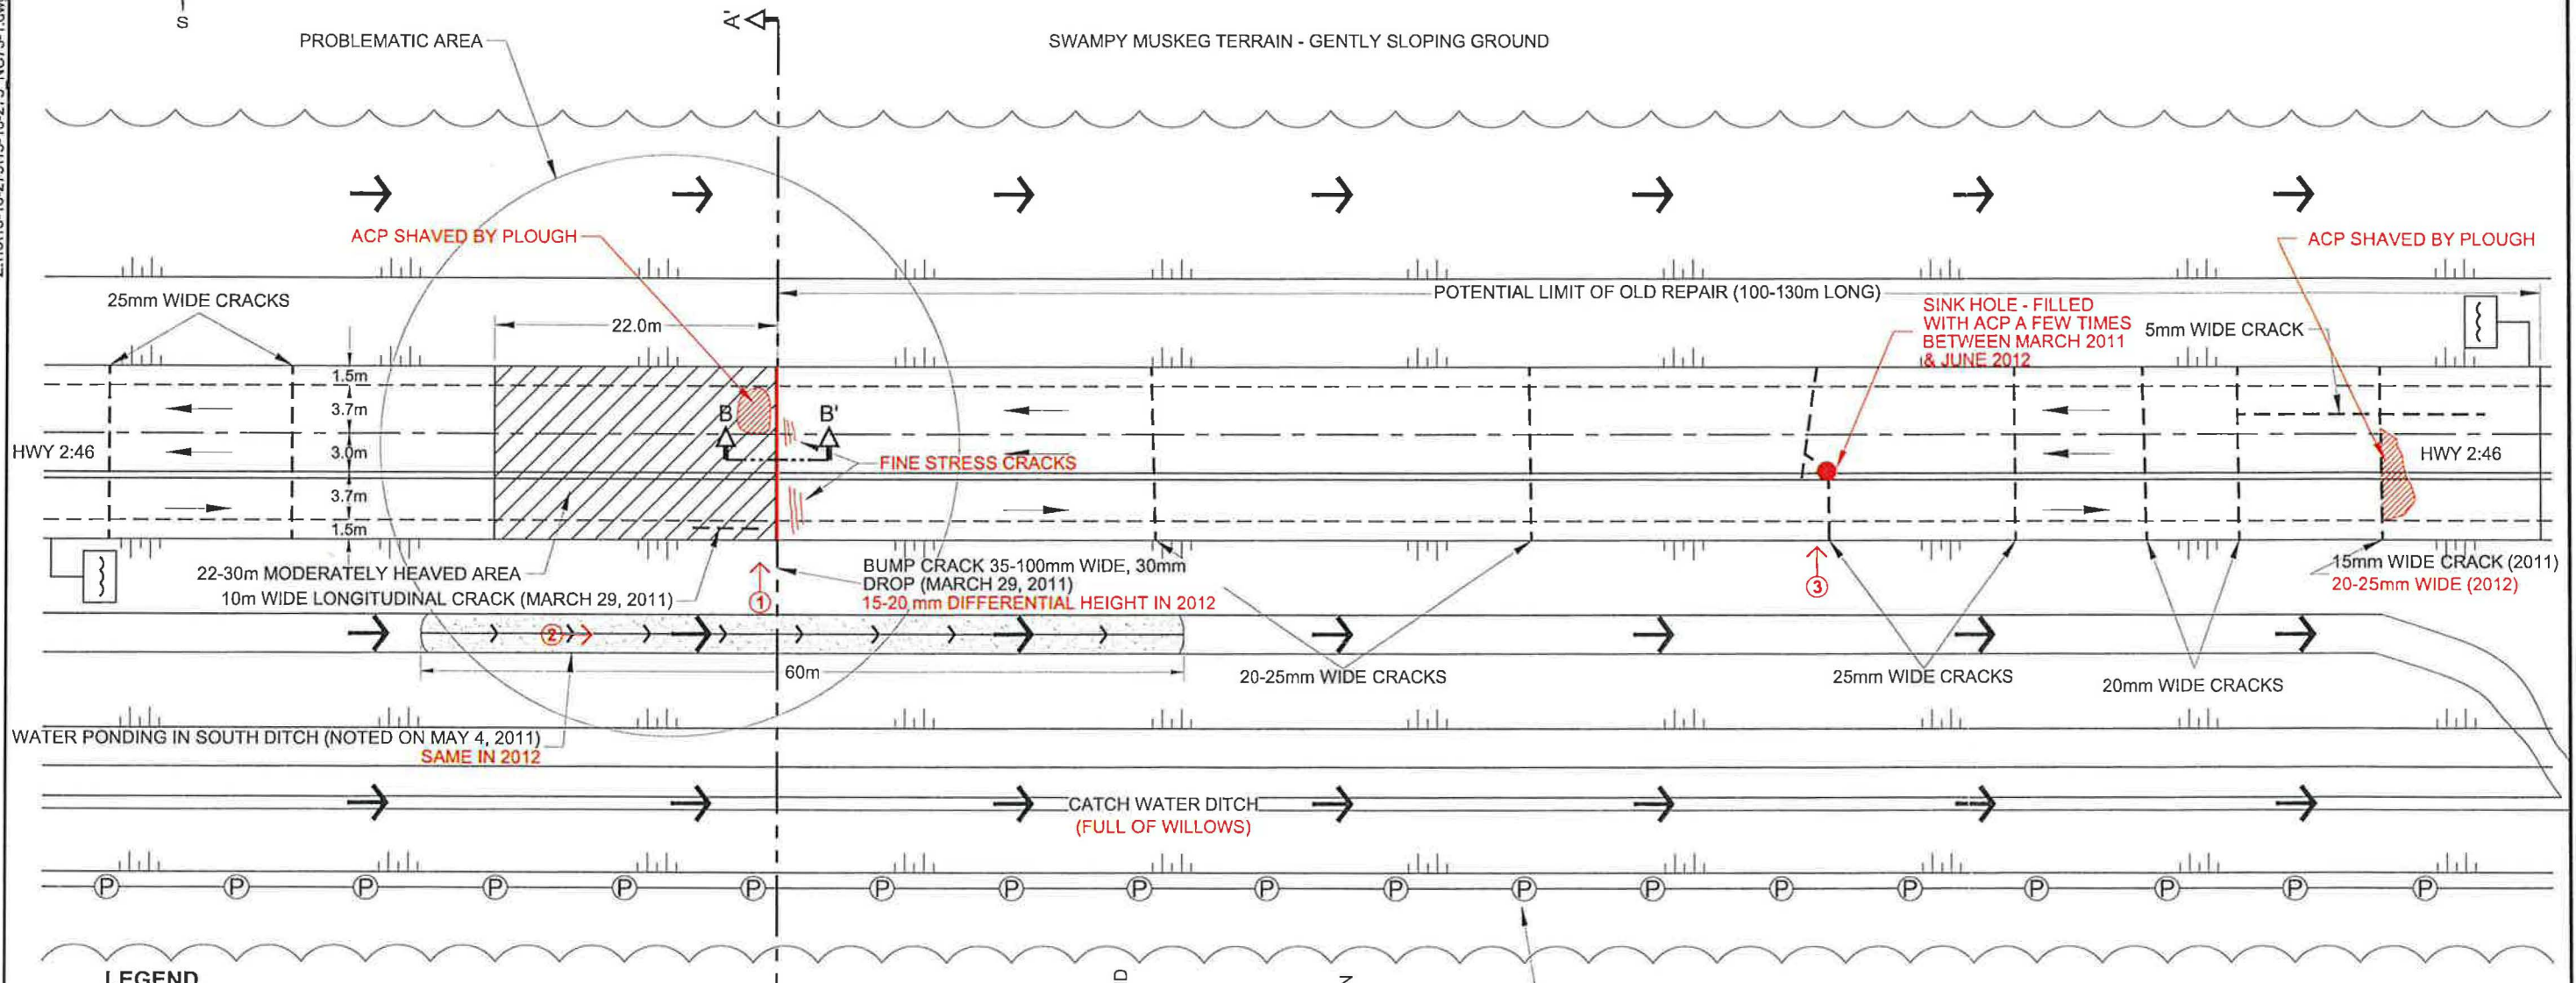
FIGURE NC73-1

The primary issue of the site is the presence of a sharp transverse bump crack across the highway surface, which continued to adversely affect the highway rideability. The bump crack is typically 35 mm to 100 mm wide with 15 mm to 20 mm differential heights across the crack surface. Details of the main features of the site are shown in a sketch on Figures NC73-1 and NC73-2. Figure NC73-2 shows a simplified cross-section across the highway.

According to existing information (refer to Section G), this section of the highway was insulated in 2008 to the east of the existing crack. Site inspection visits and review of report records indicated that the crack had developed between the insulated and uninsulated sections of the highway. It appears that the crack developed due to insufficient transition length of insulation at the crack location, resulting in differential frost heave between treated and untreated roadway sections at this location.

Presence of high ground water level (due to poor surface drainage in the ditch) and frost susceptible soils below the pavement structure in the untreated section are probably the main triggers for the ongoing seasonal frost heave issue.

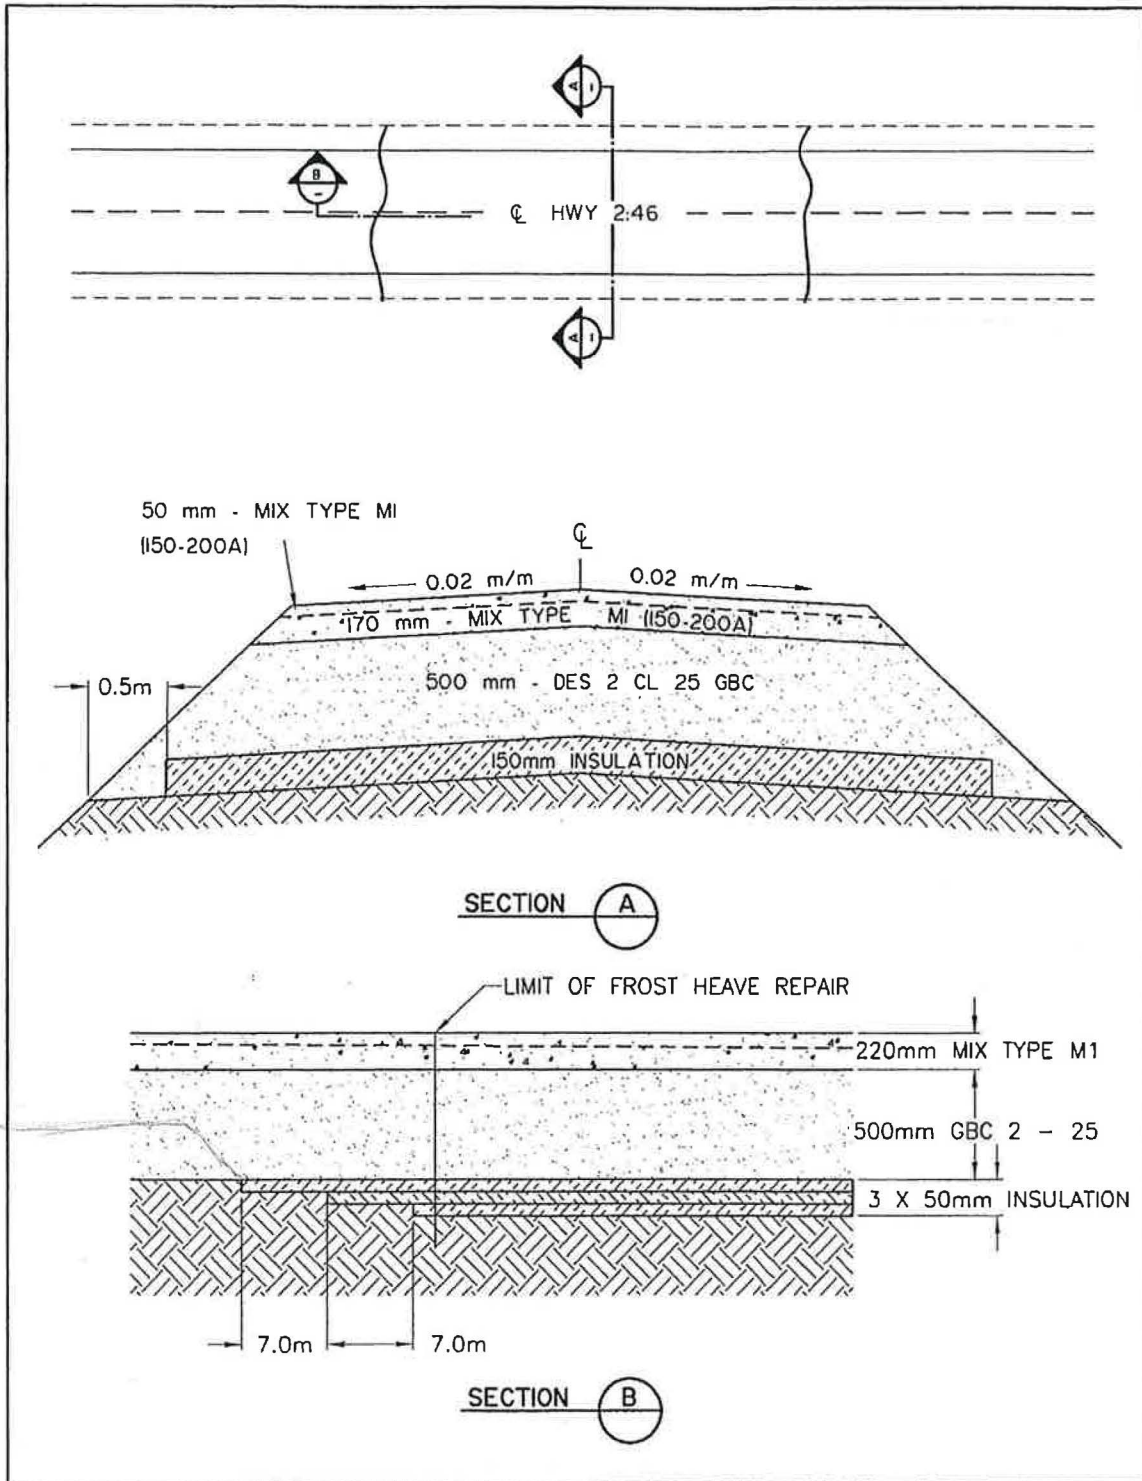
PLAN AND SECTIONS OF FROST HEAVE REPAIR				
	Region	Dwn. By	Check	Plan No. 7217-4	
	North Central	JCB	LM	03/13/07

At approximately kilometre 39.40 there is a frost heave which requires repair. The repair shall consist of the excavation of existing pavement structure and subgrade materials, installation of 150 mm of extruded polystyrene insulation ("STYROFOAM Brand High Load 100" or approved equivalent) on existing subgrade or base, 500 mm of granular base course and 220 mm of asphalt concrete pavement. Plan and sections are shown in Plan No. 7217-4. Exact limits of the repair will be staked in the field by the Consultant.

The Contractor shall sawcut, excavate and dispose of the existing pavement, base and subgrade to a depth of 800 mm below existing surface. The Contractor shall take ownership of the waste asphalt pavement.

The Contractor shall level and compact the exposed surface. Then the insulation shall be installed in three (3) layers, overlapping the boards such that there are no continuous joints through the insulation layer. The granular base course shall then be placed on top of the insulation. The Contractor shall ensure that no equipment or vehicles are operated on the exposed insulation. After the granular base is placed and compacted, the Contractor shall place the asphalt concrete pavement.

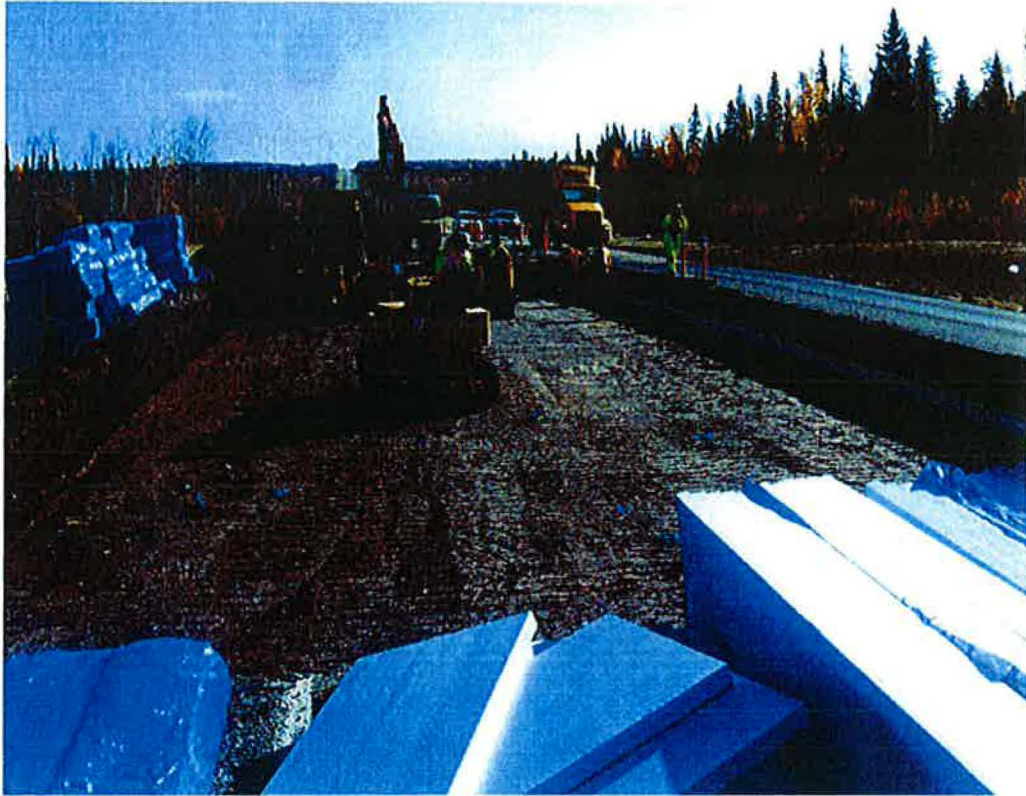
In-Line completed subgrade construction and GBC placement at the North Passing Lane of the Devonshire intersection. Frost heave repair was started on Hwy 2:46 from km 39.459 to km 39.545. Undercut was excavated to a depth of 0.82 metre below the asphalt surface and Styrofoam insulation was installed before backfilling with GBC and ACP. Topsoil, roots and stumps were noticed in some part of the excavated material at the bottom of this frost heave affected area.

Picture -15 Subgrade Excavation for Frost Heave Repair (km 39.459 to km 39.545)

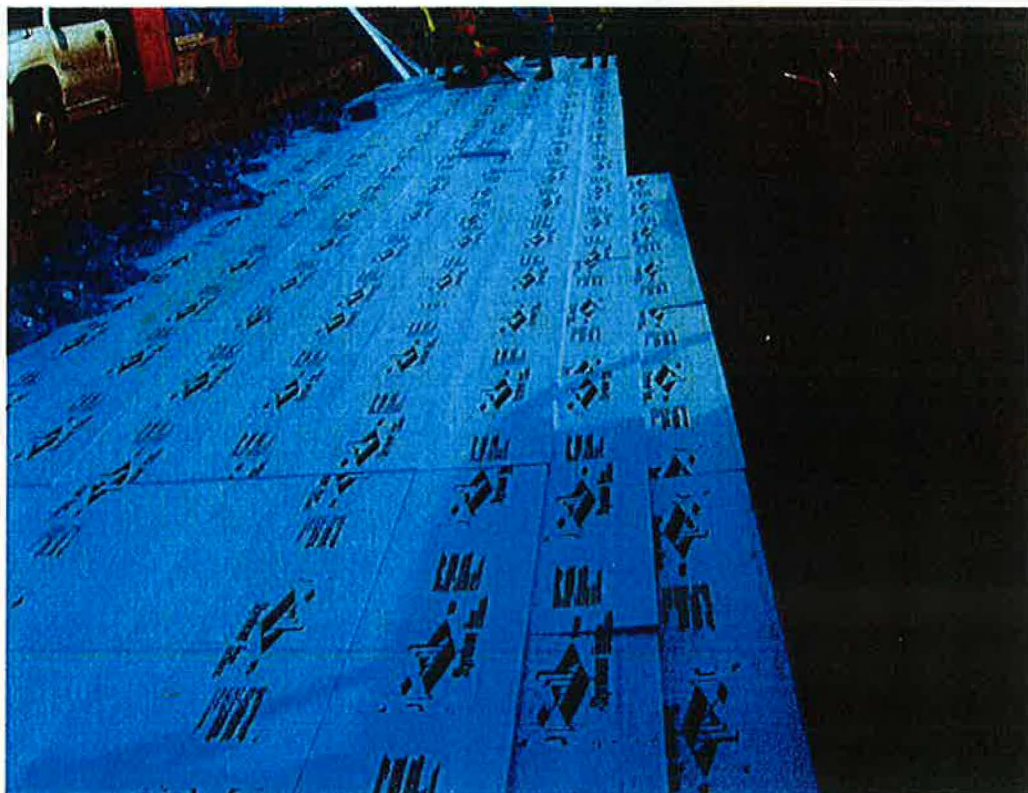
Picture -16 Styrofoam Installation for Frost Heave Repair (km 39.459 to km 39.545)
