GEOHAZARD ASSESSMENT PROGRAM
NORTH CENTRAL REGION – ATHABASCA
2020 SPRING INSPECTION

| Site Number | Location | Name | Hwy | km |
|---|---|---|---|---|
| NC 073-1 | 36 km Northwest of the Junction of Hwy 2:46 and Hwy 44:04 | Hwy 2:46 Mitsue Frost Heave | 2:46 | 39.5 |

| | Date | PF | CF | Total |
|---|--|---|---|---|
| Current Inspection: | June 05, 2020 | 9 | 2 | 18 |

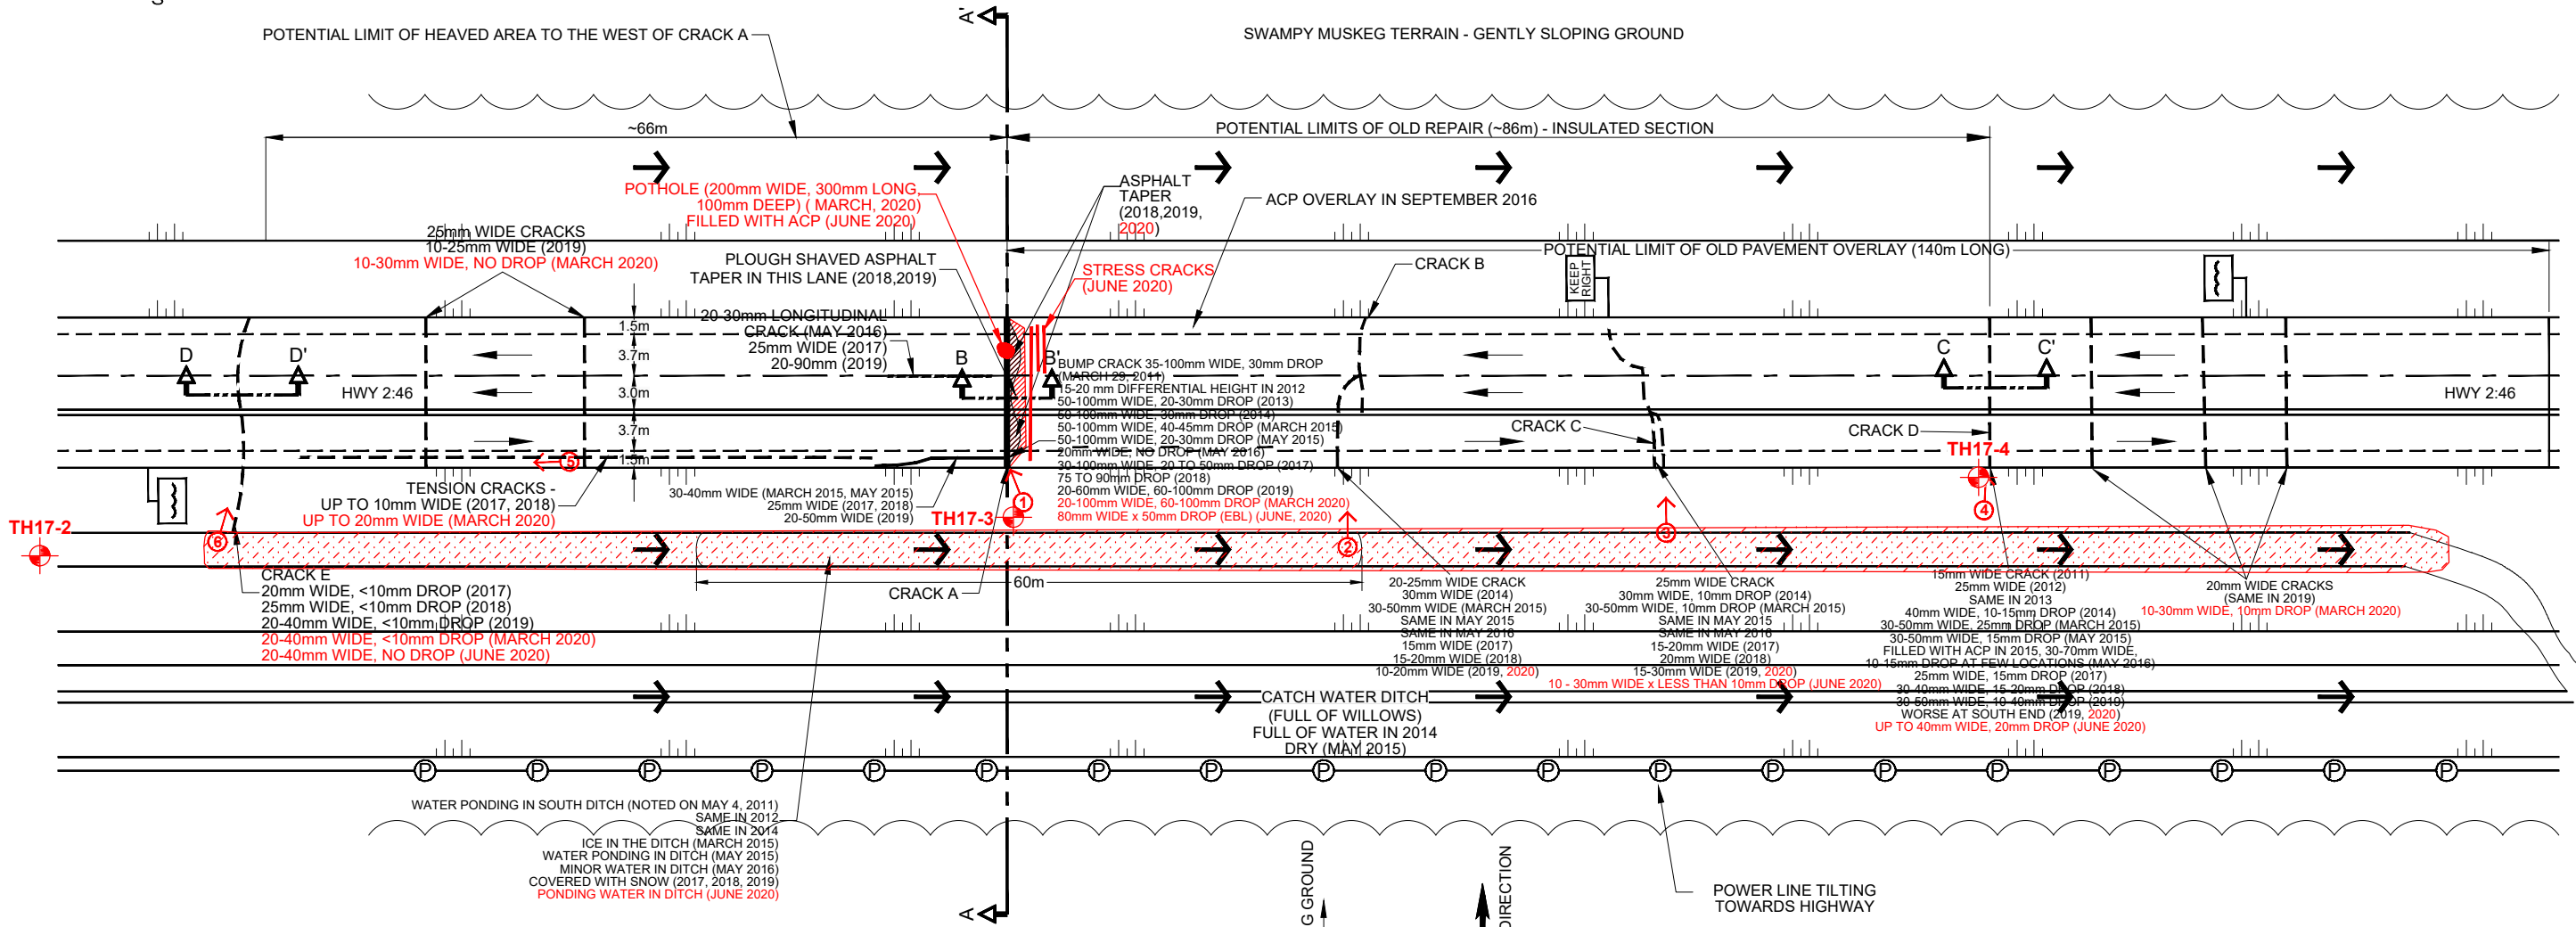
DWG NO. NC073-1-1

**NORTH CENTRAL REGION (ATHABASCA AREA)
2020 GEOHAZARD ASSESSMENT
(JUNE 5, 2020 SITE INSPECTION)
NC073-1: HWY 2:46 MITSUE FROST HEAVE
SITE PLAN**

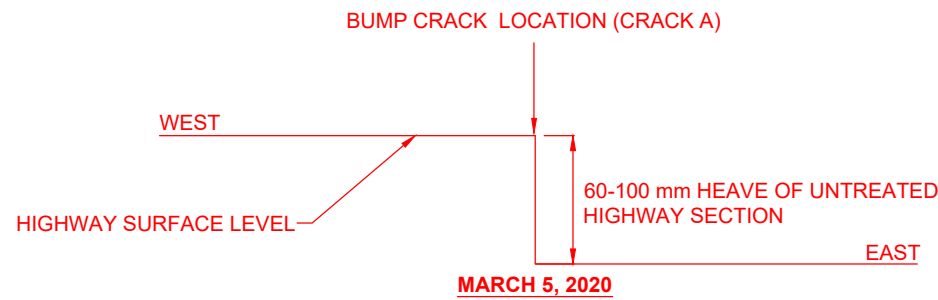
CROSS SECTION B-B' - PROFILE ALONG HIGHWAY SURFACE AT BUMP CRACK A LOCATION
SCALE 1:5

The ACP patch and pothole filling completed up to date has temporarily improved driving conditions across Crack A. However, the seasonal differential movement between the treated and untreated sections of the highway at Crack A location continued to be severe, resulting in the development of a sharp differential height across the crack surface and rough driving conditions. The sharp drop continued to constitute a safety hazard to motorists, particularly in the wintertime. It is anticipated that the existing drop across the crack surface will continue to get worse with time and impact the roadway condition until a suitable remedial measure is successfully implemented.

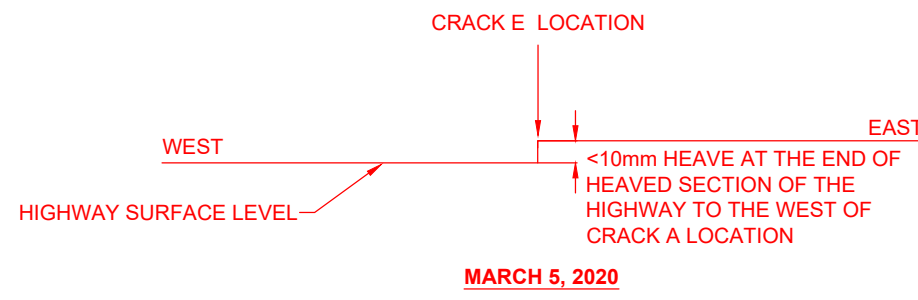
CROSS SECTION D-D' - PROFILE ALONG HIGHWAY SURFACE AT CRACK E LOCATION
SCALE 1:5

The heaved section of the highway to the west of Crack A location is about 66 m long and appears to terminate at Crack E location.

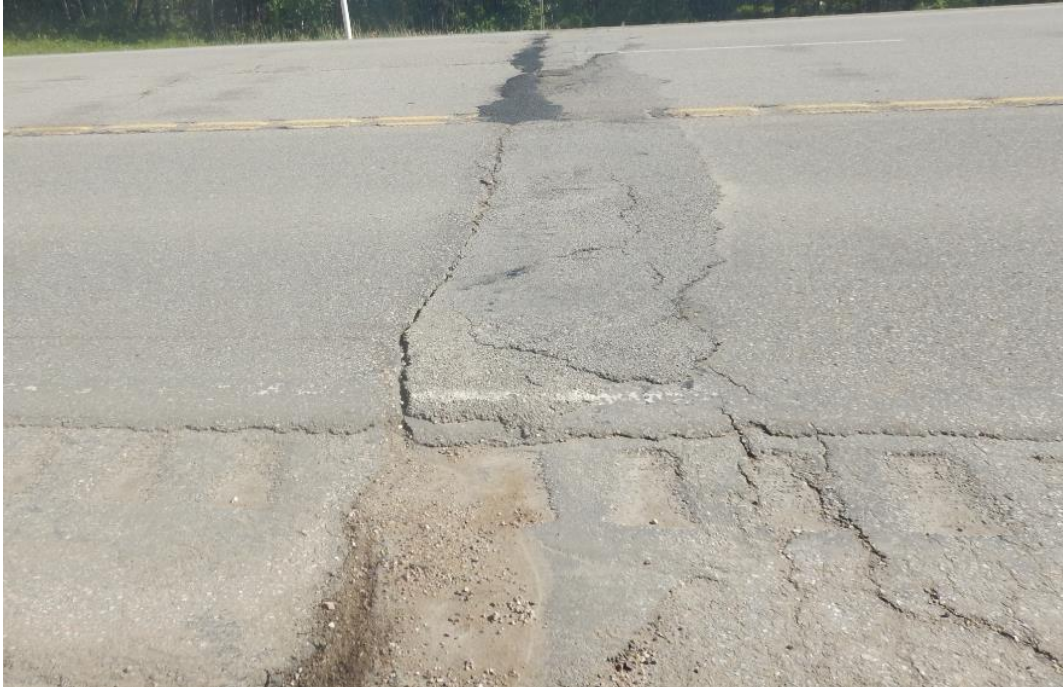
The differential frost heave issue between the treated and untreated sections of the highway is presumably due to insufficient transition length of insulation at the ends of the treated section (i.e. at Crack A and D locations). The presence of the frost-susceptible soils and high ground water levels below the pavement structure in the untreated sections are likely the main triggers for the ongoing seasonal frost heave issue.

Photo # 1 Looking north at the bump crack (Crack A); there is about 50 mm drop at the crack location; drop is more noticeable within the EBL

- Place additional asphalt on the east side of Crack A location, as needed, to further smooth existing drop. The asphalt taper should be extended long enough towards east to provide a smooth ride over the bump crack.
- Seal all open cracks inside and outside the treated section of the highway (approximately 70 m beyond each end of Cracks A and D) to prevent surface water infiltration into the sub-grade material.
- Maintain the bump warning signs and reduce the speed in both directions, particularly during the winter season, to warn motorists of existing hazard.

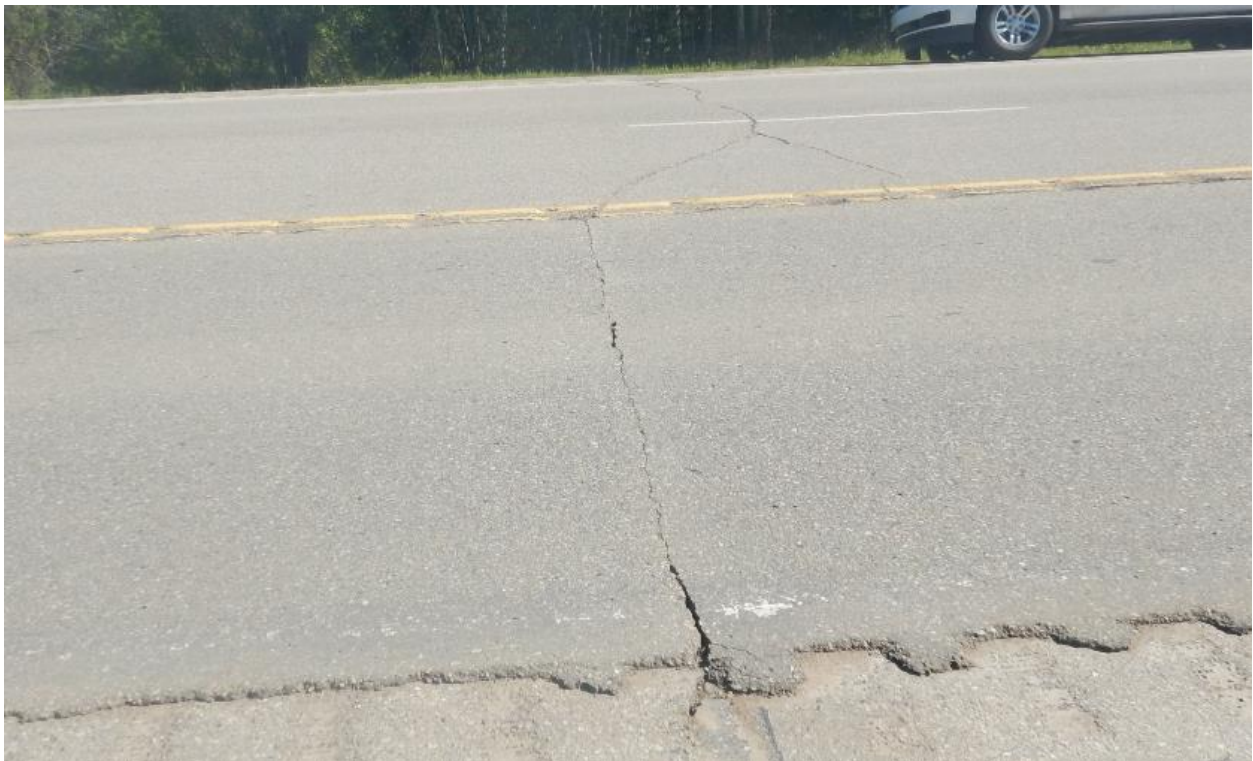
Photo # 2 Looking north at Crack B

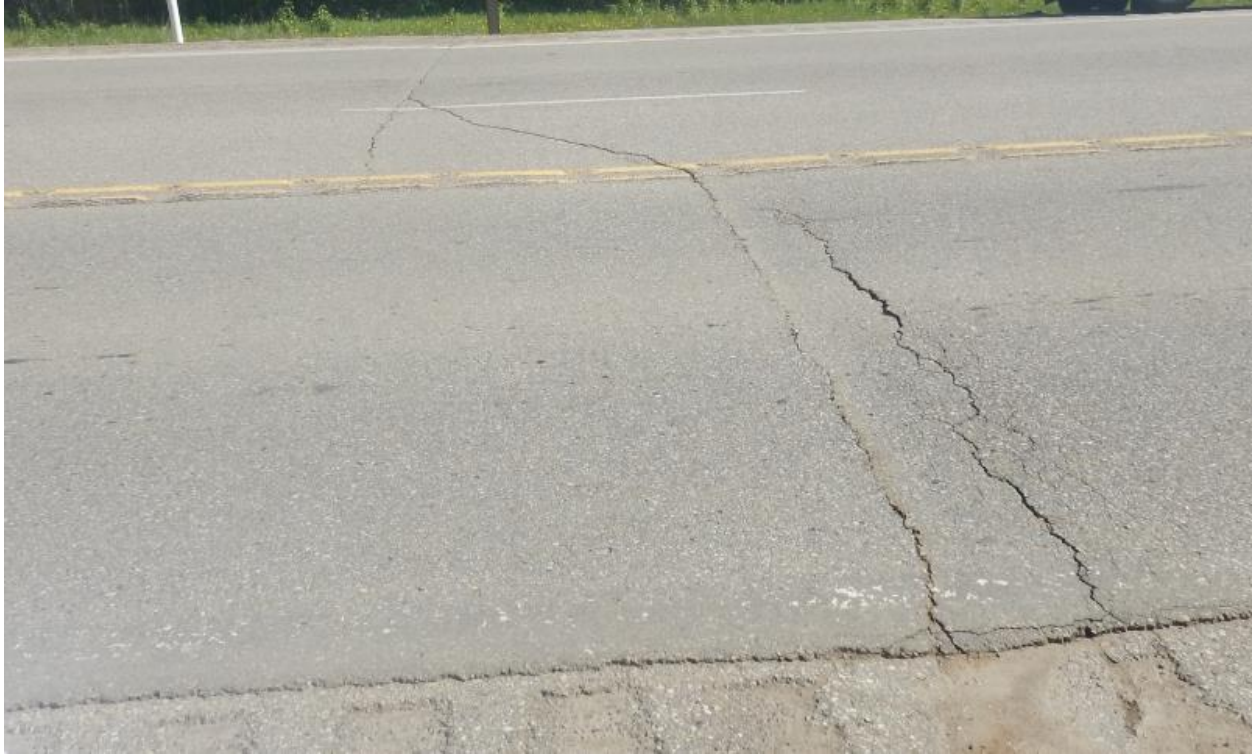
Photo # 3 Looking north at Crack C

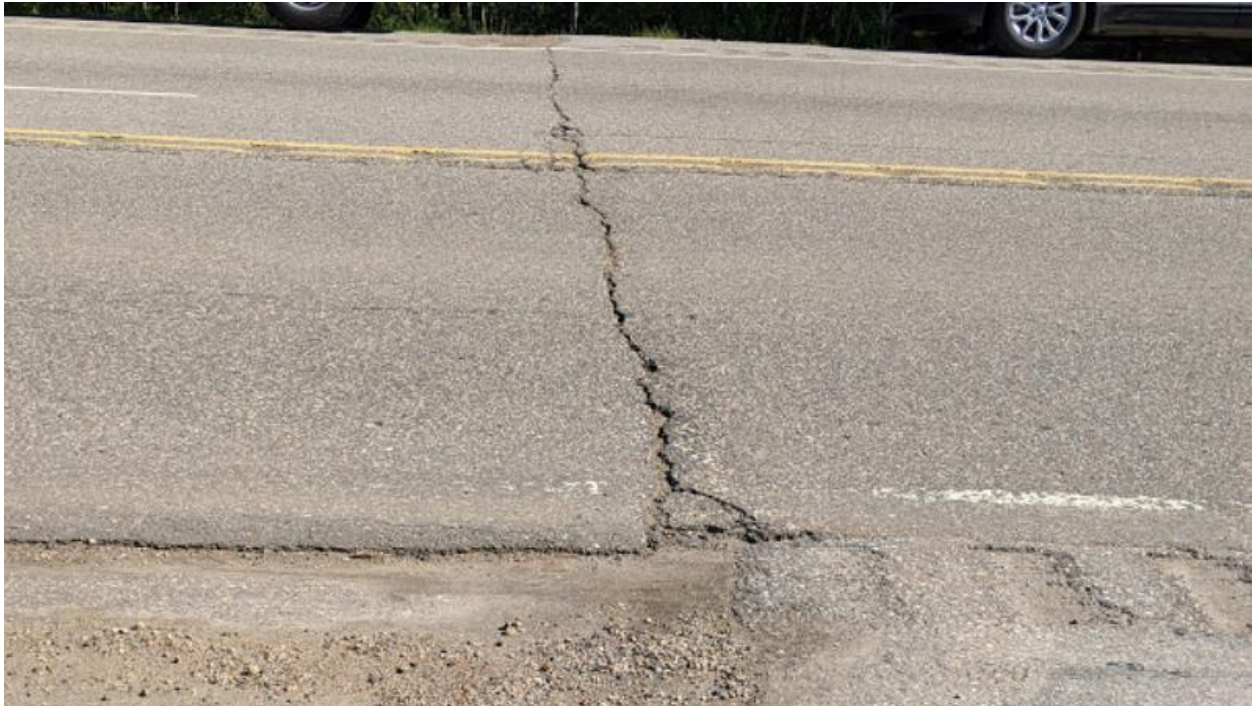
Photo # 4 Looking north at Crack D (East end of treated section)

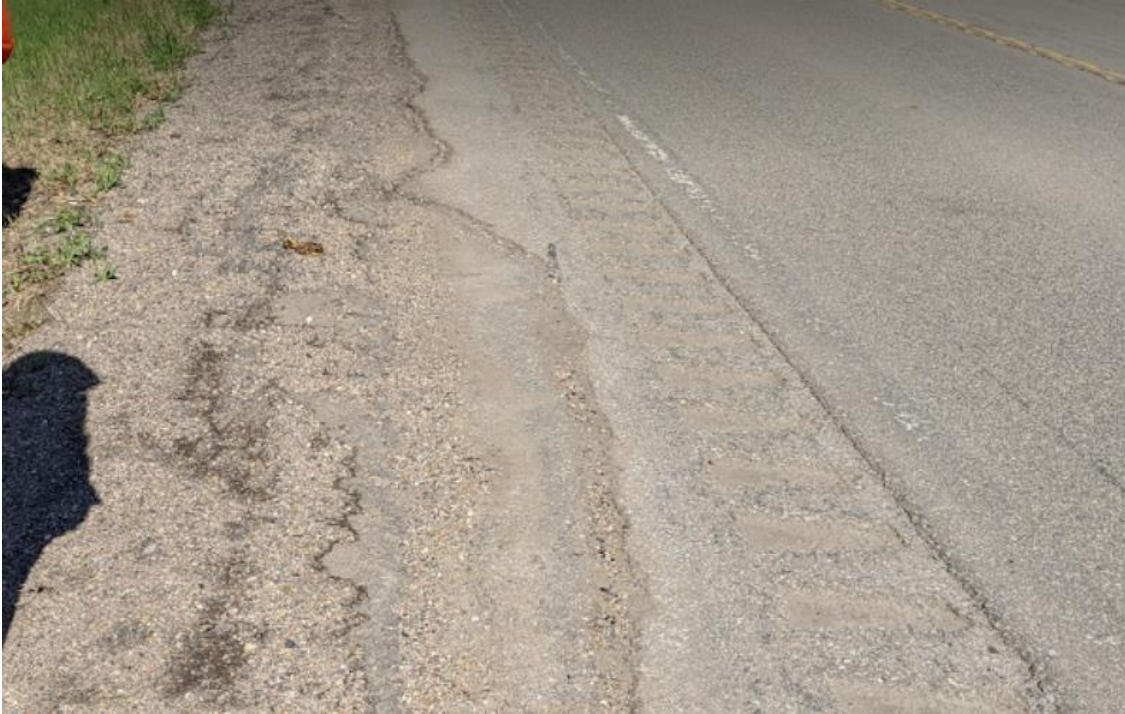
The longitudinal tension cracks in the highway EBL shoulder and side slope reflect the differential heave between the highway surface and the highway shoulder/slope surface. The differential movement is likely due to snow insulation on the side of the road.

Photo # 5 Looking west at a longitudinal crack along the highway shoulder

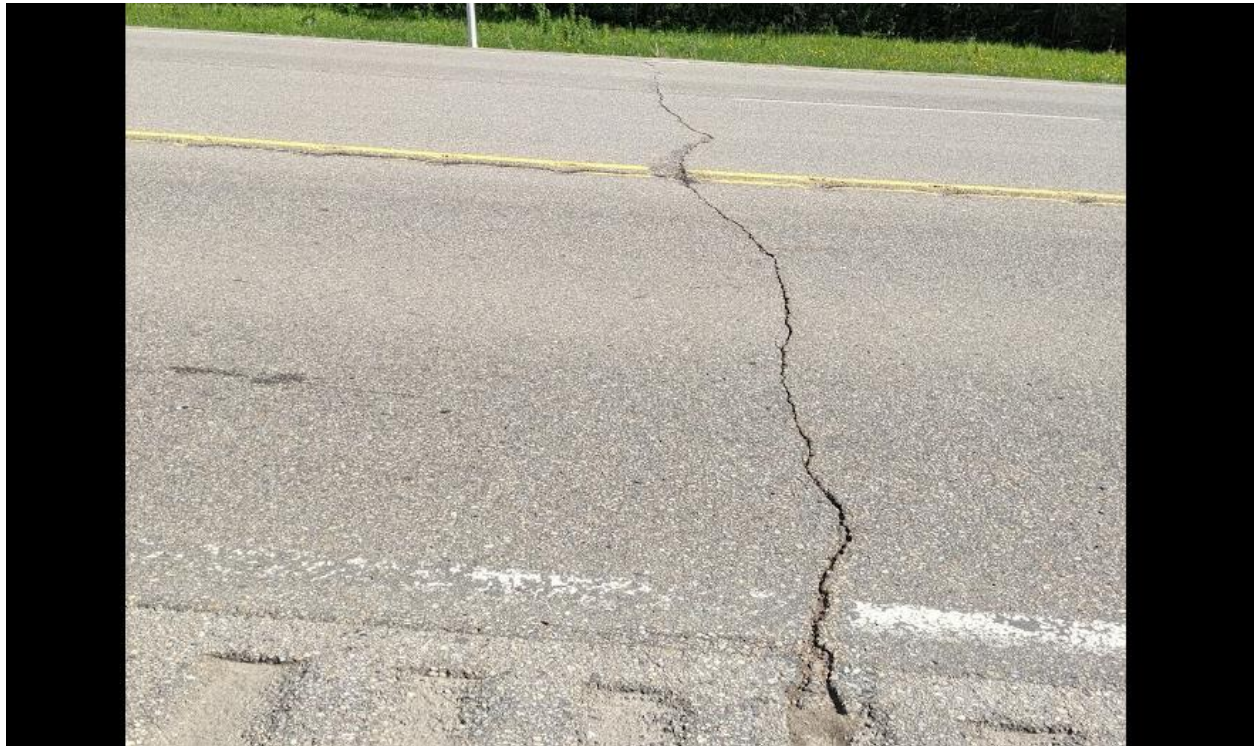
Photo # 6 Looking north at Crack E
