GEOHAZARD ASSESSMENT PROGRAM
NORTH CENTRAL REGION – ATHABASCA
2020 WINTER INSPECTION

| Site Number | Location | Name | Hwy | km |
|---|---|---|---|---|
| NC 073-1 | 36 km Northwest of the Junction of Hwy 2:46 and Hwy 44:04 | Hwy 2:46 Mitsue Frost Heave | 2:46 | 39.5 |

| | Date | PF | CF | Total |
|---|--|---|---|---|
| Current Inspection: | March 05, 2020 | 9 | 2 | 18 |

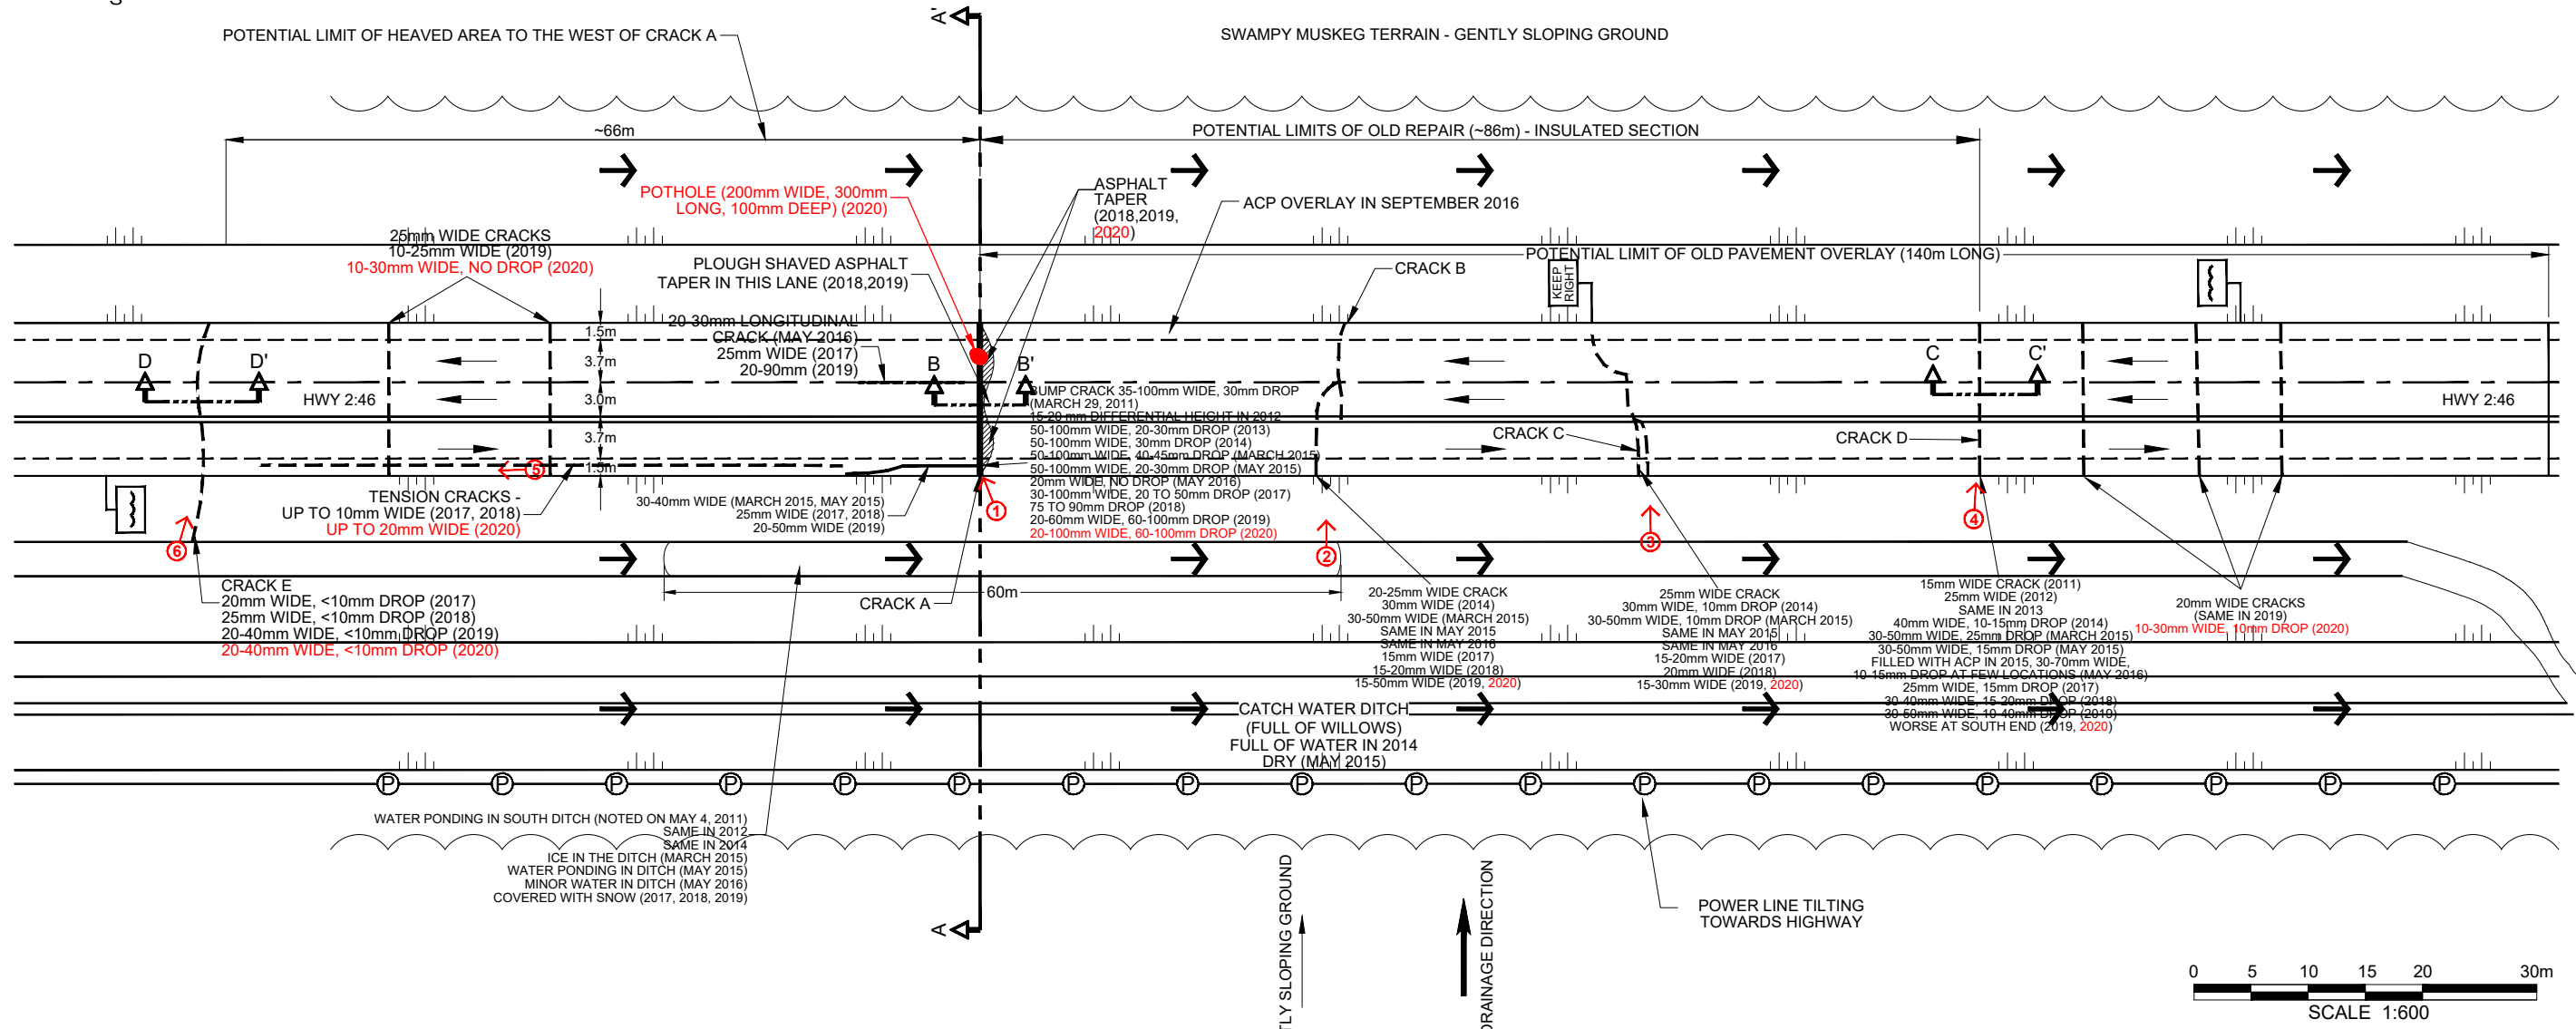
DWG NO. NC073-1-1

**NORTH CENTRAL REGION (ATHABASCA AREA)
2020 GEOHAZARD ASSESSMENT
(MARCH 05, 2020 SITE INSPECTION)
NC073-1: HWY 2:46 MITSUE FROST HEAVE
SITE PLAN**

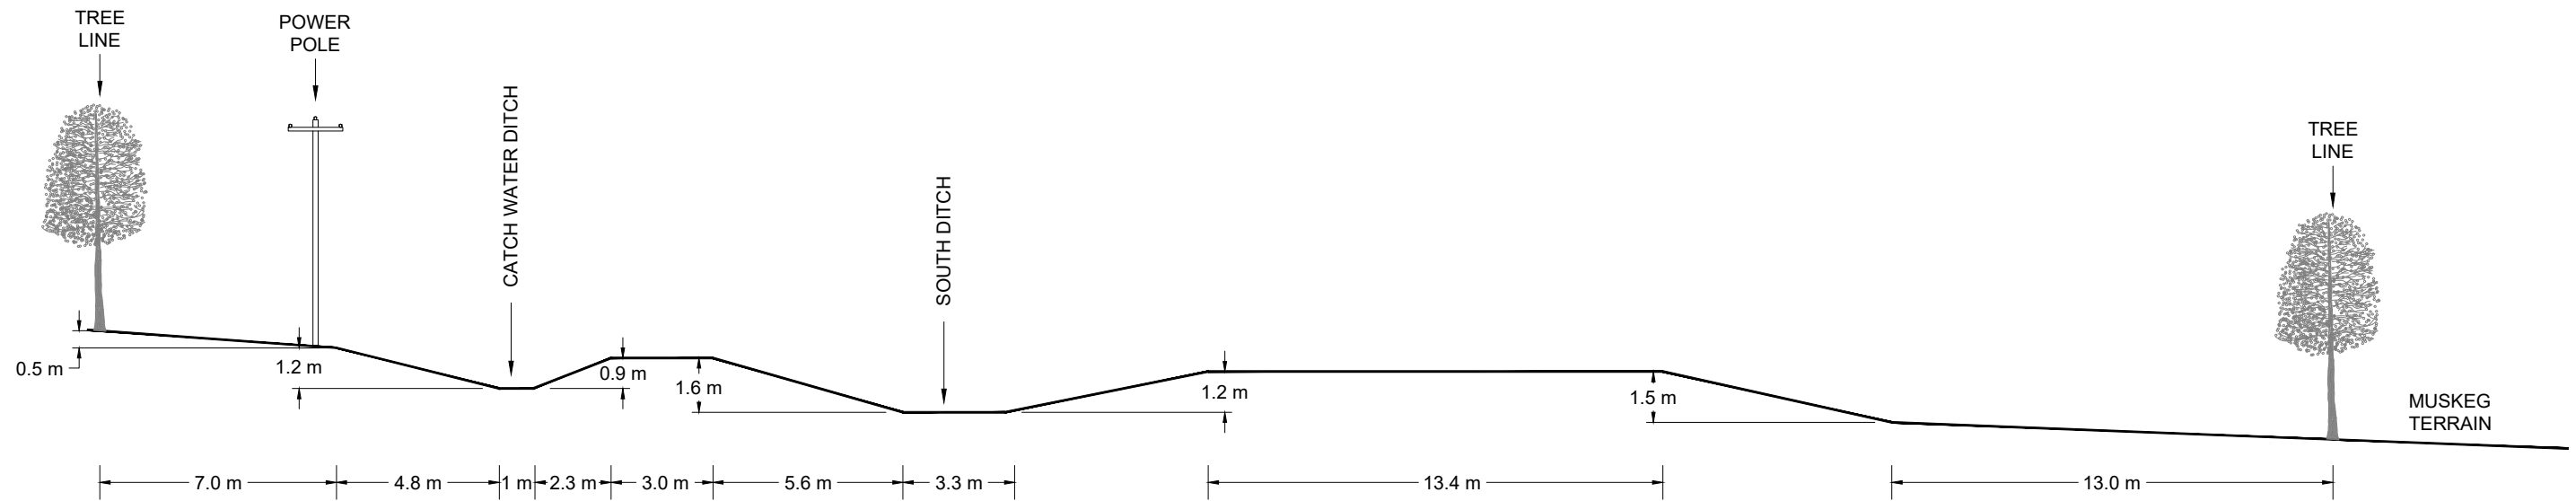
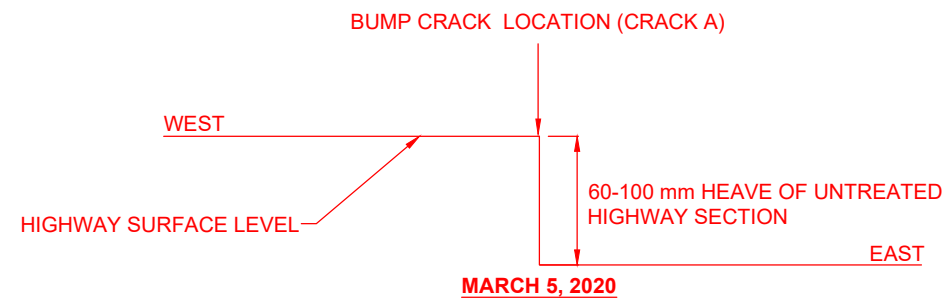
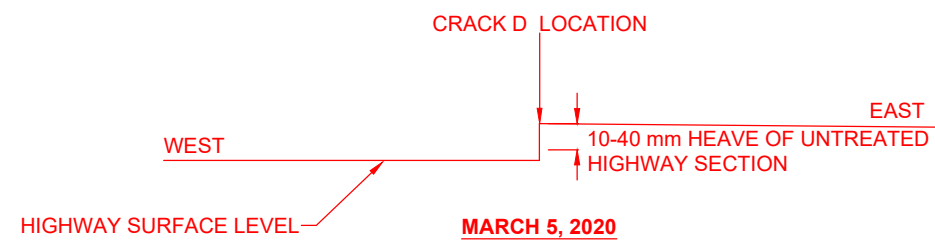
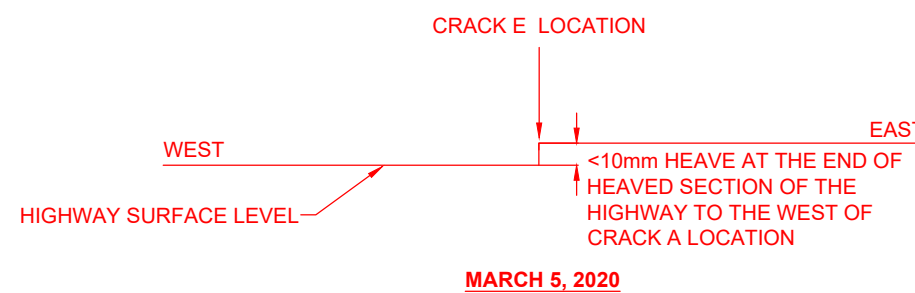
DWG NO. NC073-1-2

NC073-1: HWY 2:46 MITSUE FROST HEAVE
CROSS SECTIONS A-A', B-B', C-C' AND D-D'

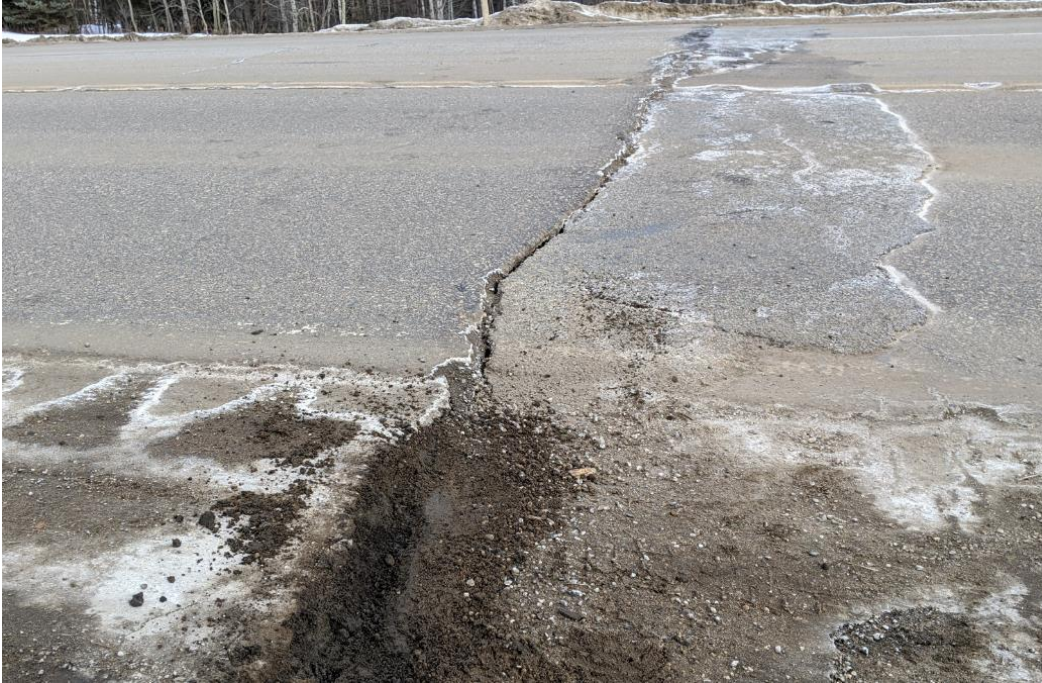
| Observations: | Description | Worse? |
|--|--|---|
| <input checked="" type="checkbox"/> Pavement Distress | <p>Crack A in the western limit of the insulated section: 60 to 100 mm drop across the crack surface and a new pothole (200 mm W, 300 mm L, and 100 mm D) developing on the west bound lane; Crack D in the eastern limit of the insulated section: 30 to 50 mm wide with 10 to 40 mm drop across the crack surface; Crack E in the western limit of the heaved section: 20 to 40 mm wide with less than 10 mm drop across crack surface; Crack B: 15 to 50 mm wide with no drop; Crack C: 15 to 30 mm wide with no drop.</p> <p>Highway eastbound lane to the west of Crack A location (approximately 66 m long section): 10 to 20 mm wide longitudinal frost heave tension cracks along the highway edge of pavement and near the crest of the south embankment. Tension cracks terminate at Crack E location.</p> | <input checked="" type="checkbox"/> |

Photo # 1 Looking north at the bump crack (Crack A); there is about 60 to 100 mm drop at the crack location and plough shaved asphalt taper in the middle lane

- Place additional asphalt on the east side of Crack A location, particularly along the northbound lanes, to further smooth existing drop. The asphalt taper should be extended long enough towards east to provide a smooth ride over the bump crack.
- Existing pothole should be filled with asphalt or cold mix.
- Seal all open cracks inside and outside the treated section of the highway (approximately 70 m beyond each end of Cracks A and D) to prevent surface water infiltration into the sub-grade material.
- Maintain the bump warning signs and reduce the speed in both directions, particularly during the winter season, to warn motorists of existing hazard.

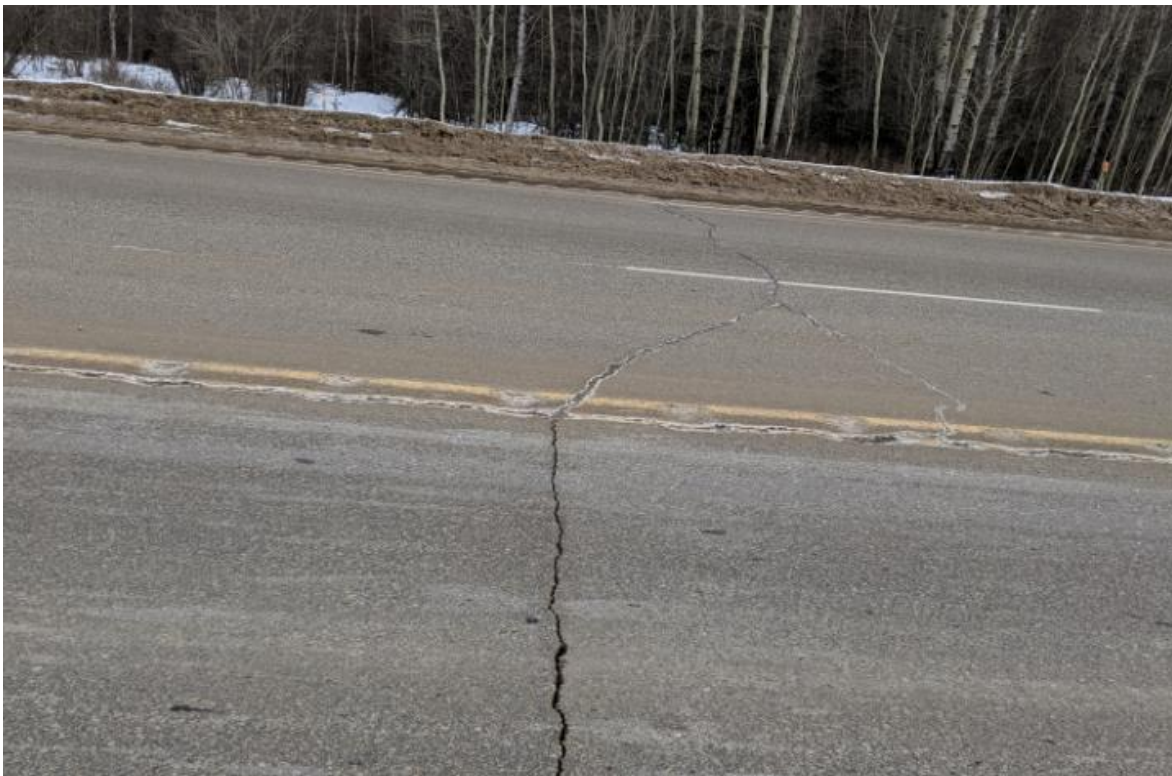
Photo # 2 Looking north at Crack B

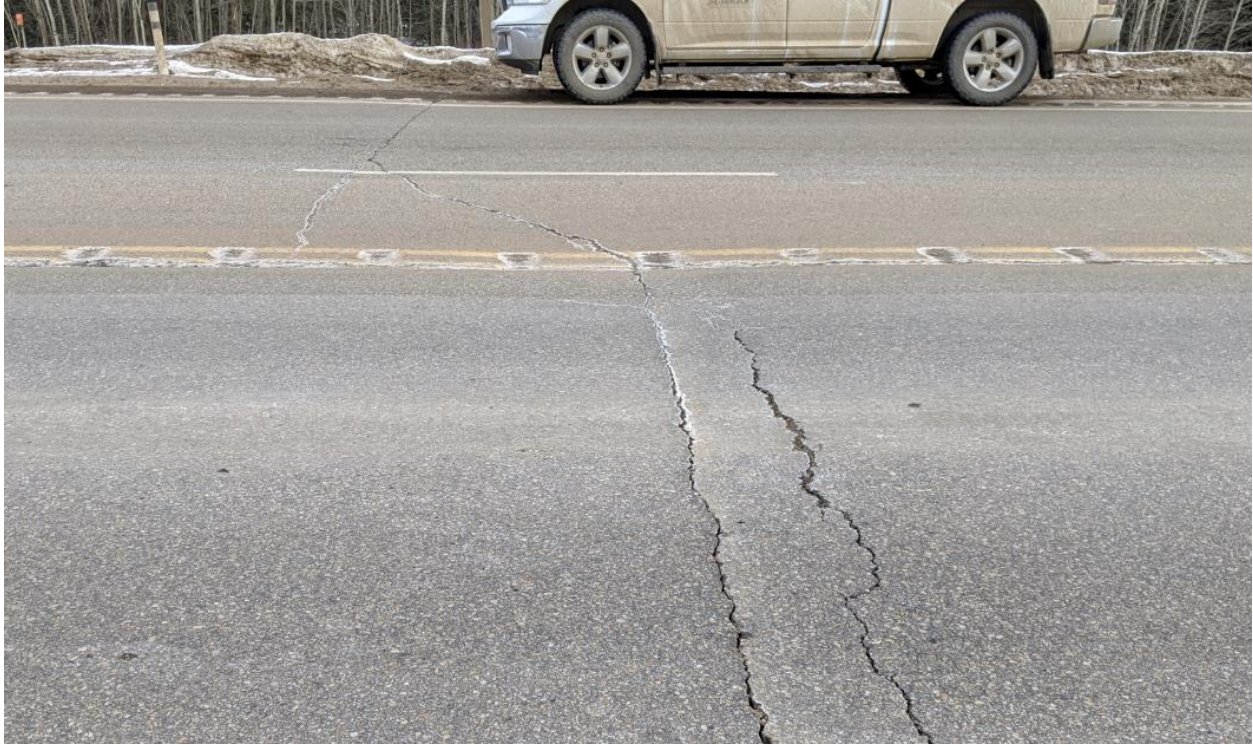
Photo # 3 Looking north at Crack C

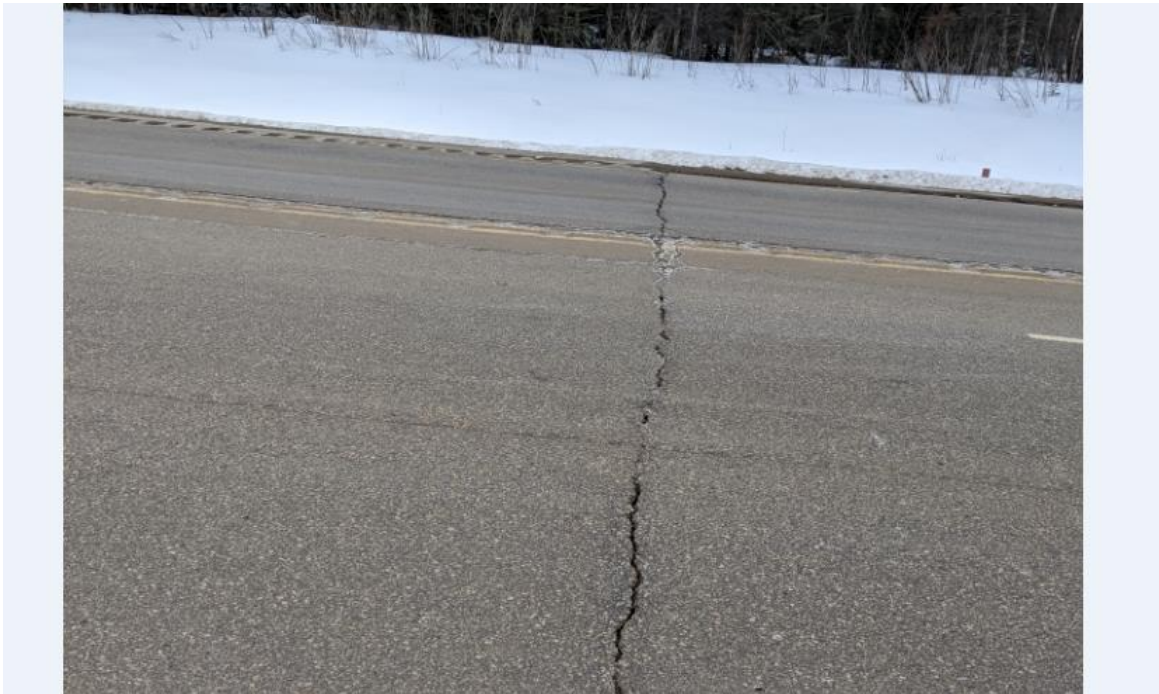
Photo # 4 Looking north at Crack D (East end of treated section)

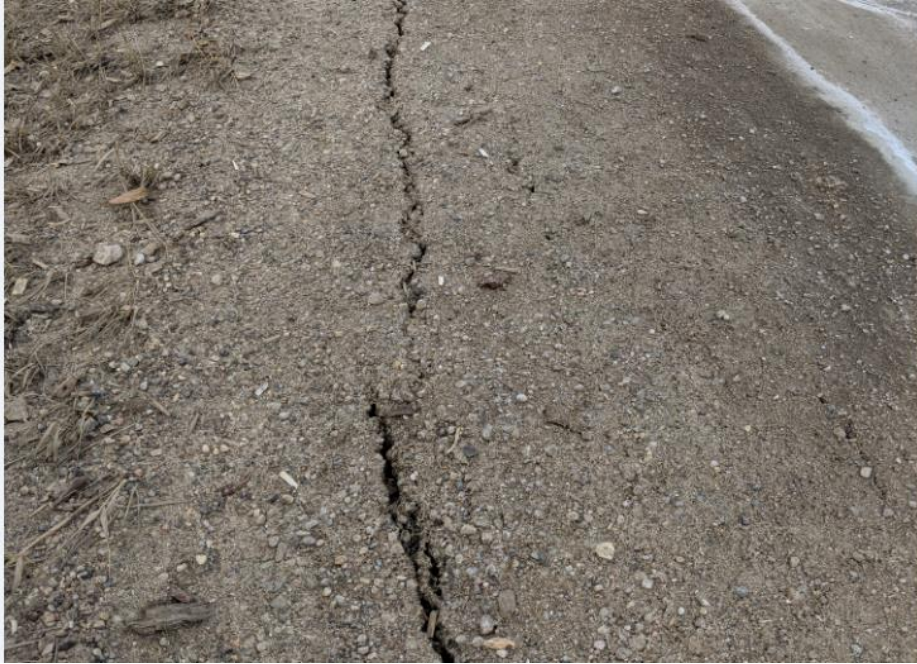
Photo # 5 Looking west at longitudinal crack along the shoulder

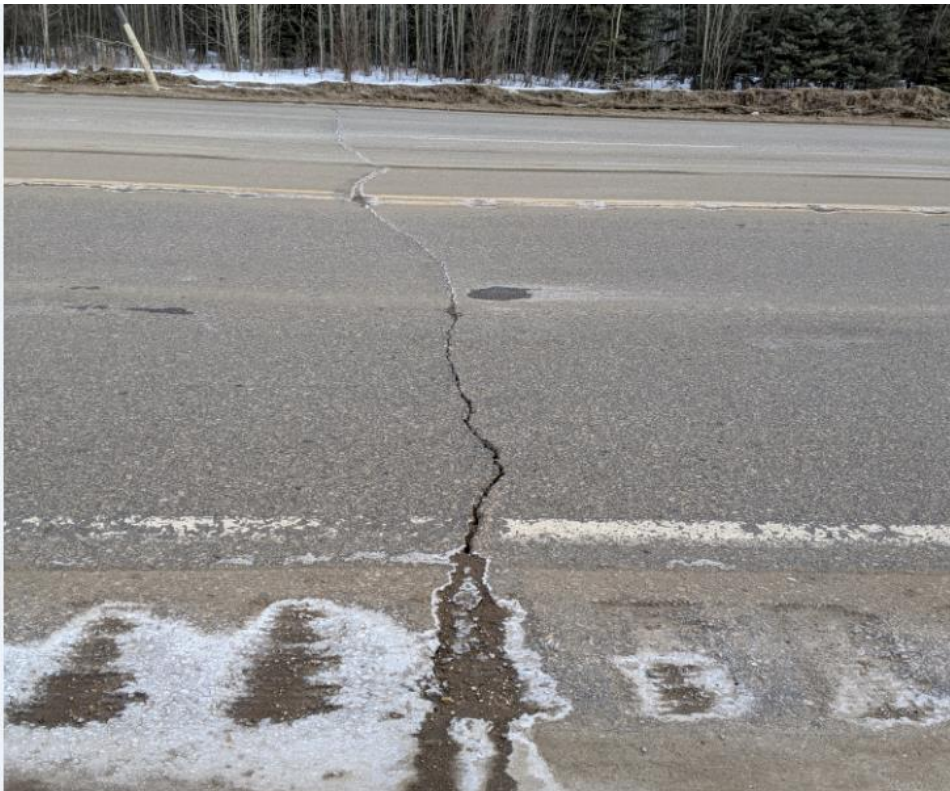
| Dimensions: | The heaved section of the highway to the west of the bump crack (Crack A) location is approximately 66 m long. Crack E defines the western limit of the heaved section of the highway. |

Photo # 6 Looking north at Crack E
