**TRANSPORTATION AND ECONOMIC CORRIDORS
GEOHAZARD ASSESSMENT PROGRAM
NORTH CENTRAL REGION – ATHABASCA &
FORT MCMURRAY DISTRICTS
2023 SITE INSPECTION**

Site Number	Location	Name	Hwy	km
NC 073-1	36 km Northwest of the Junction of Hwy 2:46 and Hwy 44:04	Hwy 2:46 Mitsue Frost Heave	2:46	39.5
Legal Description		UTM Co-ordinates (NAD 83)		
N.W.14-72-4-W5M		12 N 6124047	E 658906

**NC073-1: HWY 2:46 MITSUE FROST HEAVE
SITE PLAN**

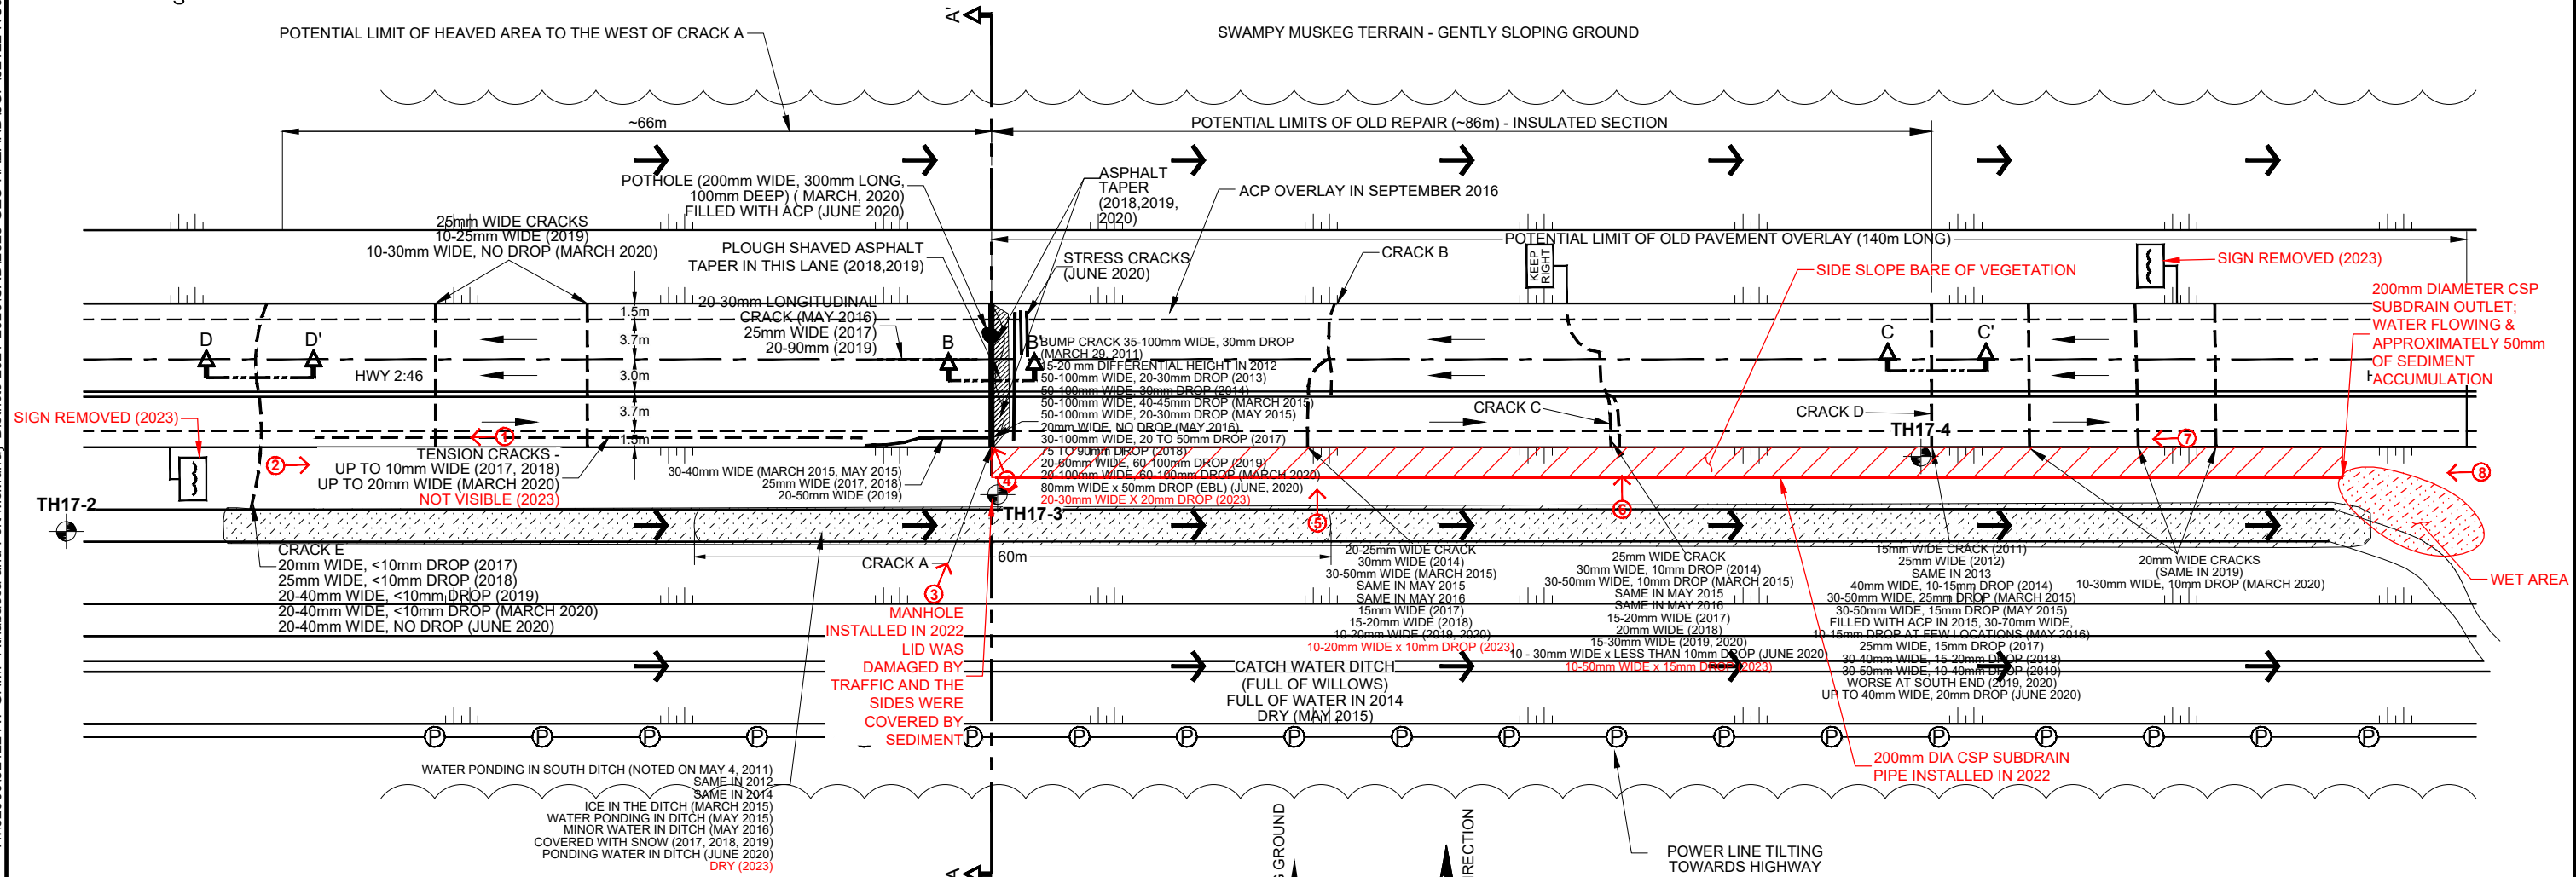
DWG NO. NC073-1-1

NOTE:
MAY 16, 2023 SITE OBSERVATIONS ARE SHOWN IN RED.

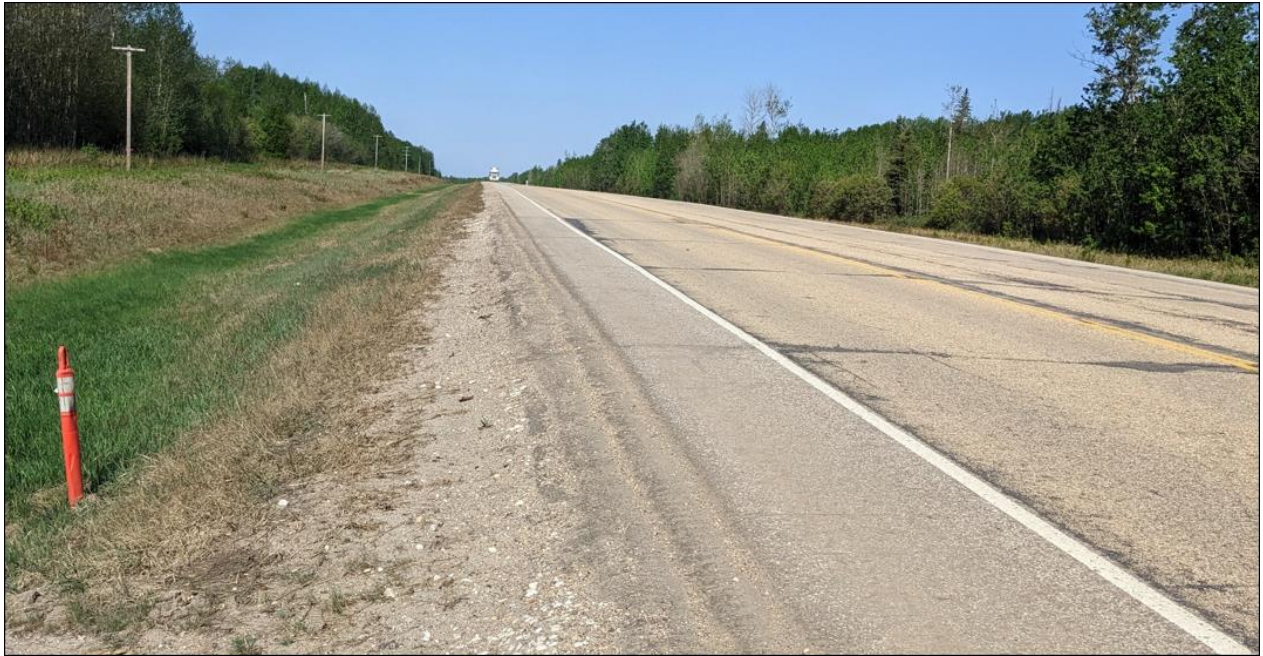
Photo # 1 Looking west at south ditch and highway shoulder from the western limit of the site

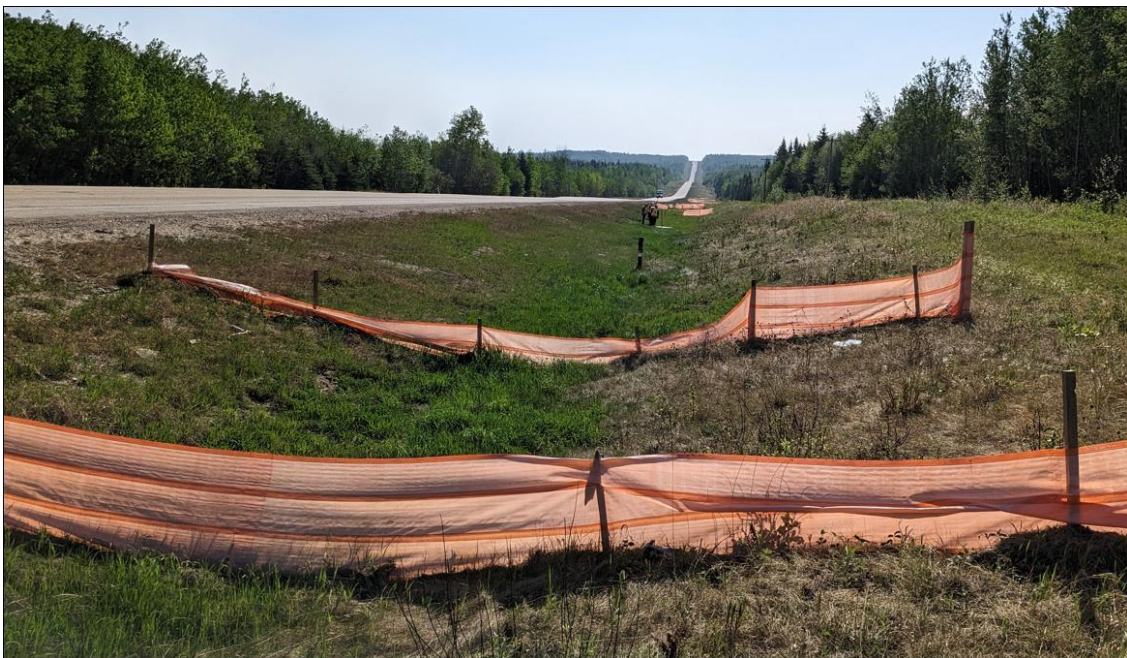
Photo # 2 Looking east at south ditch from the western limit of the site; falling silt fencing

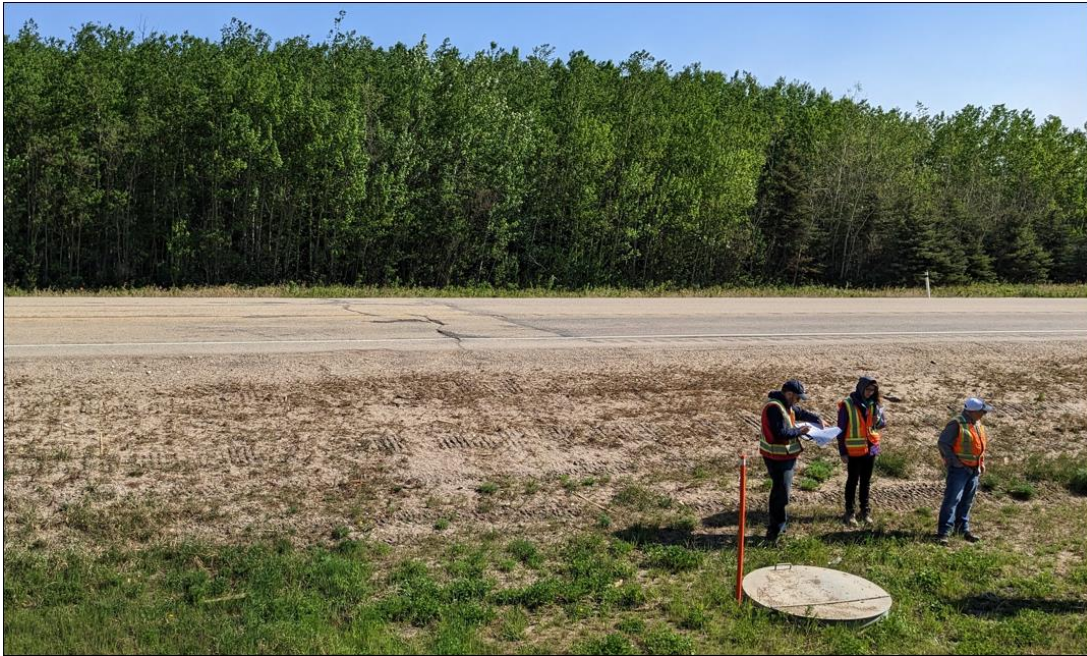
<input type="checkbox"/> Bridge/Culvert Distress		<input type="checkbox"/>
<input checked="" type="checkbox"/> Other	50 mm of sediment accumulation at the subdrain outlet; bump warning signs on both directions were removed; the lid of the manhole installed in 2022 was bent, covered with sediment, and could not be opened	<input type="checkbox"/>
Instrumentation: None		
Assessment (Refer to attached Drawings):		
<p>There is still a bit of movement along the old cracks developed within the highway surface. However, the movement at Crack A location was not as severe as noted in the past to significantly impact the highway rideability and safety of motorists. The highway condition may however get worse during the winter season.</p> <p>It is early to assess whether the interim measure is successful in mitigating the highway movement. It will likely take a couple of years to assess the effectiveness of the implemented remedial measure. During this period, future maintenance of the highway, including milling and sealing/patching of cracks, may still be required.</p> <p>There is a steady flow from the outlet of the subdrain pipe, and this should reduce groundwater levels below the highway with time. If the subdrain pipe gets plugged in the future, possibly due to sediment accumulation, groundwater levels will likely rise and impact the integrity of the highway.</p>

Photo # 3 Looking north at highway side slope and the 1.2 m CSP Manhole. The manhole lid was bent and could not be opened; accumulated sediment around the manhole

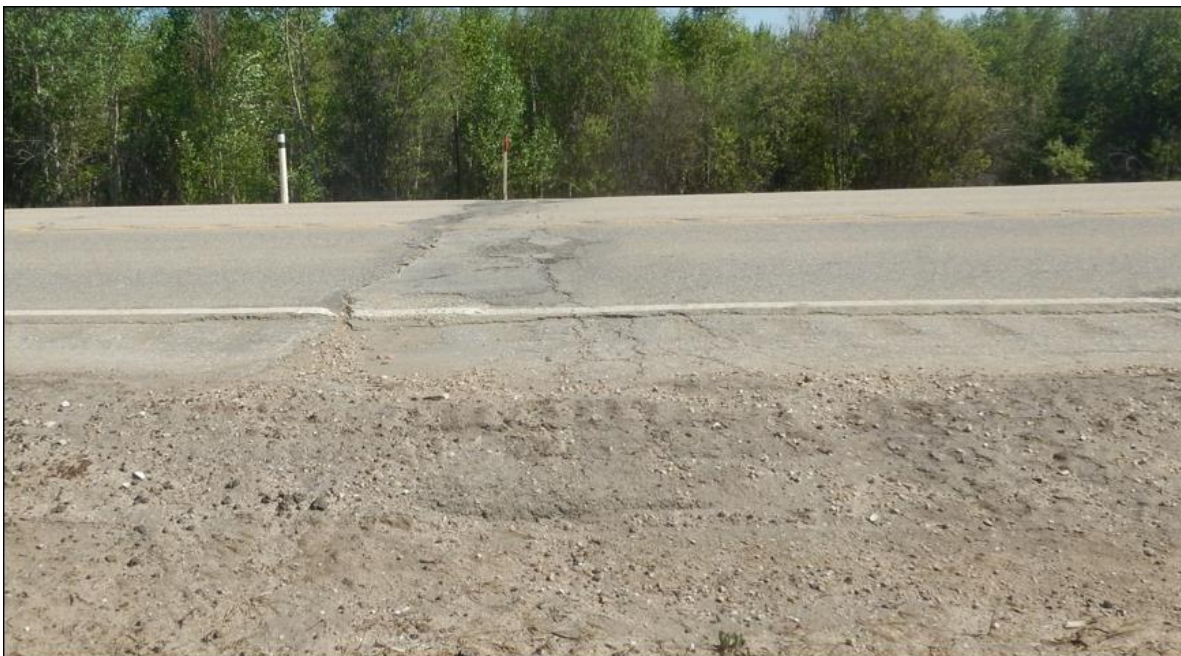
Primary Site Issue:	Differential heave between insulated and un-insulated roadway sections, resulting in sharp transverse bump cracks at the transition zones (Cracks A and D). The sharp drop across the crack surfaces, particularly at Crack A location, have been adversely affecting roadway rideability and safety of motorists. The sharp drop at Crack A location continued to constitute a safety hazard to motorists travelling along the highway surface.
Dimensions:	The heaved section of the highway to the west of the bump crack (Crack A) location is approximately 66 m long. Crack E defines the western limit of the heaved section of the highway.
Date of any remediation:	N/A
Maintenance/History:	<p>Frost heave repairs were completed in October 2008 and consisted of insulating an approximately 90 m long section of the highway to the east of existing bump crack. The repair consisted of excavating the pavement structure and placing 150 mm (3 layers, each 50 mm thick) of extruded polystyrene insulation (STYROFOAM Brand High Load 100) on the top of the prepared sub-grade. The new pavement structure consisted of 220 mm of ACP and 500 mm of granular base course.</p> <p>A temporary remedial measure was implemented after the call-out site visit in March 29, 2011 and consisted of milling the highway surface at the crack location to create an even pavement surface and provide a smooth ride to travellers.</p> <p>A sink hole developed on the highway WBL and was filled a few times with ACP between March 2011 and June 2012.</p> <p>Potholes were filled in 2014 and 2015; the highway was patched at Crack A location and ACP was used to fill around Crack D location.</p> <p>ACP overlay in September 2016; cracks reappeared on the highway surface in the winter of 2017; speed reduction and bump warning signs were placed in 2017; a sharp drop at Crack A location was noted in the early winter of 2018 and an asphalt taper was placed to smooth out the drop.</p>

Photo # 4 Looking north at the bump crack (Crack A); 20 to 30 mm wide and 20 mm drop

Recommendations:		
<p>The Local MCI should undertake the following:</p> <ul style="list-style-type: none"> • Monitor and maintain records of the highway condition (e.g., measurements of width and depth of cracks, and make observations of any bump at Crack A location), particularly during the winter season. • Seal all open cracks inside and outside the treated section of the highway to prevent surface water infiltration into the sub-grade material. • Reinstate the bump warning signs and reduce the speed in both directions, If the highway condition deteriorates significantly, particularly during the winter season, to warn motorists of the hazard. • Clear sediment accumulated around manhole; open, adjust, and relock the manhole lid. • Check periodically (at least once a year) the flow from the subdrain pipe outlet, and get the pipe flushed (as needed) using the cleanout manhole. <p>Depending on the performance of the intermediate repair measures, a long-term repair may be required. The long-term remedial measure is to extend the insulation outside the treated section of the</p>

highway for approximately 70 m to the west of Crack A location. This option will require excavating the highway surface, reconstruction of the pavement structure, and alternating lane closures to complete the repair work. The ballpark cost for the long-term repair would be in the order of \$1 million.

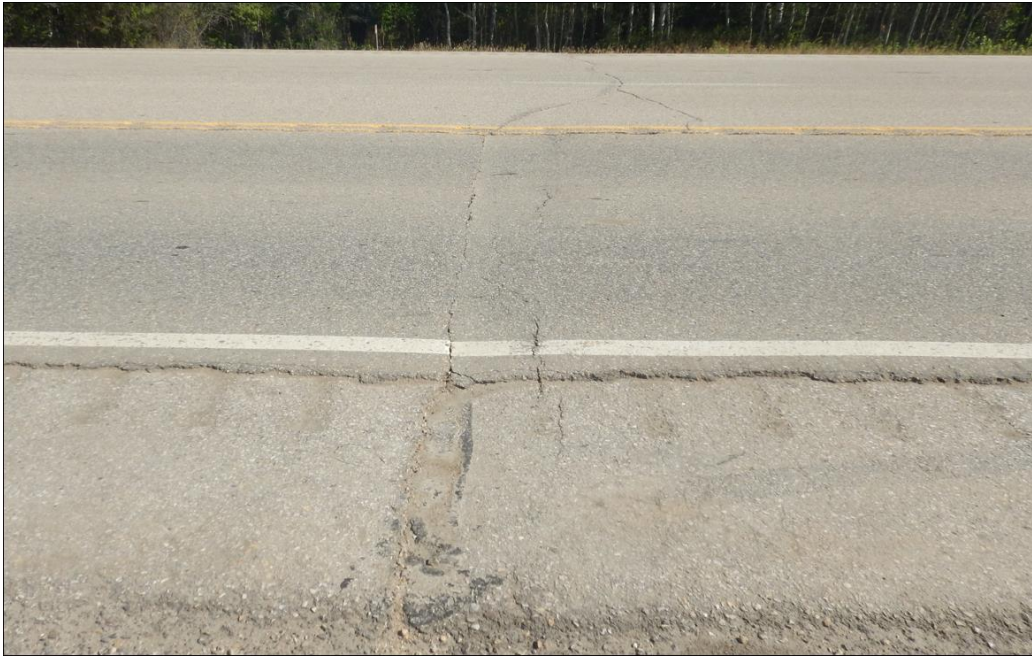
Photo # 5 Looking north at Crack B; 10 to 20 mm wide and 10 mm drop

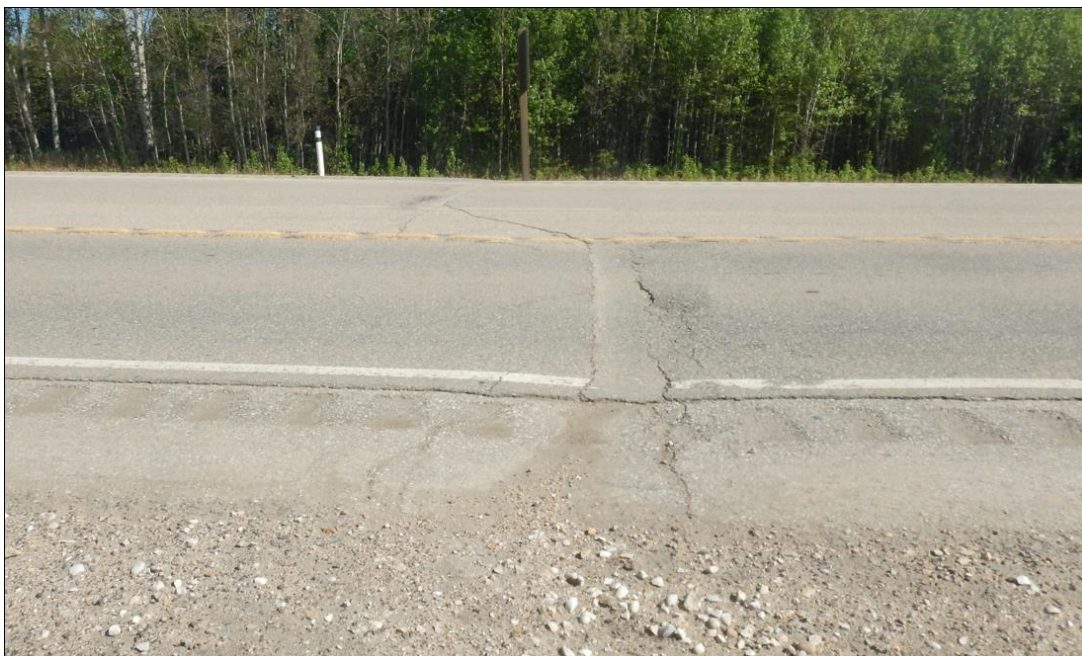
Photo # 6 Looking north at Crack C; 10 to 50 mm wide and 15 mm drop

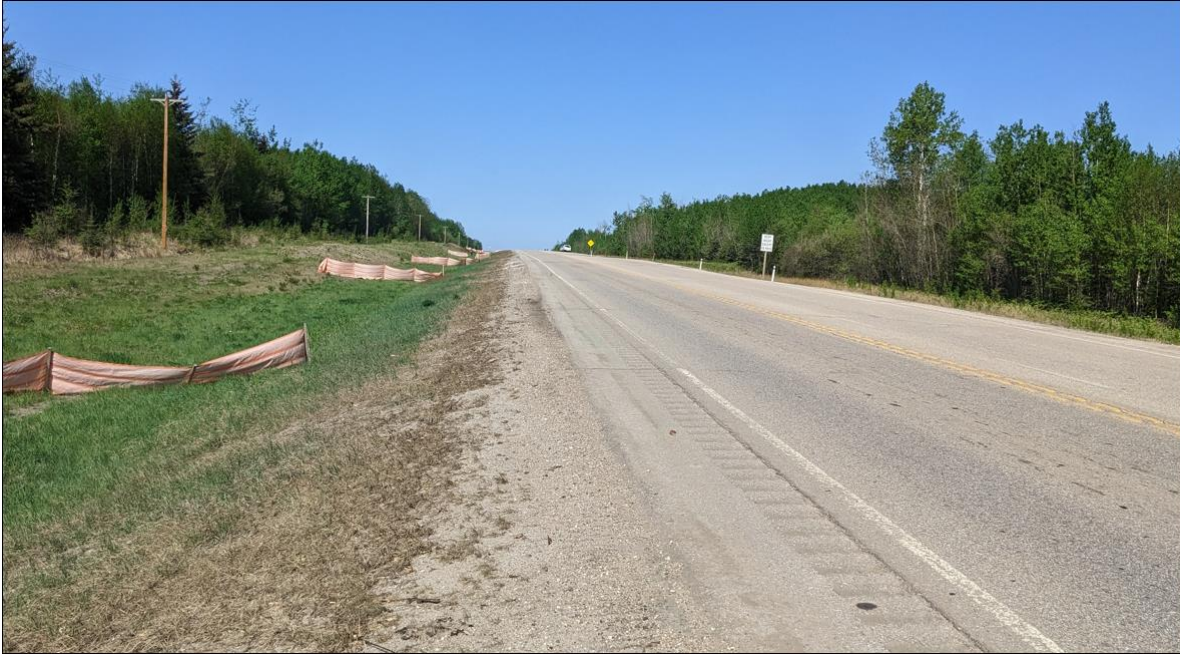
Photo # 7 Looking west from the eastern limit of the site

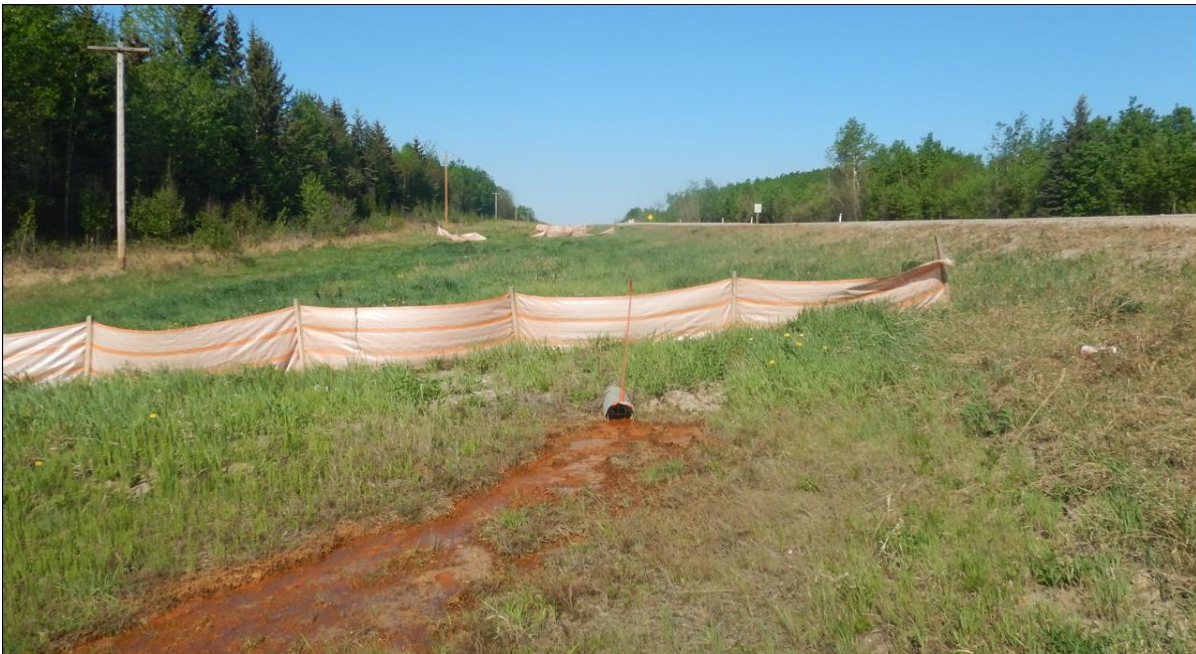
Photo # 8 Looking west at the outlet of the 200 mm diameter CSP subdrain pipe; reddish-brown stained water was flowing from the pipe and silt accumulated within the bottom of the pipe (approximately 50 mm in thickness; 25 percent of pipe diameter)
