ALBERTA TRANSPORTATION LANDSLIDE RISK ASSESSMENT

SECTION A: GEOTECHNICAL FILE REVIEW

SITE NC077-1: HWY 2:48 WEST OF CANYON CREEK (km 25)

**NC077-1: HWY 2:48 (km 26)
WEST OF CANYON CREEK LANDSLIDE
SKETCH SITE PLAN & CROSS SECTION A-A'**

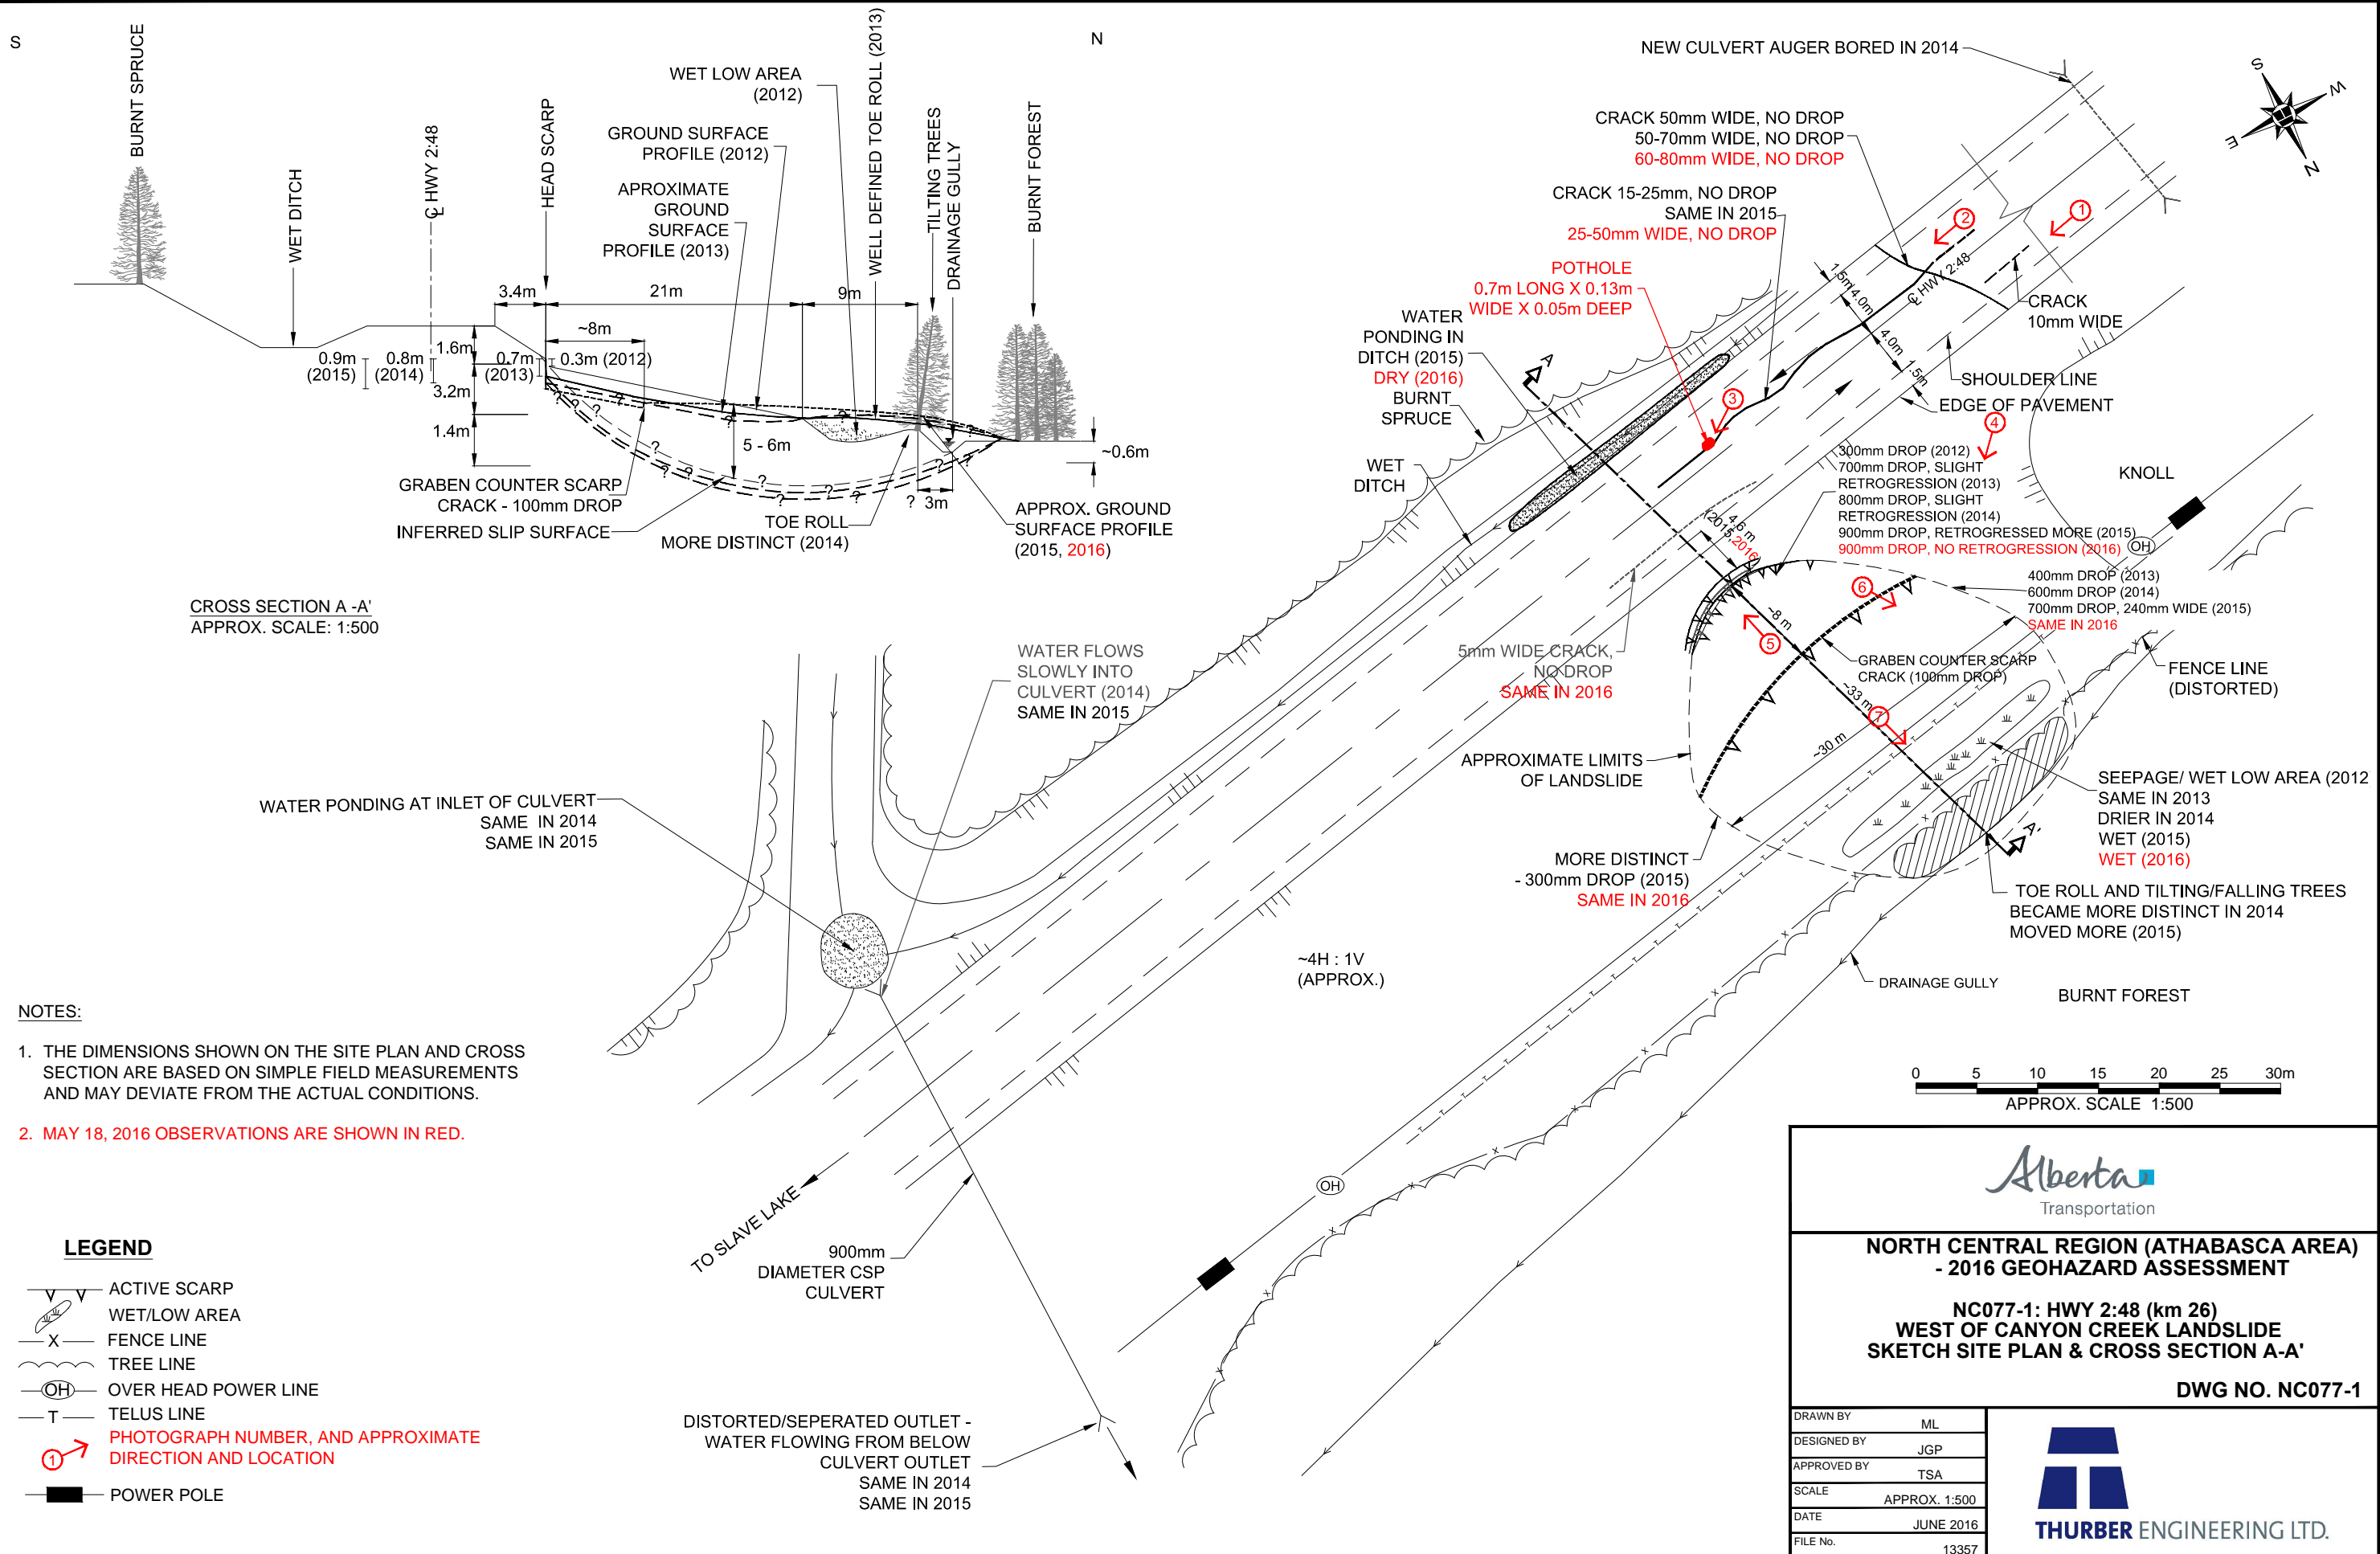
DWG NO. NC077-1

A 30 m wide landslide (i.e. parallel to the highway driving lanes) occurred within the north side slope of the highway. The head scarp crack of the landslide is located at about 3.4 m from the edge of pavement and has dropped by about 0.9 m. The landslide is toeing out into a treed area that is about 33 m north of the highway surface.

Additional details about the landslide main features are shown in Figure NC077-1.
