GEOHAZARD ASSESSMENT PROGRAM
NORTH CENTRAL REGION – ATHABASCA
2020 INSPECTION

Site Number	Location	Name	Hwy	km
NC077-1	Approximately 25 km west of Slave lake and 15.5 km east from the junction of Highways 2 and 33	West of Canyon Creek	2:48	26
Legal Description		UTM Co-ordinates (NAD 83)		
SE-34-73-8-W5M		11 N 6136974	E 617878

Date	PF	CF	Total
Previous Inspection:	May 18, 2016	11	3	33
Current Inspection:	June 5, 2020	11	3	33
Road AADT:	2310		Year:	2019
Inspected By:	Tarek Abdelaziz, José Pineda (Thurber) Roger Skirrow, Arthur Kavulok, Gordon Wolters (TRANS)			
Report Attachments:	<input checked="" type="checkbox"/> Photographs <input checked="" type="checkbox"/> Plans <input checked="" type="checkbox"/> Maintenance Items

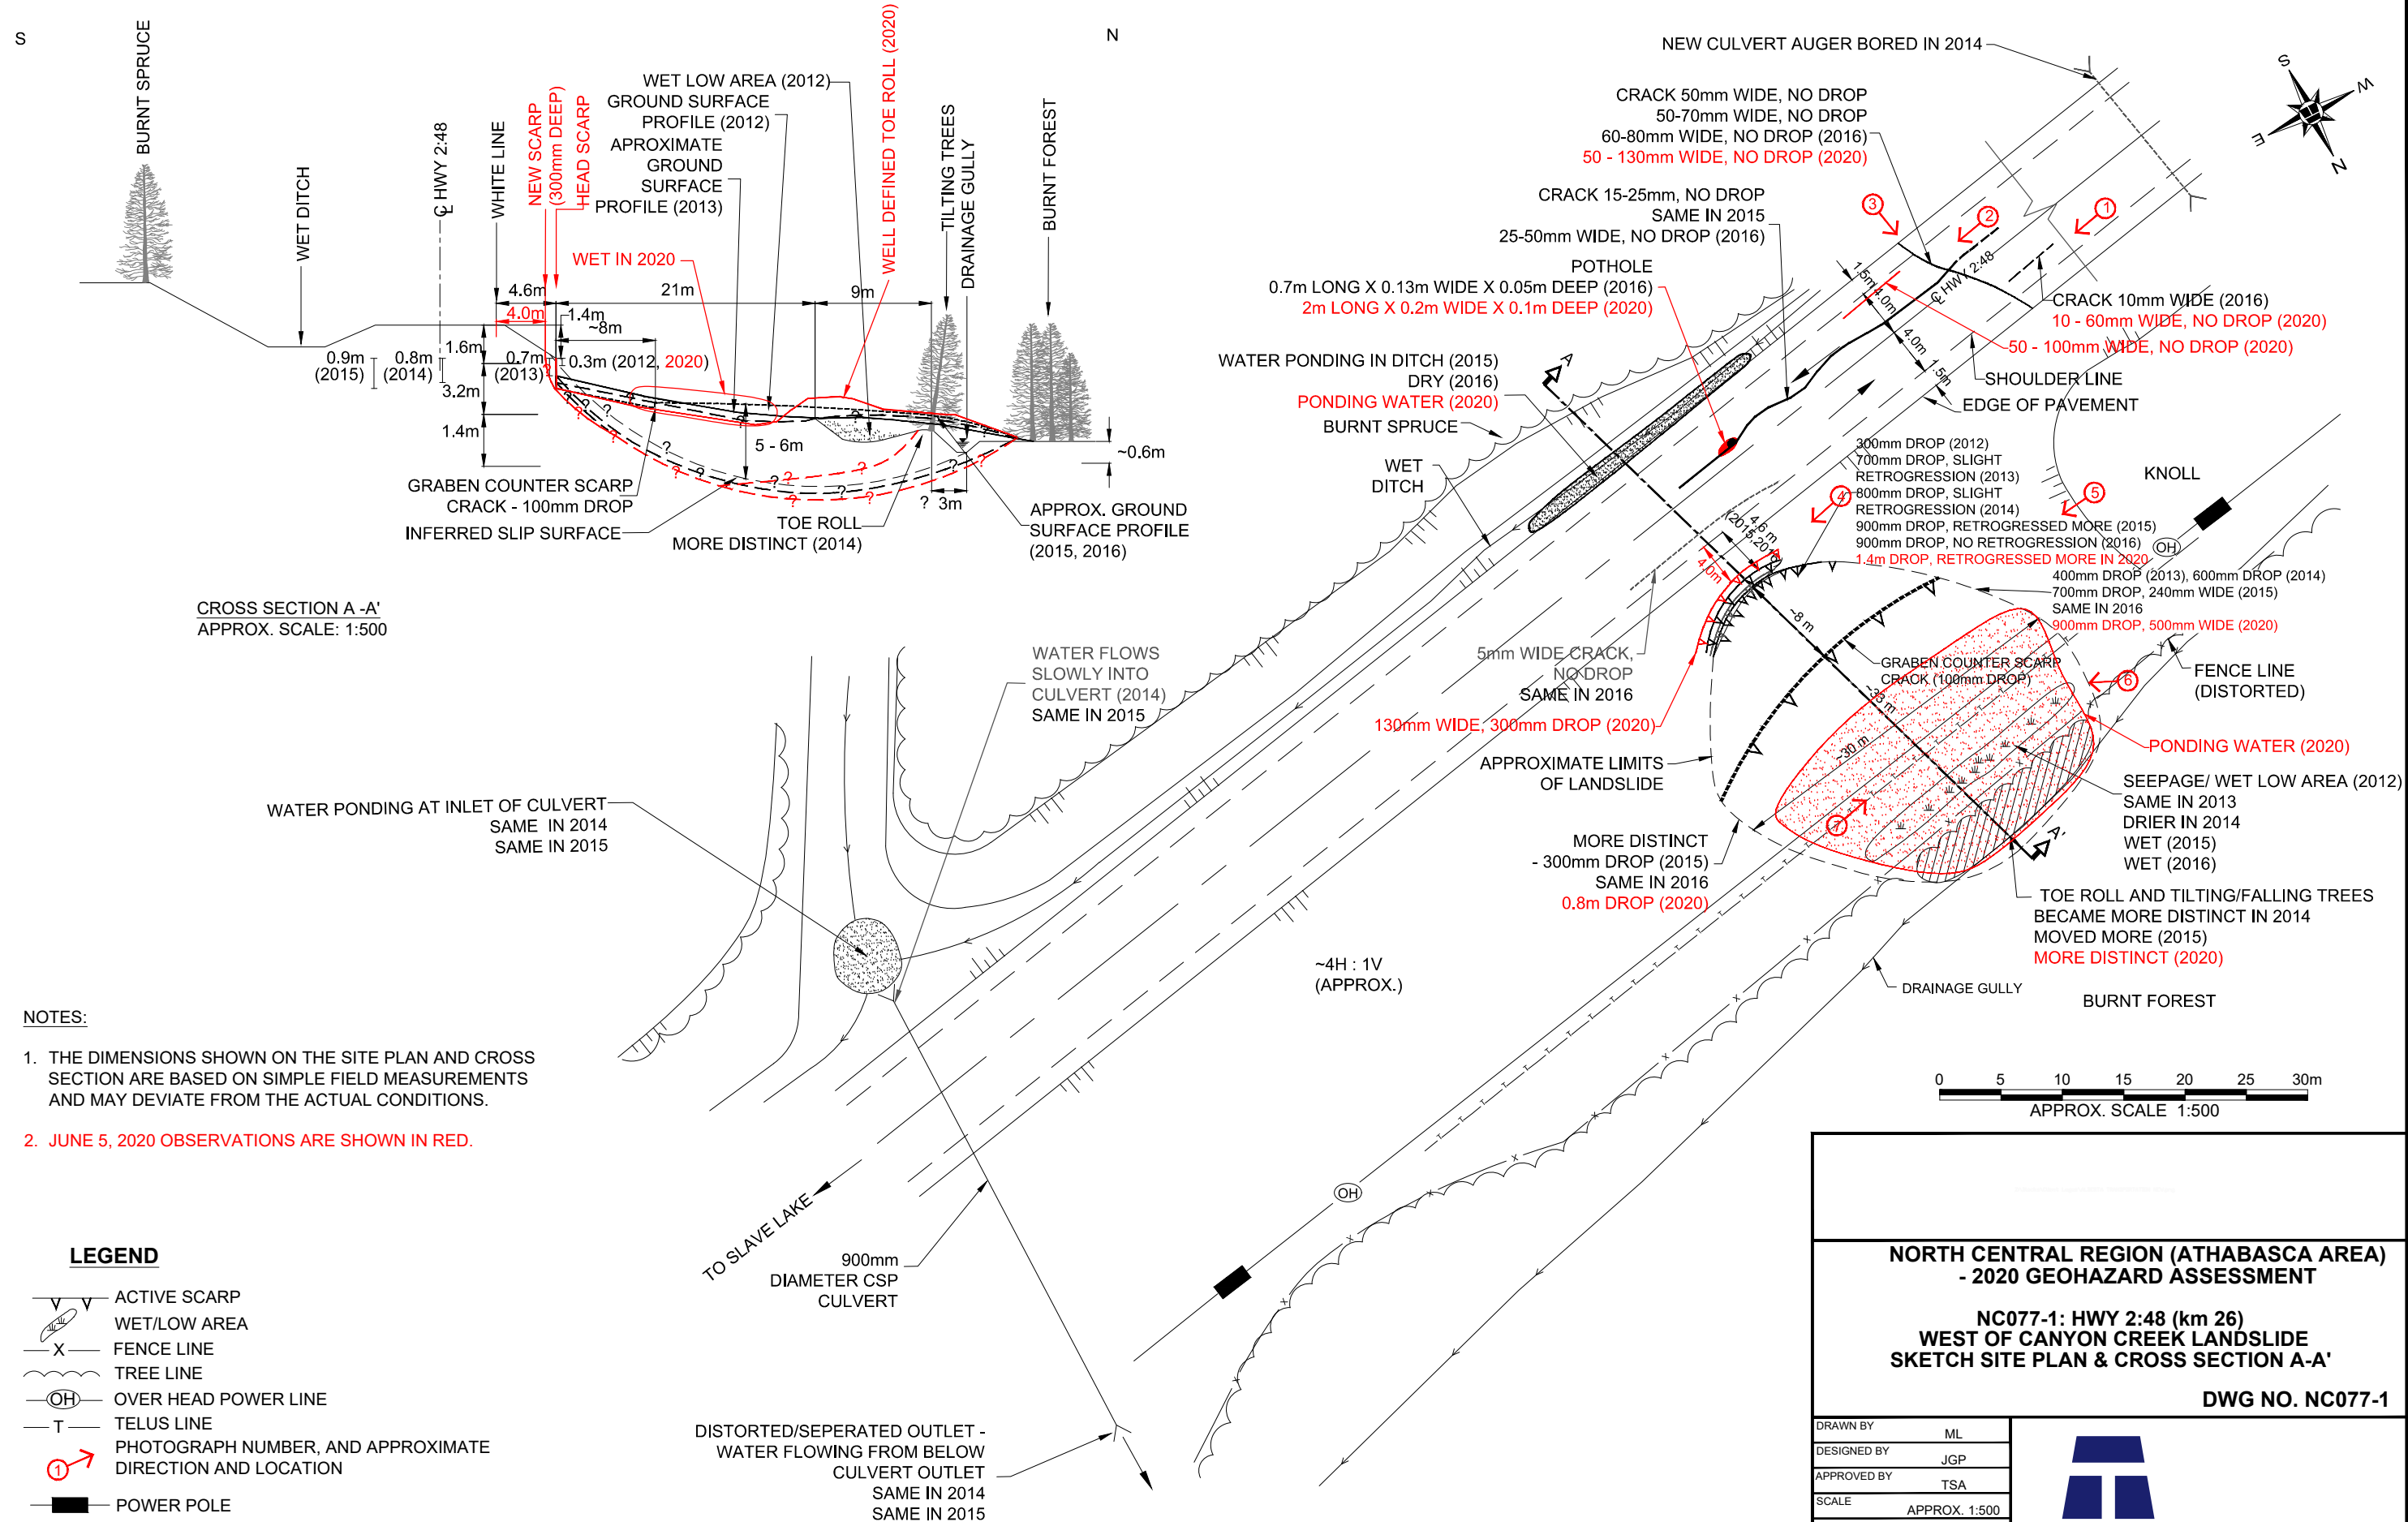
DWG NO. NC077-1

Primary Site Issue:	A landslide affecting the highway north side slope; head scarp crack is located within the highway clear zone		
Dimensions:	About 30 m wide along the highway alignment and 33 m long along the slope direction.		
Site History	The landslide's head scarp was first noticed in the spring of 2012.		
Date of any remediation:	N/A		
Maintenance:	N/A		
Observations:	Description	Worse?	
<input checked="" type="checkbox"/> Pavement Distress	10–130 mm wide longitudinal cracks on highway surface; 2 m long x 200 mm wide x 100 mm deep pothole on the highway EBL	<input checked="" type="checkbox"/>	
<input checked="" type="checkbox"/> Slope Movement	0.3 m to 1.4 m drop across the landslide head scarp cracks; most southern head scarp crack is at 4 m from white line; drop across the western and eastern flank cracks by 0.8 m and 0.9 m, respectively; well-defined toe roll at the bottom of the slope; tilting and falling trees within the bottom of the slope	<input checked="" type="checkbox"/>

Further retrogression of landslide head scarp crack towards the highway, additional drops across landslide crack surfaces, and presence of a more distinct toe roll indicate that the landslide has been active since the 2016 inspection.

The presence of seepage and wet surface conditions within the slide mass suggests that the landslide movement occurred in response to a rise in ground water conditions. Poor surface drainage in south ditch, as noted in previous years, could have aggravated the situation.

The existing drop within the highway north side slope constitutes a potential hazard for runaway vehicles.

In the short term, the local MCI should watch closely for any cracking on the highway surface and periodically measure the distance between the landslide head scarp crack and the edge of the highway (at least twice a year between the spring and fall seasons). The existing pothole should be filled with ACP and open cracks on the highway surface should be sealed to prevent surface water infiltration into the landslide mass, which would result in further landslide movement and retrogression into the highway surface. A sharp shoulder warning sign should be placed to warn motorists of the present hazard. Consideration should also be given to install a guard rail along the edge of the highway to protect runaway vehicles.

The south ditch should be slightly re-graded in the short term to drain the surface water into the existing culvert, located to the east of the site. The area surrounding the inlet of the culvert should also be cleaned of sediments to enhance surface water flow into the culvert. Consideration should also be given to digging narrow shallow trenches (perpendicular to the highway alignment and not exceeding 0.5 m wide x 0.5 m deep) within the landslide mass using a long reach excavator to drain ponded water and promote drainage within the slide area.

An intermediate-term repair option might include reinforcing the side slope area above existing headscarp. In this option, 6 m long soil nails installed in 1x1 m² grid pattern should reduce the risk/rate of headscarp retrogression into the highway shoulder and lanes. The ballpark cost of this option would be in the range of \$100,000. The estimated cost might become lower if the mobilization of the equipment could be shared with other sites.

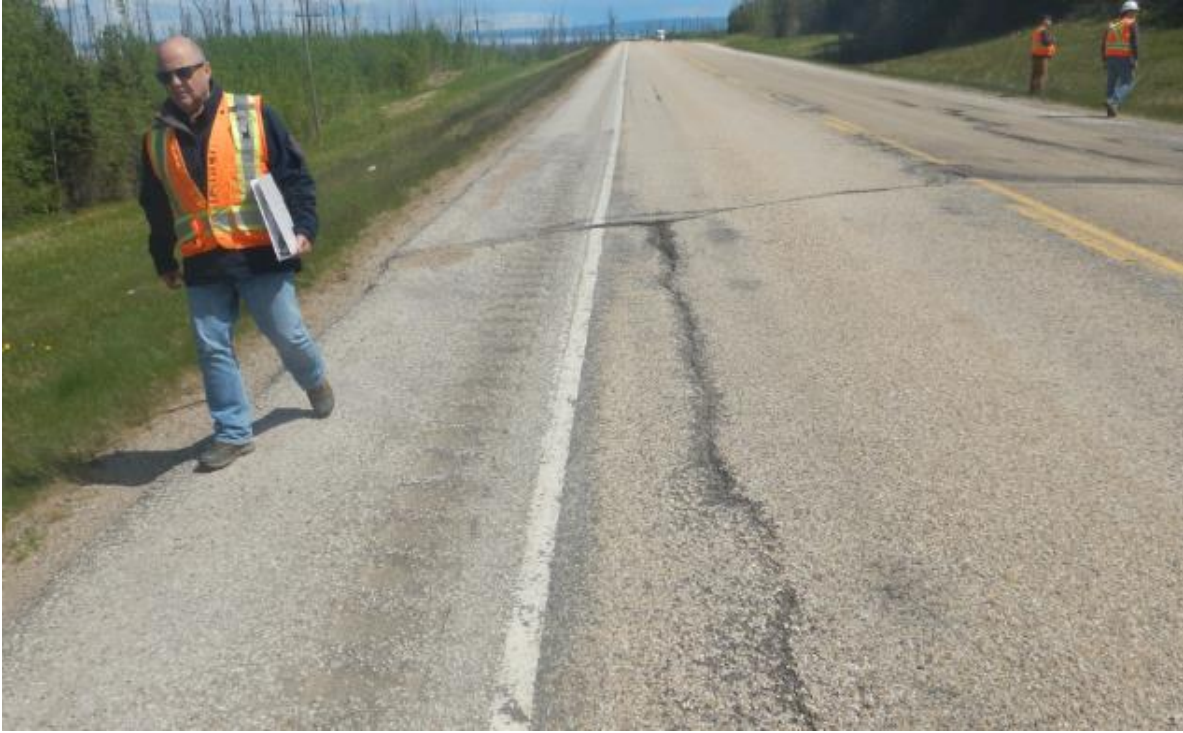
The existing cracks and pothole on the highway lanes may reflect poor/soft subgrade condition due to high ground water levels in this area, but do not appear to be landslide-related cracks.

Photo No.1 – Looking east at a longitudinal crack on the highway WBL to the east of the landslide location

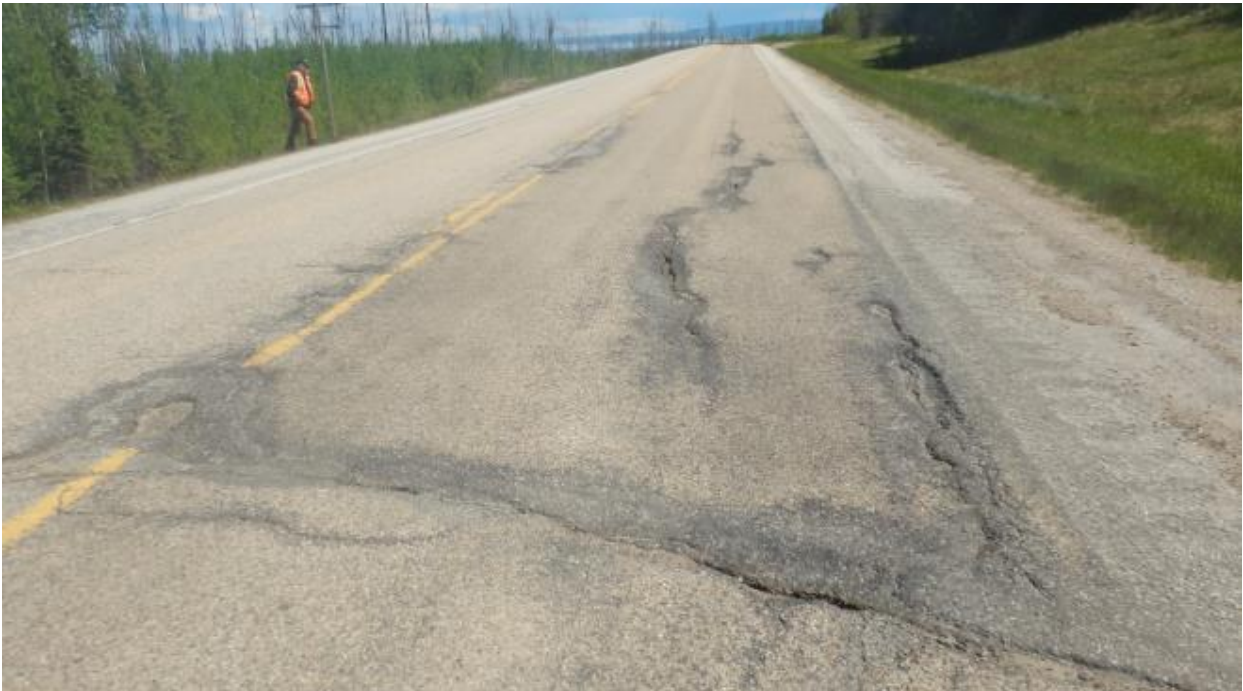
Photo No.2 – Looking east at transverse and longitudinal cracks on the highway surface at the landslide location; wide open cracks are more pronounced within the highway EBL

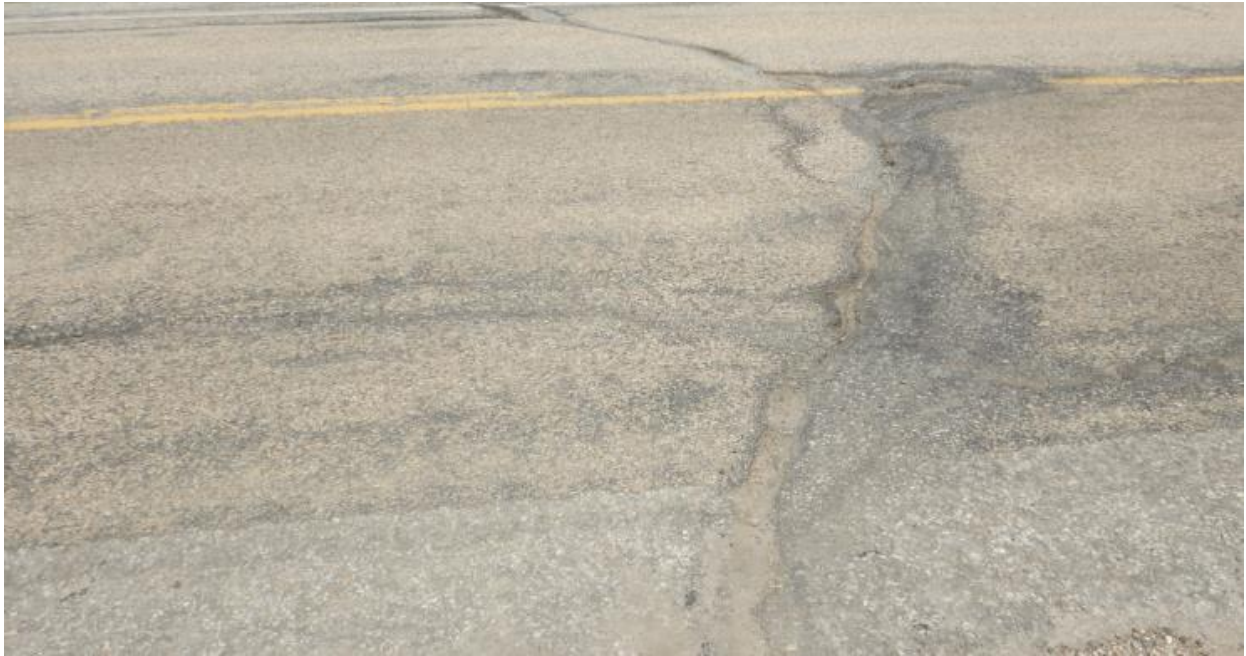
Photo No.3 – Looking north at a 50 to 130 mm wide transverse crack on the highway surface to the east of the landslide location

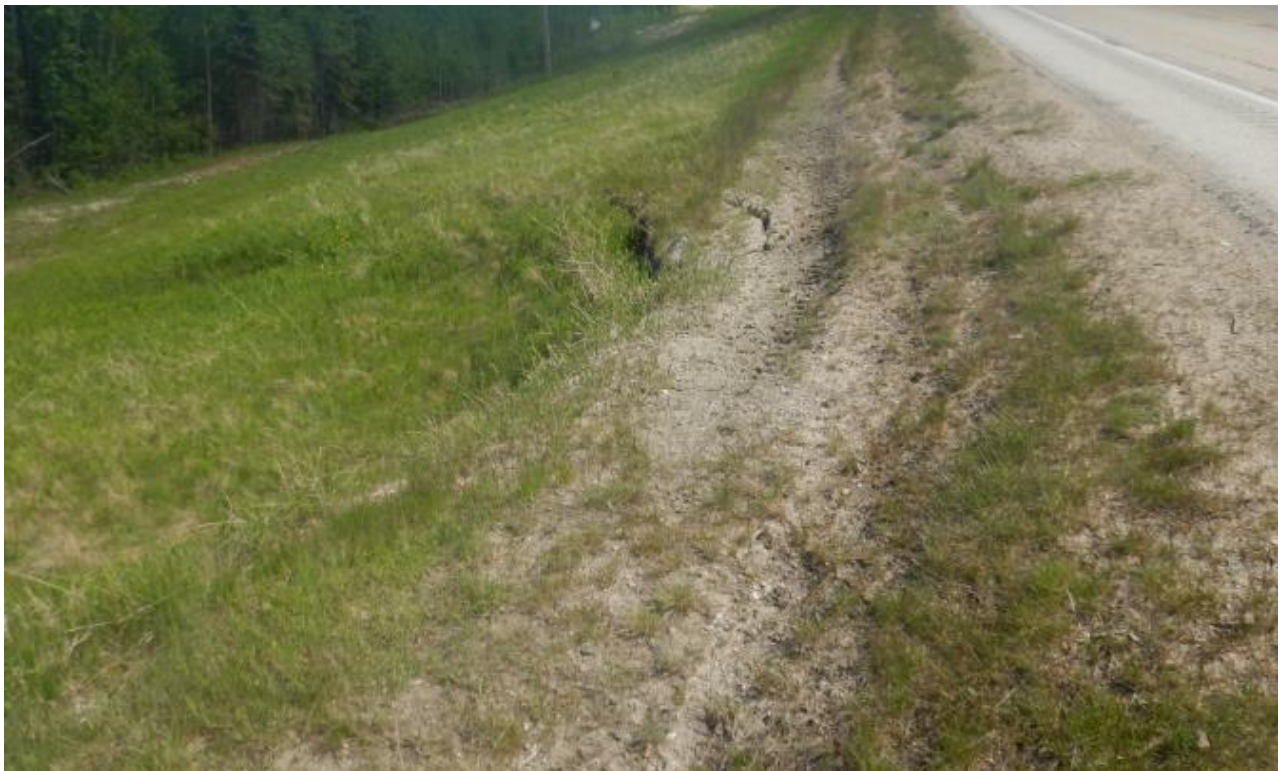
Photo No.4 – Looking east at the landslide developed on the highway side slope; note the retrogression of the landslide head scarp crack towards the highway

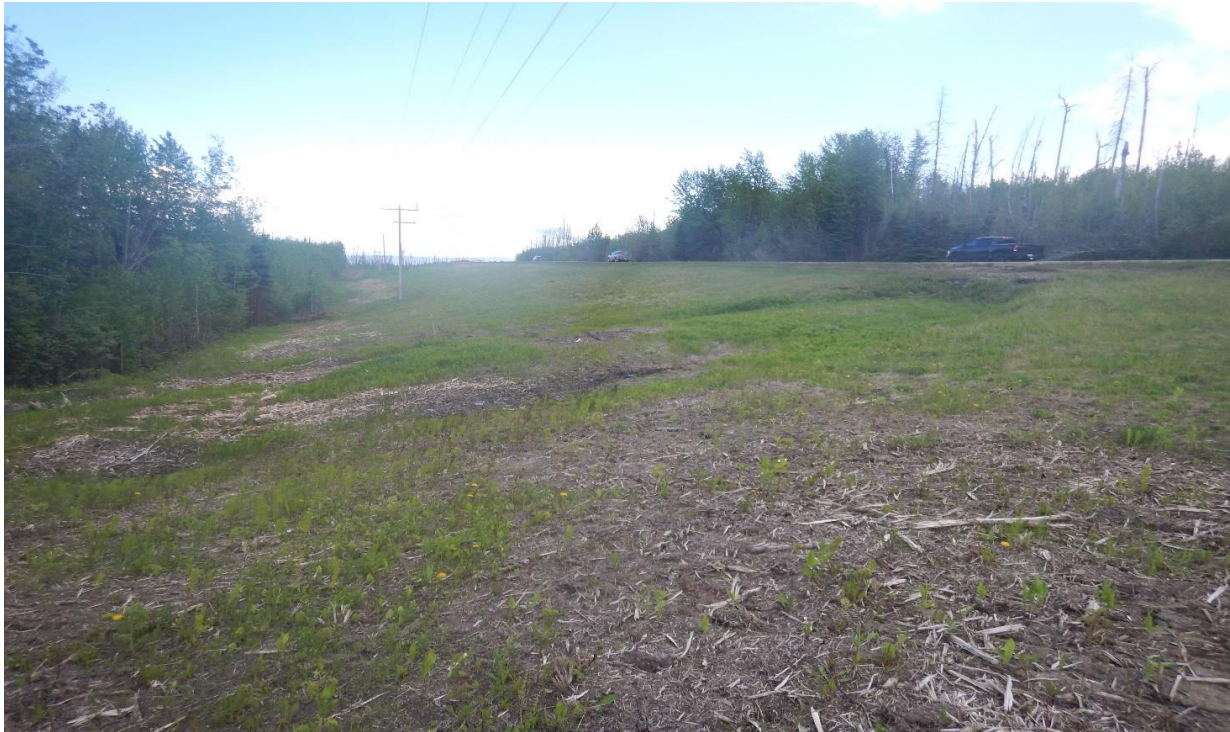
Photo No.5 – Looking east at the landslide mass and a distinct toe roll at the bottom of the slope

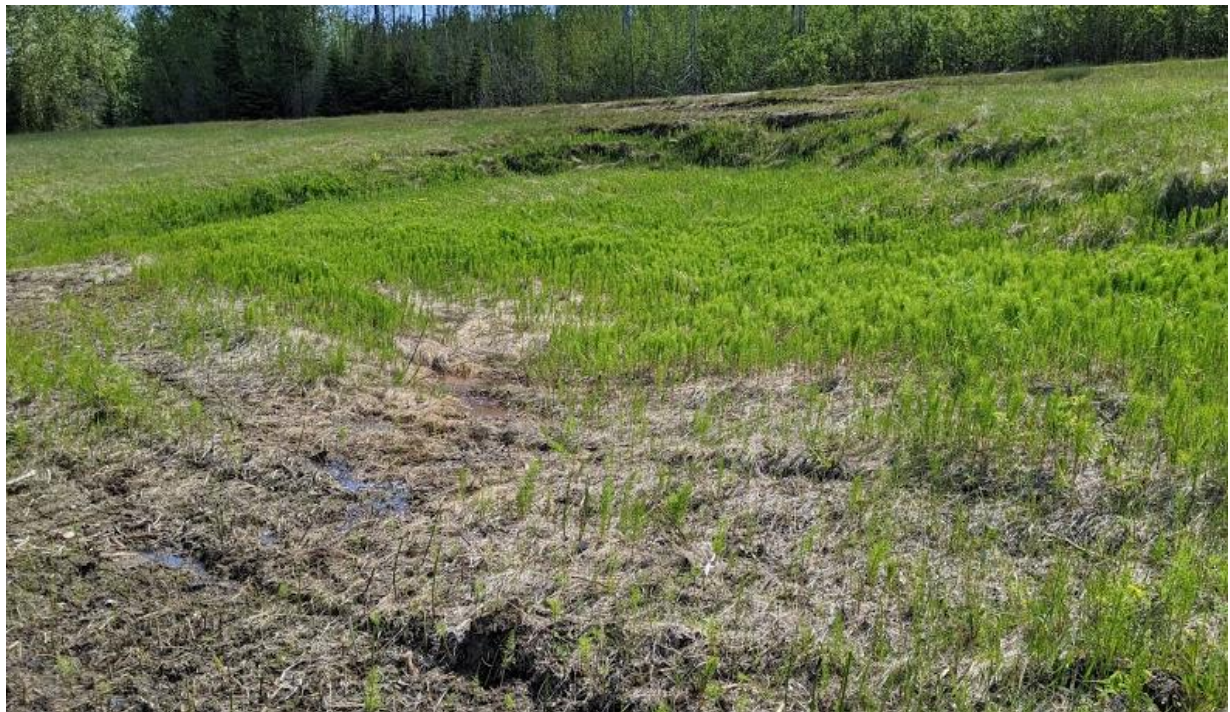
Photo No.6 – Looking southeast at the landslide head scarp crack and east flank

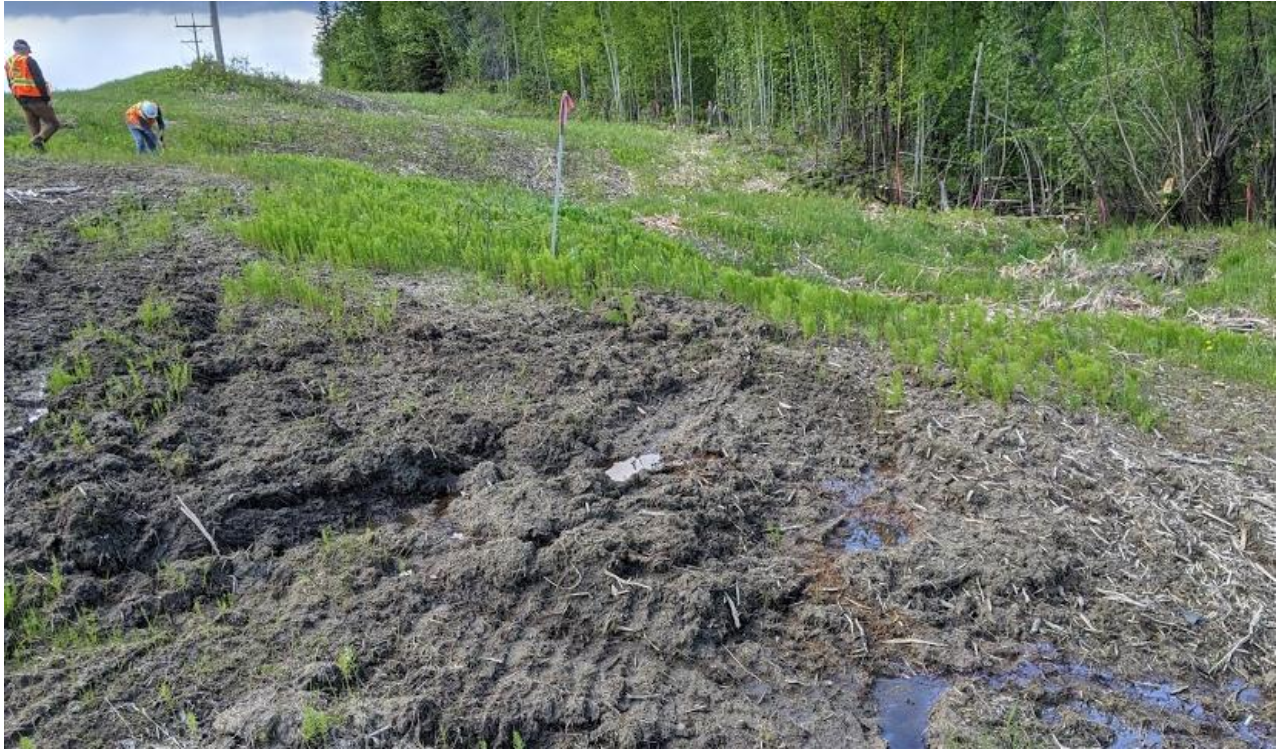
Photo No.7 – Looking north at the landslide toe roll; note the presence of seepage and Telus pedestal near the bottom of the slope
