**ALBERTA TRANSPORTATION  
GEOHAZARD ASSESSMENT PROGRAM  
NORTH CENTRAL REGION – ATHABASCA &  
FORT MCMURRAY DISTRICTS  
2022 SITE INSPECTION**

Site Number	Location	Name	Hwy	km
NC077-1	Approximately 25 km west of Slave Lake and 15.5 km east from the junction of Highways 2 and 33	West of Canyon Creek	2:48	26
Legal Description		UTM Co-ordinates (NAD 83)		
SE-34-73-8-W5M		11 N 6136974	E 617878

**NC077-1: HWY 2:48 (km 26)  
WEST OF CANYON CREEK LANDSLIDE  
SKETCH SITE PLAN & CROSS SECTION A-A'**

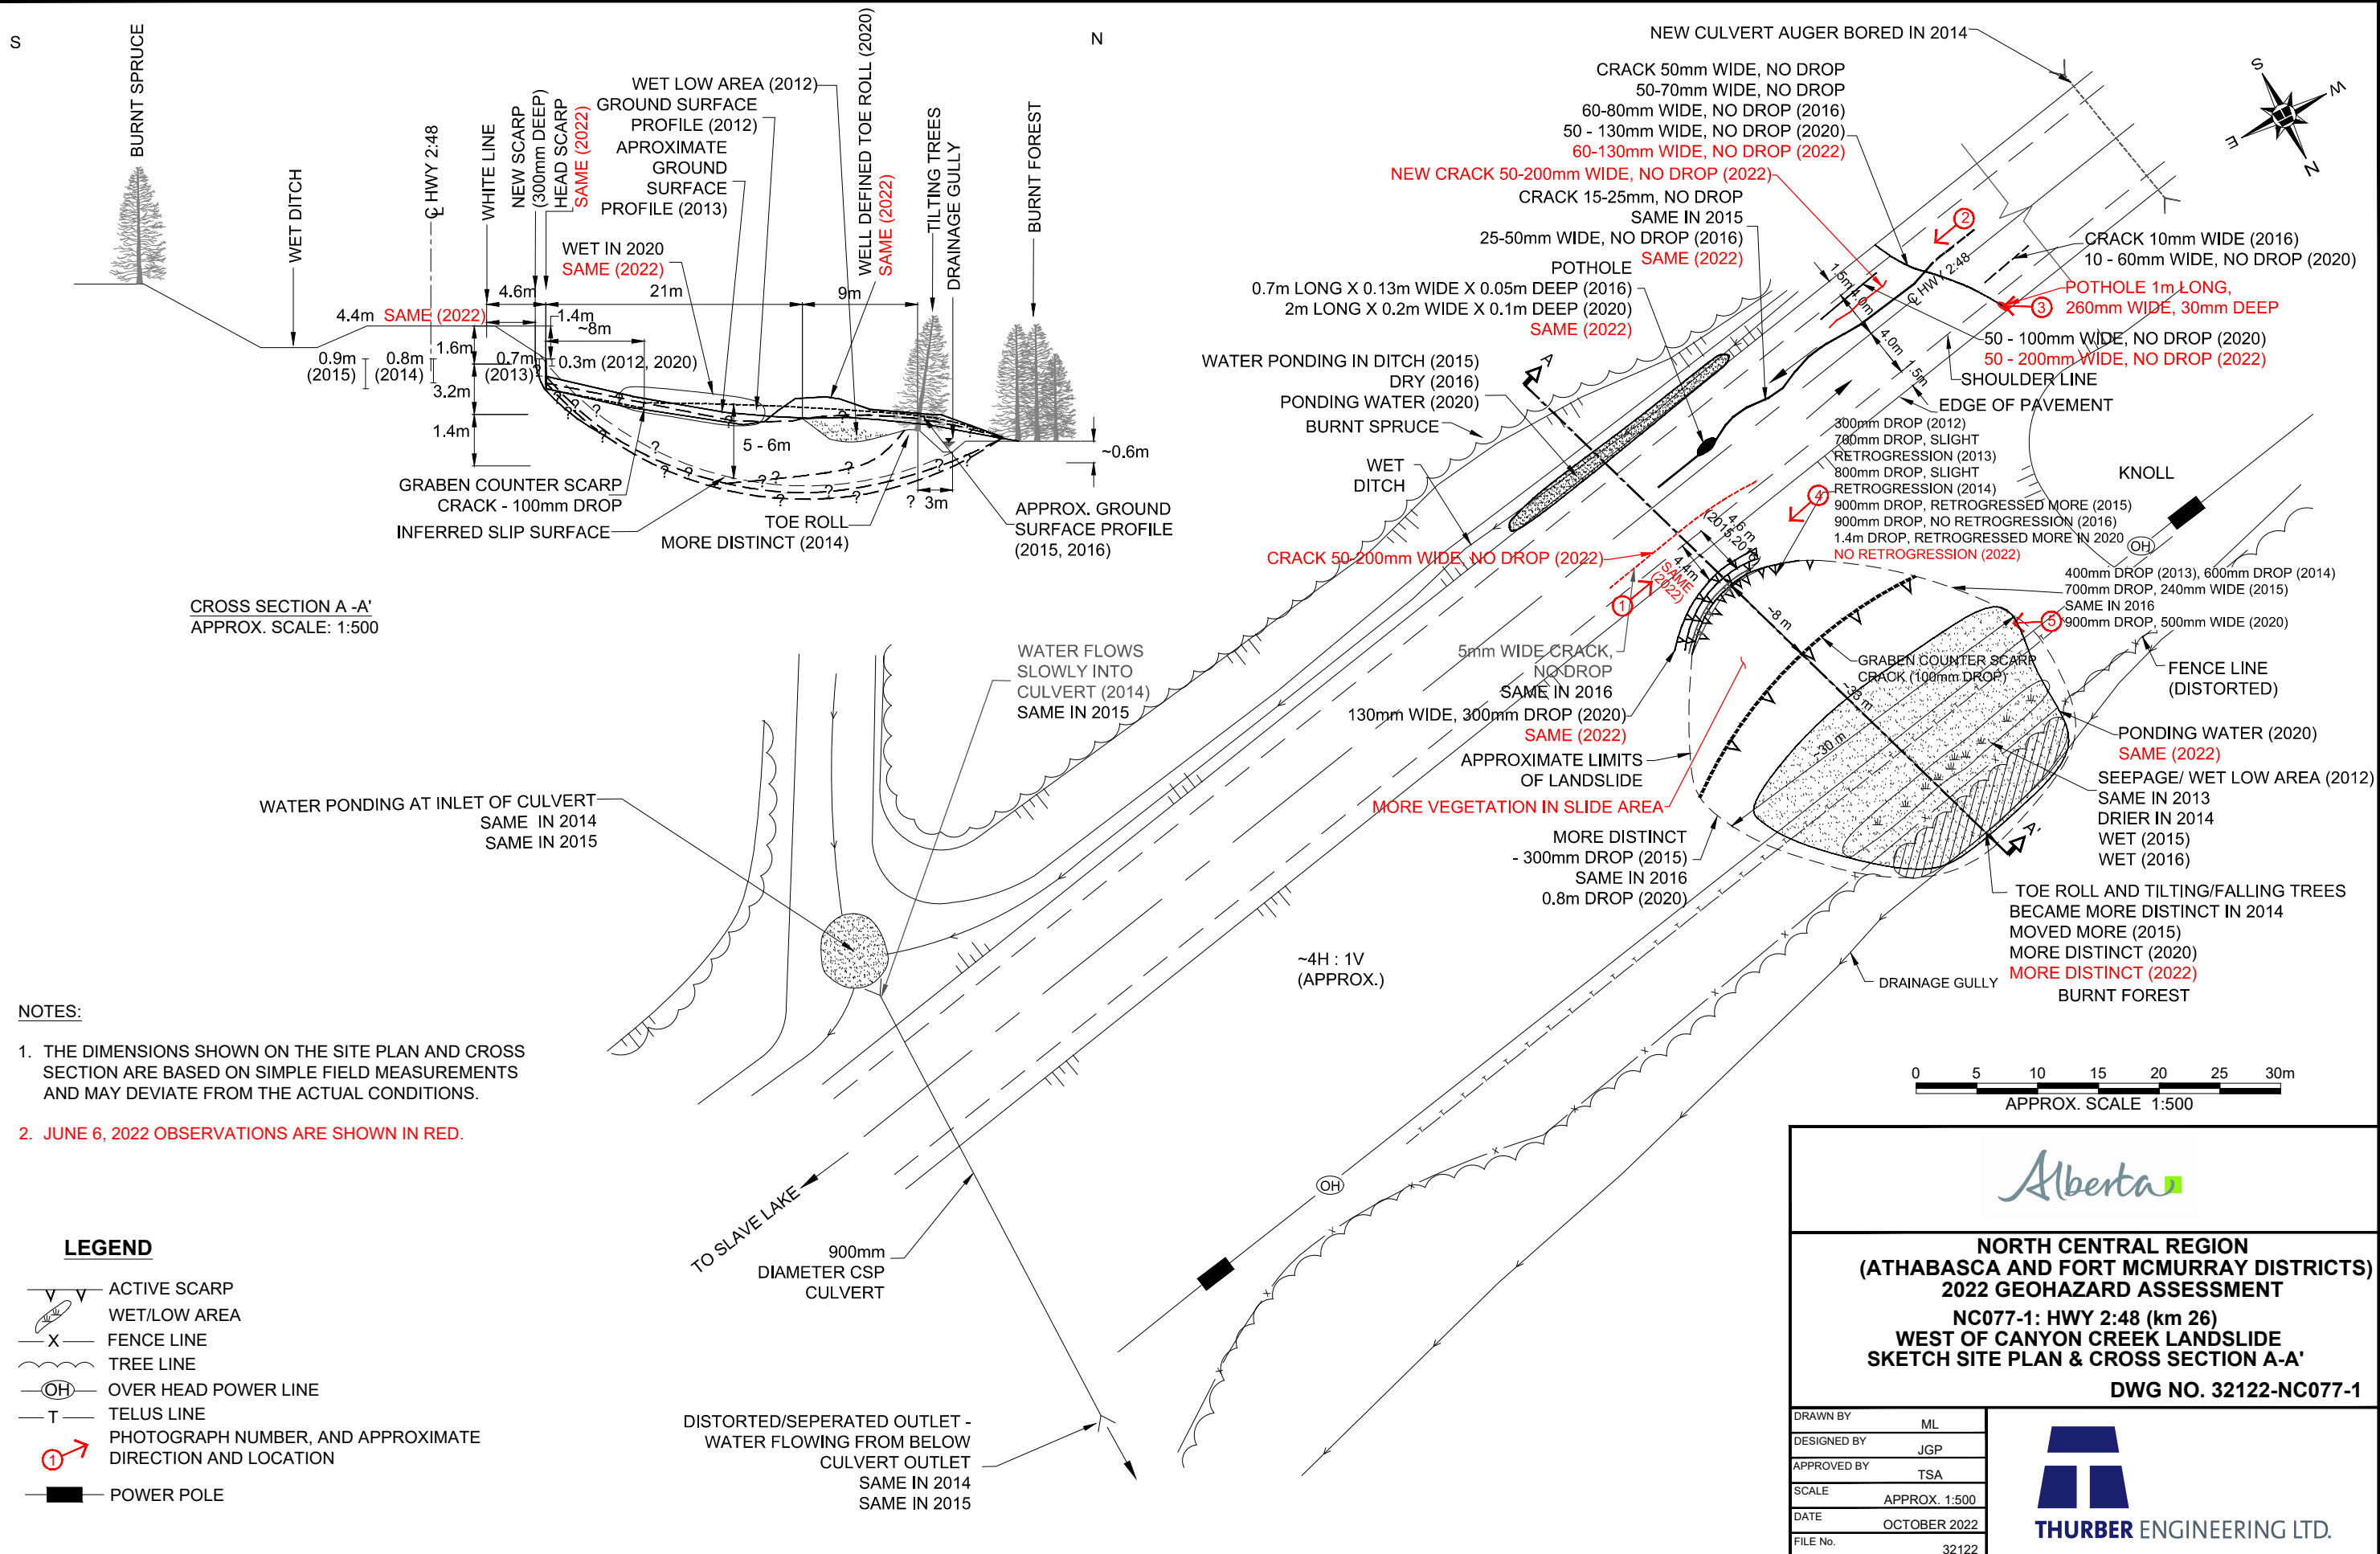
**DWG NO. 32122-NC077-1**

Further retrogression of landslide head scarp crack towards the highway was not observed and overall landslide features such as the distinct toe roll and flanks cracks remained relatively unchanged since the 2021 site inspection visit.

The highway condition has not yet been impacted by the landslide movement. However, accelerated landslide movements may occur in the future in response to further rise in groundwater levels (e.g. due to heavy rainfall events). Accelerated landslide movement could result in the head scarp retrogression into the highway driving surface and/or appearance of landslide-related cracks in the highway driving lane(s) due to partial loss of lateral support from the moving mass.

In the short term, the local MCI should watch closely for any cracking on the highway surface and periodically measure the distance between the landslide head scarp crack and the edge of the highway (at least twice a year between the spring and fall seasons). The existing potholes should be filled with ACP and open cracks on the highway surface should be sealed to prevent surface water infiltration into the landslide mass, which would result in further landslide movement and retrogression into the highway surface. A sharp shoulder warning sign should be placed to warn motorists of the present hazard. Consideration should also be given to installing a guard rail along the edge of the highway to protect runaway vehicles.

The south ditch should be slightly re-graded in the short term to drain the surface water into the existing culvert, located to the east of the site. The area surrounding the inlet of the culvert should also be cleaned of sediments to enhance surface water flow into the culvert. Consideration should also be given to digging narrow shallow trenches (perpendicular to the highway alignment and not exceeding 0.5 m wide x 0.5 m deep) within the landslide mass using a long reach excavator to drain ponded water and promote drainage within the landslide area.

An intermediate-term repair option might include reinforcing the side slope area above existing headscarp. In this option, 6 m long soil nails installed in 1x1 m<sup>2</sup> grid pattern should reduce the risk/rate of headscarp retrogression into the highway shoulder and lanes. The ballpark cost of this option would be in the range of \$130,000. The estimated cost might become lower if the mobilization of the equipment could be shared with other sites.

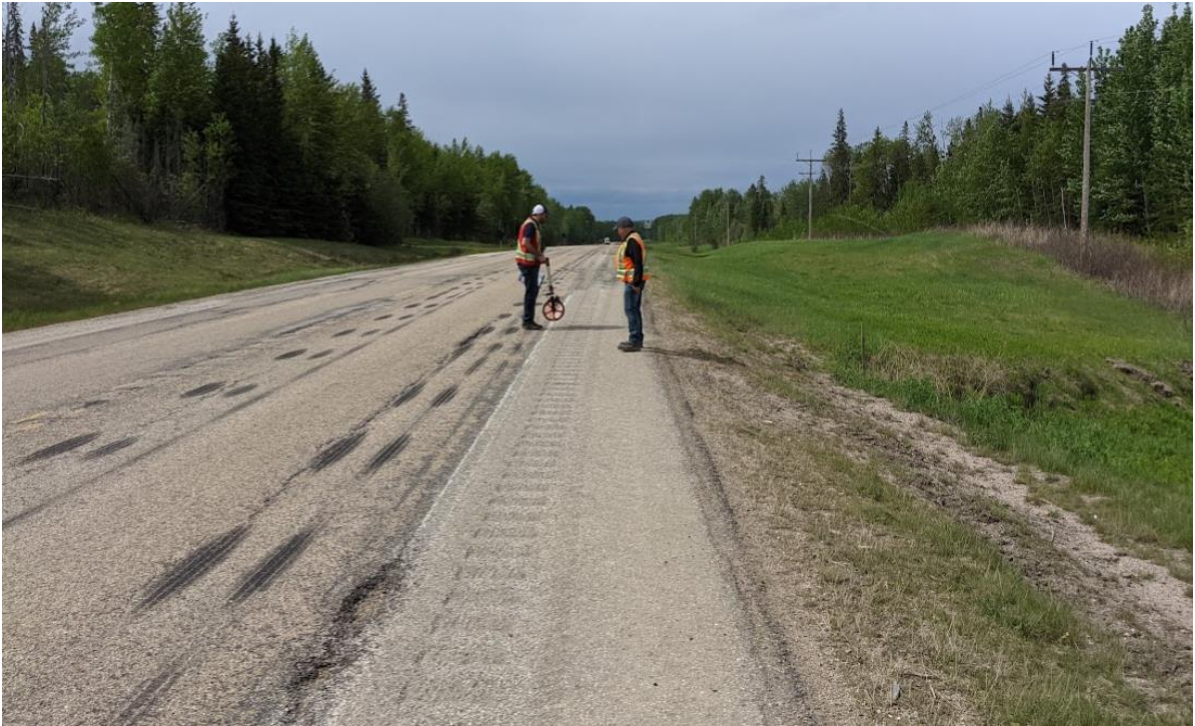
The existing cracks and potholes on the highway lanes may reflect poor/soft subgrade condition due to high ground water levels in this area and/or ongoing deterioration of pavement surface condition.

Photo No.1 – Looking west at longitudinal cracks on the highway surface at the landslide location

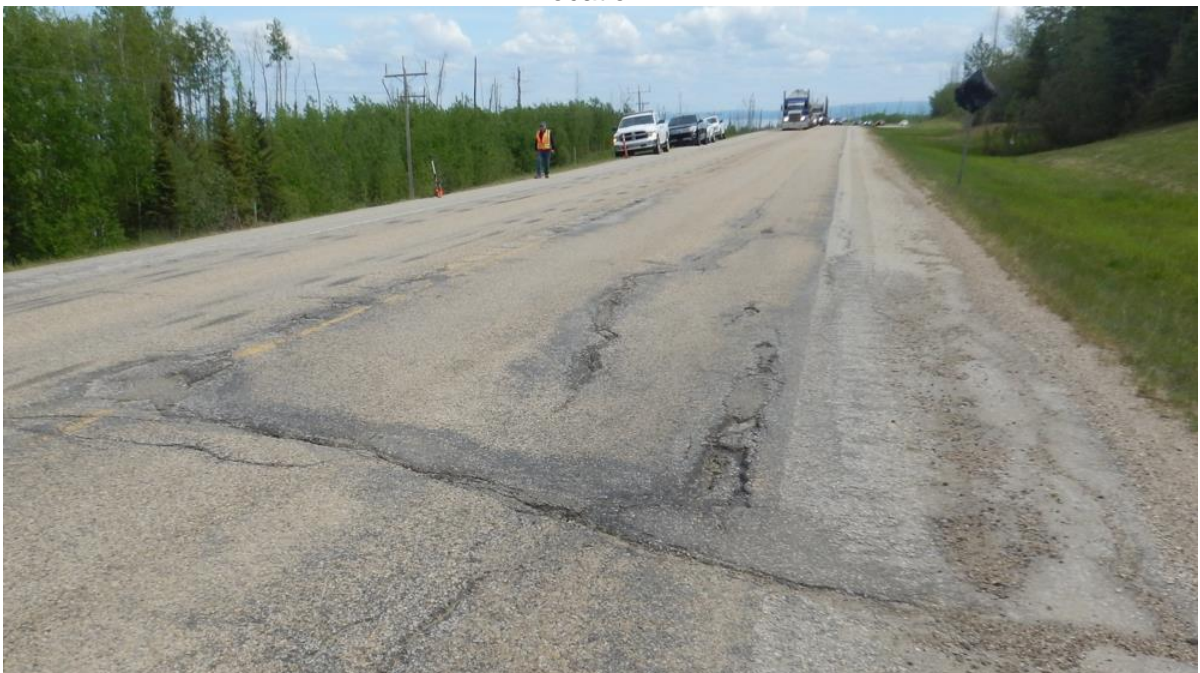
Photo No.2 – Looking east at transverse and longitudinal cracks on the highway surface at the landslide location; wide open cracks are more pronounced within the highway EBL

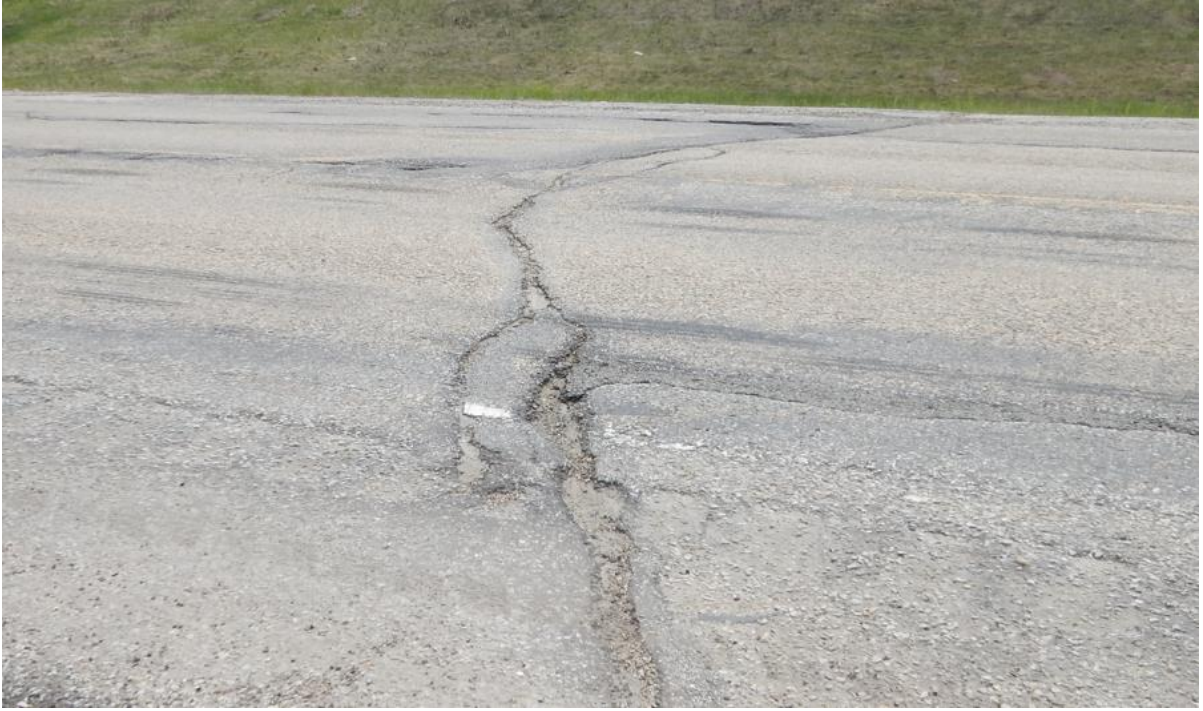
Photo No.3 – Looking north at a 60 to 130 mm wide transverse crack on the highway surface to the east of the landslide location; Pothole is 1 m long, 260 mm wide, 30 mm deep

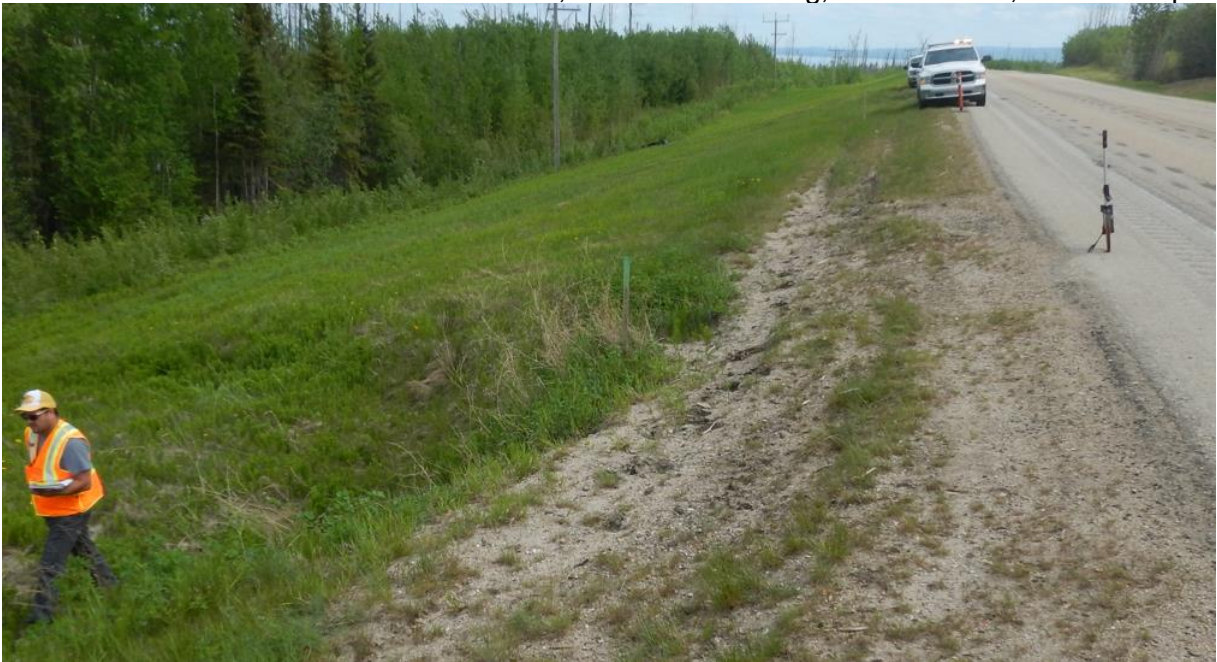
The existing drop within the highway north side slope constitutes a potential hazard for runaway vehicles.

Photo No.4 – Looking east at the landslide developed on the highway side slope; head scarp crack measured at 4.4 m from the white line (same as measured in 2020)

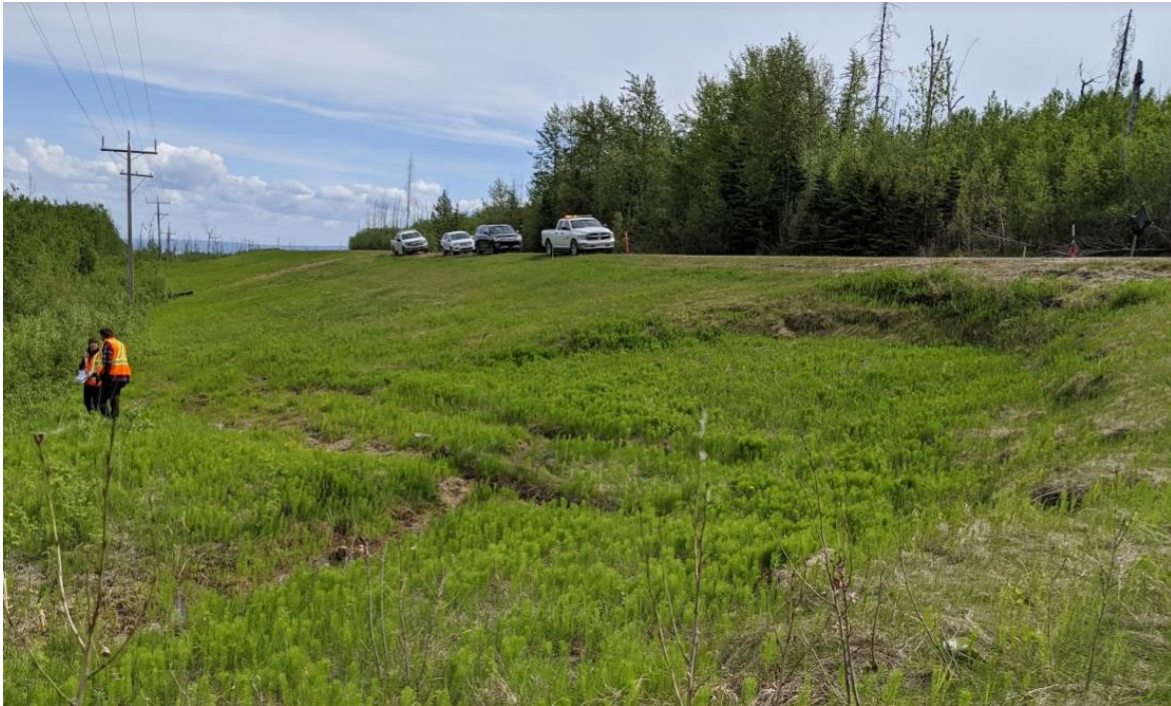
The presence of seepage and wet surface conditions within the slide mass suggests that the landslide movement occurred in response to a rise in ground water conditions. Poor surface drainage in south ditch, as noted in previous years, could have aggravated the situation.

Photo No.5 – Looking southeast at the head scarp crack of landslide mass; a distinct toe roll was noted at the bottom of the slope; more vegetation grew within the landslide mass
