**ALBERTA TRANSPORTATION AND  
ECONOMIC CORRIDORS GRMP  
NORTH CENTRAL (ATHABASCA AND FORT  
MCMURRAY DISTRICTS)  
2024 SITE INSPECTION**

<b>Site Number</b>	<b>Location</b>	<b>Name</b>	<b>Hwy</b>	<b>km</b>
NC077-1	Approximately 25 km west of Slave Lake and 15.5 km east from the junction of Highways 2 and 33	West of Canyon Creek	2:48	26
<b>Legal Description</b>		<b>UTM Co-ordinates (NAD 83)</b>		
SE-34-73-8-W5M		11 N 6136974	E 617878

<b>Primary Site Issue:</b>	A landslide affecting the highway north side slope; head scarp crack is located within the highway clear zone	
<b>Dimensions:</b>	About 30 m wide along the highway alignment and 33 m long along the slope direction.	
<b>Site History</b>	The landslide's head scarp was first noticed in the spring of 2012.	
<b>Date of any remediation:</b>	N/A	
<b>Maintenance:</b>	Mr. Wolters indicated that an old 900 mm diameter centre line culvert, located east of the landslide, was lined with a 600 mm diameter SWSP in 2022 and Class 1 Riprap was placed at the inlet and outlet; the highway surface was overlain in 2022.	
<b>Observations:</b>	<b>Description</b>	<b>Worse?</b>
<input checked="" type="checkbox"/> Pavement Distress	Highway surface: 5

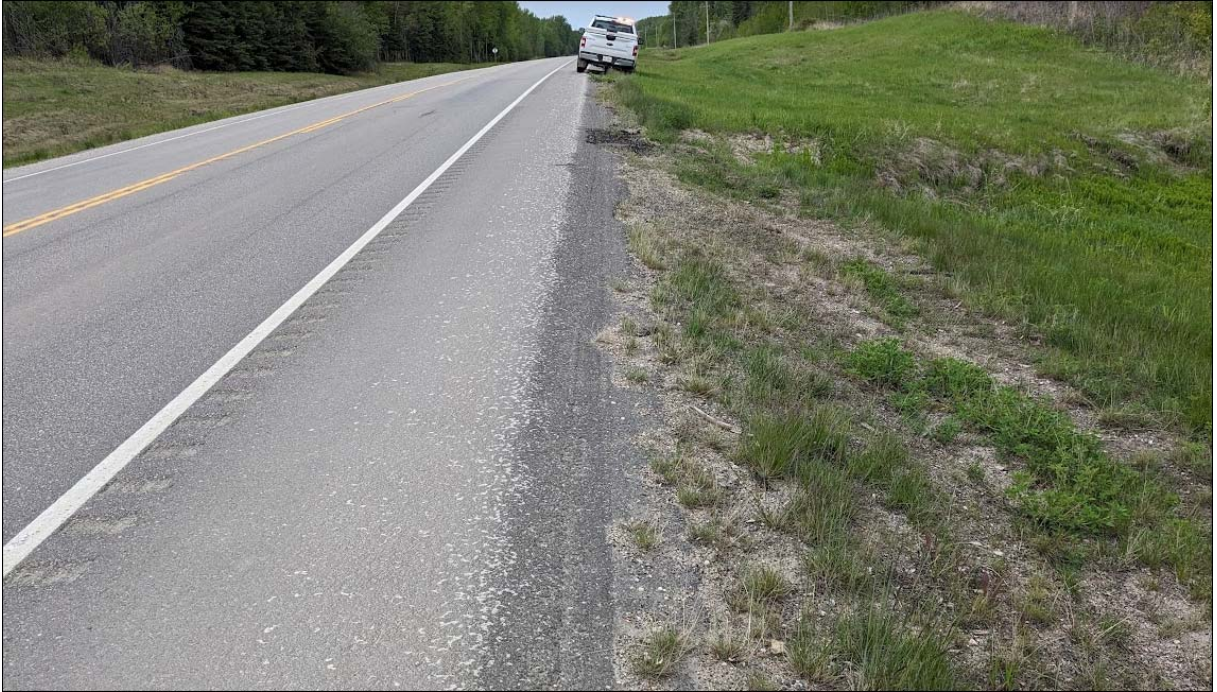
Photo No. 1 – Looking west at highway surface at the landslide location. Highway was overlaid in 2022

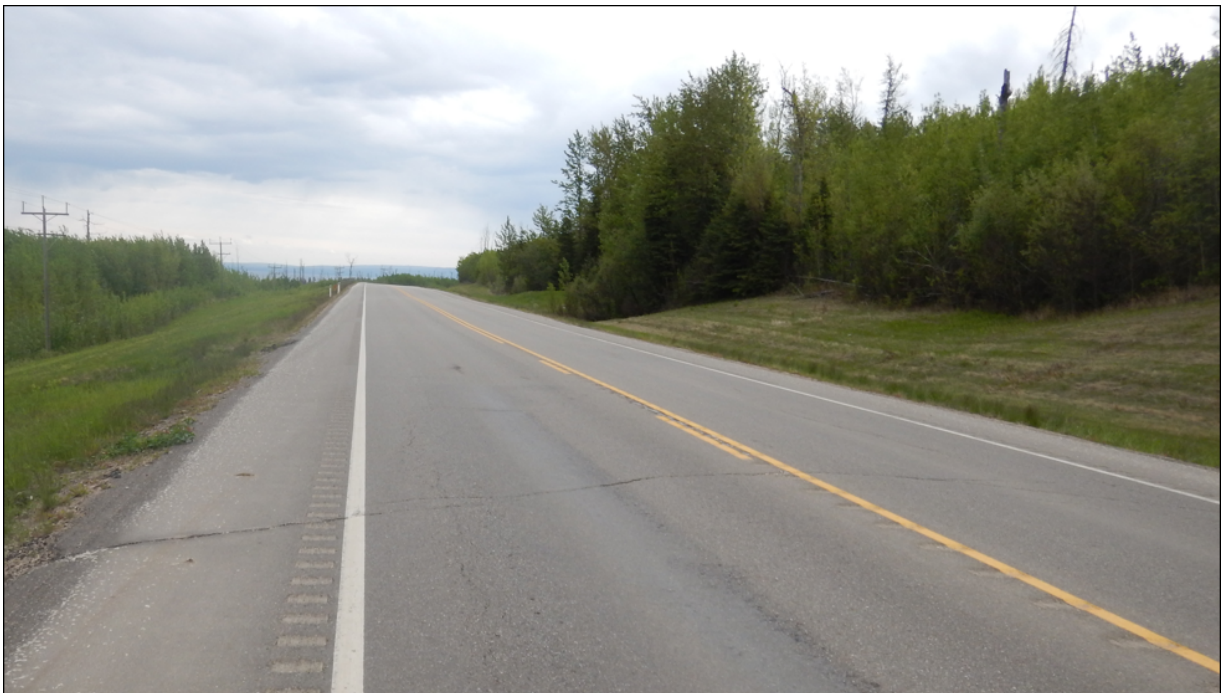
The existing cracks on the highway lanes may reflect poor/soft subgrade condition due to high ground water levels in this area and/or ongoing deterioration of pavement surface condition.

Photo No. 2 – Looking east at transverse and longitudinal reflective cracks on the highway surface at the landslide location

In the short term, the local MCI should watch closely for any cracking on the highway surface and periodically measure the distance between the landslide head scarp crack and the edge of the highway (at least twice a year between the spring and fall seasons). Open cracks on the highway surface should be sealed to prevent surface water infiltration into the landslide mass, which would result in further landslide movement and retrogression into the highway surface. A sharp shoulder warning sign should be placed to warn motorists of the present hazard. Consideration should also be given to installing a guard rail along the edge of the highway to protect runaway vehicles.

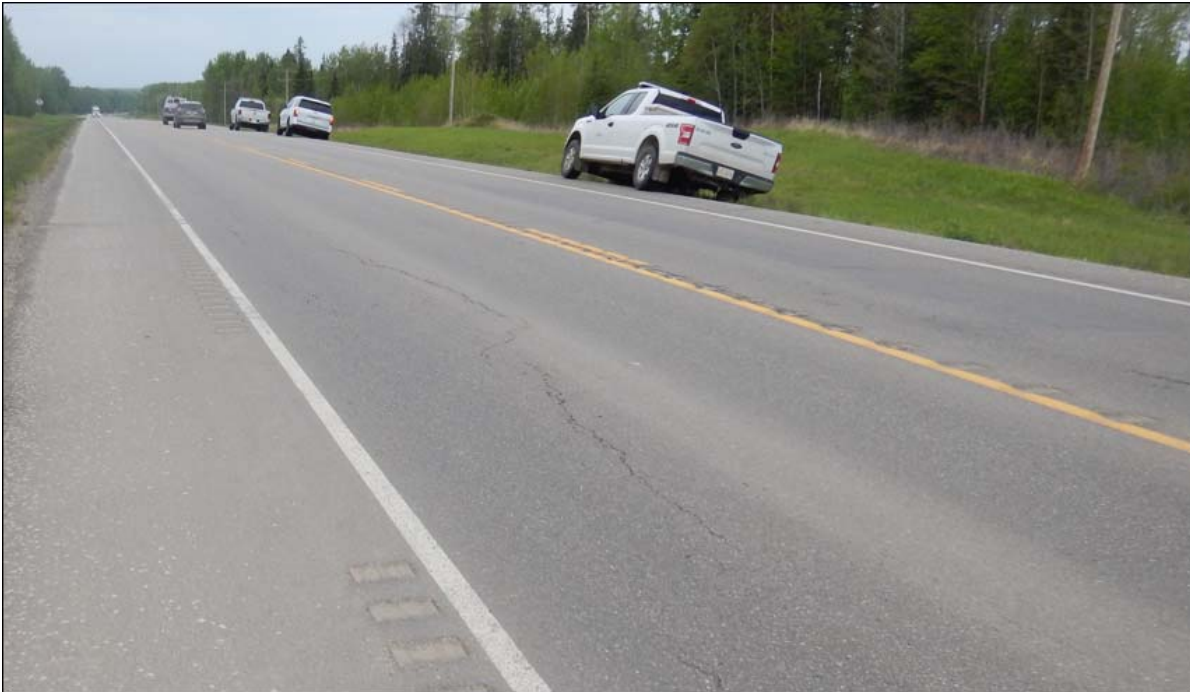
Photo No. 3 – Looking west at a 5 to 10 mm wide longitudinal crack on the highway surface

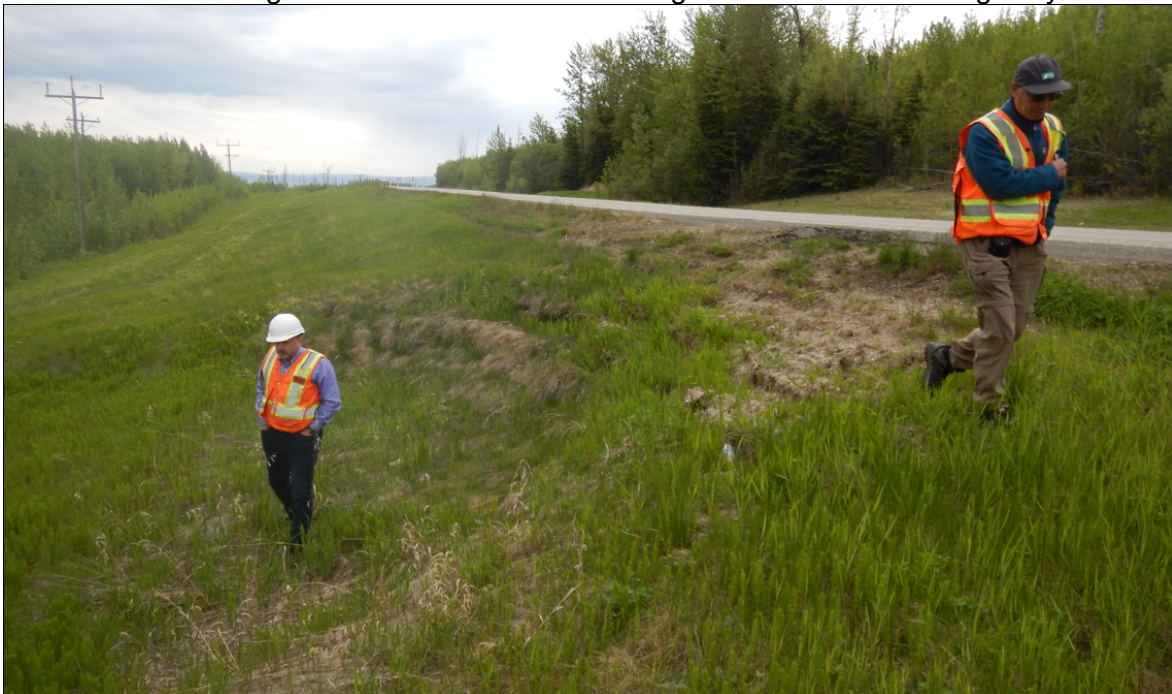
Further retrogression of landslide head scarp crack towards the highway was not observed and overall landslide features such as the distinct toe roll and flanks cracks remained relatively unchanged since the 2022 site inspection visit.

The existing drop within the highway north side slope constitutes a potential hazard for runaway vehicles.

Photo No. 4 – Looking east at the landslide developed on the highway side slope; head scarp crack measured at 4.4 m from the white line (same as measured in 2022)

An intermediate-term repair option might include reinforcing the side slope area above existing headscarp. In this option, 6 m long soil nails installed in 1x1 m<sup>2</sup> grid pattern should reduce the risk/rate of headscarp retrogression into the highway shoulder and lanes. The ballpark cost of this option would be in the range of \$180,000. The estimated cost might become lower if the mobilization of the equipment could be shared with other sites.

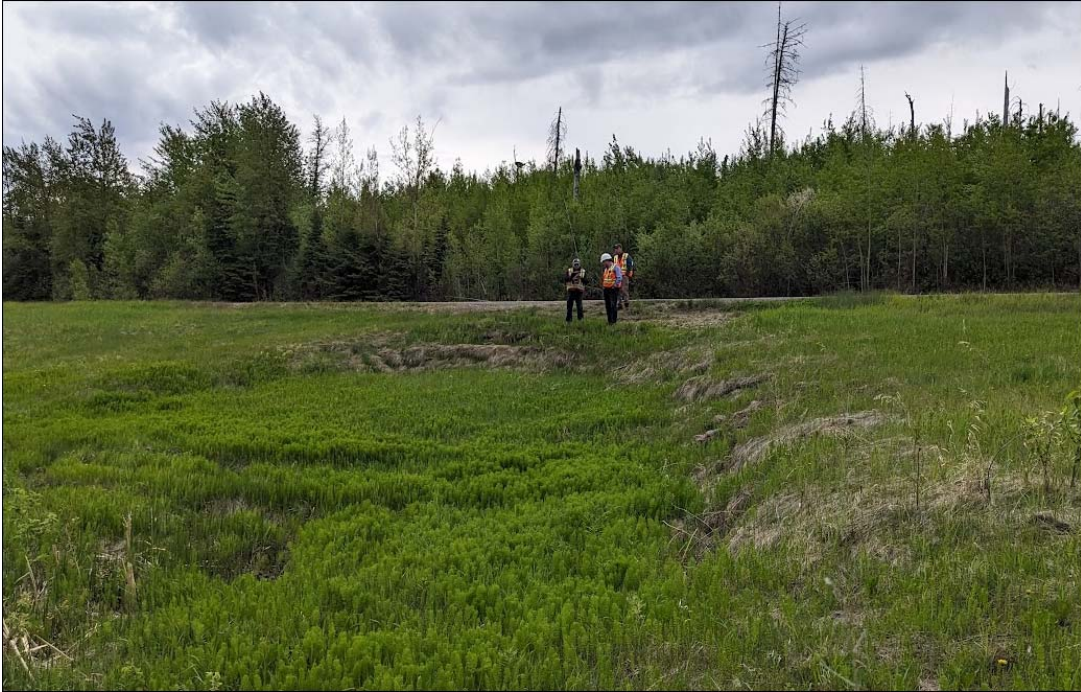
The presence of seepage and wet surface conditions within the slide mass suggests that the landslide movement was influenced by an increase in groundwater levels. Inadequate surface drainage in south ditch, as noted in previous years, might have triggered the landslide. Maintenance work carried out by TEC on the centre-line culvert east of the landslide seems to have improved water ponding on the south ditch. As a result, the rate of landslide movement appears to have decreased compared to previous years.

Photo No. 5 – Looking southeast at the head scarp crack of landslide mass; a distinct toe roll noted at the bottom of the slope; more vegetation grew within the landslide mass

Consideration should also be given to digging narrow shallow trenches (perpendicular to the highway alignment and not exceeding 0.5 m wide x 0.5 m deep) within the landslide mass using a long reach excavator to drain ponded water and promote drainage within the landslide area.

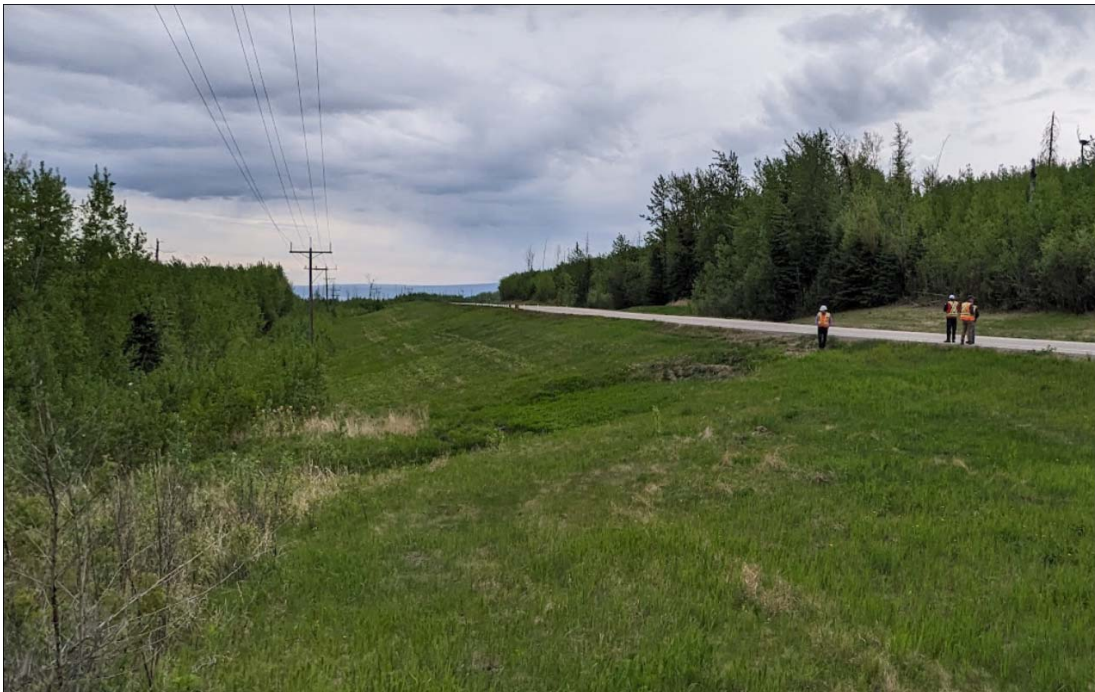
Photo No. 6 – Looking east at north highway embankment side slope with the slide in the central portion of the photo

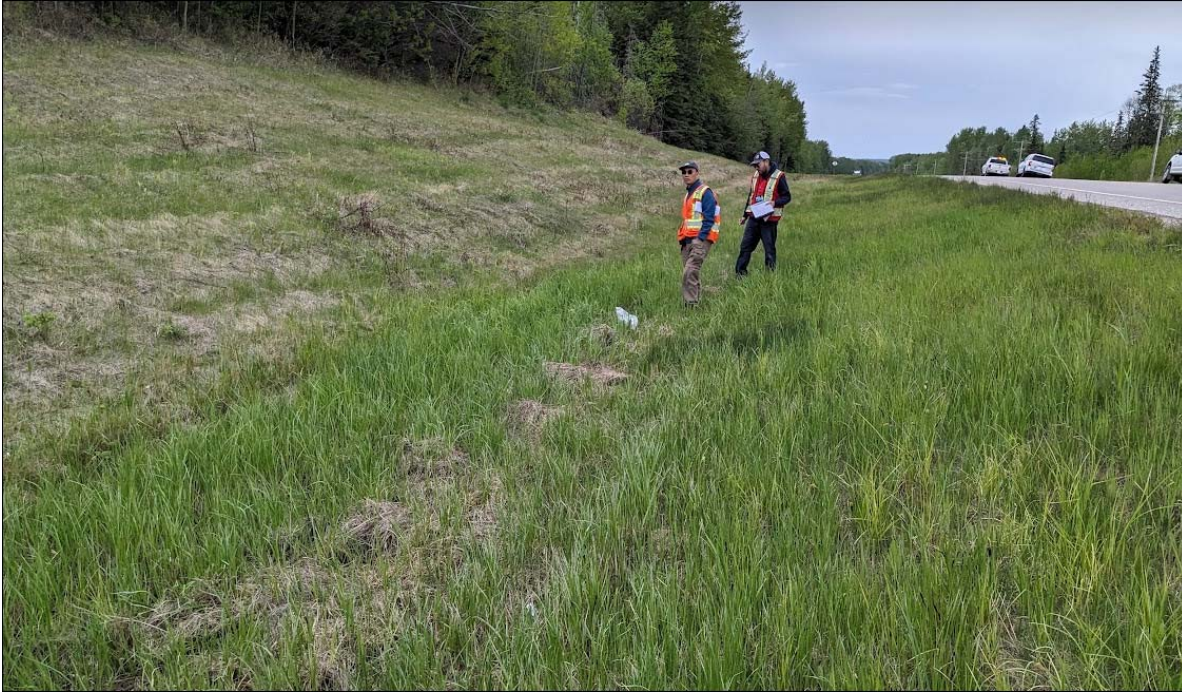
Photo No. 7 – Looking west at low lying zone in the southern ditch (dry in 2024)

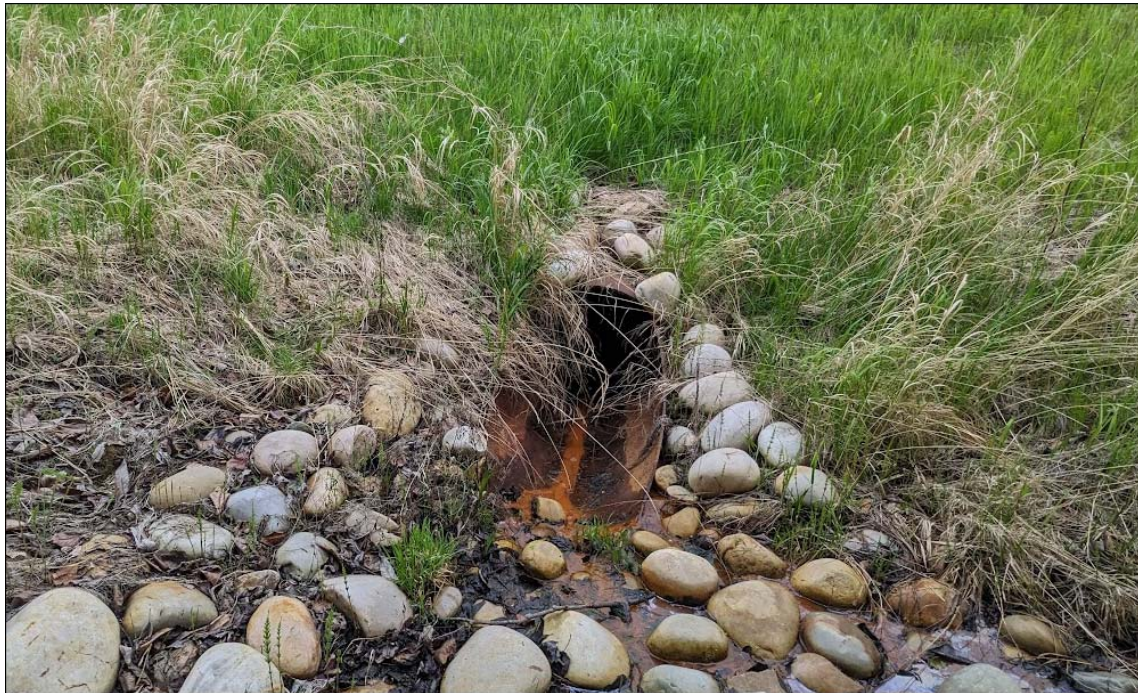
Photo No. 8 – Looking northeast at the inlet of the 600 mm diameter SWSP culvert

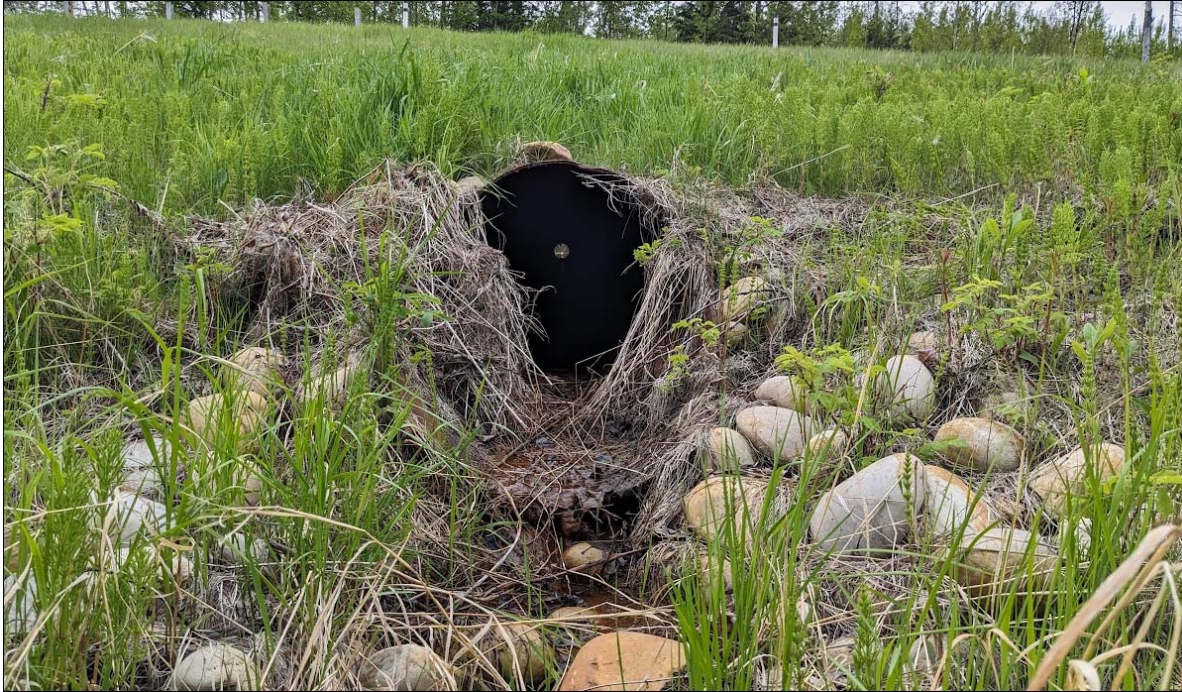
Photo No. 9 – Looking south at the outlet of the 600 mm diameter SWSP culvert
