**ALBERTA TRANSPORTATION
GEOHAZARD ASSESSMENT PROGRAM
NORTH CENTRAL REGION – ATHABASCA
2019 INSPECTION**

Site Number	Location	Name	Hwy	km
NC024-2 (NC24D)	Adjacent to Hwy 41, N. of Junction Hwy 29 at km 8.8	Kehiwin Lake SBL Pavement Distress to the South of NC24B Pile Wall	41:23	8.7
Legal Description		UTM Co-ordinates (NAD 83)		
SW-31-58-6-W4M		12U N 507240	E 5989184

**NC024-2 (NC24B & D): HWY 41:23 SLIDE (km8.8)
SITE PLAN SHOWING FEATURES AND
INSTRUMENT LOCATIONS**

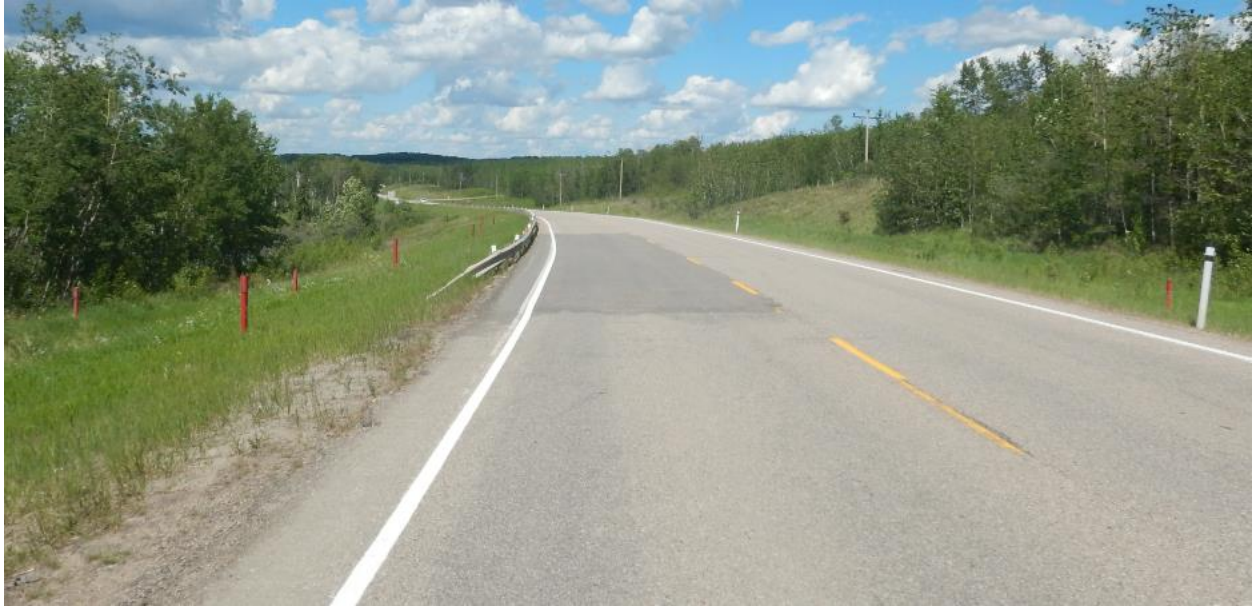
Photo No.1 - Looking north at the 2017 ACP patch placed at NC24D location; no visible dip on highway surface

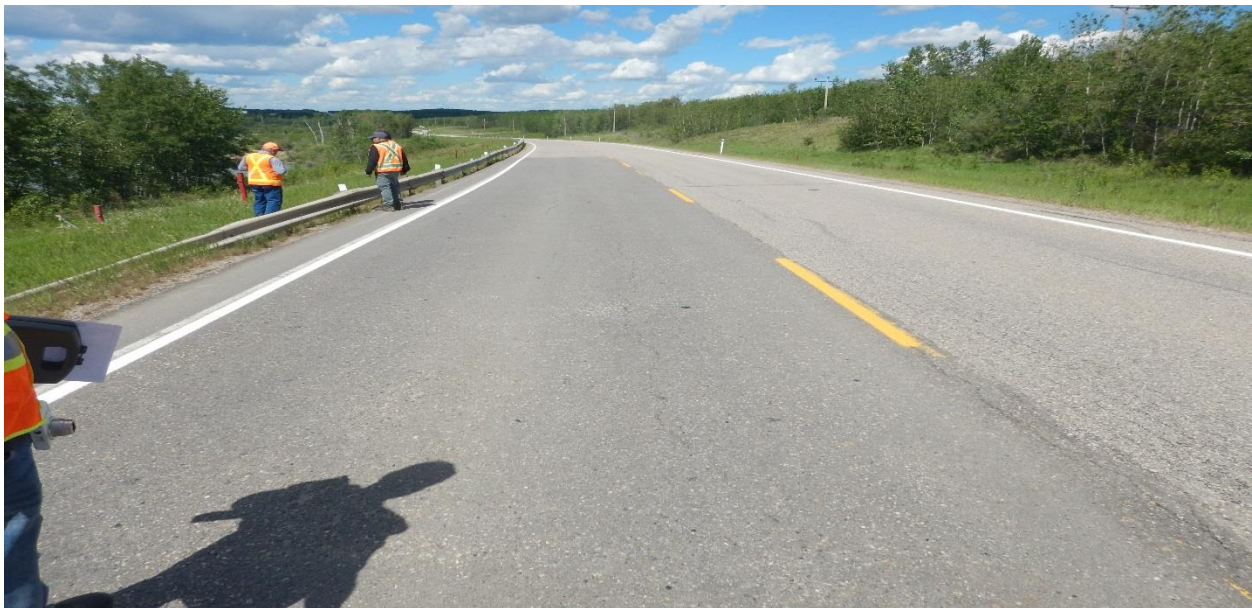
Photo No.2 - Looking north at up to 10 mm wide reflective crack on the SBL at NC24D location

<p>Recommendations:</p> <p>The site visit could be skipped next year; however, instrumentation monitoring should be continued at this site.</p> <p>The local MCI should watch for the development of any new cracks on the highway lanes, particularly upslope of SI15-4 location. Open cracks above the pile walls should be sealed to reduce groundwater infiltration into the landslide masses.</p>

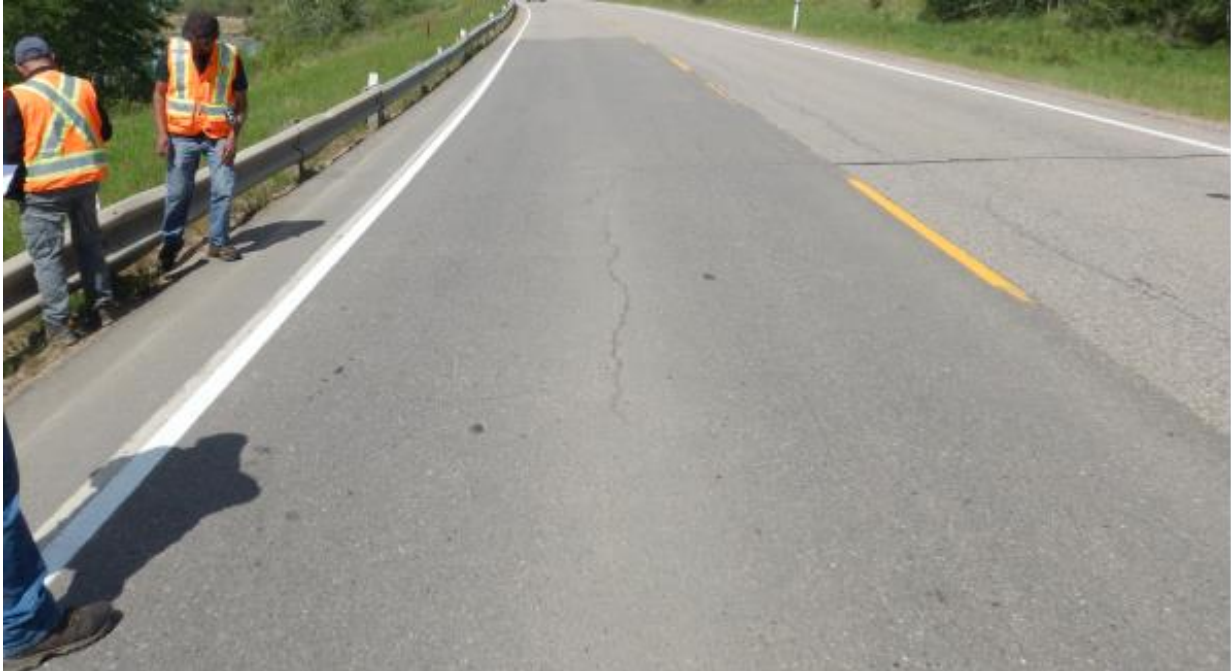
Photo No.2A - Looking north at up to 10 mm wide reflective crack on the SBL at NC24D location

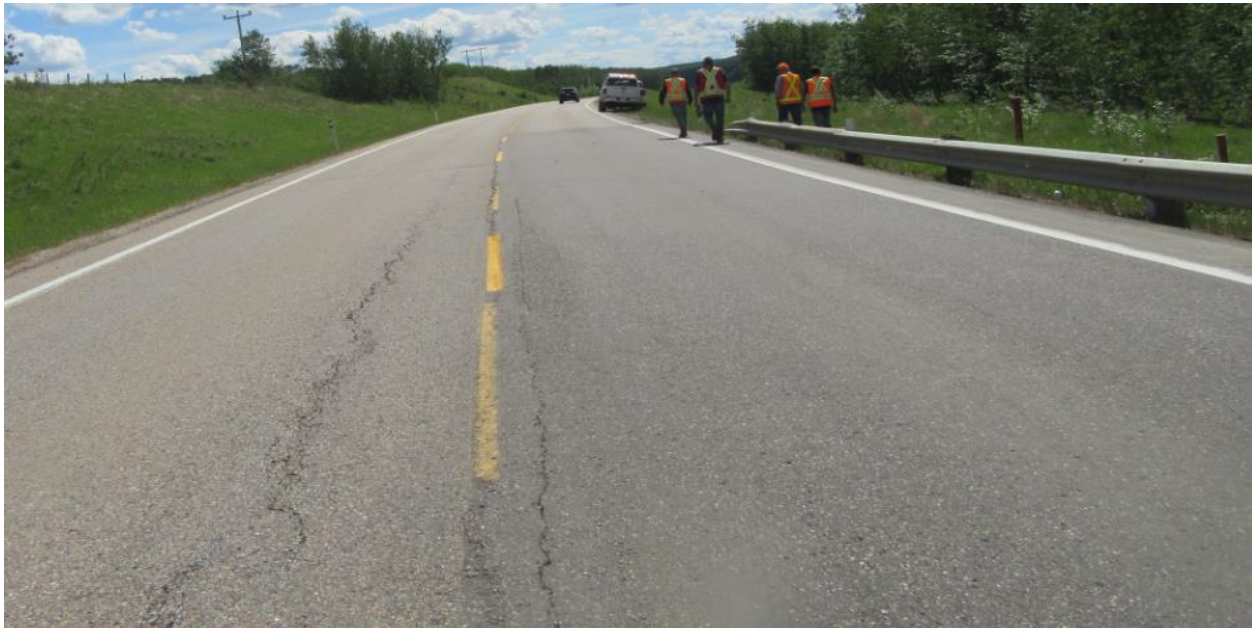
Photo No.3 - Looking south at reflective longitudinal open cracks (10 to 20 mm wide) at NC24D location

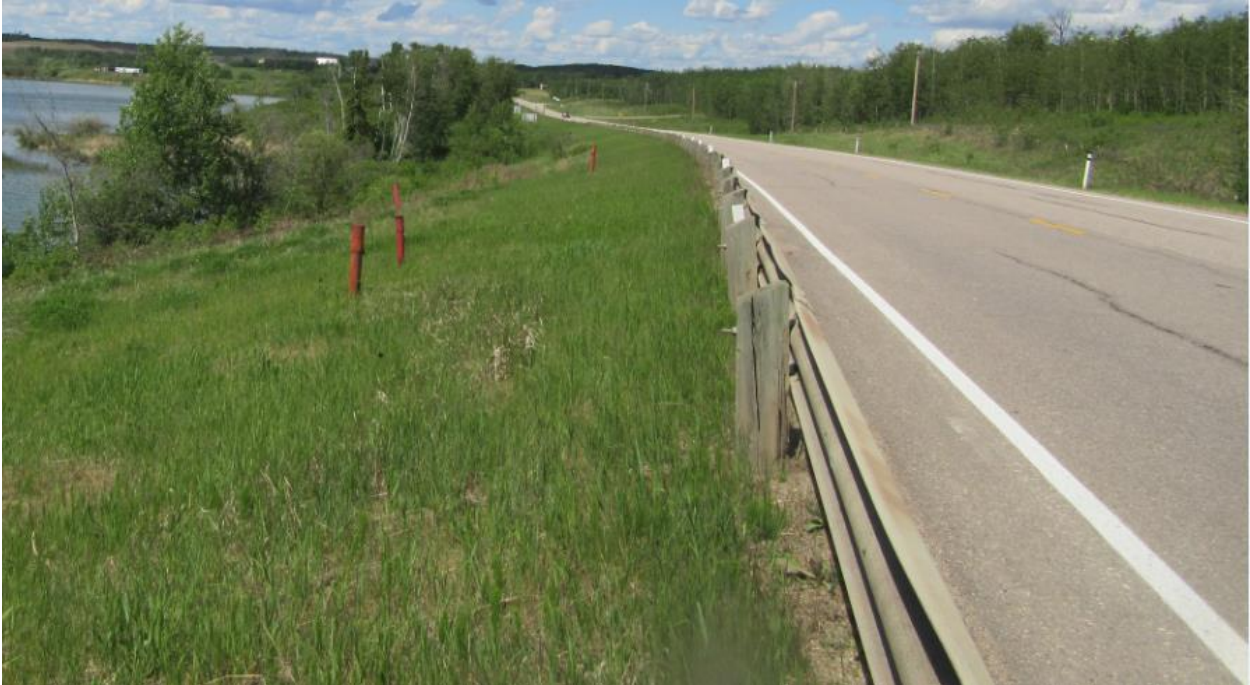
Photo No.4 - Looking north at the highway side slope downslope at NC24D location; no signs of cracking or bulging noted on the side slope

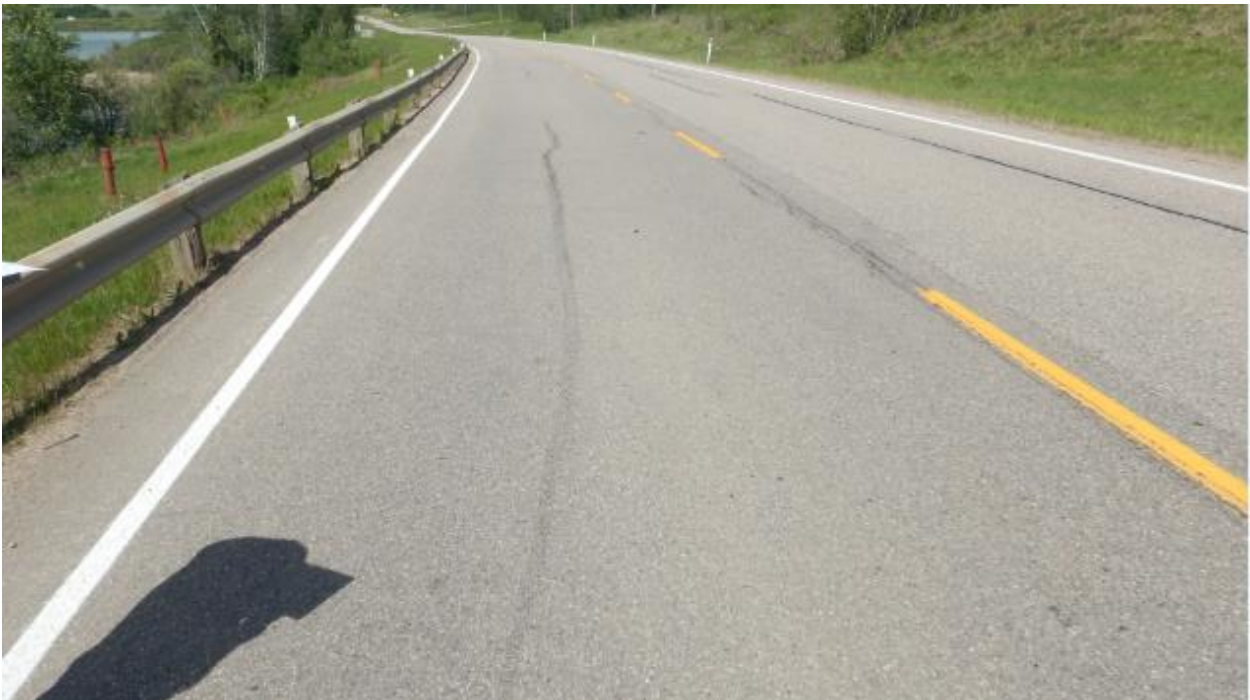
Photo No. 5 – Reflective cracks along the highway above NC24 B Pile Wall
