**ALBERTA TRANSPORTATION
GEOHAZARD ASSESSMENT PROGRAM
NORTH CENTRAL REGION – ATHABASCA &
FORT MCMURRAY DISTRICTS
2021 SITE INSPECTION**

Site Number	Location	Name	Hwy	km
NC102 (previously known as NC24B and NC24D)	Adjacent to Hwy 41, N. of Junction Hwy 29 at km 8.8	Kehiwin Lake	41:23	8.7
Legal Description		UTM Co-ordinates (NAD 83)		
SW-31-58-6-W4M		12U N 507240	E 5989184

**NC102: HWY 41:23 KEHIWIN LAKE (km8.8)
SITE PLAN SHOWING FEATURES AND
INSTRUMENT LOCATIONS**

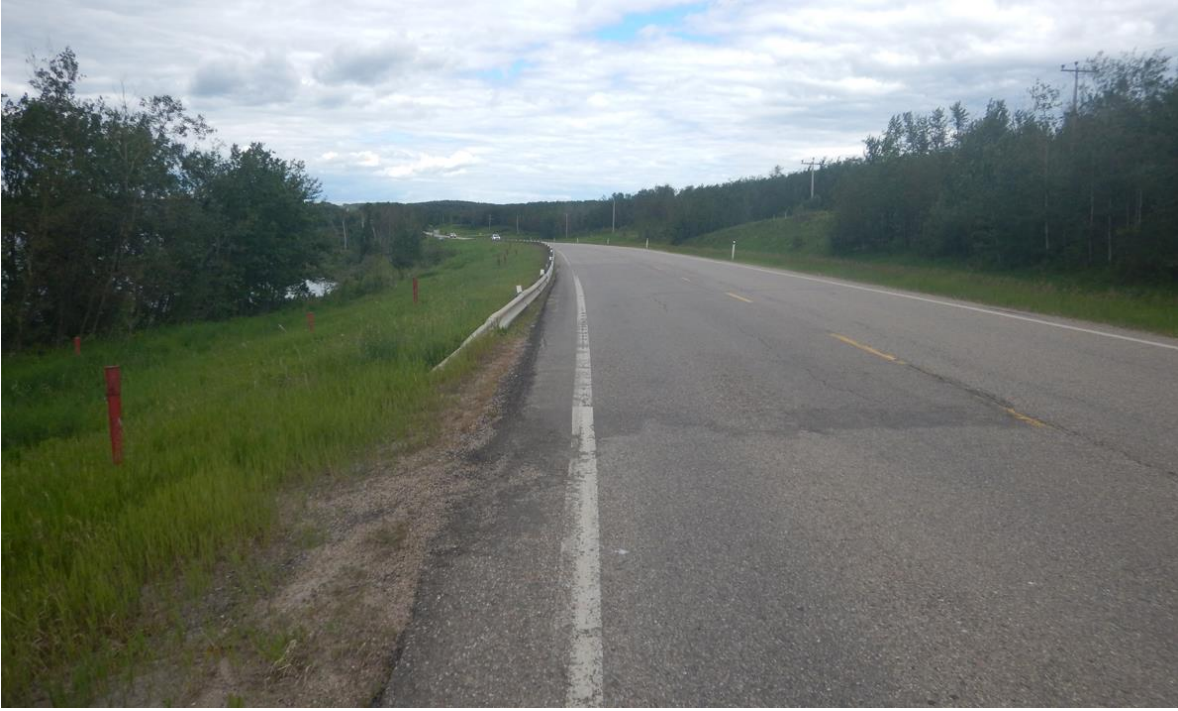
Photo No.1 - Looking north at the 2017 ACP patch placed on the highway surface at the NC24D pile wall location; no visible dip on highway surface

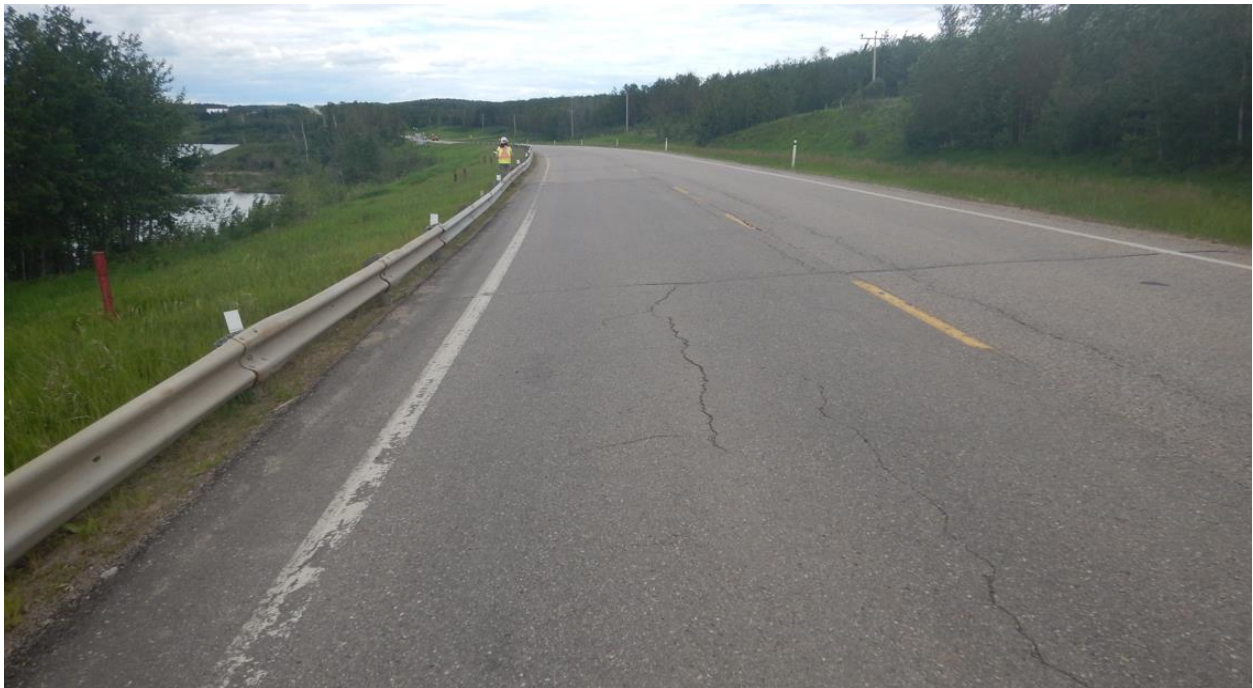
Photo No.2 - Looking north at up to 20 mm wide reflective cracks, no drop on the SBL at the NC24D pile wall location

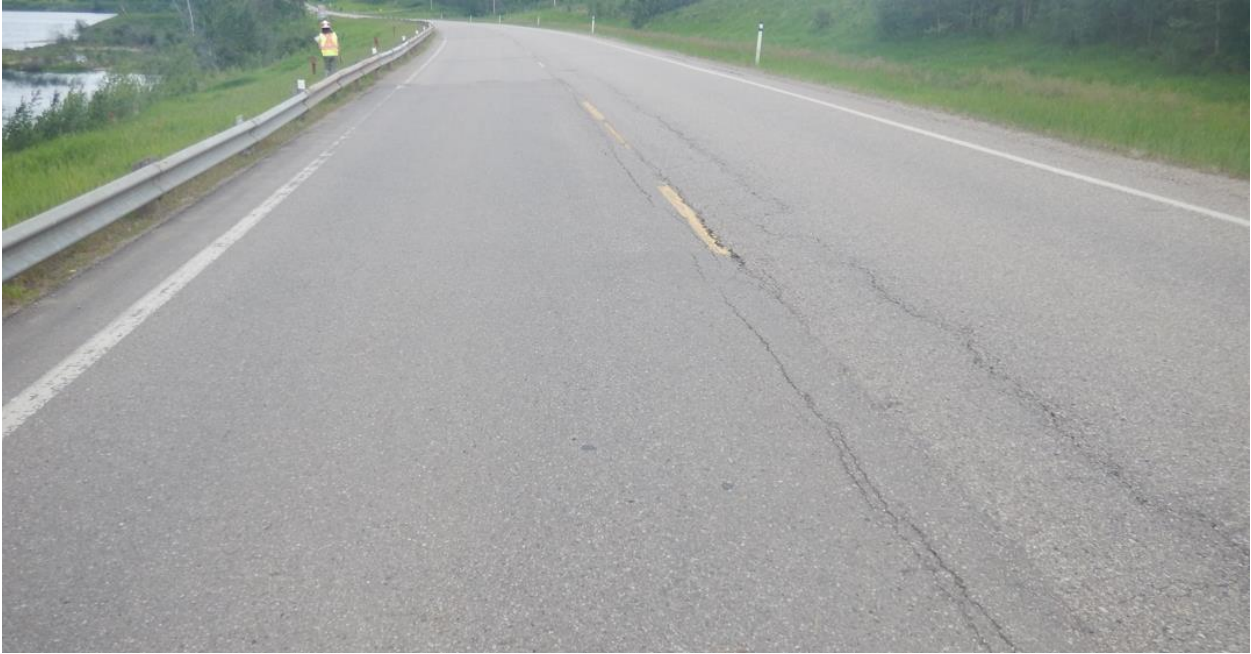
Photo No.3 - Looking north at up to 30 to 40 mm wide reflective cracks on the highway surface at the NC24D pile wall location

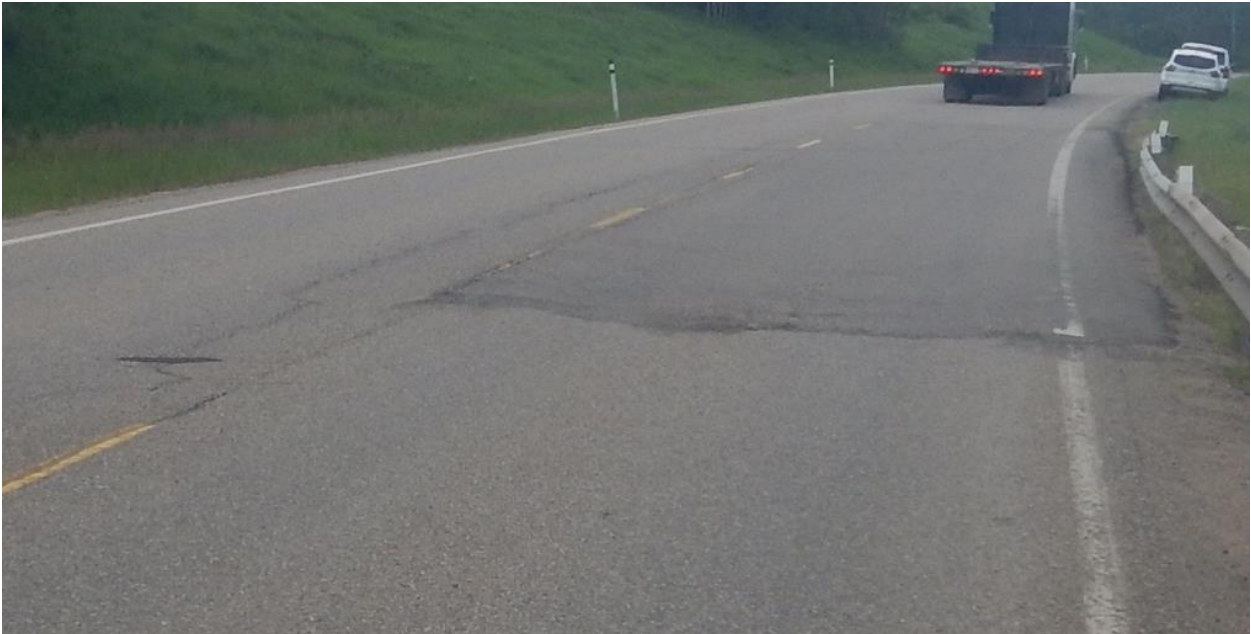
Photo No.4 - Looking south at longitudinal open cracks (10 to 40 mm wide) on the highway at the NC24D pile wall location

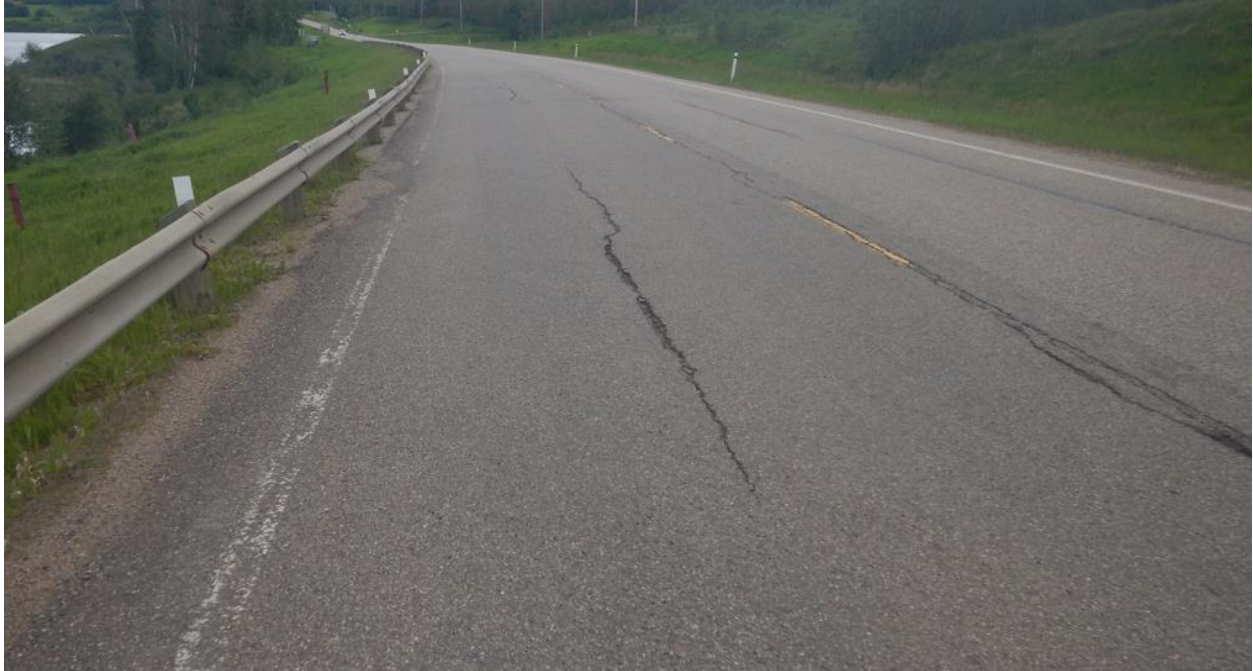
Photo No. 5 – Looking north at 11 m long x 50 mm wide reflective crack on the highway at the NC24B pile wall location

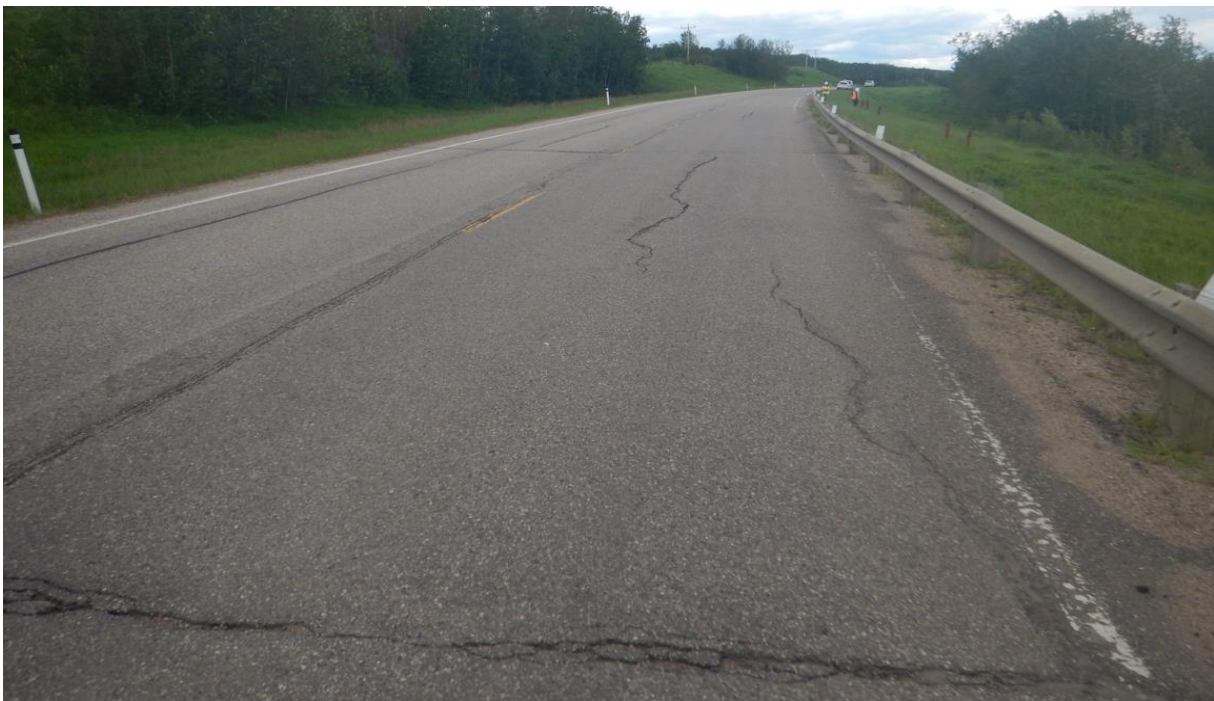
Photo No. 6 – Looking south from the northern flank of the NC24B landslide location at open reflective cracks (20 to 50 mm wide with no drop)
