**ALBERTA TRANSPORTATION AND ECONOMIC CORRIDORS  
GEOHAZARD ASSESSMENT PROGRAM  
NORTH CENTRAL REGION – ATHABASCA &  
FORT MCMURRAY DISTRICTS  
2023 SITE INSPECTION**

Site Number	Location	Name	Hwy	km
NC102 (previously known as NC24B and NC24D)	Adjacent to Hwy 41, N. of Junction Hwy 29 at km 8.8	Kehiwin Lake	41:23	8.7
Legal Description		UTM Co-ordinates (NAD 83)		
SW-31-58-6-W4M		12U N 507240	E 5989184

**NC102: HWY 41:23 KEHIWIN LAKE (km8.8)  
SITE PLAN SHOWING FEATURES AND  
INSTRUMENT LOCATIONS**

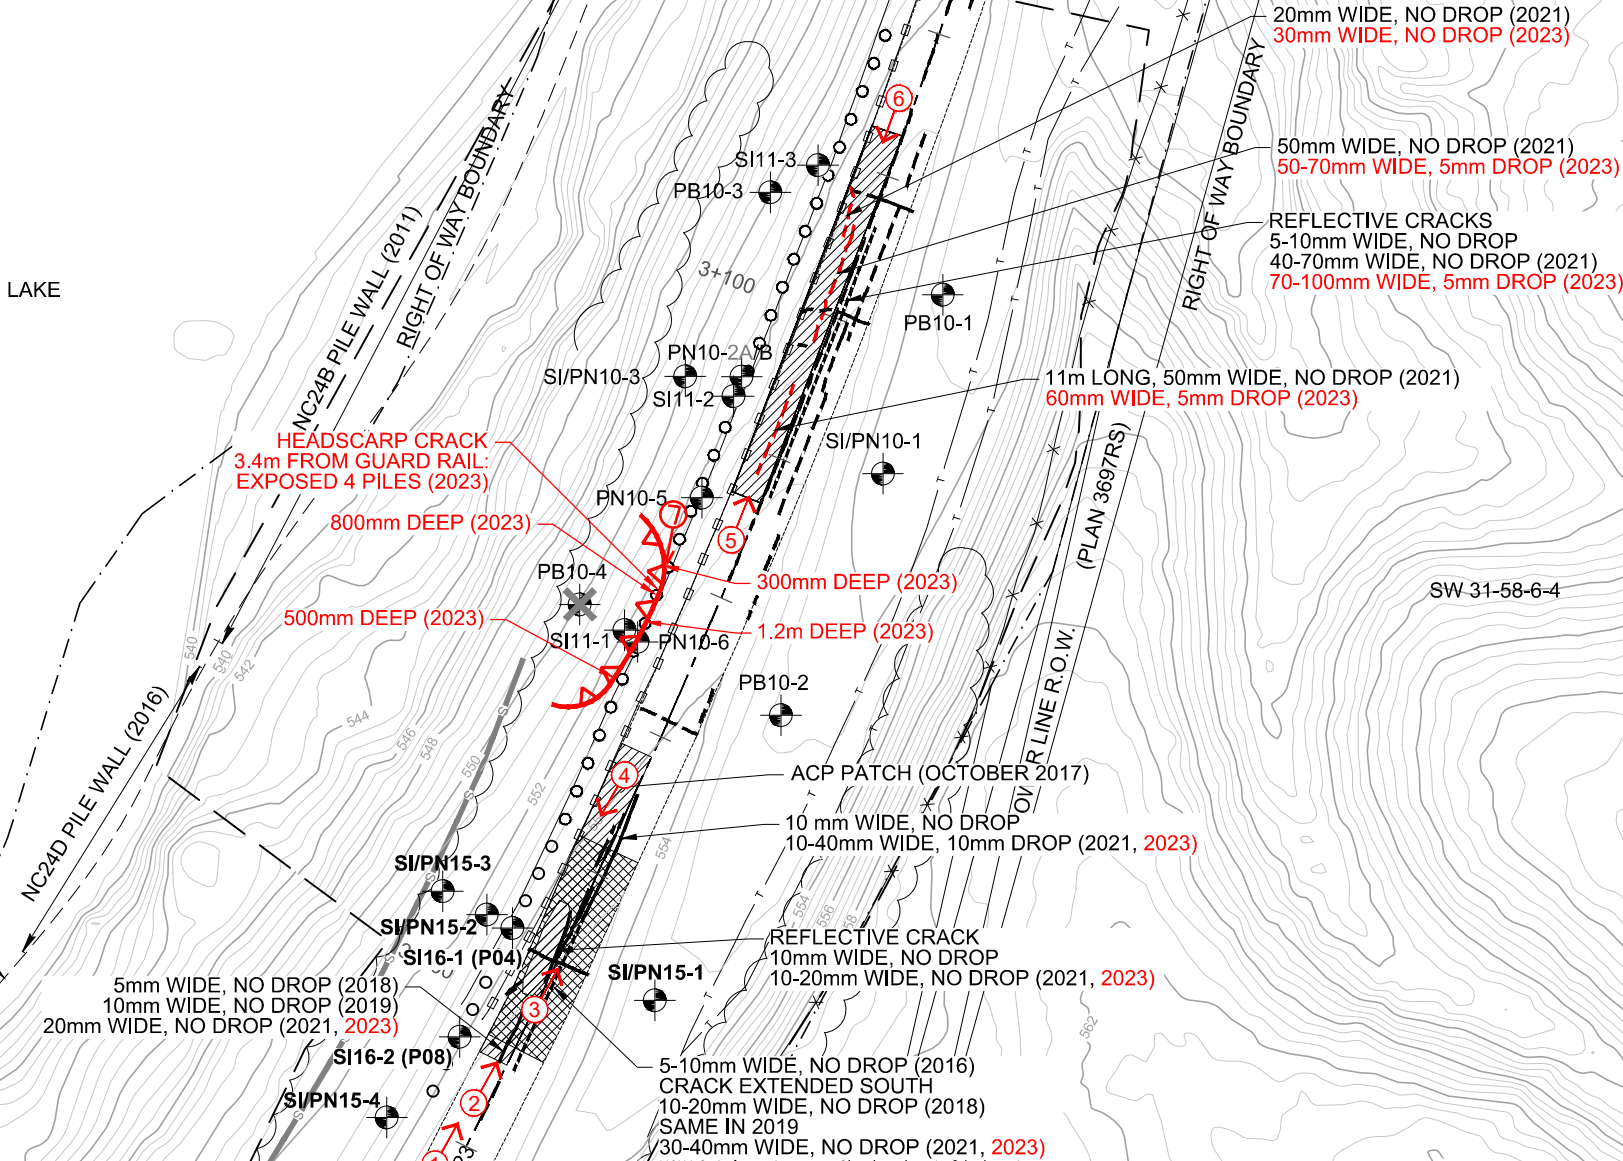
**DWG NO. 32122-NC102-1**

<p><b>Assessment</b> (Refer to attached Figure):</p> <p>The NC24B and NC24D pile walls have been effective in stabilizing the landslide movements. The reflective landslide cracks appeared on the highway surface above both walls will continue to open and widen over time until the pile walls mobilize the full magnitudes of the landslide stabilizing forces.</p> <p>The design of the NC24B pile wall accounted for partial loss of the downslope soil mass (i.e., up to 4 m). Hence, the integrity of the wall should not be impacted due to the exposure of the concrete piles unless the downslope mass drops by more than 4 m. However, the slump developed downslope of the wall may get bigger and deeper in the future, and the head scarp crack may potentially expose more piles. Future loss of the exposed soils between the spaced piles, if occurs for example due to repeated freeze/thaw cycles or saturation of soils after a heavy rainfall event, may eventually impact the integrity of the highway due to progressive loss of soils the wall and the highway.</p>

<p><b>Recommendations:</b></p> <p>The site visit could be skipped next year; however, instrumentation monitoring should be continued at this site.</p> <p>Open cracks on the highway surface above the pile walls should be sealed to reduce groundwater infiltration into the landslide masses.</p> <p>The local MCI should watch for the development of any new cracks on the highway lanes, particularly upslope of SI15-4 location (i.e., SI located outside the pile wall extent).</p> <p>The slump area around the exposed four piles should be monitored and any cracks on the side slopes or the highway above this location should be sealed.</p> <p>It is recommended that fill be brought to site to slightly grade/contour the slump area and cover the exposed four piles. The fill should be lightly compacted around the exposed piles.</p>

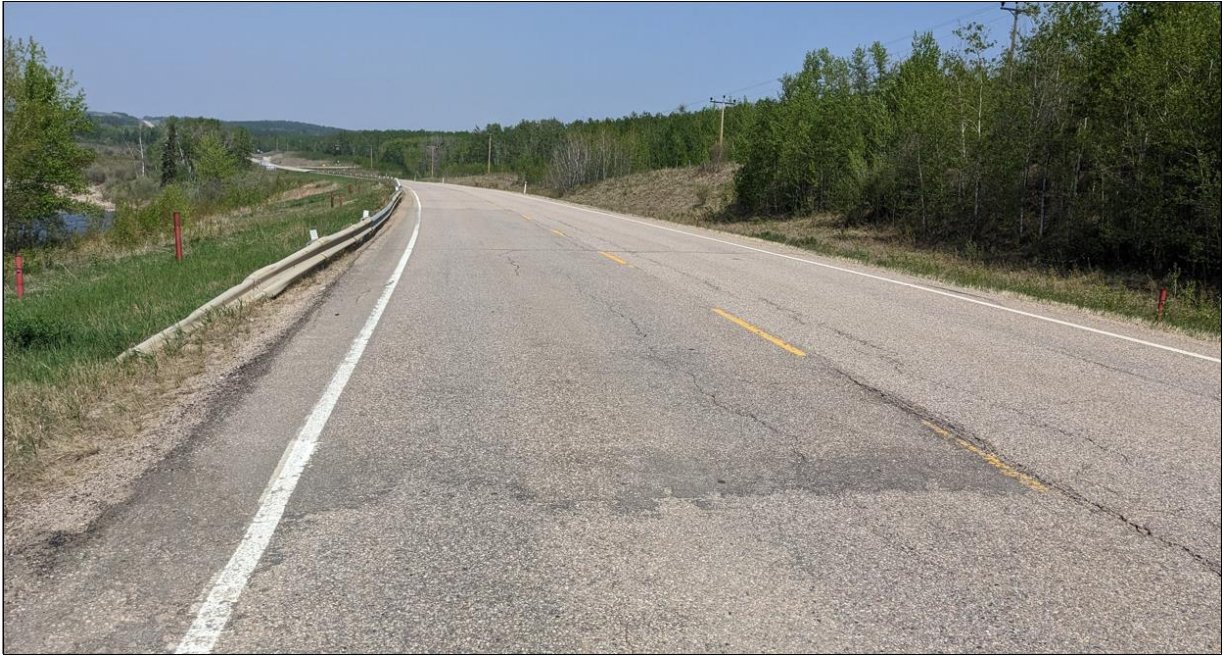
**Photo No.1 - Looking north at the 2017 ACP patch placed on the highway surface at the NC24D pile wall location; no visible dip on highway surface.**

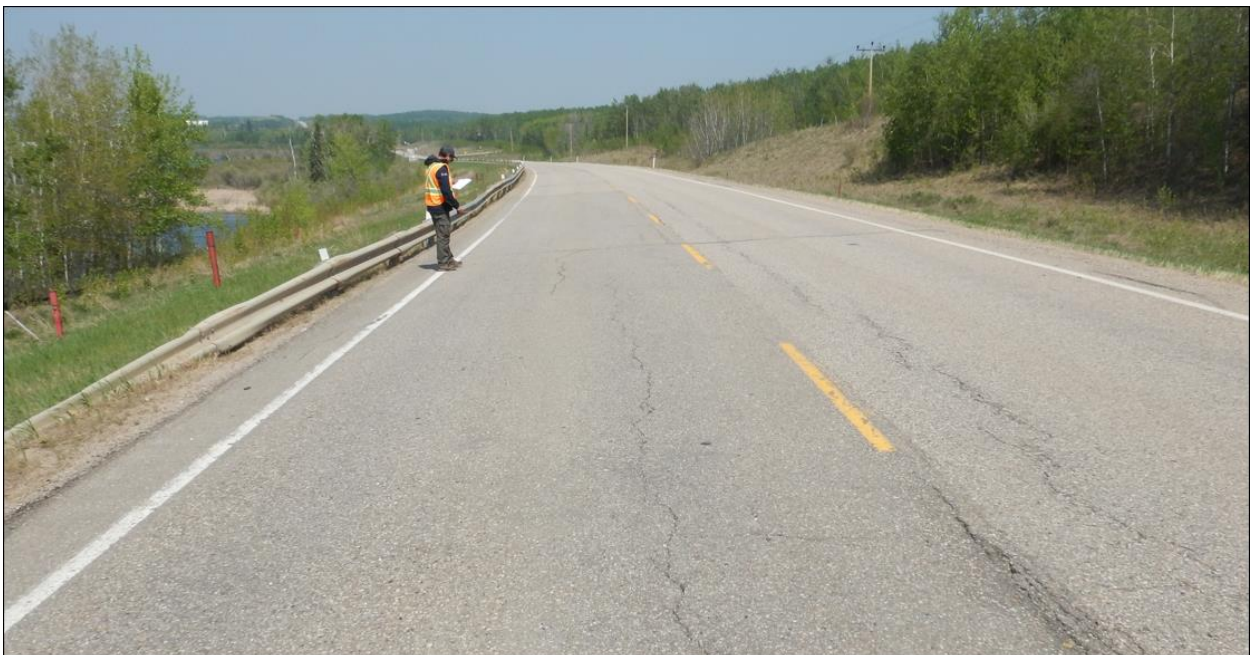
**Photo No.2 - Looking north at up to 20 mm wide reflective cracks, no drop on the SBL at the NC24D pile wall location**

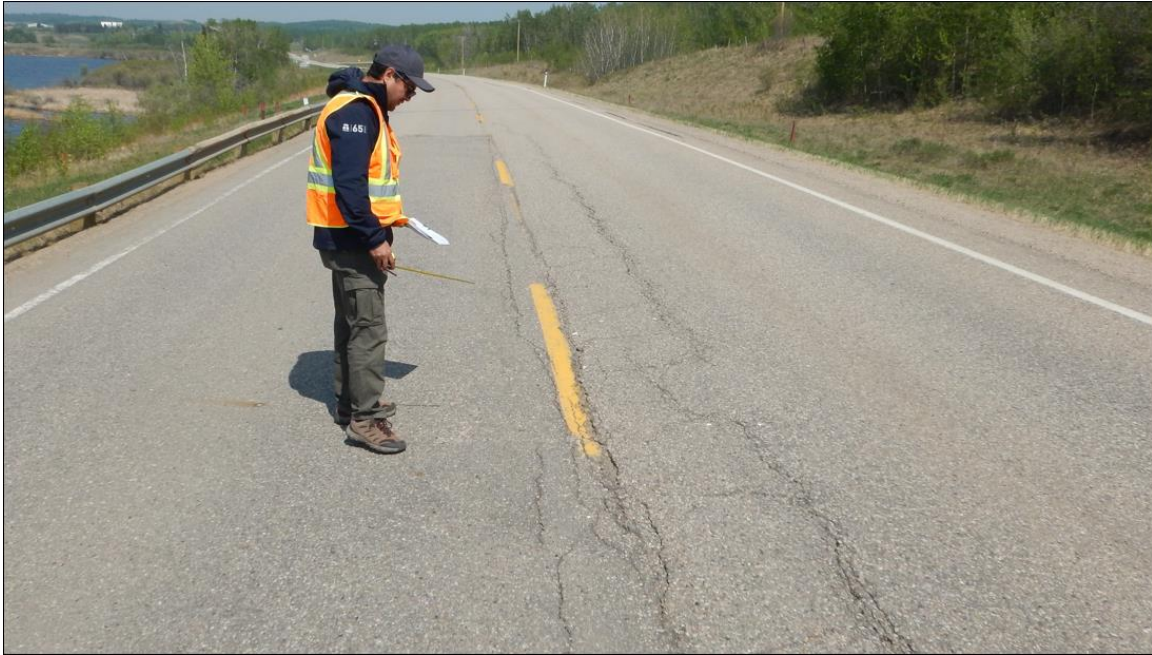
**Photo No.3 - Looking north at up to 30 to 40 mm wide reflective cracks on the highway surface at the NC24D pile wall location**

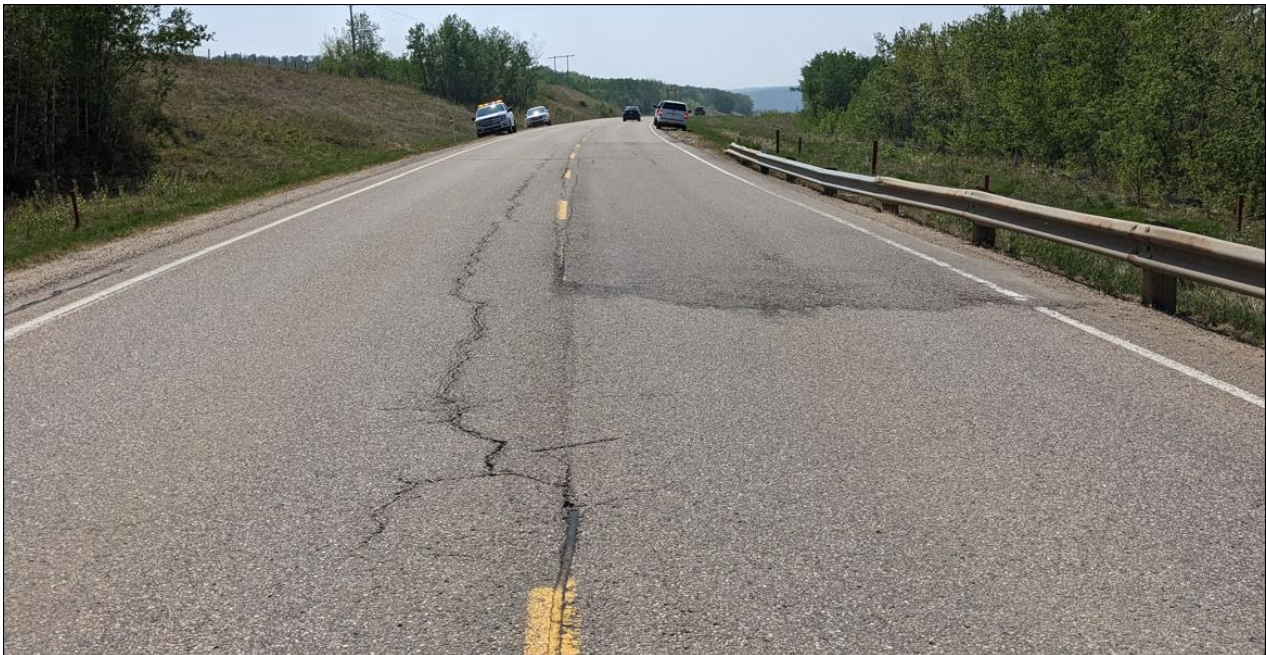
**Photo No.4 - Looking south at longitudinal open cracks (10 to 40 mm wide) on the highway at the NC24D pile wall location**

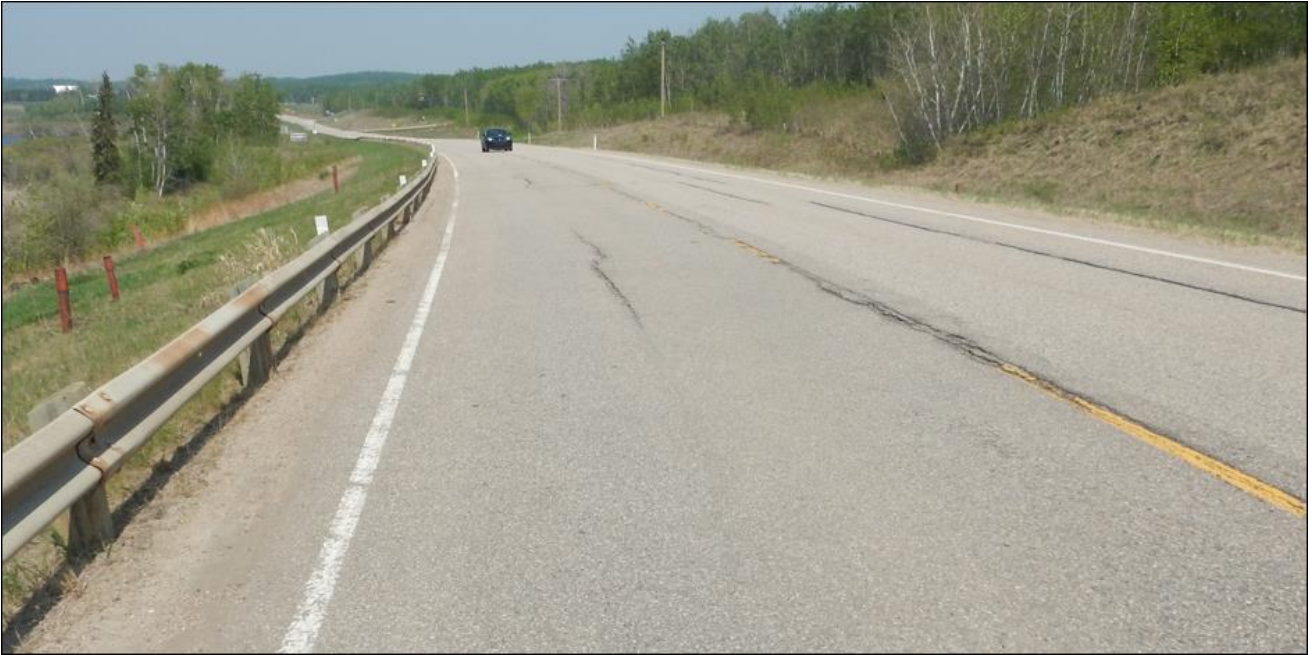
**Photo No. 5 – Looking north at a reflective crack (60 mm wide with 5 mm drop) on the highway surface above NC24B pile wall location**

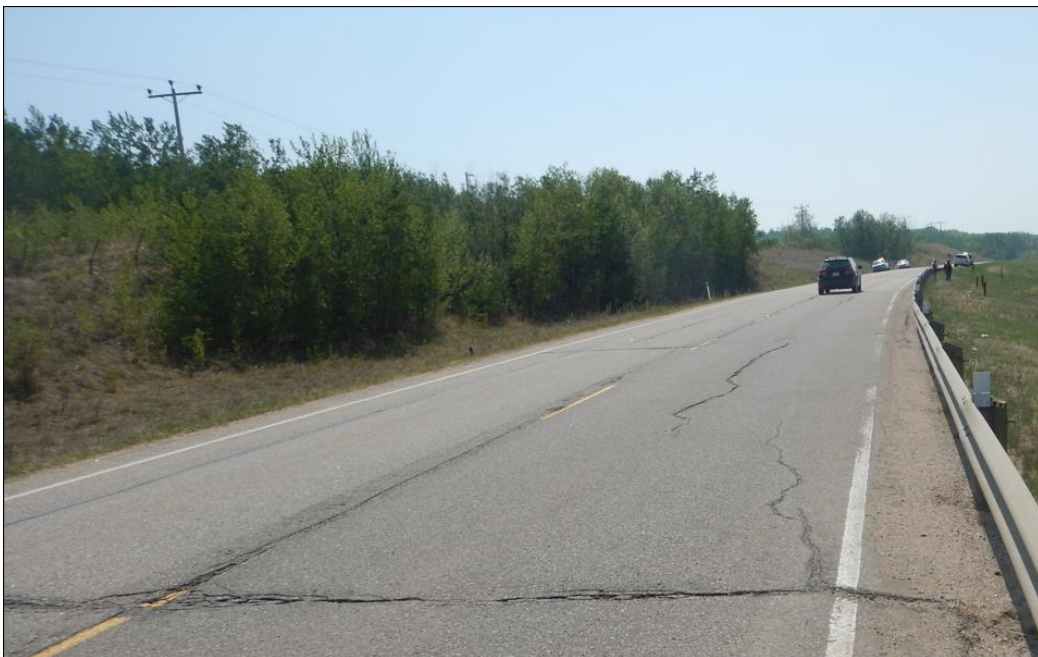
**Photo No. 6 – Looking south from the northern flank of the NC24B landslide location at open reflective cracks (30 to 100 mm wide with 5 mm drop)**

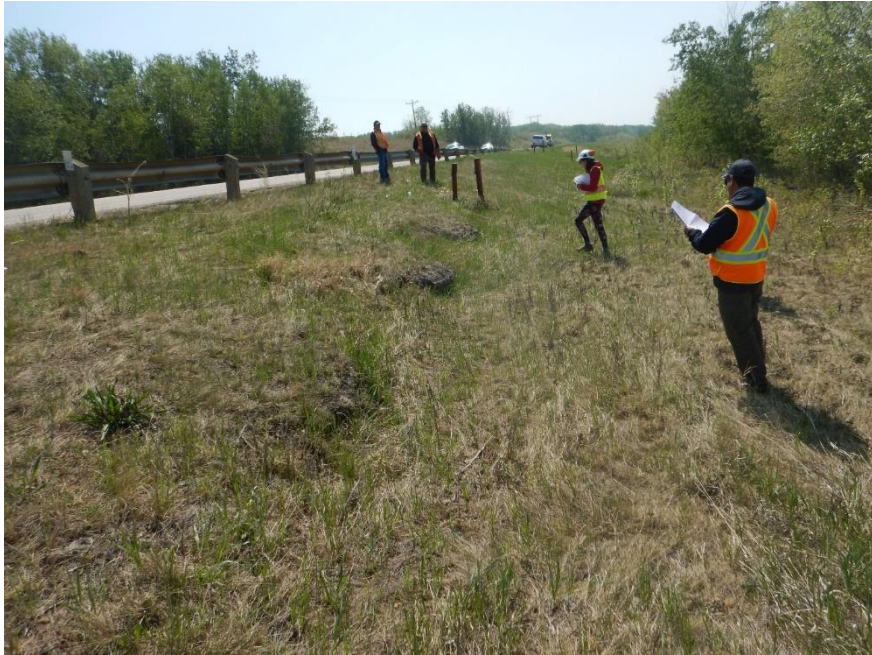
**Photo No. 7 – Looking south at a minor slump developed immediately downslope of the NC24B pile wall; the slump exposed the tops of four concrete piles.**
