**ALBERTA TRANSPORTATION AND
ECONOMIC CORRIDORS GRMP
NORTH CENTRAL (ATHABASCA AND FORT
McMURRAY DISTRICTS)
INSTRUMENTATION MONITORING- SPRING 2024**

Site Number	Location	Name	Hwy	km
NC102 (NC024-2)	HWY 41:23 C1 8.88	Kehiwin Lake	41:23	Km 8.8
Legal Description: 3-31-58-6 W4		UTM Co-ordinates		
		12U E 507287.34	N	5989236.19

Current Monitoring:	05-June-2024	Previous Monitoring	24-May-2023
Instruments Read By:	Mr. Niraj Regmi, G.I.T and Mr. Nixson Mationg, of Thurber

SITE NC102 (NC024-2): HWY 41:23 KEHIWIN LAKE (km 8.8)

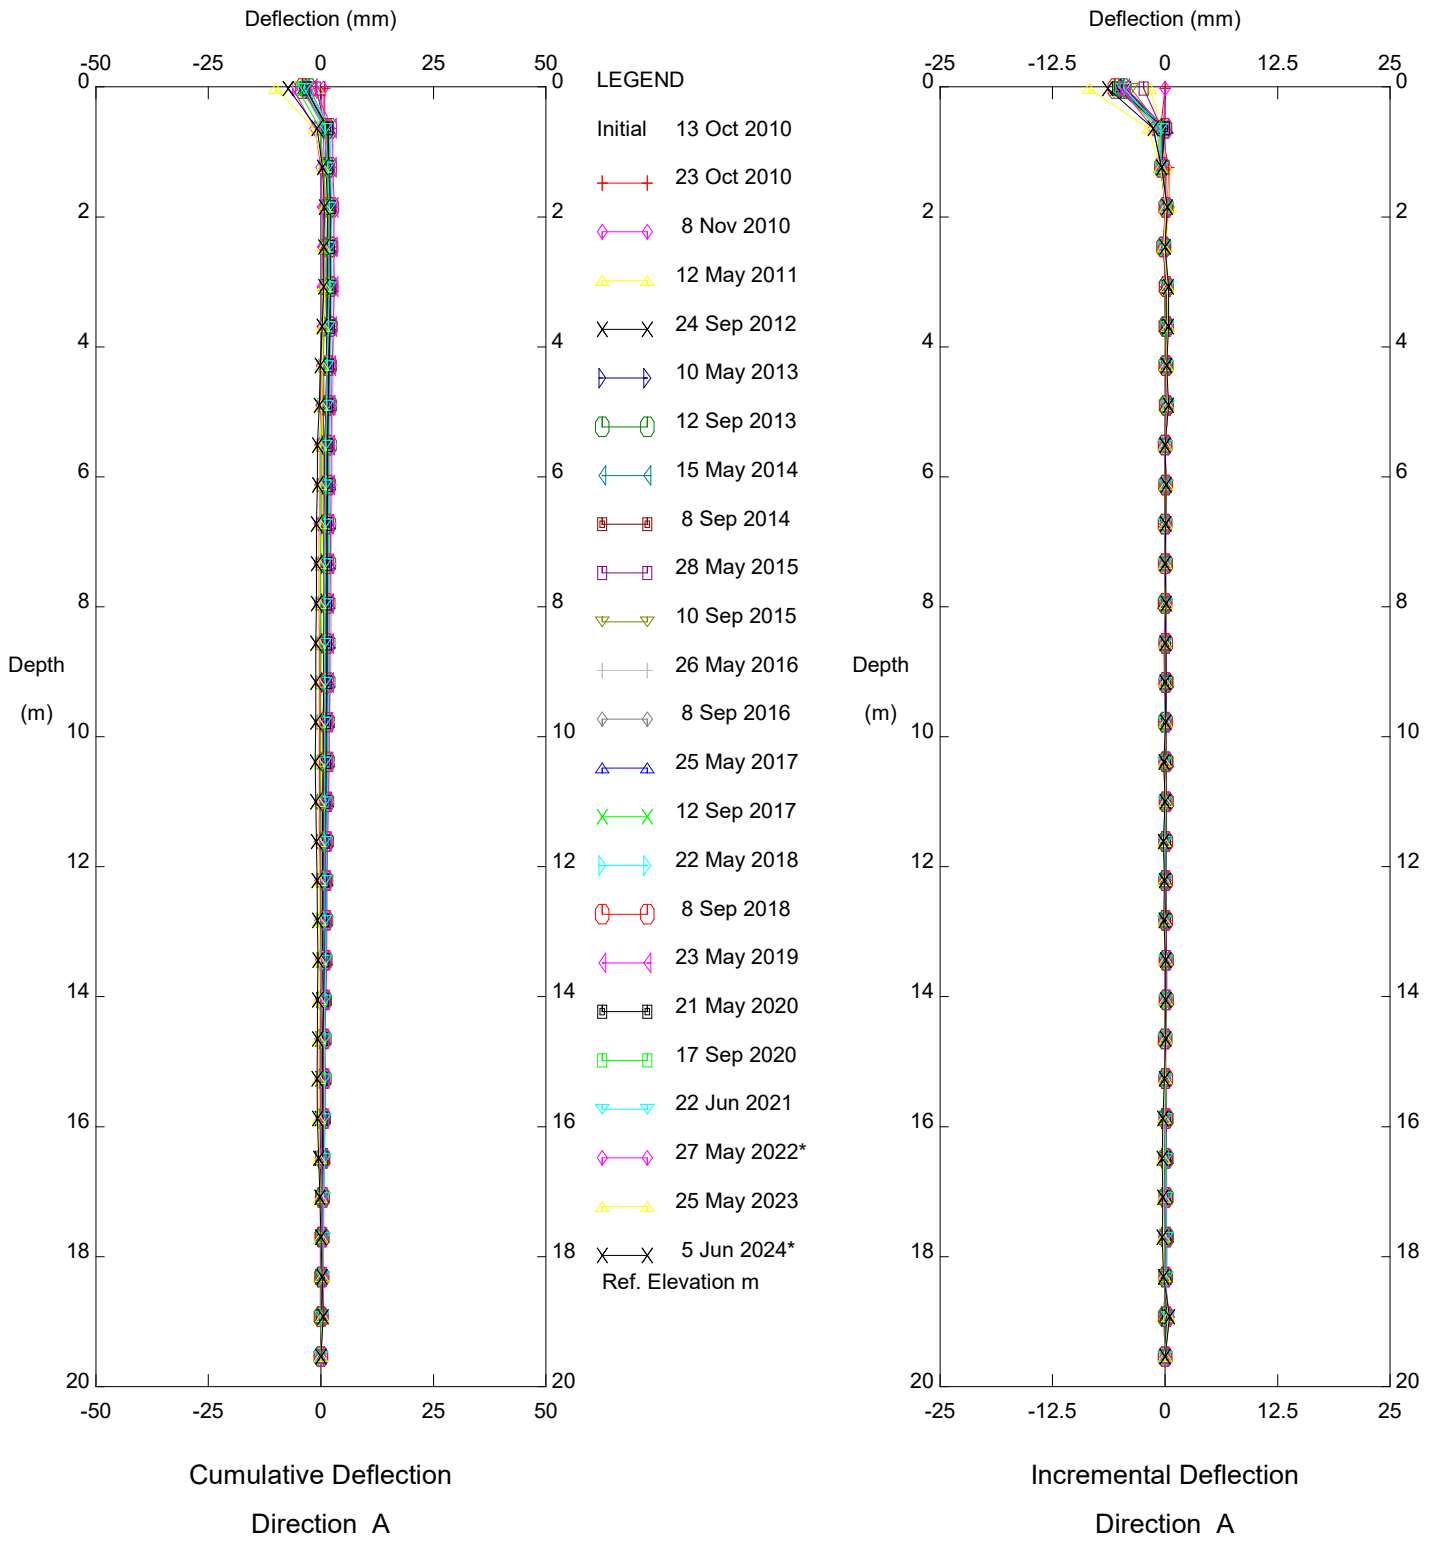
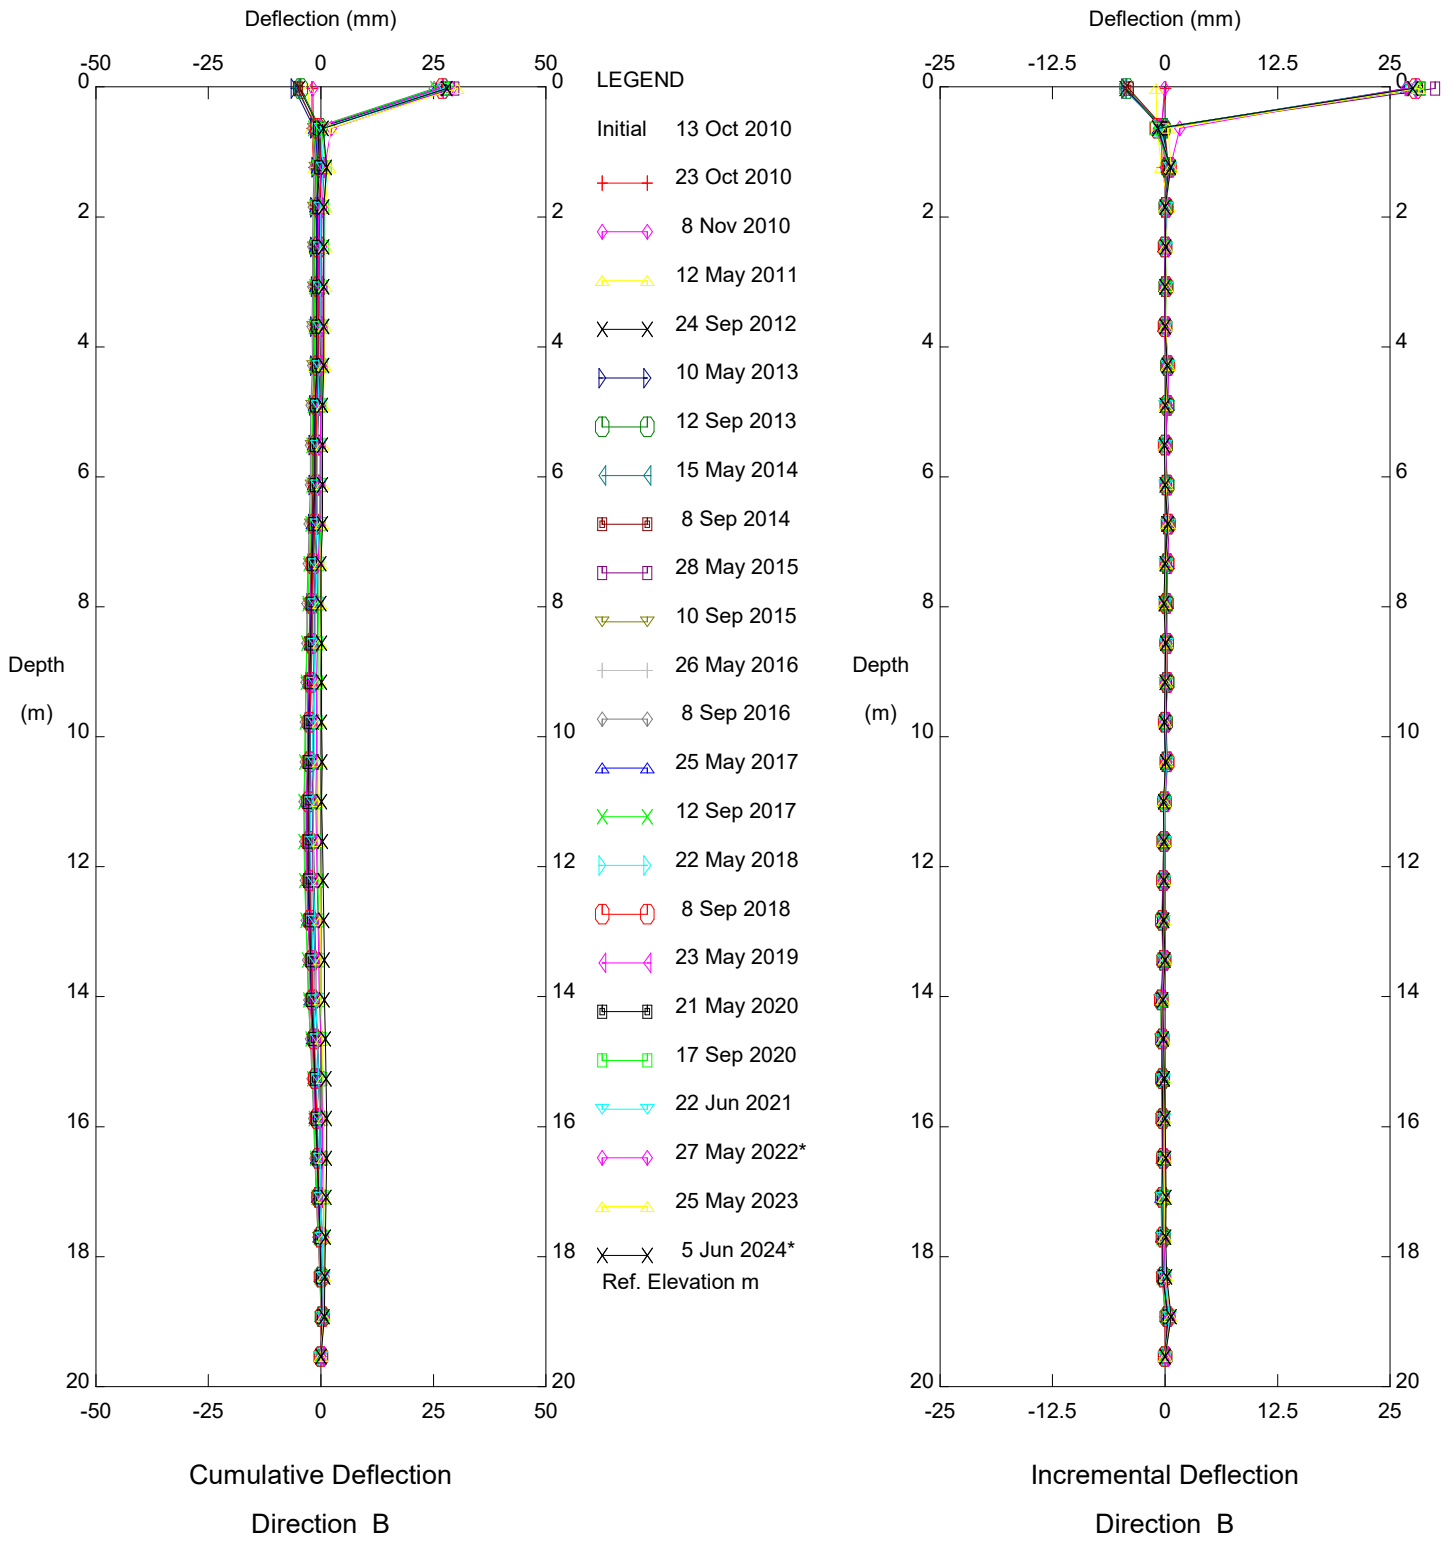
Hwy 41:23 Kehiwin Lake (NC102), Inclinometer SI10-1

Discussion	
Zones of New Movement:	None
Interpretation of Monitoring Results:	<p>Slope inclinometer SI10-1, installed in the highway east ditch upslope of the NC24B pile wall, continued to show no discernible movement. SI10-3 installed downslope of the NC24B pile wall, showed a rate of movement of 2.2 mm/yr over 0.0 m to 2.4 m of depth since the spring of 2023 readings.</p> <p>SI11-1 through SI11-3 were installed in piles P7, P16 and P24, respectively, of the NC24B pile wall. SI11-1 showed a rate of movement 0.7 mm/yr over 0.1 m to 9.3 m depth since the spring of 2023 readings.</p>

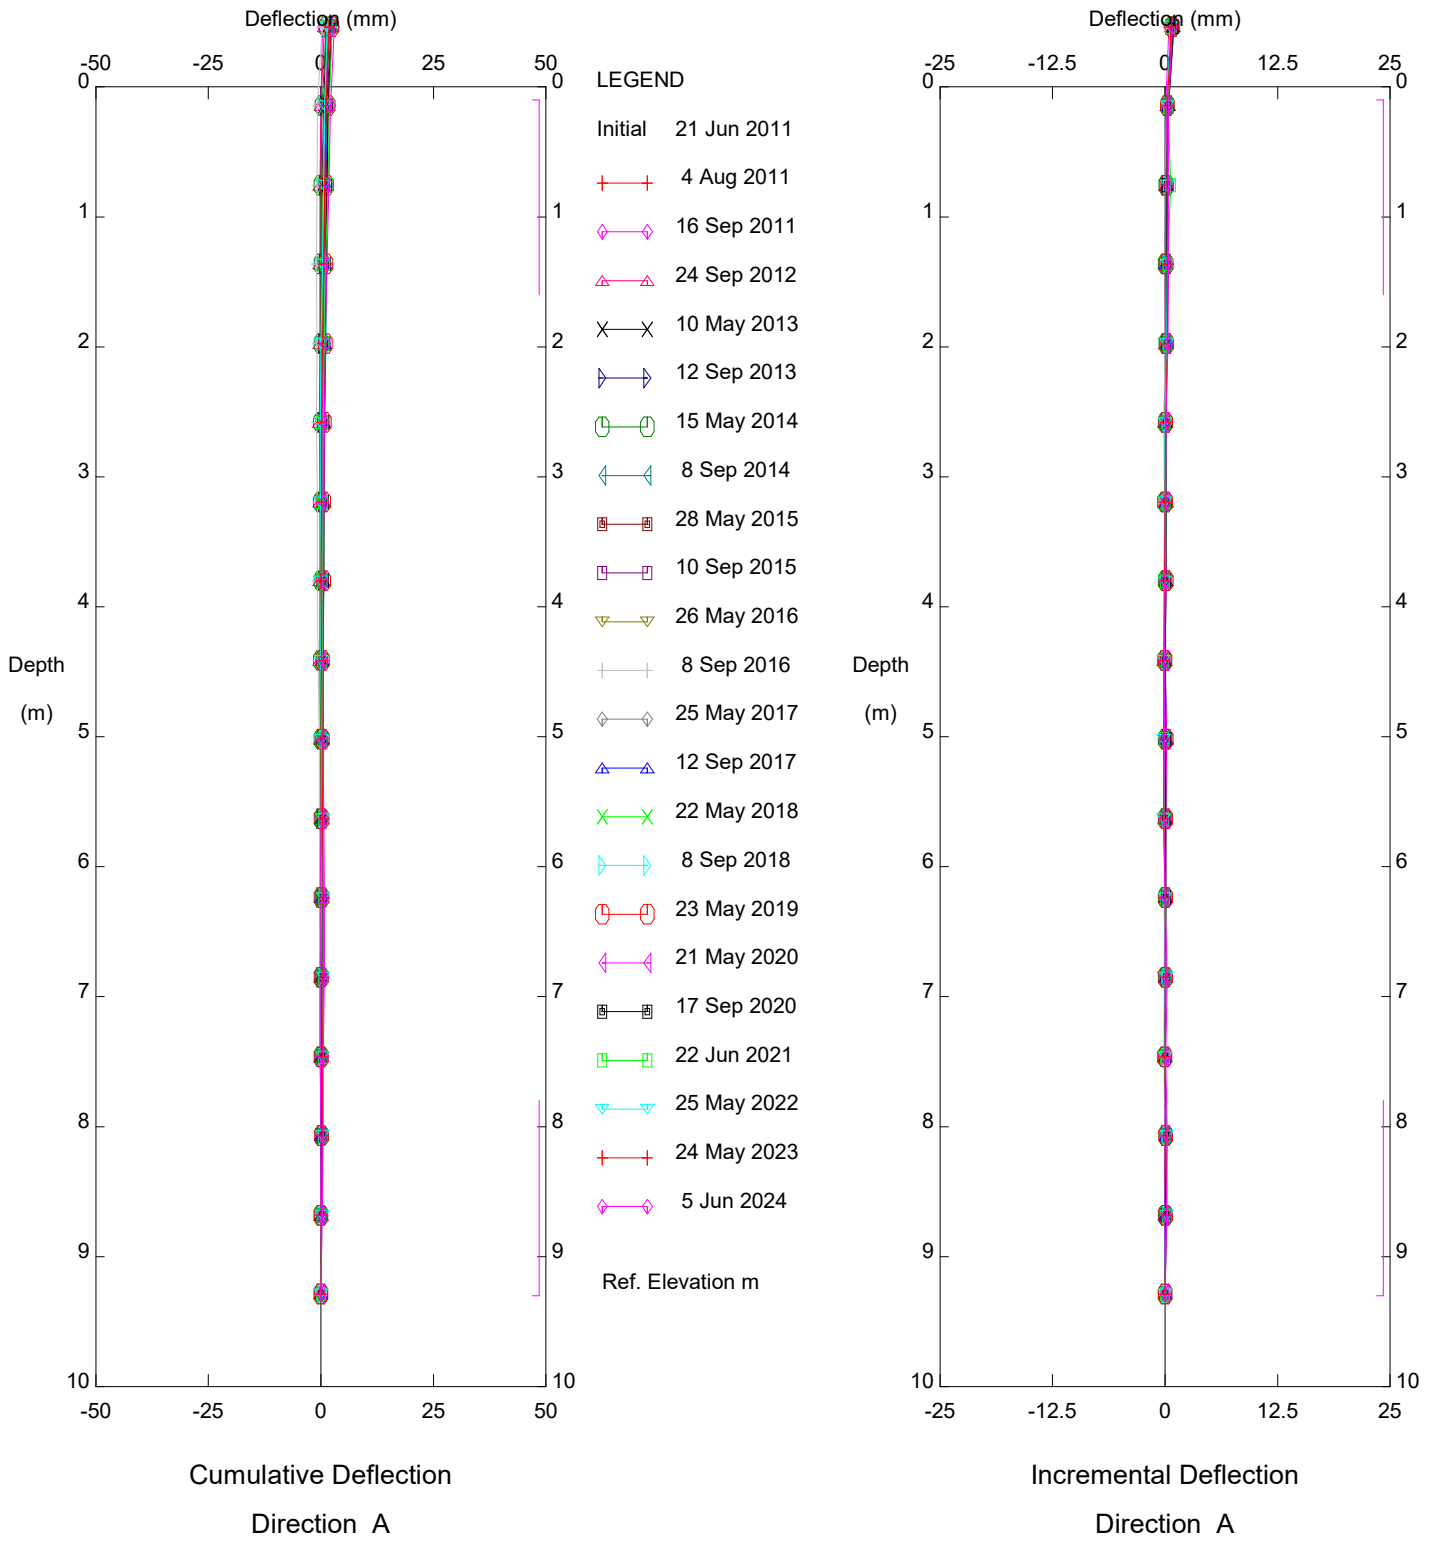
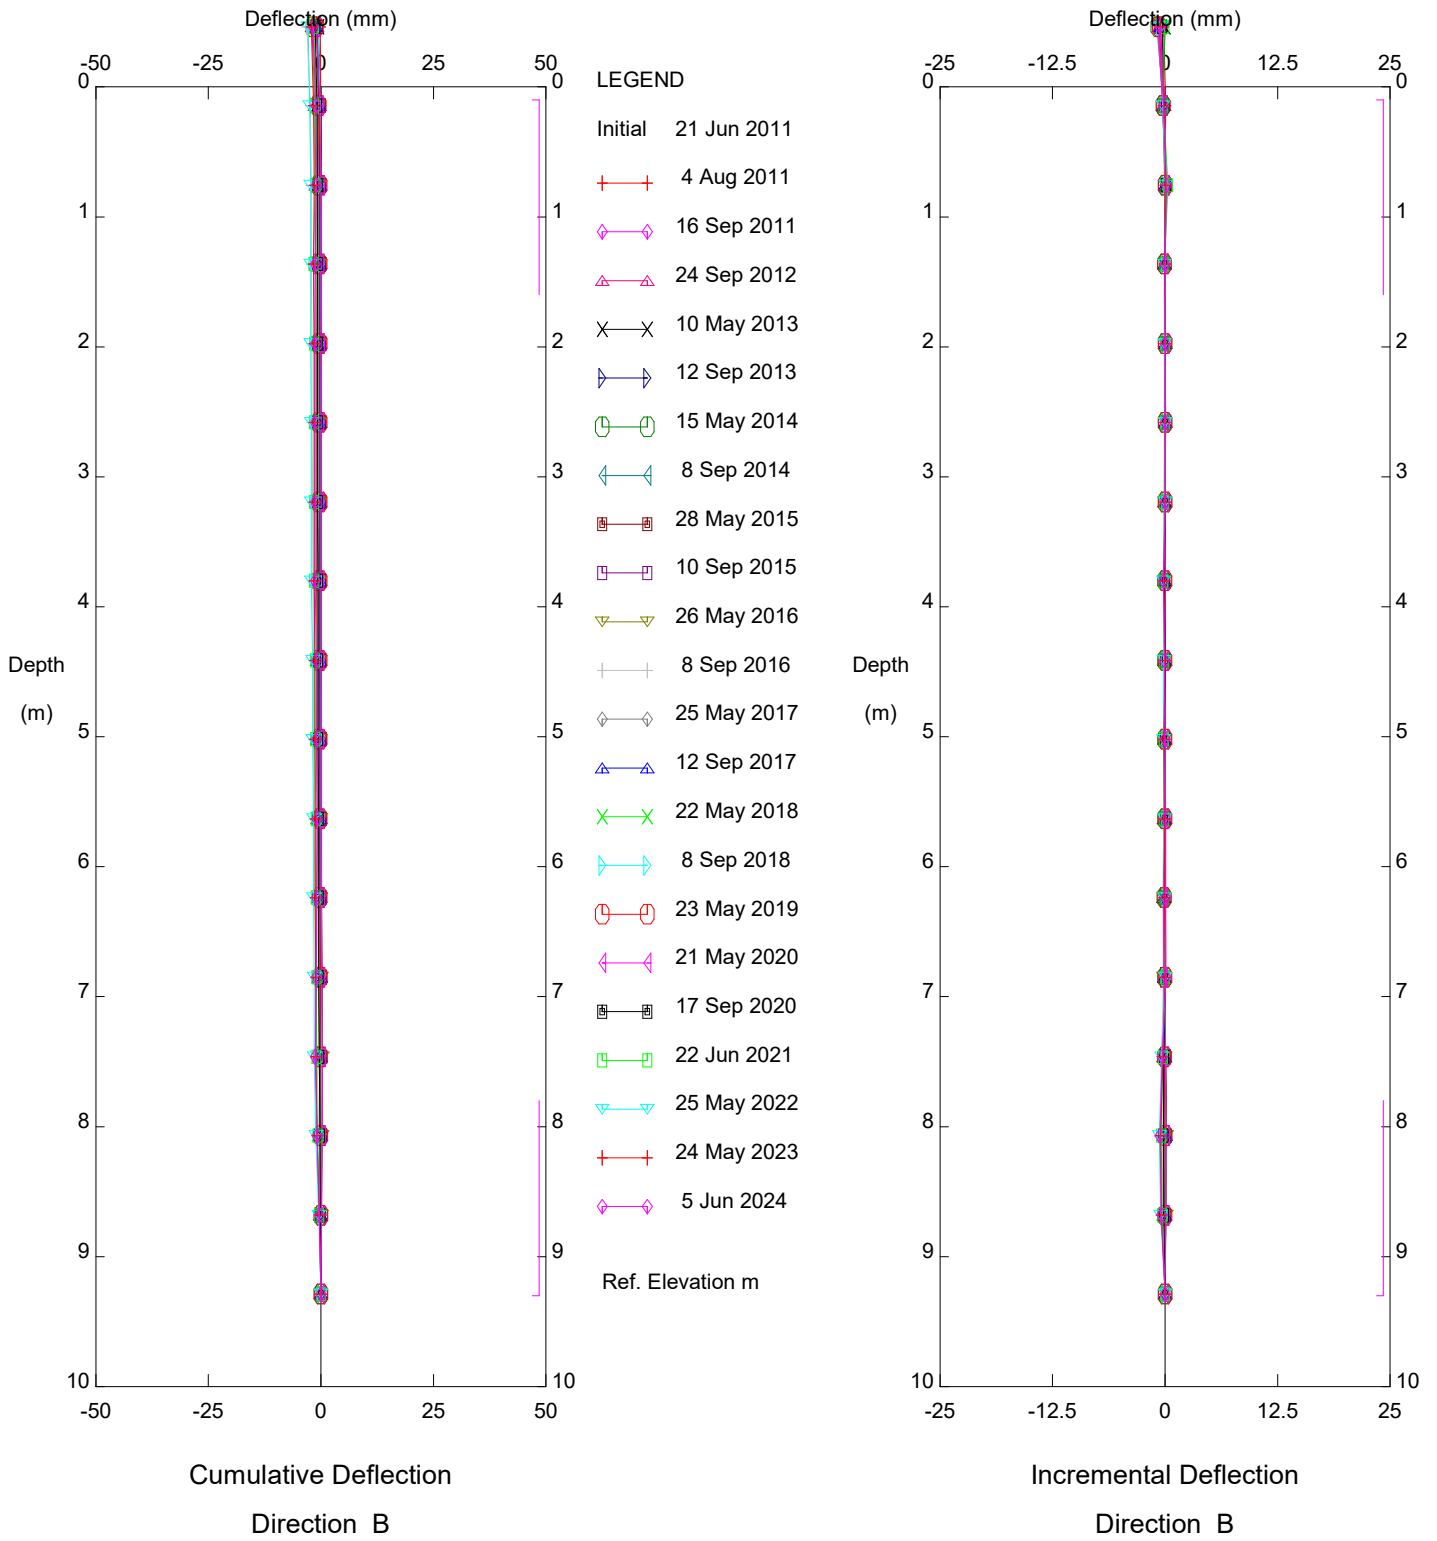
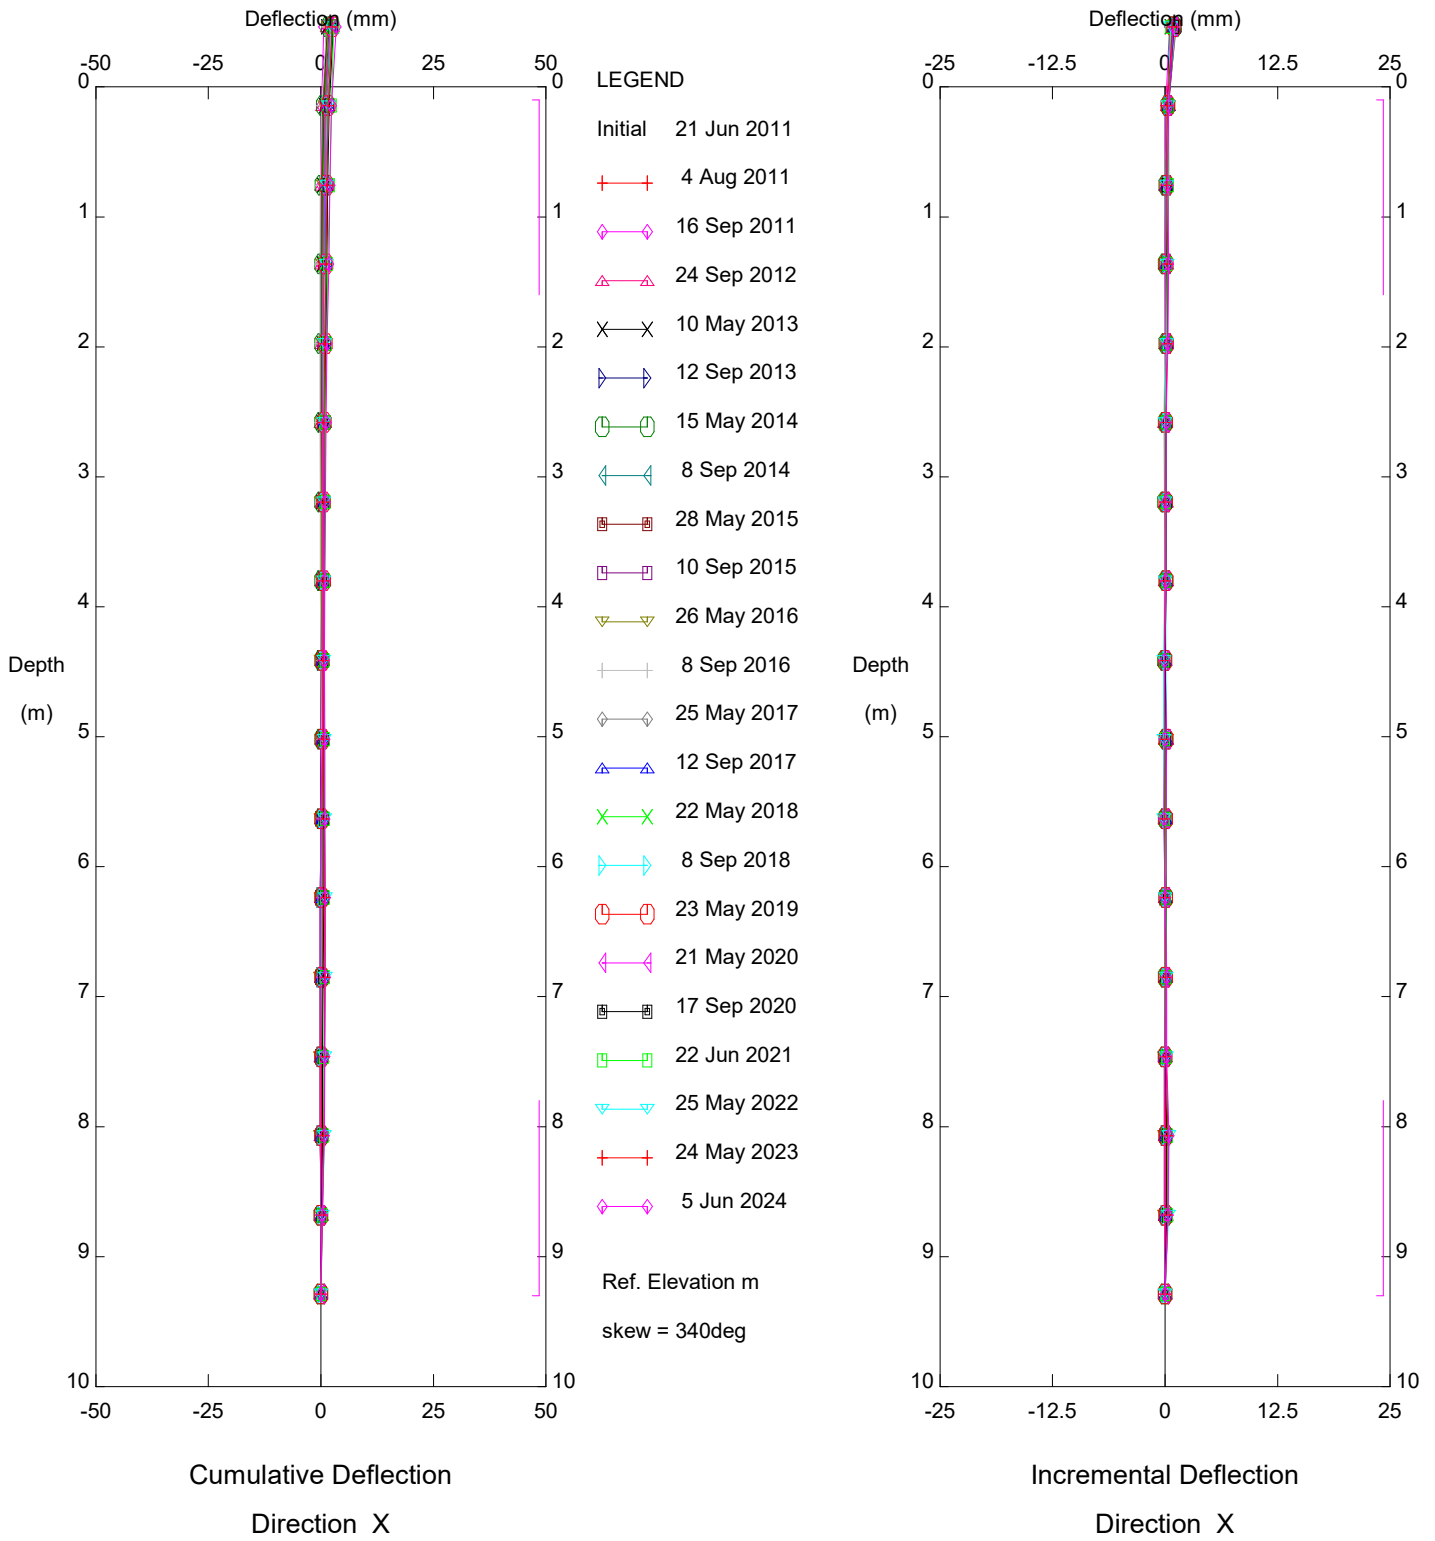
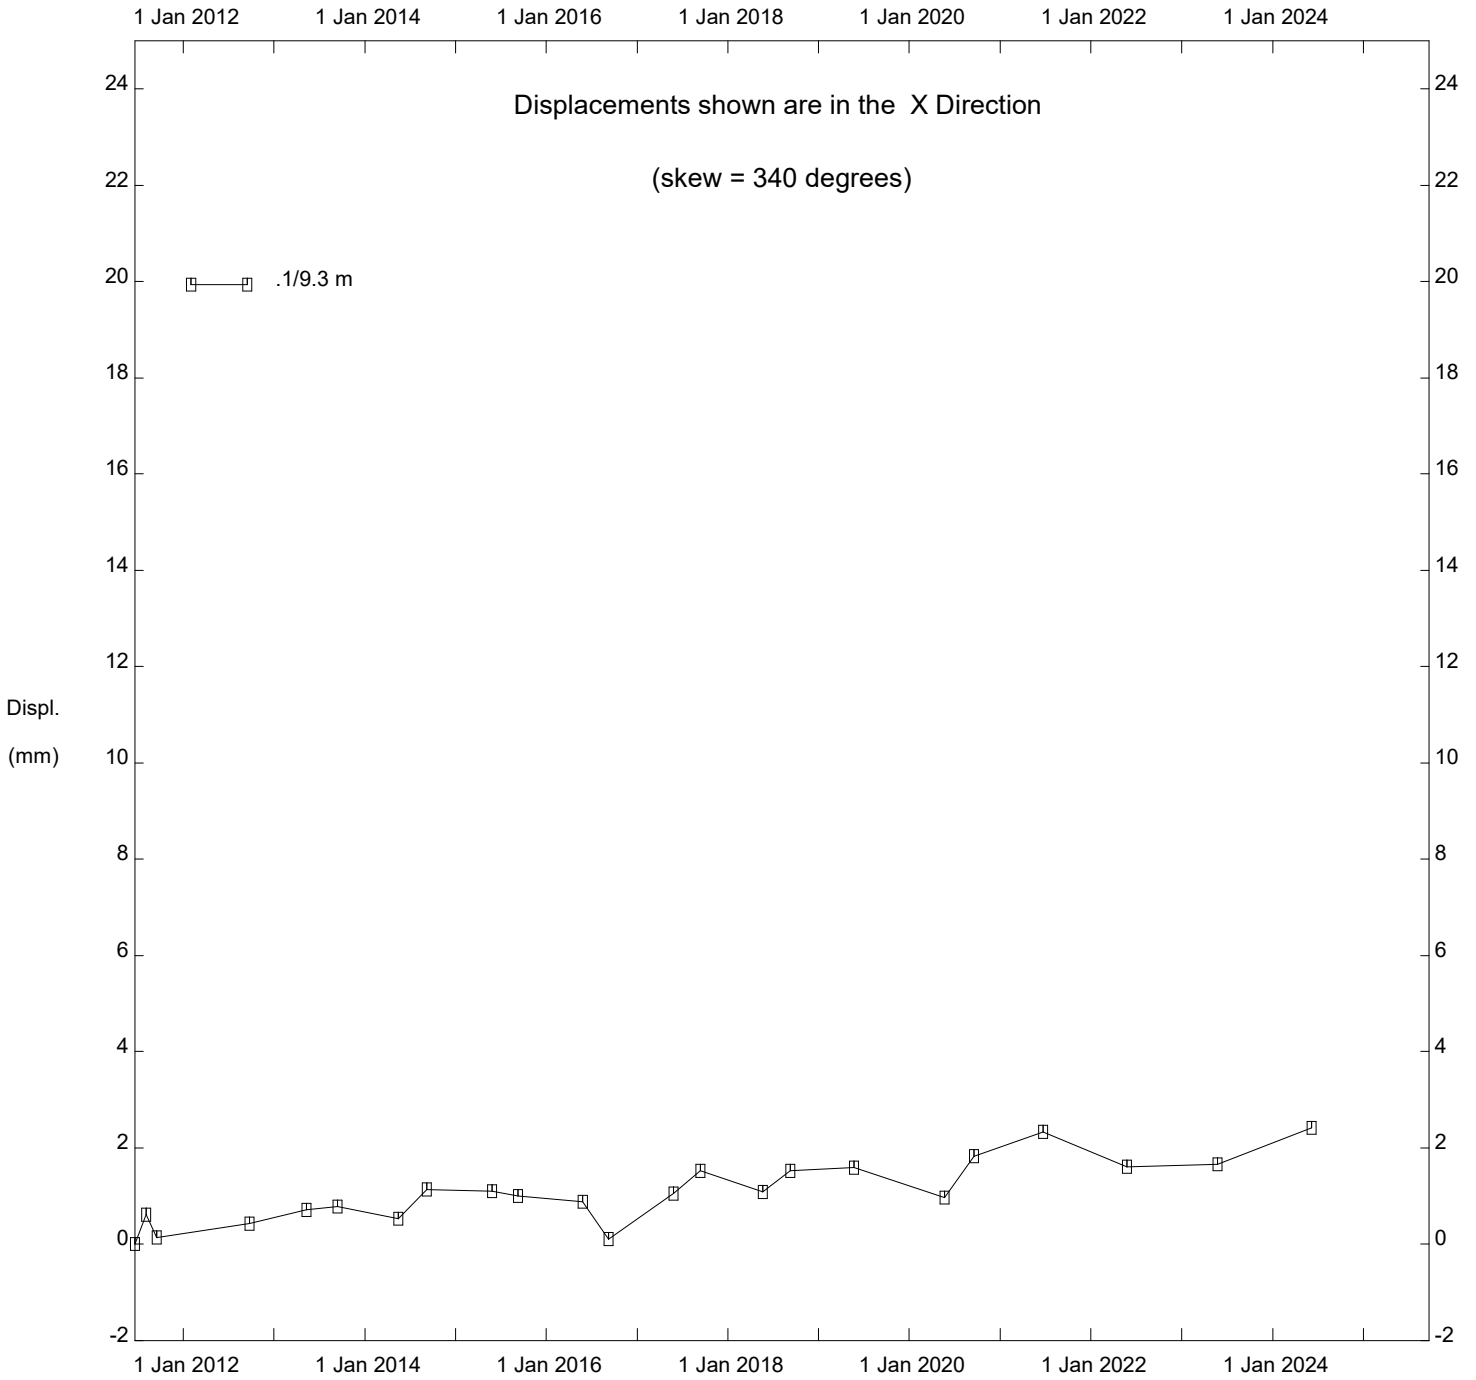
Hwy 41:23 Kehiwin Lake (NC102), Inclinometer SI11-1 (P7)

<p>Slope inclinometer SI11-2 showed a rate of movement of 1.2 mm/yr over 0.1 to 9.9 m depth since the spring of 2023 readings. SI11-3 showed a rate of movement of 1.2 mm/yr over 0.4 m to 9.6 m depth since the spring of 2023 readings.</p> <p>SI11-1, SI11-2 and SI11-3 have shown total pile head movements of 2.4 mm, 2.9 mm, and 1.2 mm, respectively, since installation.</p> <p>Slope inclinometer SI15-1, installed in the highway east ditch upslope of the NC24D pile wall, has shown no discernible movement since initialization. SI15-2, installed immediately downslope of the NC24D pile wall, showed a rate of movement of 0.1 mm/yr over 3.0 m to 4.8 m depth since the spring of 2023 readings. SI15-4, installed near the west edge of the highway to the south of the NC24D pile wall, showed no discernible movement over 1.6 m to 3.4 m depth and a rate of movement of 0.3 mm/yr over 3.4 m to 4.7 m depth since the spring of 2023.</p> <p>SI16-1, installed in the 2016 pile wall (NC24D), showed no discernible movement over the length of the pile from 0.0 m to 12.2 m depth since the spring of 2023 readings. SI16-1 has shown a total pile head movement of 4.4 mm to date. SI16-2, also installed in the 2016 pile wall, showed no discernible movement over the length of the pile from 0.0 m to 12.2 m depth since the spring of 2023 readings. SI16-2 has shown a total pile head movement of 4.6 mm to date.</p> <p>In general, the pile wall appears to have performed well since the completion of construction.</p> <p>Pneumatic piezometers PN10-1, PN10-5, and PN15-2 showed increases in groundwater level of 0.16 m, 0.42 m, and 0.06 m, respectively, since the spring of 2023 readings. PN10-3, PN10-6, PN15-1, PN15-3, and PN15-4 showed decreases in groundwater levels of 0.06 m, 0.22 m, 0.58 m, 0.14 m, and 0.09 m, respectively since the spring of 2023 readings.</p> <p>Standpipe piezometers PB10-1 showed a decrease in groundwater level of 1.21 m since the spring of 2023 readings. Standpipe piezometers PB10-3 and PB10-4 showed increases in groundwater level of 0.59 m and 0.23 m, respectively, since the spring of 2023 readings.</p>
