**ALBERTA TRANSPORTATION AND
ECONOMIC CORRIDORS GRMP
NORTH CENTRAL (ATHABASCA AND FORT
McMURRAY DISTRICTS)
INSTRUMENTATION MONITORING- SPRING 2024**

Site Number	Location	Name	Hwy	km
NC102 (NC024-2)	HWY 41:23 C1 8.88	Kehiwin Lake	41:23	Km 8.8
Legal Description: 3-31-58-6 W4		UTM Co-ordinates		
		12U E 507287.34	N	5989236.19

Current Monitoring:	05-June-2024	Previous Monitoring	24-May-2023
Instruments Read By:	Mr. Niraj Regmi, G.I.T and Mr. Nixson Mationg, of Thurber

SITE NC102 (NC024-2): HWY 41:23 KEHIWIN LAKE (km 8.8)

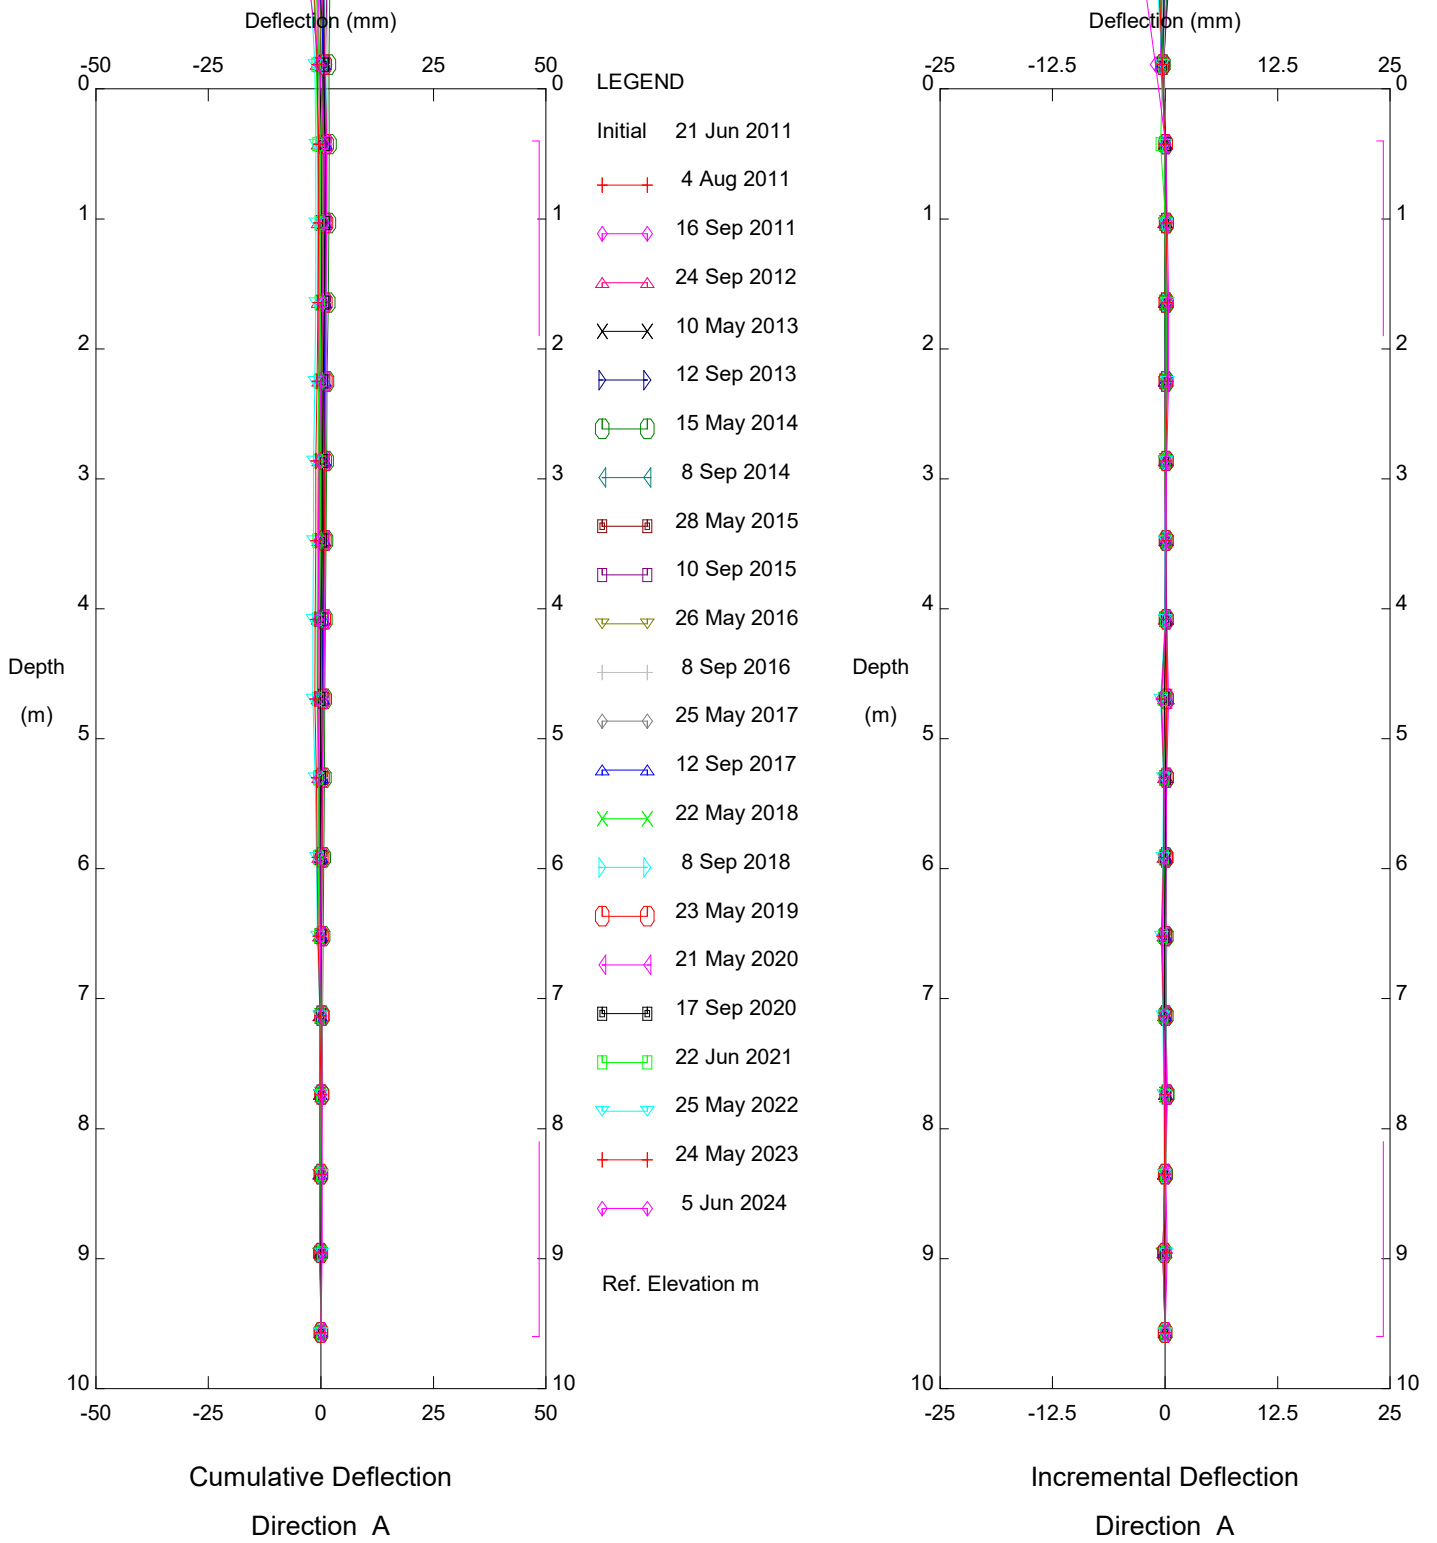
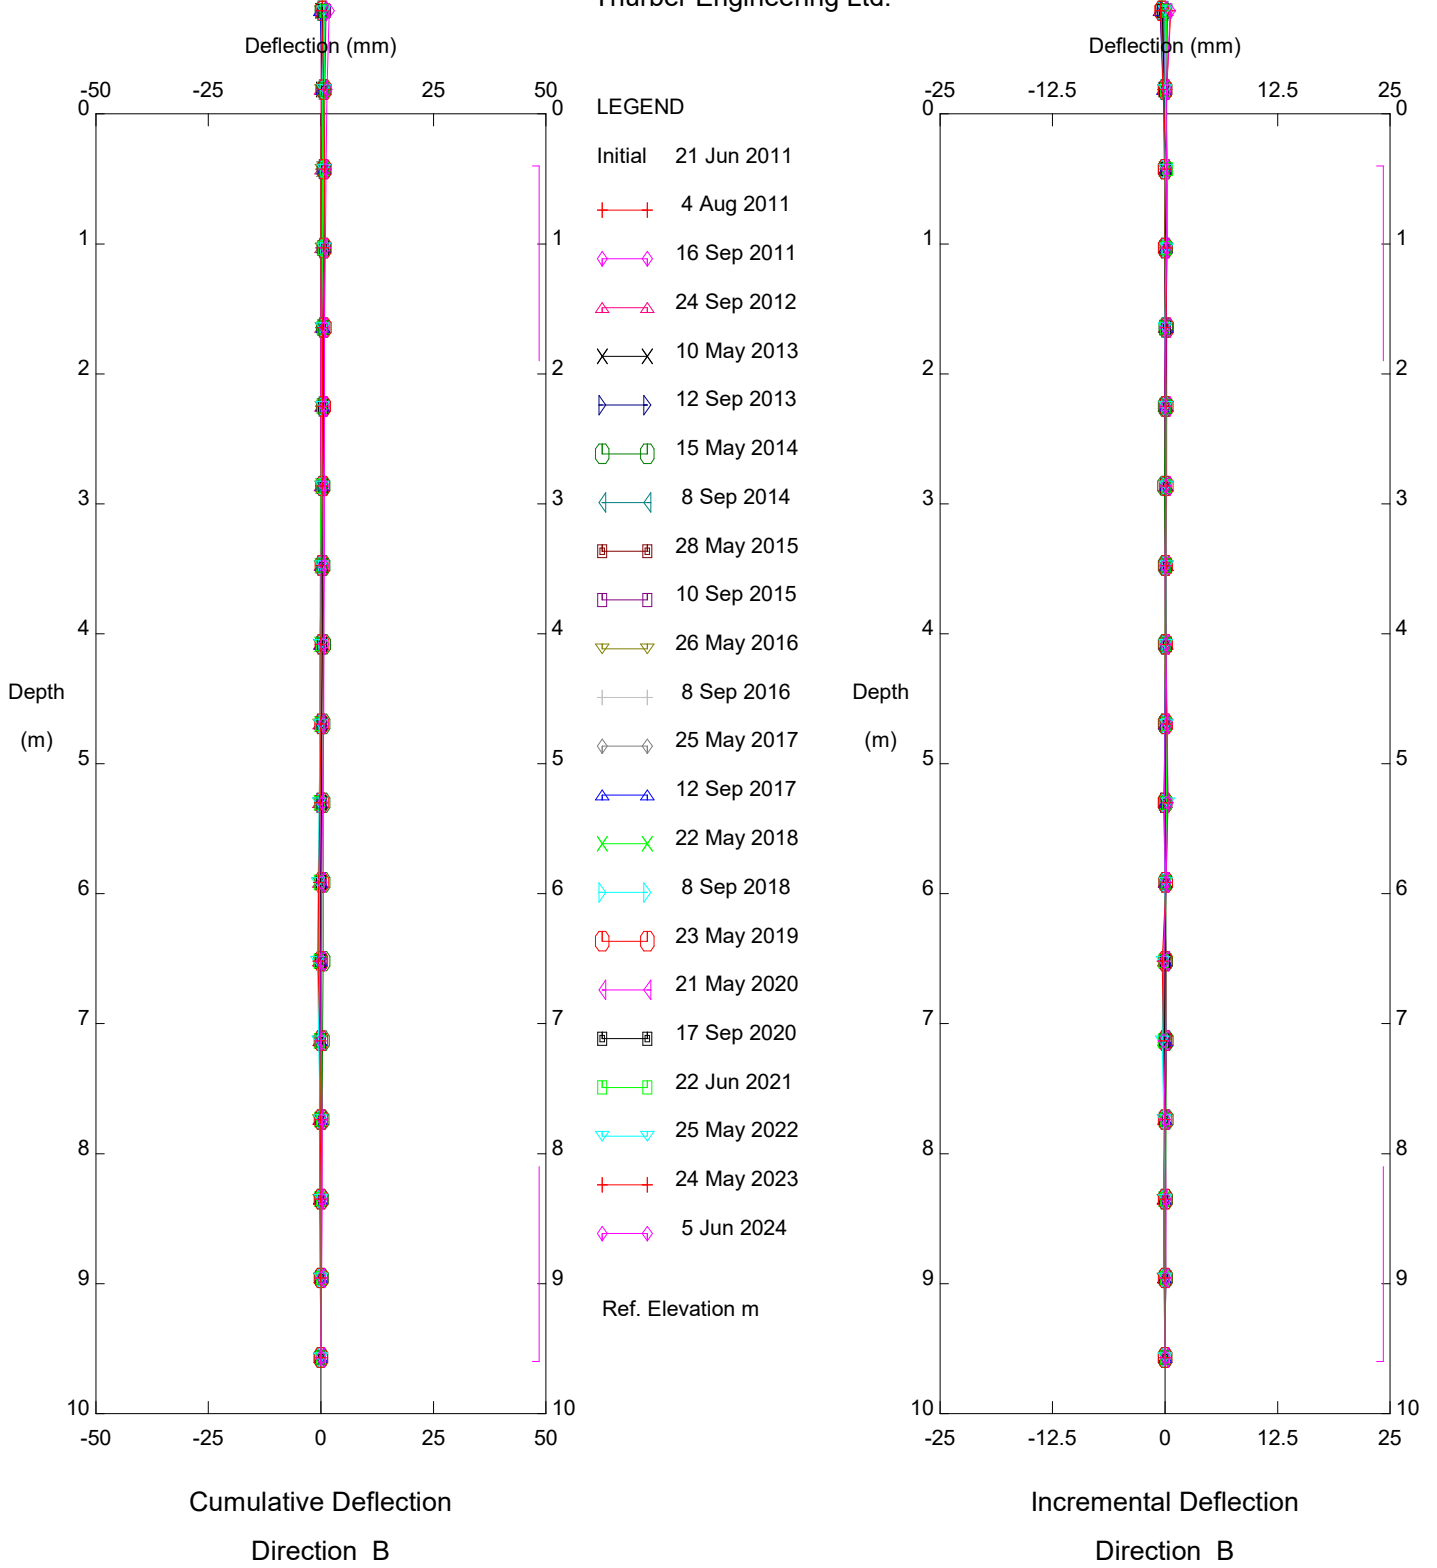
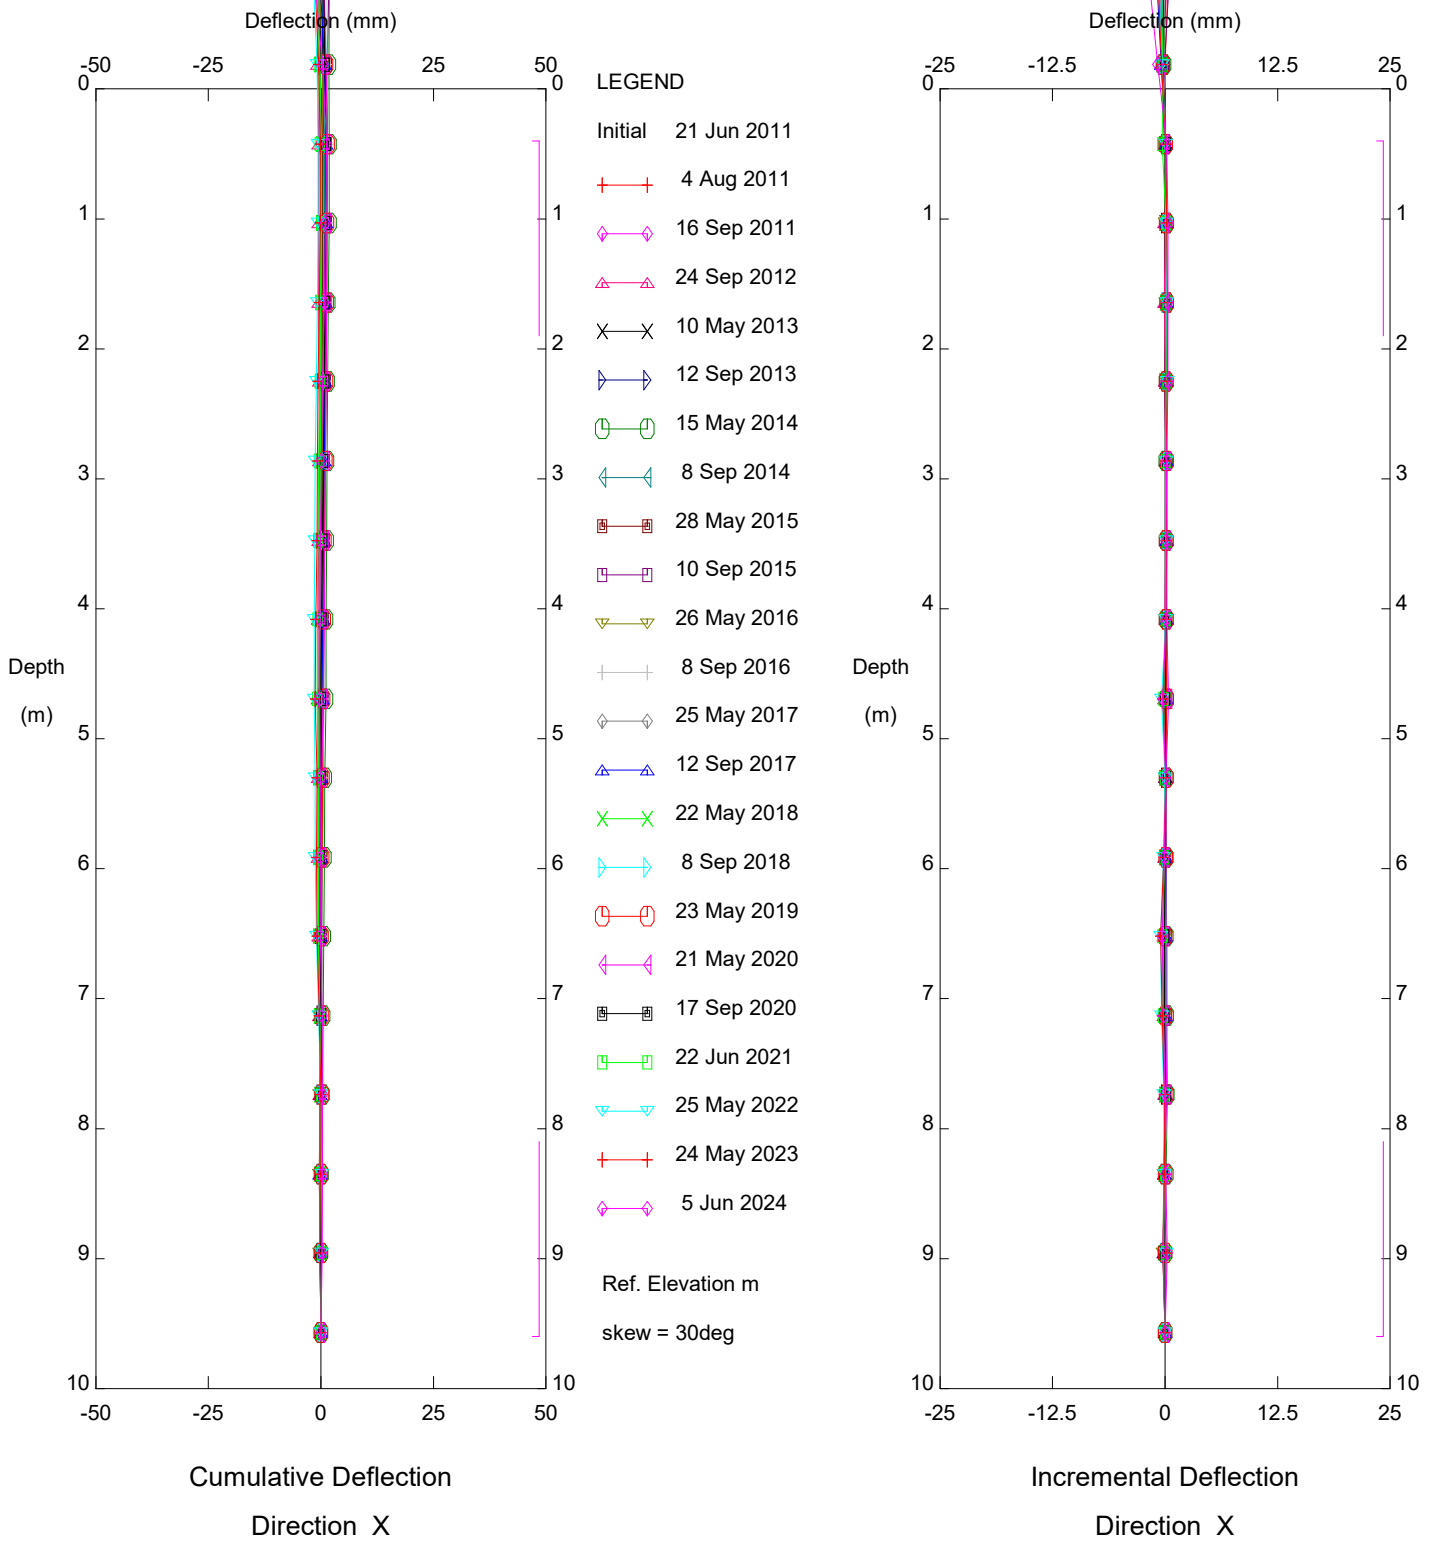
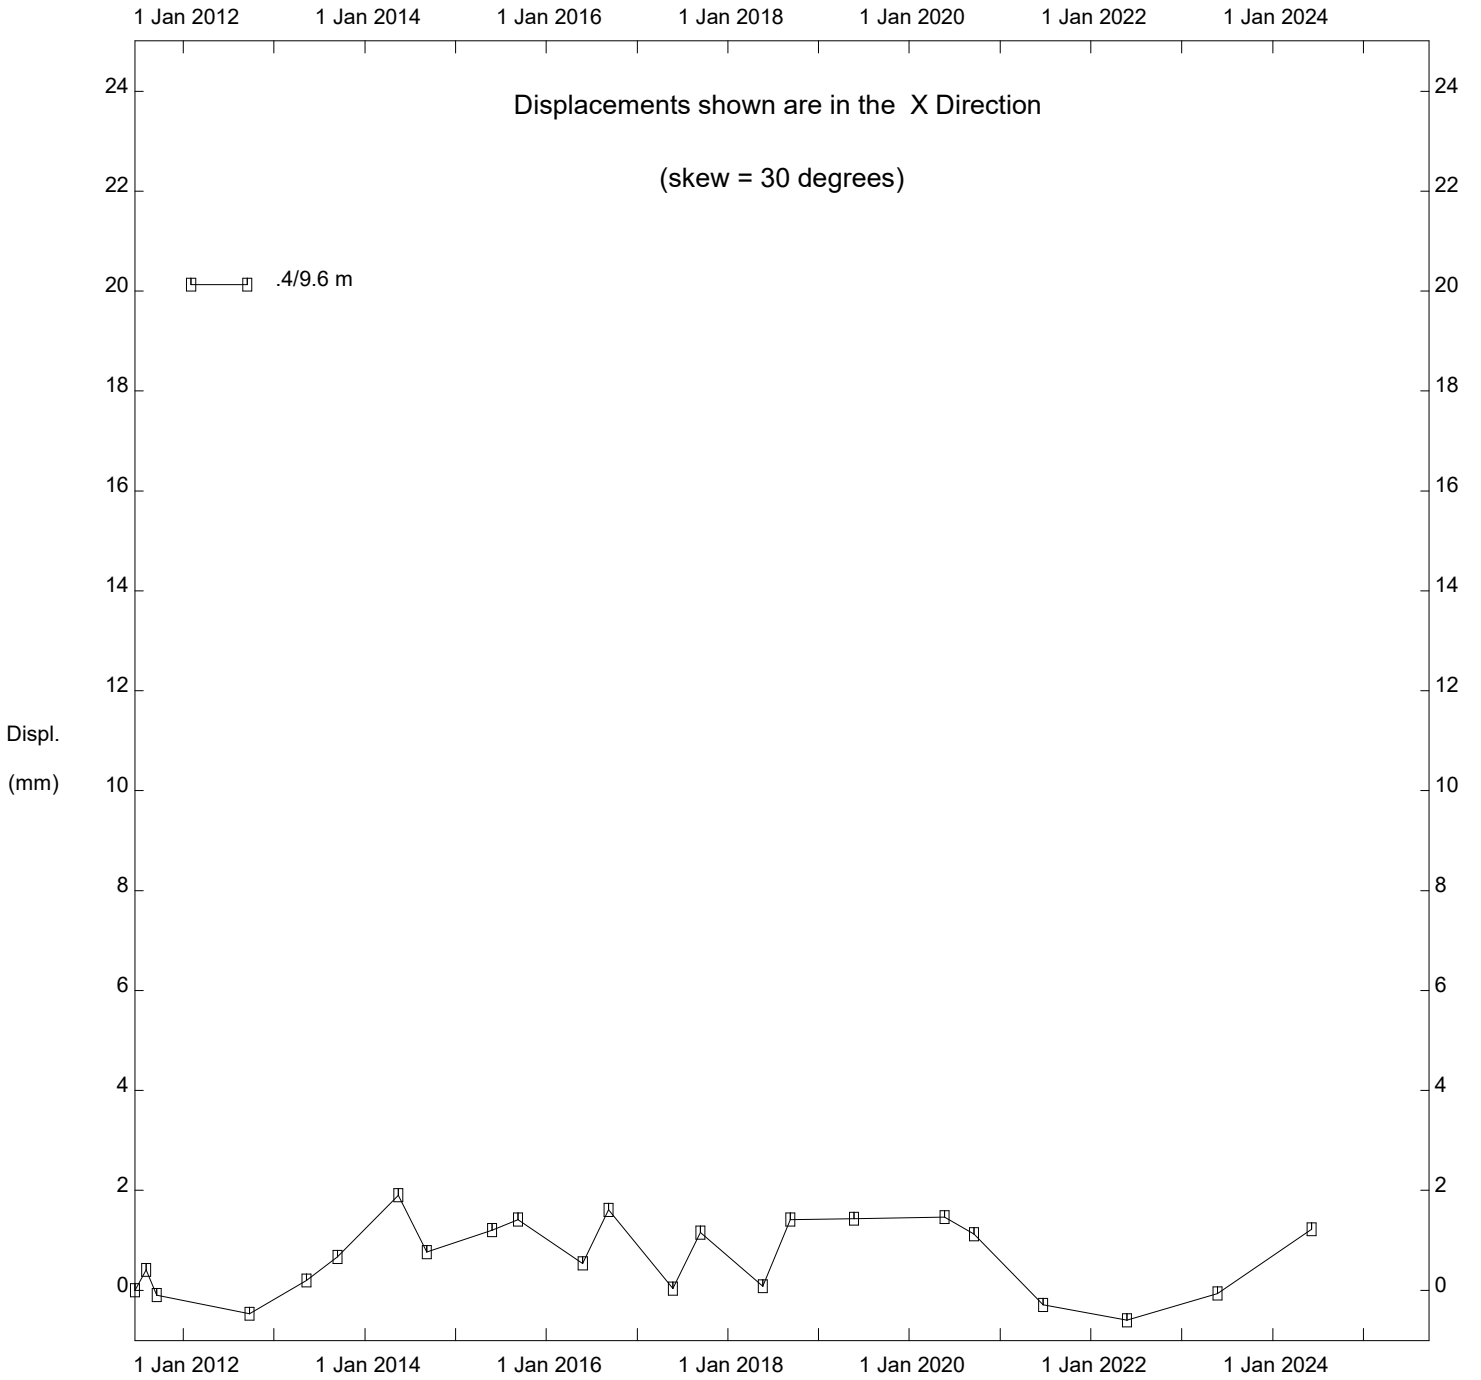
Hwy 41:23 Kehiwin Lake (NC102), Inclinometer SI11-3 (P24)

<p>Slope inclinometer SI11-2 showed a rate of movement of 1.2 mm/yr over 0.1 to 9.9 m depth since the spring of 2023 readings. SI11-3 showed a rate of movement of 1.2 mm/yr over 0.4 m to 9.6 m depth since the spring of 2023 readings.</p> <p>SI11-1, SI11-2 and SI11-3 have shown total pile head movements of 2.4 mm, 2.9 mm, and 1.2 mm, respectively, since installation.</p> <p>Slope inclinometer SI15-1, installed in the highway east ditch upslope of the NC24D pile wall, has shown no discernible movement since initialization. SI15-2, installed immediately downslope of the NC24D pile wall, showed a rate of movement of 0.1 mm/yr over 3.0 m to 4.8 m depth since the spring of 2023 readings. SI15-4, installed near the west edge of the highway to the south of the NC24D pile wall, showed no discernible movement over 1.6 m to 3.4 m depth and a rate of movement of 0.3 mm/yr over 3.4 m to 4.7 m depth since the spring of 2023.</p> <p>SI16-1, installed in the 2016 pile wall (NC24D), showed no discernible movement over the length of the pile from 0.0 m to 12.2 m depth since the spring of 2023 readings. SI16-1 has shown a total pile head movement of 4.4 mm to date. SI16-2, also installed in the 2016 pile wall, showed no discernible movement over the length of the pile from 0.0 m to 12.2 m depth since the spring of 2023 readings. SI16-2 has shown a total pile head movement of 4.6 mm to date.</p> <p>In general, the pile wall appears to have performed well since the completion of construction.</p> <p>Pneumatic piezometers PN10-1, PN10-5, and PN15-2 showed increases in groundwater level of 0.16 m, 0.42 m, and 0.06 m, respectively, since the spring of 2023 readings. PN10-3, PN10-6, PN15-1, PN15-3, and PN15-4 showed decreases in groundwater levels of 0.06 m, 0.22 m, 0.58 m, 0.14 m, and 0.09 m, respectively since the spring of 2023 readings.</p> <p>Standpipe piezometers PB10-1 showed a decrease in groundwater level of 1.21 m since the spring of 2023 readings. Standpipe piezometers PB10-3 and PB10-4 showed increases in groundwater level of 0.59 m and 0.23 m, respectively, since the spring of 2023 readings.</p>

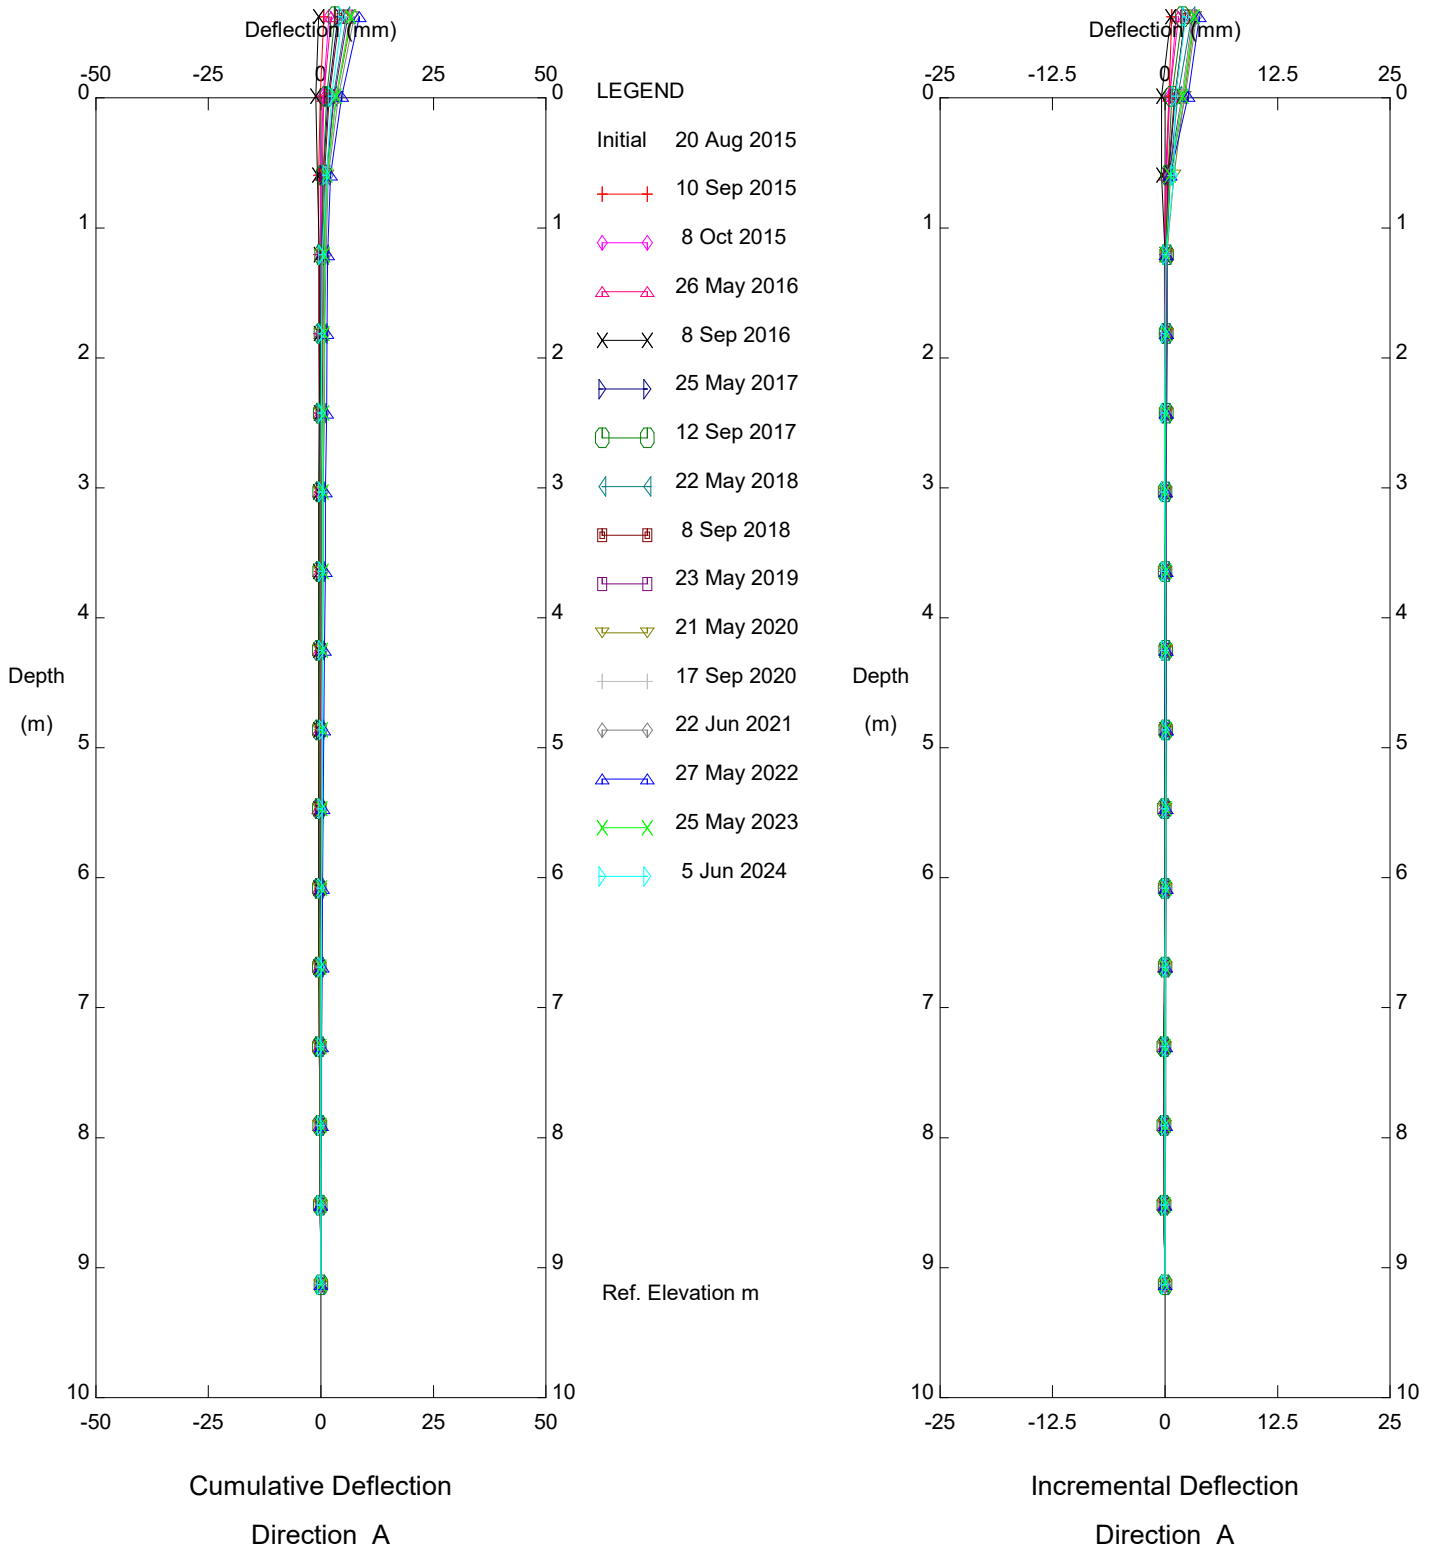
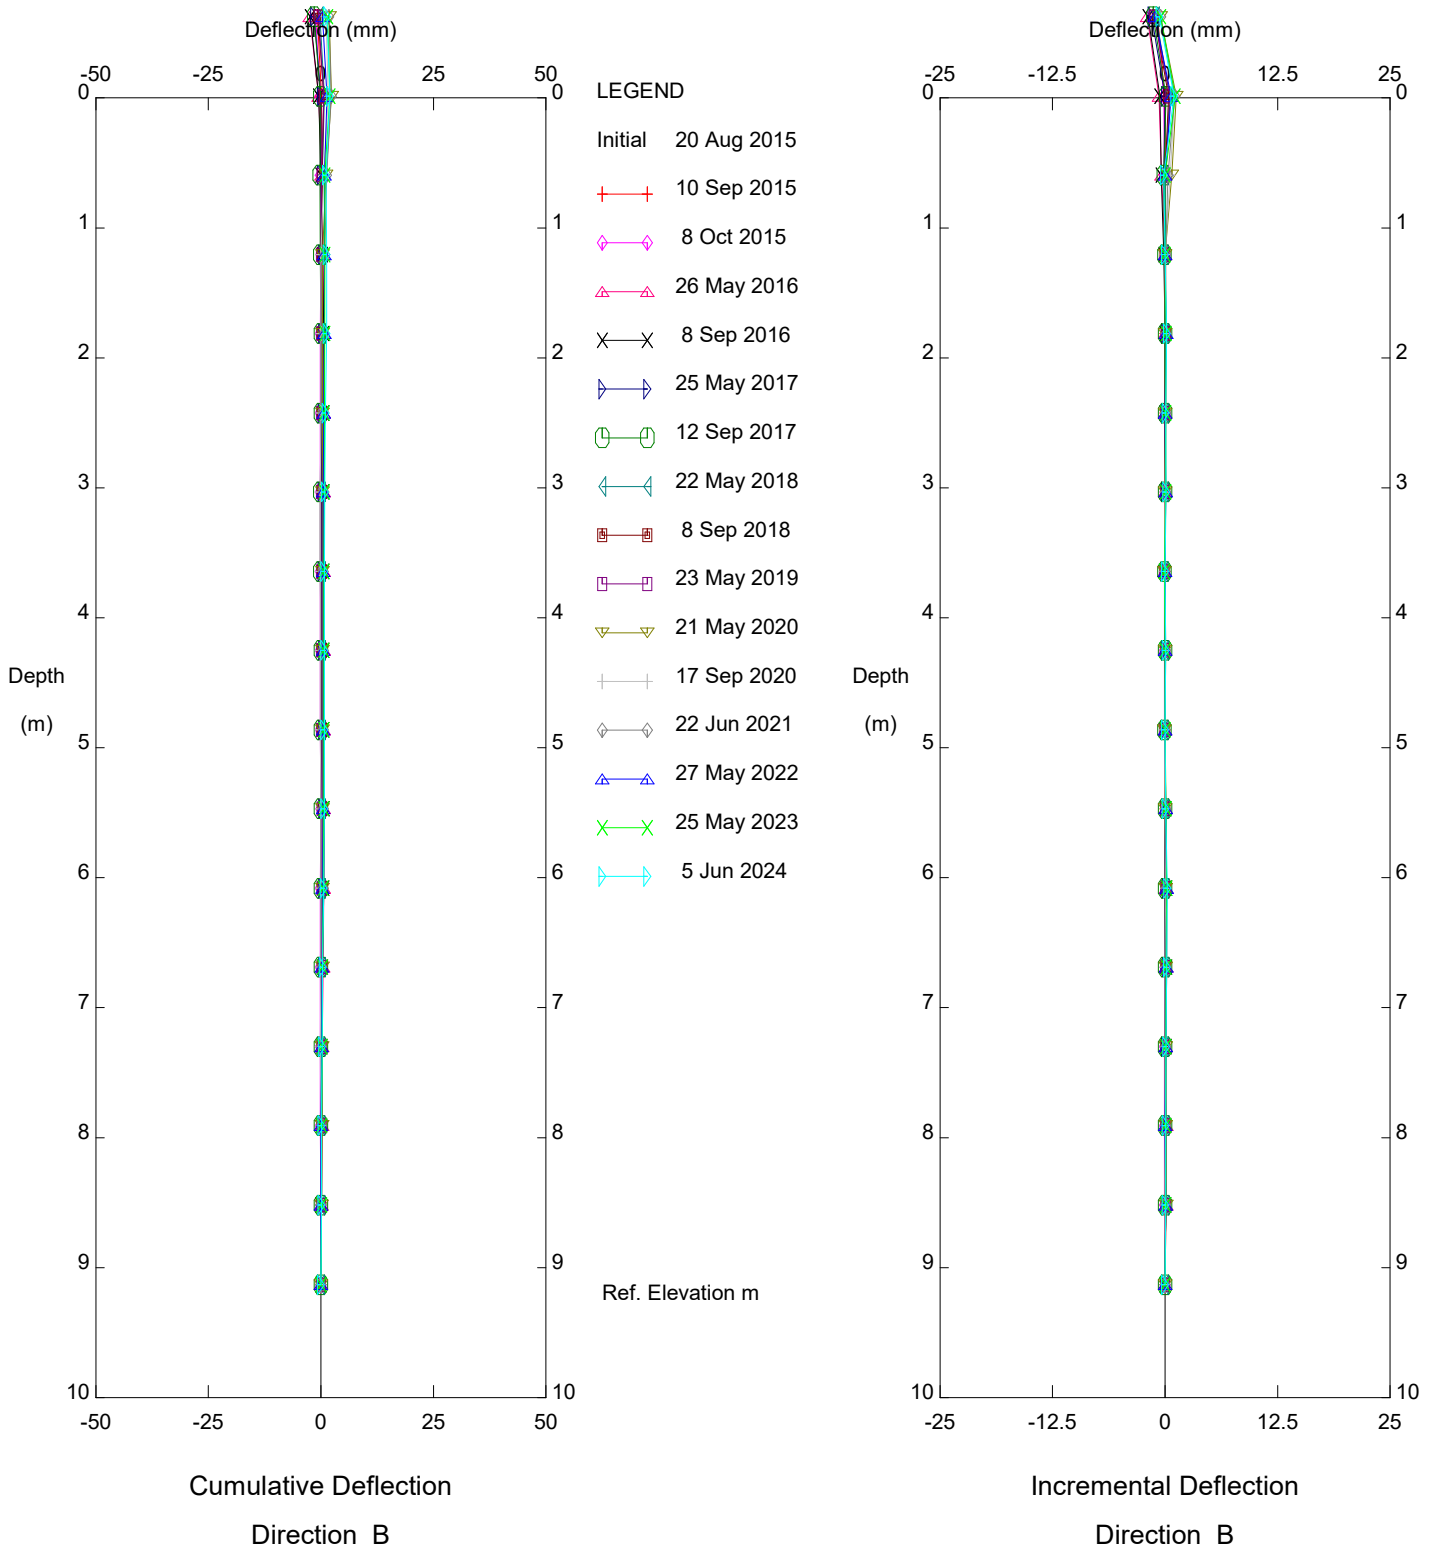
Hwy 41:23 Kehiwin Lake (NC102), Inclinometer SI15-1

SI15-1	August 20, 2015	No discernible movement	No discernible movement	Operational	May 24, 2023	N/A	N/A	N/A
SI15-2	August 20, 2015	16.5 over 3.0 m to 4.8 m depth in 328° direction	15.4 in September 2020	Operational	May 24, 2023	0.2	0.1	-2.2
SI15-3	August 20, 2015	87.3 over 1.7 to 3.5 m depth in 337° direction	233.8 in September 2020	Sheared off at 3.7 m below top of casing	May 27, 2022	N/A	N/A	N/A
