October 26, 2022

**ALBERTA TRANSPORTATION GRMP (CON0022163)  
NORTH CENTRAL (ATHABASCA AND FORT McMURRAY DISTRICTS)  
INSTRUMENTATION MONITORING RESULTS – FALL 2022**

**SITE NC103 (NC024-3): HWY 41:23 KEHIWIN LAKE (km 7.8)**

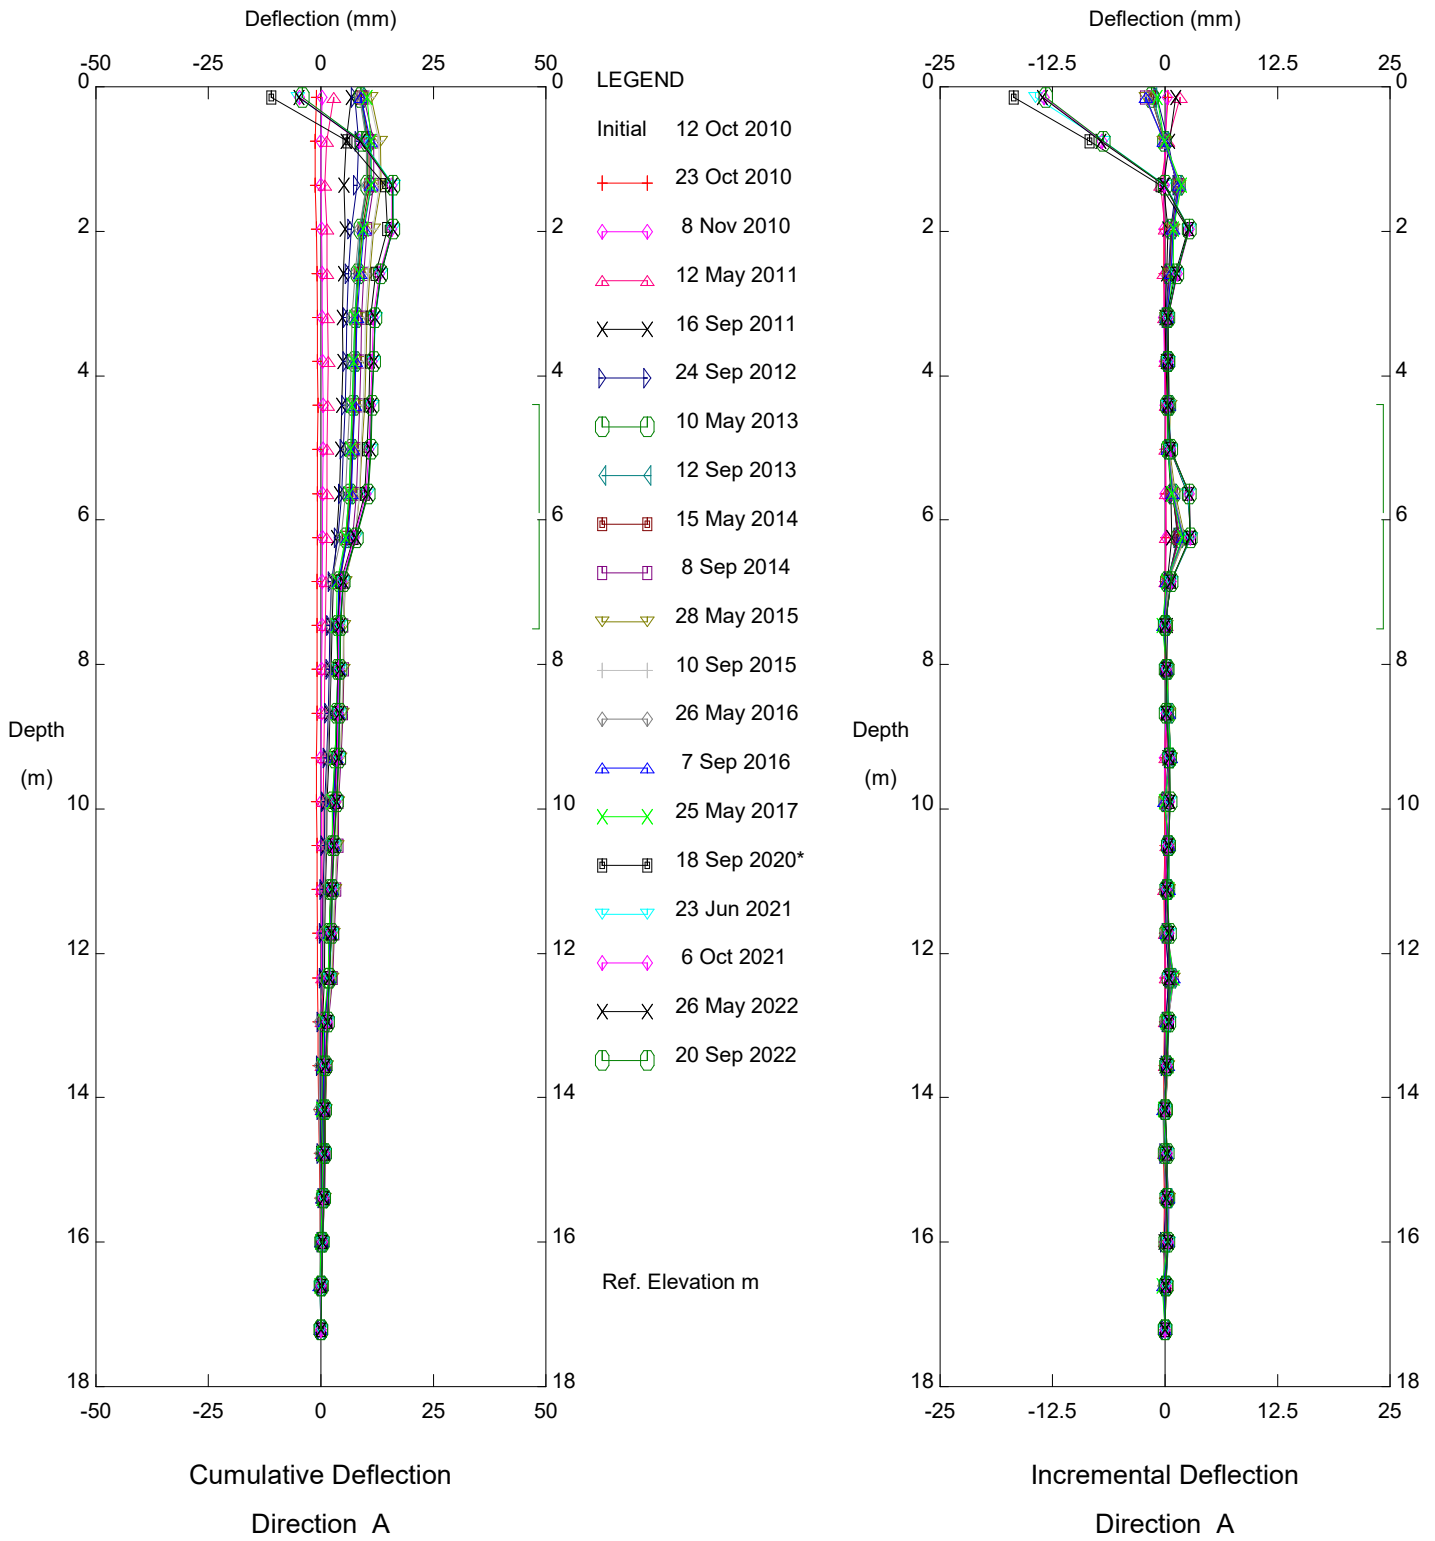
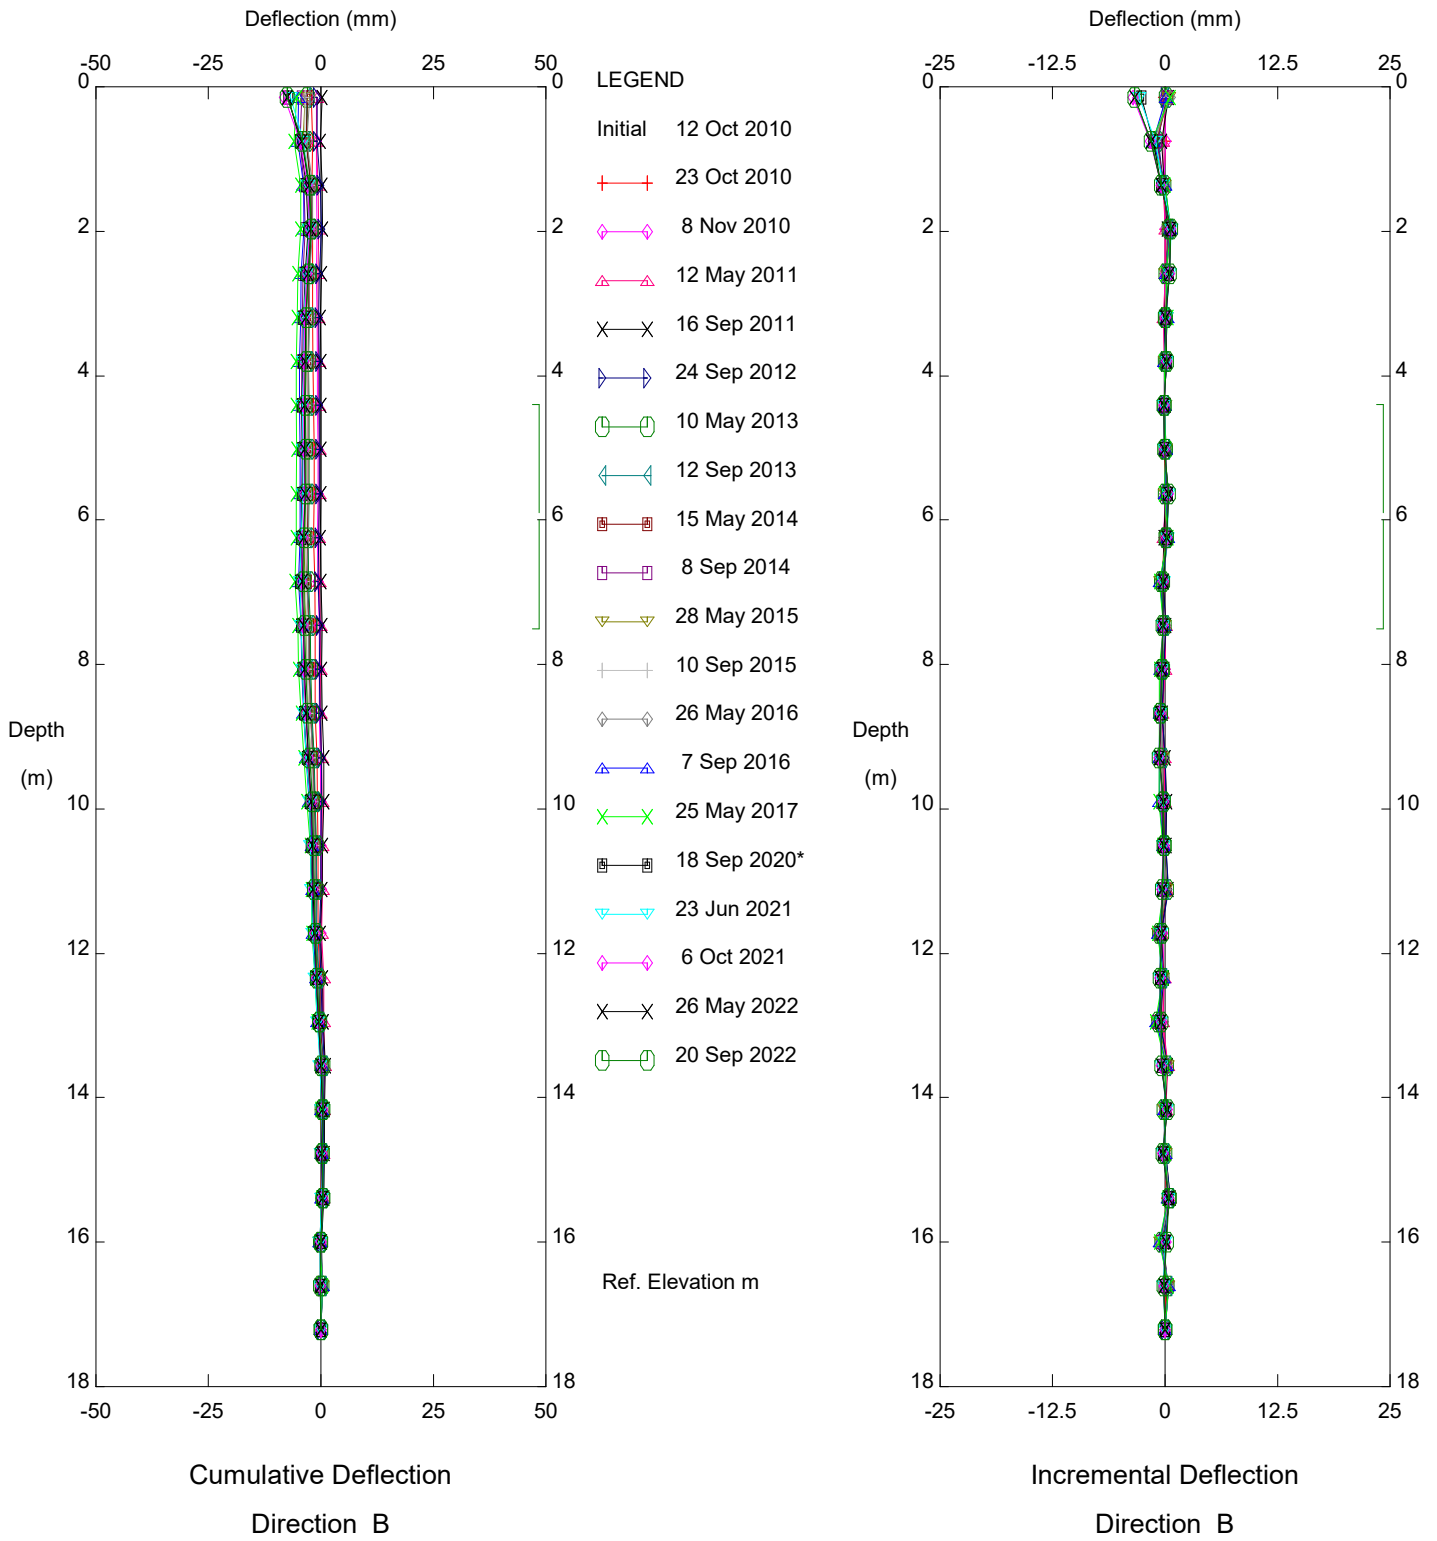
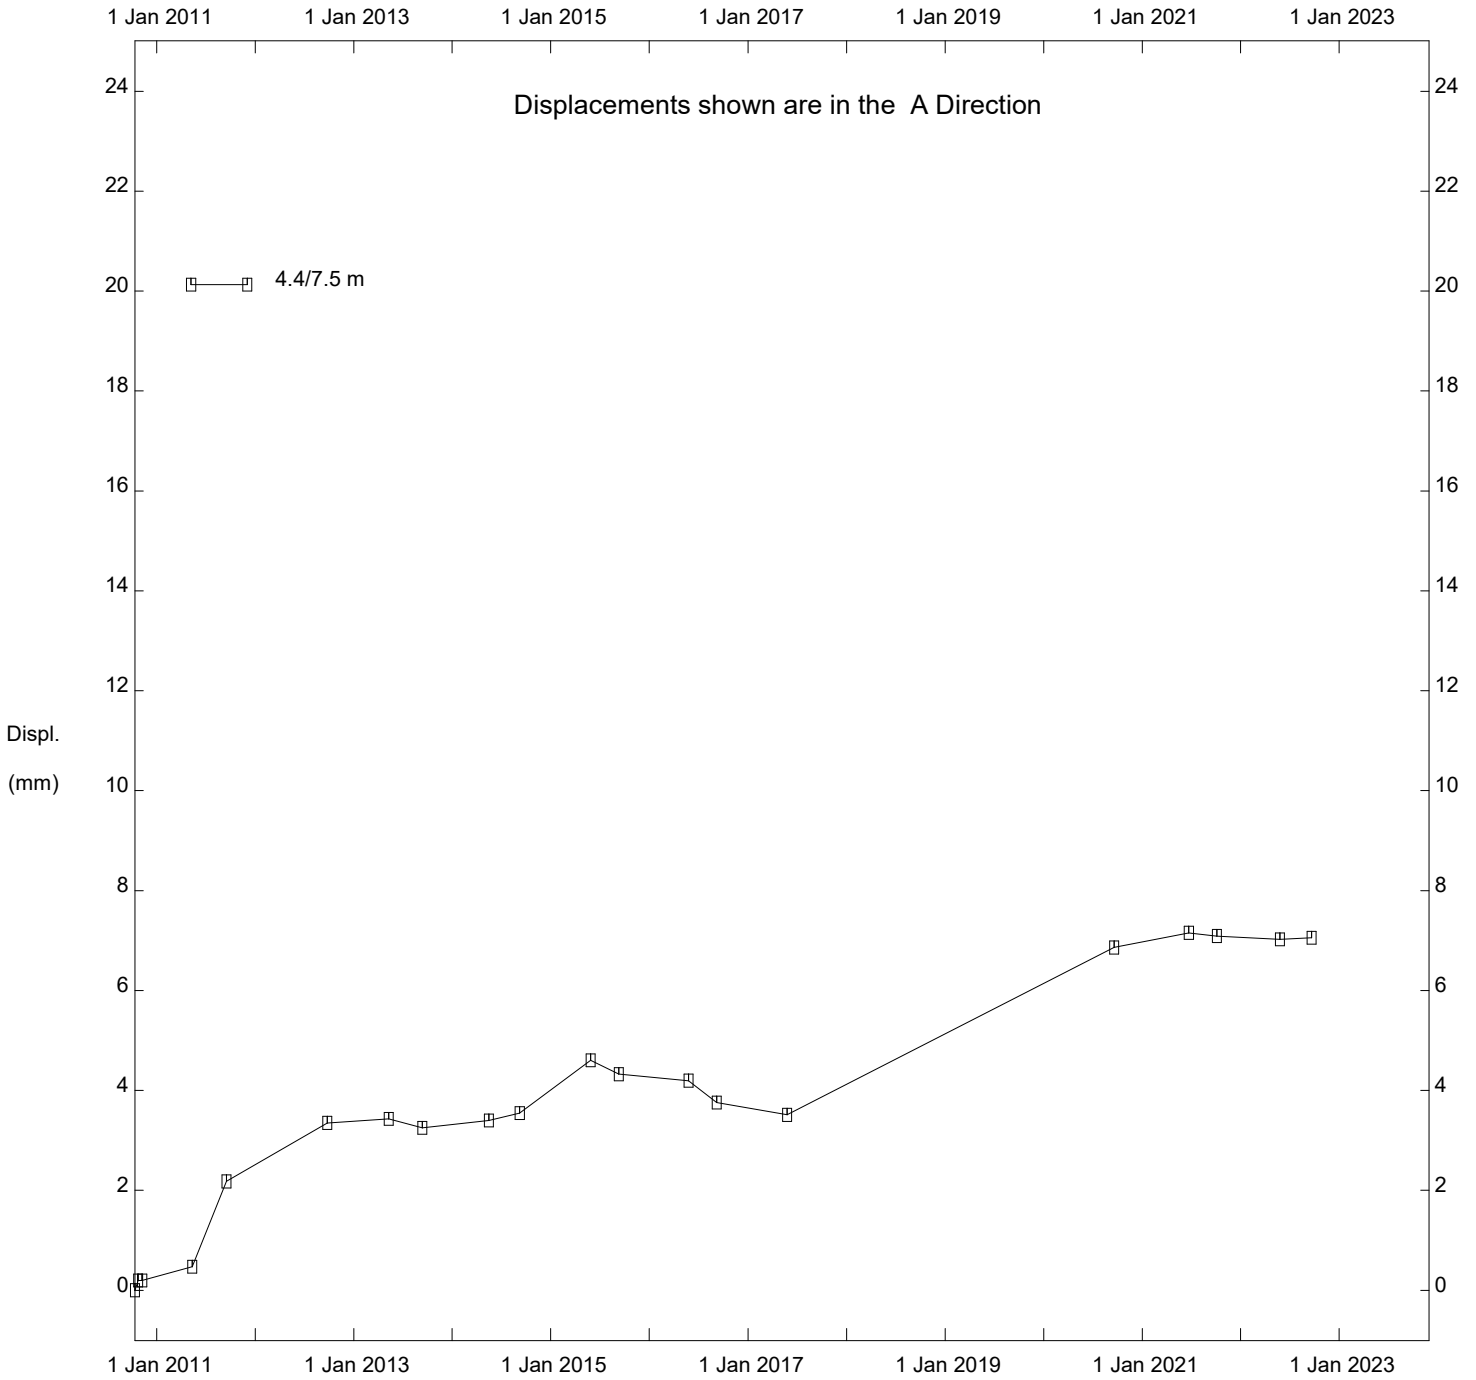
Hwy 41:23 Kehewin Lake (NC103), Inclinometer SI10-1

SI10-1, installed in the east highway ditch, showed a rate of movement of 0.1 mm/yr over 4.4 to 7.5 m depth since the spring of 2022 readings. SI10-3, installed at the bottom of the slope downslope of the pile wall location, showed a rate of movement of 2 mm/yr over 9.9 m to 12.3 m depth since the spring of 2022 readings. SI11-1 and SI11-4 showed no discernible movement since the spring of 2022 readings. SI11-2 showed a rate of movement of 6.2 mm/yr since the spring of 2022 readings. SI11-3 showed a rate of movement of 2.8 mm/yr since the spring of 2022 readings.

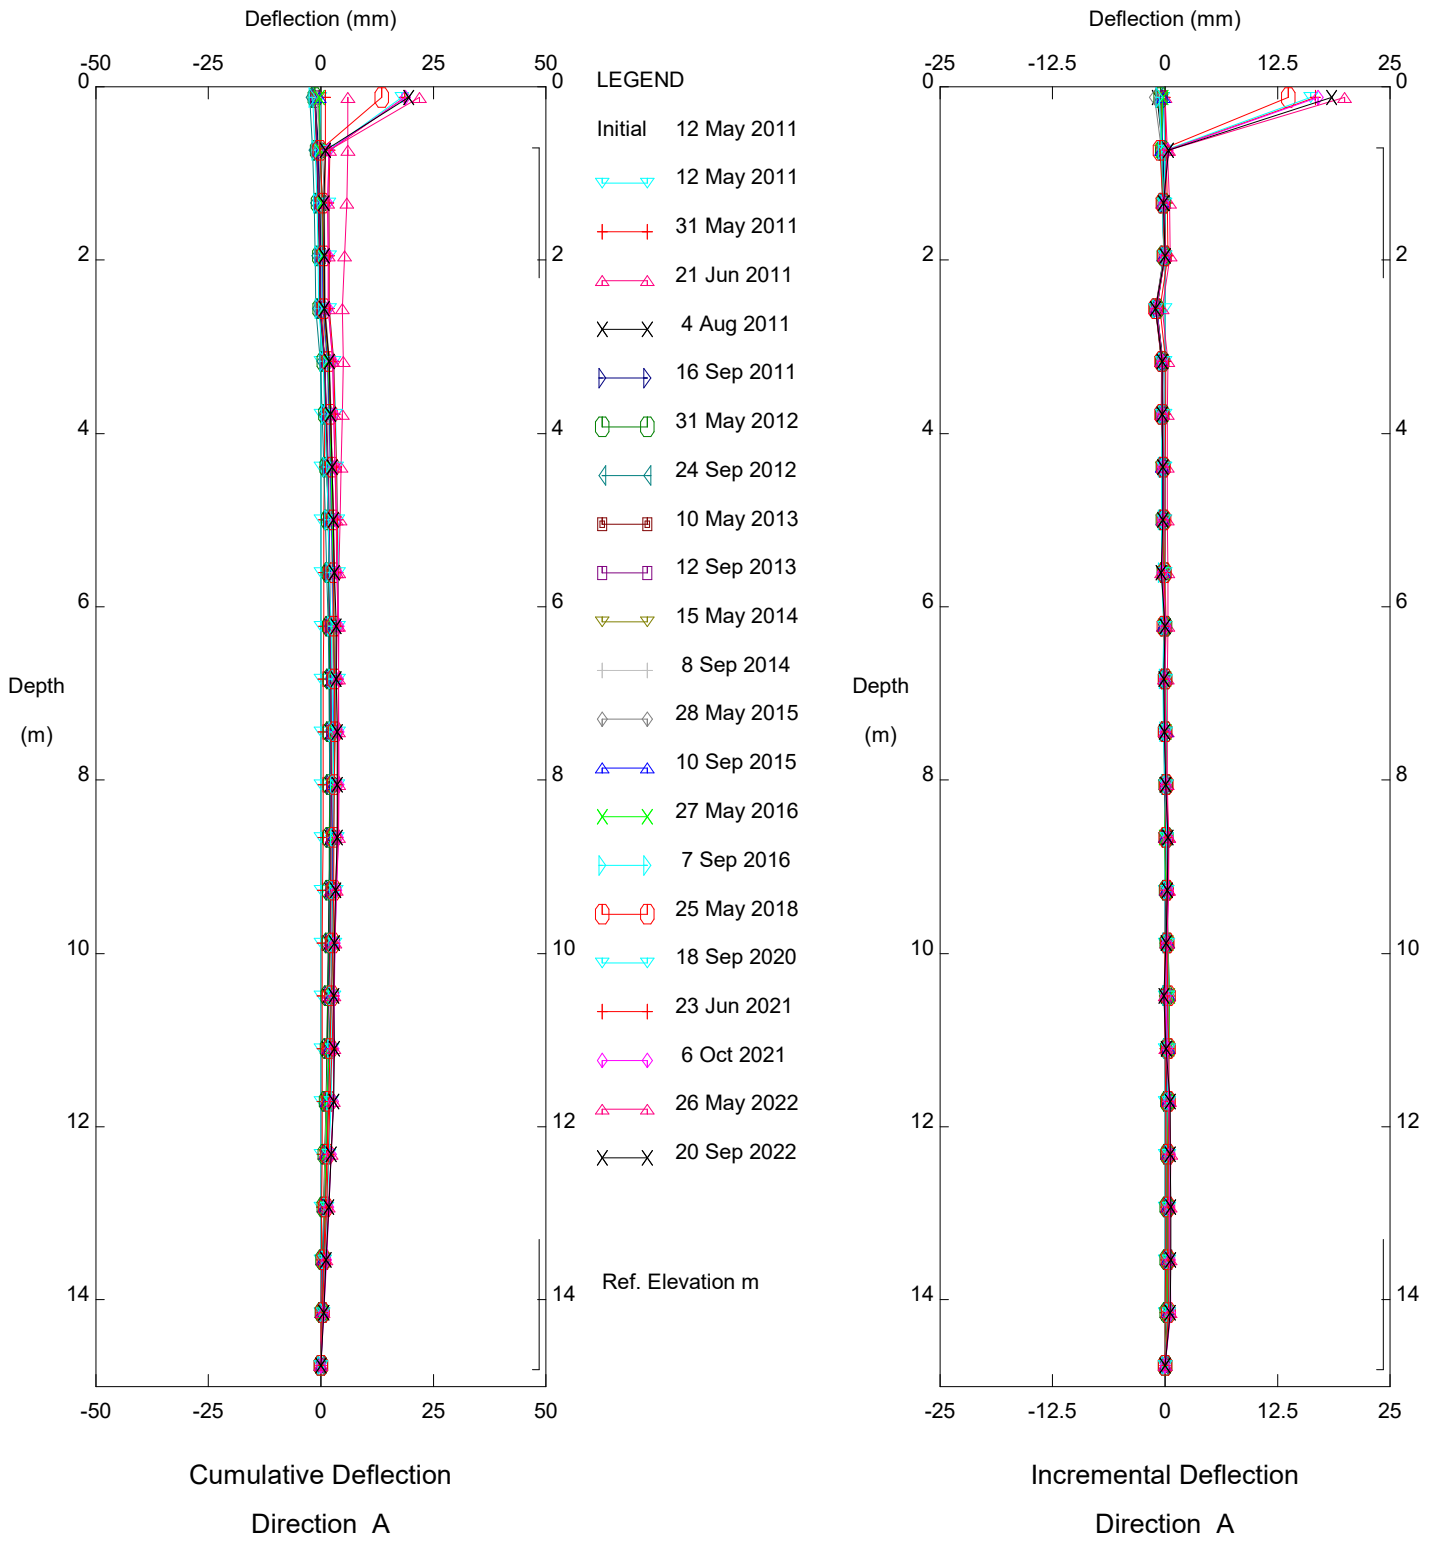
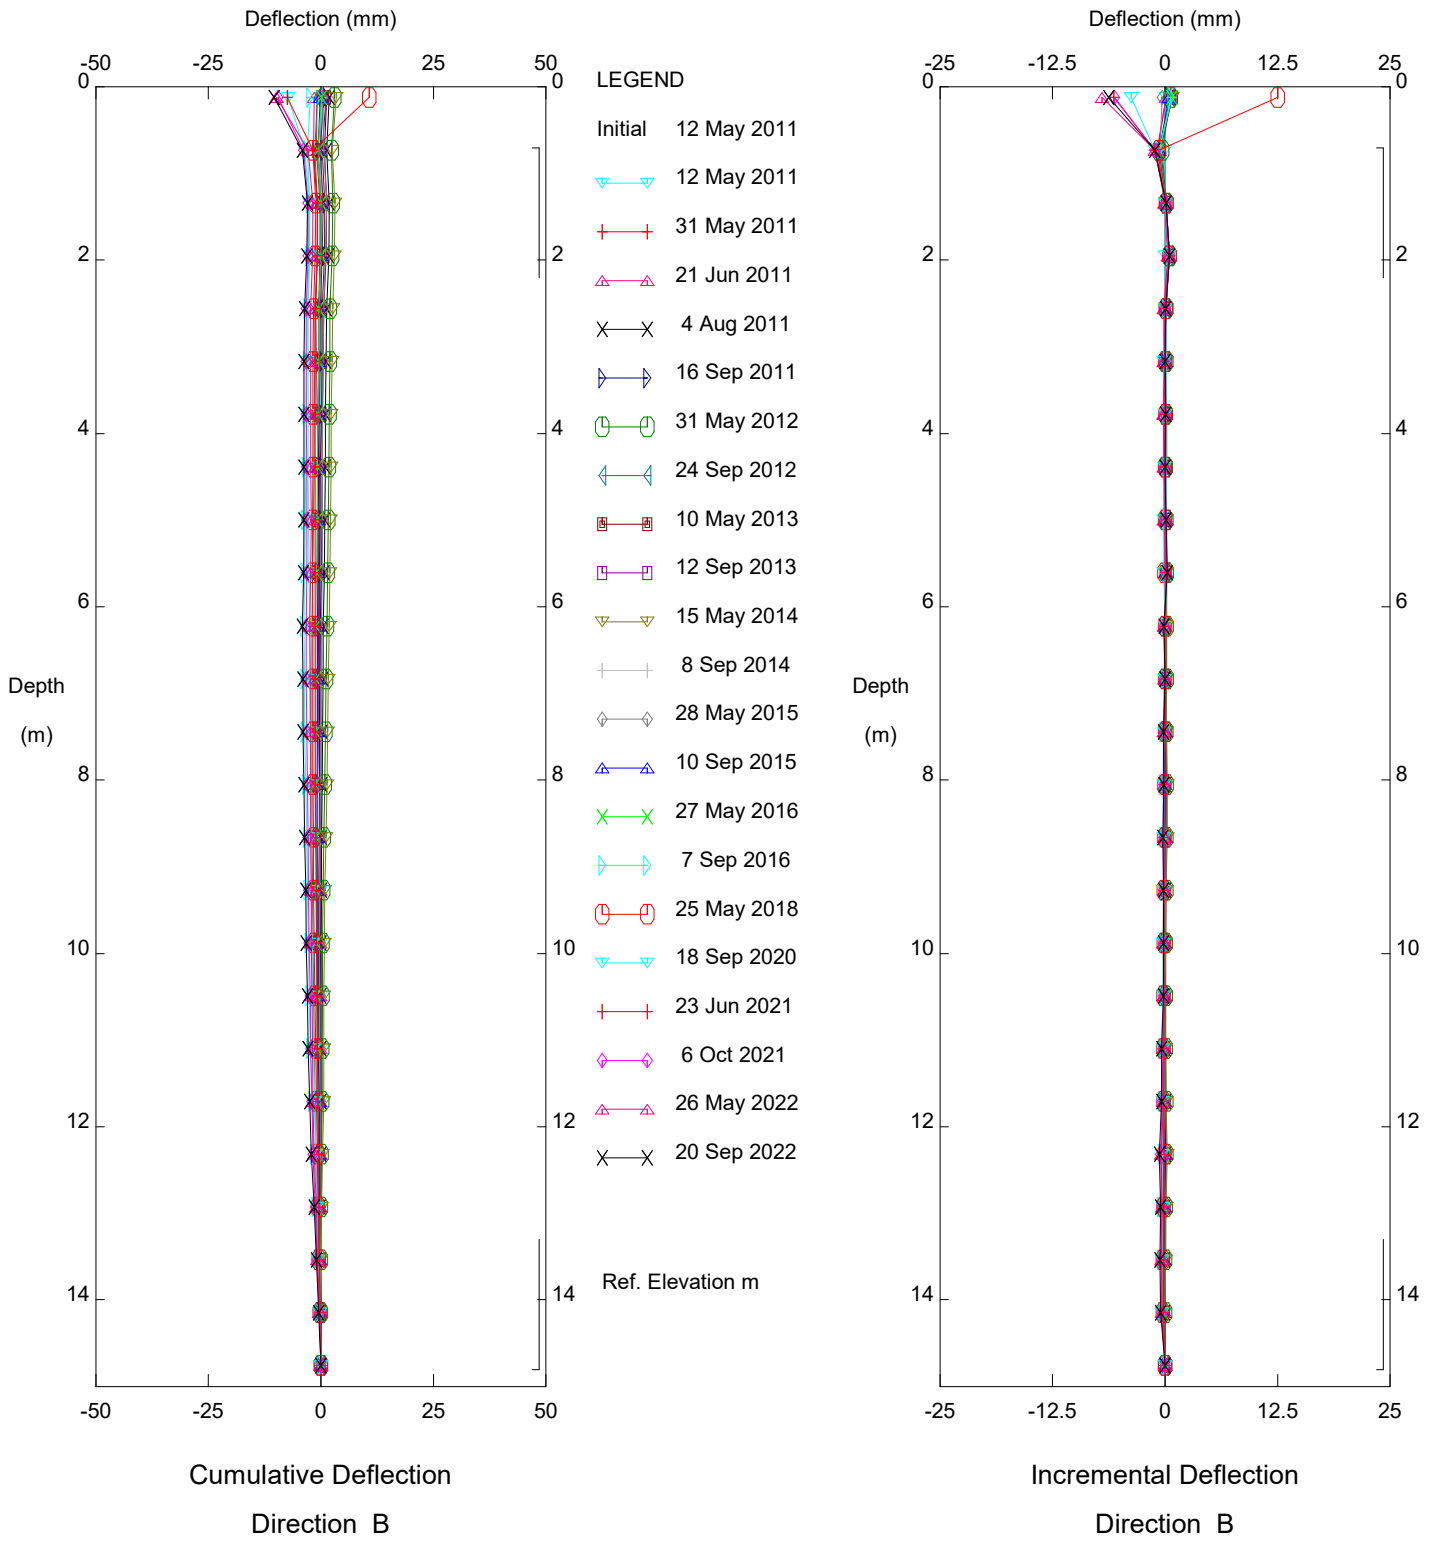
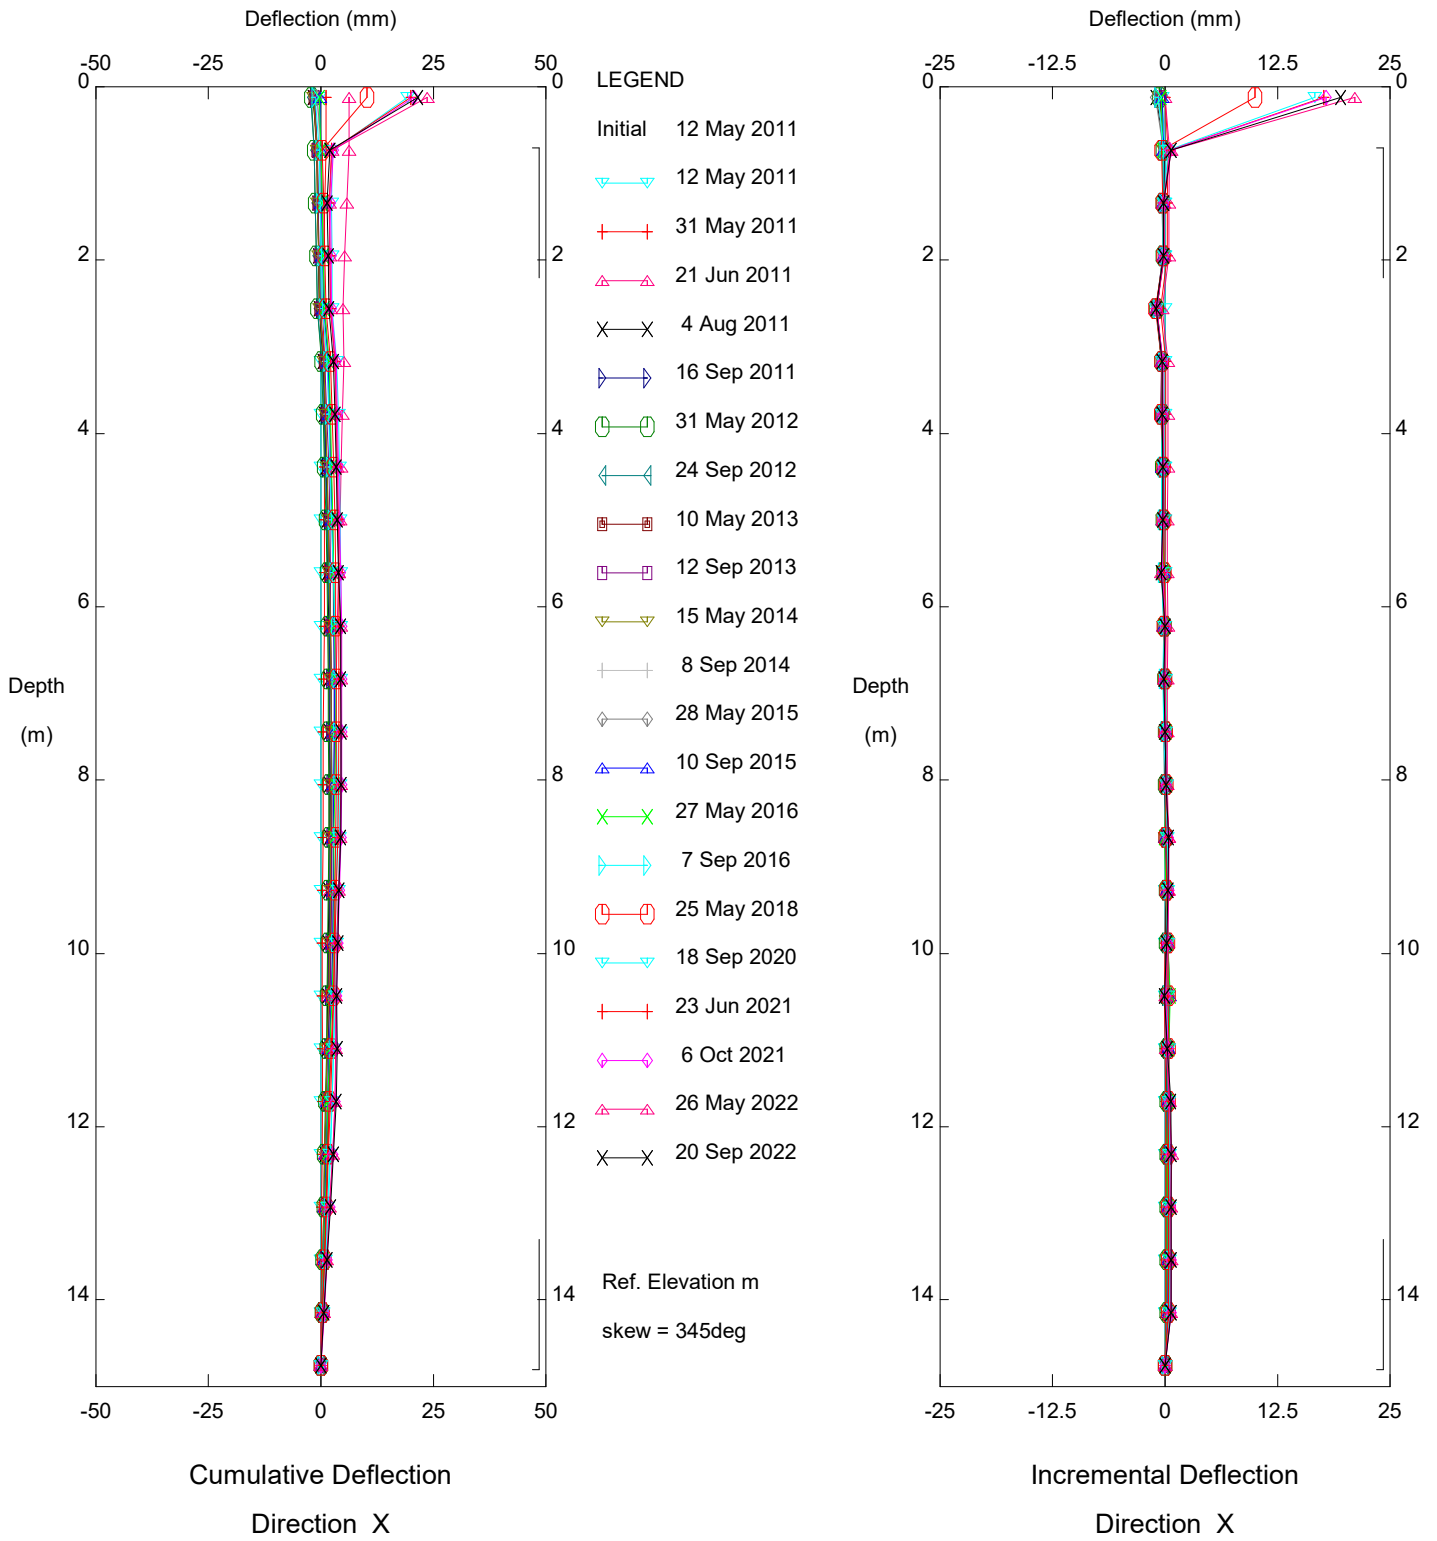
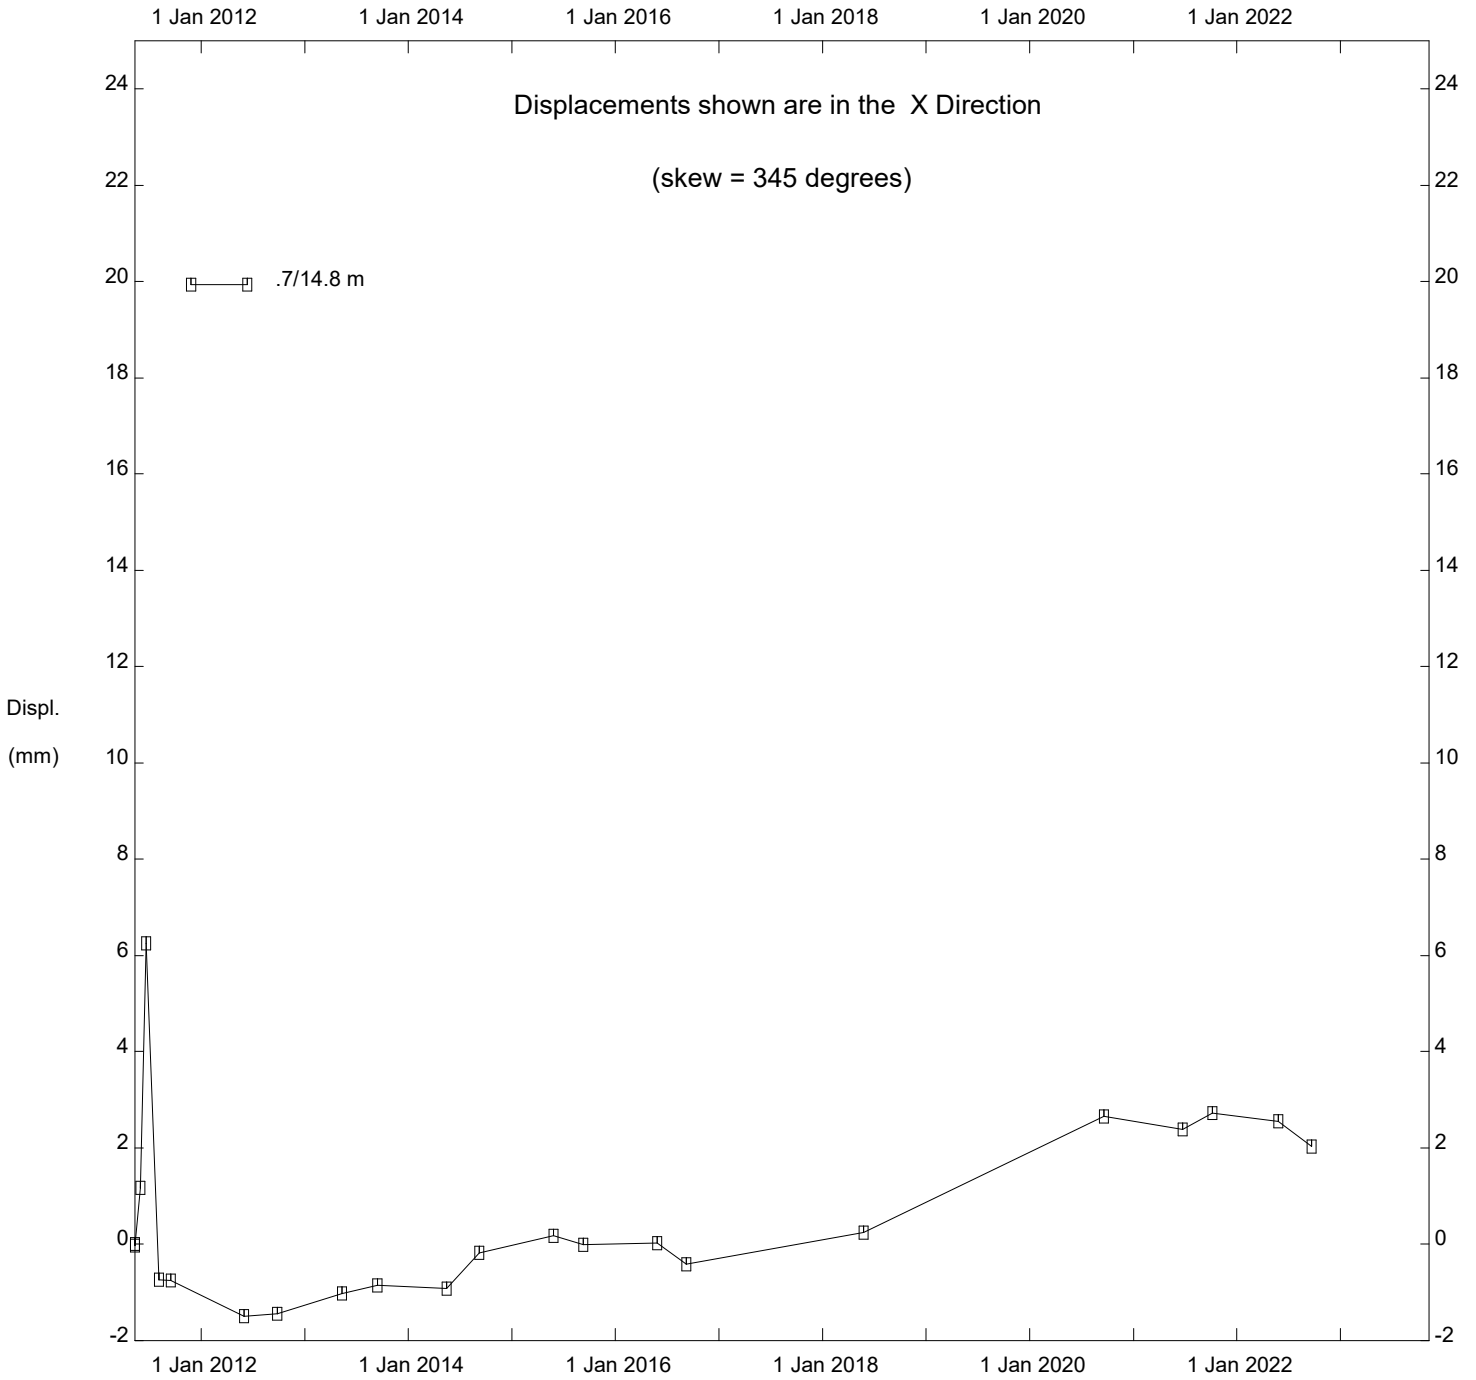
Hwy 41:23 Kehewin Lake (NC103), Inclinometer SI11-1(P9)

- SI11-1 = 2.0 mm pile head movement over 0.7 to 14.8 m depth
- SI11-2 = 2.0 mm pile head movement over 0.7 to 14.7 m depth
- SI11-3 = -7.0 mm pile head movement over 0.5 to 14.6 m depth
- SI11-4 = -8.3 mm pile head movement over 0.8 m to 14.9 m depth
