October 26, 2022

**ALBERTA TRANSPORTATION GRMP (CON0022163)  
NORTH CENTRAL (ATHABASCA AND FORT McMURRAY DISTRICTS)  
INSTRUMENTATION MONITORING RESULTS – FALL 2022**

**SITE NC103 (NC024-3): HWY 41:23 KEHIWIN LAKE (km 7.8)**

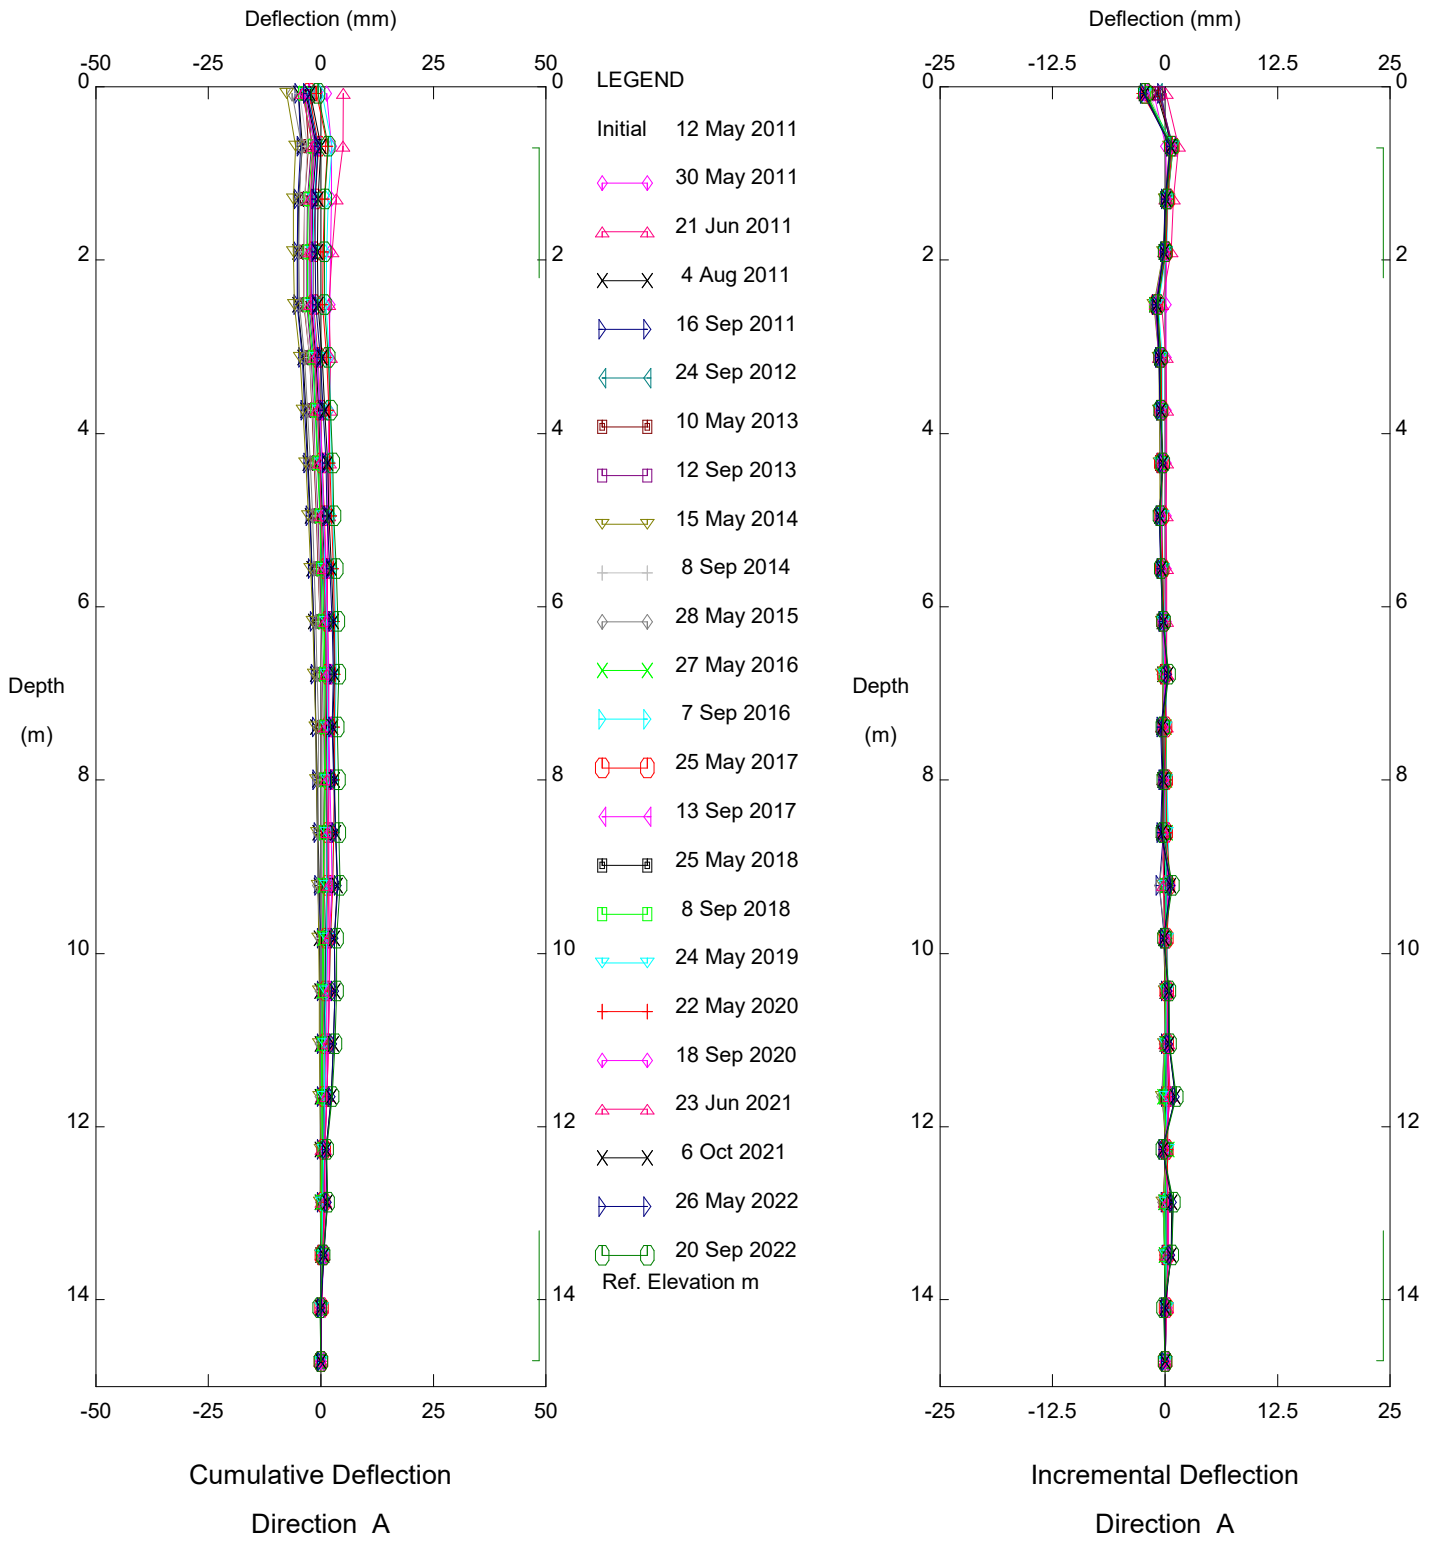
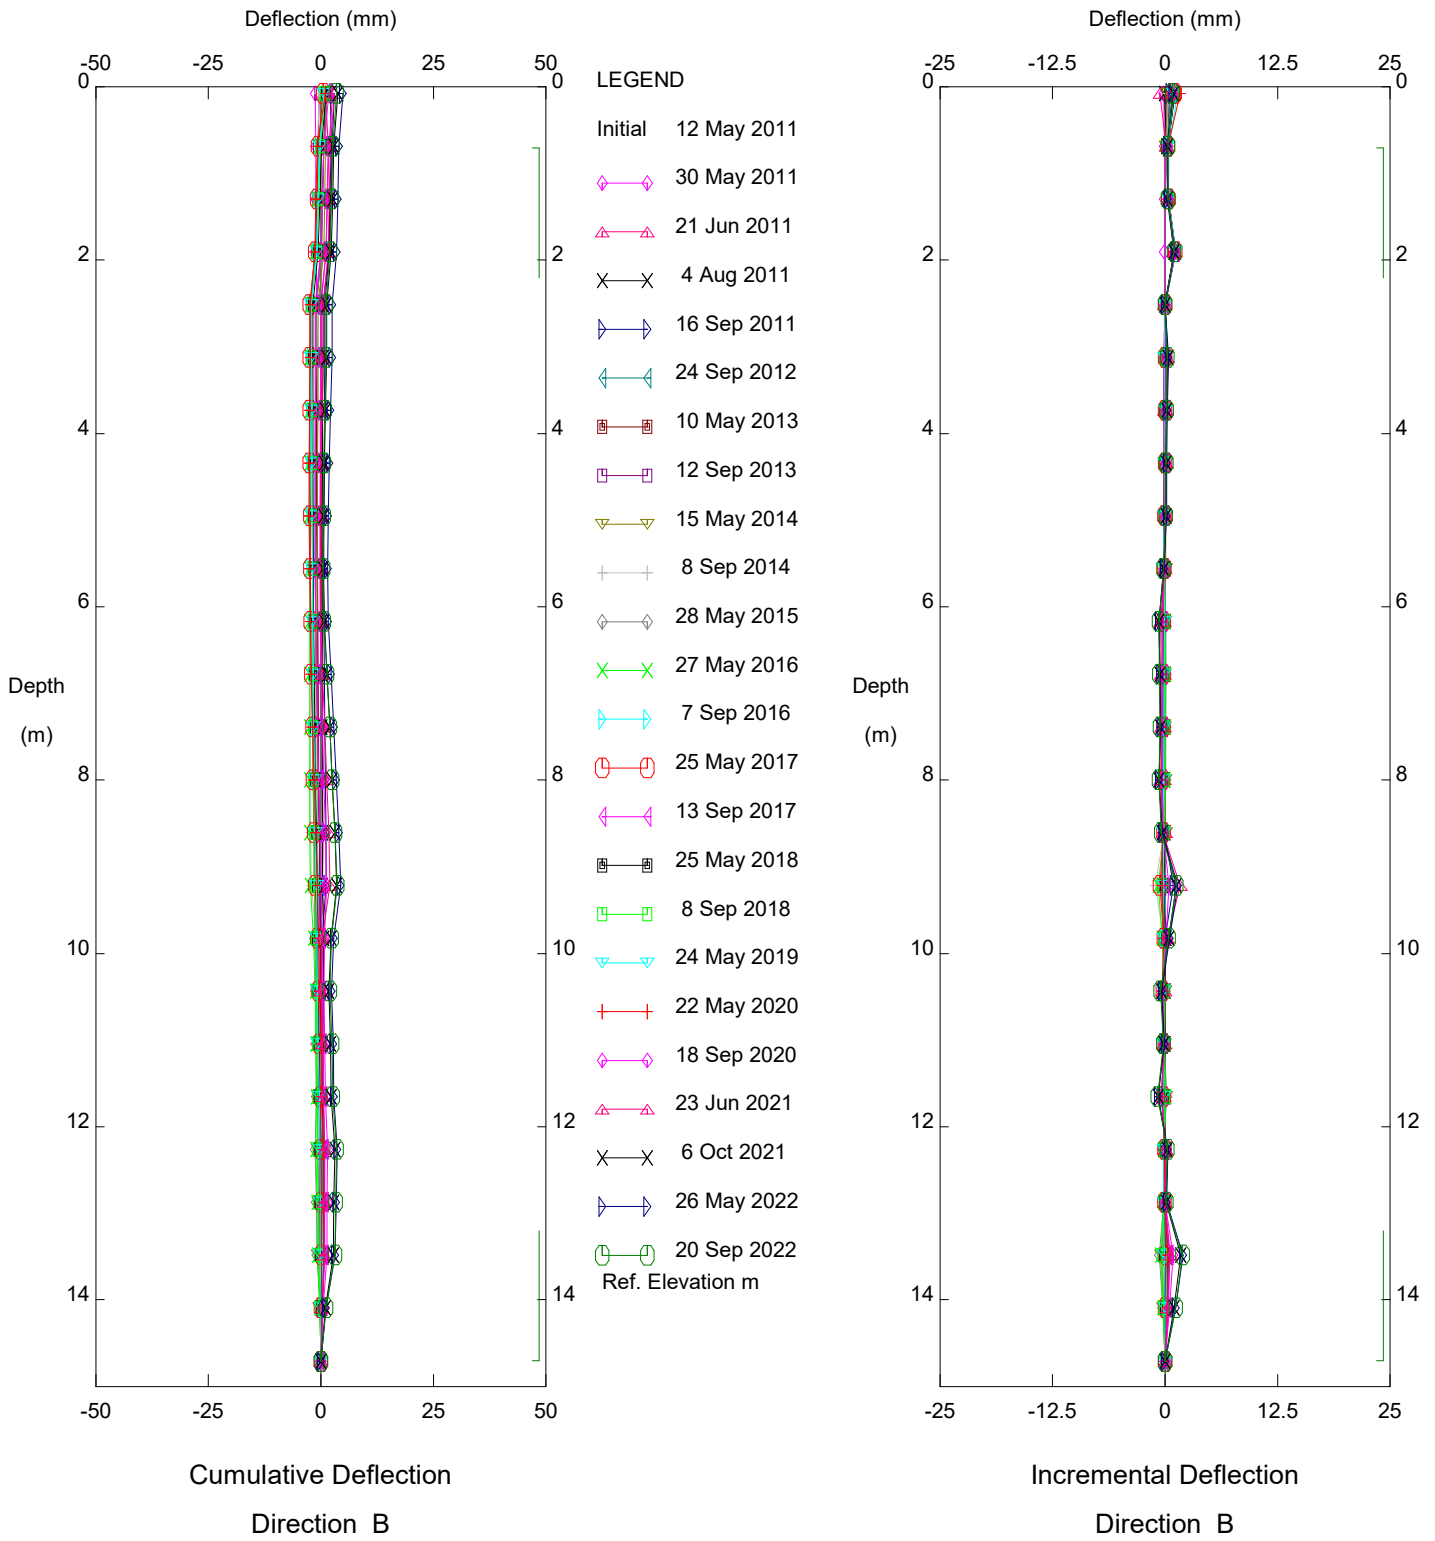
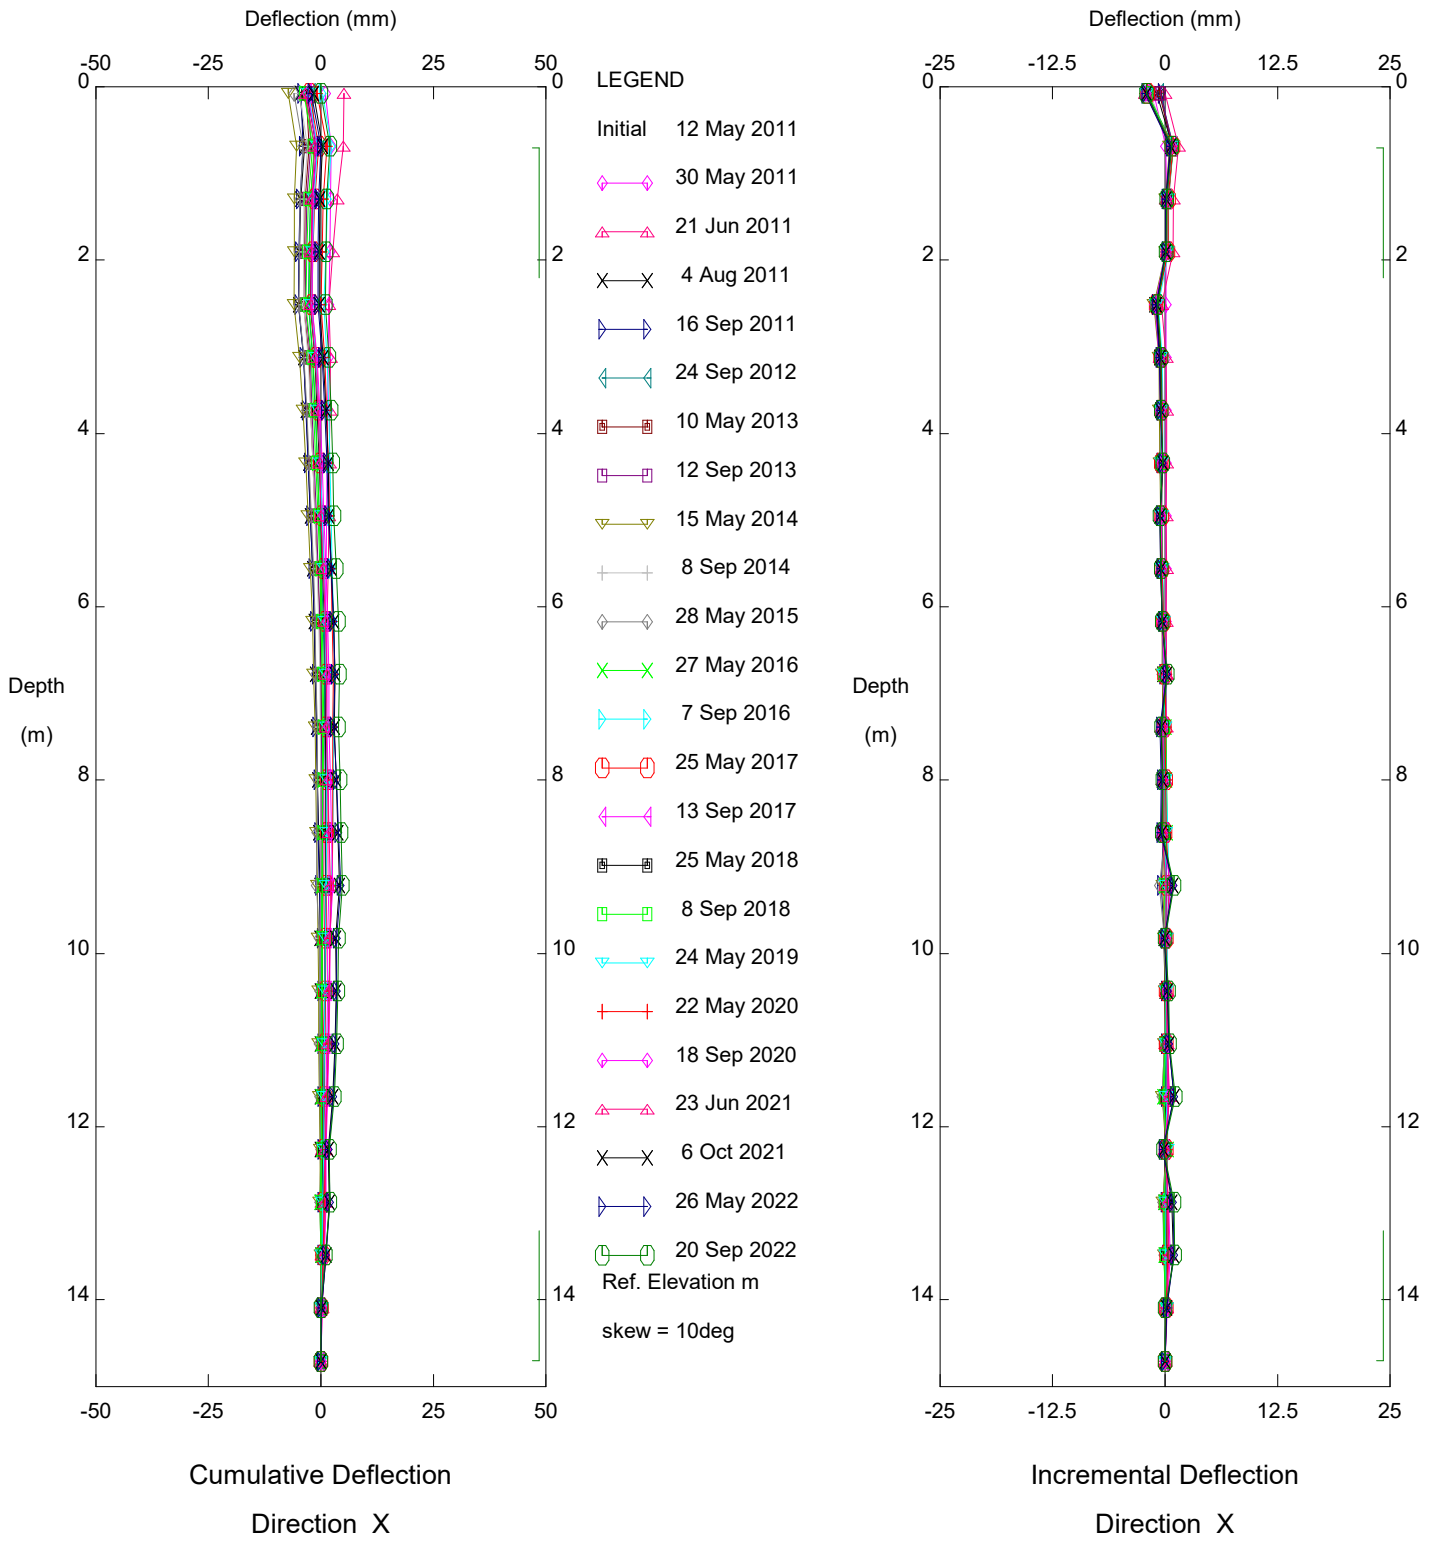
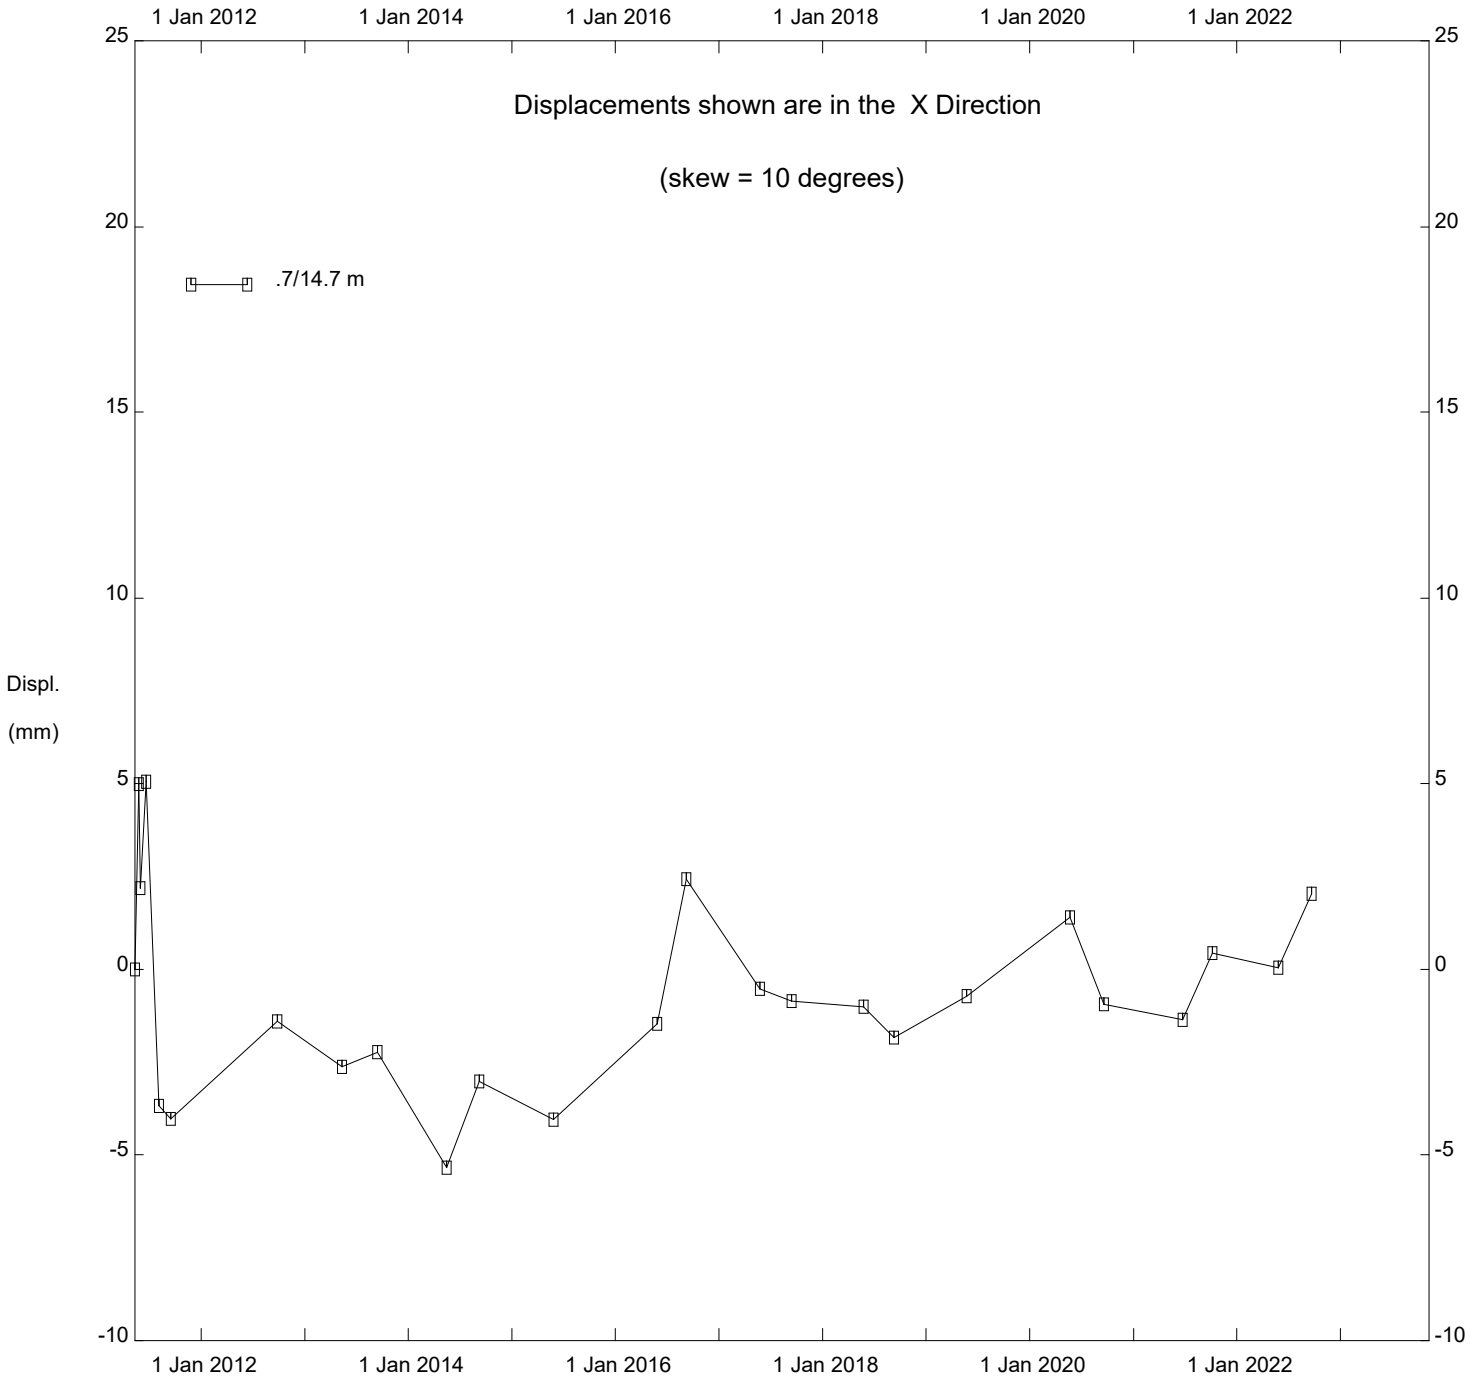
Hwy 41:23 Kehiwin Lake (NC103), Inclinometer SI11-2 (P27)

- SI11-1 = 2.0 mm pile head movement over 0.7 to 14.8 m depth
- SI11-2 = 2.0 mm pile head movement over 0.7 to 14.7 m depth
- SI11-3 = -7.0 mm pile head movement over 0.5 to 14.6 m depth
- SI11-4 = -8.3 mm pile head movement over 0.8 m to 14.9 m depth

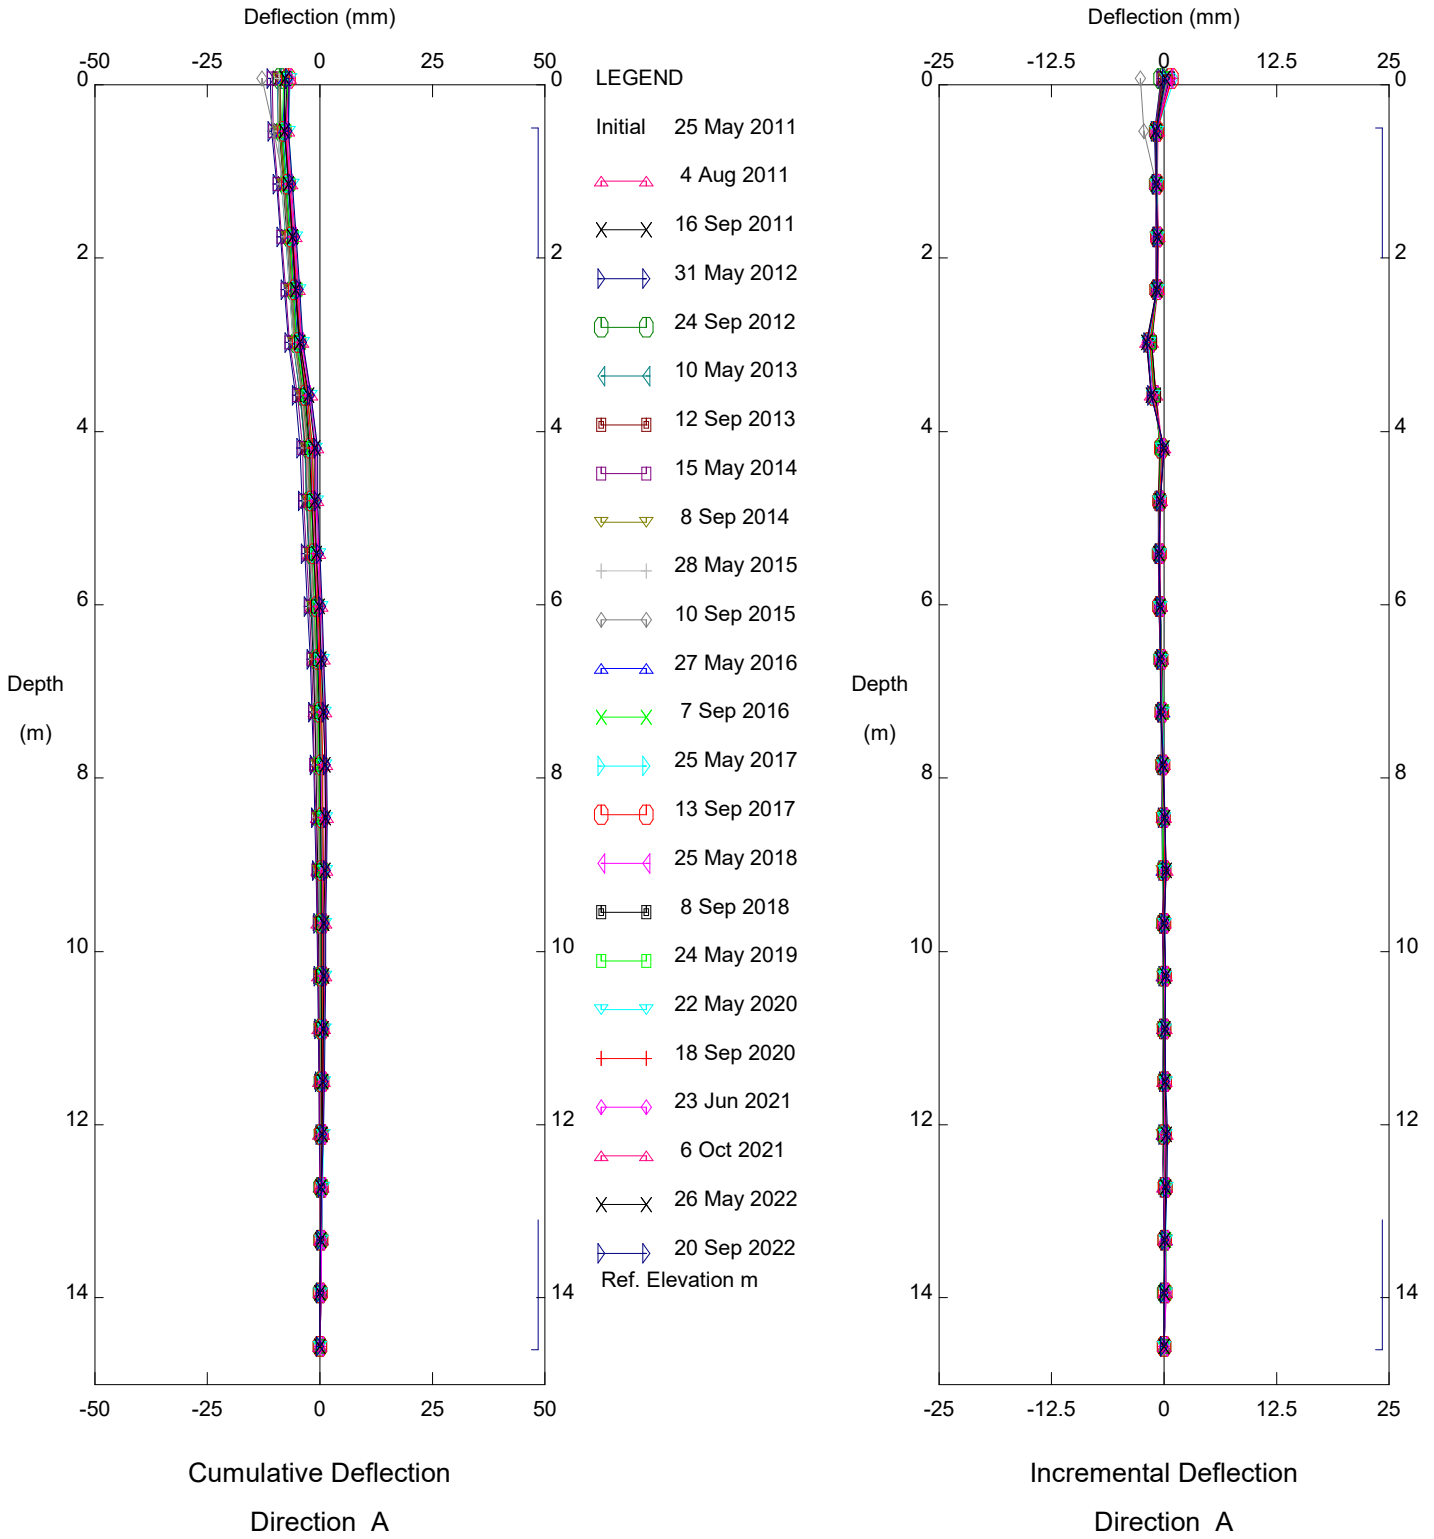
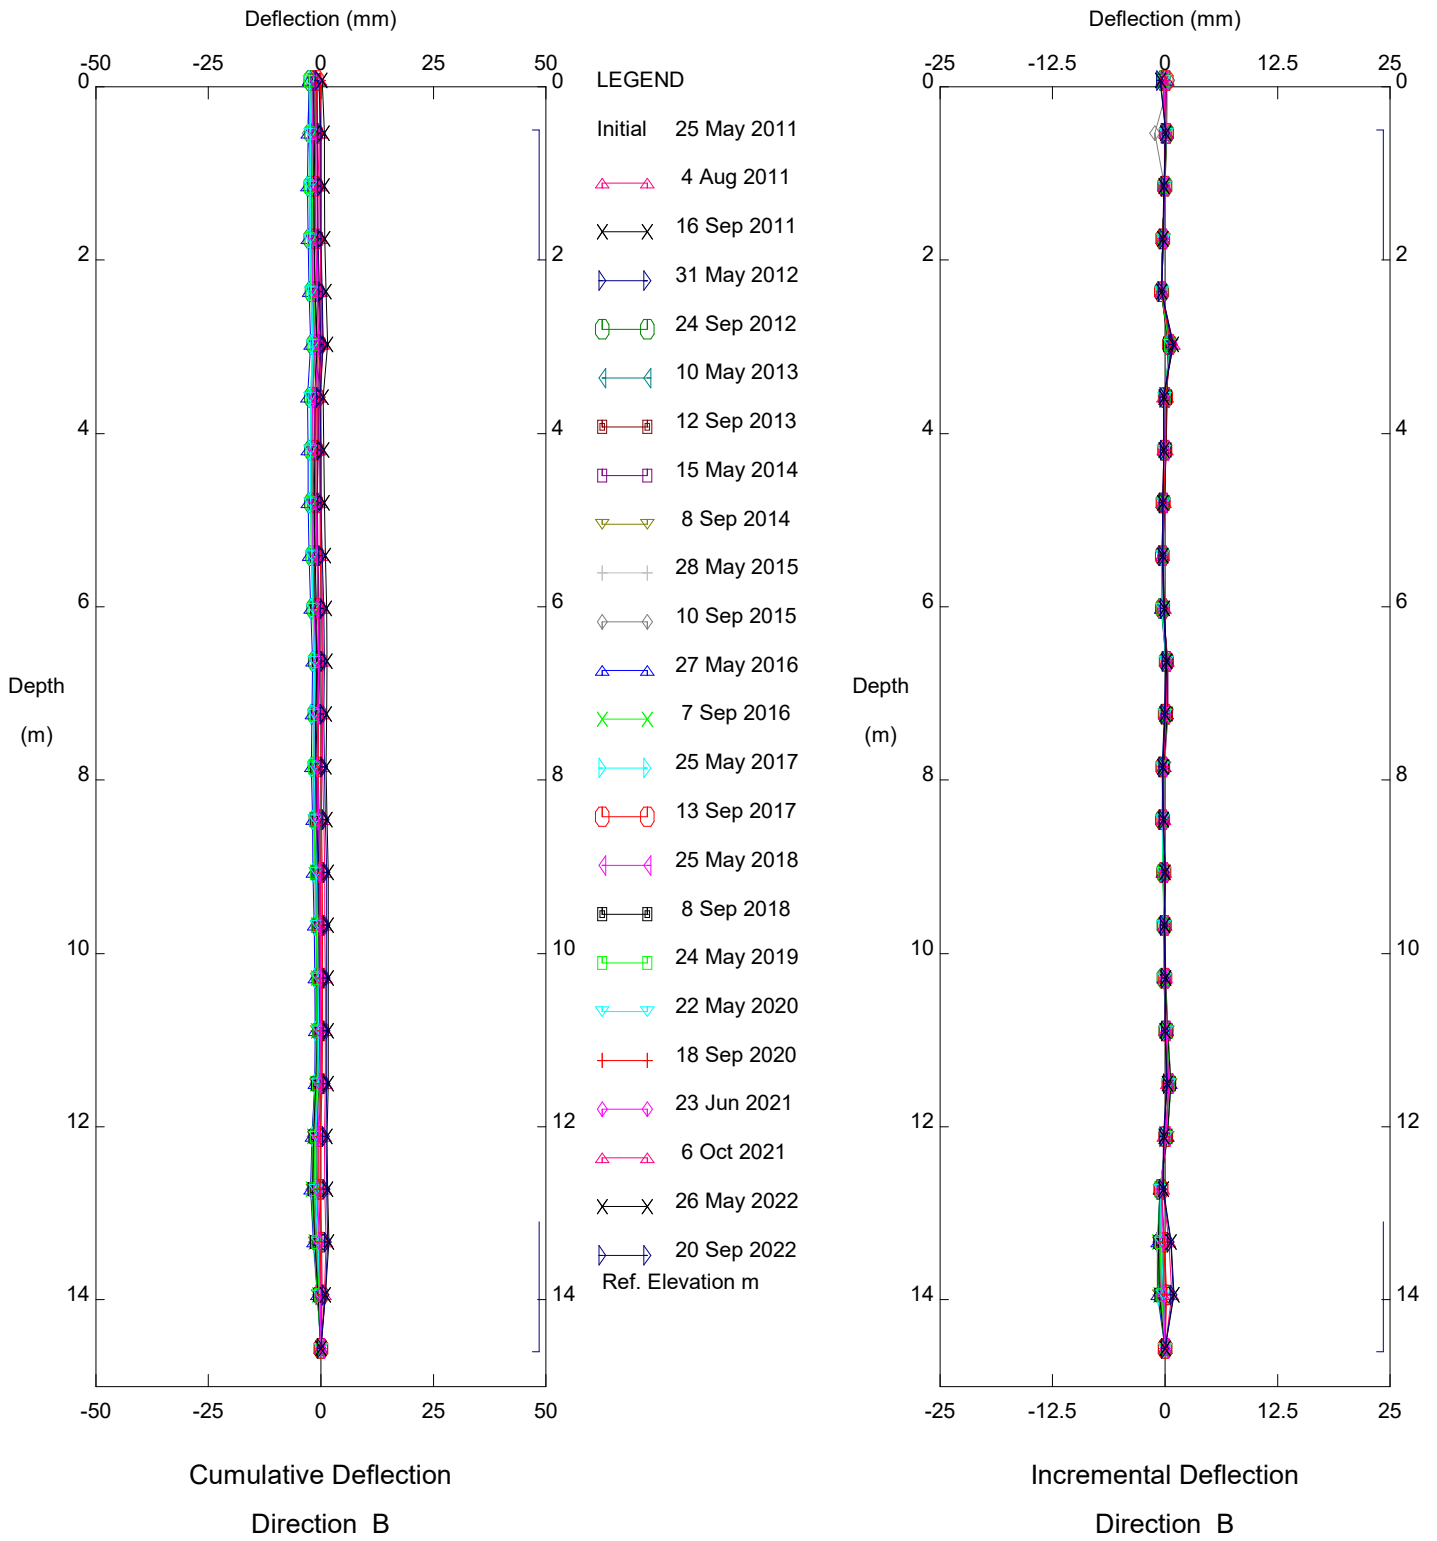
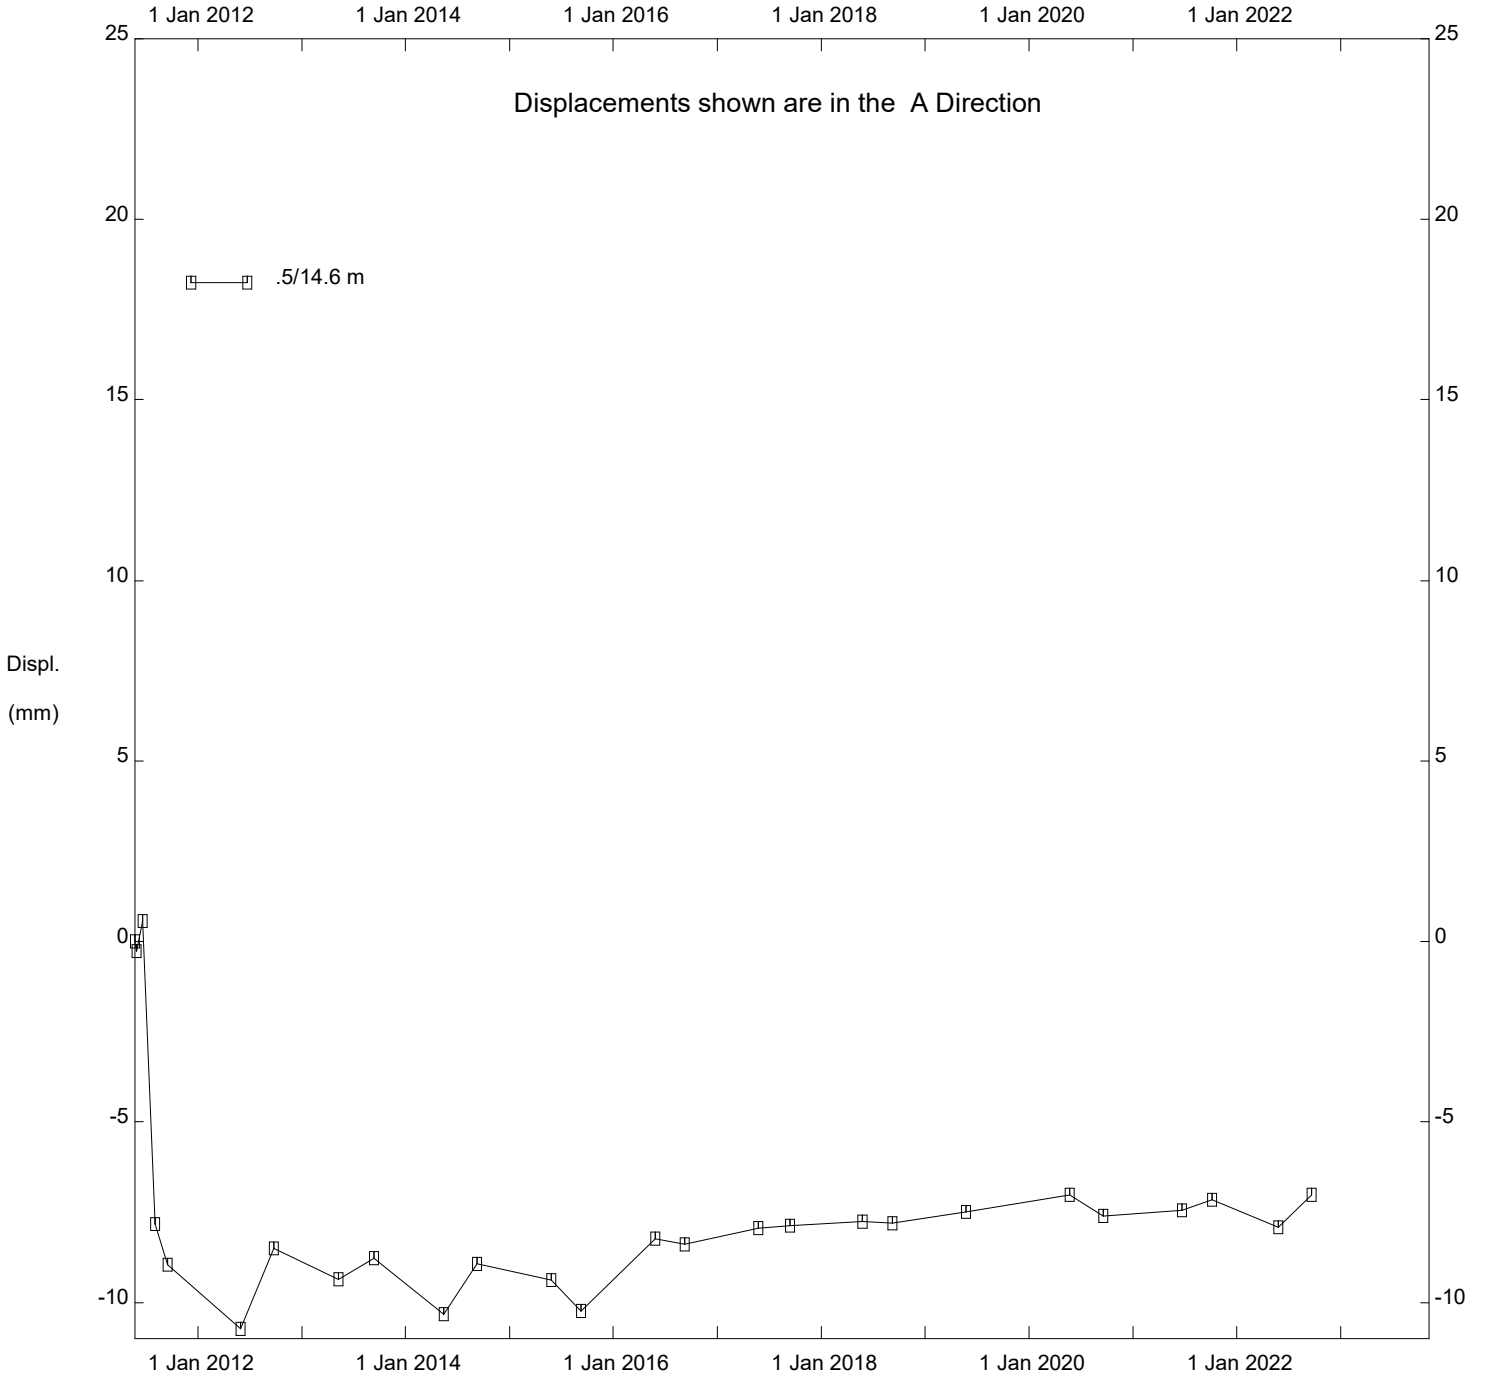
Hwy 41:23 Kehiwin Lake (NC103), Inclinometer SI11-3(P45)

SI10-1, installed in the east highway ditch, showed a rate of movement of 0.1 mm/yr over 4.4 to 7.5 m depth since the spring of 2022 readings. SI10-3, installed at the bottom of the slope downslope of the pile wall location, showed a rate of movement of 2 mm/yr over 9.9 m to 12.3 m depth since the spring of 2022 readings. SI11-1 and SI11-4 showed no discernible movement since the spring of 2022 readings. SI11-2 showed a rate of movement of 6.2 mm/yr since the spring of 2022 readings. SI11-3 showed a rate of movement of 2.8 mm/yr since the spring of 2022 readings.

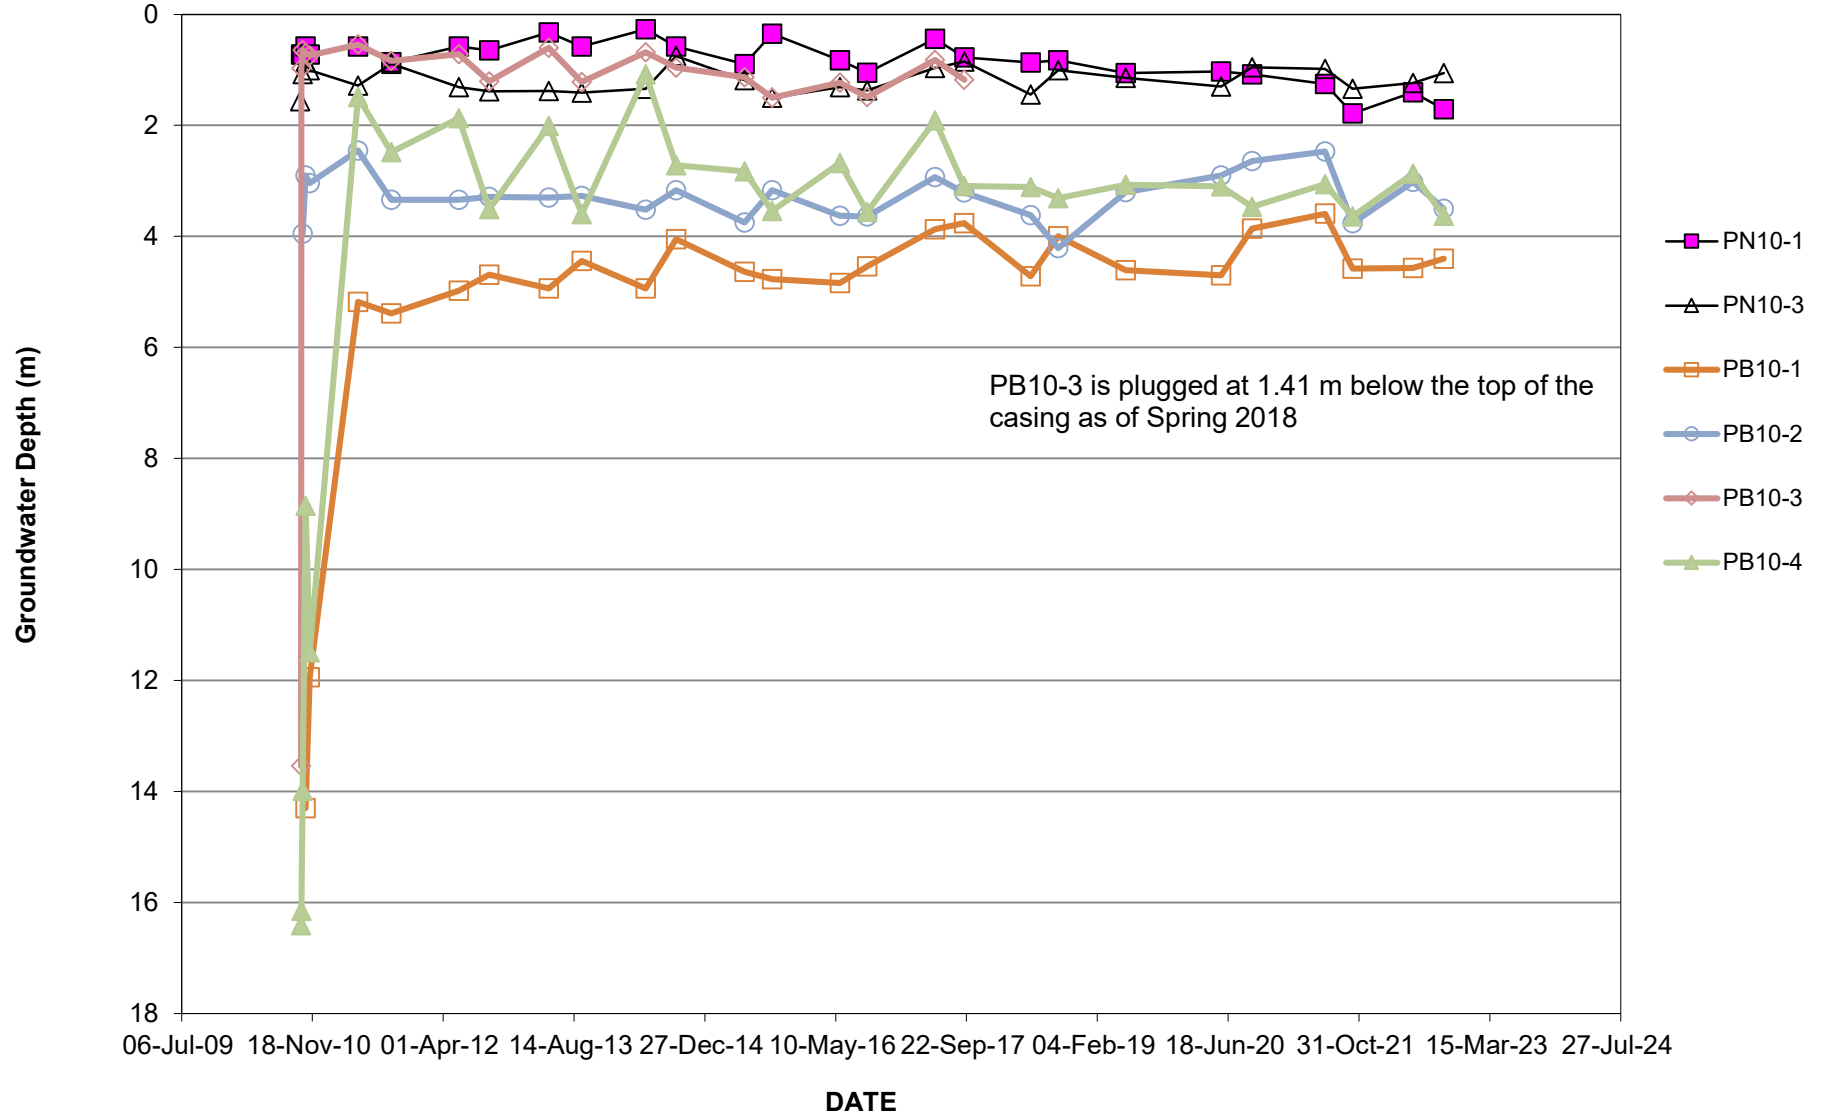
**FIGURE NC103-1  
PIEZOMETER DATA FOR HWY 41:23, KEHIWIN LAKE (KM 7.8)**

Pneumatic piezometer PN10-1 showed a decrease in groundwater level of 0.30 m since the spring of 2022 readings. PN10-3 showed an increase in groundwater level of 0.19 m since the spring of 2022 readings. The pneumatic piezometer readings are summarized in Table NC103-2.

Standpipe piezometer PB10-1 showed an increase in groundwater level of 0.17 m since the spring of 2022 reading. Standpipe piezometers PB10-2 and PB10-4 showed decreases in groundwater level of 0.48 m, and 0.76 m, respectively, since the spring of 2022 readings. The standpipe piezometer readings are summarized in Table NC103-3. The pneumatic and standpipe piezometer readings are plotted on Figure NC103-1 in Appendix A.

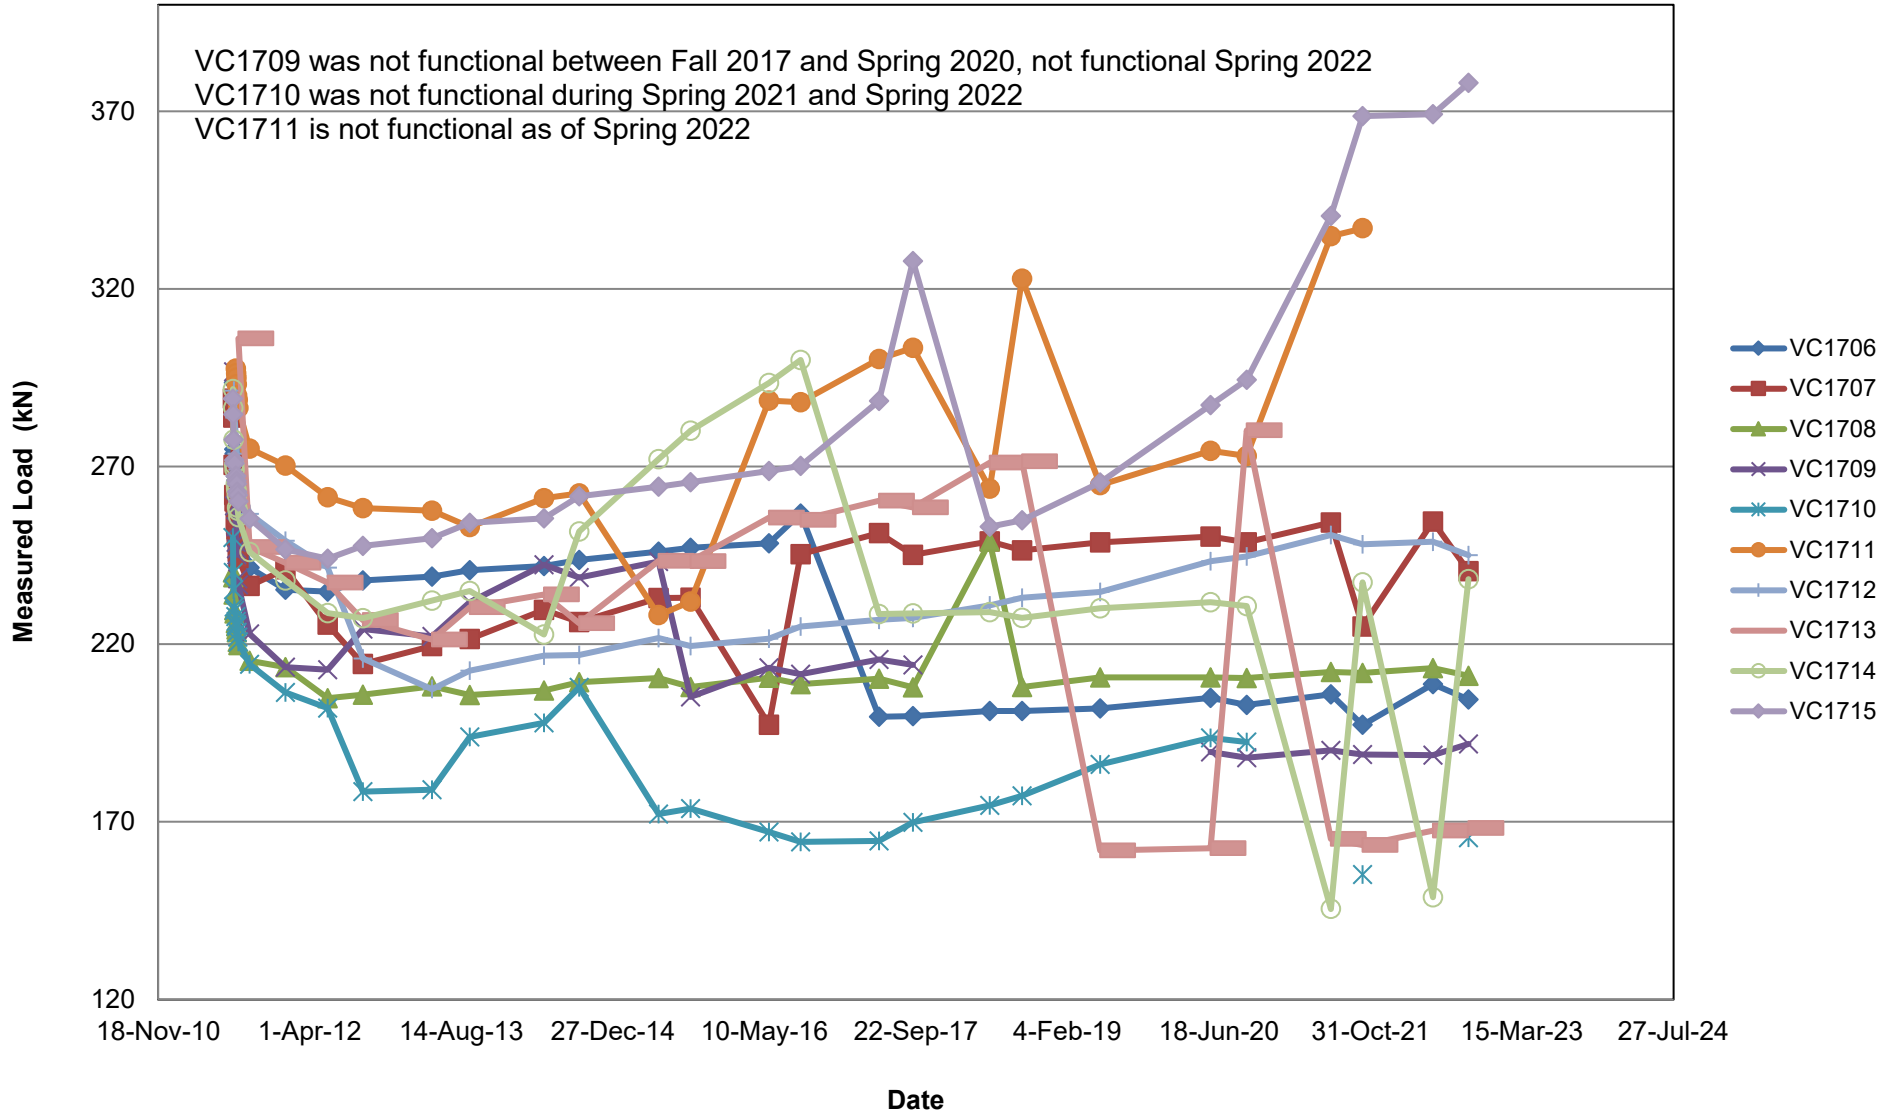
**FIGURE NC103-2  
VIBRATING WIRE LOAD CELL DATA FOR  
HWY 41:23, KEHIWIN LAKE (km 7.8)**

Load cells VC1706, VC1707, VC1708, and VC1712 showed decreases in the measured load of 4.30 kN, 13.91 kN, 2.20 kN, and 3.74 kN, respectively, since the spring of 2022 readings. VC1709, VC1713, VC1714, and VC1715 showed increases in measured load of 3.17 kN, 0.69 kN, 89.50 and 8.83 kN, respectively, since the spring of 2022 readings. The current measured load in VC1715 is the highest ever recorded in this load cell, and this load cell has shown a trend of gradually increasing loads for several reading cycles. VC1714 showed an apparent increase in the measured load by 88.5 kN since the spring of 2022 readings. Between the fall of 2021 and the spring of 2022, this load cell showed a reduction in the measured load by 88.58 kN. Hence, the seasonal variation in the measured load in VC1714 is only a reflection of the inconsistency in the number of operational vibrating wire channels during the reading events. VC1710 showed an increase in the measured load by 11.32 kN, when compared to the last reading recorded in the fall of 2021.

The current load in VC1715 is about 30.0 percent higher than the lock off load. The remaining load cells have shown decreases in measured load, when compared to the lock off load, ranging from 12.0 percent to 48.7 percent. However, the load cells with the largest variations in load values have lost one or more vibrating wire channels over several reading cycles. In addition, the

reductions in the loads have not been consistent with the observed movement patterns of the walls, based on the slope inclinometer readings.

If significant reductions in anchor loads occur in the future in response to the wall deflection towards west, the anchors will need to be restressed to maintain the wall's lateral deflection within the design limit.
