**ALBERTA TRANSPORTATION  
GEOHAZARD ASSESSMENT PROGRAM  
NORTH CENTRAL REGION – ATHABASCA &  
FORT MCMURRAY DISTRICTS  
2022 SITE INSPECTION**

Site Number	Location	Name	Hwy	km
NC103-2	Approximately 7.9 km north of Hwy 29 (North of Elk Point)	<b>KEHIWIN LAKE</b>	41:23	7.9
<b>Legal Description</b>		<b>UTM Co-ordinates (NAD 83)</b>		
9-25-58-07 W4		12 N 5988463.22	E	506745.73

**NORTH CENTRAL REGION  
(ATHABASCA AND FORT MCMURRAY DISTRICTS)  
2022 GEOHAZARD ASSESSMENT**

**NC103-2: HWY41:23 KEHIWIN LAKE WEST SIDE  
SLOPE SLUMP (km 7.9)**

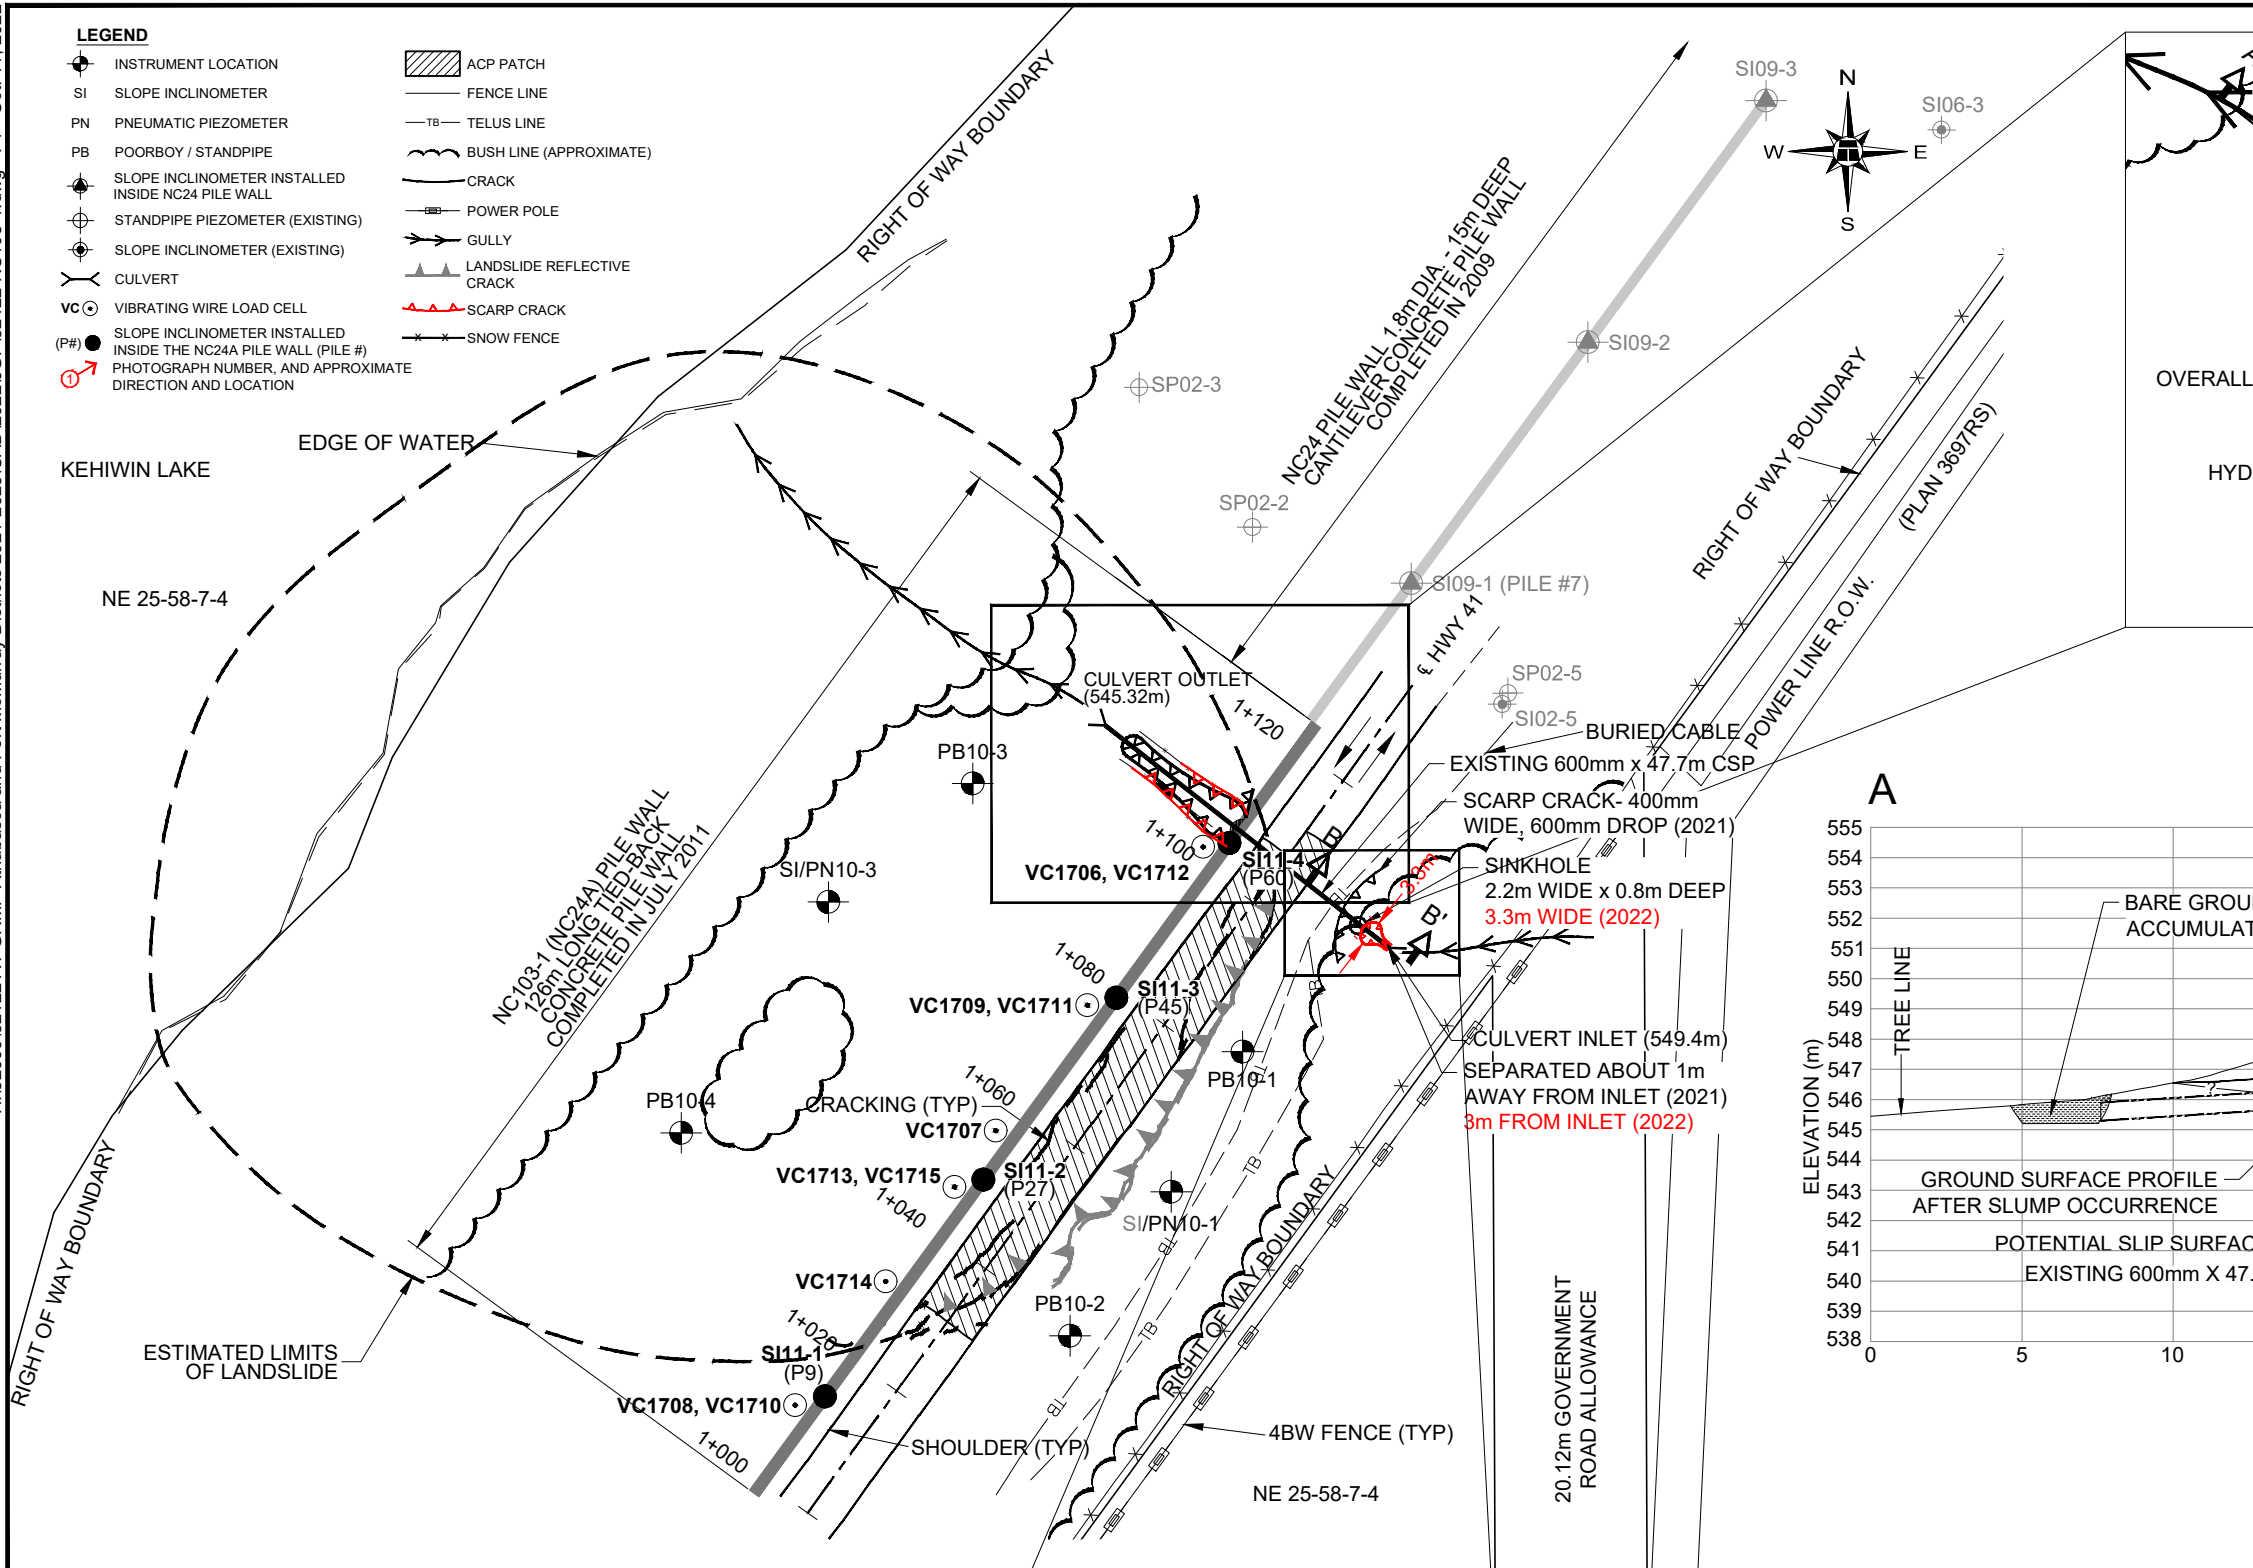
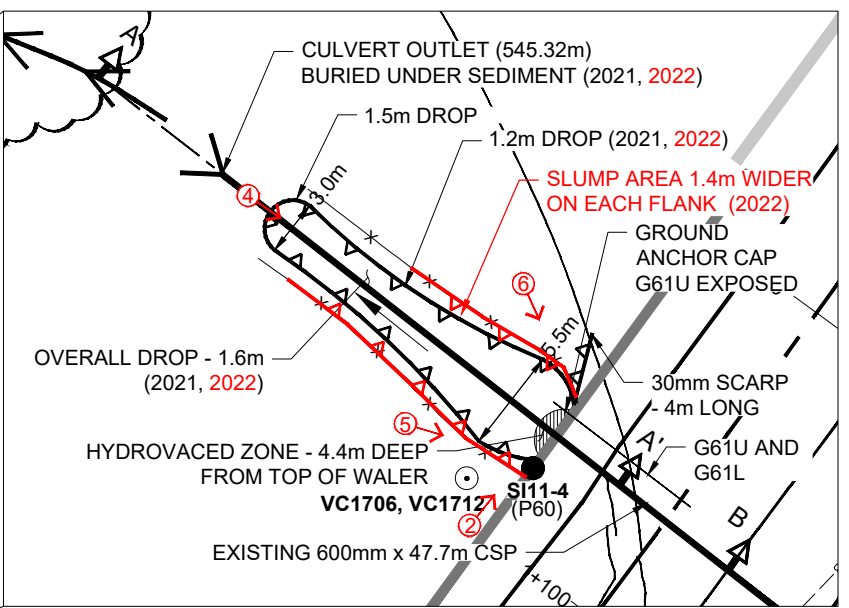
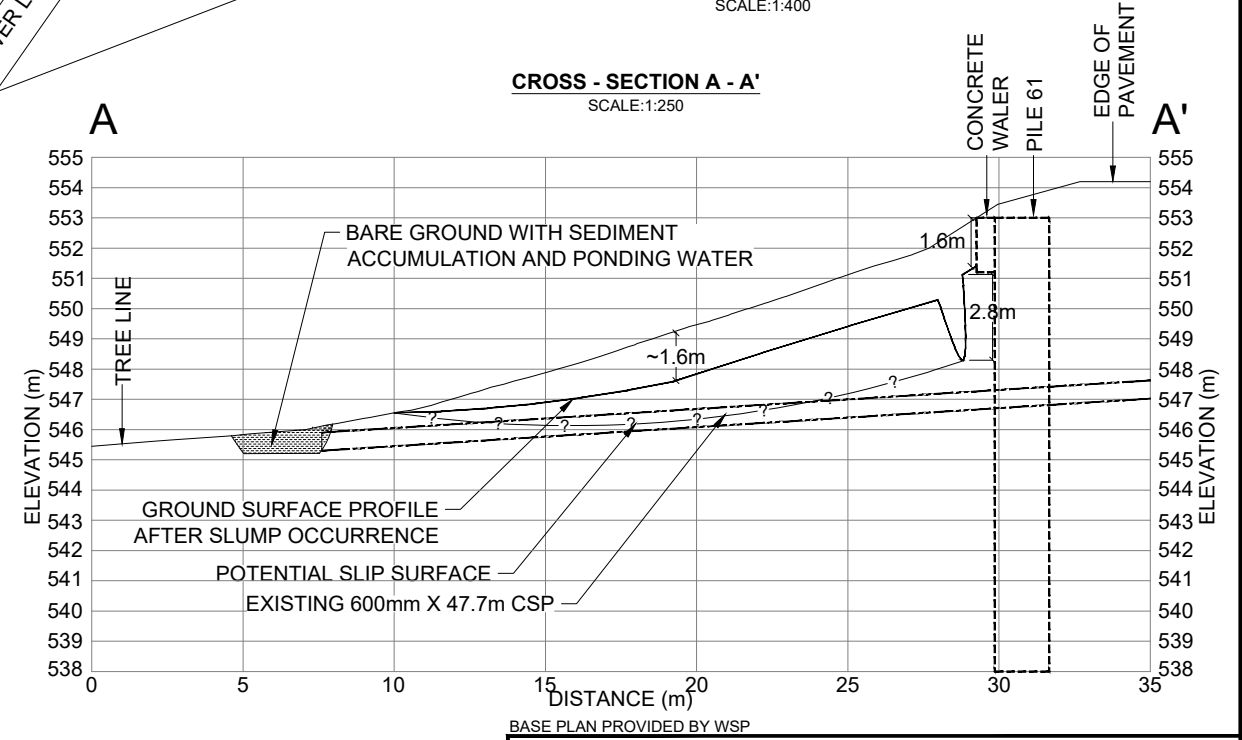
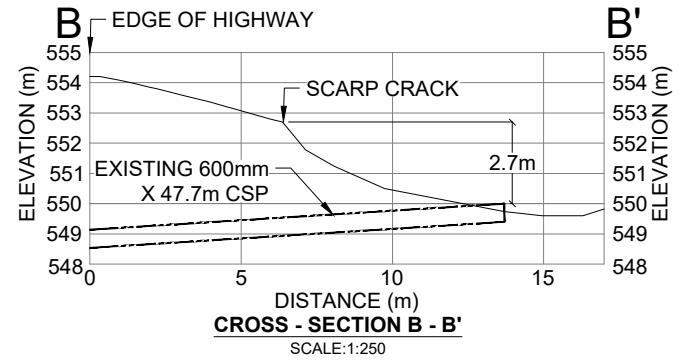
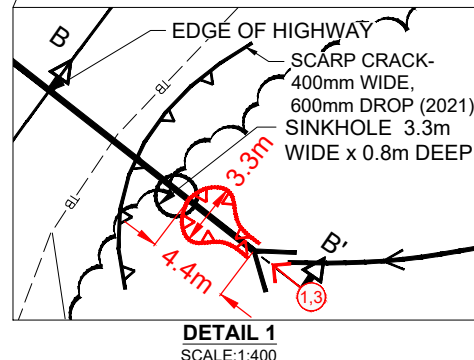
**FIGURE 1**

- NOTES:**
- JUNE 8, 2022 OBSERVATIONS ARE SHOWN IN RED.
  - CROSS - SECTION A - A' IS BASED ON APPROXIMATE FIELD MEASUREMENTS, MAY NOT REPRESENT THE ACTUAL PROFILE.
  - CULVERT IS LOCATED BETWEEN PILES P60 AND P61. THE CENTER TO CENTER SPACING BETWEEN THE CULVERT AND EACH OF THE PILES IS 1.5m.

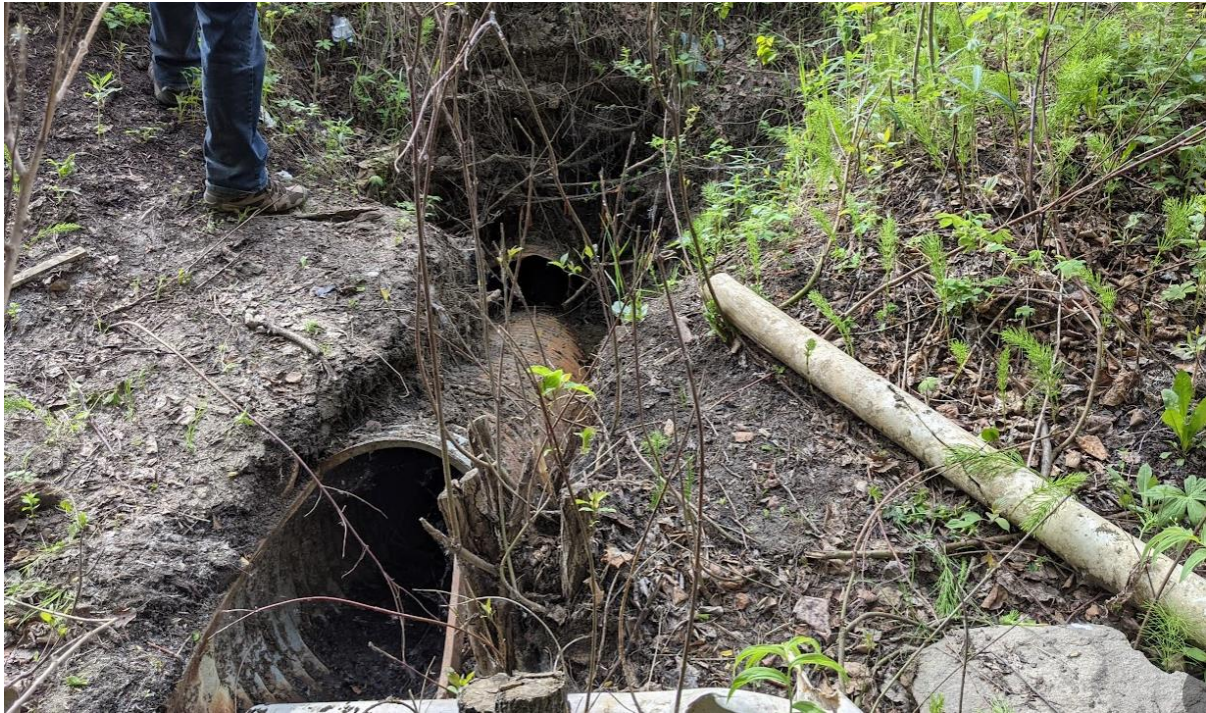
The sinkhole located on the east side of the highway also appears to have developed in response to the culvert separation at the inlet location. The existing scarp crack on the east side, currently located about 7 m from the edge of the road, of the highway may eventually retrogress back and impact the highway condition.

Photo No. 1 – 600 mm CSP culvert separated at 3 m from inlet. Note sinkhole developed above culvert separation

Prior to the design of the long-term repair measure, it is recommended that the toe of the embankment southeast slope at the inlet location be excavated to remove the broken and corroded floor sections of the culvert to allow further culvert inspection from the inlet side of the pipe.

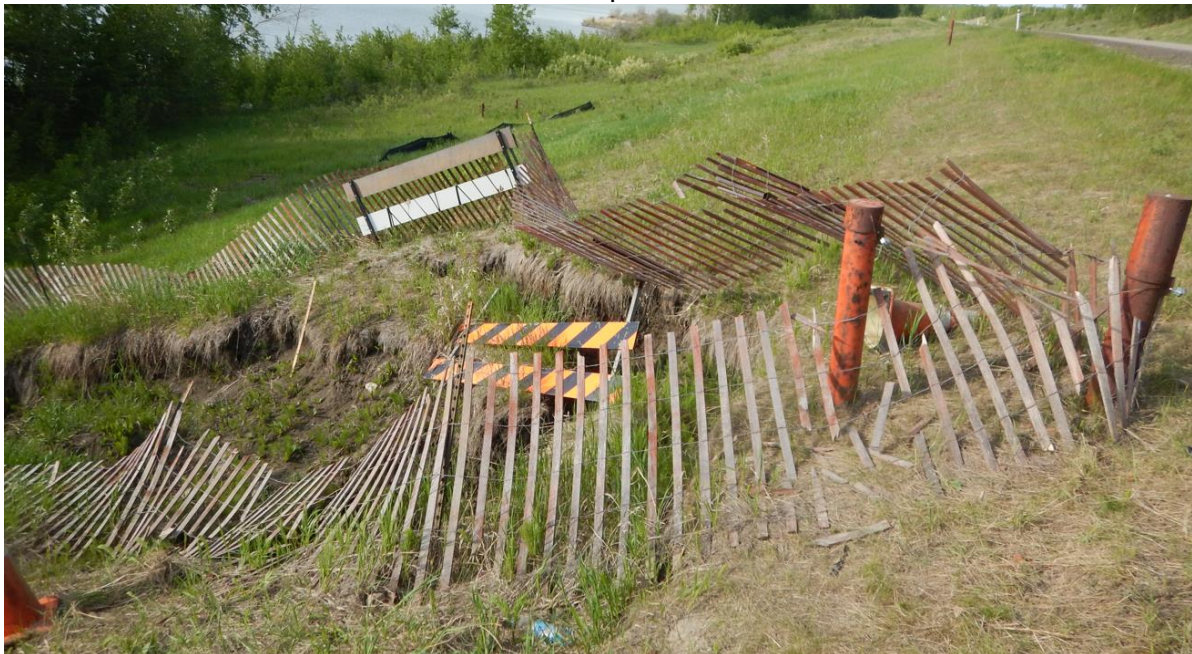
Photo No. 2 – Looking northeast at the observed slump downslope of the pile wall location. Snow fence collapsed due to ongoing movement of the slump.

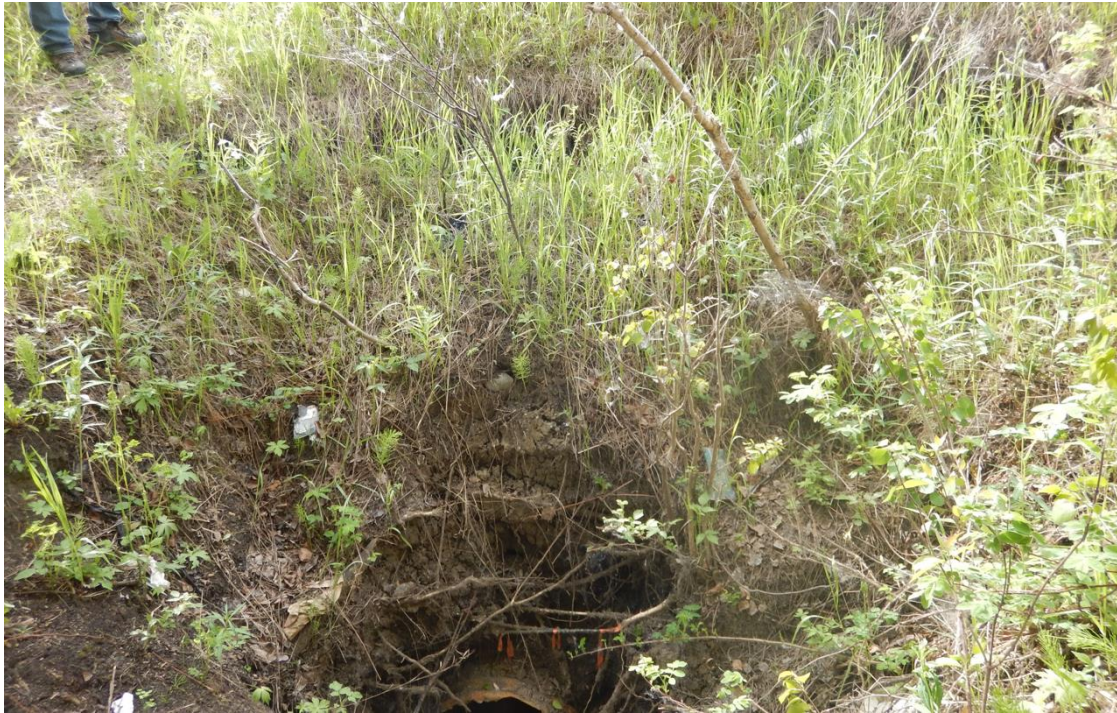
Photo No. 3 – Scarp crack above the culvert inlet (400 mm wide, 600 mm drop)

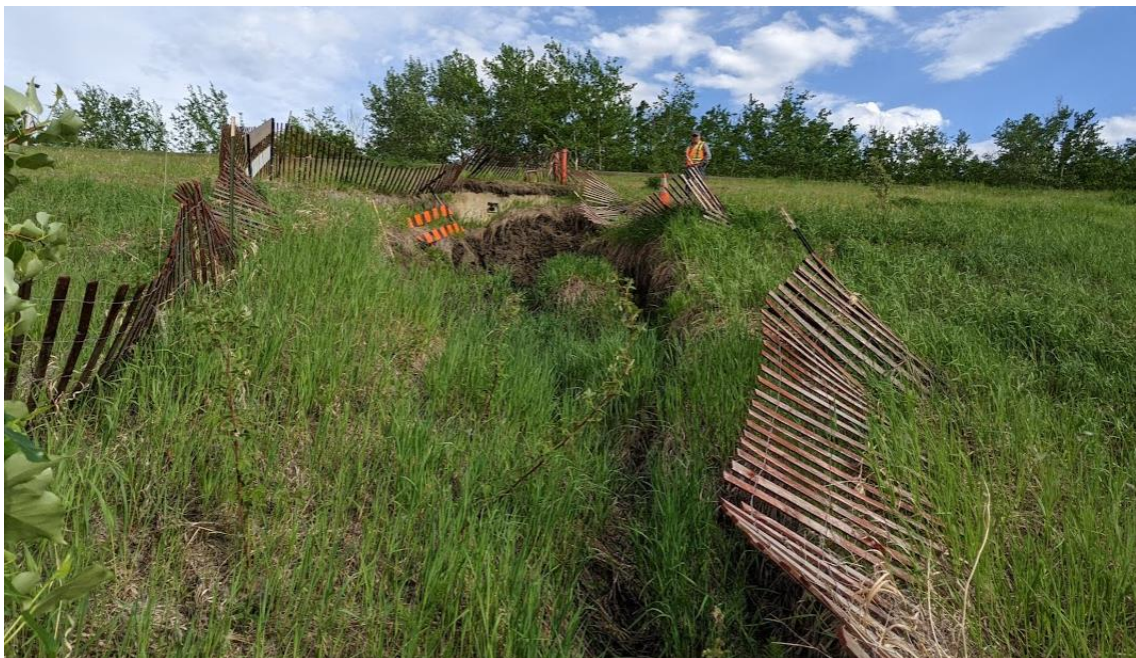
Photo No. 4 – Looking east at the head scarp crack of the slump. Slump area approximately is 1.4 m wider on each flank.

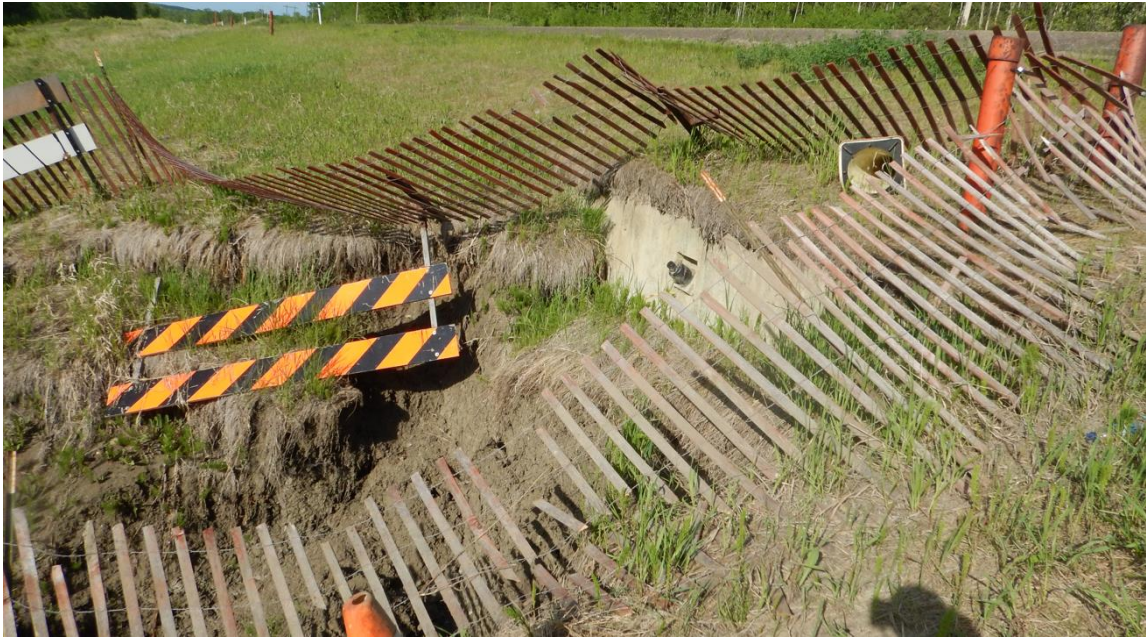
Photo No. 5 – Looking at the northeast flank of the slump; the slump exposed a 5 m long section of the concrete water

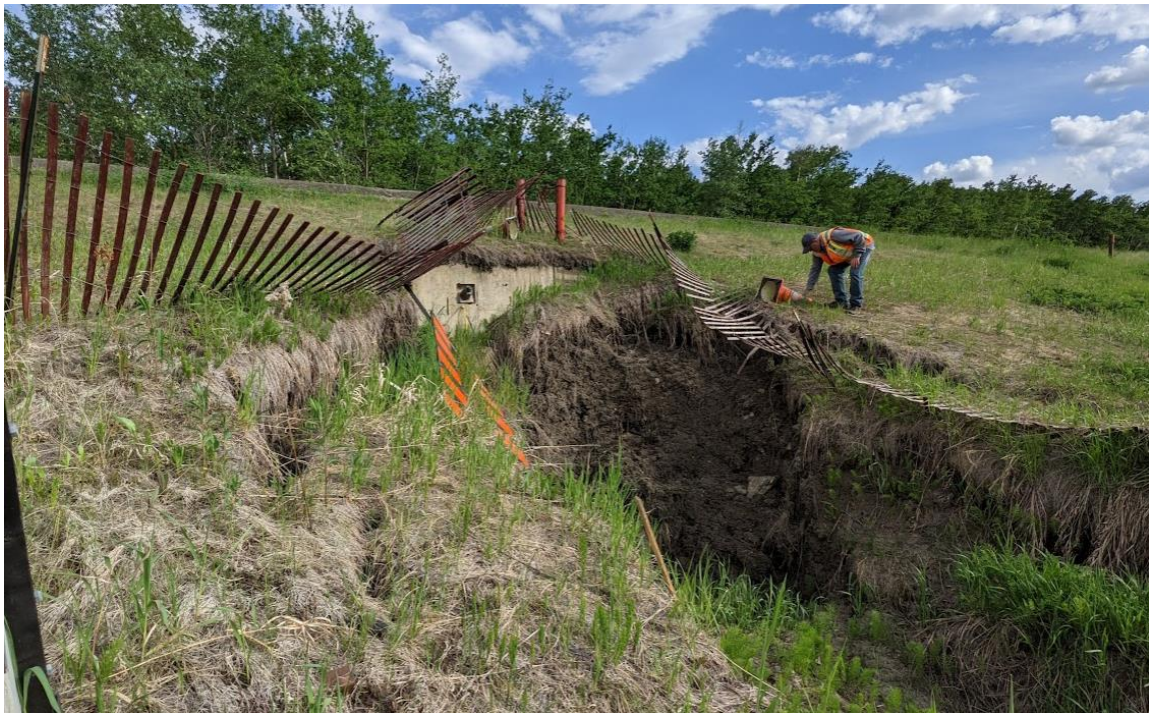
Phot No. 6 – Looking at southeast flank of the slump
