**ALBERTA TRANSPORTATION AND ECONOMIC CORRIDORS  
GEOHAZARD ASSESSMENT PROGRAM  
NORTH CENTRAL REGION – ATHABASCA &  
FORT MCMURRAY DISTRICTS  
2023 SITE INSPECTION**

Site Number	Location	Name	Hwy	km
NC103-2	Approximately 7.9 km north of Hwy 29 (North of Elk Point)	<b>KEHIWIN LAKE</b>	41:23	7.9
<b>Legal Description</b>		<b>UTM Co-ordinates (NAD 83)</b>		
9-25-58-07 W4		12 N 5988463.22	E	506745.73

**NC103-2: HWY41:23 KEHIWIN LAKE WEST SIDE  
SLOPE SLUMP (km 7.9)**

**FIGURE 1**

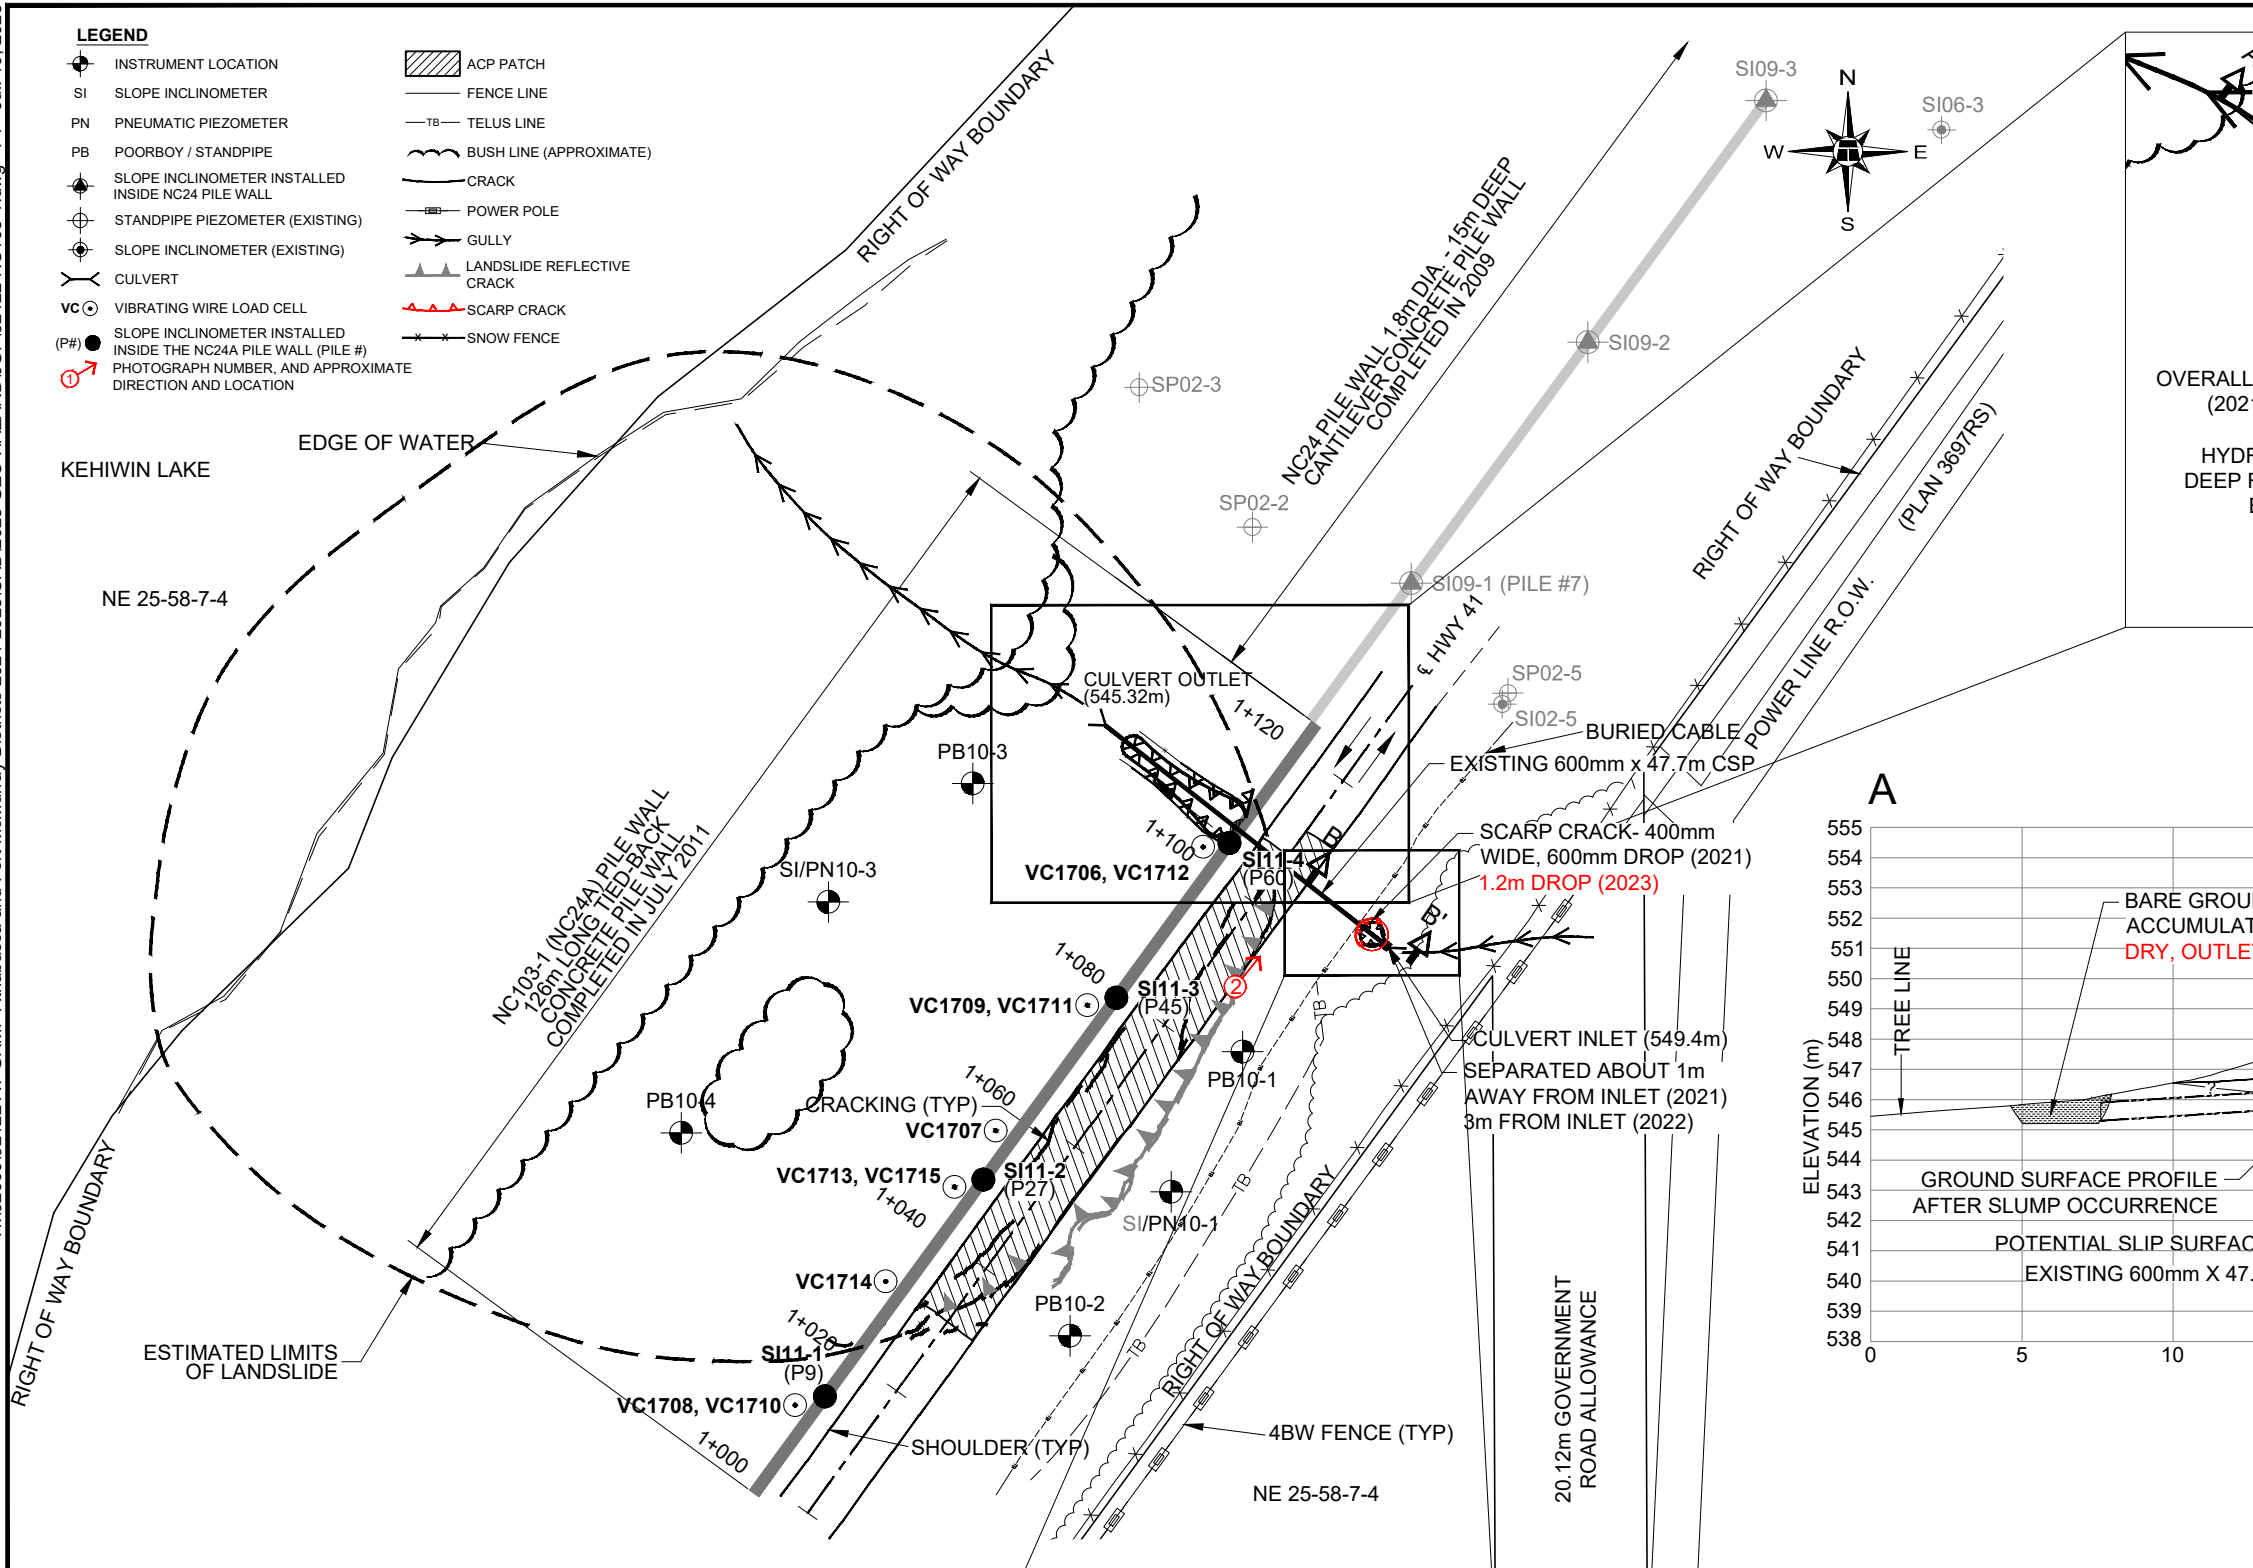
**SITE PLAN SHOWING SLUMP ABOVE THE 600mm CSP**  
SCALE:1:400

<b>Primary Site Issue</b>	<p>A slump on the west side of the highway downslope of the NC103-1 pile wall location. The slump occurred above an existing 600 mm CSP centre line culvert.</p> <p>A sinkhole developed on the east side of the highway above the 600 mm CSP centre line culvert inlet.</p>
<b>Dimensions:</b>	<p>The slump on the west side of the highway is approximately 5.5 m wide, 20 m long, and about 1.6 m deep below the original ground surface.</p> <p>The sinkhole on the east side of the highway is about 3.3 m wide 2 m deep.</p>
<b>Site History/Maintenance:</b>	<p>The slump occurred in a section of the highway that is known for multiple landslides that have been repaired by TEC using various configurations of pile walls on the west side of the highway. At the location of the west slump failure, a tied-back concrete pile wall was constructed in 2011 under TEC contract No. 11165. The pile wall consisted of 15 m deep, 1.8 m diameter concrete piles, connected at the top using a 1.8 m deep concrete waler. Two rows of 200 mm diameter grouted anchors, 22 m long, were installed within the waler to further restrain the wall movement.</p> <p>At the location of the side slope failure, a centre line culvert was present prior to the construction of the pie wall. Hydrovac excavation was completed prior to the installation of the pile wall to expose the 600 mm CSP culvert. The top of the culvert was at an approximate elevation of 547.3 m (~6 m below the top of waler). The pile spacing at the culvert location was 3 m (i.e., 1.2 m clear space between concrete piles).</p> <p>TEC noted that the slope failure occurred in 2019. The maintenance contractor attempted to expose the centre line culvert downslope of the</p>

<b>Observations:</b>	<b>Description</b>	<b>Worse?</b>
<input type="checkbox"/> Pavement Distress		<input type="checkbox"/>
<input checked="" type="checkbox"/> Slope Movement	Ongoing movement of the slump located on the west side of the highway caused the snow fence to collapse. The slump is about 1.6 m deep and 5 m wide.	<input checked="" type="checkbox"/>
<input checked="" type="checkbox"/> Erosion	The slump located near the culvert inlet is about 4.3 m wide, 5 m long, and 3.2 m deep	<input checked="" type="checkbox"/>
<input type="checkbox"/> Seepage		<input type="checkbox"/>
<input checked="" type="checkbox"/> Bridge/Culvert Distress	Culvert separated at about 3 m from the inlet. Centre line culvert is completely blocked at about 24.8 m from the culvert separation based on the 2023 CCTV inspection	<input checked="" type="checkbox"/>
<input type="checkbox"/> Other		<input type="checkbox"/>
<b>Instrumentation Readings (1 Slope Inclinator and 2 Piezometers):</b>

In the short term, the roadway surface should be monitored for the development of new cracks or extension of existing cracks. Any open cracks should be sealed to prevent further rise in ground water levels. Sharp shoulder signs should be erected to warn motorists of the hazard. If TEC is not planning to remediate this site soon, consideration should be given to placing guardrail to protect runaway vehicles from the existing hazard. The guardrail should extend a sufficient distance beyond the limits of the slump.

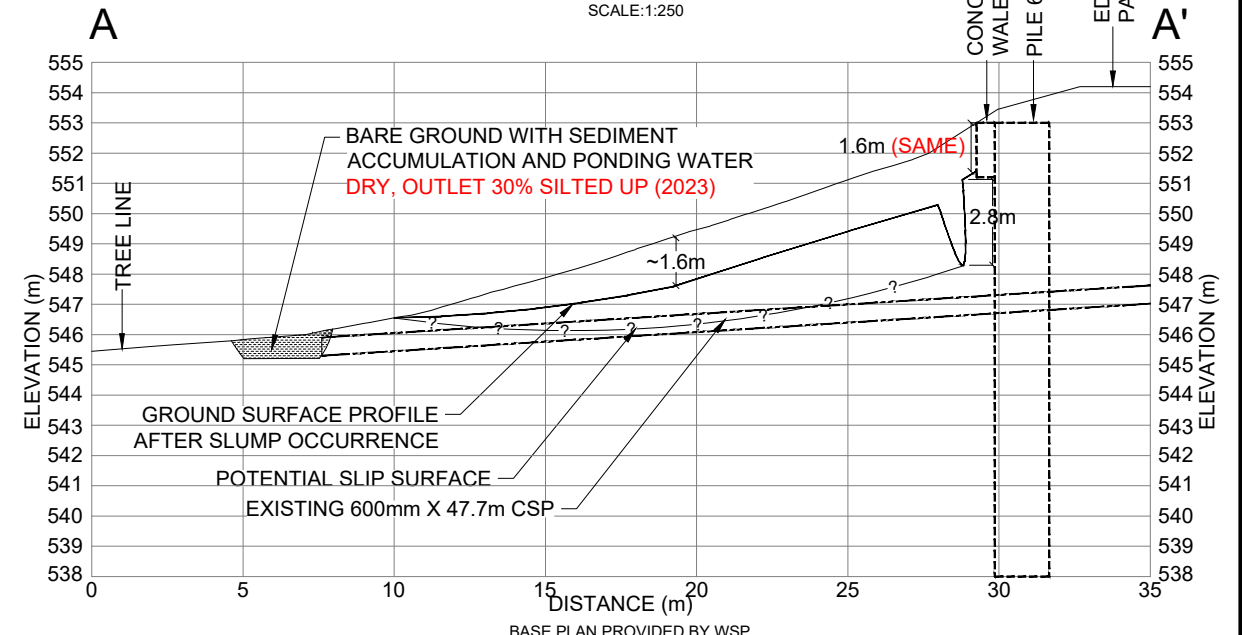
**CROSS - SECTION A - A'**  
SCALE:1:250

The depth of the waler is 1.8 m and the current drop in the ground surface along the face of the waler is about 1.6 m below the ground surface. The local MCI should frequently measure the drop along the face of the waler, and add minimal gravel wedge, as needed, to avoid exposure of the piles/gap below the underside of the waler.

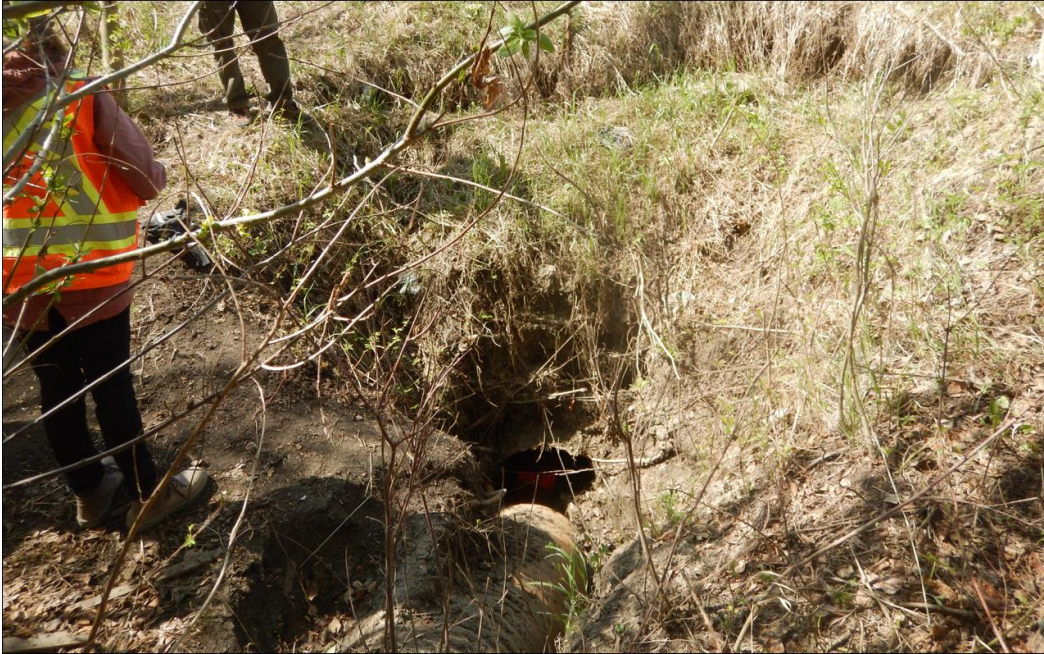
The sinkhole located on the east side of the highway also appears to have developed in response to the culvert separation at the inlet location. The back scarp of the slump, located above the culvert inlet location, is currently located about 7 m from the edge of the road and could eventually retrogress back and impact the highway condition.

**Photo No. 1 – 600 mm CSP culvert inlet got separated, resulting in a sinkhole and a slump at the bottom of the highway side slope.**

- excavate existing slump above the inlet location to remove damaged/corroded section of the pipe,
- install a liner from the inlet location (if feasible) to the break point location. Weld a piece of SWSP to the exposed end of the liner pipe, and extend the welded pipe section to the outlet location of the old culvert,

- backfill the east side slope with granular fill,
- place riprap at the at the culvert inlet and outlet locations; daylight the subdrain pipe at the culvert outlet riprap location, and

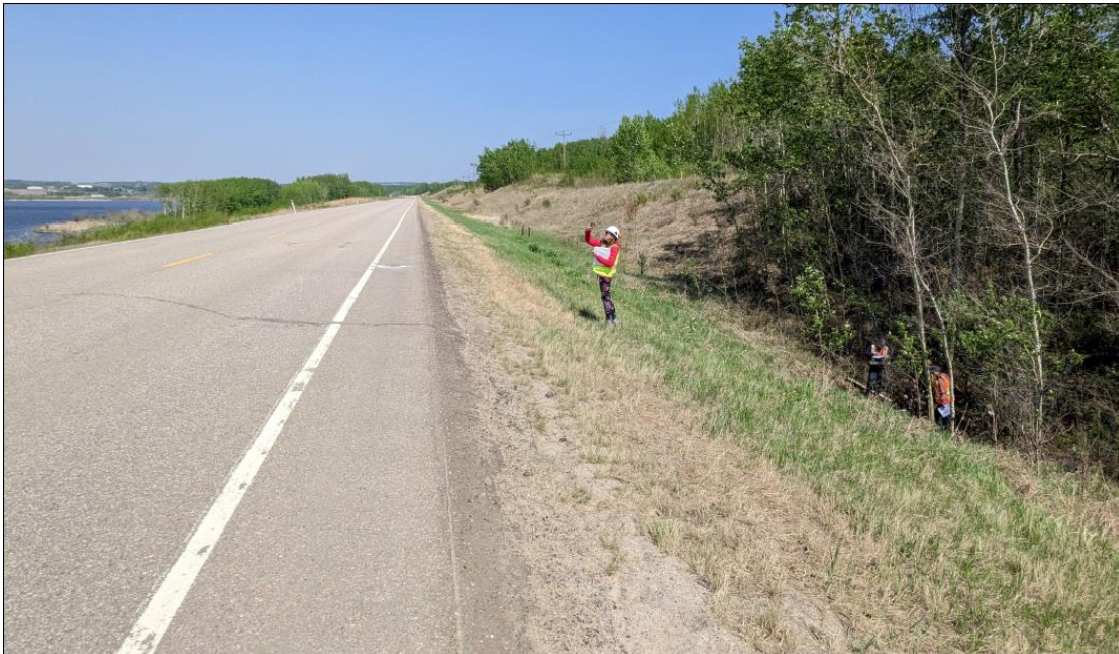
**Photo No. 2 – Looking at the highway southeast side slope upslope of the 600 mm CSP culvert inlet location**

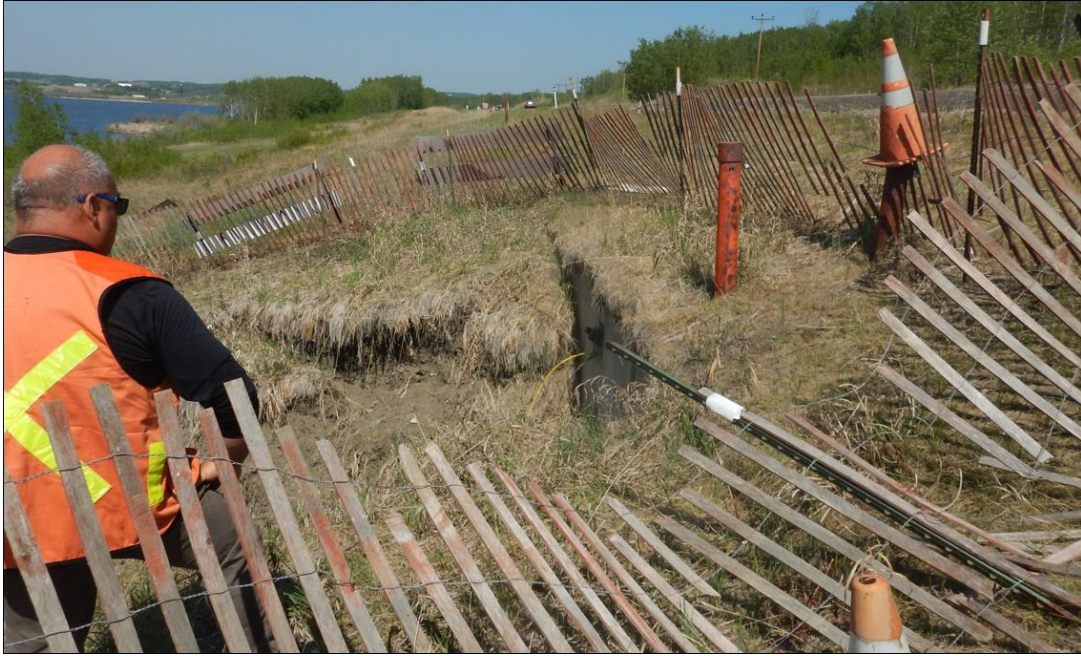
SI11-4 installed in Pile 60 adjacent to the slump on the west side of the highway did not show discernable movement in the spring 2023.		
The maximum groundwater level recorded at PB10-1 and PB10-3 was 3.6 m and 0.5 m, respectively.		
<b>Assessment:</b>		
The failure of the culvert is the main cause of the slump developed downslope of the pile wall location.		
In general, the existing culvert is old, rusted and may have surpassed its design life span. The 2022 and 2023 CCTV inspections of the culvert confirmed that (a) the culvert has collapsed approximately 16 m from the outlet location (i.e., the rupture is located on the west side of the pile wall) and (b) there are no elbows present along this culvert.		
Based on site observations and instrumentation results, the west side slope failure has not yet impacted the highway pavement surface condition, or the performance of the NC103-1 pile wall. The performance of the wall is not expected to be impacted since the design assumed complete loss of the downslope soil mass. However, the slump may become larger and deeper in the future, resulting in soil loss and formation of voids between the piles, and accordingly a dip or a sink hole on the highway surface.

**Photo No. 3 – Looking northeast at the slump downslope of the pile wall location**

- excavate the west side slope to remove wet slump material and expose the broken section of the pipe; the use of a trench box or an alternative supporting excavation method is highly suggested to minimize the size of excavation and to avoid disturbing the soil below the underside of the waler,

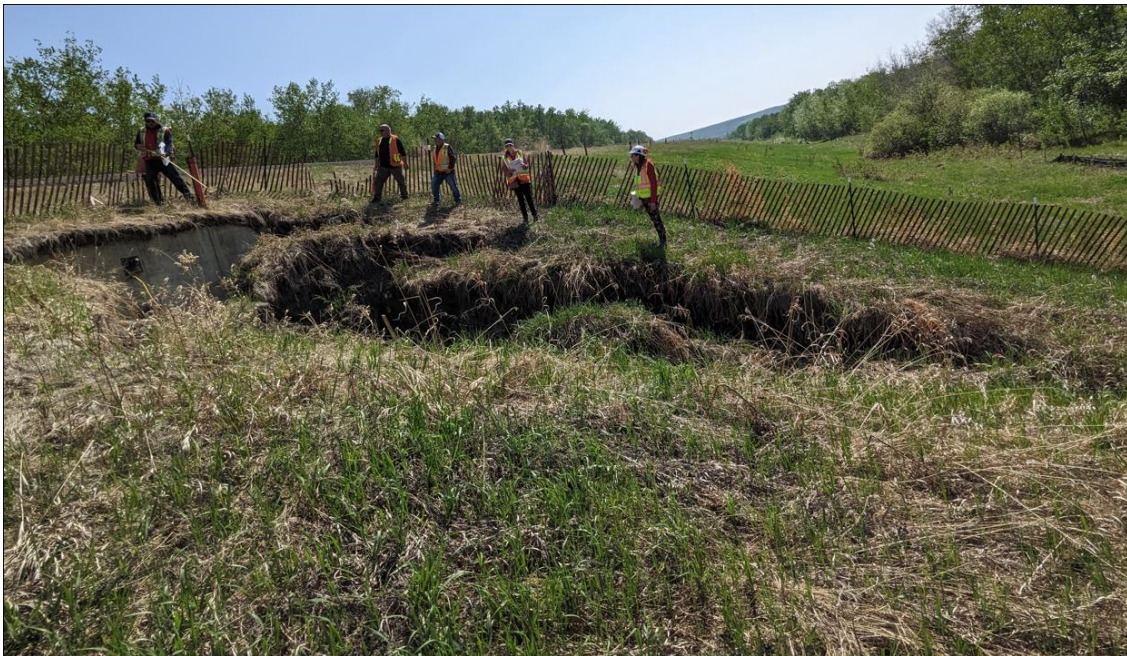
**Photo No. 4 – Looking south at the slump downslope of the pile wall location**

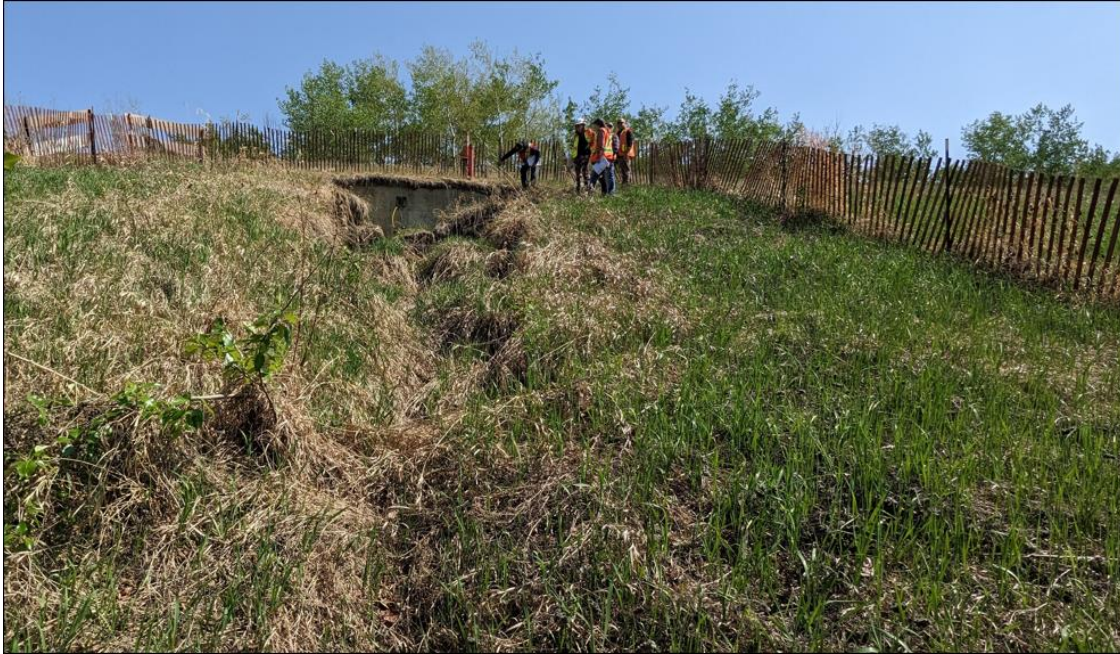
**Photo No. 5 – Looking southeast at the head scarp crack of the slump; the slump exposed the waler and a couple of anchor caps.**

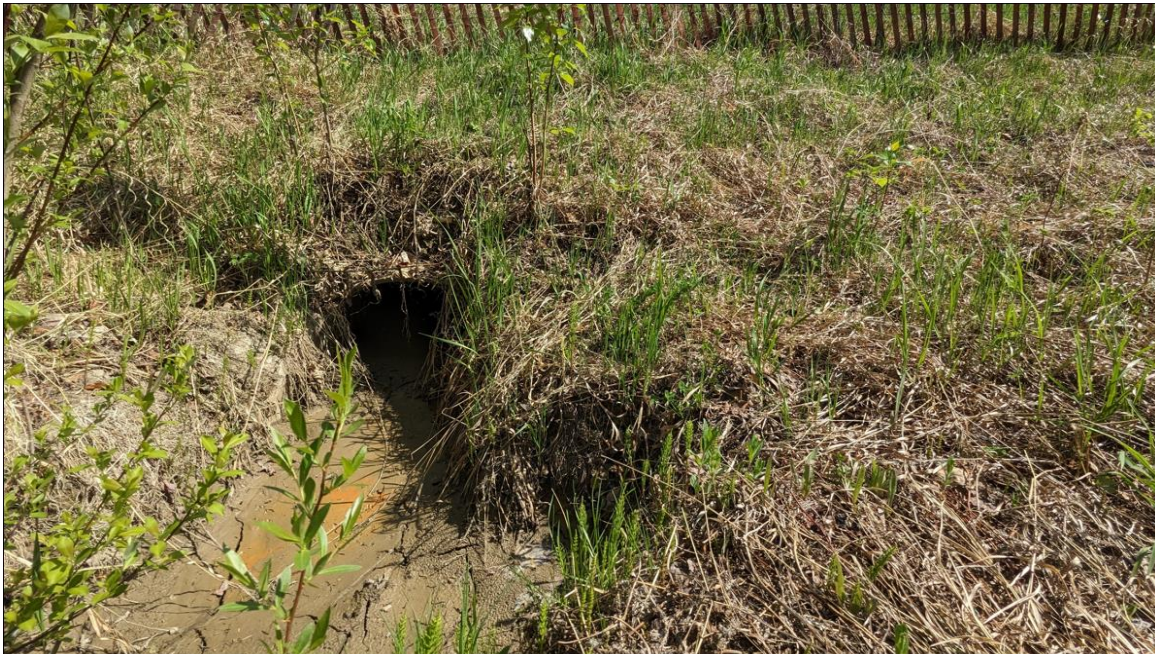
**Photo No. 6 – Culvert outlet partially filled with sediment. No flow observed in 2023.**
